CORROSION OF ALLOY 22 AND TITANIUM ALLOYS UNDER SEEPAGE WATER DRIPPING CONDITION

**U.S. Nuclear Regulatory Commission
Contract NRC-02-07-006**

**¹Center for Nuclear Waste Regulatory Analyses
San Antonio, Texas**

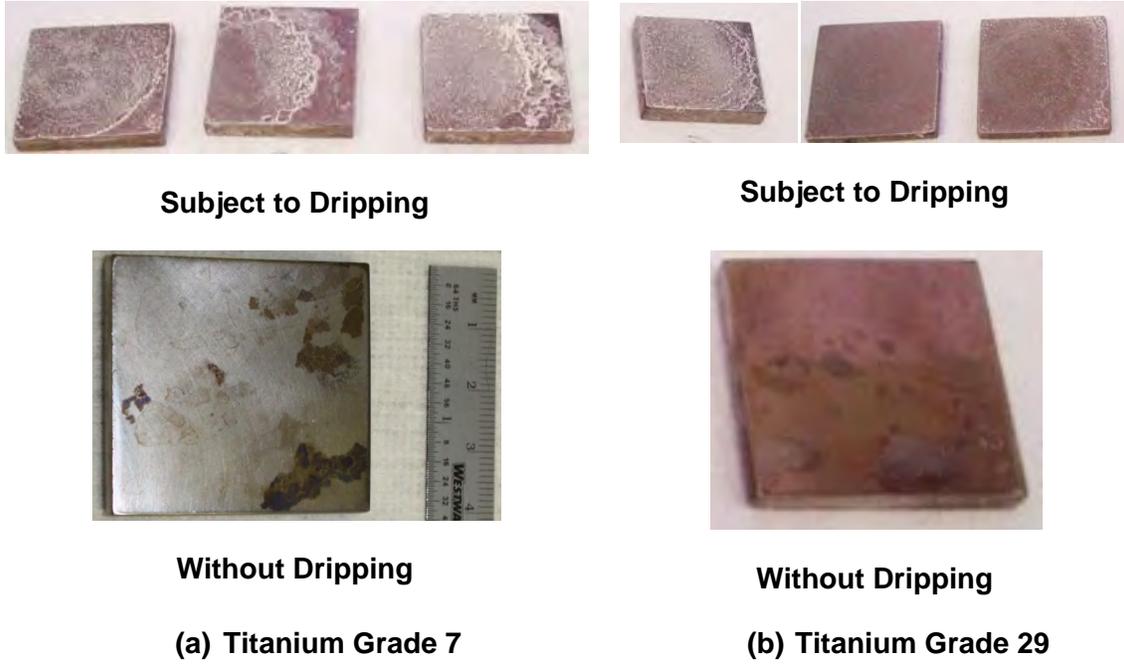
Figure 3-20. Second Batch of Posttest (a) Titanium Grade 7 and (b) Titanium Grade 29 Specimens at Temperature of 95 °C [203 °F] and Relative Humidity of 75 Percent

The second batch of tests was terminated after 64 days. Figure 3-20 shows the posttest specimens. The specimens subject to dripping were covered with white deposits. EDS shows that the chemical composition is similar to that from the first batch of tests. The specimens without dripping showed some stains on the surface. Table 3-7 summarizes the weights before and after the test, the weight loss, and corrosion rates. All the specimens showed weight gain after the test because of the deposits and scales formed on the surface. After the first HCl cleaning, all the specimens subject to dripping still showed weight gain compared to the original
