# PWSCC/LPSCC in PWRs (+ Steam Generator Corrosion)

# PWSCC/LPSCC Learning Objectives

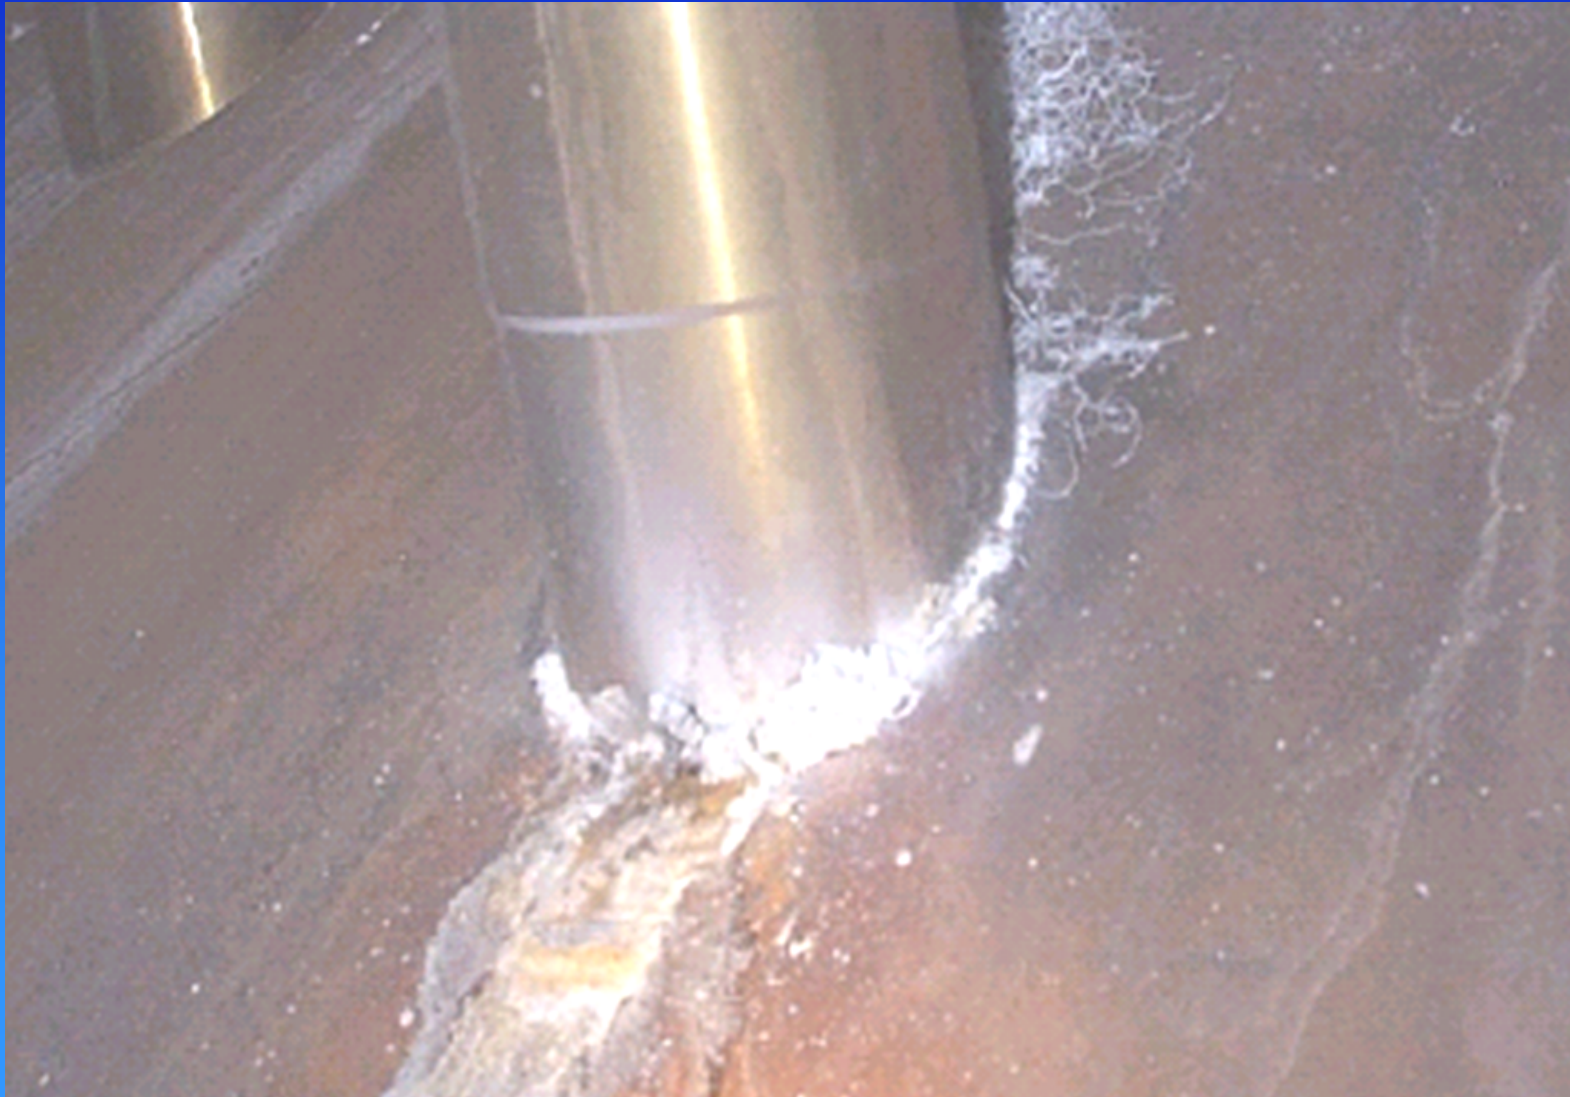
# Leaking CRDM Nozzle at Oconee Unit 3

- Visual inspection reactor vessel head 2/01 showed boric acid deposits around nine CRDM nozzles (# 3, 7, 11, 23, 28, 34, 50, 56 and 63)
- PT of underside of the head on each of the 9 suspected leaking nozzles revealed multiple rejectable indications on each nozzle
- ET of 9 leaking nozzles indicated clusters of shallow axial cracks located either above the weld or below the weld, or, in some cases, both
- Nozzles 50 and 56 had non-typical clusters above the weld with circumferential cracks extending 165° around the nozzle

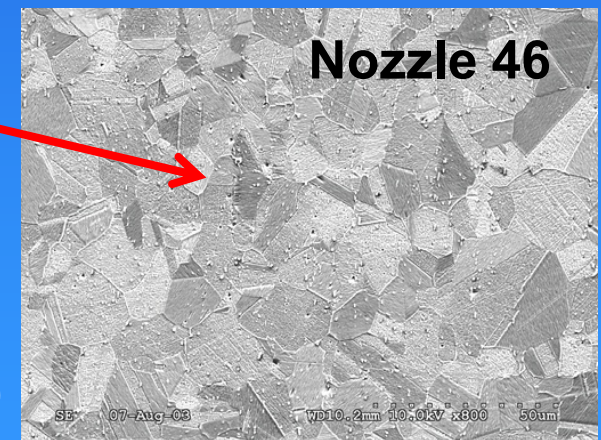
- 1<sup>st</sup> reported PWSCC in Alloy 600 BMI nozzles located at the reactor vessel bottom head
  - ♦ Alloy 182 J-groove welds at the reactor vessel inlet temperature ( $T_{\text{cold}}$ ) of 293°C (560°F)
- PWSCC contributing factors:
  - ♦ Intragranular carbides with little carbide coverage on the grain boundaries
  - ♦ Very fine grain size
  - ♦ High bulk yield strength
  - ♦ Cold-worked ID surface
  - ♦ High residual stresses (no PWHT)

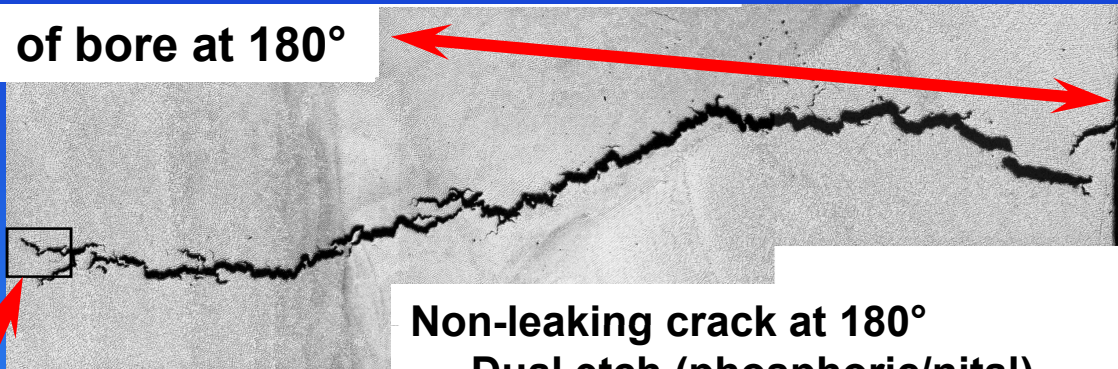
Non-leaking crack at 180°  
Dual etch (phosphoric/nital)

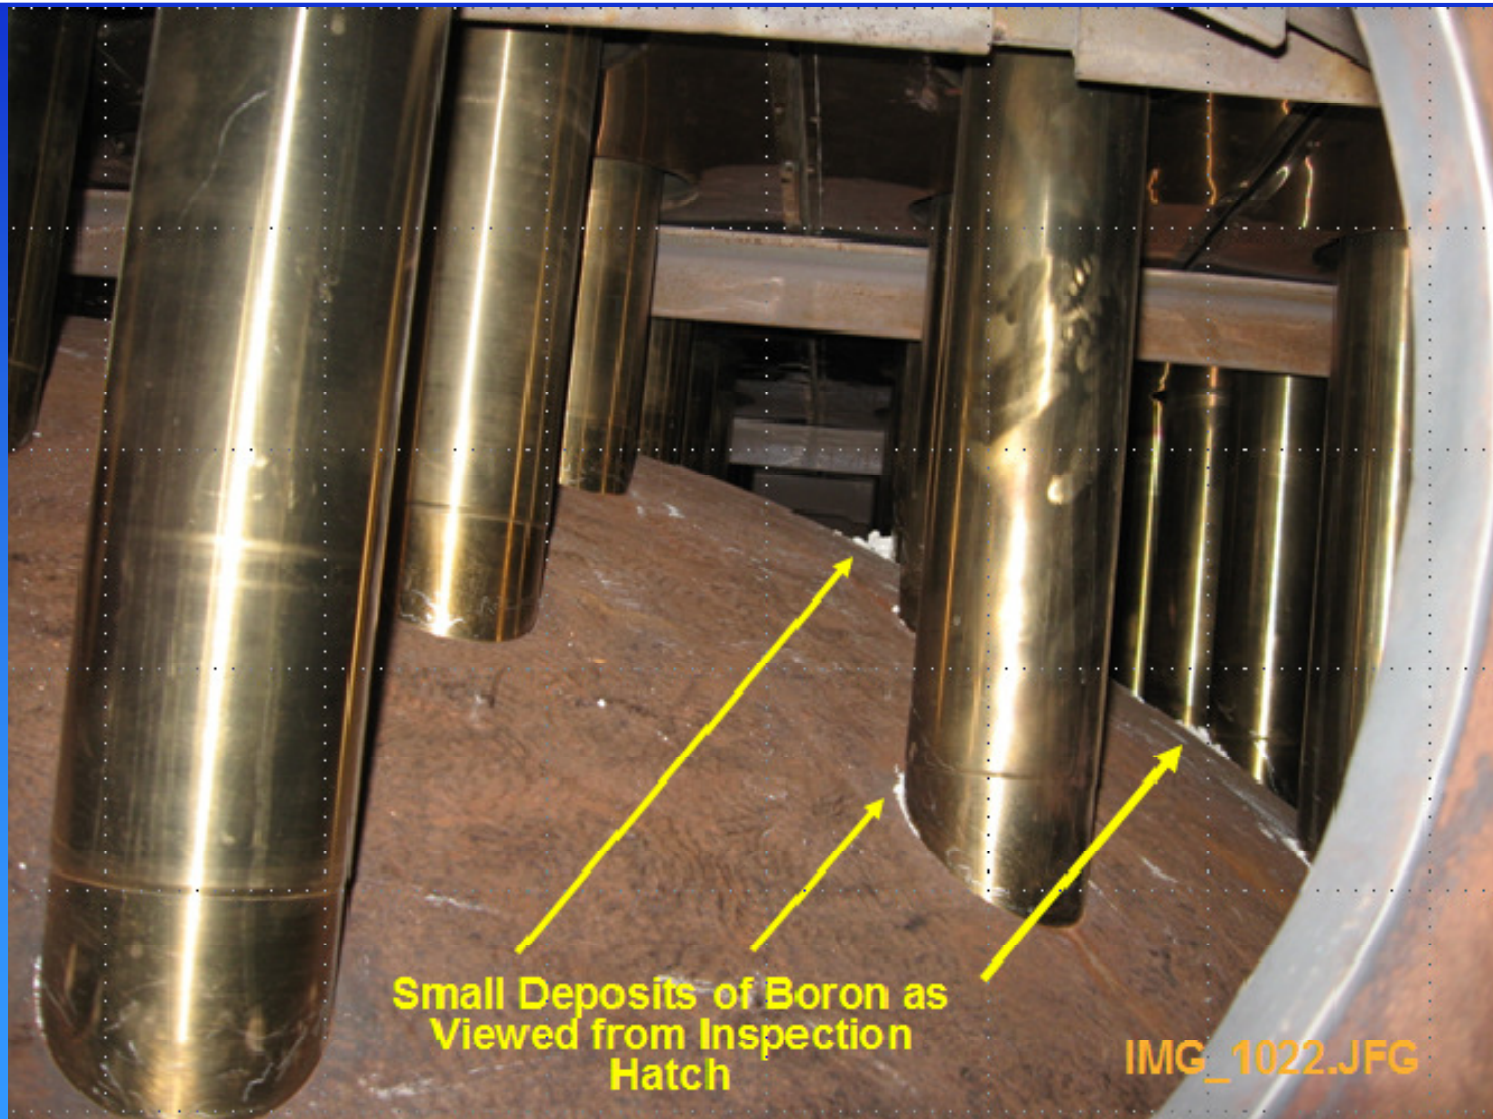
# 2010 Davis-Besse Inspection Results

- Bare metal visual inspections performed:
  - ♦ 2003, 2005, 2006 and 2008 with no identifiable boron leakage
- March 12, 2010 – Identified indications in CRDM penetration nozzles during axial UT scans – initiated 8 hour report to the NRC
- March 13, 2010 - Bare metal visual examinations reveal boron deposits on the RVH – updated 8 hour report to the NRC

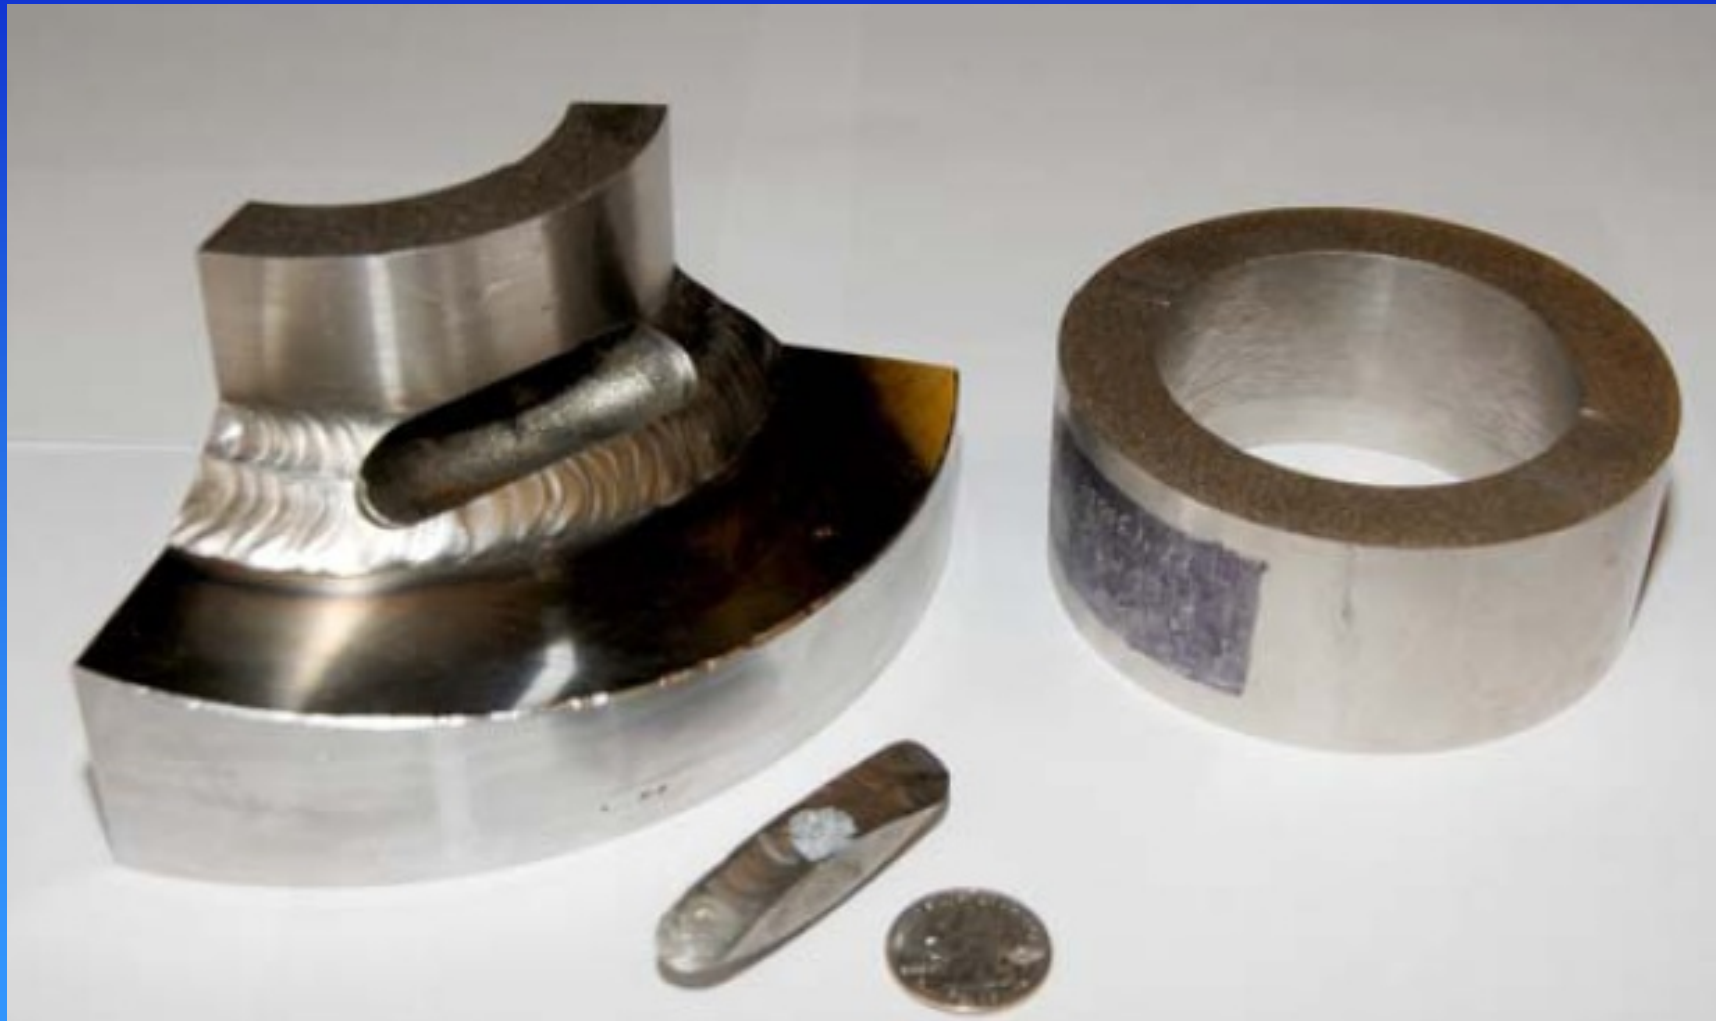
# Davis-Besse Boat and Ring Specimens

- 24 of 69 nozzles identified for modification
- Samples taken of weld and nozzle metal for lab analysis
  - ♦ Indications cut out of nozzles 4 and 10 for analysis
  - ♦ Nozzle 4 and 10 ends removed for lab analysis

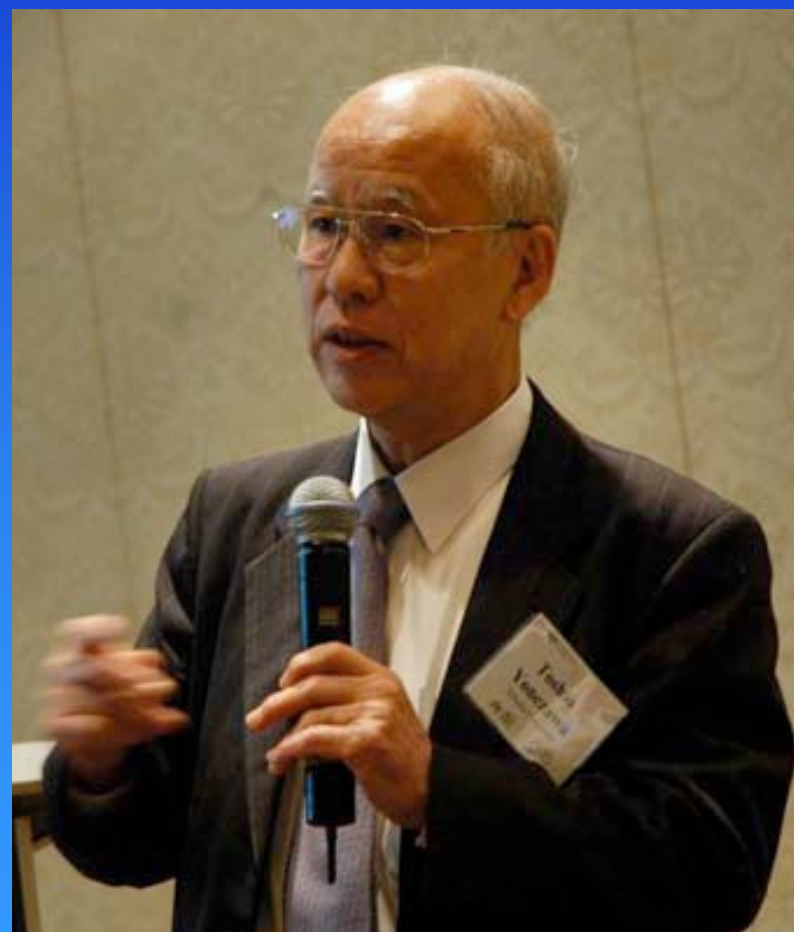
Old data suggests that Alloy 600 with 14-17% Cr is good stuff!

T. Yonezawa, et, al., JAIF 1988

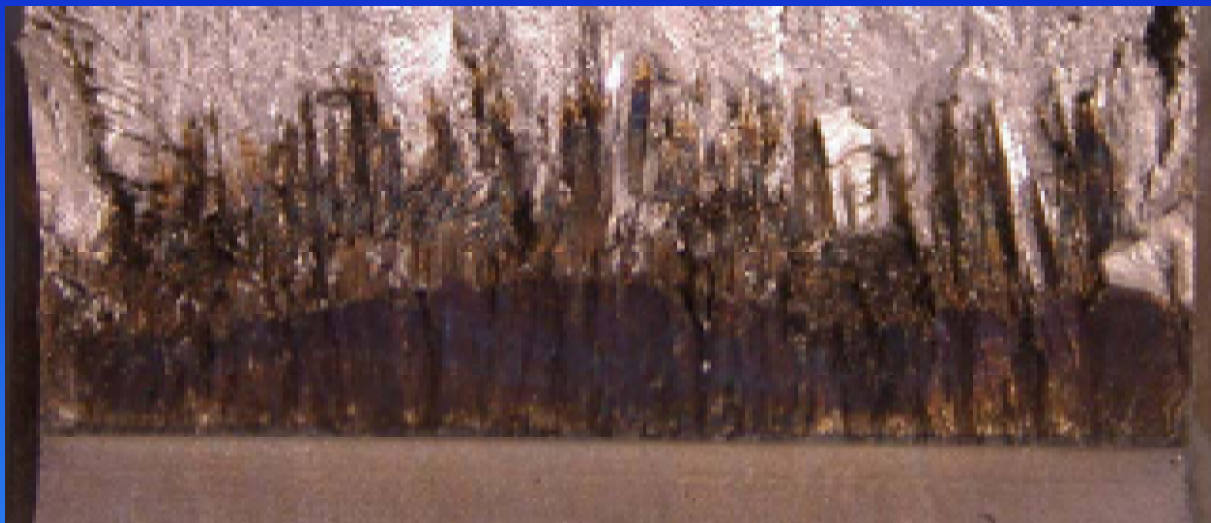
c385, 10.4 cc/kg H<sub>2</sub>  
– more crack  
advance

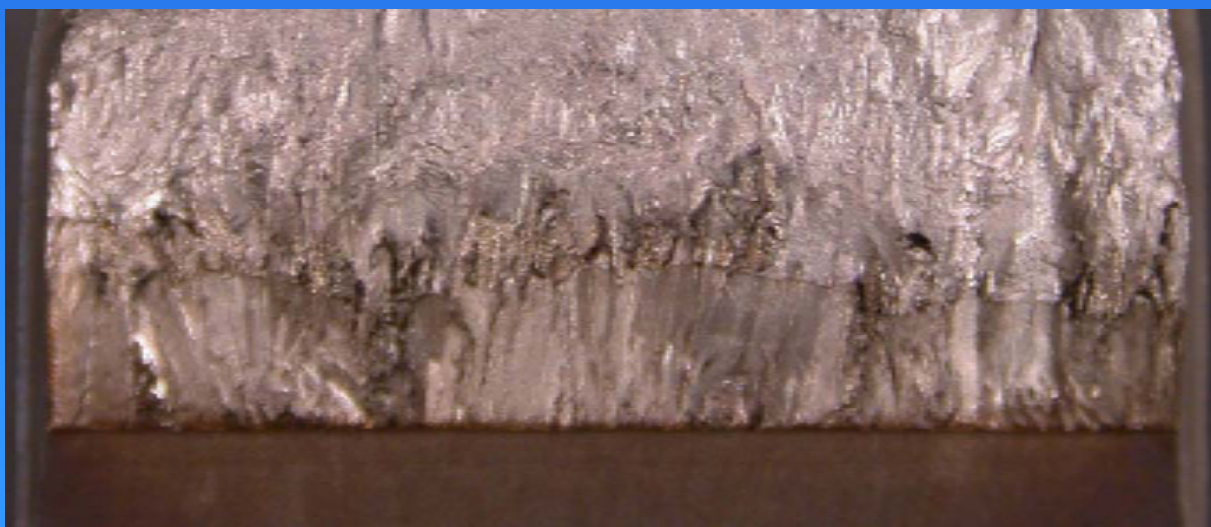
c386, 80 cc/kg H<sub>2</sub> –  
less crack  
advance  
(Note Ni-metal  
stability gives shiny  
fracture surface)
