## 4 Validation Testing and Round-Robin SCC Crack-Growth Rate Testing

## 5 SCC Crack-Growth-Rate Testing of Alloy 690 and Its Weld Metals

Pacific Northwest National Laboratory Investigation of Stress Corrosion Cracking in Nickel-Base Alloys, Volume 1

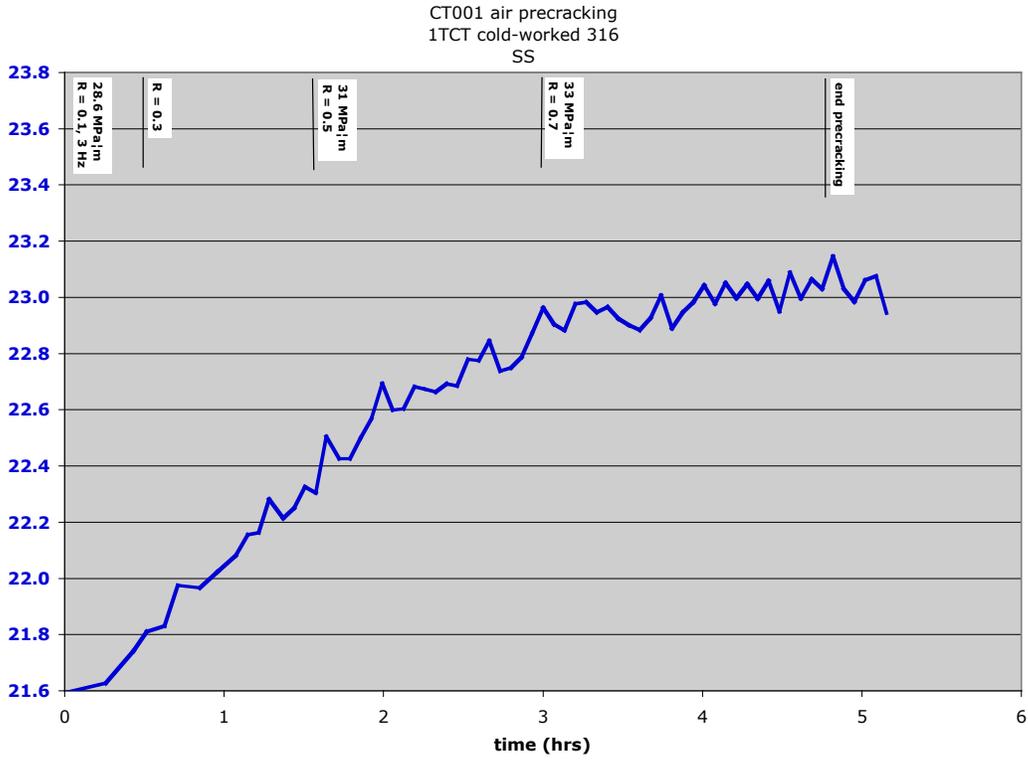
**Figure 4-1 Pre-Cracking Response for CW316SS Sample CT001**

The first test was on a 1T CT sample from 316SS heat #1 with no side grooves. This sample was air pre-cracked prior to being inserted into the autoclave. The reason for pre-cracking ex-situ was to get some hands-on experience with running the servohydraulic machine using the GEG software. The pre-cracking curve is shown in Figure 4.1. The pre-cracking steps shown along the top of the plot are more aggressive than what is usually done, but still illustrate the pre-cracking progression. The dcPd data for this exercise were extremely noisy, and the issue that was causing the noise has since been determined and corrected. After air pre-cracking, the sample was loaded into System #1 for SCC testing.

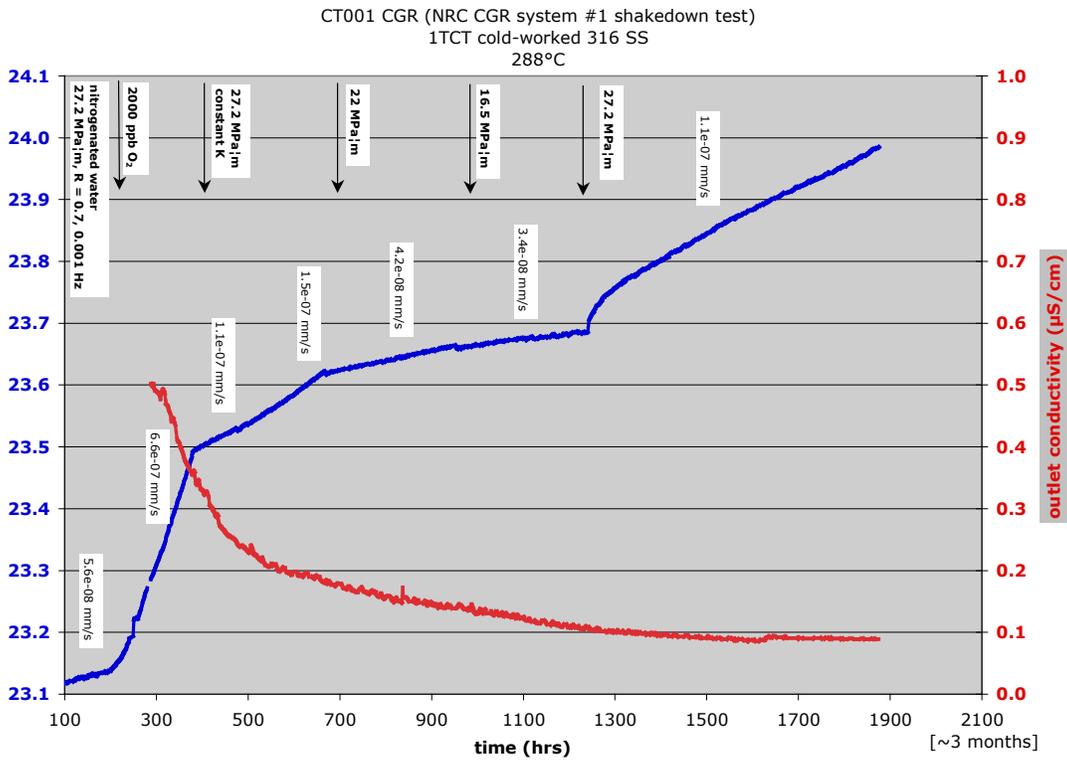
**Figure 4-2 Overall SCC Crack-Growth Response for CW316SS in Test CT001**

The overall crack growth curve in BWR oxidizing water (288°C/550°F, 2000 ppb O<sub>2</sub>) is shown in Figure 4.2. As part of the process of learning about the operation of the equipment, the goal of this test was to look at the effect of different K values on the propagation rate. Testing was performed at three different K values, and at each successively lower K, the CGR rate dropped as demonstrated in Figure 4.2. Conventional theory states that there is a threshold K value below which SCC will cease, but that K value was not reached in this test. After running through the decreasing K values, the K value was then increased back up to the starting value, and the resulting CGR increased back up to the value ( $1.1 \times 10^{-7}$  mm/s) observed previously. From this series of K changes, we were able to observe corresponding reductions in SCC propagation rates and then reestablish the original CGR at higher K. The ability to obtain reproducible CGR response under identical conditions is a key aspect for determining quantitative SCC behavior.

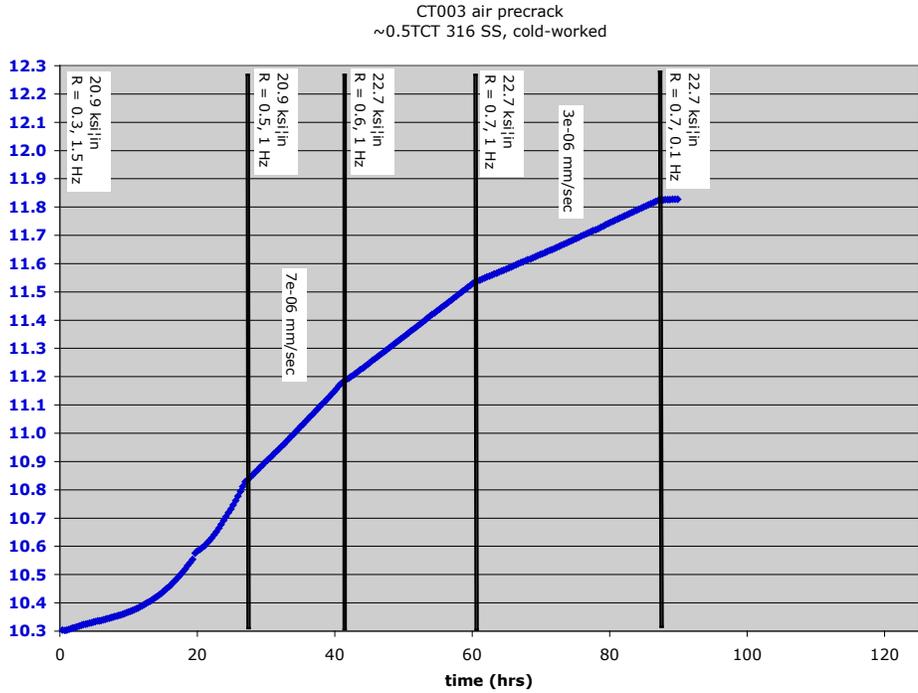
**Figure 4-3 Air Pre-Cracking of Sample CT003**

The next validation test was to observe the crack growth response of a pair of CW316SS (heat #2) samples in series in System #2. This goal was to demonstrate that we can evaluate samples in series and also to show the ability to apply HWC to reduce the CGR in BWR conditions. For reasons described previously, the two samples were pre-cracked in air prior to being loaded into the autoclave. The pre-cracking curves for CT003 and CT004 are shown in Figures 4.3 and 4.4, respectively. The pre-cracking for CT004 initially started at 20 MPa√m (18.2 ksi√in), but after no increase in crack length was observed after 22 hrs,  $K_{max}$  was increased slightly to 22.5 MPa√m (20.5 ksi√in), which immediately caused a crack to begin growing. Pre-cracking of CT003 was then started at 22.5 MPa√m.

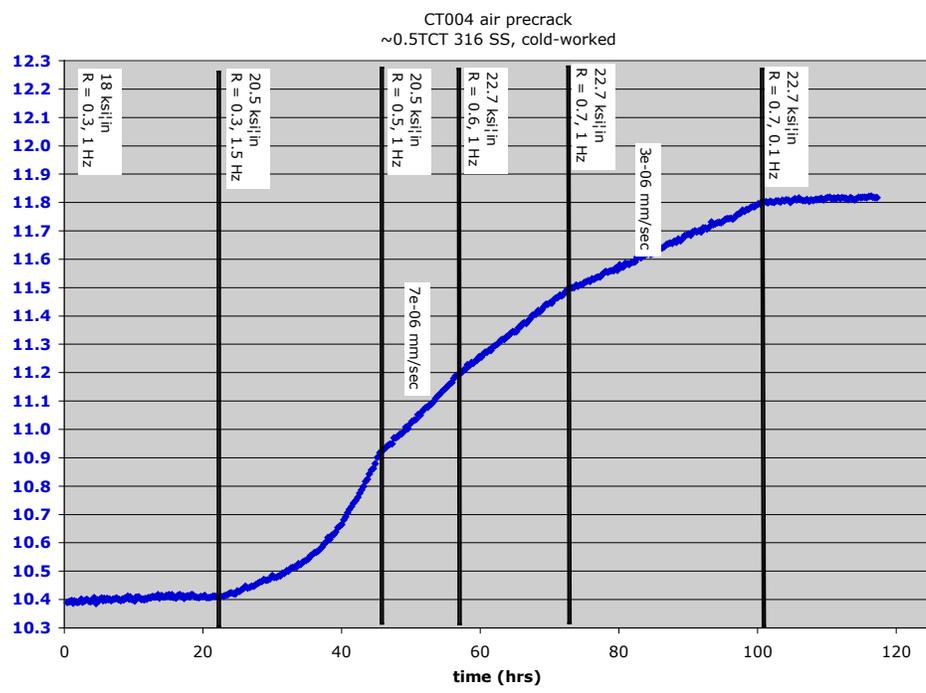
**Figure 4-4 Air Pre-Cracking of Sample CT004**

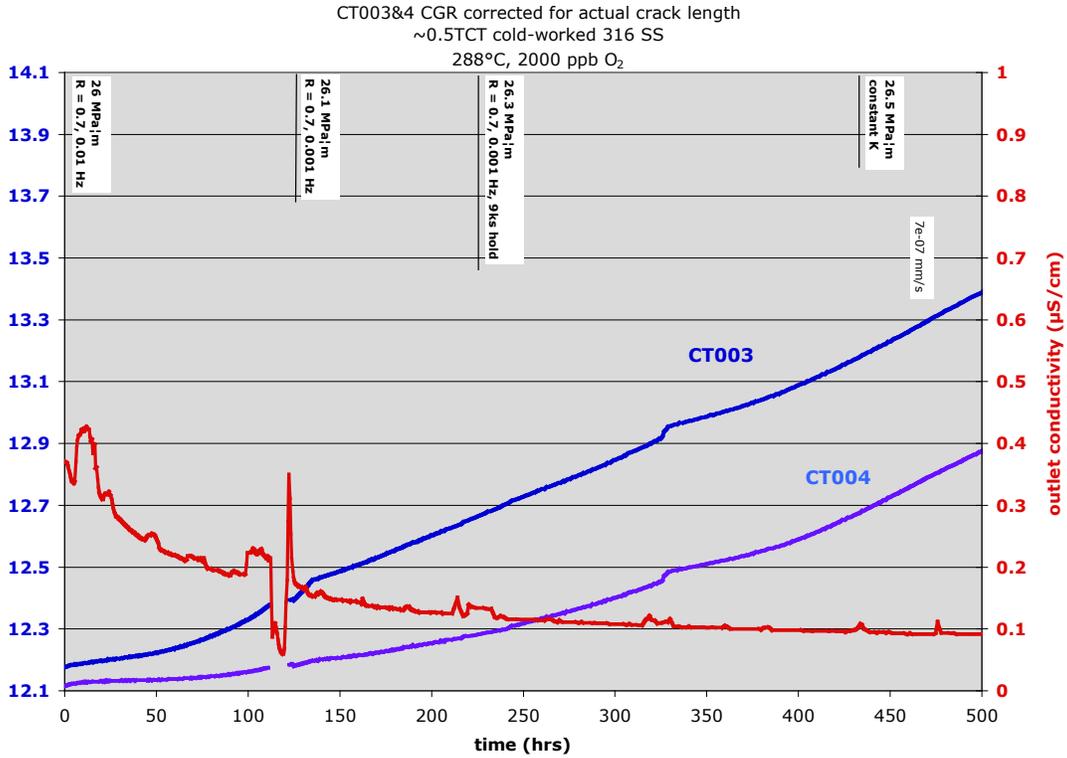
**Figure 4-5 Crack-Transitioning Steps for Samples CT003 and CT004 Tested in Series**

Testing in high-temperature water again began with BWR oxidizing conditions (288°C/550°F, 2000 ppb O<sub>2</sub>). The first phase of the test was to transition from a TG fatigue crack to an intergranular (IG) stress corrosion crack by slowly decreasing the cycle rate and adding a hold time prior to constant K. This response is shown in Figure 4.5. After transitioning to a constant K value of 25 MPa√m (corrected value of 26.5 MPa√m or 24.1 ksi√in), the CGR of both samples settled at  $\sim 4.5 \times 10^{-7}$  mm/s which is typical for a CW316SS in oxidizing water. The next steps in the test were to switch back and forth between normal water chemistry (NWC) and HWC conditions. Under both phases of HWC conditions, the CGR of the samples decreased by  $\sim 100X$  to a rate of approximately  $3 \times 10^{-9}$  mm/s as documented in Figure 4.6.<sup>(a)</sup> When returning to NWC conditions, the CGRs increased back to the original NWC value of  $4.5 \times 10^{-7}$  mm/s. Thus, we were able to produce repeatable behavior on two specimens in series and show that the PNNL test systems produce the expected crack-growth response of 316SS under both BWR oxidizing and HWC conditions.

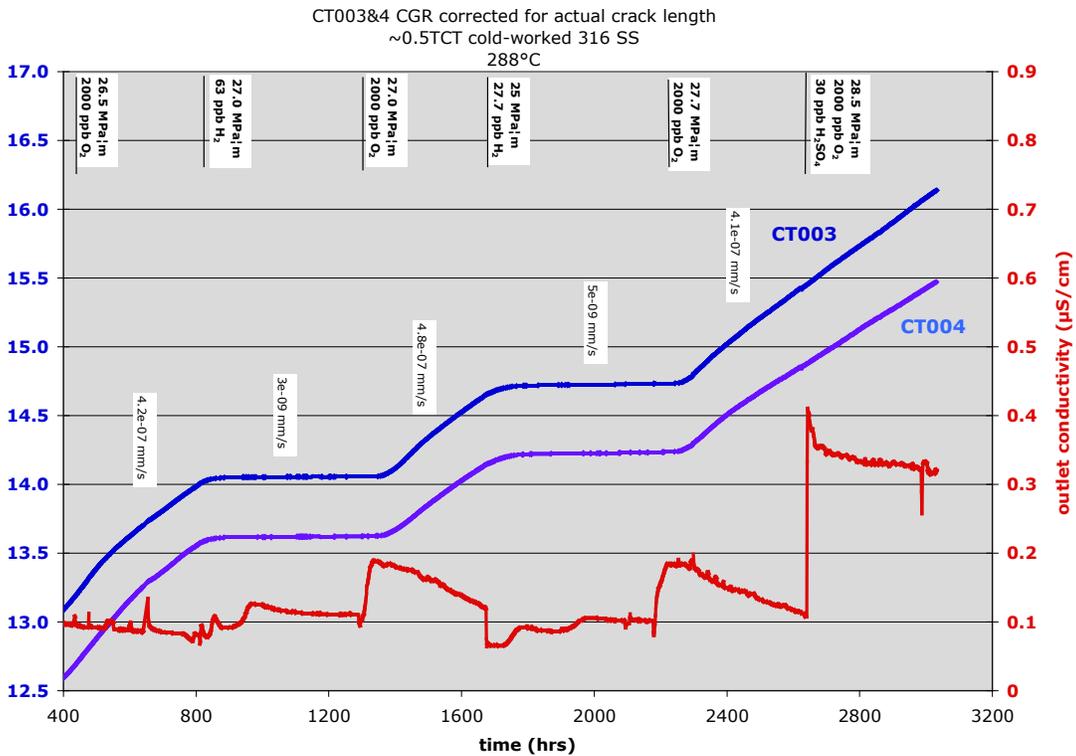
**Figure 4-6 Overview of SCC CGR Response under Constant K Condition Switching from BWR Oxidizing to BWR HWC for CT003 and CT004 Tested in Series**

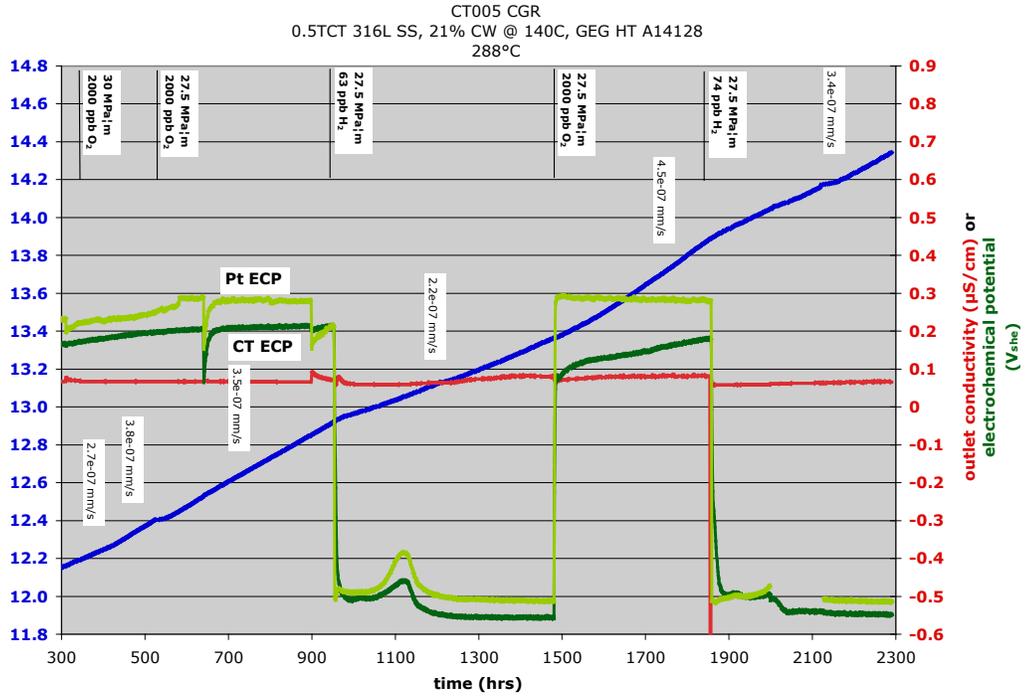
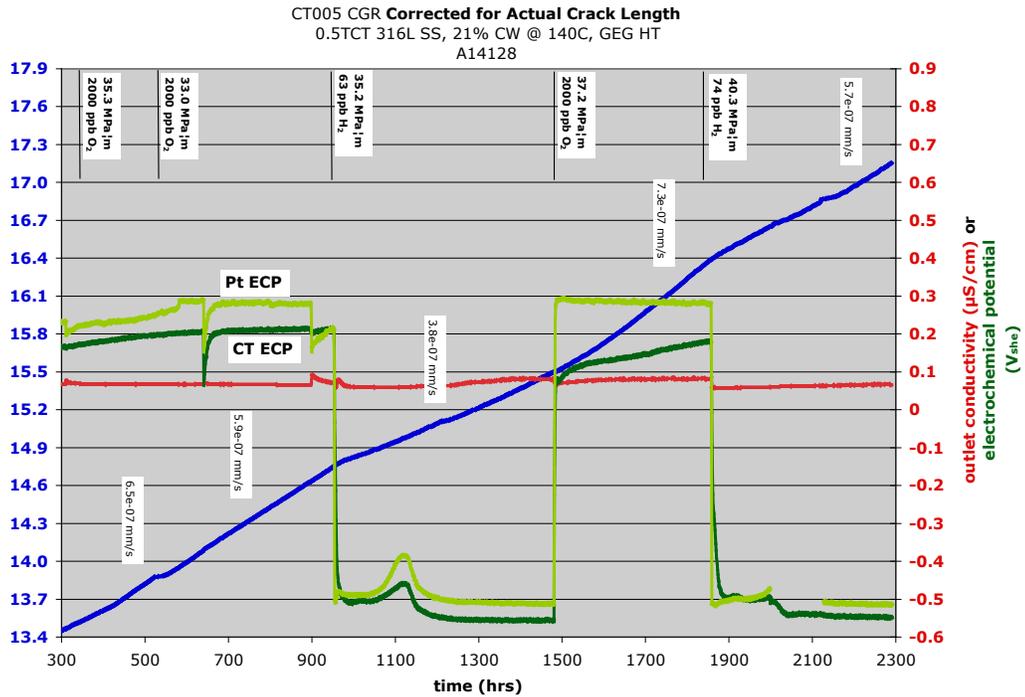
Figure 4-7 Crack-Growth Test for CT005 Sample: (a) full test with uncorrected K levels and crack length, and (b) full test with corrected K levels and crack length

A rapid transition from the TG fatigue pre-crack to SCC occurred for this test with cycling ended by  $\sim 330$  h and constant K conditions established as shown in Figure 4.7(a). Stable and consistent SCC crack growth ( $\sim 3.5 \times 10^{-7}$  mm/s) was established for the next  $\sim 600$  hours before removing O<sub>2</sub> and adding H<sub>2</sub> at  $\sim 950$  h. This resulted in a rapid decrease in the measured ECPs on the CT sample and on the Pt electrode from  $+0.2 V_{SHE}$  to  $-0.5 V_{SHE}$ . The propagation rate, however, only decreased by  $\sim 40$  percent, which is far less than that documented on the other stainless steel samples. A rate of  $\sim 2 \times 10^{-7}$  mm/s was maintained for  $\sim 500$  h before the decision was made to again re-establish oxidizing water conditions. The CGR after switching back to oxidizing water conditions shows a distinct increase over the next 200 h and reached a value similar to, or slightly greater than seen earlier in the test. During the final testing sequence, stable growth was again established under HWC conditions starting at  $\sim 1850$  h and propagation

A critical result for this sample was discovered during post-test fractography examinations. Measurements of crack extension by dcpd were found to significantly underpredict the actual crack length. Corrected K levels and crack length are shown in Figure 4.7(b). By the end of the test, the K level had increased to approximately 37 percent beyond the validity criterion (Eq. 3.1). This will be discussed in more detail along with the results of a second test on this same heat.

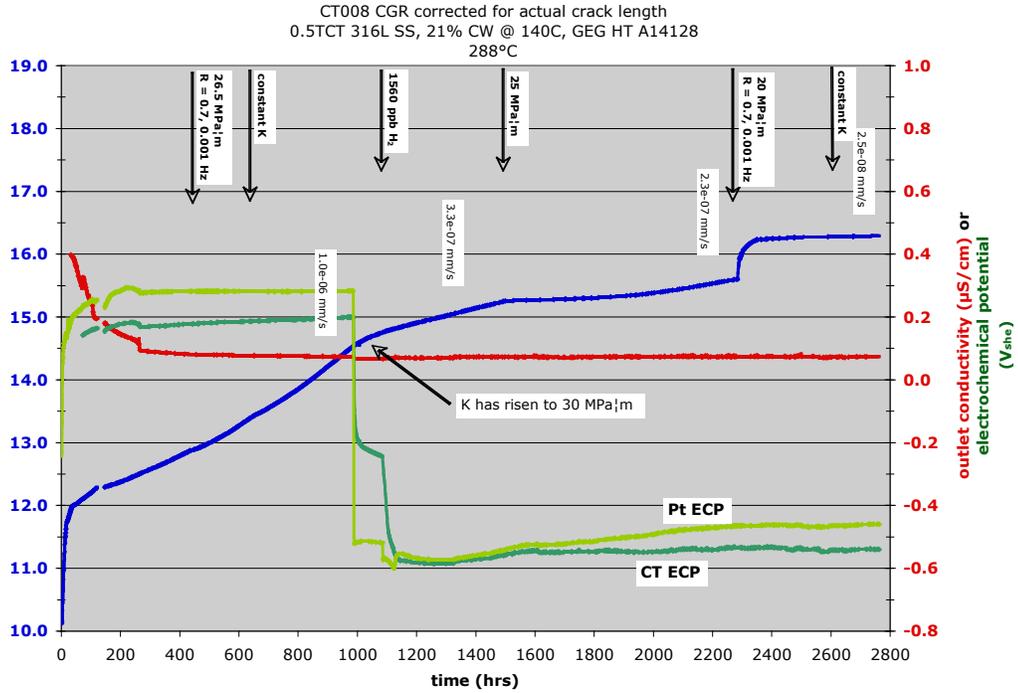
**Figure 4-8 Crack Length, Electrochemical Potential, and Outlet Conductivity Plotted Versus Test Time for the CW316LSS Sample. Corrected K values are shown after post-test examination of the fracture surface.**

A second test on this heat of material was performed to verify the crack growth and dcpd behavior of this heat of 316LSS. In anticipation of possible large underprediction of crack length again, this second test was set up to initially run at  $25 \text{ MPa}\sqrt{\text{m}}$  ( $22.8 \text{ ksi}\sqrt{\text{in}}$ ) rather than the  $30 \text{ MPa}\sqrt{\text{m}}$  ( $27.3 \text{ ksi}\sqrt{\text{in}}$ ) target in the previous test. Post-test crack length observation revealed that as with the previous test, dcpd significantly underestimated crack length in this second test. The crack growth curve with actual crack length and K values is shown in Figure 4.8. The pre-cracking sequence for this test was identical to the previous test on this material, and after establishing a crack growth rate of  $1.0 \times 10^{-6}$  mm/s at  $27.5$  to  $30 \text{ MPa}\sqrt{\text{m}}$  ( $24.9$  -  $27.3 \text{ ksi}\sqrt{\text{in}}$ ) under NWC conditions,  $\text{O}_2$  was removed and  $1560$  ppb  $\text{H}_2$  was added. As with the prior test (CT005) at a higher K level, rapid crack growth rates under HWC ( $1560$  ppb  $\text{H}_2$ ) of  $3.3 \times 10^{-7}$  mm/s and  $2.3 \times 10^{-7}$  mm/s were measured at  $30 \text{ MPa}\sqrt{\text{m}}$  and  $25 \text{ MPa}\sqrt{\text{m}}$ , respectively, as shown in Figure 4.8. This crack growth rate once again identifies the unique behavior of this 316LSS heat even under valid K values (as defined by Eq. 3.1). The final testing step was to drop the K level to a target value of  $15 \text{ MPa}\sqrt{\text{m}}$  (corrected to  $20 \text{ MPa}\sqrt{\text{m}}$  after post-test examination of actual crack length) and gently cycle the crack ( $0.001$  Hz, then  $0.001$  Hz with  $9000$  s hold). This was done to grow the crack beyond the plastic zone established at the higher K before changing to constant K conditions at  $\sim 2525$  hours. The final 450 hours of the test are shown in Figure 4.9. After transitioning to constant K, a lower CGR is immediately observed and then followed by an increase to a rate of  $\sim 2.5 \times 10^{-8}$  mm/s, which is approximately an order of magnitude lower than the values measured at higher K levels (corrected for actual crack length) earlier in the test as illustrated in Figure 4.8.

It is important to note that dcpd again significantly underpredicted the crack length. In-situ dcpd measurements gave a value for the total crack length of  $\sim 14.42$  mm, while post-test exams revealed the actual crack length to be  $\sim 16.28$  mm. As a result, the target constant K values of  $25$ ,  $20$ , and  $15 \text{ MPa}\sqrt{\text{m}}$  turned out to be  $\sim 30$ ,  $25$ , and  $20 \text{ MPa}\sqrt{\text{m}}$  ( $27.3$ ,  $22.6$ ,  $18.2 \text{ ksi}\sqrt{\text{in}}$ ) after correction. In the end, these corrected values are still within the K validity criterion of  $\sim 32 \text{ MPa}\sqrt{\text{m}}$  ( $29.1 \text{ ksi}\sqrt{\text{in}}$ ).

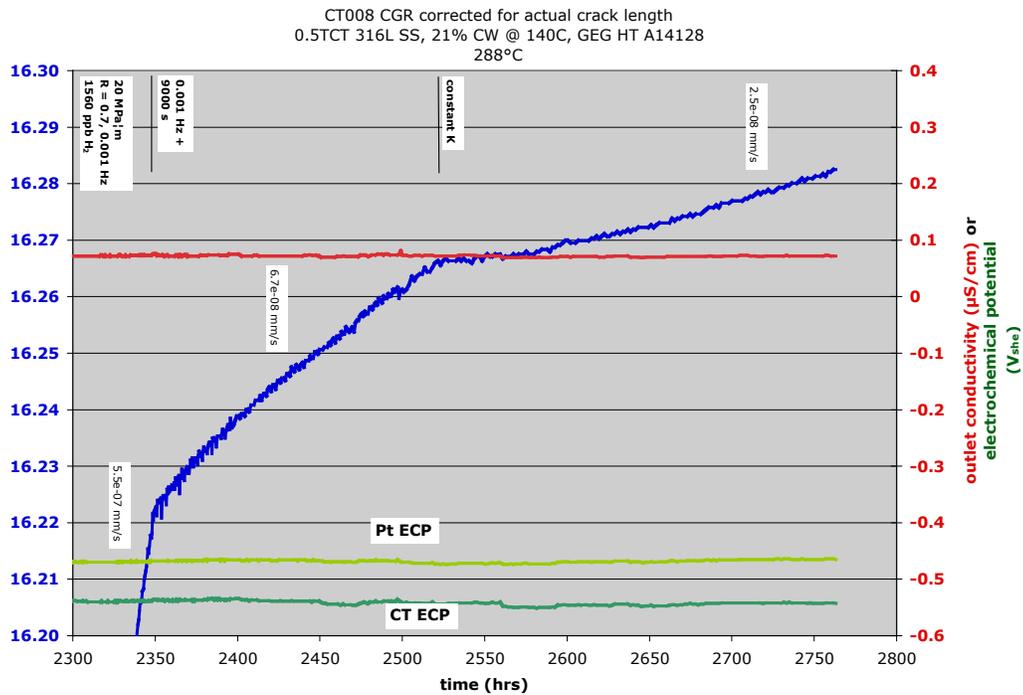
**Figure 4-9 Crack Length, Electrochemical Potential, and Outlet Conductivity Plotted Versus Test Time for the CW316LSS Sample. The final transition to constant K is at 2525 h.**

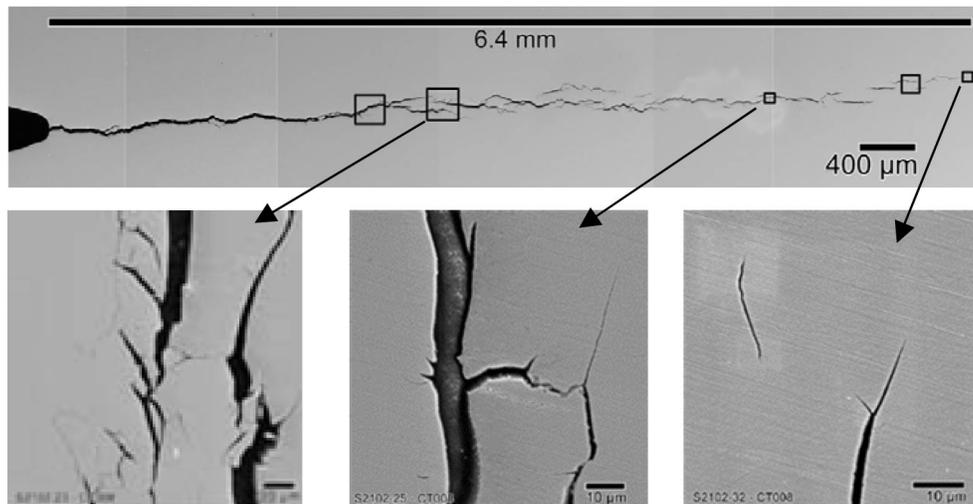
**Figure 4-10 Optical Micrographs Showing Cracks From the Inside Surface of the CW 316LSS CT008 Test Sample. Lower enlarged micrographs need to be rotated by 90° clockwise from image above. Area shown on left is from part of the test in 2000 ppb O<sub>2</sub>, while the areas in the center and on right are during HWC with 1560 ppb H<sub>2</sub>.**

Metallography and scanning electron microscopy (SEM) were conducted on the crack profile prior to fracturing the sample for crack surface examinations. The sample was cut into two thinner samples, and the crack profile was taken from a surface that represents an interior surface of the original sample. Examples from these examinations are presented in Figures 4.10 and 4.11. Cross-section metallography in Figure 4.10 shows the entire length of the ~6.4-mm-long crack including the initial pre-cracking, crack transitioning, SCC in oxidizing BWR water, and SCC in BWR-HWC conditions documented in Figure 4.8. Cracks are highly branched with what appear to be parallel cracks in some regions. In this cross-section, there are unbroken ligaments as far as 0.65 mm behind the crack tip that suggest unbroken ligaments are playing a role in the crack length underprediction by dcpd. Both IG and TG cracks can be identified in the crack profile throughout the constant K testing under 2000 ppb O<sub>2</sub> and 1560 ppb H<sub>2</sub> conditions. This mixed-mode SCC is better revealed by SEM characterization of the fracture surface as shown in Figure 4.11. The crack front is clearly TG during fatigue pre-cracking and changes to mixed IG and TG during transitioning and the constant K regions. Surprisingly, the distribution of IG and TG is similar during cracking in BWR oxidizing and HWC conditions. Prior work on other CW stainless steels has produced primarily intergranular stress corrosion cracking (IGSCC) during testing in BWR oxidizing water.

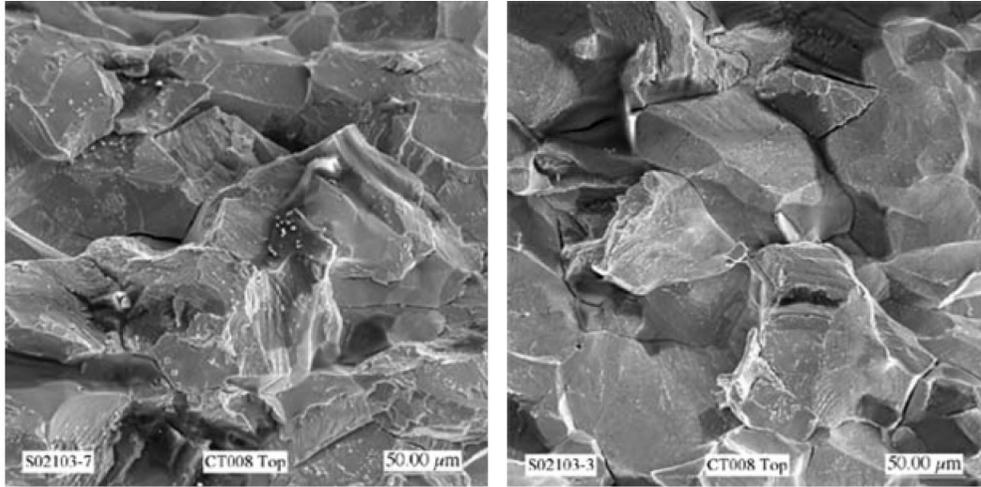
**Figure 4-11 Scanning Electron Micrographs Showing Mixed-Mode, IG/TG Fracture Surface Morphology for CW316LSS CT008 Sample. Area shown on left is from part of the test in 2000 ppb O<sub>2</sub>, while the area on right is during HWC with 1560 ppb H<sub>2</sub>.**

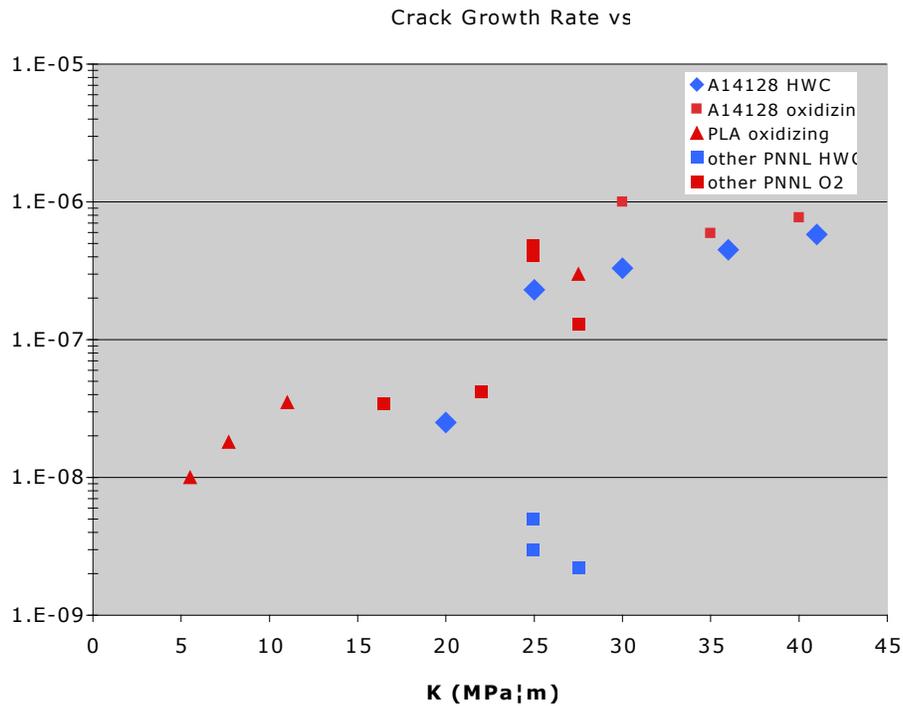
**Figure 4-12 Summary of PNNL Measured Crack-Growth-Rate Data for CW316SS Heats Showing High Propagation Rates for the One Heat under HWC Conditions.**

The PNNL crack-growth-rate data for CW316SS-type heats are summarized in Figure 4.12 as a function of the corrected crack length and K value. Although we only have a few examples of response under HWC conditions for other 316SS type heats besides the GEG heat A14128, the low propagation rates of these other heats ( $<1 \times 10^{-8}$  mm/s) are consistent with most data in the literature. Current results for the GEG heat show very little improvement over the 2000 ppb O<sub>2</sub> condition and are 50–100X greater than expected under high hydrogen, low ECP conditions.

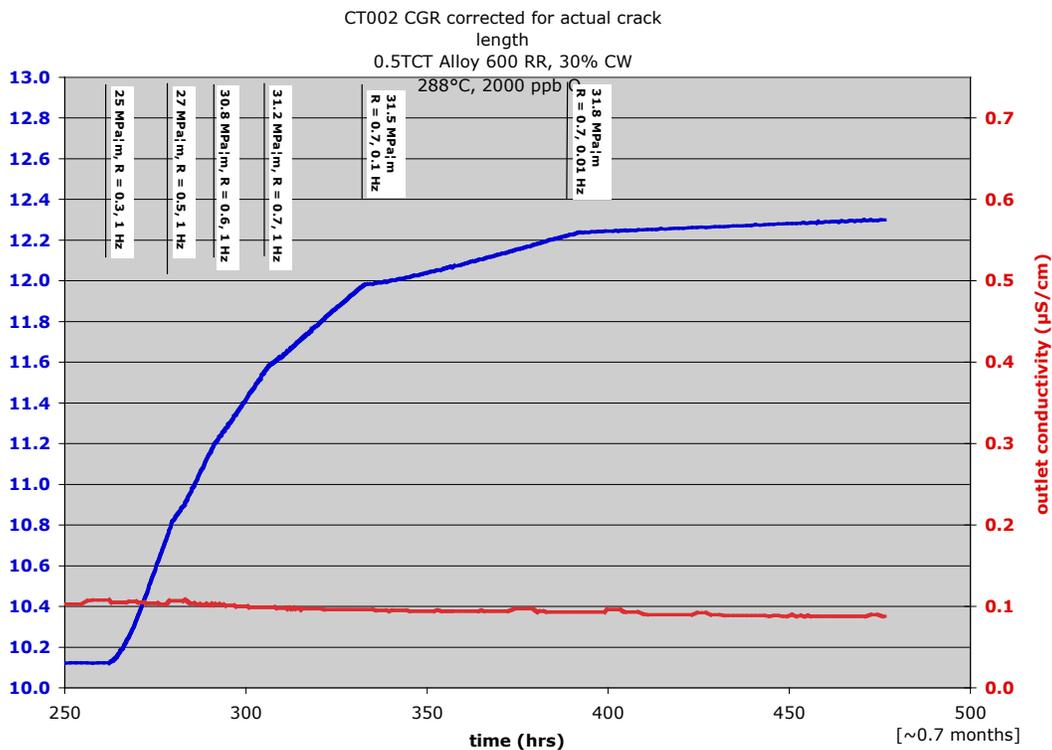
Figure 4-13 In-situ Pre-Cracking and Crack Transitioning Steps for Alloy 600 Test

Crack-growth-rate testing was performed on a 30-percent CW Alloy 600 0.5T CT sample as part of the International Cooperative Group on Environment-Assisted Cracking (ICG-EAC) round robin. Initial SCC transitioning and early crack-growth response according to a prescribed regiment is summarized in Figure 4.13. Consistent, but slow, crack growth was measured during transitioning to lower cyclic frequencies in steps 6 and 7. Measured growth rates were ~5X lower than anticipated and the step 5 cyclic conditions were re-established at ~1110 h into the test as shown in Figure 4.14. Once again, the crack-growth response at R=0.7 and 0.1 Hz (step 5 conditions) was reasonable, but decreased to low rates when the frequency was dropped to 0.01 Hz when repeating the step #6 conditions. This suggests a difficulty in transitioning from TG corrosion fatigue to IGSCC, and prompted the need for additional intermediate steps. The first attempt was a change in R ratio at ~1275 h from 0.7 to 0.5 while maintaining the reduced cyclic frequency of 0.01 Hz. The initial response was quite promising with the crack-growth rate increasing from ~1 to ~6×10<sup>-7</sup> mm/s, but subsequent steps again demonstrated slow crack-growth under step 6 and 7 conditions. As shown in Figure 4.14, growth rates dropped to ~2×10<sup>-7</sup> mm/s for R=0.7 and 0.01 Hz and to ~4×10<sup>-8</sup> mm/s at 0.001 Hz.

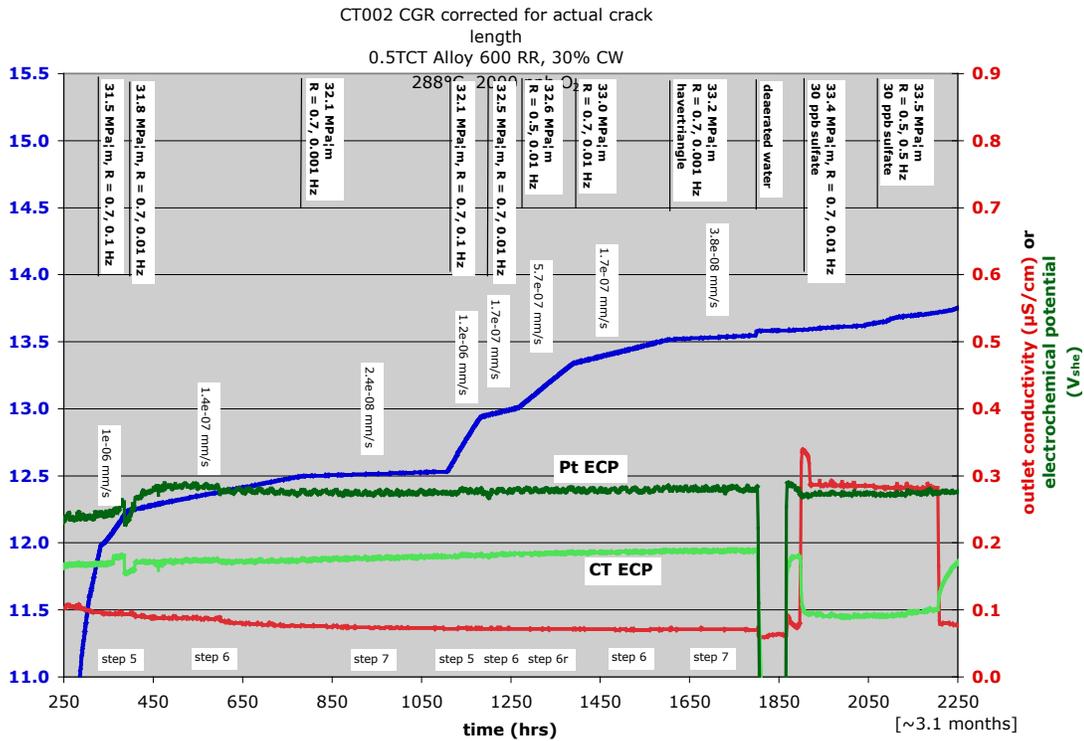
**Figure 4-14 Alloy 600 CGR Test Results Following Round-Robin Prescribed Steps**

stringers. It was decided that several subsequent steps should be applied to this sample to confirm the cracking characteristics. The first was to remove oxygen from the feedwater and monitor the change in electrochemical potential. An immediate drop in ECP was measured on the sample and on the Pt electrode at ~1800 h when deaerated conditions were established, and then the ECPs returned to the previous high values when oxygen was again added to the system. In a final attempt to coax SCC, 30 ppb sulfate was added as an impurity to the oxidizing BWR water environment at ~1890 h. The small  $H_2SO_4$  addition (at  $R=0.7$  and  $f=0.01$  Hz) caused a small drop in ECP on the CT sample from 0.2 to 0.1  $V_{she}$ . Over a period of 200 h, the sulfate did not accelerate the CGR beyond that of the sluggish rate of the non-sulfate condition (see step 6 for the non-sulfate CGR).

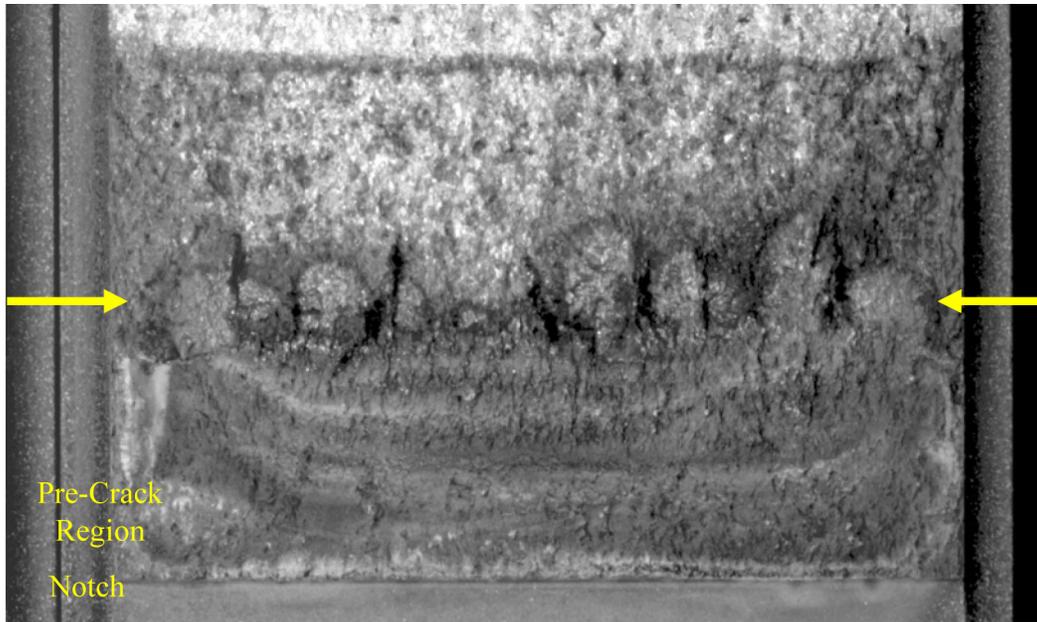
**Figure 4-15 Optical Micrograph Showing Fracture Surface for Alloy 600 Round-Round Sample (CT002) tested in Simulated BWR Oxidizing Water with 30 ppb Sulfate Added**

In an attempt to promote more rapid crack advance, the R ratio was changed to 0.5 and the frequency was increased to 0.5 Hz at ~2080 h. However, no increase in growth rate was observed. All results for this test raised concerns for this alloy 600 material. Due to the extensive length of this test and known problems with this heat of alloy 600, the decision was made to terminate this test and move forward on another aspect of the capability demonstration sequence. Fatigue cycling in air was employed to fracture the alloy 600 sample for subsequent surface examinations to investigate the cracking morphology and calibrate the dcpd measurements of crack length. An overview of the sample fracture surface is presented in Figure 4.15. Slow crack growth was experienced over the nearly 4-month test time and alloy 600 microstructural problems are suggested by the torturous appearance at crack depths from ~1.5 to 3 mm measured from the crack notch (see arrows in micrograph).

SEM examinations of the alloy 600 round-robin test sample fracture surface were performed and comparisons were made to the dcpd measurements of crack extension. The fracture surface shown in Figure 4.15 documents a reasonably straight crack front and a total average crack length of 17.1 mm. The dcpd system underpredicted the actual crack length with an estimated value 15.4 mm.

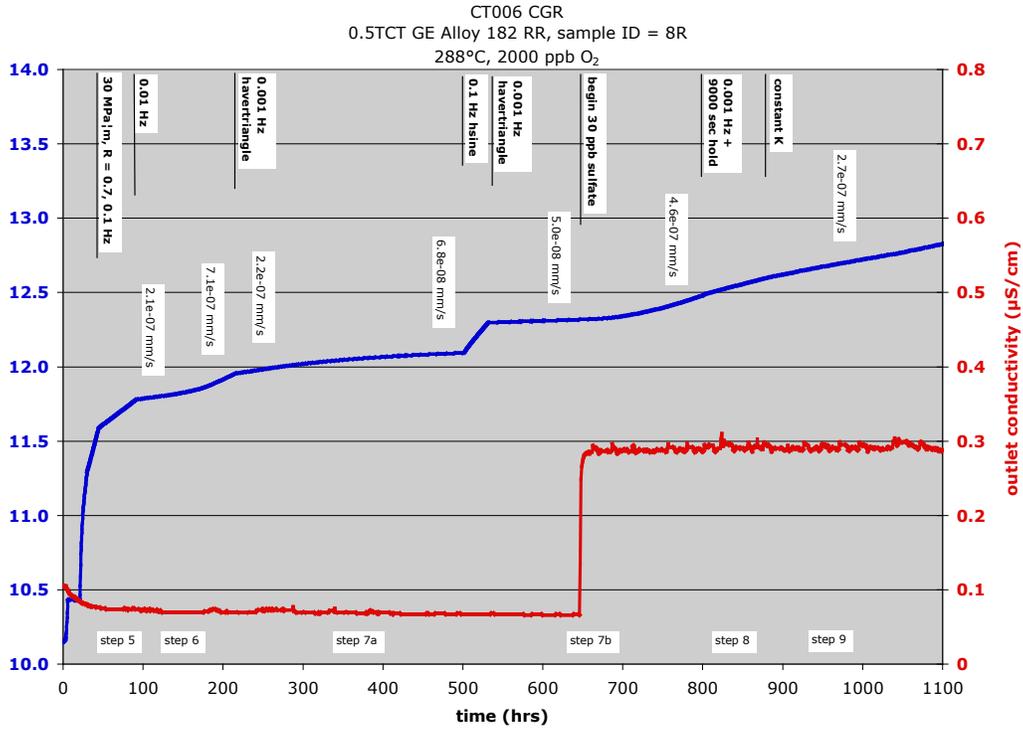
**Figure 4-16 Pre-Cracking and Transitioning Stages for Alloy 182 Test in BWR Oxidizing Water**

The next validation test evaluated a 0.5T CT, alloy 182 weld metal sample from a second ICG-EAC round robin with the test performed in high-purity oxidizing BWR water (2000 ppb  $O_2$ ). Crack-transitioning steps were initiated at ~45 h with a load ratio of 0.7 and cycling at a frequency of 0.1 Hz as shown in Figure 4.16. The cyclic frequency was then decreased to 0.01 Hz and a crack-growth rate established of  $\sim 2.1 \times 10^{-7}$  mm/s before decreasing the frequency further to 0.001 Hz with a haversine loading form at 220 h. SCC response was evaluated in high-purity water until a test time of ~650 h. Crack growth rates were extremely low even with the load cycling, so 30 ppb sulfate was added to solution. As expected, the growth rate increased after sulfate addition and the test was converted to constant K at ~900 h. Under constant K conditions, a stable growth rate of  $\sim 3$  to  $4 \times 10^{-7}$  mm/s in sulfate was observed over a period of ~850 h (34 d) as shown in Figure 4.17. As per the round-robin instructions, a fatigue cycle (helping ensure that the crack front was straight) was applied at ~1780 h and then constant K conditions were briefly re-established before the test was ended at ~2000 h.

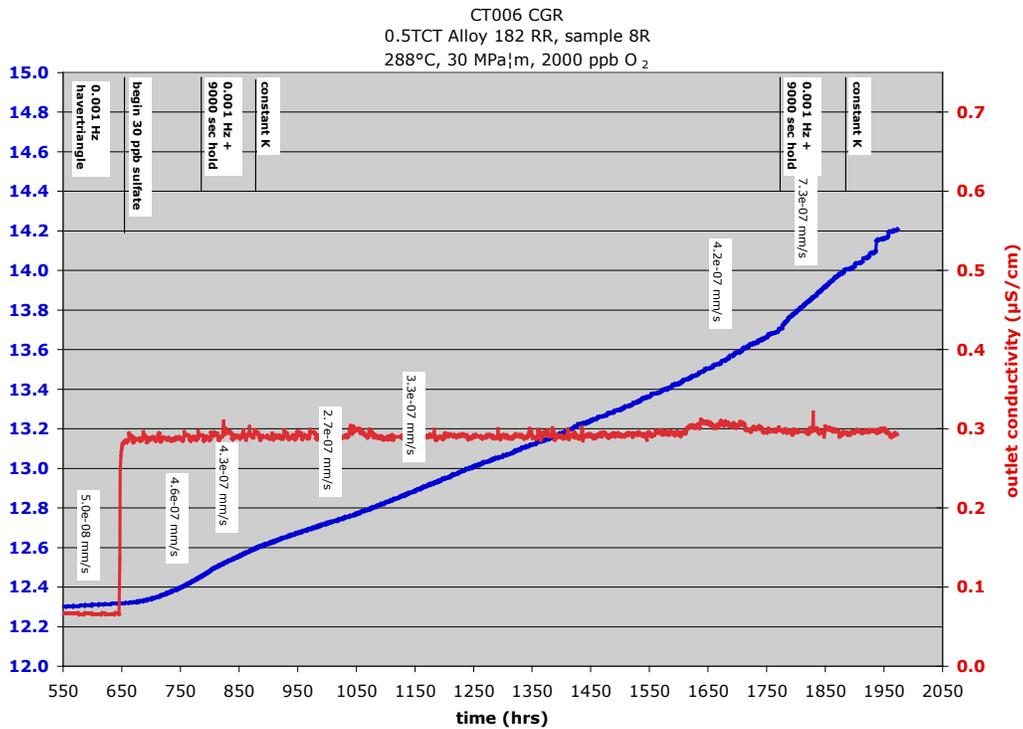
**Figure 4-17 Crack-Growth Response for Alloy 182 in BWR Oxidizing Water During Steps Under Constant K and then with Cyclic Loading with a Hold Time.**

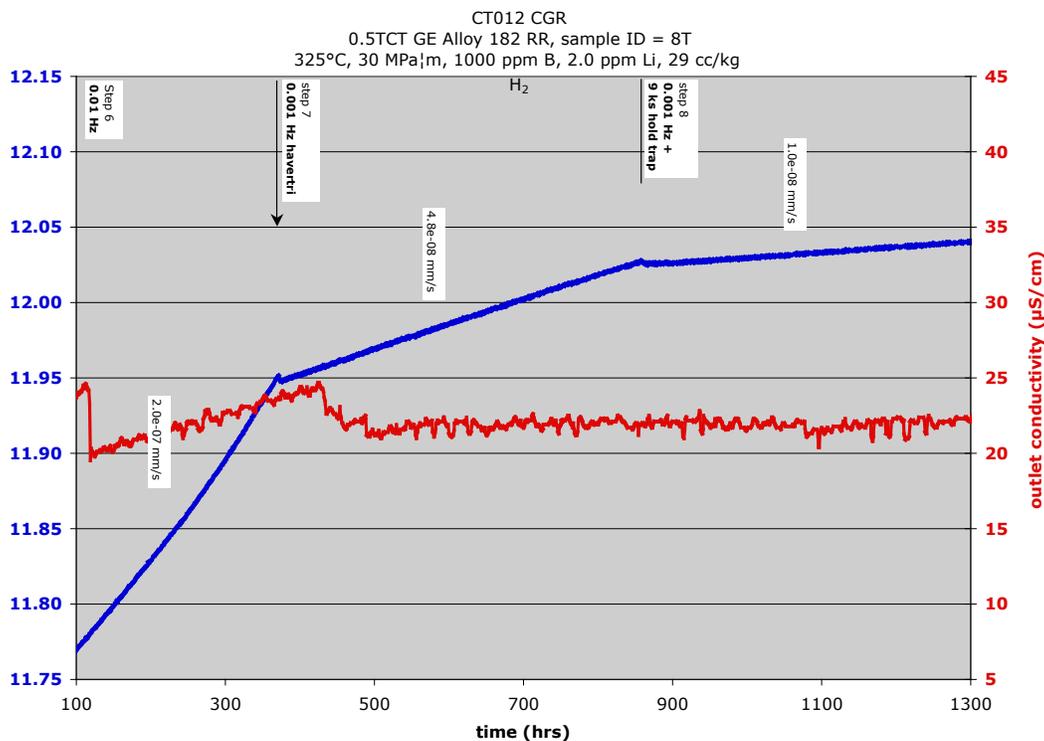
**Figure 4-18 Crack Transitioning Stages for Alloy 182 Round Robin Test in PWR-Simulated Primary Water at 325°C (617°F).**

Crack-growth-rate testing was also initiated on the alloy 182, 0.5T CT sample from the ICG-EAC round robin in PWR water. The test conditions are 325°C (617°F), 1000 ppm B, 2.0 ppm Li, 29 cc/kg H<sub>2</sub>, and a stress intensity of 30 MPa√m (27.3 ksi√in). This represented our first test in PWR-simulated water and at temperatures greater than 290°C (554°F). A reasonable learning curve was required to establish and maintain the target PWR primary water, B and Li chemistry. Several minor B/Li additions were needed and are reflected in the reductions in outlet conductivity. The gradual increase in water conductivity that occurs from ~100 h to 430 h is due to Fe<sup>++</sup> and chromate displacing Li<sup>+</sup> in the demineralizer. At 430 h, auto injection of Li-free water was established to automatically control B/Li levels during a test. Initial pre-cracking phases (following the round-robin procedure) were conducted leading up to the cycling at 0.01 Hz. Crack growth behavior during initial pre-cracking and crack transitioning steps is shown in Figure 4.18. Cyclic loading at 0.01 Hz produced a crack-growth rate of  $\sim 2 \times 10^{-7}$  mm/s. The cyclic loading rate was decreased to 0.001 Hz at ~370 hours and a significant decrease in growth rate was observed reaching a stable rate of  $\sim 5 \times 10^{-8}$  mm/s. A final SCC transitioning step with a 9000 second hold time further decreased the measured propagation rate to  $\sim 1 \times 10^{-8}$  mm/s.

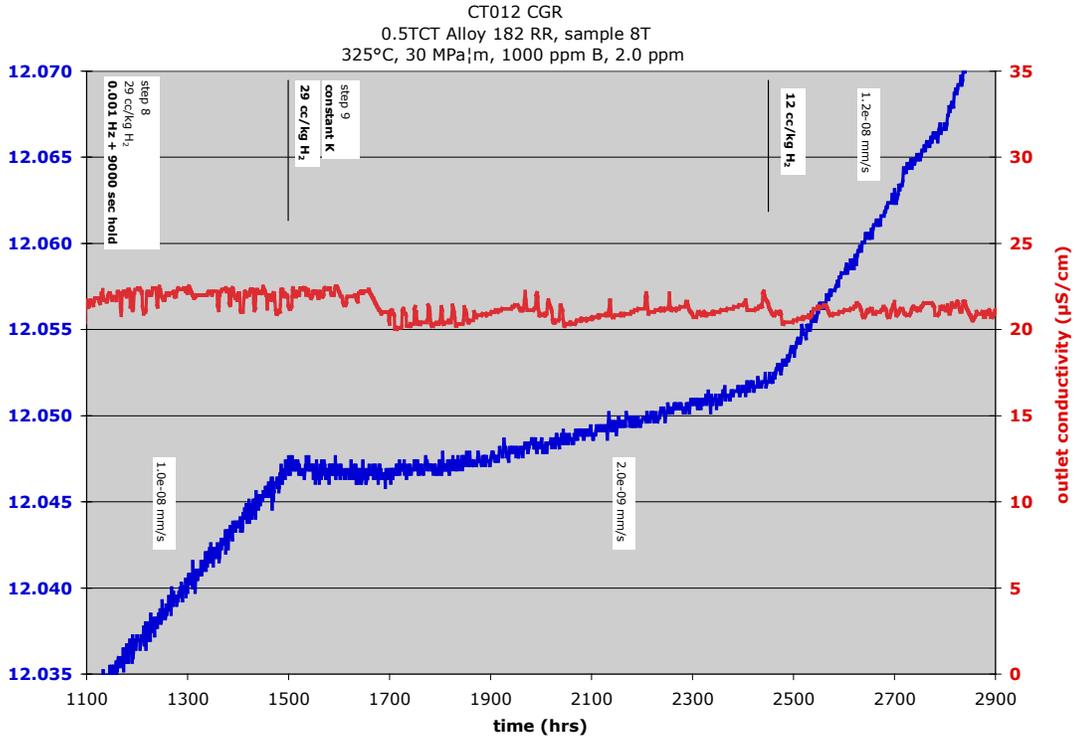
**Figure 4-19 Hydrogen Effects on SCC CGR of Alloy 182 under Constant K Conditions**

At 1510 h, the final stage of the round-robin procedure was applied by going to constant K conditions. Test behavior under constant K conditions is shown in Figure 4.19. No crack growth was detected over the first ~300 h, but then a stable propagation rate of  $\sim 2 \times 10^{-9}$  mm/s was observed over the next ~600 hours. PNNL results are consistent with experience of other

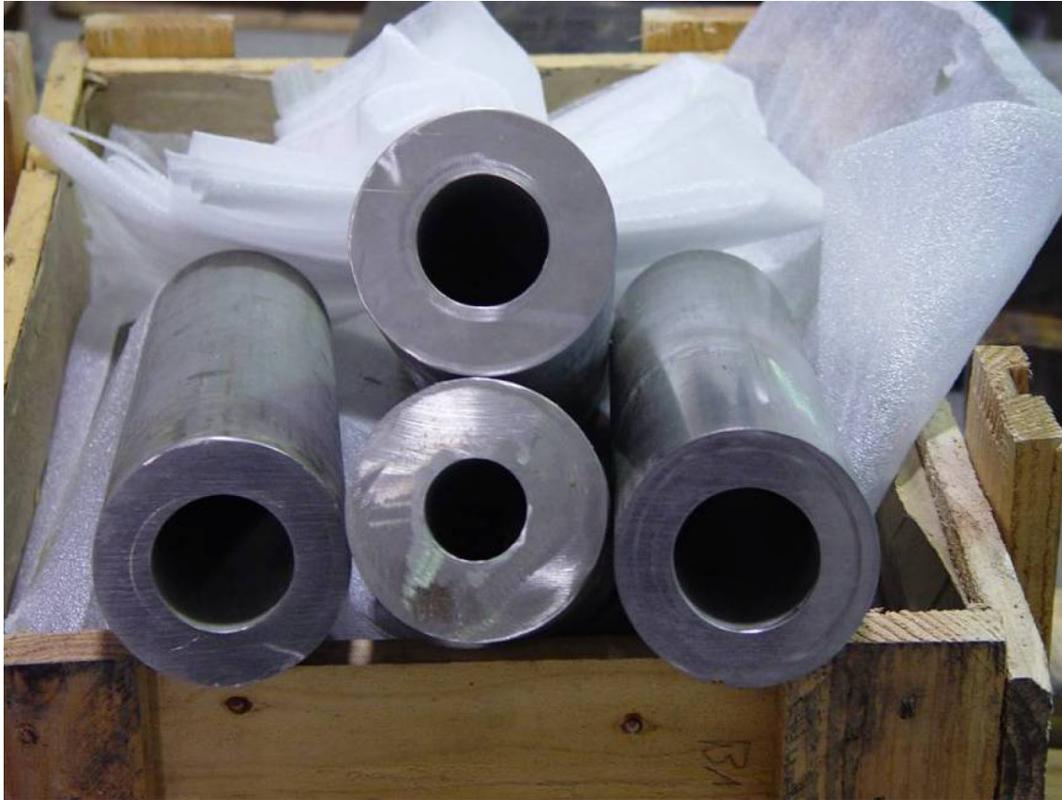
**Figure 5-1 Four of the Alloy 690 CRDM Tubes Received at PNNL**

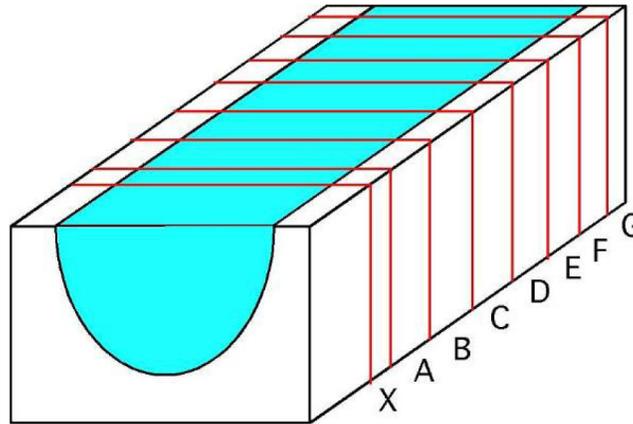
**Figure 5-2 Sectioning Diagram for the 152 Welded Block. End sections X and G are 0.5-in. thick and are used for metallographic observations while sections A-F are 0.75-in. thick and are to be used for CT samples. There is approximately 3 in. of welded block in front of section “X”.**

Initial 690/152 material analysis and testing started with the alloy 152 mockup weld obtained from EPRI. The mockup weld was produced for the Kewaunee pressure vessel head replacement by MHI. It was made using 2.4-in. thick plates of 304SS butted together and with a u-groove across the butt cross section. Alloy 152 butter passes were applied, and then the plates were welded together with alloy 152. A portion of the weldment was sectioned at PNNL into 0.75-in.-thick blocks (Figure 5.2) and metallographically prepared to reveal the individual weld passes and the butter zone. Sections C, D, and E indicated in Figure 5.2 were selected for fabricating CT samples. These samples were marked for machining so as to locate the end of the pre-crack in a single weld pass and enable >1 mm of growth in that weld pass. A close examination was made to select a weld pass where the dendrites would be parallel to the pre-crack. The machined notch in section C is shown in Figure 5.3. Crack growth testing will take place in the weld pass below the pass where the machined notch is located. The pre-crack will end in the same weld pass for sections C and D, but the slight wandering of the welds along the length of the mockup meant that it was necessary to use a different weld pass for crack growth testing (moving one up) of section E.

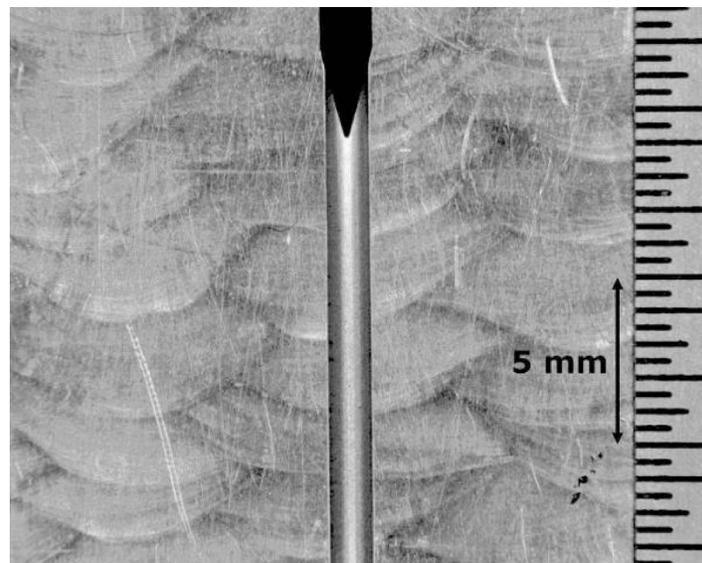
**Figure 5-3 Optical Micrograph of Section C Showing the Location of the Machined Notch. This same weld pass was selected in section D, while the one just above and to the left was selected in section E.**

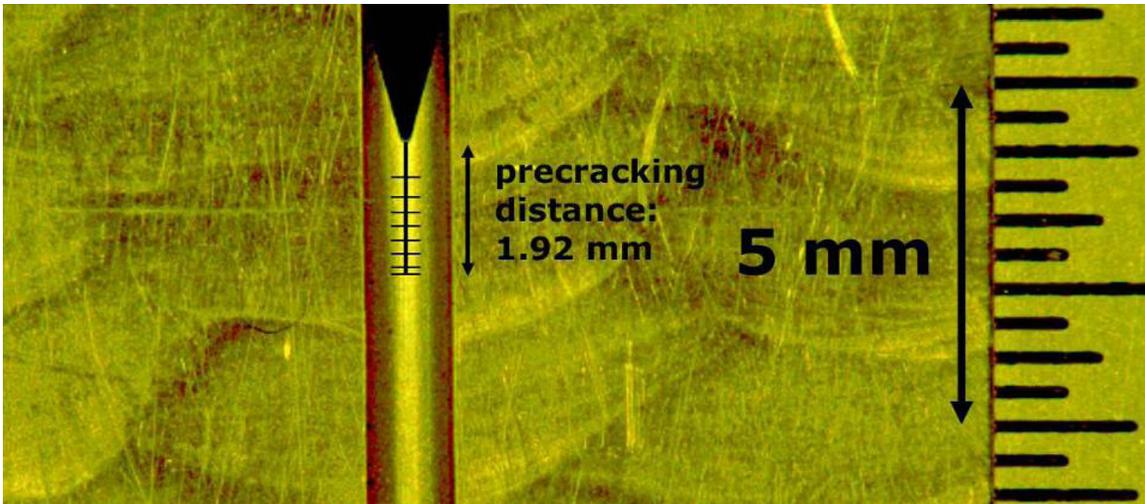
**Figure 5-4 Intended Pre-Crack Increments for CT013 Alloy 152 MHI Mock-Up Weld Crack-Growth Test Being Conducted in NRC System #1**

The first alloy 152 weld metal test (from the MHI mock-up weld) was set up in NRC System #1 using PWR water chemistry identical to that used for the alloy 182 round robin test. A pre-cracking process similar to that for the 182 round robin (RR) has also been adopted with a target K value of  $30 \text{ MPa}\sqrt{\text{m}}$  ( $27.3 \text{ ksi}\sqrt{\text{in}}$ ) for constant K testing. The pre-crack increments on the 0.5T CT sample are shown in the weld macro in Figure 5.4.
