## 4 Validation Testing and Round-Robin SCC Crack-Growth Rate Testing

## 5 SCC Crack-Growth-Rate Testing of Alloy 690 and Its Weld Metals

Pacific Northwest National Laboratory Investigation of Stress Corrosion Cracking in Nickel-Base Alloys, Volume 1

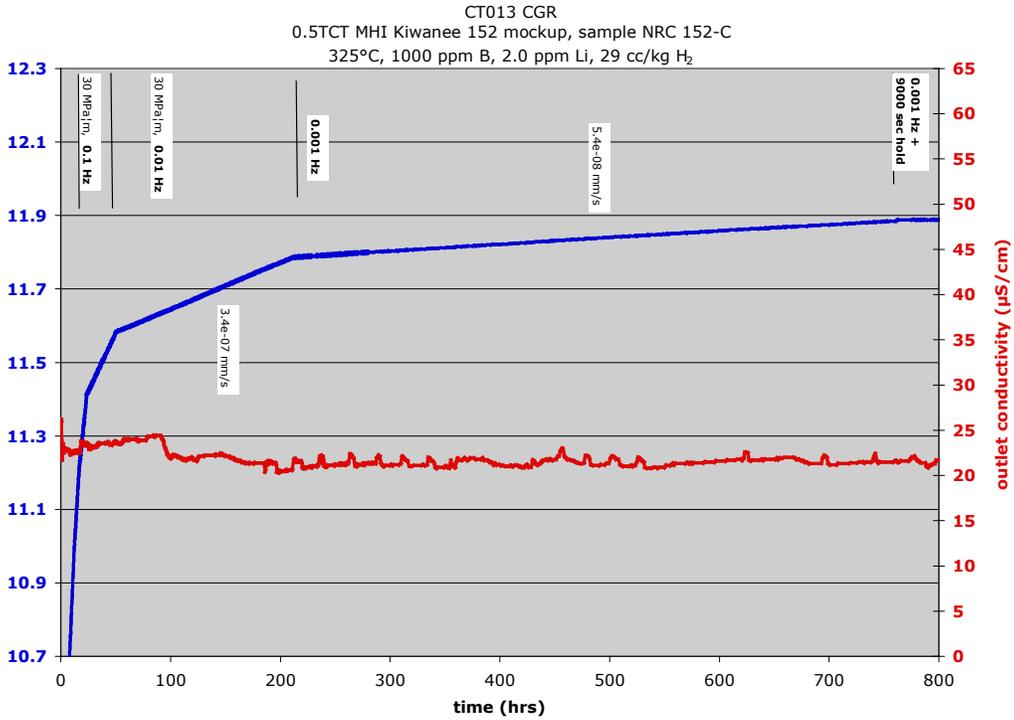
**Figure 5-5 Pre-Cracking and Initial Crack Transitioning for the First Alloy 152 CGR Test in PWR-Simulated Primary Water at 325°C (617°F).**

The pre-crack was grown to ~1.3 mm in fatigue over the first 25 h so that crack-growth testing would begin in the middle of a weld pass. Crack transitioning from fatigue to corrosion fatigue was then continued through the next three steps cycling first at 0.01 Hz for ~0.2 mm of crack growth giving a rate of  $\sim 3.5 \times 10^{-7}$  mm/s which was followed by cycling at 0.001 Hz for ~0.1 mm giving a rate of  $5.4 \times 10^{-8}$  mm/s. The last transition step of 0.001 Hz with a 9000 s hold was intended to run for 0.1 mm, but the low crack growth rate of  $6.8 \times 10^{-9}$  mm/s dictated an increment of only 0.01 mm (taking approximately 3 weeks). The steps are documented in Figures 5.5 and 5.6. Because of the extremely slow, but stable propagation rate at the 9000s hold time, a longer hold time of 86,400 s (24 h) was selected as a final crack transitioning step to constant K. An apparent near-stable CGR of  $\sim 1.6 \times 10^{-9}$  mm/s was measured during the first 2.5 weeks in this test condition. However, the dcpcd-measured extension has been less than 2  $\mu\text{m}$  as illustrated in Figure 5.7. Plans are for this test to continue for several more months attempting to establish SCC crack-growth rates in alloy 152 under constant K, and perhaps under several gentle cycling conditions. We anticipate investigating the influence of temperature and hydrogen level on the SCC response. It is possible that temperatures up to  $\sim 340^\circ\text{C}$  ( $644^\circ\text{F}$ ) will be evaluated and temperatures down to  $\sim 100^\circ\text{C}$  ( $212^\circ\text{F}$ ) may be examined at the end of this test.

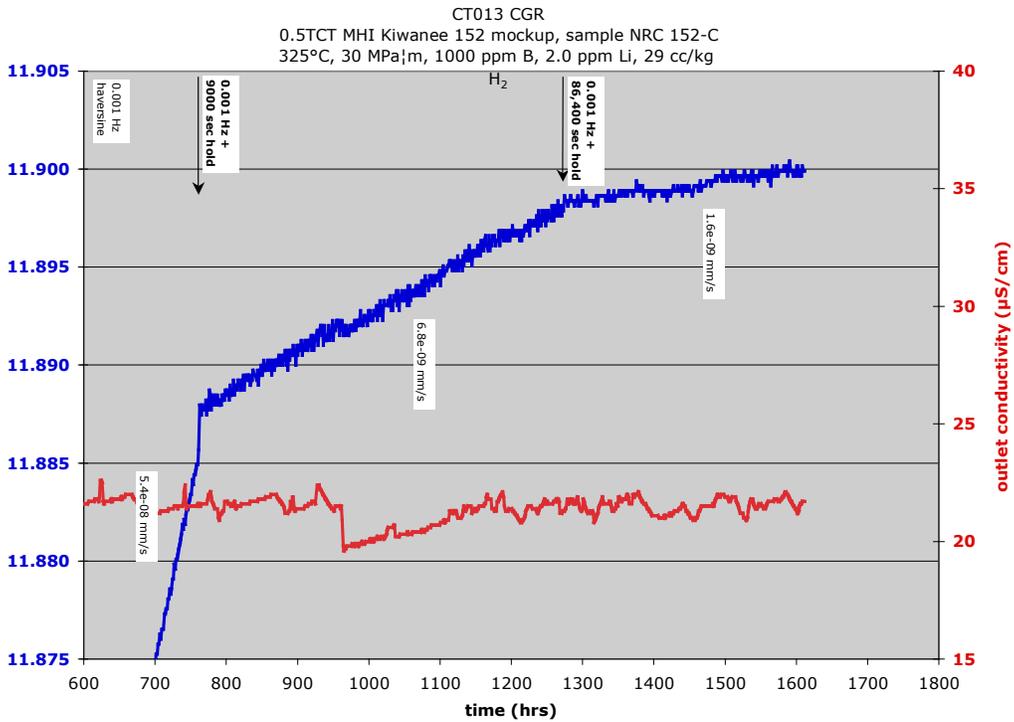
**Figure 5-6 Crack Transitioning for the First Alloy 152 CGR Test in PWR-Simulated Primary Water at 325°C (617°F).**

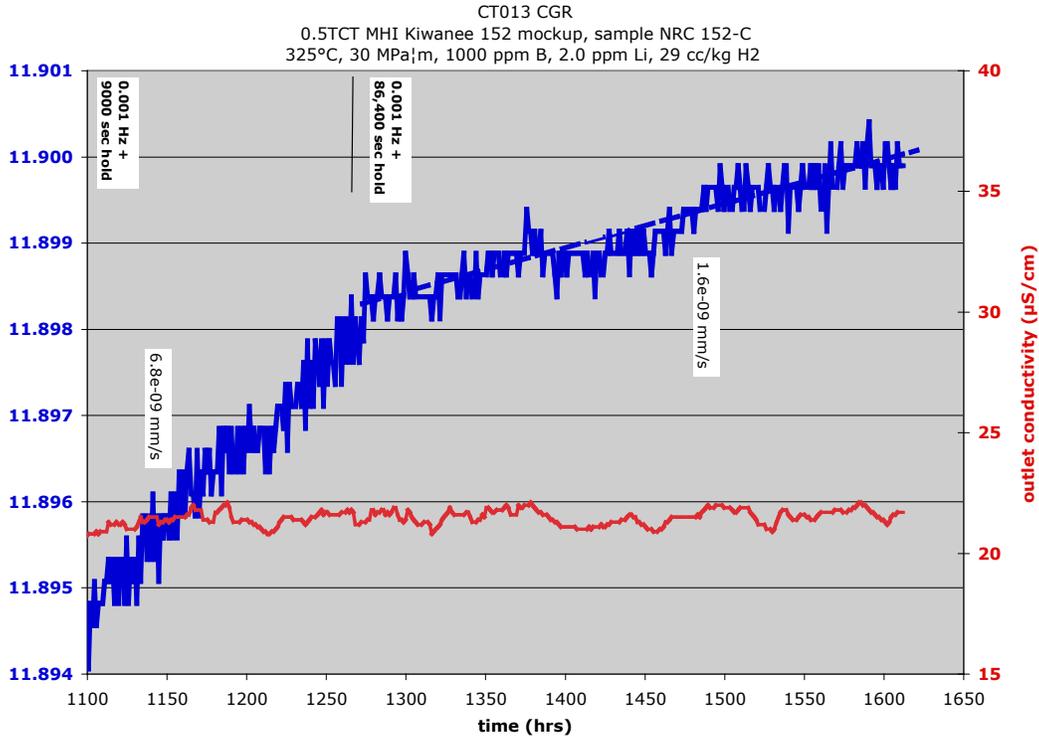
**Figure 5-7 Expanded View of Final Crack Transitioning Step in the First Alloy 152 Test. The test is on-going.**

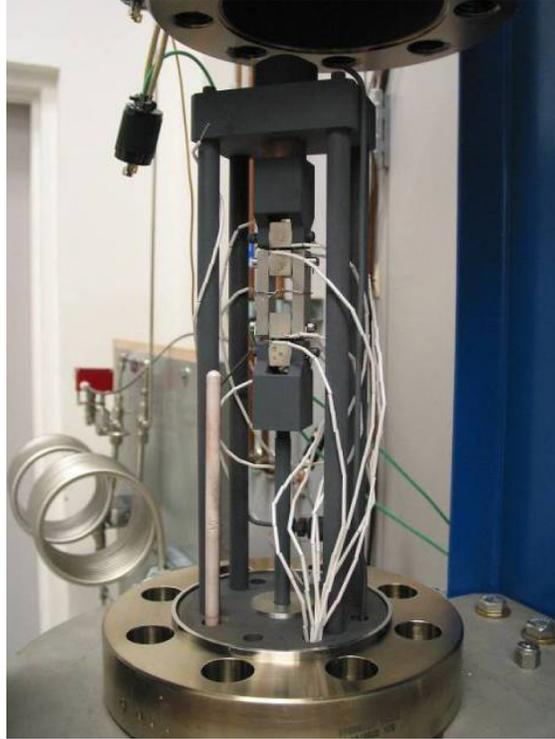
**Figure 5-8 Image Showing the Two Alloy 690, 0.5T CT Samples Mounted in Series Within SCC CGR Test System #3**

In order to test these samples in series (as illustrated in Figure 5.8), it was necessary to pre-crack each of these samples (CT014 and CT015) in air prior to loading the samples into the autoclave. A difference in initial fatigue response was observed for the two alloy 690 samples. This is shown in Figure 5.9 with the SA alloy 690 (b) exhibiting an unexpected linear response with initial aggressive cycling, while the as-received alloy 690TT (a) revealed the more typical increasing response. The later air-fatigue steps, however, gave a similar pre-crack characteristic. After pre-cracking, the samples were mounted into the high-temperature autoclave.

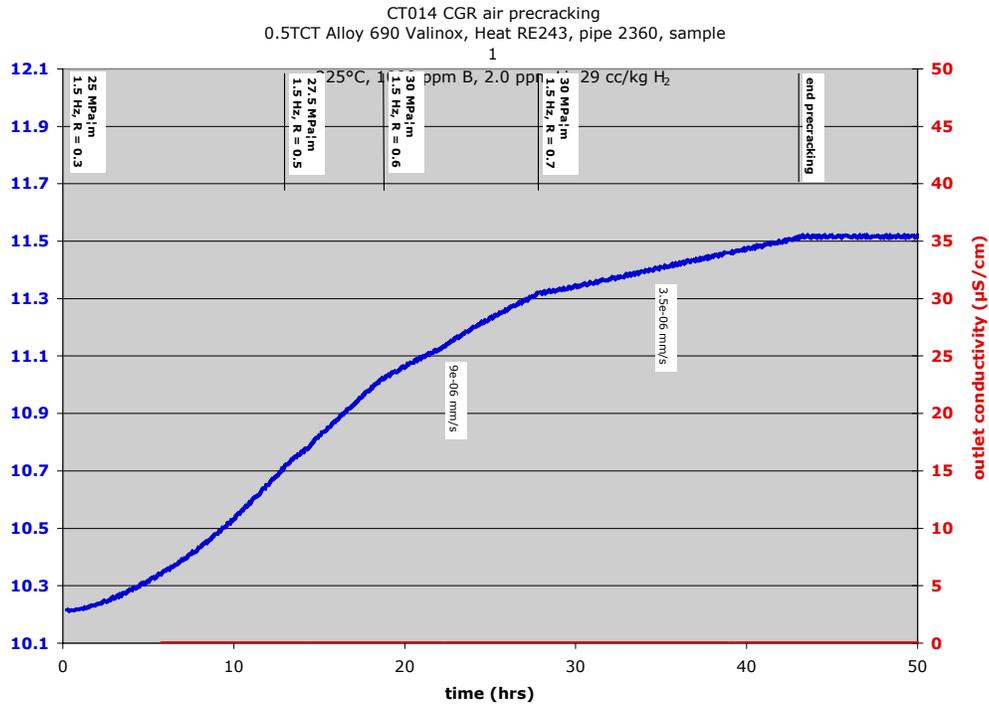
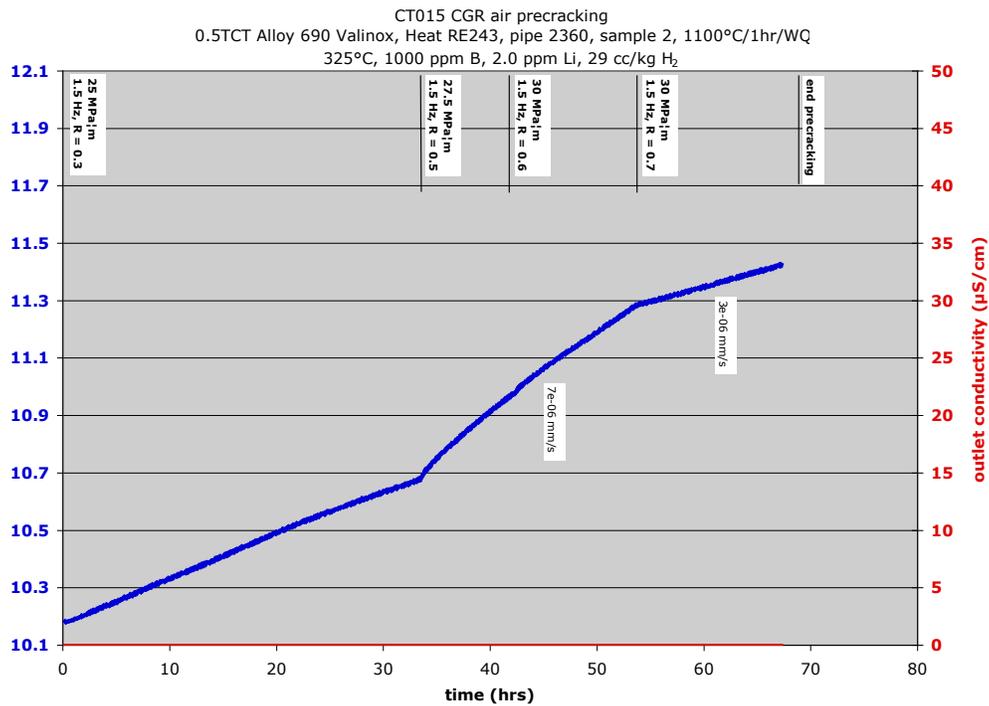
**Figure 5-9 Air Fatigue Pre-Cracking of Alloy 690 Samples to be Tested in Series: (a) as-received CRDM material in TT condition (CT014) and (b) solution-annealed material (CT015).**

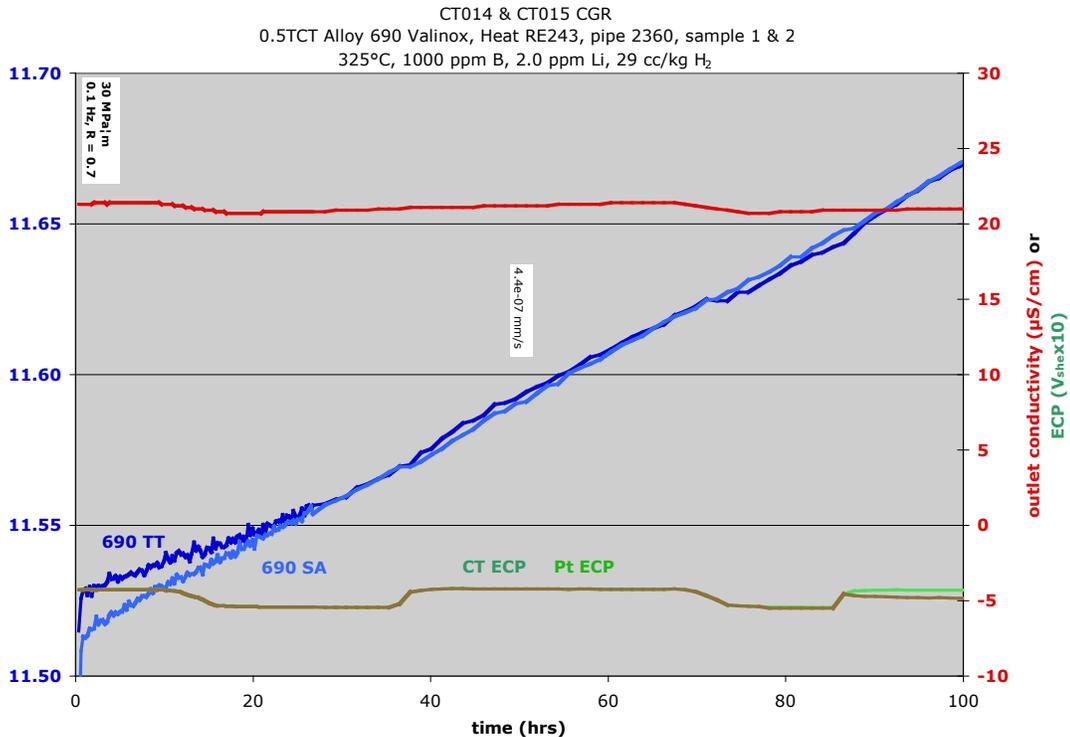
**Figure 5-10 Initial Crack Transitioning Step for Alloy 690 Samples Tested in Series**

As noted earlier, the SCC CGR test on these two samples in series was just initiated at the time of this report. The first stage of the crack transitioning sequence is shown in Figure 5.10 for the CT014 (CRDM alloy 690 in the thermally treated condition) and CT015 (SA alloy 690) samples. The measured CGRs are consistent between the two samples, but are somewhat lower than expected based on our alloy 152 results and isolated alloy 690 results available from other laboratories. At the current test step of 0.1 Hz, the cracks in these two 690 samples are growing at  $4.4 \times 10^{-7}$  mm/s, while for the alloy 152 sample, the CGR was  $1.6 \times 10^{-6}$  mm/s which is over an order of magnitude higher than the 690 samples. This would seem to suggest very low crack growth rates later in the test, but it is too early in this test for any meaningful assessments of the alloy 690 crack-growth rates to be made. The only purpose of presenting this early data is to document that our tests on alloy 690 and alloy 152 are underway after the successful construction, demonstration, and validation of the PNNL test systems and CGR testing capabilities.

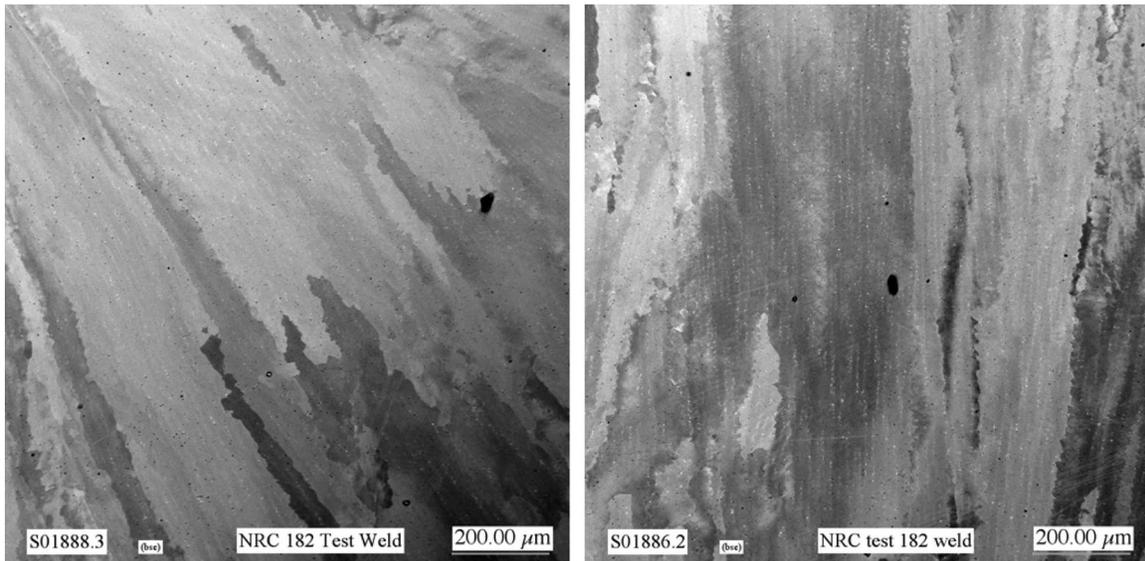
**Figure 6-1 SEM Backscatter Electron Images Showing Elongated Grain Structure in the Round-Robin Alloy 182 Weld Metal.**

Microstructural and microchemical characterization was performed on the alloy 182 weld metal obtained as part of the ICG-EAC round robin (CT006 and CT012). Optical metallography, SEM, and TEM were used to document the general grain structures, identify precipitates and inclusions, and assess local compositional variations. Most regions showed large and elongated grains as illustrated in Figure 6.1. A distribution of large and small second-phase particles were present as indicated by the light or dark contrast features in the SEM backscatter image in Figure 6.2. Boundaries often had a crenulated appearance due to IG carbides.

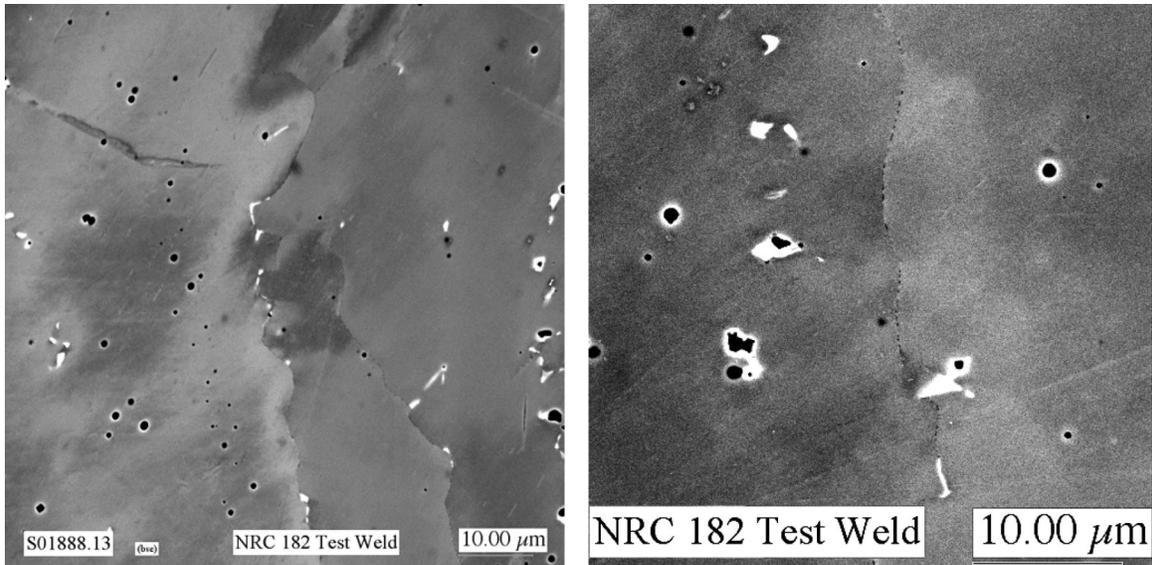
**Figure 6-2 SEM Backscatter Electron Images Showing “Crenulated” Boundaries Caused by Presence of Carbide Precipitates.**

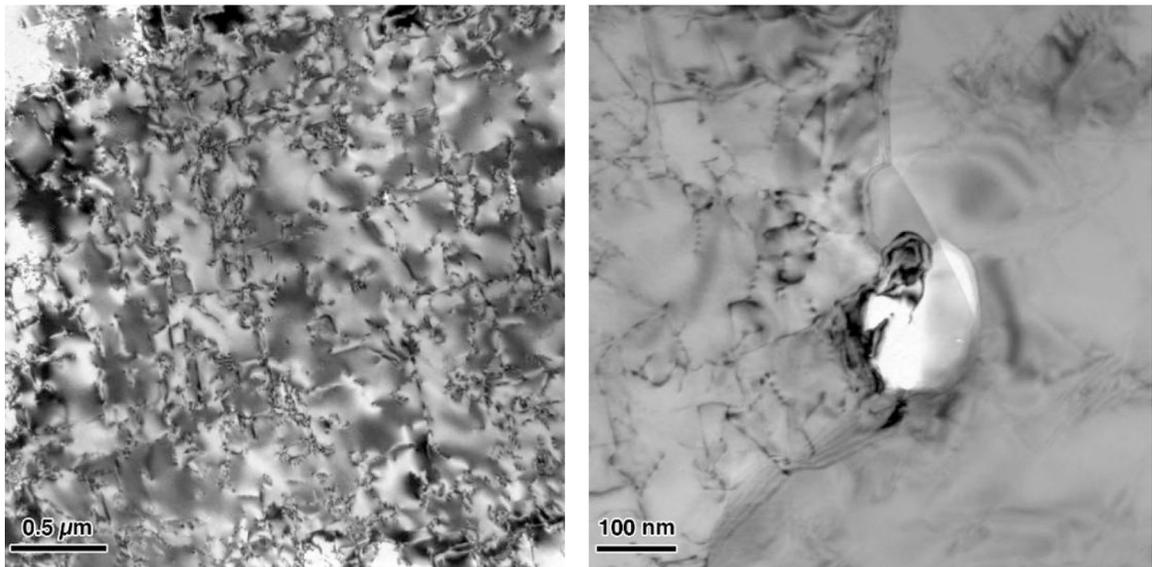
**Figure 6-3 TEM Brightfield Images Illustrating High Dislocation Densities in Most Regions (left) and  $M_{23}C_6$  and MC Carbides in the Matrix and at Grain Boundaries (right).**

Higher-magnification TEM examinations revealed a high dislocation density in most grains along with micrometer-sized carbides in the matrix and at grain boundaries as presented in Figure 6.3. A high density of much smaller, nanometer-sized  $M_{23}C_6$  and MC carbides were also found at most grain boundaries. An example of these fine precipitates is shown by the darkfield images in Figure 6.4. Nanometer-scale measurements of grain boundary composition between  $M_{23}C_6$  carbides indicated strong Cr depletion with levels down to ~5 wt% (matrix 13–15 wt%).

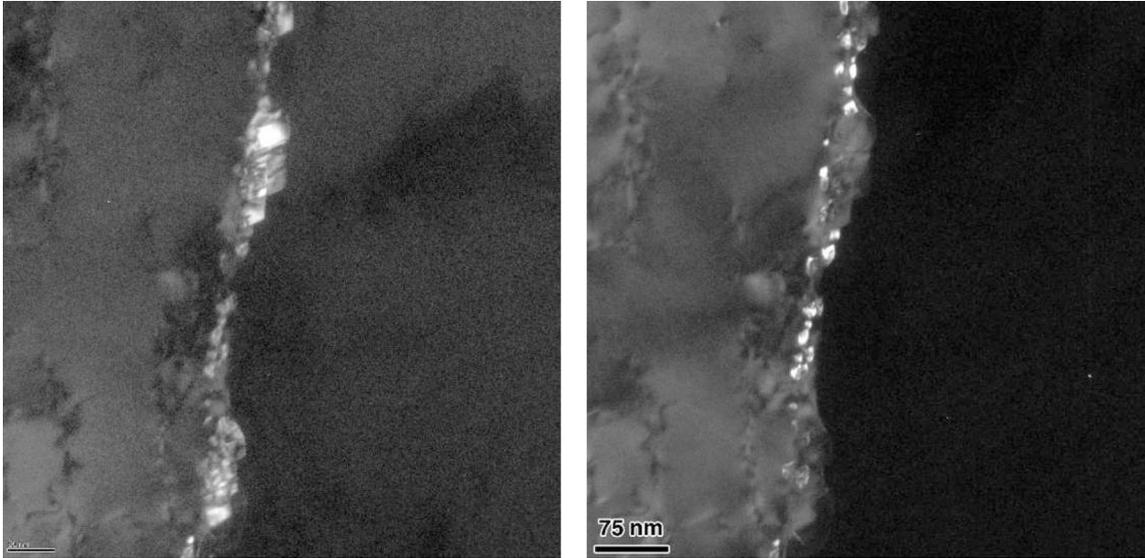
**Figure 6-4 TEM Darkfield Images Showing High Density of Fine  $M_{23}C_6$  (left) and MC Carbides (right) at Grain Boundaries.**

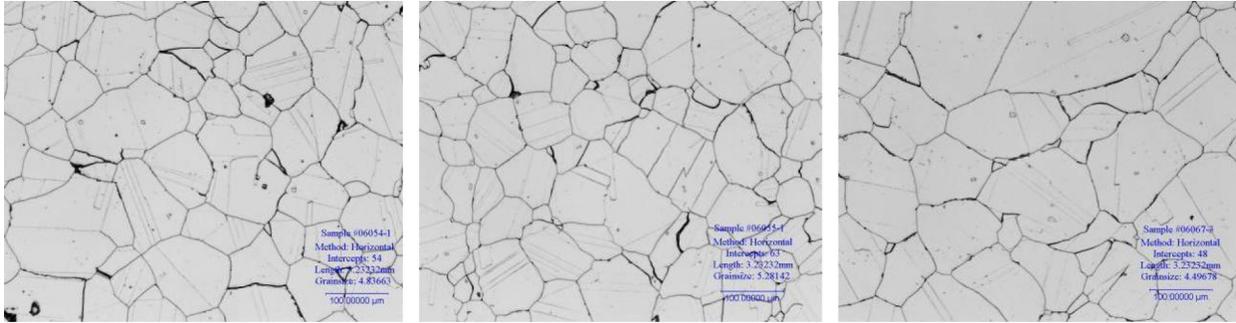
**Figure 6-5 Optical Metallographs Showing Grain Structures for Alloy 690 Heat RE243 in the Transverse (left), Longitudinal (middle), and Circumferential (right) Orientations.**

Optical metallography was performed on the six heats of alloy 690 CRDM tubing obtained from Vallourec in the longitudinal, transverse, and circumferential orientations to document grain structures, inclusions, and precipitates. Grain size and shape were reasonably consistent for all three orientations among the six heats. In addition, alloy 690 heat RE243 showed similar structures in the two different tubing thicknesses (1.0-in. and 1.4-in. thick wall) obtained. Microstructure examples for several of the heats are shown in Figures 6.5 and 6.6. Typical average grain sizes are somewhat large at approximately 100  $\mu\text{m}$  in diameter. Grain boundary carbides can be seen in the etched samples, but additional examinations by both SEM and limited TEM are required to estimate boundary coverages. Based on these examinations, three heats will be selected for solution-anneal heat treatments to remove IG carbides and maintain a similar strength level. Lower-temperature heat treatments will be performed to alter grain boundary precipitation and segregation. In the end, several of these conditions will be cold worked and machined into CT samples for future SCC crack-growth testing. Plans are for initial SCC tests to be on solution-annealed and as-received thermally treated materials followed by testing on samples made from alloy 690 material that has either been cold rolled or forged.

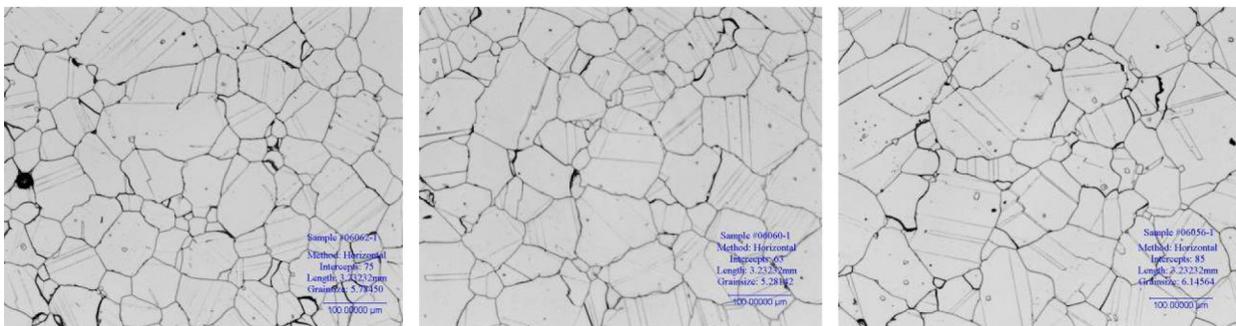
**Figure 6-6 Optical Metallographs Showing Grain Structures for Alloy 690 Heats WP016 (left), WP140 (middle), and RE169 (right).**

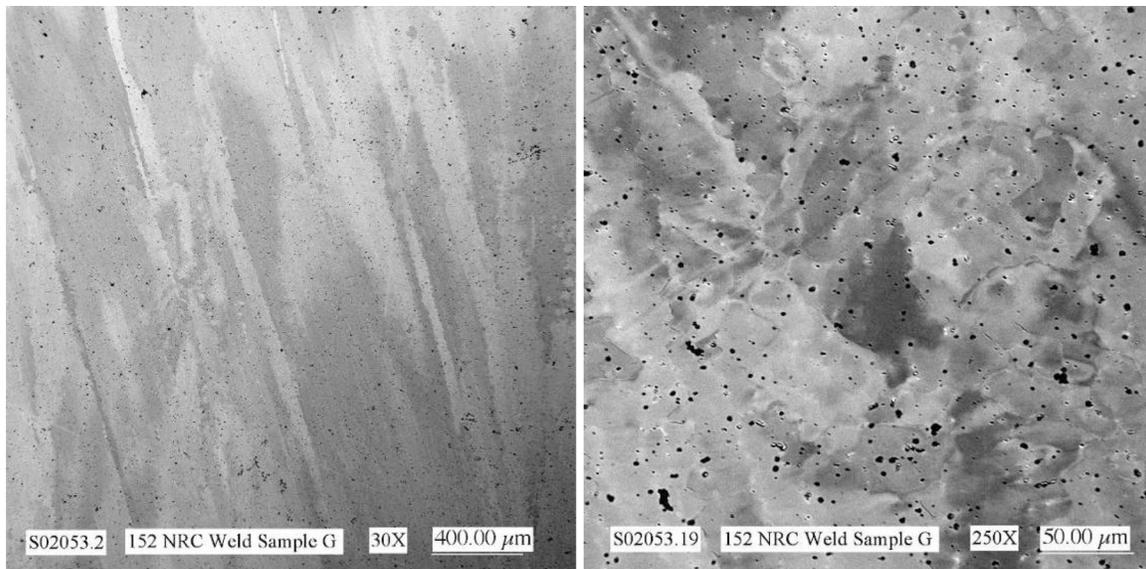
**Figure 6-7 SEM Micrographs of the Alloy 152 Weld Showing Long Dendrites (left) and Much Smaller, Equiaxed Dendrites (right). The latter are generally present at the intersection of two weld passes but some of the long dendrites pass through that region uninterrupted.**

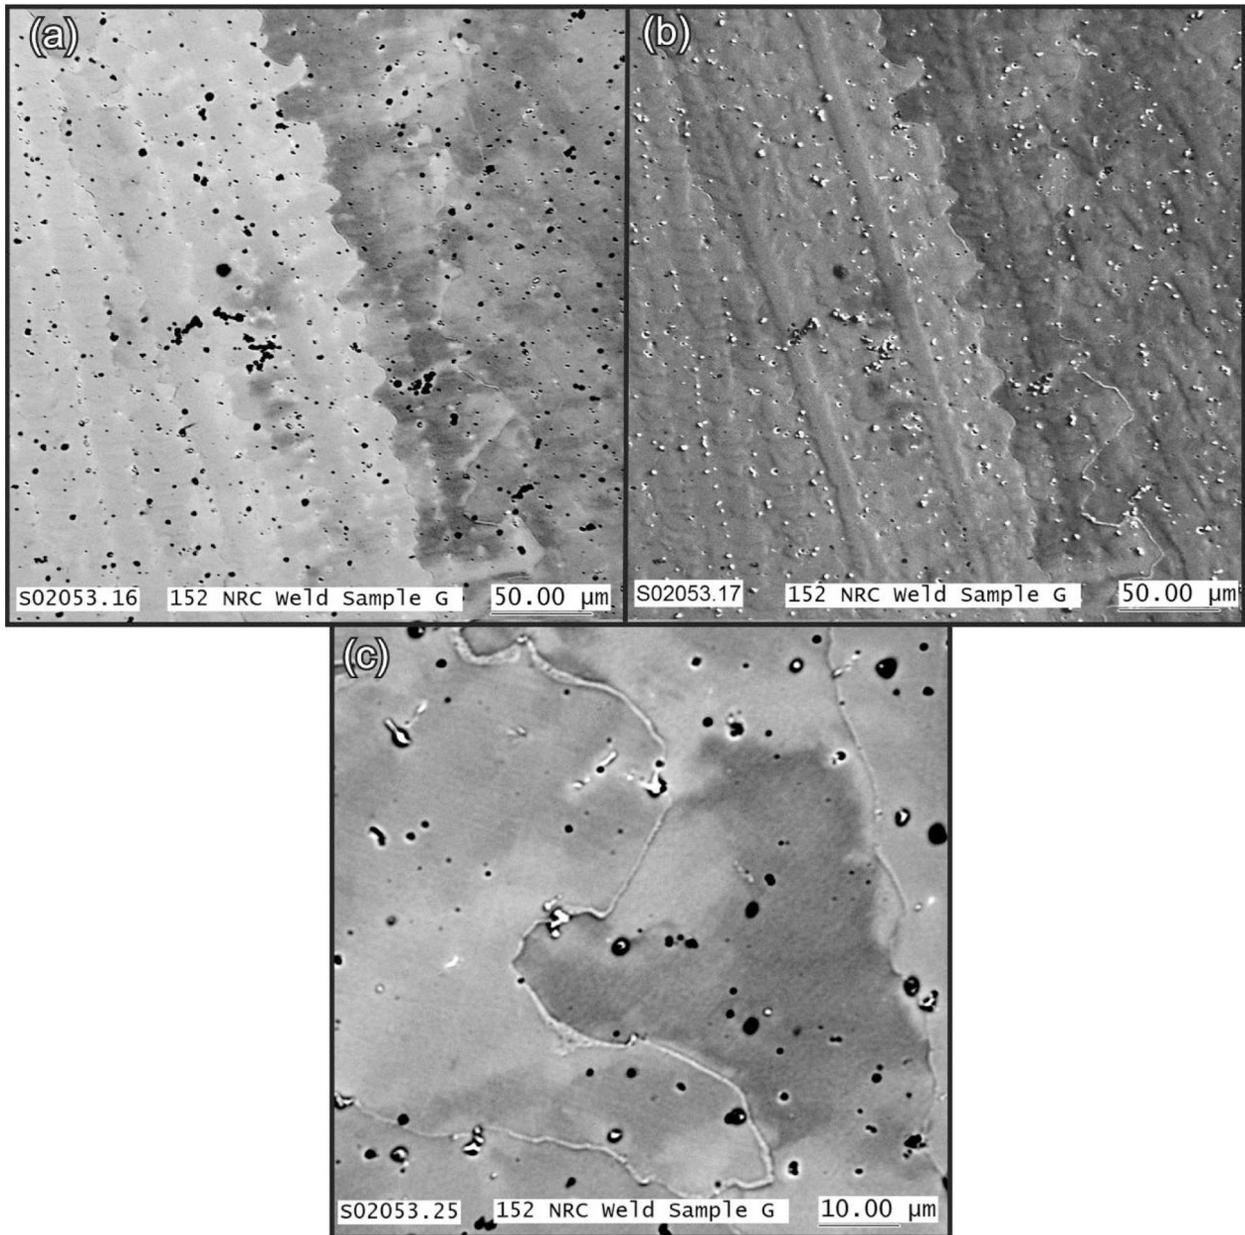
**Figure 6-8** Scanning Electron Microscope Images are shown from the Alloy 152 Weld Material. The image in (a) was taken using backscattered electrons, (b) and (c) was taken in secondary electron imaging mode.

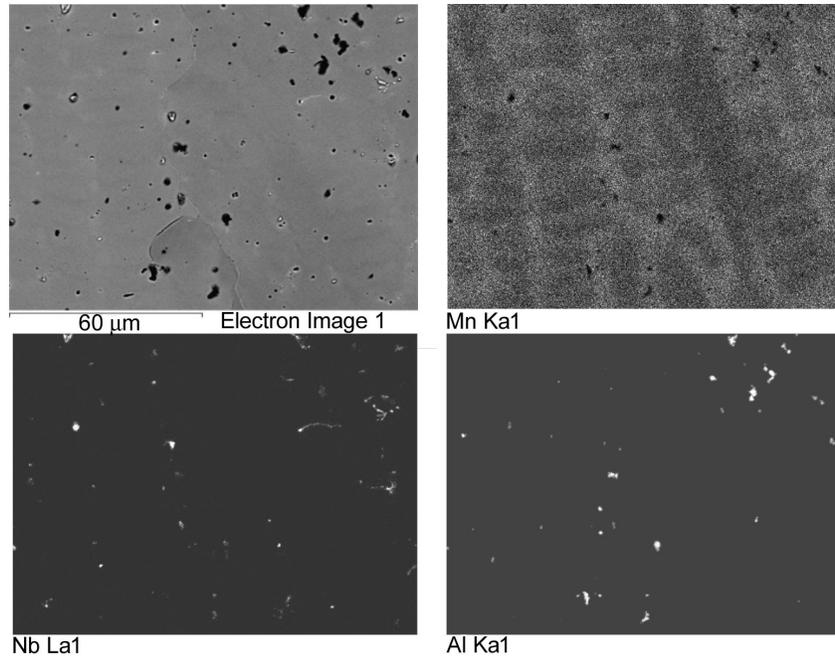
**Figure 6-9 SEM Secondary-Electron Image is shown Along with Composition Maps for Mn, Nb and Al. The Mn map indicates a slight degree of coring and the other two maps show the locations of the large NbC and the Ti-Al particles in the microstructure.**

Optical micrographs of sections X and G were compared to study the consistency of the weld passes along the length of the weld. Though they were similar and generally one could track an individual weld pass from one end to the other, it was decided that each individual CT sample blank would need to be examined to dictate the location of the CT sample pre-crack. Locations were selected to align the pre-crack with the elongated dendrites in a single weld pass for the alloy 152 CT samples. SEM examinations were carried out in Section X and revealed a standard dendritic structure with some long dendrites interspersed with smaller ones at the junctions of the weld passes. The boundaries between dendrites were often wavy. Examples of these are seen in Figures 6.7 and 6.8. Based on SEM examination of the microstructure of the alloy 152 weld, the weld is composed of a mixture of a cellular and columnar dendritic structure with heavy precipitation in both the interiors of the dendrites and the dendritic boundaries. Backscatter electron (BSE) images of the dendrites reveal a mottled contrast that is presumed to arise due to strain in the matrix. The carbides scattered throughout the dendrites show up as dark particles in BSE images, whereas in the secondary electron (SE) images, the particles typically show up as bright particles because they are sticking out from the specimen surface. Some of the dendritic boundaries etched differently than the surrounding matrix, possibly due to either compositional changes or from precipitation on the boundaries. Additionally, EDS composition maps were made to elucidate compositional inhomogeneities in the structure and identify the major second-phase particles. As seen in Figure 6.9, there is a

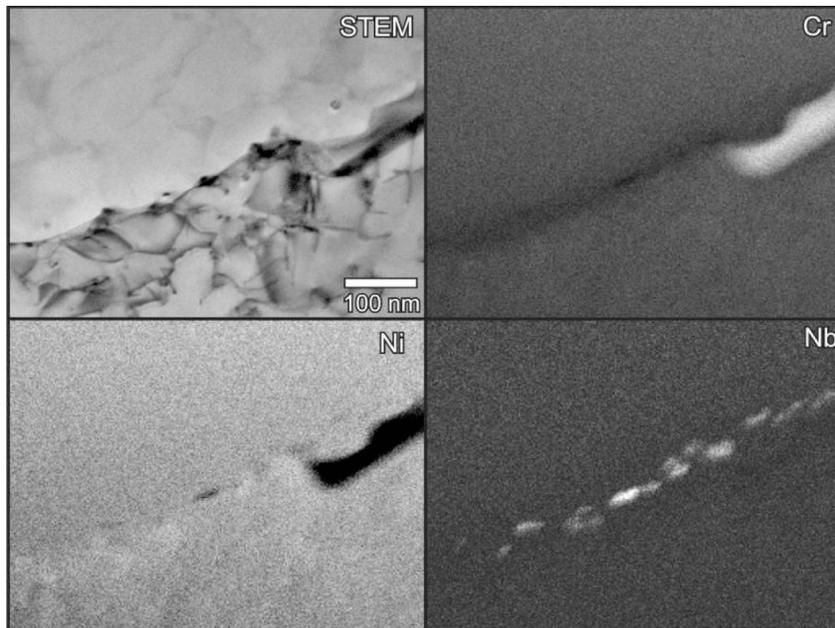
**Figure 6-10 An Example of a Different Dendritic Boundary that Shows a Single Large Cr-carbide, with Numerous Smaller Nb-carbides along the Boundary. In this case, Ti was not found associated with the Nb carbides.**

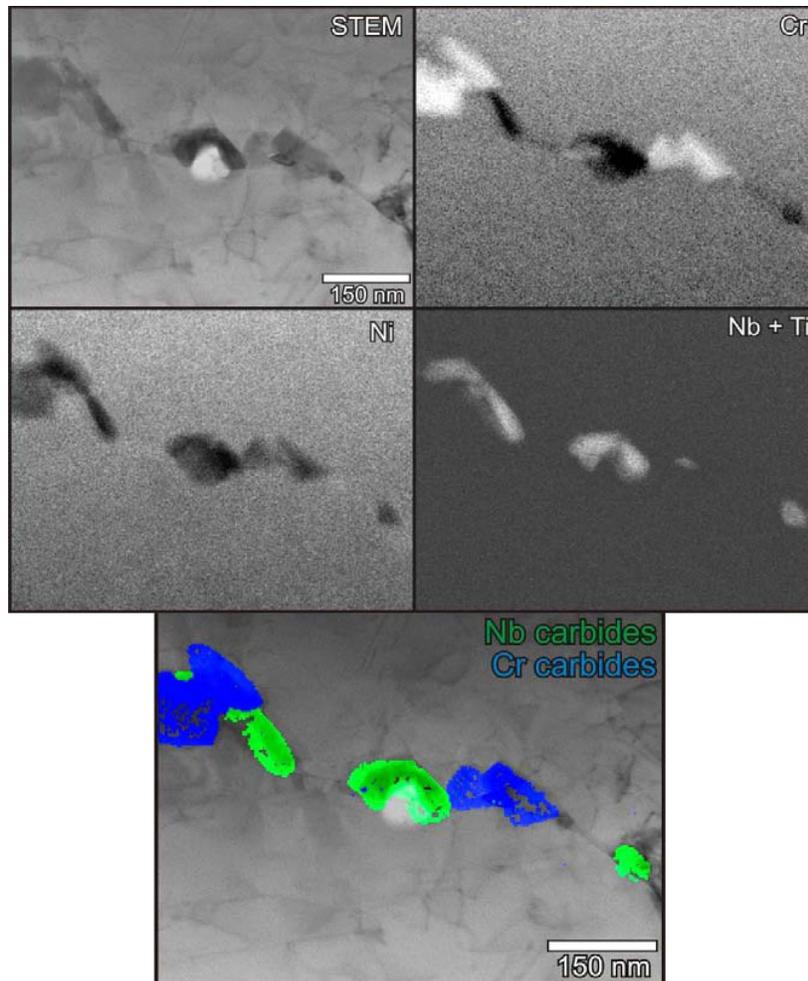
**Figure 6-11 Compositional Maps Taken in STEM Mode from the JEOL 2010F Transmission Electron Microscope Revealed that Both Cr- and Nb-rich Carbides are Present on the Boundary Between Two Dendrites. The bottom image reveals that the two carbide phases can sometimes be superimposed with each other. In this example, Nb and Ti were associated with the same particles.**

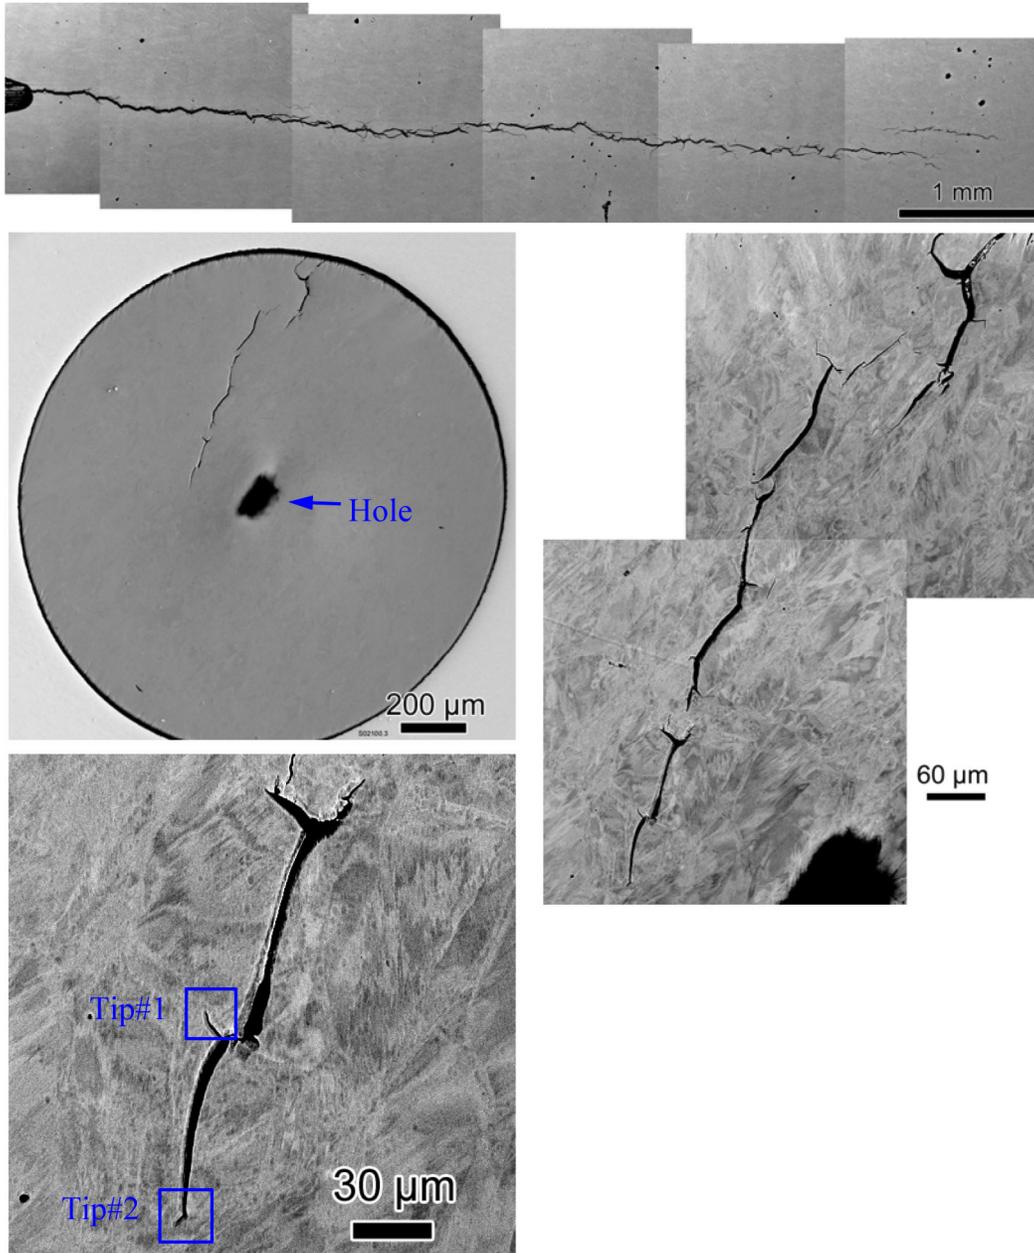
**Figure 6-12 Overall Composite Image of Crack in Cross-Section for Crack-Growth Sample CT005 is Shown in (a) with SEM of TEM sample 6025B, region near crack tip in (b). Perforation in TEM disc near the center was produced during ion milling. Higher magnification BSE images of crack-tip region are documented in (c) and (d). Metal matrix appears to be highly strained causing the contrast in the BSE images.**

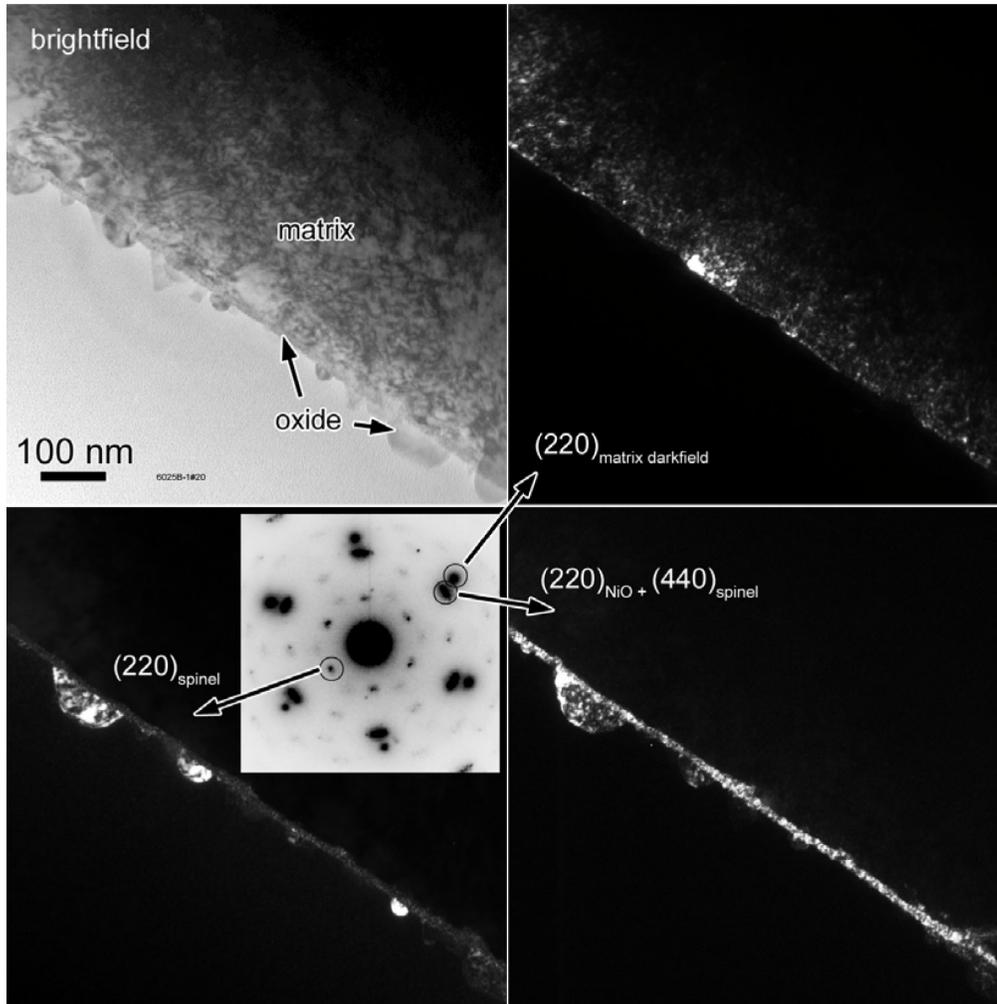
**Figure 6-13 Crack Wall Oxides in Cold-Worked 316LSS Test Sample CT005. (a) TEM brightfield image showing strained matrix and surface oxide. (b) Darkfield image taken with matrix reflection. (c) Darkfield image taken with spinel-only reflection, highlighting crystallites on outer oxide surface. (d) Darkfield image taken with coincident spots from spinel and FeO-structure oxide. Differences between (c) and (d) identify uniform oxide layer as FeO-type rather than spinel. Inset diffraction pattern from [111] matrix and parallel-oriented oxides.**

Electron diffraction analyses of the oxide crystal structures, performed by nano-area diffraction and darkfield imaging methods, identified the wall films as oriented single-crystal rocksalt-type oxide (FeO/NiO type), and the Fe-rich crystallites as spinel. This is illustrated in Figure 6.13 by differences between darkfield images taken with spinel-only and FeO + spinel type reflections. [Note: The cubic spinel and FeO-type crystal structures produced by corrosion of Fe-Ni-Cr alloys have the same lattice frameworks with different atomic site occupancies of the ordered cations. The FeO-type spots in diffraction patterns are a subset of the spinel reflections, so that oxide darkfield images can be taken to show the spinel regions only or both structures together.] Both oxide structures in the open cracks had cube-on-cube orientation relationships with the adjacent metal grains.

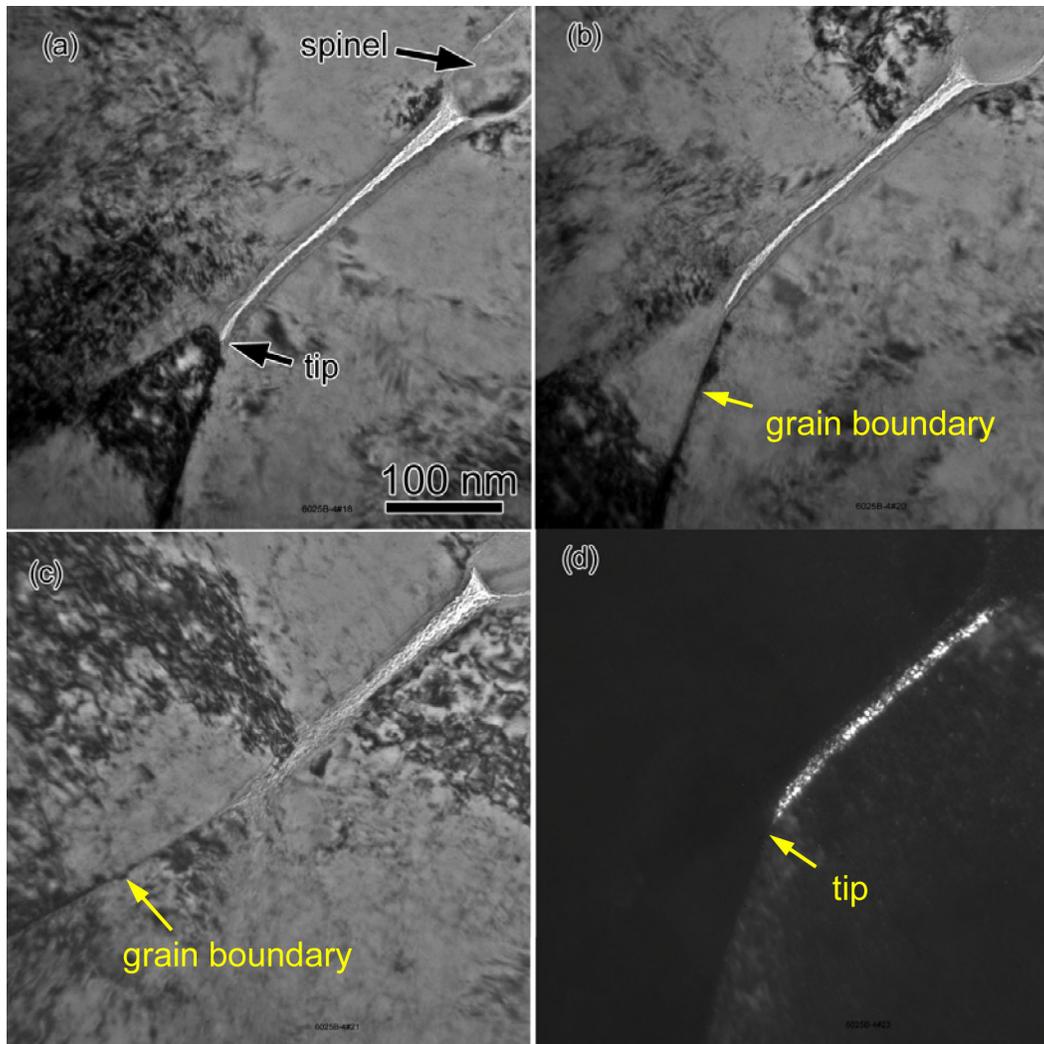
**Figure 6-14 Crack Tip#1 in Cold-Worked 316LSS Test Sample CT005. (a-c) TEM brightfield images taken at different tilts to show tip splitting at grain-boundary triple-point junction. Slightly underfocused image shows gap extending along crack center almost to tip. (d) FeO darkfield image highlighting oriented oxide layer on one side of crack. Oxide ends at tip.**

Tip#1 in this sample ended just past a grain-boundary triple-point as shown in Figure 6.14, with very short branches on both grain boundaries after the intersection. The boundary inclinations differed slightly so that different tilts were needed to bring the boundaries on edge. The image in Figure 6.14(a) shows the body of the crack on edge. A narrow gap along the crack center continues between the wall oxide layers until the crack intersects the grain boundary junction. The curved appearance of the grain boundary near the junction point is due to the oxide formed near the crack tip. When tilted to an inclined position as in Figure 6.14(c), the crack has a porous appearance caused by the Fresnel contrast at slight underfocus.

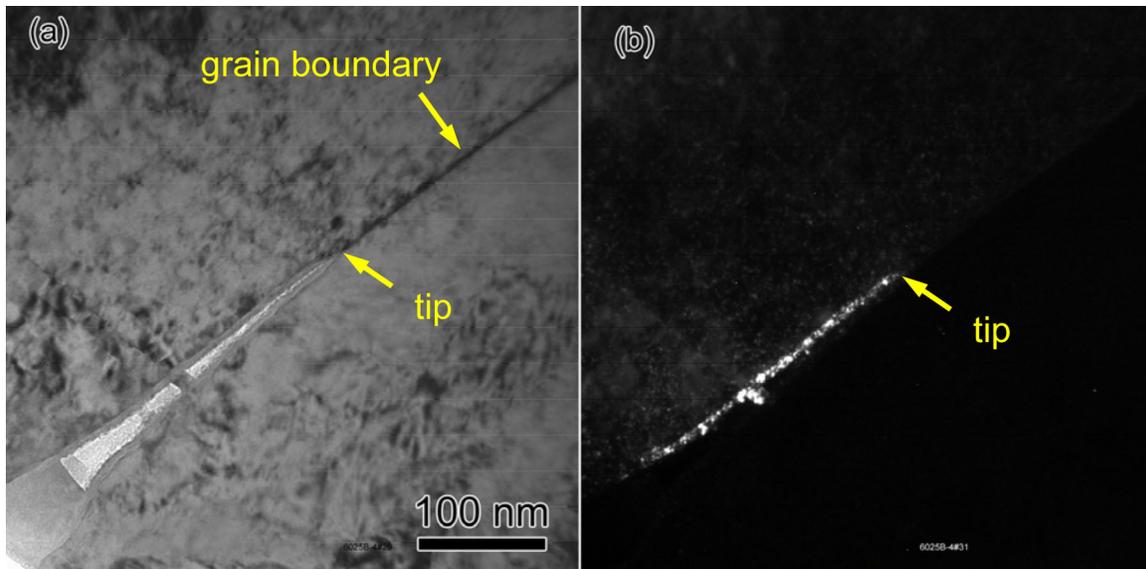
**Figure 6-15 Crack Tip #2 in Cold-Worked 316LSS Test Sample CT005. (a) TEM brightfield image with grain boundary viewed on edge. (b) FeO darkfield image highlighting oriented oxide layer on one side of crack.**

Tip #2 in Figure 6.15 ended with a sharp point along a particle-free section of grain boundary. This crack also appeared bulged around oversized spinel particles near the tip. It contained an epoxy-filled gap nearly to the end, and oriented narrow uniform films of Cr-rich oxide up to the tip. An oxide darkfield image in Figure 6.15(b) shows the uniform (single-crystal) oxide layer on one side of the crack. EDS maps revealed these oxide layers were present all the way to the
