2 Laboratory Testing and Evaluation of Expedient Flood-Fighting Barriers

Introduction

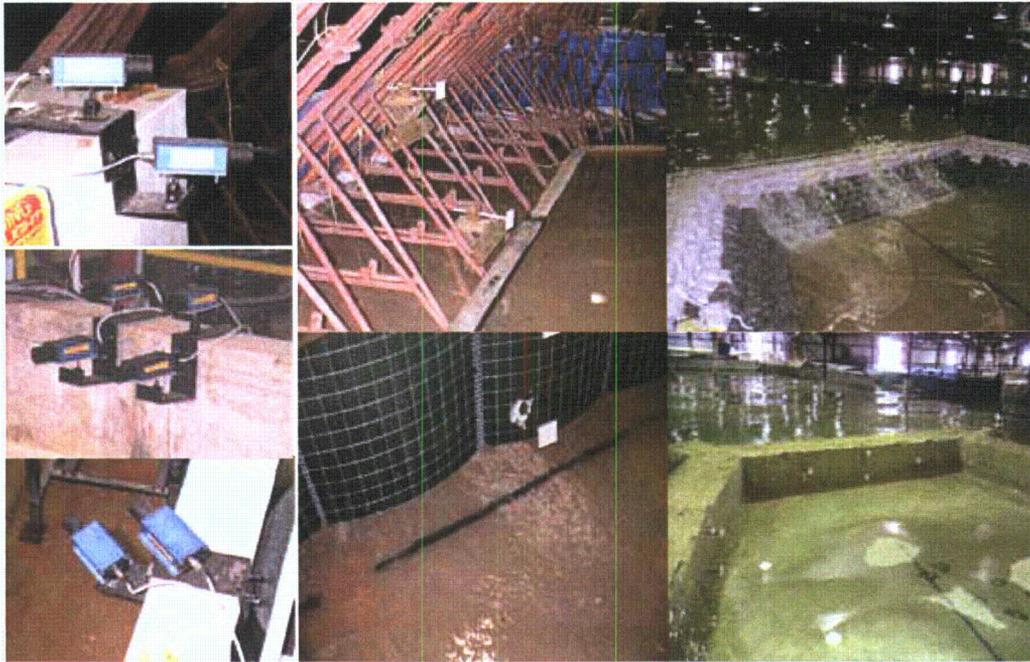
Figure 2-7. Lasers and laser targets. Left side, top to bottom: three pictures of lasers. Top middle: laser targets on Portadam. Top right: laser targets on sand bags. Bottom middle: laser targets on Hesco Bastion. Bottom right: laser targets on RDFW

The displacement (horizontal and overturning) of the protective side of the levee was measured with optical lasers having a maximum range of 50 m and an accuracy of ± 3 mm. Movement was measured with the lasers at the top and bottom of each levee wall section at its longitudinal center, and movement is monitored at either end of the center section. The lasers reflected off white standoff targets attached to the levee. These standoff targets were placed approximately 12 in. in front of the levee to allow uninterrupted laser measurements during water overtopping (Figure 2-7).

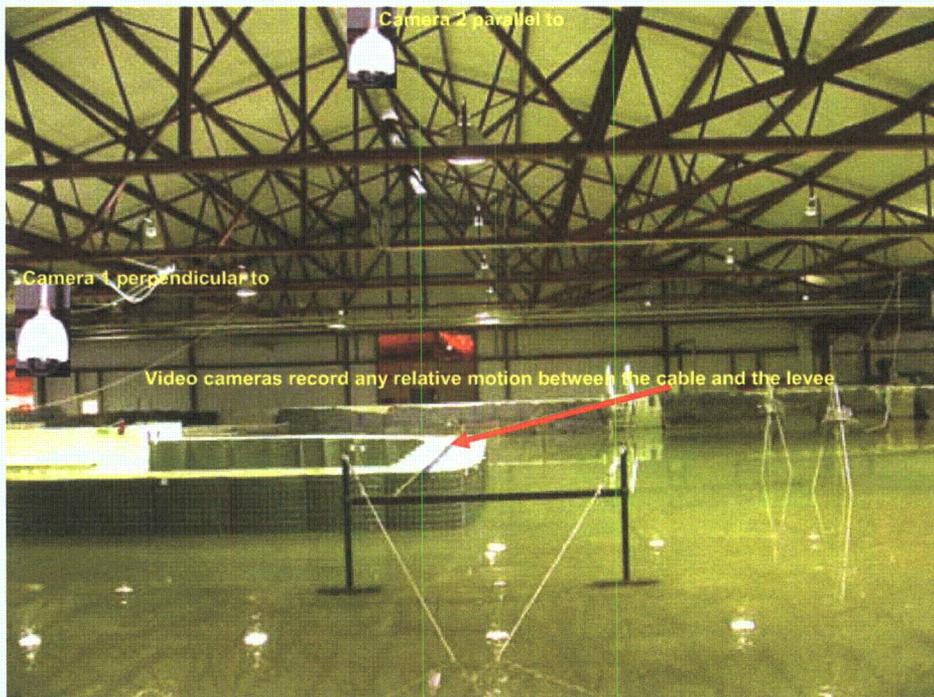
Figure 2-8. Relative movement and video monitoring system

perpendicular axes during the tests. The relative movement system is shown in Figure 2-8.

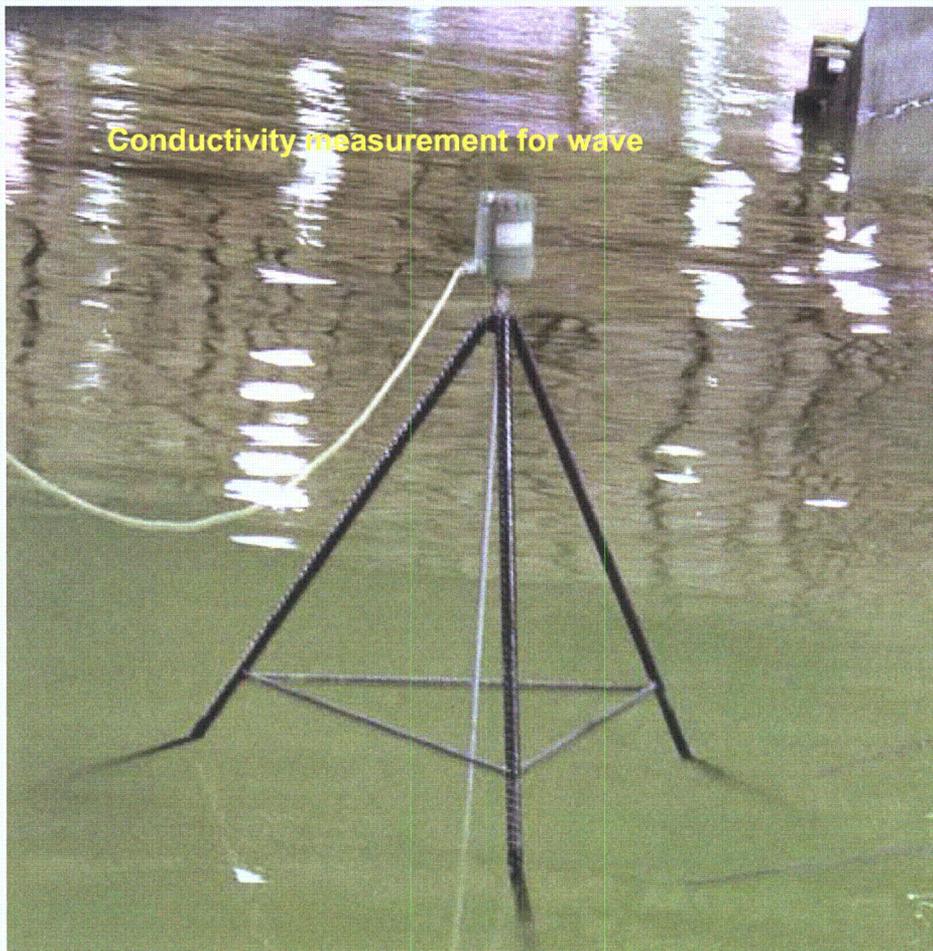
Figure 2-13. Separate wave conductivity rod, correlating waves with seepage

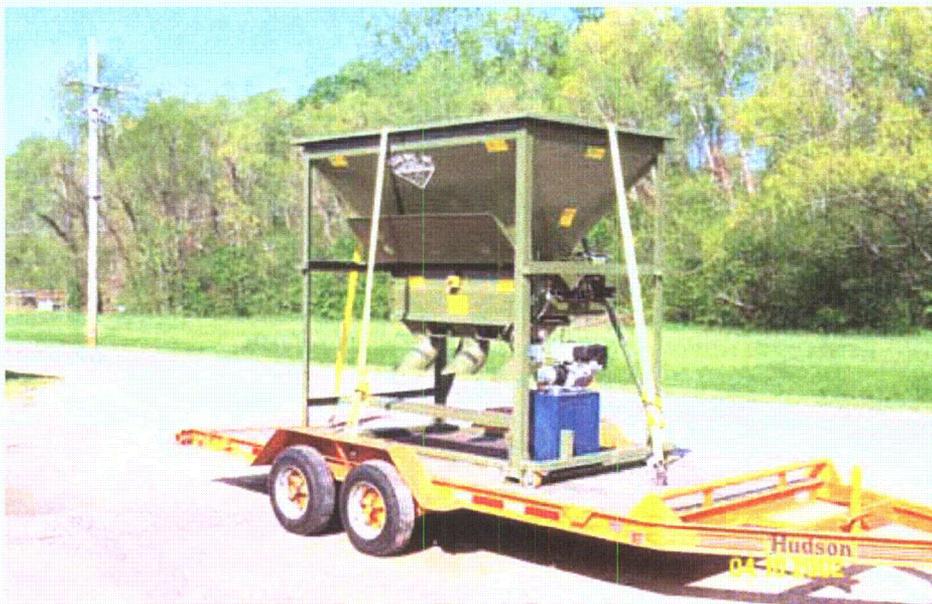
Figure 2-15. Hogan Manufacturing Co. sandbag filling machine used to build pretest sandbag levee

The Seattle District protocol allows the use of sandbags filled to two-thirds full and the bags occupy a space of 10 in. wide by 12 in. long by 4 in. high. The weight of a bag filled two-thirds full is determined by the density of the fill material. The bags filled in the 2002 test were 45 lb \pm 3 lb. The bags used to construct the sandbag structure were filled with a sandbag filling machine manufactured by Hogan Manufacturing Co. The Hogan machine uses a fixed volume auger and produces sandbags with constant volume (machine shown in Figure 2-15).

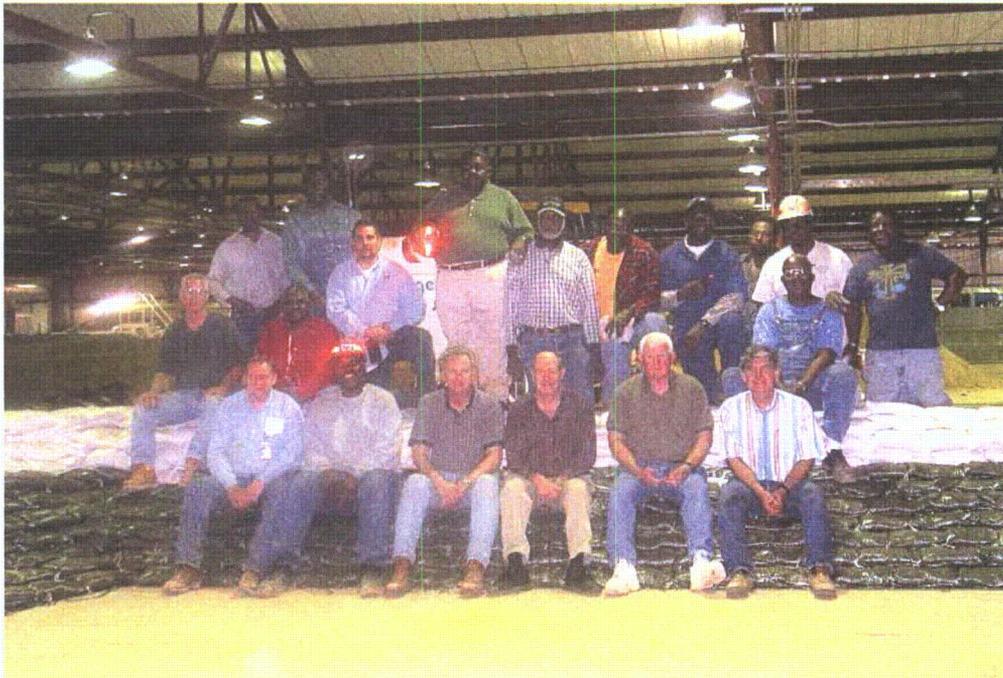
Figure 2-22. Complete sandbag levee with partial construction crew

The 25-lb sandbags filled by the Vicksburg District when laid flat were about 10 in. wide, 12 in. long, and 3 in. high. The maximum base allowed by the testing protocol is 10 ft wide or 12 bags wide (120 in.). To have two sandbags on top would require only 11 layers or 33 in. high. One more 2-wide layer (layer 12) was placed on top of layer 11 to reach the 36-in. height. Since not all of the sandbags were 3 in. thick, there were high and low places on the levee. Various sandbags were laid alongside the top layers on either side of the levee; however, they were not tied into the main sandbag structure. This made a weak zone that was discovered during hydrodynamic testing. The finished levee and partial crew is shown in Figure 2-22.

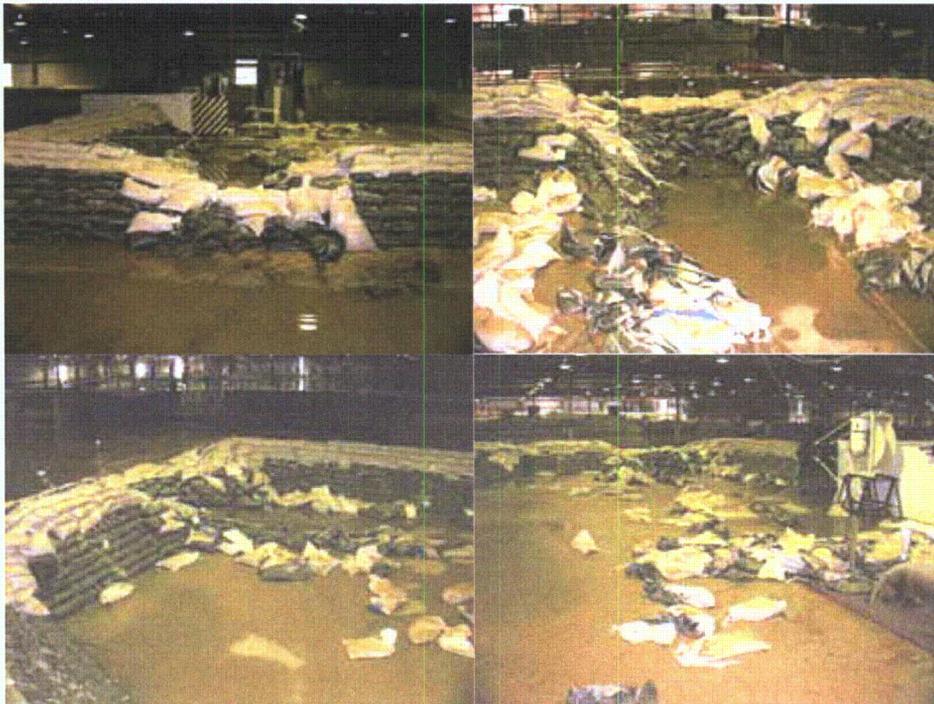
Figure 2-39. Sandbag levee after failure

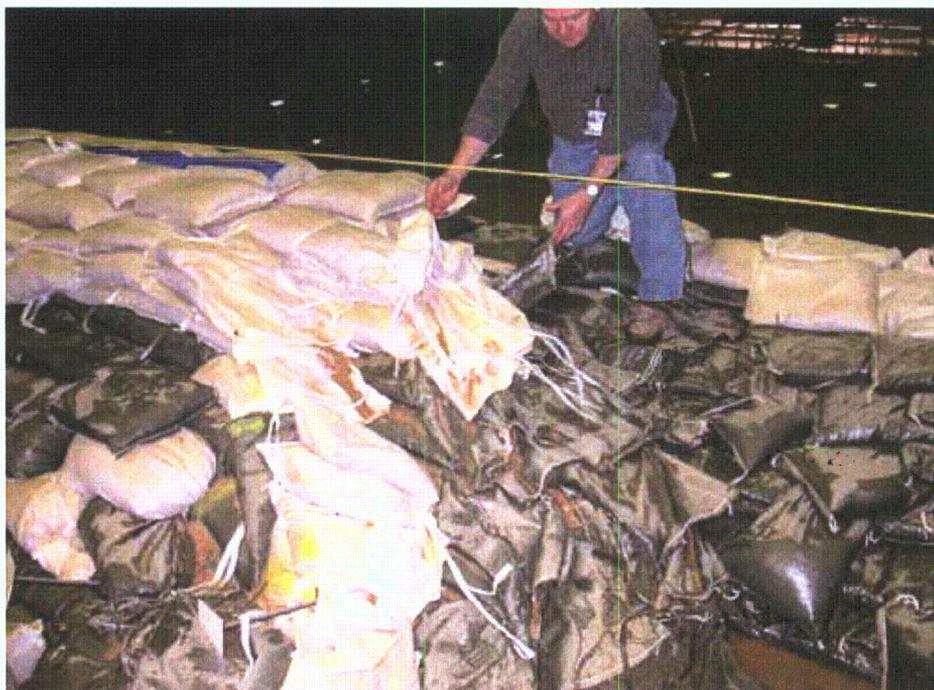
Figure 2-40. Sandbag levee autopsy after overtopping

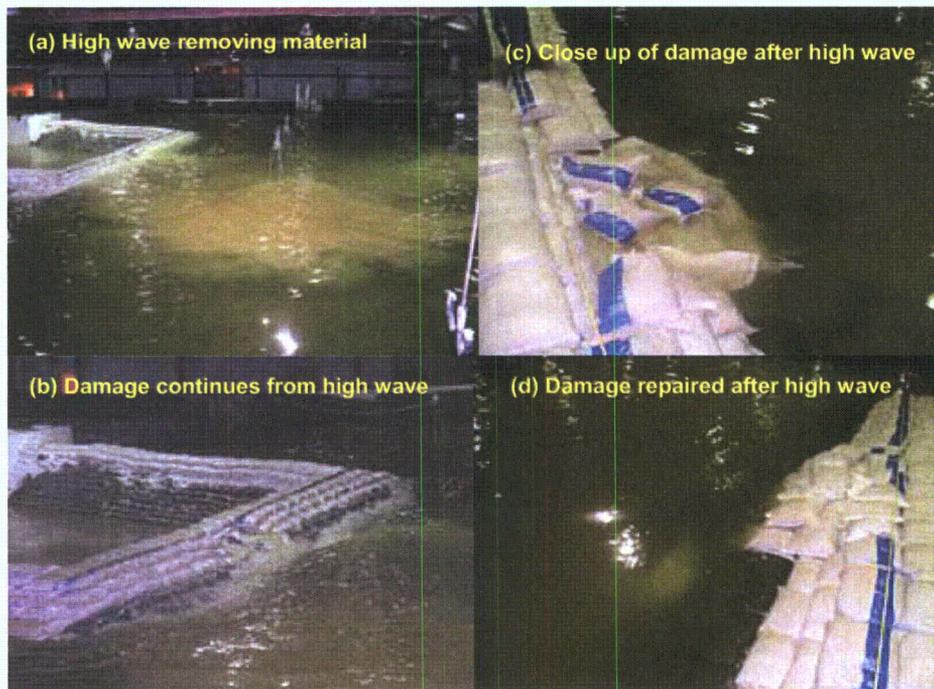
Figure 2-41. Sandbag levee damage and levee after field repair 1

Repair 1 was required to repair damage from the dynamic high-wave test performed with the pool at 66 percent of levee height. A four-man crew took 30 min (total time 2 man-hours) to remove damaged sandbags, reposition existing sandbags, and fill and place new sandbags on the pool side of the barrier. A Bobcat® with operator transported the new sandbags from the sand pile to the barrier.

The levee experienced damage at the center section. Sandbags were pulled back into the pool as the waves overtopped and water rushed back into the pool as the waves moved back toward the wave machine. Figure 2-41 shows the levee during the test, the damage after the test, and the levee after Repair 1.

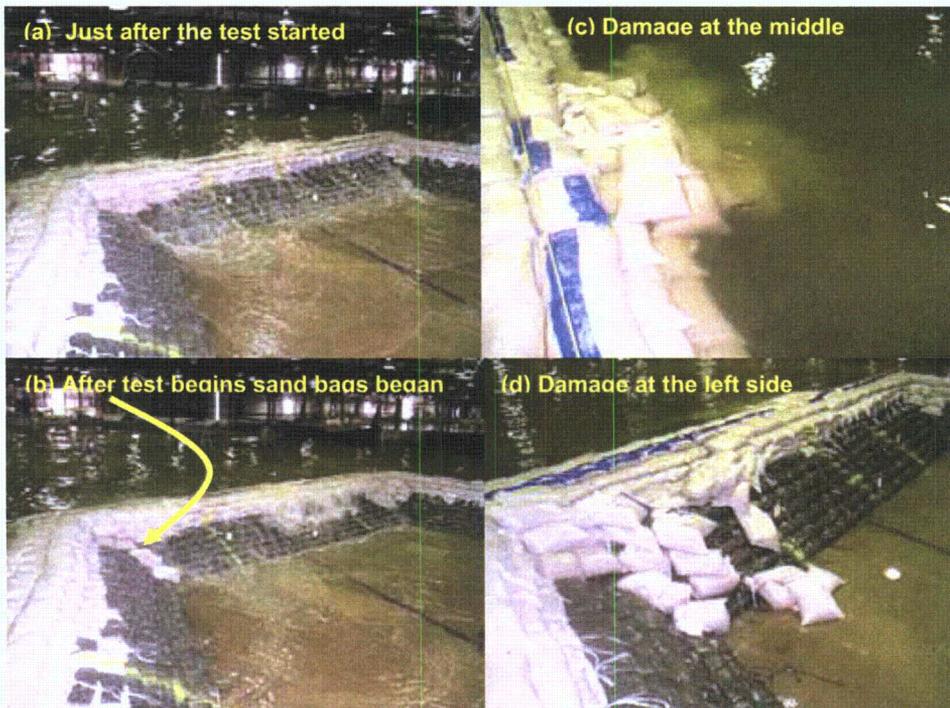
Figure 2-42. Damage to levee during the 10- to 13-in. waves, water at 80 percent of barrier height

Repair 2 was needed after testing with the pool at 80 percent of levee height and 10- to 13-in. waves. A four-man crew took 30 min (total time 2 man-hours) to remove damaged sandbags and repair the barrier.

Overtopping caused by the 10- to 13-in. waves resulted in movement of individual sandbags in both directions from the crest of the structure. Figure 2-42a-d shows the progressive movement of sandbags during and after this test.

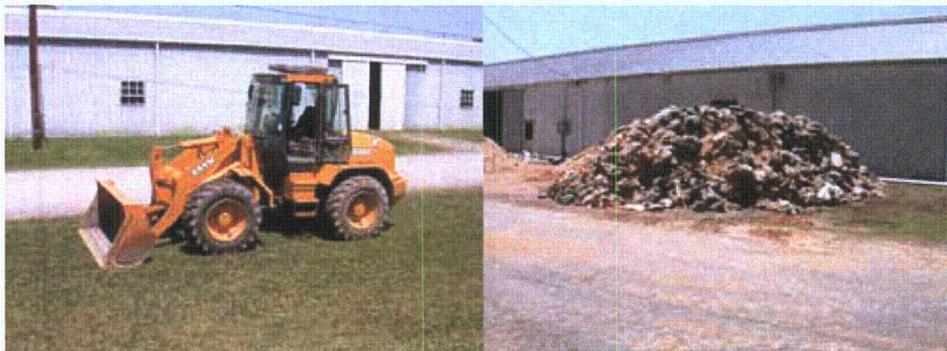
Figure 2-43. Heavy equipment used to disassemble sandbags and waste sandbags

The sandbags were broken and torn during removal and were not fit to be used again. The sandbags were piled into one large stack, similar to that seen in real-world flood fights. The equipment and sandbag pile can be seen in Figure 2-43.

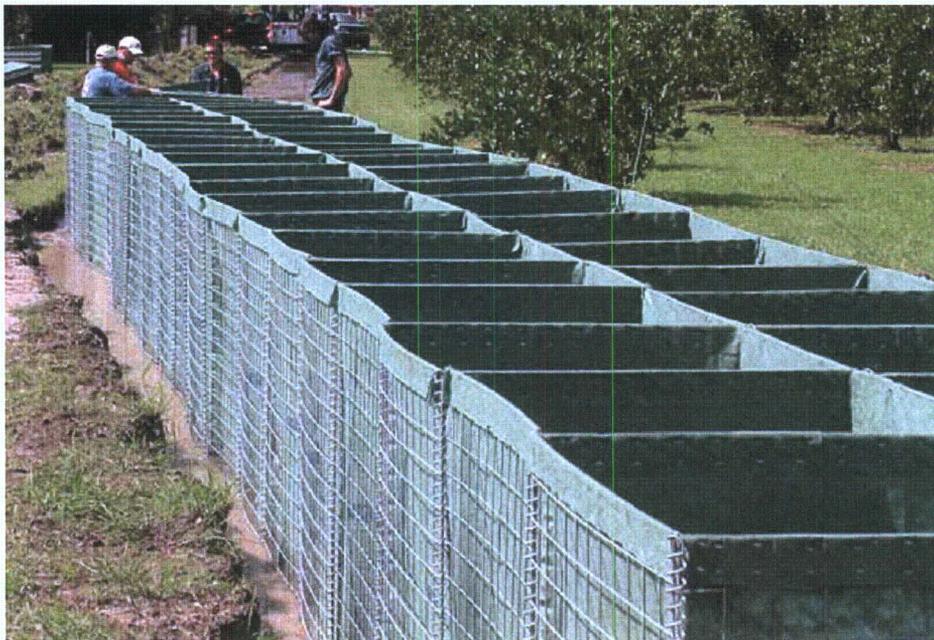
Figure 2-44. Hesco Bastion Concertainer® basket units, assembled and empty

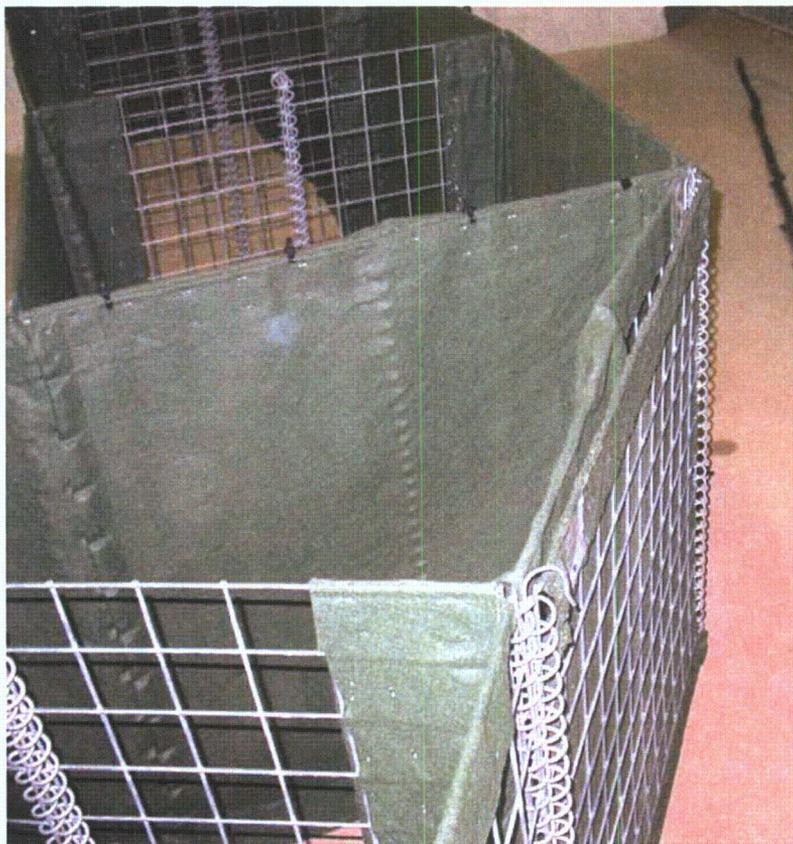
Figure 2-49. Top view of angled unit at intersection of left and center walls

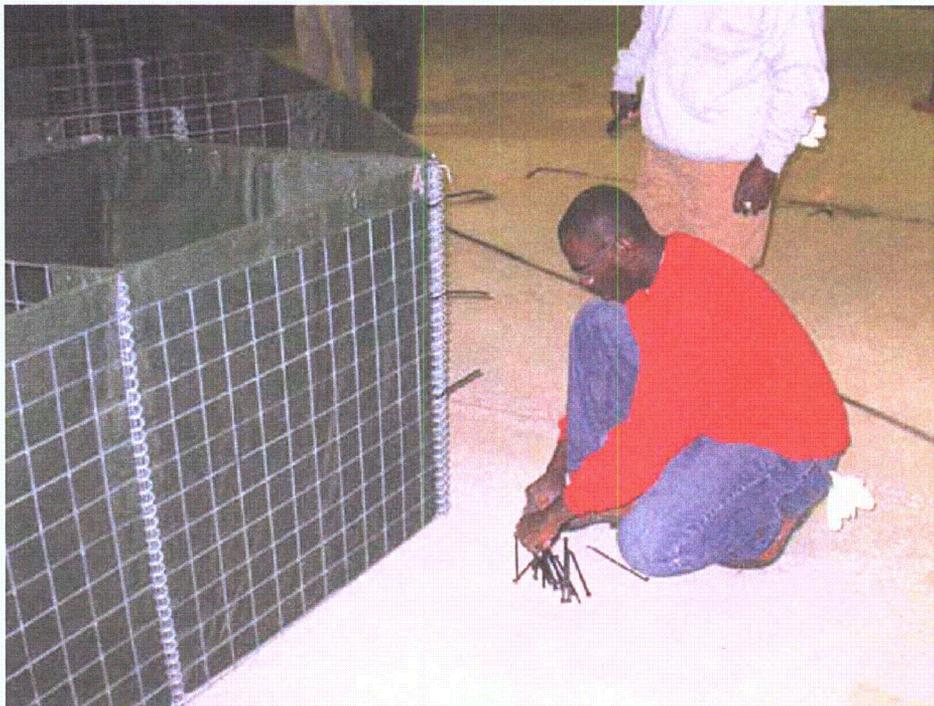
Figure 2-50. Cable ties at joint connections

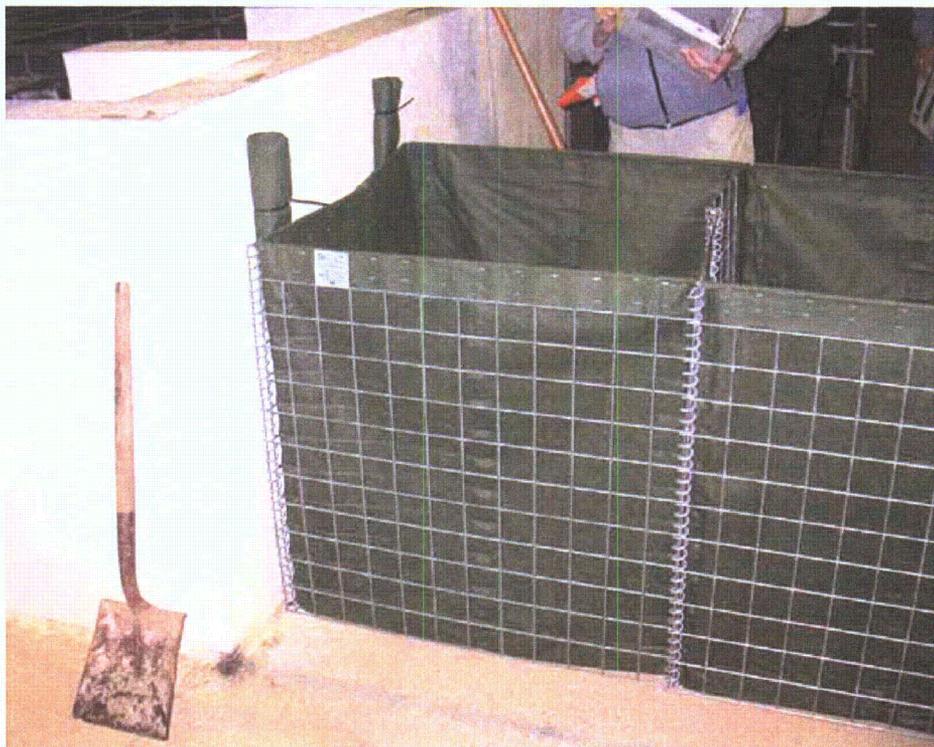
Figure 2-51. Right concrete wall abutment

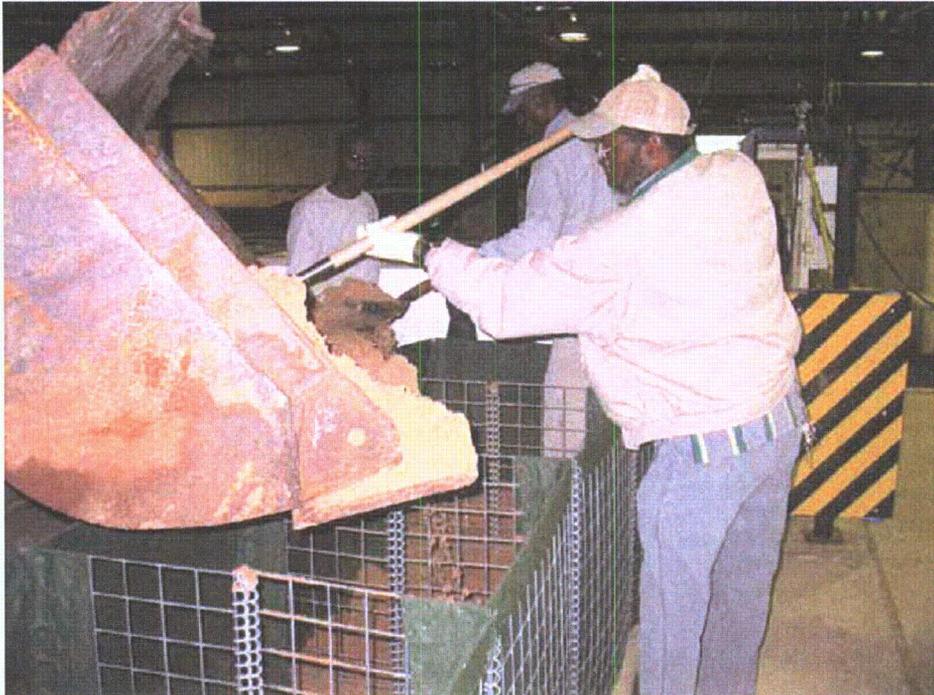
Figure 2-54. Shoveling sand into unit

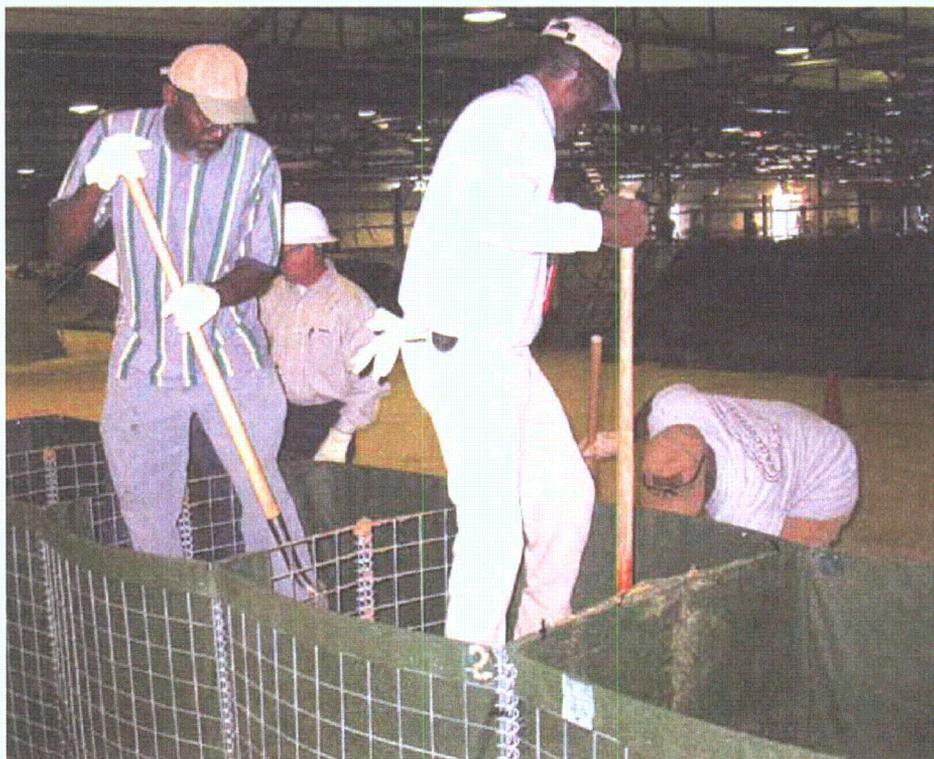
Figure 2-55. Leveling and compacting sand within each unit

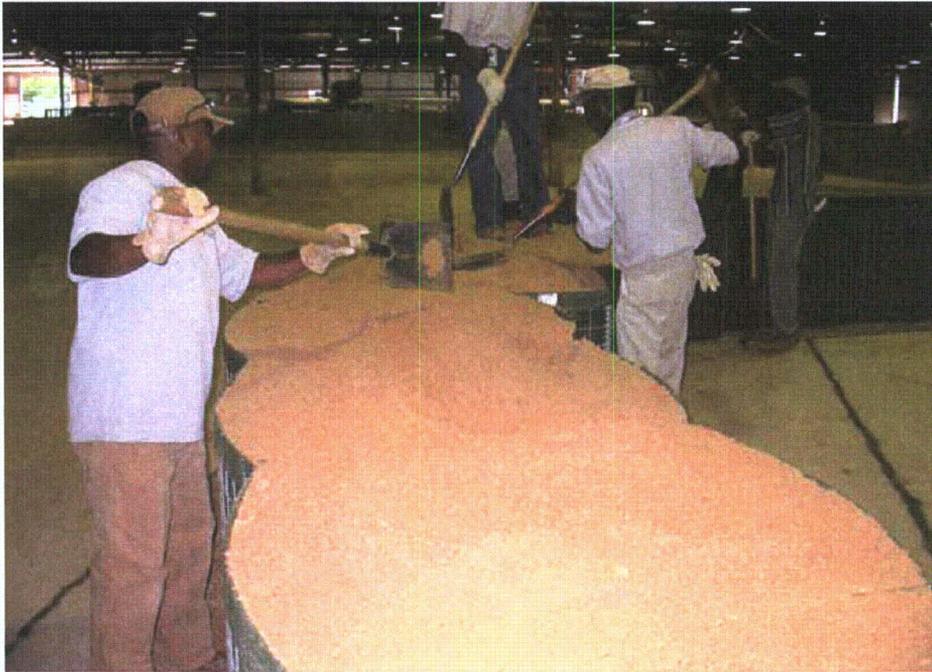
Figure 2-56. Filled with sand, view from left concrete wall abutment

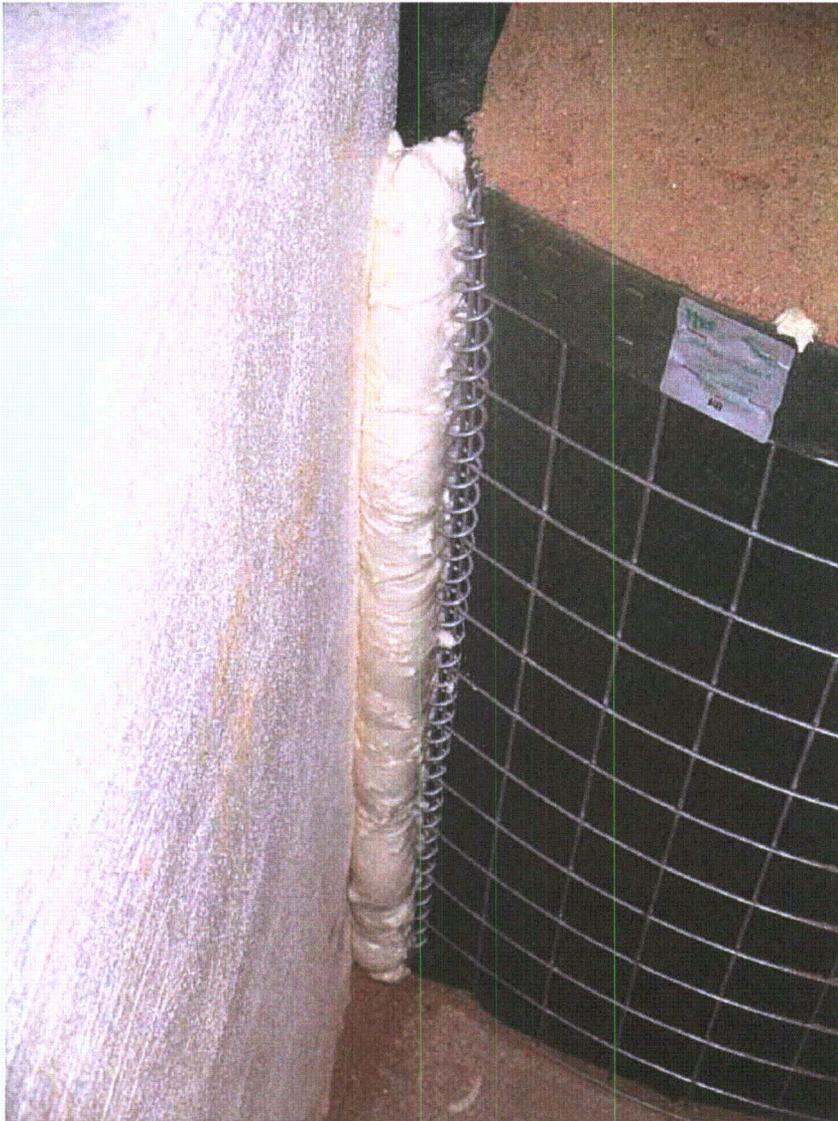
Figure 2-59. Expanded foam at abutment with concrete wall

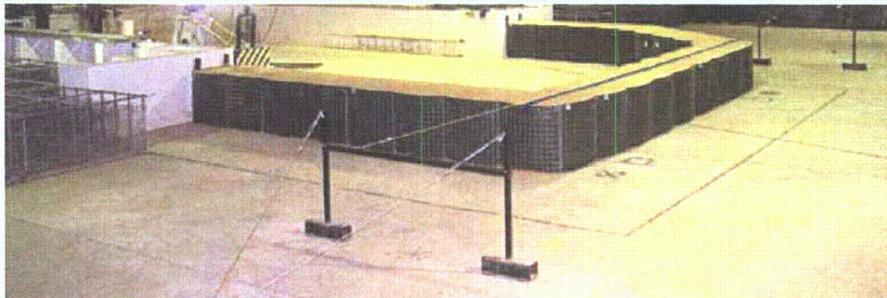
Figure 2-61. Center wall displacement monitoring system

Prior to filling the reservoir to begin the hydrostatic tests, laser targets were positioned in the levee walls and sealed with expandable foam (Figure 2-60). The completed structure was instrumented with the center-wall displacement monitoring system and was readied for static testing (Figure 2-61). The vendor representative agreed in writing that the levee had been constructed properly and was ready for testing.
