SRNL-ESB-2008-00017

Re: Video Survey of Saltstone Vault 4, Cell G

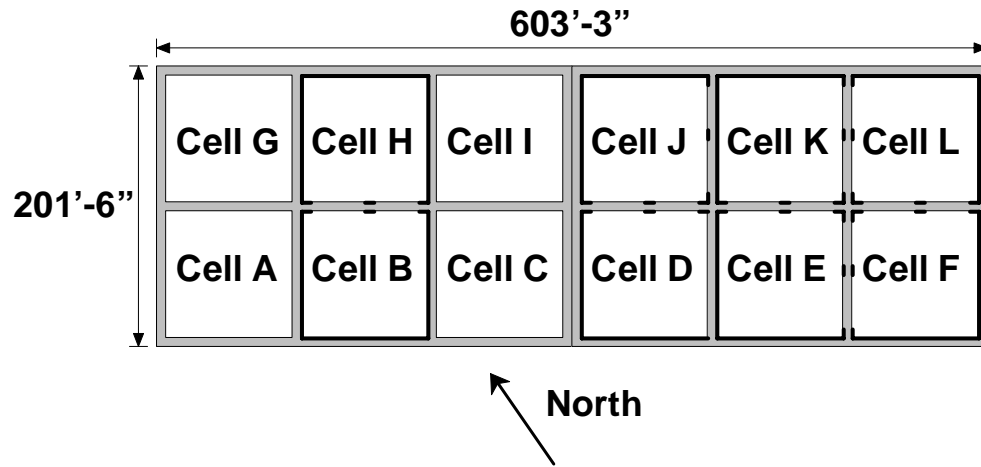
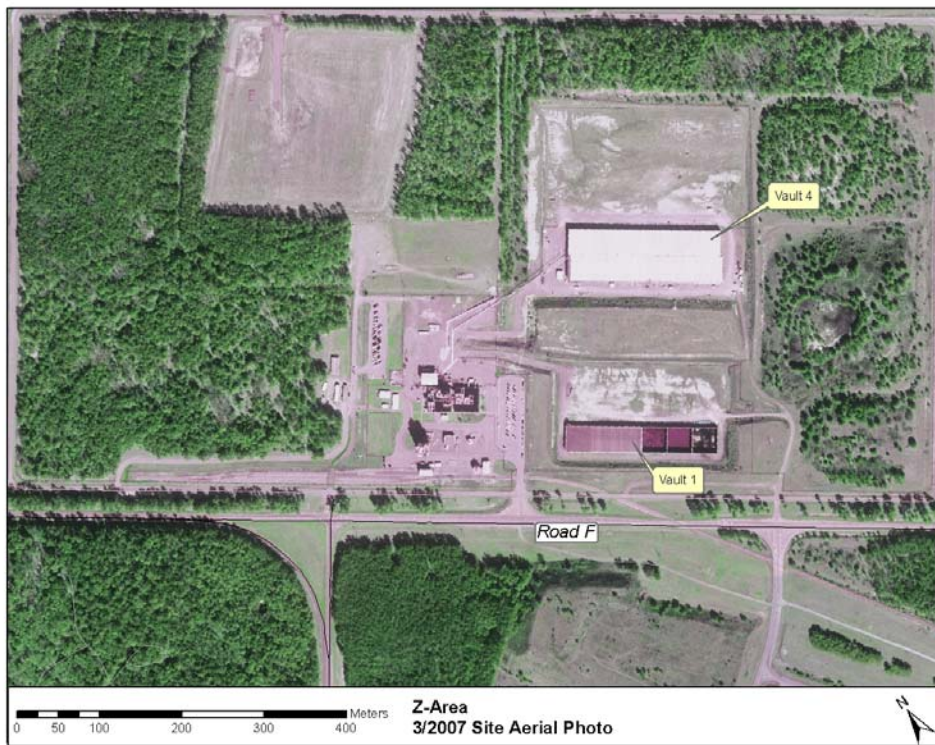
Figure 1. Layout of Saltstone Vault 4 showing Cell G where the video survey was performed.

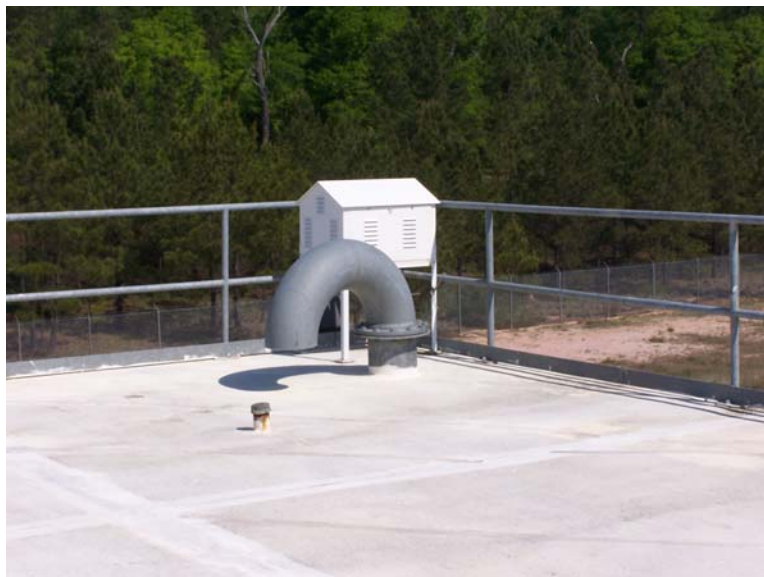
Figure 2. Twelve inch diameter pipe vent located near the north corner of Saltstone Vault #4 Cell G. The pipe elbow was removed to provide an access point for lowering the remote controlled camera.
