# Calculation Continuation Sheet

Calculation No.  
T-CLC-P-00004

## 1 INTRODUCTION AND SCOPE

### 1.2 Purpose

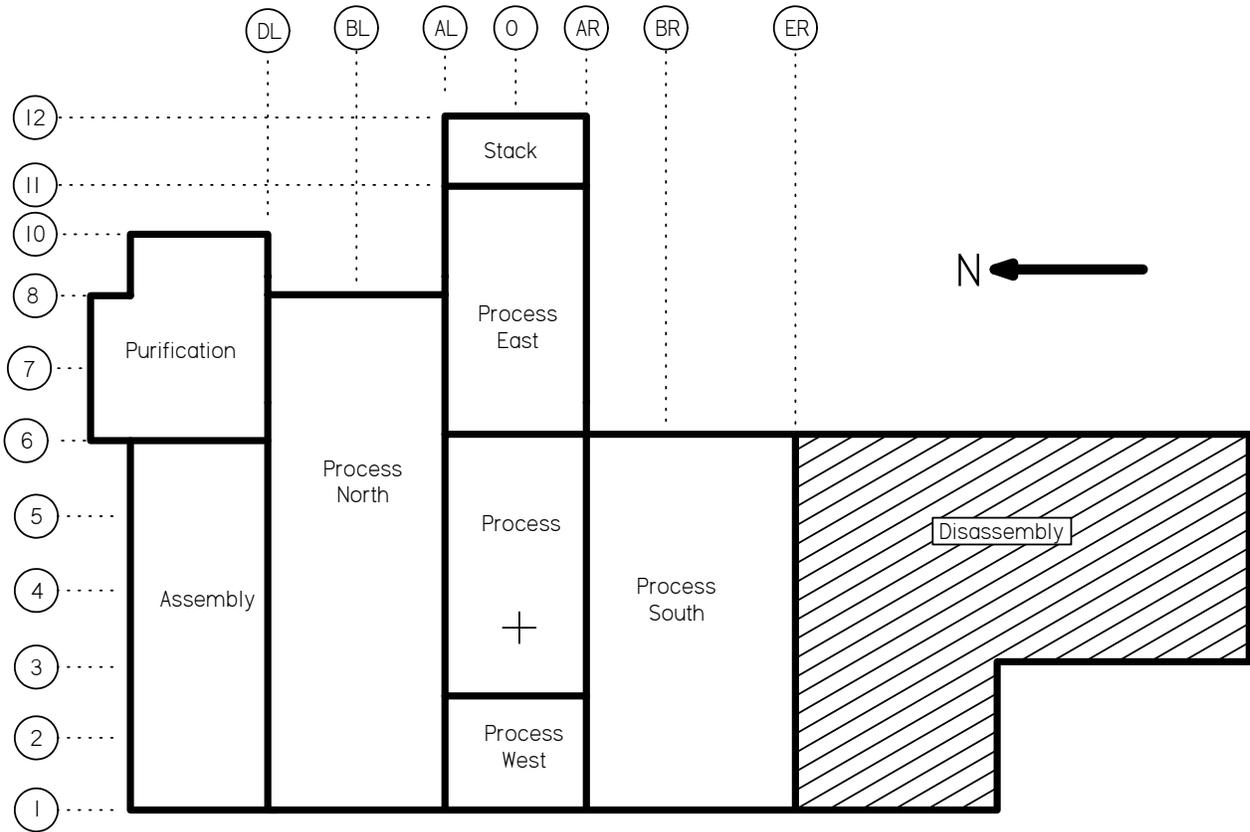
Figure 3.1 General Areas/ Layout of 105-P Facility.

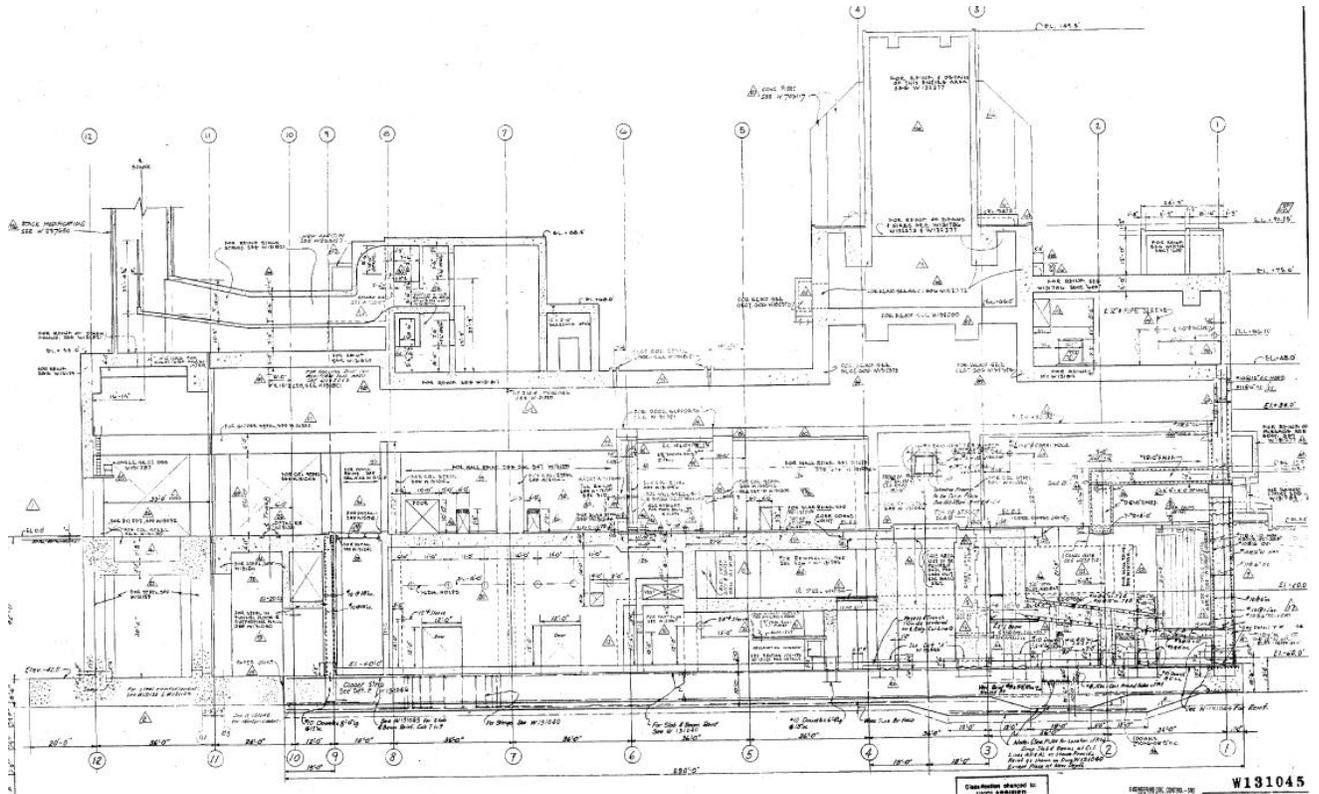
Figure 3.2 Cross-Section of 105-P Facility (looking south).

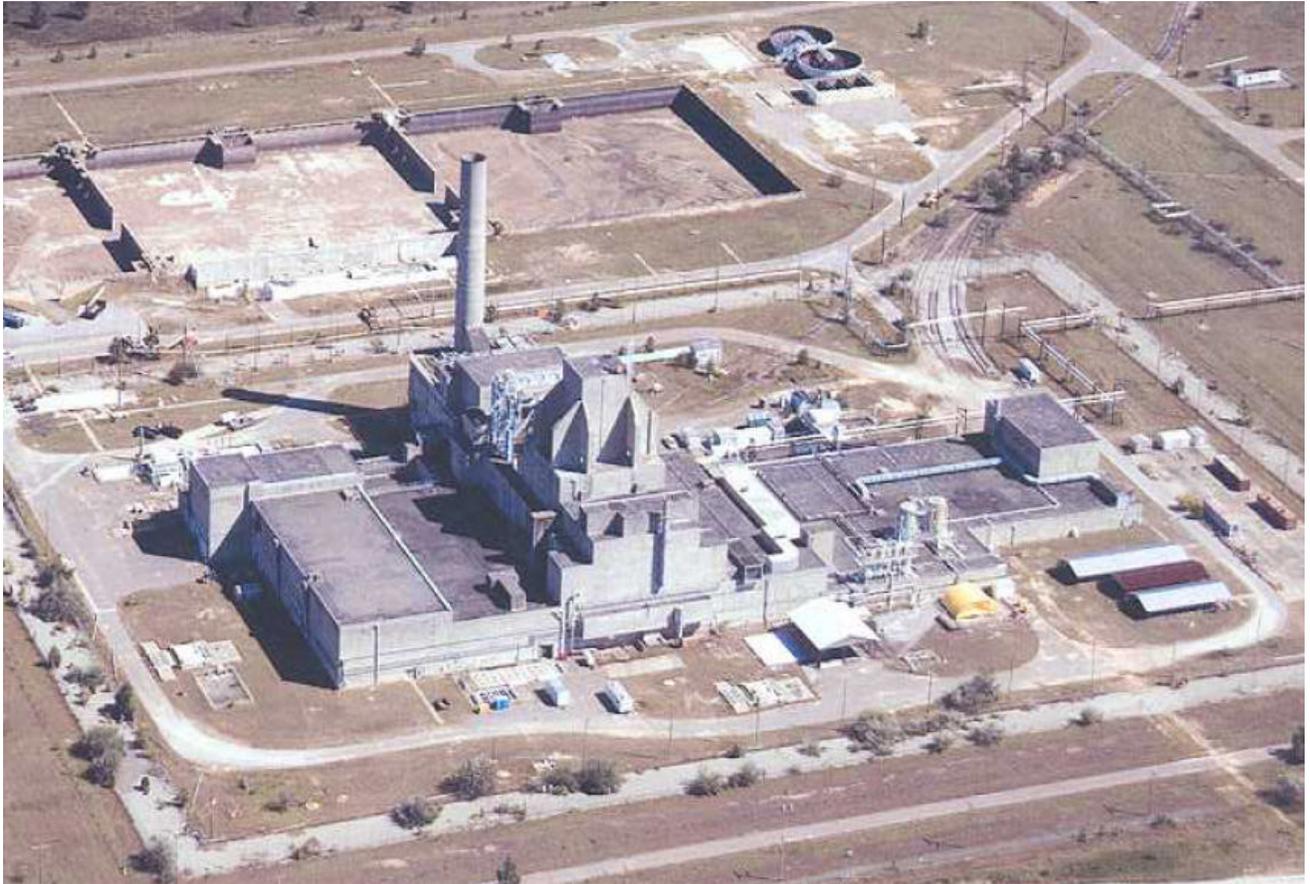
Figure 3.3 Aerial Picture of 105-P Facility.

The general portions of the structure that are considered are the process room, areas north, south, east, and west of process room, assembly area, purification, and stack. These general areas these portions cover is shown in Figure 3.1. Figure 3.2 shows a cross-section through the structure and Figure 3.3 shows a recent aerial photograph of the facility.

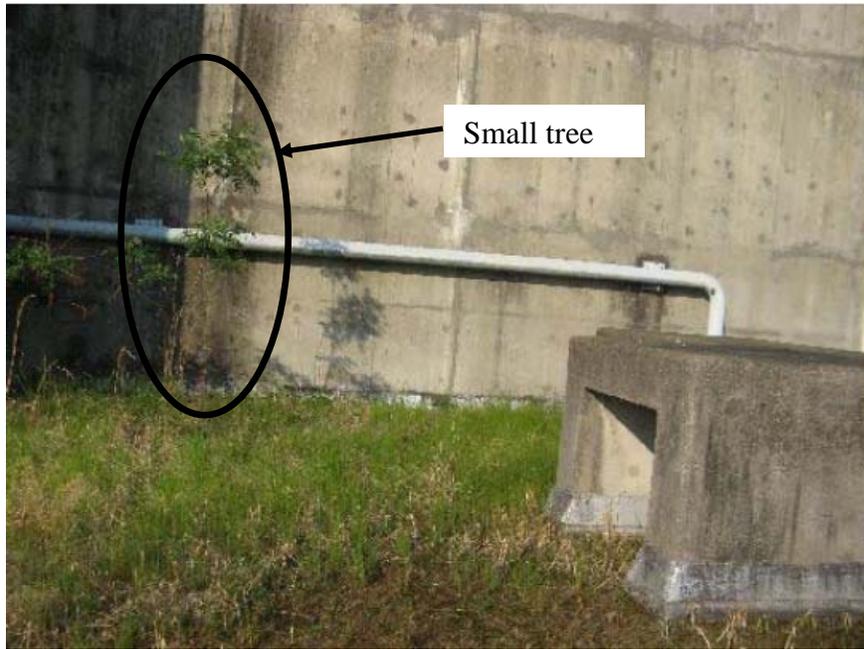
a) El +34 near Elevator #2.

b) El +48 under shield door frame

Figure 6.1 Vegetative growth of roof of 105-R [19].

The length of time for this to occur is very difficult to gauge. Lack of maintenance on R-reactor has allowed small trees and grasses to grow on the roof in certain areas as shown in Figure 6.1 [19]. This has occurred in less than 25 years. However, this vegetative growth has not yet caused any water infiltration or rebar corrosion according to visual observation. However, water infiltration and rebar corrosion would eventually occur.

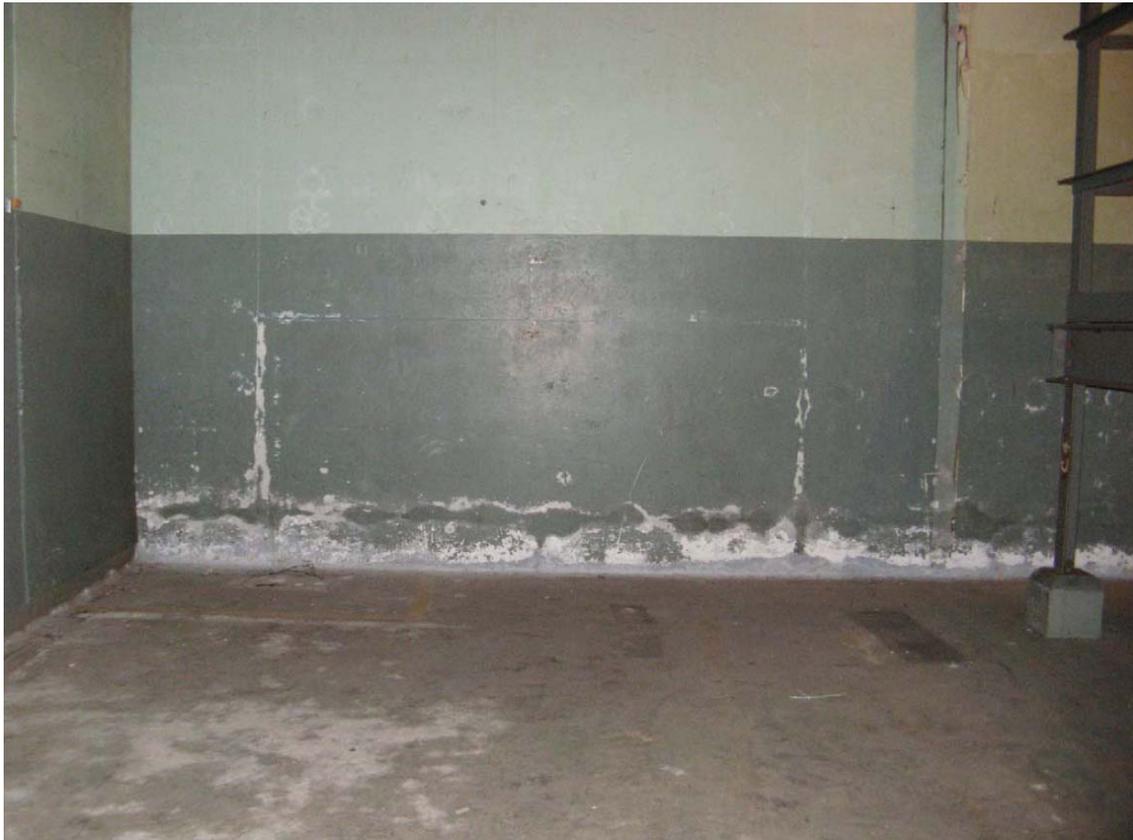
Figure 6.2 Efflorescence in R-reactor Assembly area [19].

A primary weak spot for water infiltration into the structure will be the expansion joints. Expansion joint degradation has not been observed in 105-P, but has been observed in other reactor buildings. For example, in R-reactor the expansion joint between the Assembly and Purification areas allows for water build-up in the 2 inch gap between the buildings, producing a large amount of efflorescence, as shown in Figure 6.2. Left as-is, the expansion joints would likely degrade and allow water infiltration within 50-100 years.

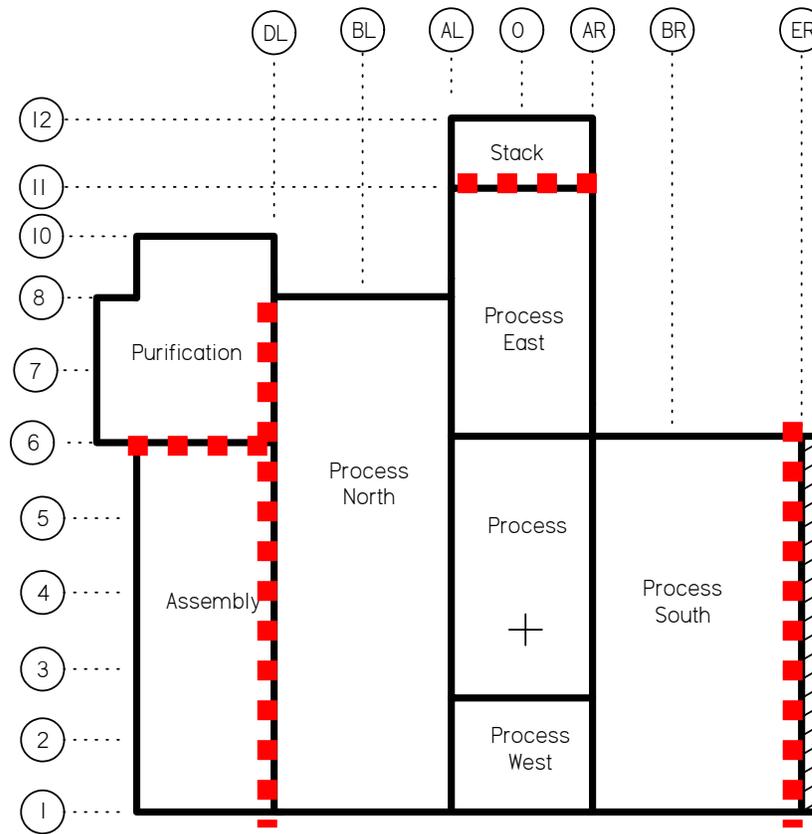
Figure 6.3 Expansion joint locations.

The expansion joint locations in 105-P are shown in Figure 6.3. It is noted that all the expansion joint locations are away from the Process room and reactor vessel. Degradation of the expansion joints would allow for more water infiltration into the structure, but not in critical areas. Only localized degradation would be expected in the roof slab around the joints. The only potential exception is the joint between the Assembly and Purification areas where the wall could be degraded. This would still have no effect on the process room however. The expansion joint between the process and disassembly building will be removed with the above grade portion of the disassembly building.
