Re: Florida Power & Light Company
Proposed Turkey Point Units 6 and 7
Docket Nos. 52-040 and 52-041
Response and Response Schedule to NRC Request for Additional Information
Letter No. 043 (eRAI 5875) SRP Section - 02.05.03 Surface Faulting

Attachment : FPL Response to NRC RAI No. 02.05.03 - 1 (eRAI 5875)

NRC RAI Number: 02.05.03-1 (eRAI 5875)

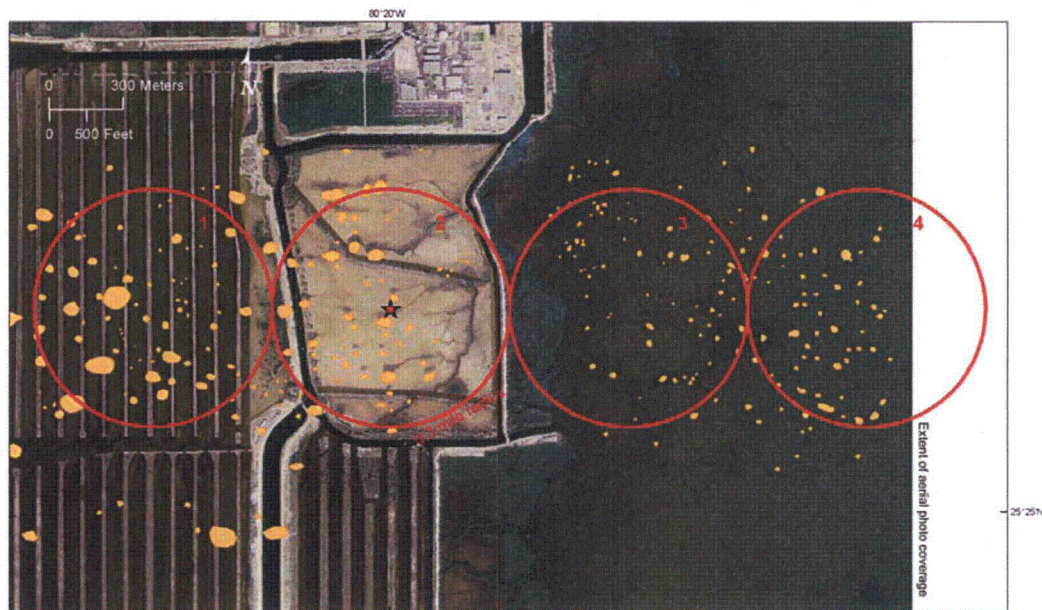
Figure 1: Areas evaluated for size and density of vegetated patches

Further analysis of the submarine vegetated patches was conducted. Four circular areas with radii of 0.3 mi were evaluated for density of surficial depressions or vegetated patches. Two onshore circles were drawn, one centered on the site (circle 2) and one just west of the site (circle 1). Similarly, two offshore circles were drawn, both east of the site (Figure 1). Subaerial depressions were interpreted from 1940 aerial photography (1:40,000 scale), and submarine vegetated patches were interpreted from 1986 aerial photography (1:40,000 scale) (Figure 2.5.3-202 and Figure 1). Detailed mapping was performed to a scale of about 1:2,000 to define the locations and extents of patches within, and immediately surrounding each circular area. Data from the two subaerial circular areas (circles 1 and 2 in Figure 1) and the two submarine circular areas (circles 3 and 4 in Figure 1) are shown in Table 1.

a) The seafloor of Biscayne Bay east of the Turkey Point Units 6 & 7 site includes many dark vegetated patches that appear to be similar to the dark vegetated patches mapped subaerially at the site (Figure 2.5.3-202 and Figure 1). Initial analysis conducted for the FSAR, mapping of the subaerial and submarine features, did not identify a significant pattern in the distribution of the vegetated patches. The re-analysis, in response to this RAI, noted occasional areas of a shoreline-perpendicular linear pattern or alignments of the vegetated patches (Figure 2). This pattern is commonly noted throughout southern Florida, in particular the Everglades, and corresponds with tidal and/or surface water flow directions (FSAR Subsections 2.5.1.1.1.1.1.1 and 2.5.3.2).

The average areas of the individual vegetated patches in the subaerial circles 1 and 2 are 780 m² and 540 m² and the average areas for the submarine circles are 320 m² and 180 m² (Table 1). While the submarine patches have a lower average area, the values for both locations (subaerial and submarine) are of the same order of magnitude. The size distribution of the patches in both the subaerial and submarine environments is variable, with high standard deviations for the average patch area, and a size range that varies from 20-30 m² to >100 m². Very similar vegetated patch densities are calculated for subaerial and submarine areas (Table 1). The statistics for the subaerial circles are somewhat skewed by the presence of a few very large patches (especially in circle 1), reflected by the fact that the standard deviations in these circles are actually larger than the mean. These outliers may in fact consist of several smaller patches, which have been obscured by vegetation. Otherwise, the patches in all four circles display very similar characteristics, with similar minimum patch sizes and population densities. The similarity of the vegetated patch size and distribution in all four circles suggests that they could have been formed by the same process, namely surficial erosion and/or solution (see FSAR p. 2.5.3-3 and RAI 02.05.02-1 response (FPL Letter L-2011-234, dated June 24, 2011)).

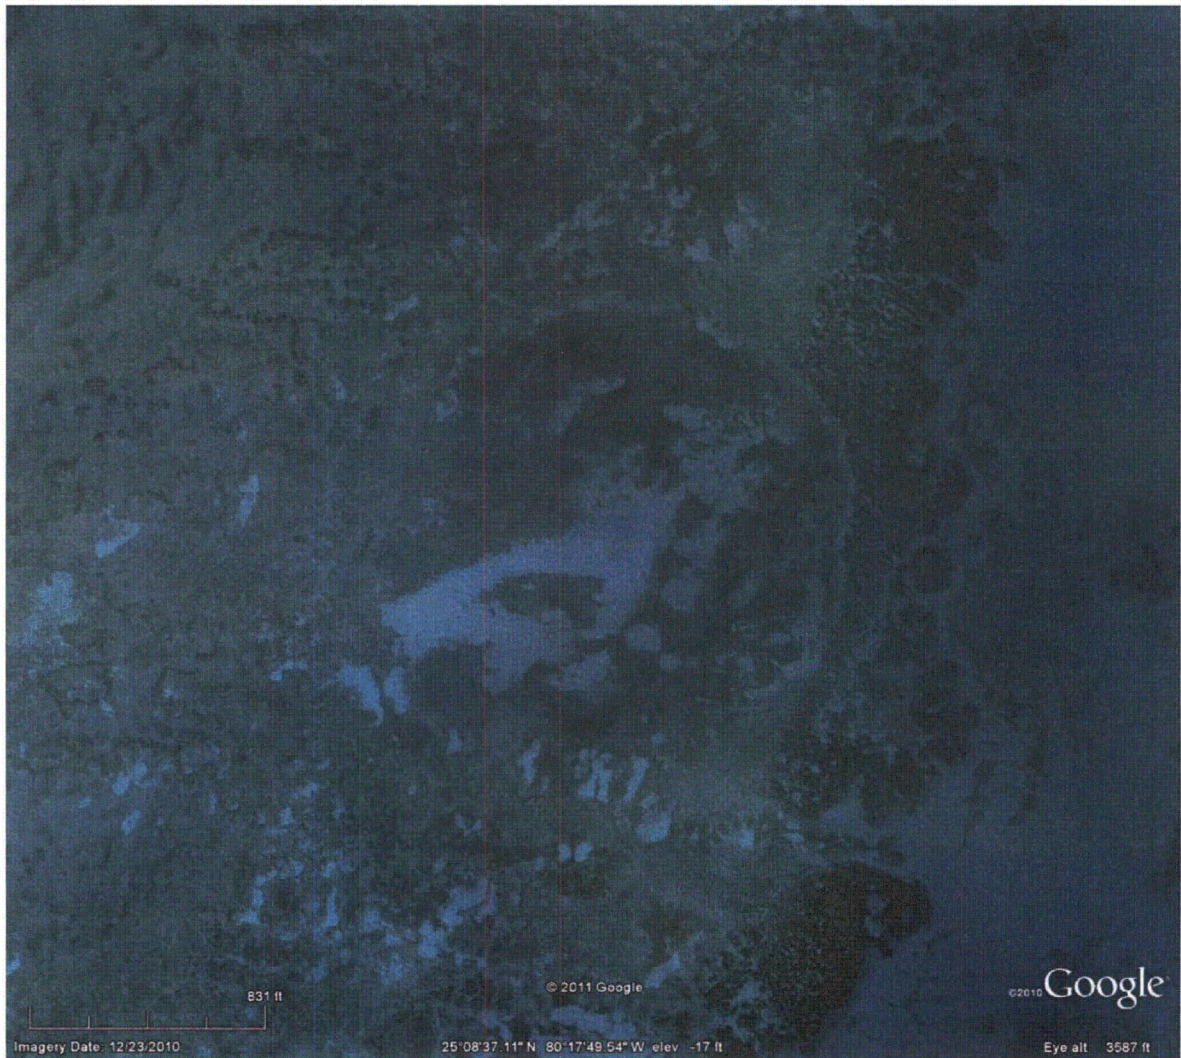
Figure 4: Image of Google Earth image of the sinkhole reported by Shinn et al, (FSAR Reference 228)

It is difficult to find other similarities between the Key Largo sinkhole in Figure 4 and this semi-circular arrangement of vegetated patches in Figure 3. The different morphology (a circle versus a semi-circle) and differing vegetation patterns of the two features is apparent in Figures 3 and 4. The Key Largo sinkhole, and other sinkholes reported on the Miami and Pourtales terraces are typically associated with a topographic relief on the order of 5 to 200 meters (FSAR Reference 228 and Land and Paul, 2000). While very detailed bathymetry is not yet available for this area, inspection of available lower resolution bathymetric data and published literature does not indicate a similar topographic feature at this location (NOAA, 1998). Earlier air photos of the possible semi-circular feature show a less well-defined concave-north arc of vegetation (Figure 5). In addition, the model for formation of the large sinkholes found east of the Florida Keys indicates that these features form in a linear belt near the southeast edge of the Pourtales and Miami terraces that represents a paleo-mixing zone for fresh and saline water (Land and Paull, 2000). Hence, similar sinkhole features would not be expected near the Turkey Point Units 6 & 7 site and west of this linear belt. For similar reasons, the semi-circular arrangement of vegetated patches east of the Turkey Point Units 6 & 7 site does not share significant similarities with cenotes of the Yucatan peninsula. The Belize Blue Hole, for example, is 125 m deep, and such dramatic topography is not seen at the Turkey Point Units 6 & 7 site (Gischler et al., 2008).

The imagery available through Google Earth was reviewed specifically to look for possible semi-circular alignments in the surficial depressions or vegetated patches and depressions located in Biscayne Bay. One possible semi-circular arrangement of vegetation patches can be observed just east of the site (Figures 2 and 3). This concave-north arc of vegetation seems to have a radius of roughly 300 meters. Hence, if it were a complete circle, rather than a half-circle or arc, it would be similar in diameter to the Key Largo sinkhole of Shinn et al (FSAR Reference 228). For reference, a Google Earth image of the Shinn et al, (FSAR Reference 228) sinkhole is shown on Figure 4.
