Low Temperature testing of Parker V1289-75 O-rings

Test Report No: RC 19356A

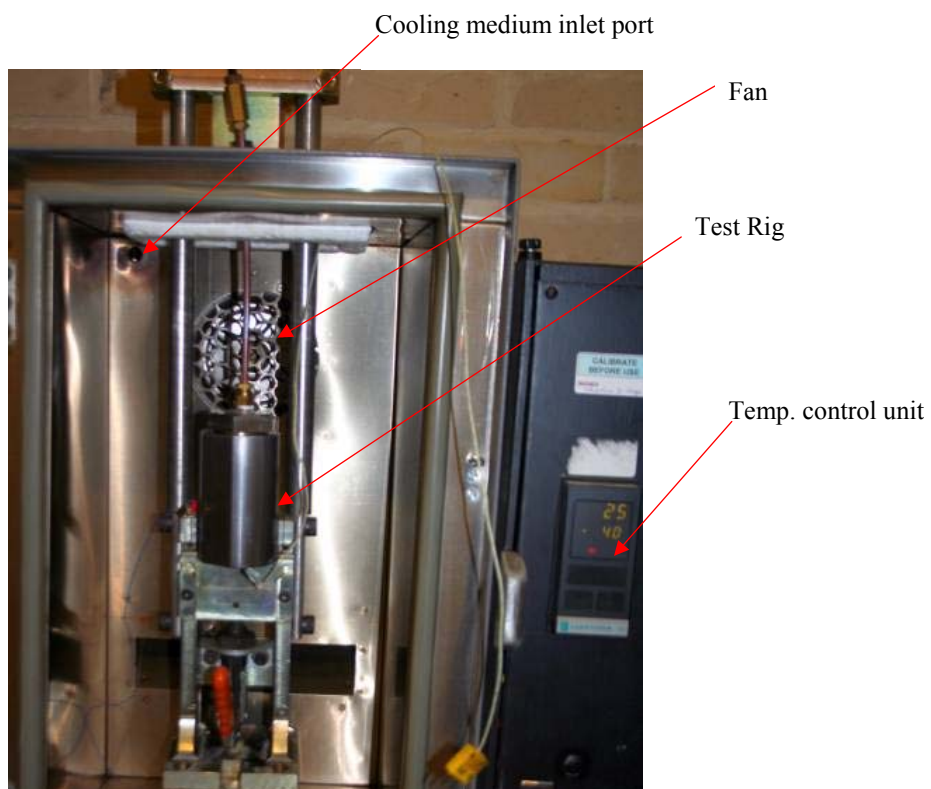
Figure 3 Close up of environmental test chamber

Fittings were attached to enable the test rig to be pressurised and connected to a digital pressure meter. These are illustrated in Figure 2. The rig was placed within the test chamber (a modified Instron environmental test chamber) as illustrated in Figure 3. Gaseous CO₂ was used as the cooling medium and the chamber was connected to a CO₂ cylinder, as illustrated in Figure 4. The thermocouple was attached to a data-logging unit. The thermocouple, located within the test rig, was calibrated together with the data-logging unit prior to conducting studies with a pressurised system.

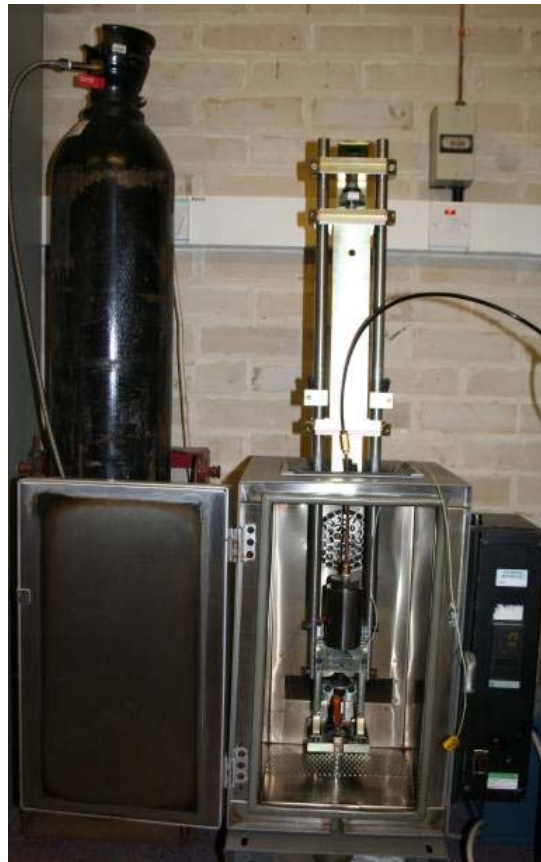
Figure 4 Test Chamber with CO₂ cylinder attached
