REVISS Services
Technical and Manufacturing Group

Test Report No. RTR 250

1.0m Punch Test – Angled Side

The purpose of this document is to record the performance of the R7021 specimen, 3981/01, in an IAEA drop test for Type B radioactive materials package designs. The full test programme is discussed, justified and detailed in the test plan, RTM 118.

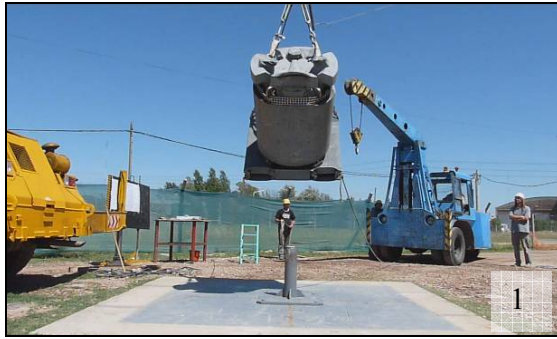
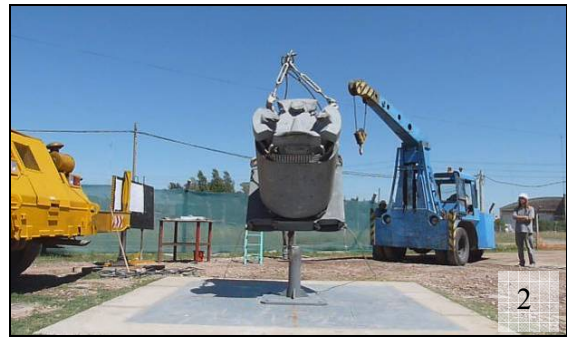
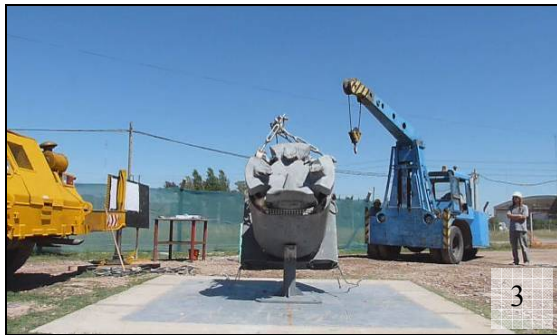
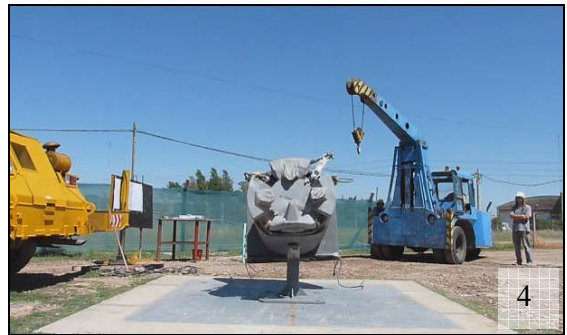
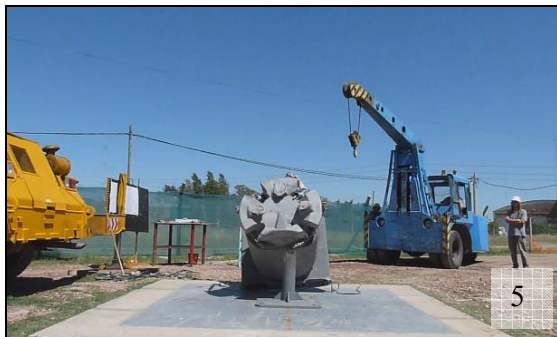
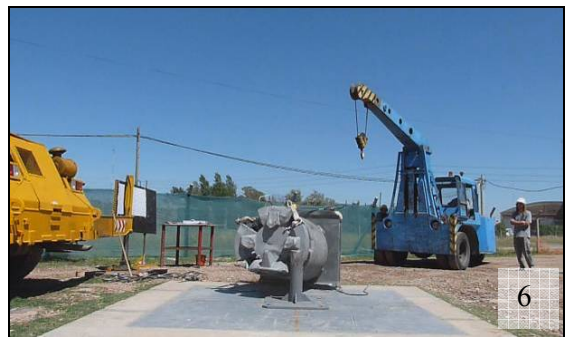
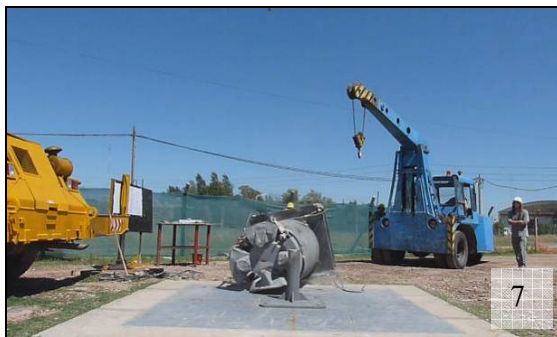
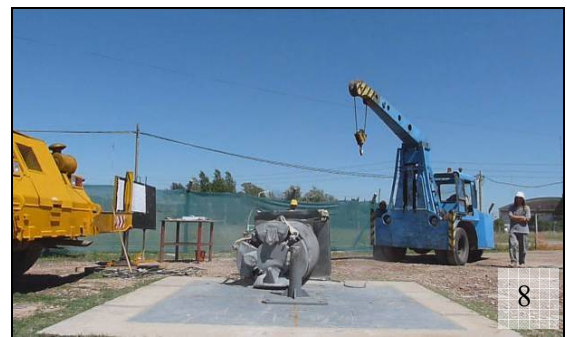
Figure 2: Test action sequence – Angle 1

- The test was executed correctly (Figures 2, 3, 5 6). The angle measured on the jacket was 37.0° from the horizontal (Figure 7).
- The pallet, jacket, top shield and grill were all securely attached (Figure 8).
- The outer skin of the jacket was indented to a depth of approximately 85mm with no cracking or shearing (Figures 9-11). The inner skin was clear of the drain plug by approximately 10mm.
- The punch showed no significant damage (Figure 12).
- No other damage was visible externally.

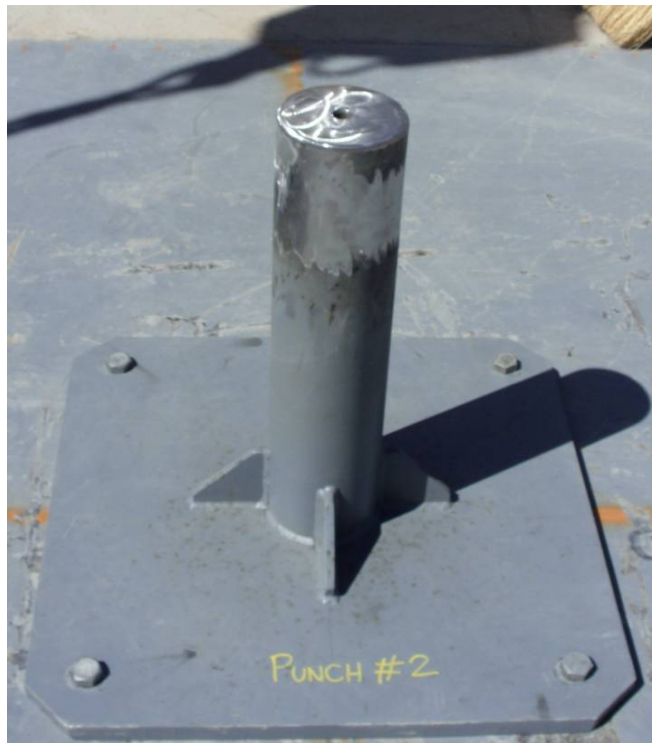
Figure 4: Extended punch

The punch (Drg. No. R8099/002) met RTM 118 requirements and was securely fastened to the target with four M24 screws. The punch was extended by 100mm to 600mm (by welding on a section from a second punch) to avoid any risk of the specimen contacting the target (Figure 4).

17. Pass/Fail (if, applicable see Test Plan)	Pass (fit to continue).
18. Notes * Extended by 100mm to 600mm using section from second punch to avoid any risk of pallet contacting ground before package stops descending. * Dimension "120" to aiming mark changed to 90mm to ensure impact with corner of drain plug. 35° changed to 37° to maintain CoG over point of impact (see also CF757C). • Outer skin of jacket indented to a depth ~ 85mm (no cracking or shearing). Inner skin clear of drain plug by ~ 10mm. • No other damage visible externally. • Pallet, jacket, top shield and grill securely attached.

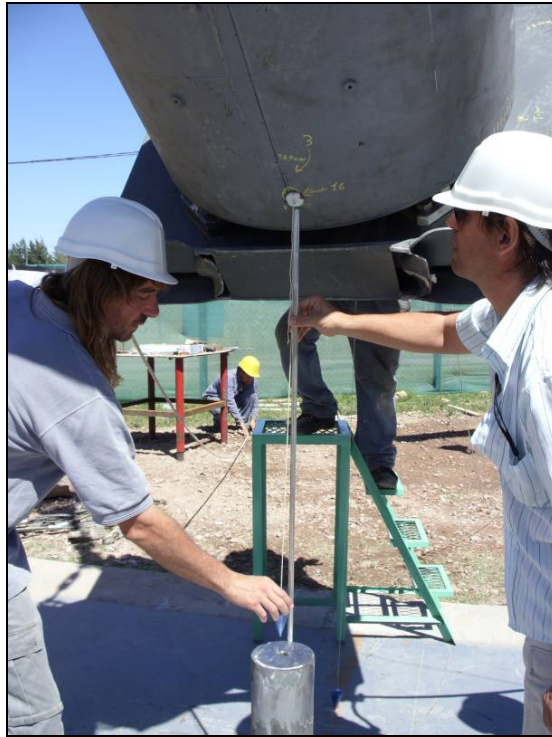
Figure 6: 1.030m above target (with height gauge)

As the weight of the container assembly was less than the design maximum gross weight (4500kg), the drop height was increased pro rata to compensate. The test height was therefore $(4500/4374) \times 1.0 = 1.030\text{m}$.

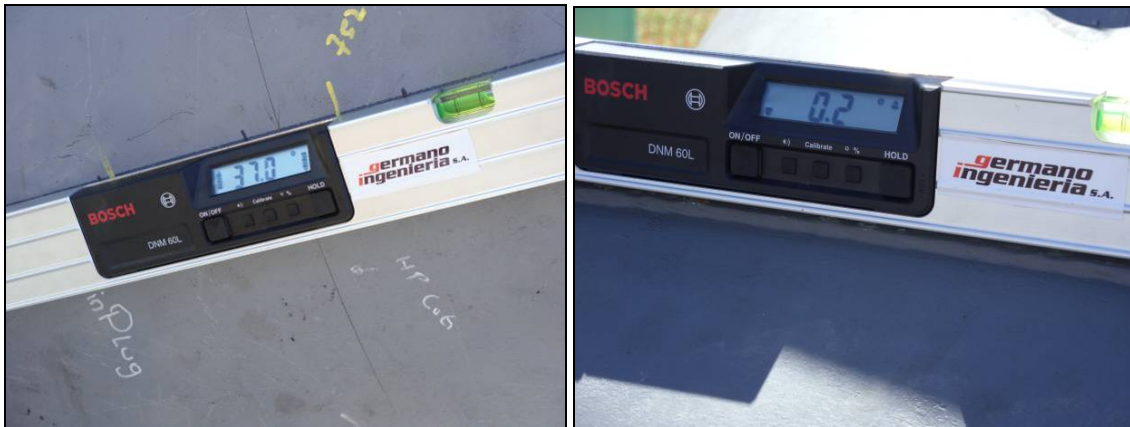
Figure 7: Inclinometer readings (2 planes)

The specified angle was 35° from the horizontal and the impact point 120mm from the base of the jacket however, on review with the DfT engineer, these were changed to 37° and 90mm to
