**Prototype SAFKEG LS 3979A/0002**  
**NCT and HAC Regulatory Test Report**

Title	Prototype Safkeg LS 3979A/0002 NCT and HAC Regulatory Test Report	Number	CTR 2009/21
		Issue	B
		File Ref	CTR 2009-21-B-v1-SAFKEG 3979A- Regulatory Test Report.docx
Compiled.

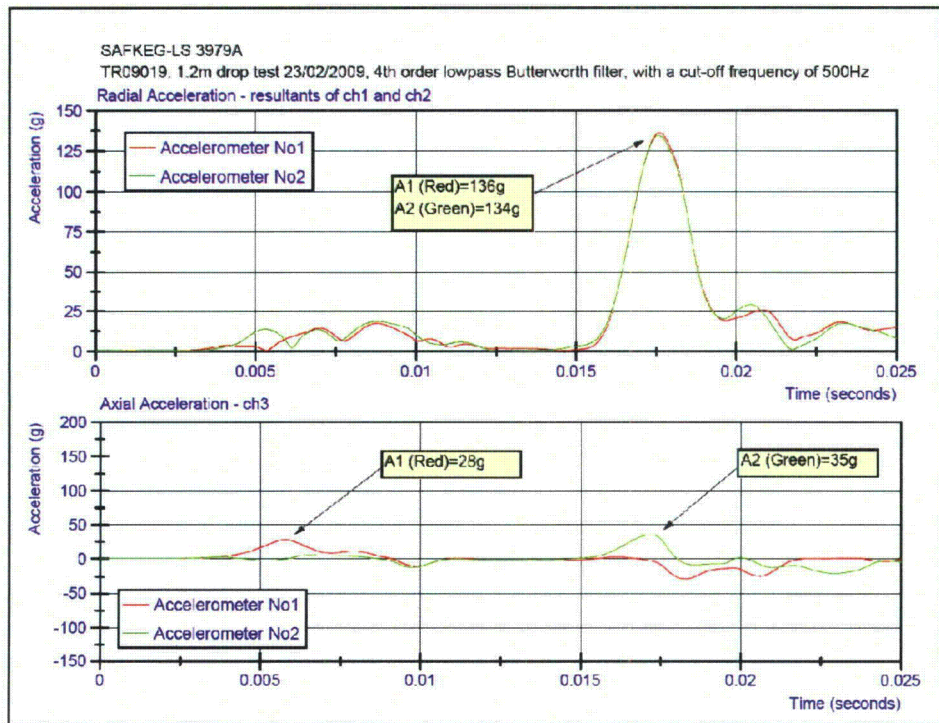
Figure 11 – Test 4 Filtered Acceleration Time History

The package impacted the target slightly bottom down as shown in photograph 25 and experienced minimal damage to the rim as shown in photograph 26. The filtered acceleration data recorded during the drop test is presented in Figure 11.

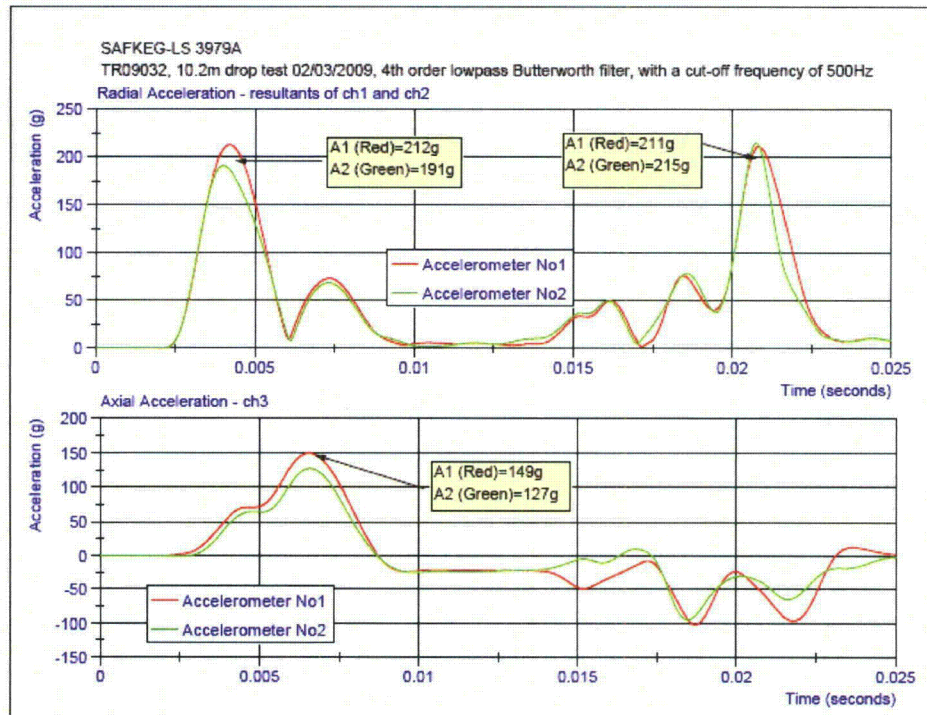
Figure 14 – Test 10 Filtered Acceleration Time History

The temperature of the keg was recorded in Reference 21. The keg internals remained at < -40°C during the drop test. The point of impact was on the bottom rim as shown in photograph 37 with a secondary impact 40 milliseconds later on the top rim as shown in photograph 38. Photograph 39 shows the initial damage already present on the keg prior to the test, from the invalid drop. On repeating the drop the package impacted at the same point causing little additional damage to the primary impact point as shown in photograph 40. Minimal damage was caused to the keg from the secondary impact as shown in photograph 41. The filtered acceleration data taken during the drop test is shown in Figure 14. The maximum measured accelerations are given in Table 8.

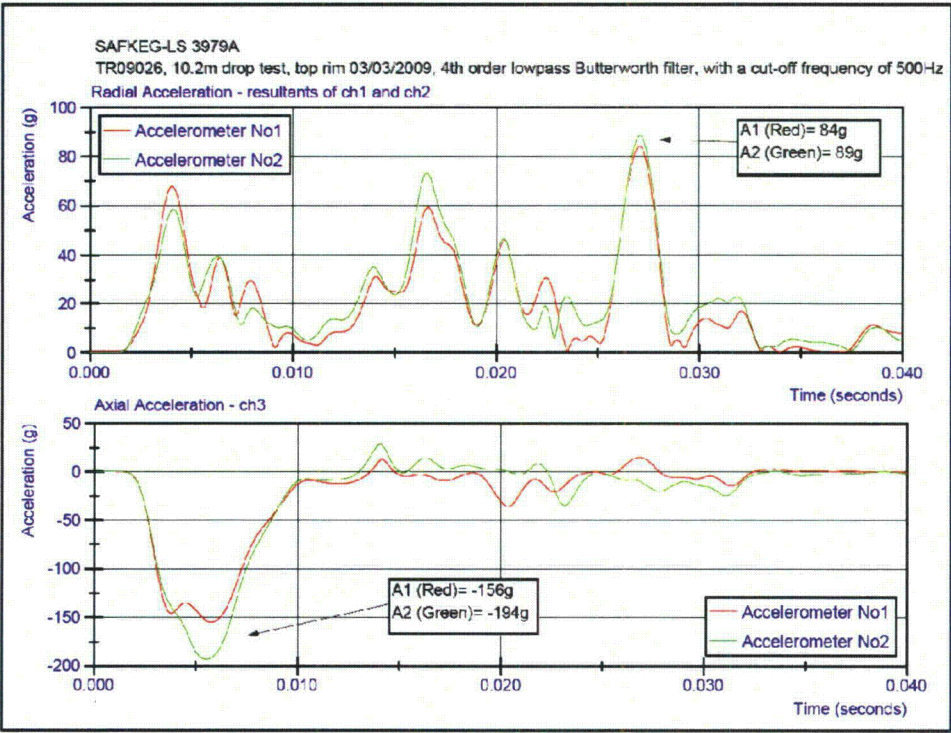
Figure 15 – Test 11 Filtered Acceleration Time History

The keg impacted the target on the top rim as shown in photograph 42 with the secondary impact shown in photograph 43. The impact caused 12 mm of deformation to the top rim of the keg as shown in photograph 44. The acceleration data recorded during the drop is shown in Figure 15. The maximum measured accelerations are given in Table 8.

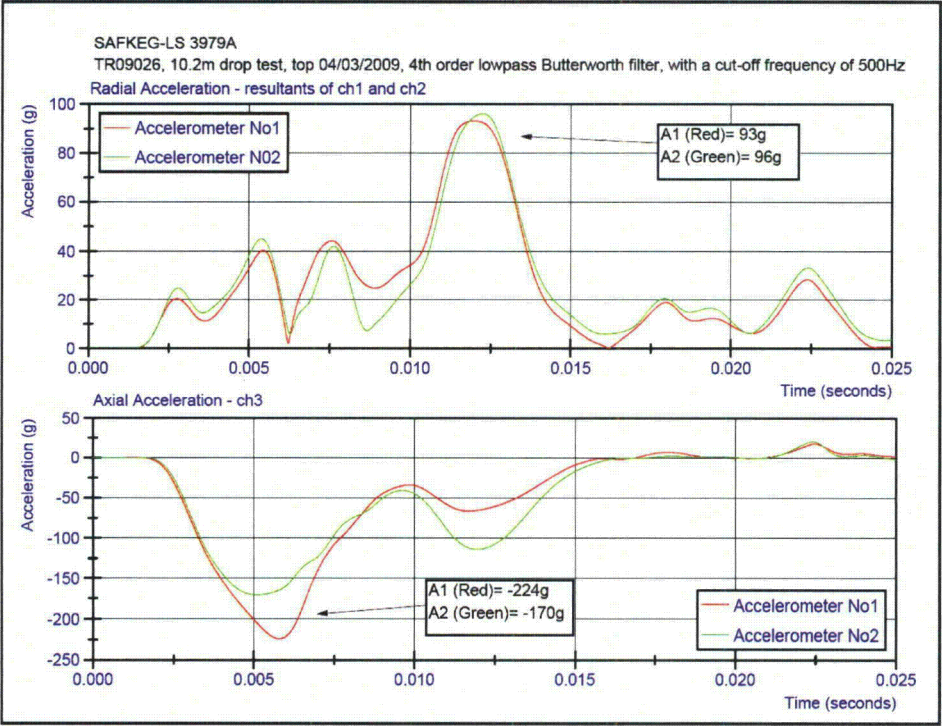
Figure 16 – Test 12 Filtered Acceleration Time History

The top of the keg impacted the target as shown in photograph 45. The impact caused minimal damage to the top of the keg as shown in photograph 46. However there was a degree of bellowing to the keg body beneath the rim as shown in photograph 47. The acceleration data recorded during the drop is shown in Figure 16. The maximum measured accelerations are given in Table 8.

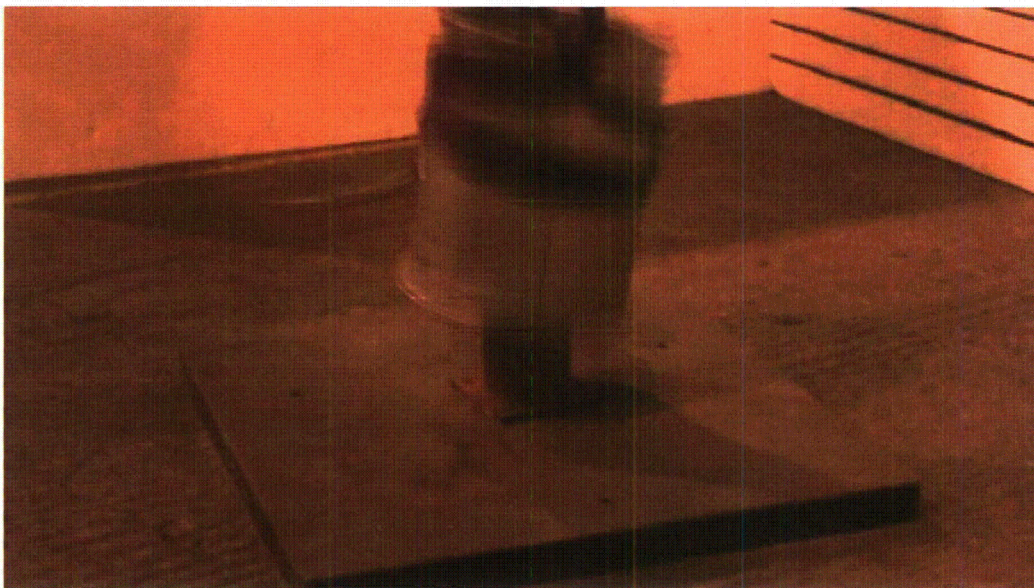
**Photograph 33 – Test 8 point of impact**

The package impacted the punch on the bottom of the package as shown in photograph 33. The impact caused minimal damage as shown in photograph 34.

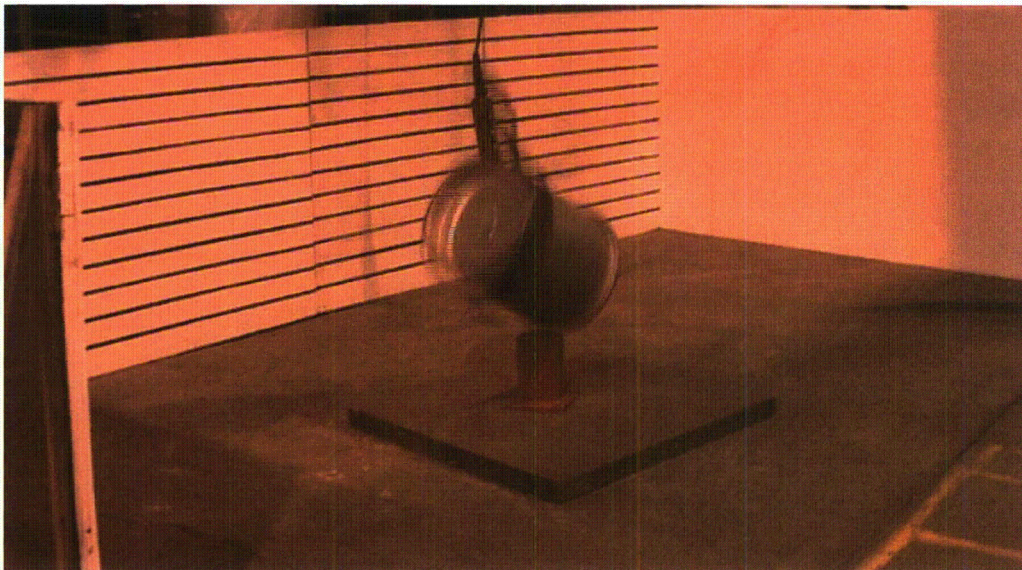
**Photograph 35 – Test 9 point of impact**

The package impacted the punch on the top rim edge of the package as shown in photograph 35. The impact caused minimal damage as shown in photograph 36.
