An Evaluation of Ultrasonic Phased Array Testing for Cast Austenitic Stainless Steel Pressurizer Surge Line Piping Welds

Confirmatory research is being conducted for the U.S. Nuclear Regulatory Commission at the Pacific Northwest National Laboratory to assess the effectiveness and reliability of advanced nondestructive examination methods for the inspection of primary system pressure boundary components and materials in light-water reactors. The work reported here provides a technical evaluation to assess the capabilities of phased-array (PA) ultrasonic testing (UT) methods as applied to the inspection of welds in cast austenitic stainless steel (CASS) pressurizer (PZR) surge line piping. A set of thermal fatigue cracks (TFCs) were implanted into CASS PZR surge-line specimens (pipe-to-elbow welds) salvaged from cancelled nuclear power plants that were fabricated of vintage materials formed in the 1970s. Responses from these cracks were used to evaluate detection and sizing performance of the PA-UT methods applied. Custom arrays, operating nominally at 800 kHz, 1.0 MHz, 1.5 MHz, and 2.0 MHz were employed. Raster and line-scan data were acquired as a function of probe frequency and

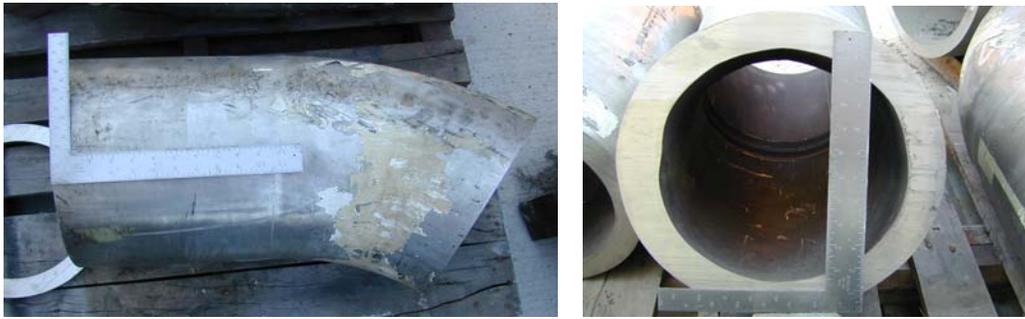
Figure 4.1 Photographs of the Side-View (left) and End-View (right) of the CASS PZR Ring Segment (specimen 7C-059)

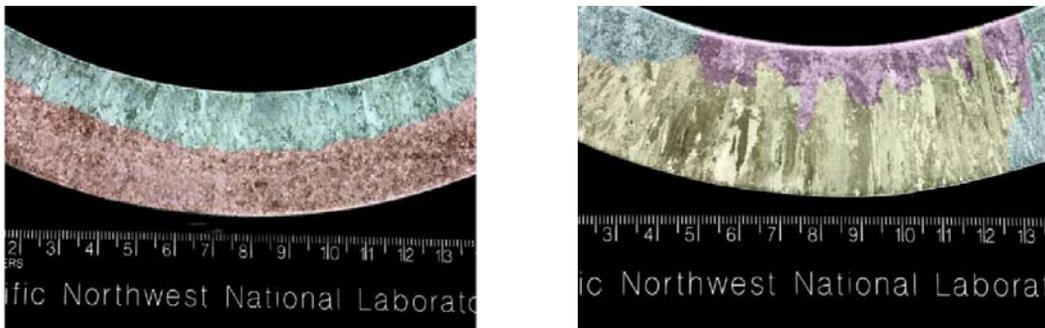
The PZR surge-line specimens consist of a CCSS pipe segment welded to a SCSS elbow segment. Rings from both ends were cut, polished, and etched to show the microstructures of the pipe and elbow ends (centrifugally and statically cast microstructures, respectively) as illustrated in Figure 4.2 for specimen 7C-059. False colors have been added to Figure 4.2 to assist the viewer in judging microstructural transitions, variation and banding. Nominal wall thickness on the pipe side of specimen 7C-059 was 30 mm (1.2 in.) and on the elbow side, 39 mm (1.5 in.). Four circumferentially oriented TFCs were implanted in the weld region of this specimen.

Figure 4.2 Photographs of Polished and Chemically Etched CASS PZR Ring Segment (specimen 7C-059) Showing the Pipe-Side (CCSS) Grain Microstructure (left) and the Elbow-Side (SCSS) Grain Microstructure (right)

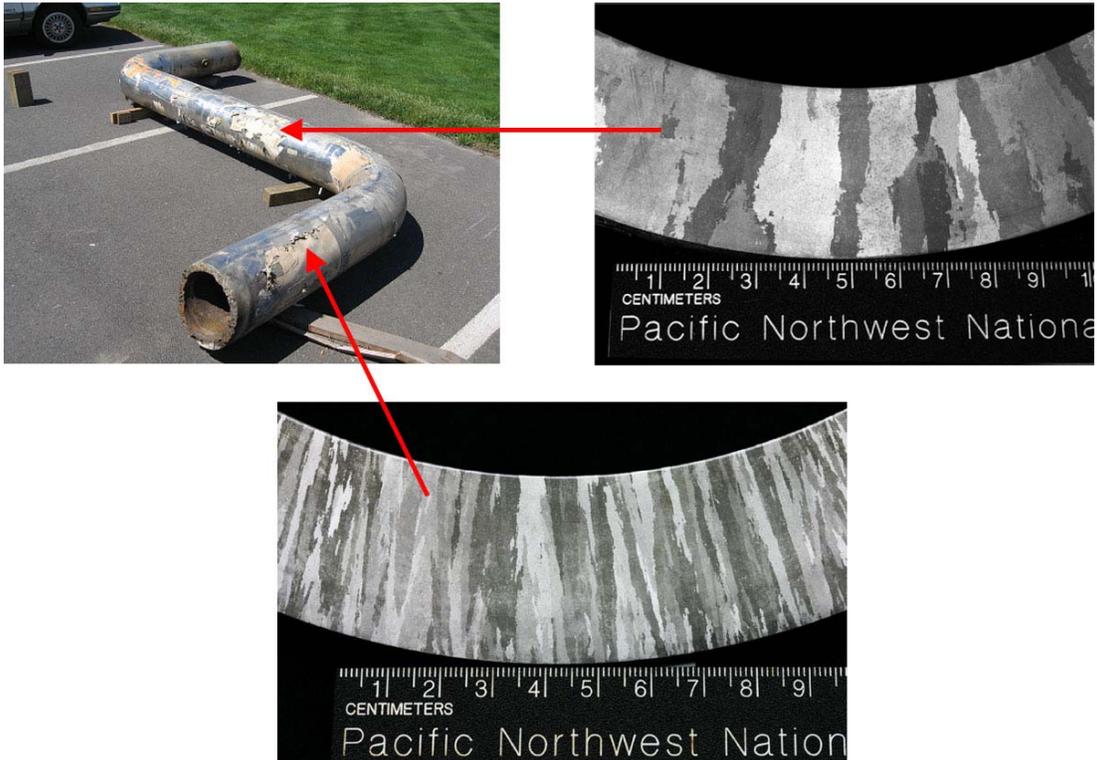
Figure 4.3 WNP-3 Surge Line Section Showing the Locations of the Pipe and Elbow Cuts to Produce Two Pipe-to-Elbow Specimens, 9C-001 and 9C-002. The centrifugally cast pipe microstructures are displayed for both specimens.

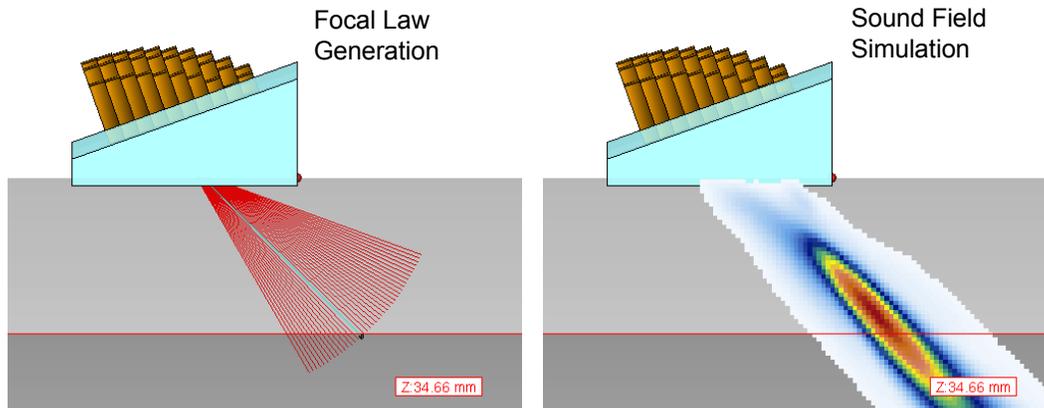
steering desired, and density mapping to enable the viewer to see how well the sound field responds for a particular angle and whether grating lobes exist that may be detrimental to the examination. Figure 5.1 shows an example of the ray tracing for a probe on the left with the sound field density mapping on the right. It should be noted that this simulation is performed in isotropic material; that is, the velocity of sound is maintained throughout any angle for a particular wave mode, which is not really the true state for CASS, but enables the user to estimate sound field parameters and transducer performance for optimal array design and focal law development.

Figure 5.1 The ZETEC Advanced Phased Array Calculator is Useful for Generating Focal Laws (left) and Simulating the Sound Field for the Focal Law (right) to Determine Beam Characteristics

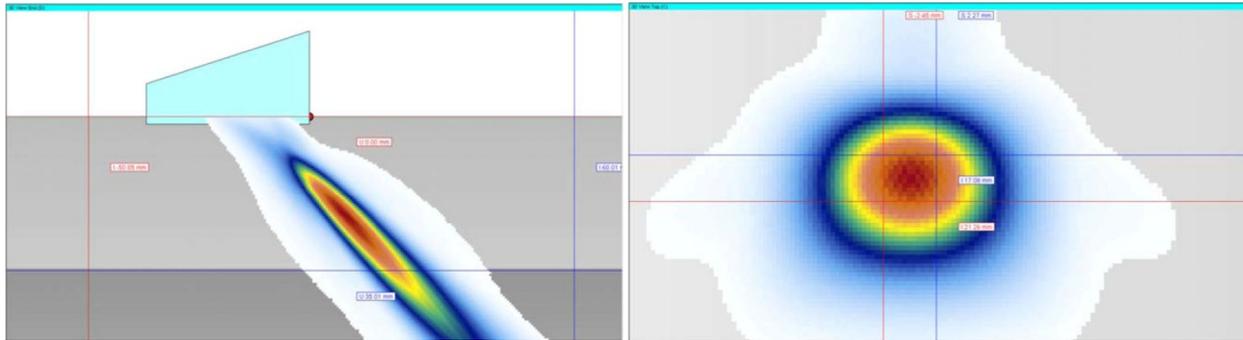
Figure 5.3 Un-normalized Beam Simulations for the 2.0-MHz PA Probe at 45° Incidence in the Cast PZR Surge-Line Specimen, Using a Half-Path Focus at 50 mm (1.97 in.). Top: side-view of focused sound field at 45° incident angle in the part. Bottom: cross-sectional view of sound field at the focal spot, where cursors mark the -3 dB points.

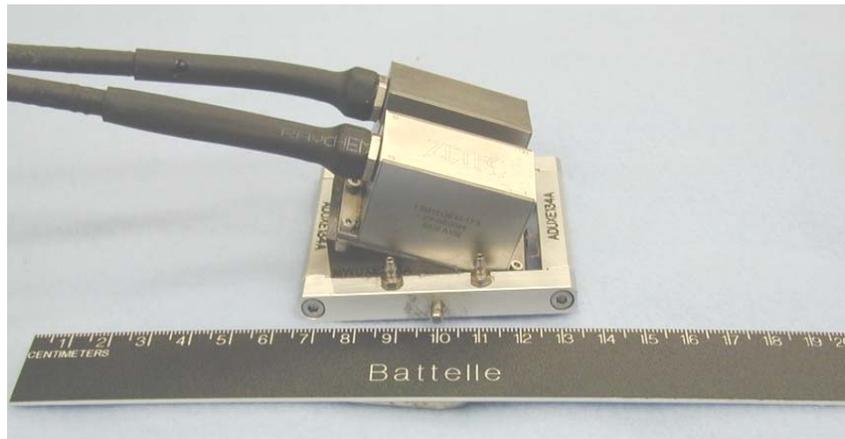
together by an aluminum frame. The wedge dimensions are 49×50 mm (1.93×1.97 in.). Both transmit and receive probes were identical in design with a 3×10 element array, an active area of 35×17.5 mm (1.38×0.69 in.) and a greater than 60% bandwidth at -6 dB. The 1.5-MHz probe has been used in previous examinations of flaws on the near and far sides of austenitic welds in WSS. Similar to the 2.0-MHz array, 1.5 MHz is generally considered to be too high in frequency for examining CASS components which have larger and more complex grain structures than WSS. The 1.5-MHz TRL probe was included in this study because the probe has proven effective in examining materials of similar thickness to the surge line and provides a point of comparison for the other techniques. Skew angles of ± 10 degrees were possible with this array. The probe is shown in Figure 5.4.

Figure 5.4 1.5-MHz TRL Probe Originally Designed for Wrought Stainless Steel Welds

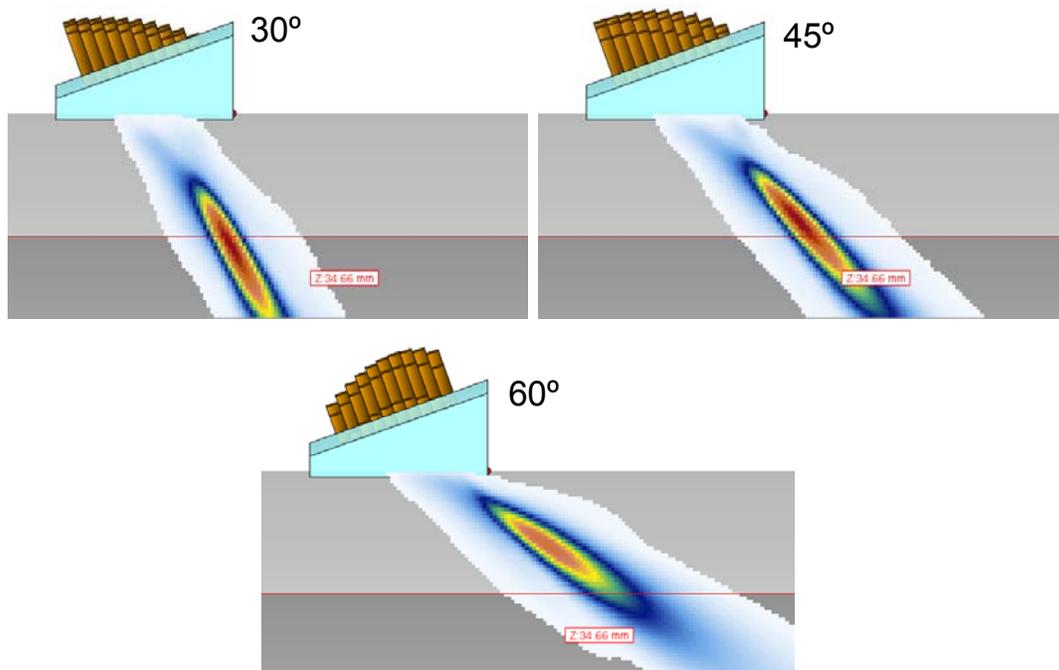
Specific focal laws were generated for the surge line based on the thickness of the piping and the width of the weld in the surge line pipe-to-elbow specimens. The sound field simulations indicated that the 1.5-MHz probe would be able to produce a well-focused beam at distances from directly below the probe to approximately 45 mm (1.8 in.) in front of the wedge. Multiple focal laws were used in the examinations to obtain optimal results. Example simulations of the 1.5-MHz probe steered to 30° , 45° , and 60° , focused at a depth of 36 mm (1.4 in.), is shown in Figure 5.5. The wavelength for a 1.5-MHz probe is 3.8 mm (0.15 in.). From Figure 5.6, the 1.5-MHz probe was found to produce a beam with a horizontal width of 5.01 mm (0.20 in.) by vertical width of 3.81 mm (0.15 in.) at 45° at the -3 dB points.

Figure 5.5 Simulations of the Beams Created by the 1.5-MHz TRL Arrangement for 30°, 45°, and 60°

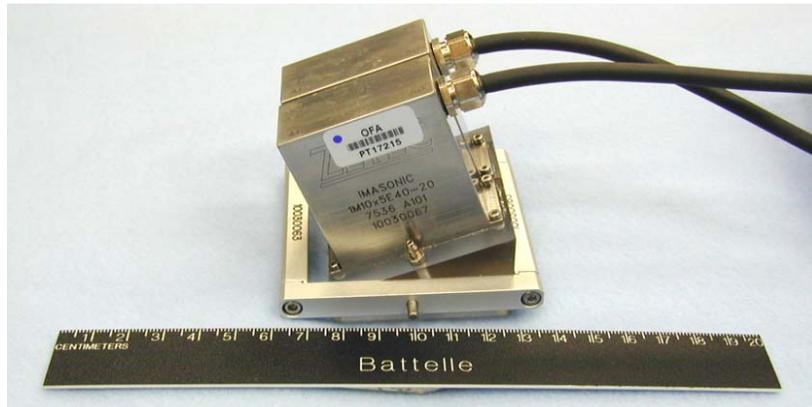
The 1.0-MHz TRL array (Figure 5.7) was originally designed for evaluating inspection effectiveness of PA methods on components with inlays, onlays, and overlays. It consists of two 5-element by 10-element matrix arrays. One array is used for transmitting, the other for receiving ultrasonic signals. This probe has a 58% BW at -6 dB and an approximately 50-mm^2 (1.97-in.^2) footprint with a customized wedge for data collection in tight geometrical configurations. The probe's nominal wavelength in stainless steel is 5.31 mm (0.21 in.) at its average center frequency of 1.1 MHz. Skew angles of ± 20 degrees were possible with this array.

Figure 5.7 1.0 MHz, Phased-Array Probe, Originally Developed for Inlays, Onlays, and Overlays

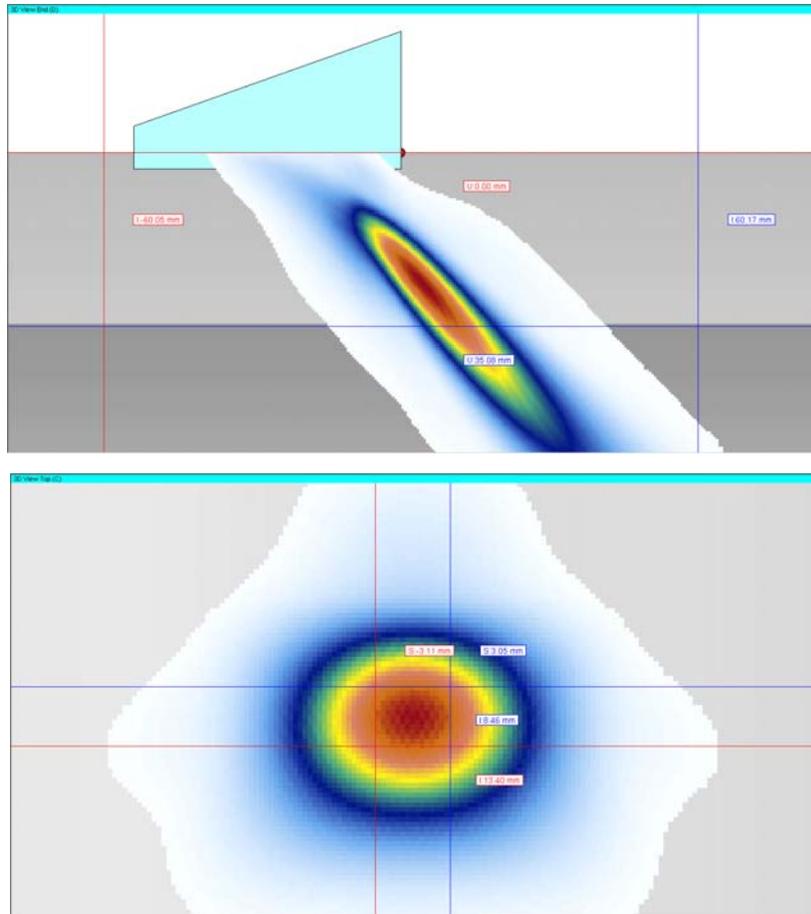
The 1.0 -MHz probe was found to produce a beam with a horizontal width of 6.16 mm (0.24 in.) by vertical width of 4.94 mm (0.19 in.) at 45° at the -3 dB points. This probe is able to provide an effective sound field at distances from almost directly under the probe to a distance approximately 45 mm (1.8 in.) in front of the wedge. As with the 1.5 -MHz probe, the ability of the probe to accurately measure crack width and depth improves with proximity between the probe focal spot and the flaw, as this is the location of tightest focusing and highest sensitivity.

Figure 5.8 Un-normalized Beam Simulations for the 1.0-MHz PA Probe at 45° Incidence in the Cast PZR Surge-Line Specimen, Using a Half-Path Focus at 50 mm (1.97 in.). Top: side-view of focused sound field at 45° incident angle in the part. Bottom: cross-sectional view of sound field at the focal spot, where cursors mark the -3 dB points.

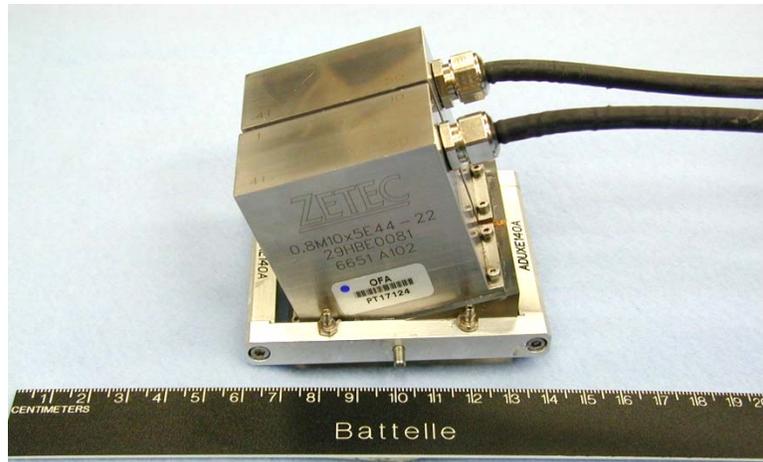
The 800-kHz probe was designed to provide a more optimal wavelength to allow ultrasonic penetration in the large grain structure of CASS, while maintaining suitable flaw resolution. The probes are mounted on a Rexolite wedge side-by-side to operate in a pitch-catch mode and are shown in Figure 5.9. The wedge dimensions were 63 × 63 mm (2.48 × 2.48 in.). The transmit-and-receive probes are identical in design and consisted of a 10 × 5 element array with an active area of 43.2 × 21.2 mm (1.70 × 0.84 in.) and a greater than or equal to 50% bandwidth at -6 dB. The wedges are curved to match the approximate 318-mm (12.5-in.) diameter of the surge line specimens.

Figure 5.9 800-kHz TRL Probe

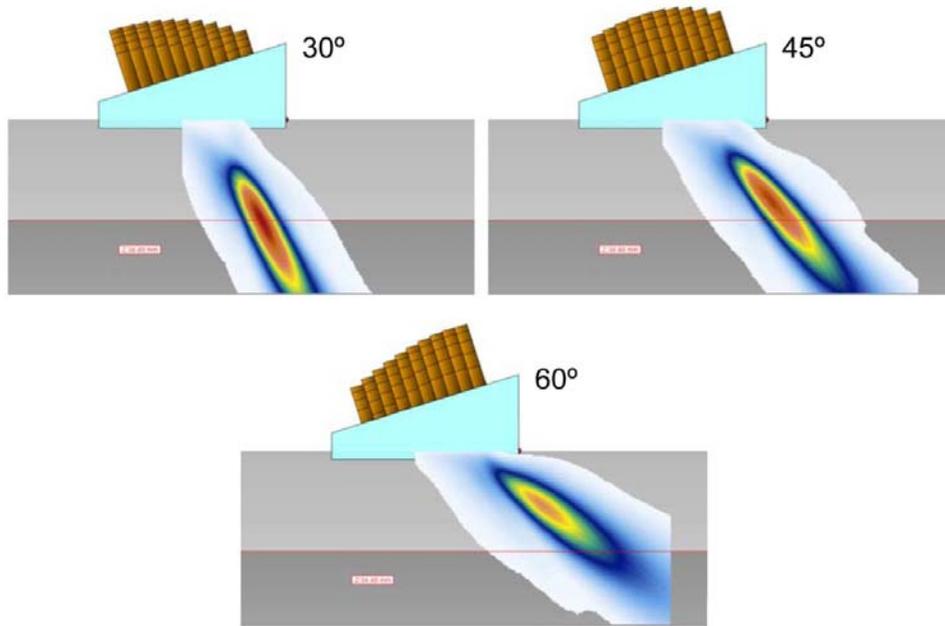
Using the modeling and simulation capabilities of the UltraVision software, the focal dimensions of the sound field as a function of frequency (for the four probes used in this study) and incident angle were computed for the dimensions corresponding to the CASS PZR specimens. The focal spot size was computed at both the -3 dB and -6 dB points in both horizontal and vertical planes. Table 5.2 summarizes the focal spot size data.

Figure 5.10 Simulations of the Beams Created by the 800-kHz TRL Arrangement for 30°, 45°, and 60°

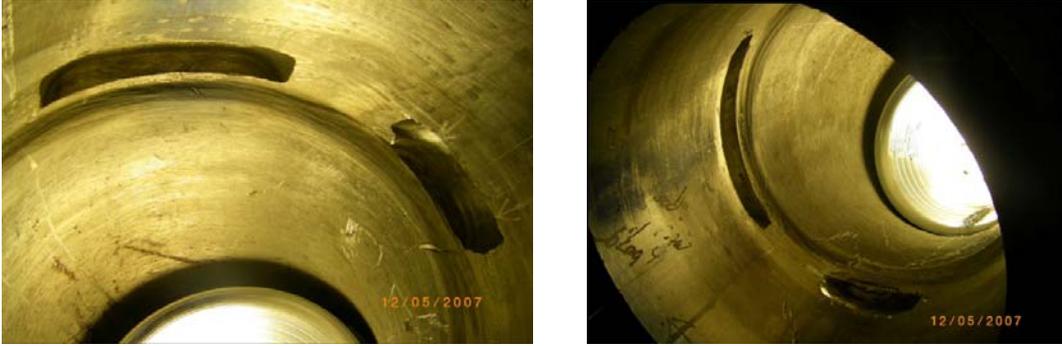
Figure 7.1 Photographs of the Inside Surface of the CASS PZR Surge-Line after Excavation and Preparation of the Areas Targeted for Flaw Implantation (courtesy of FlawTech, Inc.)

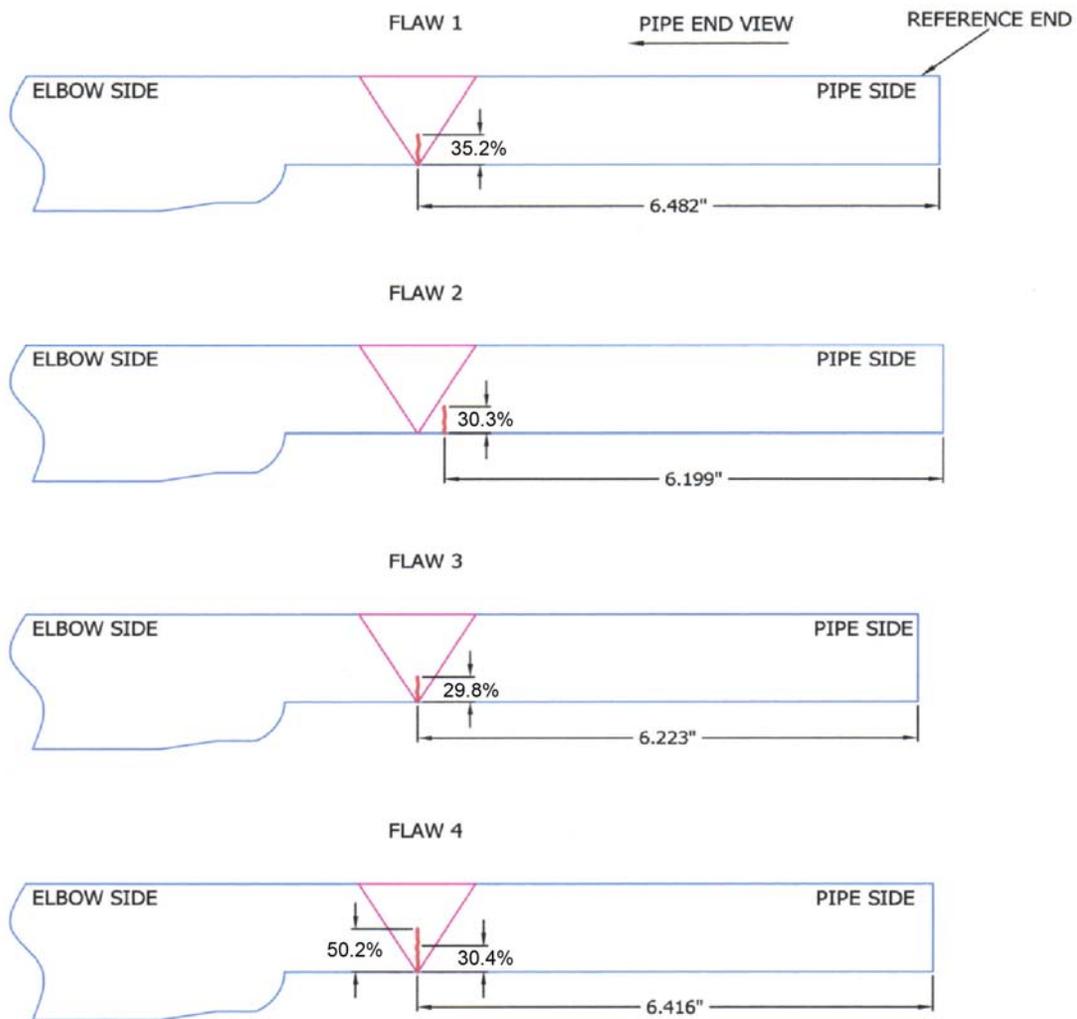
A schematic (side view illustration) of the four TFCs depicting flaw position relative to the weldment and flaw depth is provided as Figure 7.2. Figure 7.3 shows a full circumferential view of all flaw positions and extents on specimen 7C-059. This pipe end-view depicts the circumferential extent (length) of the implanted ID surface-connected cracks, relative to the radial position along the pipe circumference.

Figure 7.2 Side View Illustration of All Four Thermal Fatigue Cracks Implanted Into PZR CASS Specimen 7C-059 (courtesy of FlawTech, Inc.)

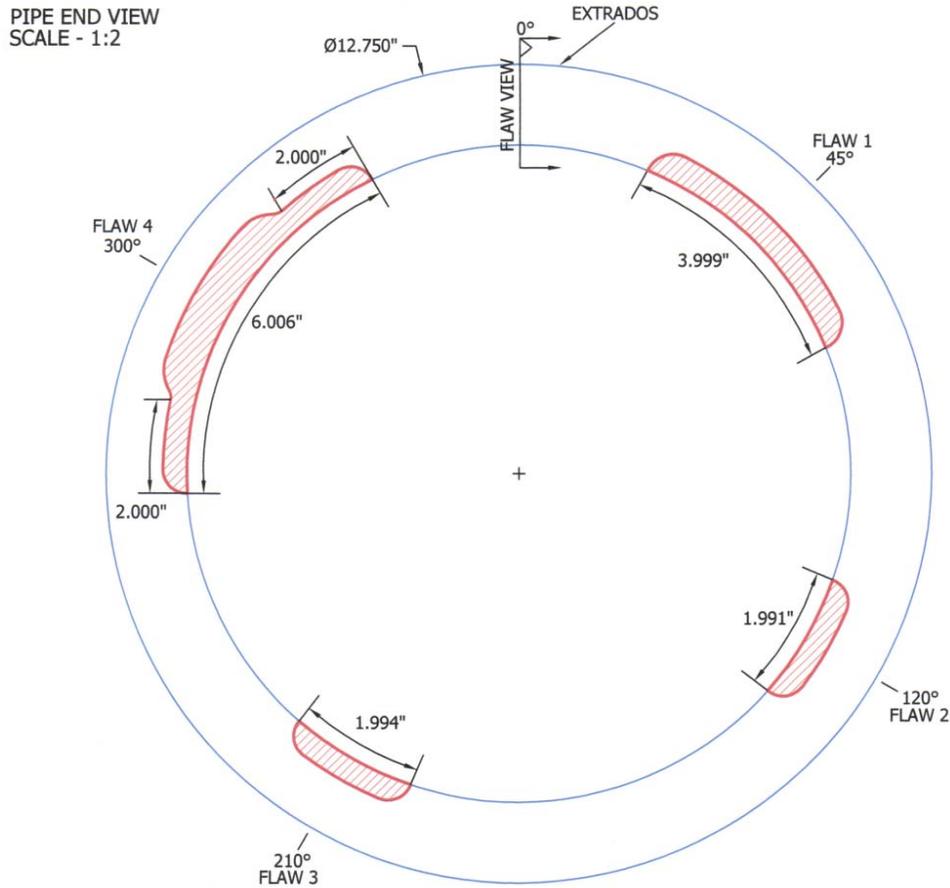
Figure 7.3 End View Illustration of All Four Thermal Fatigue Cracks Implanted into PZR CASS Specimen 7C-059 (courtesy of FlawTech, Inc.)

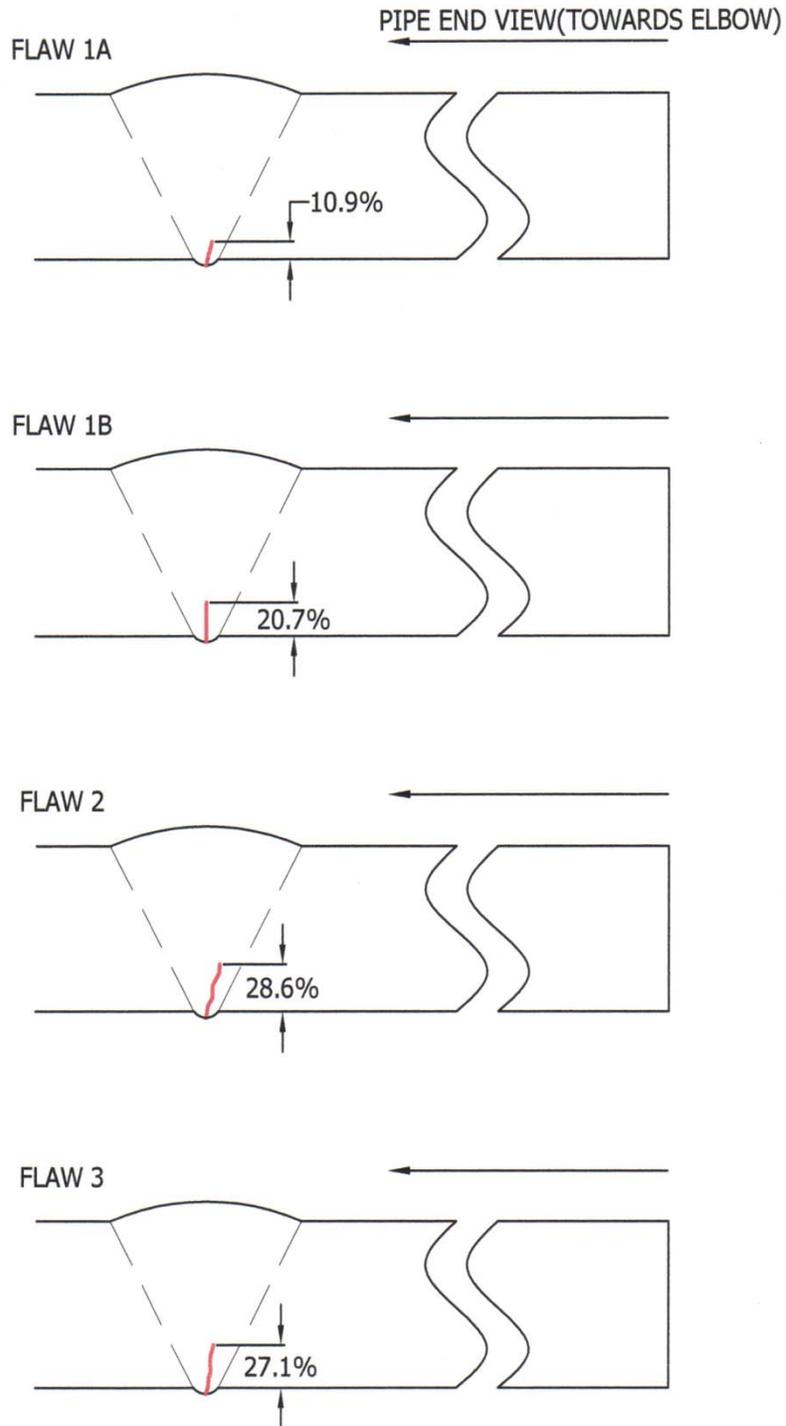
This CASS PZR surge-line segment is 304.8-mm (NPS 12-in.) Schedule 160 pipe, with a CCSS pipe segment welded to a SCSS elbow. This CASS PZR surge-line specimen is approximately 762 mm (30 in.) in length, 324 mm (12.75 in.) OD, and is approximately 31.8-mm (1.25-in.) in wall thickness on the centrifugally cast side of the weld (pipe side). This pipe-to-elbow specimen was cut from a longer segment of a surge line salvaged from Washington Nuclear Power, Unit 3 (WNP-3). FlawTech, Inc. performed all crack implantations in this specimen. Three implanted TFCs were introduced. These cracks were inserted via a coupon implant technique and were all circumferentially oriented flaws. Flaw number one has two distinct through-wall depths associated with it; thus, for reference purposes, each depth region will be identified individually as Flaw 1A and Flaw 1B. A side view illustration of the three flaws depicting flaw position relative to the weldment and flaw depth is provided in Figure 7.4. Figure 7.5 shows a full circumferential view of all flaw positions and extents on specimen 9C-001. This pipe end-view depicts the circumferential extent (length) of the implanted ID surface-connected cracks, relative to the radial position along the pipe circumference.

Figure 7.4 Side View Illustration of All Four Thermal Fatigue Cracks Implanted into PZR CASS Specimen 9C-001 (courtesy of FlawTech, Inc.)

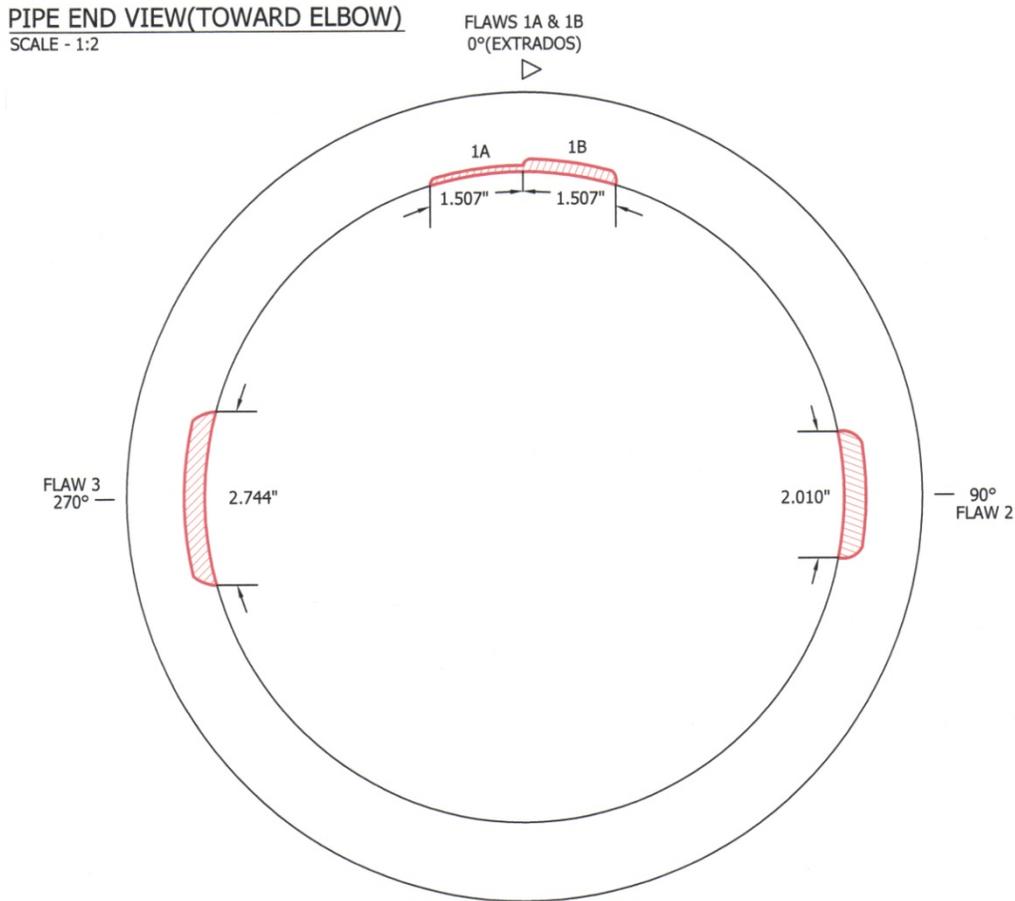
Figure 7.5 End View Illustration of All Four Thermal Fatigue Cracks Implanted into PZR CASS Specimen 9C-001 (courtesy of FlawTech, Inc.)

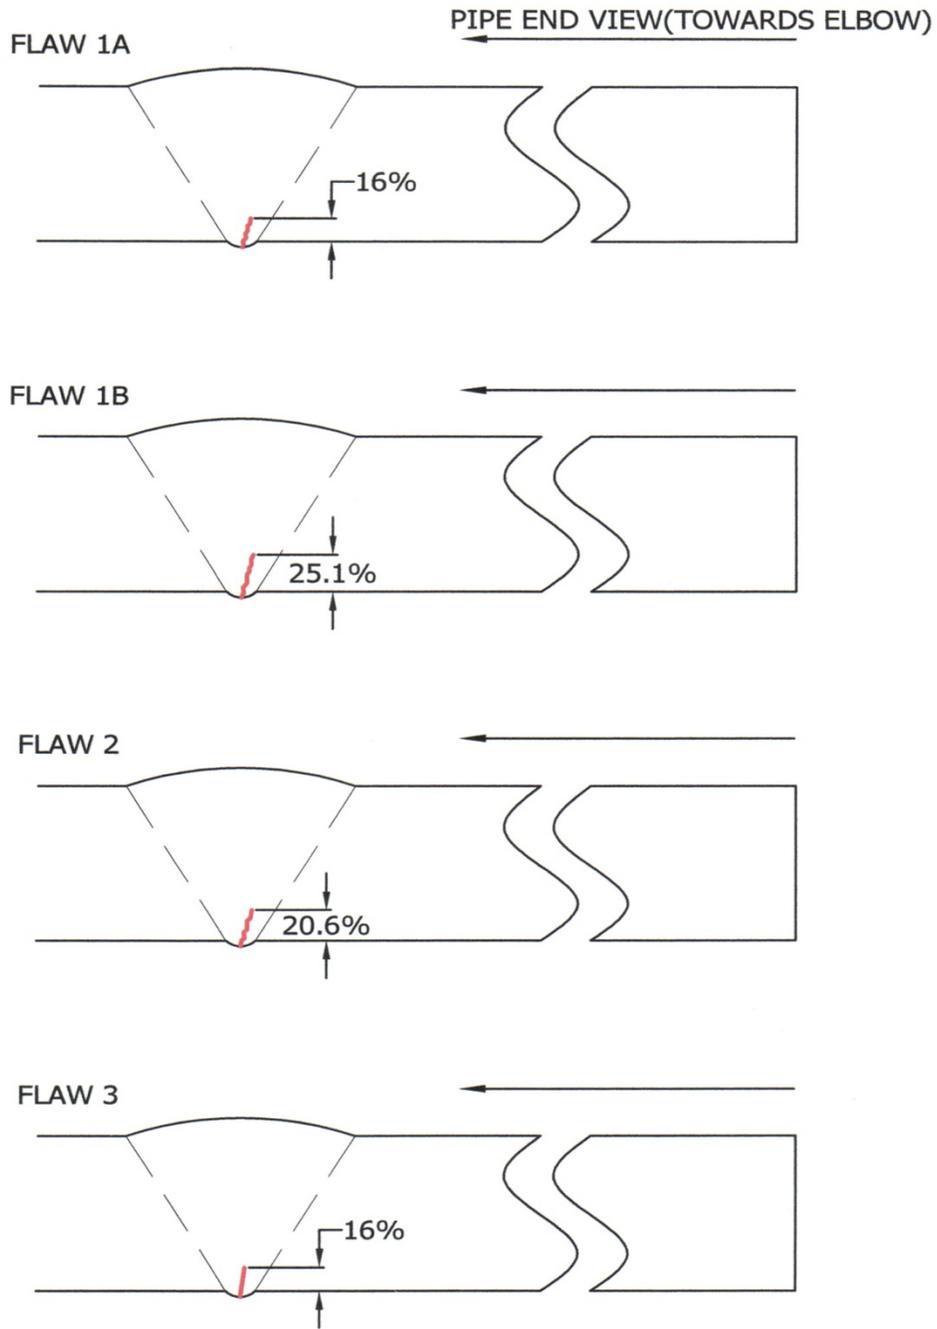
This CASS PZR surge-line segment is NPS 12-in. Schedule 160 pipe, with a CCSS pipe segment welded to a SCSS elbow. This CASS PZR surge-line specimen is approximately 762 mm (30 in.) in length, 324 mm (12.75 in.) OD, and is approximately 31.8-mm (1.25-in.) in wall thickness on the centrifugally cast side of the weld (pipe side). This pipe-to-elbow specimen was also cut from a longer segment of a surge line from WNP-3. As with the previous specimen described above, FlawTech, Inc. performed all crack implantations, with three implanted TFCs being introduced into this specimen. These cracks were inserted via a coupon implant technique and were all circumferentially oriented flaws. Flaw number one has two distinct through-wall depths associated with it. Therefore, in referencing this crack, each depth region will be identified individually as Flaw 1A and Flaw 1B. A side-view illustration of the three flaws depicting flaw position relative to the weldment and flaw depth is provided in Figure 7.6. Figure 7.7 shows a full circumferential view of all flaw positions and extents on specimen 9C-002. This pipe end-view depicts the circumferential extent (length) of the implanted ID surface-connected cracks, relative to the radial position along the pipe circumference.

Figure 7.6 Side View Illustration of All Four Thermal Fatigue Cracks Implanted into PZR CASS Specimen 9C-002 (courtesy of FlawTech, Inc.)

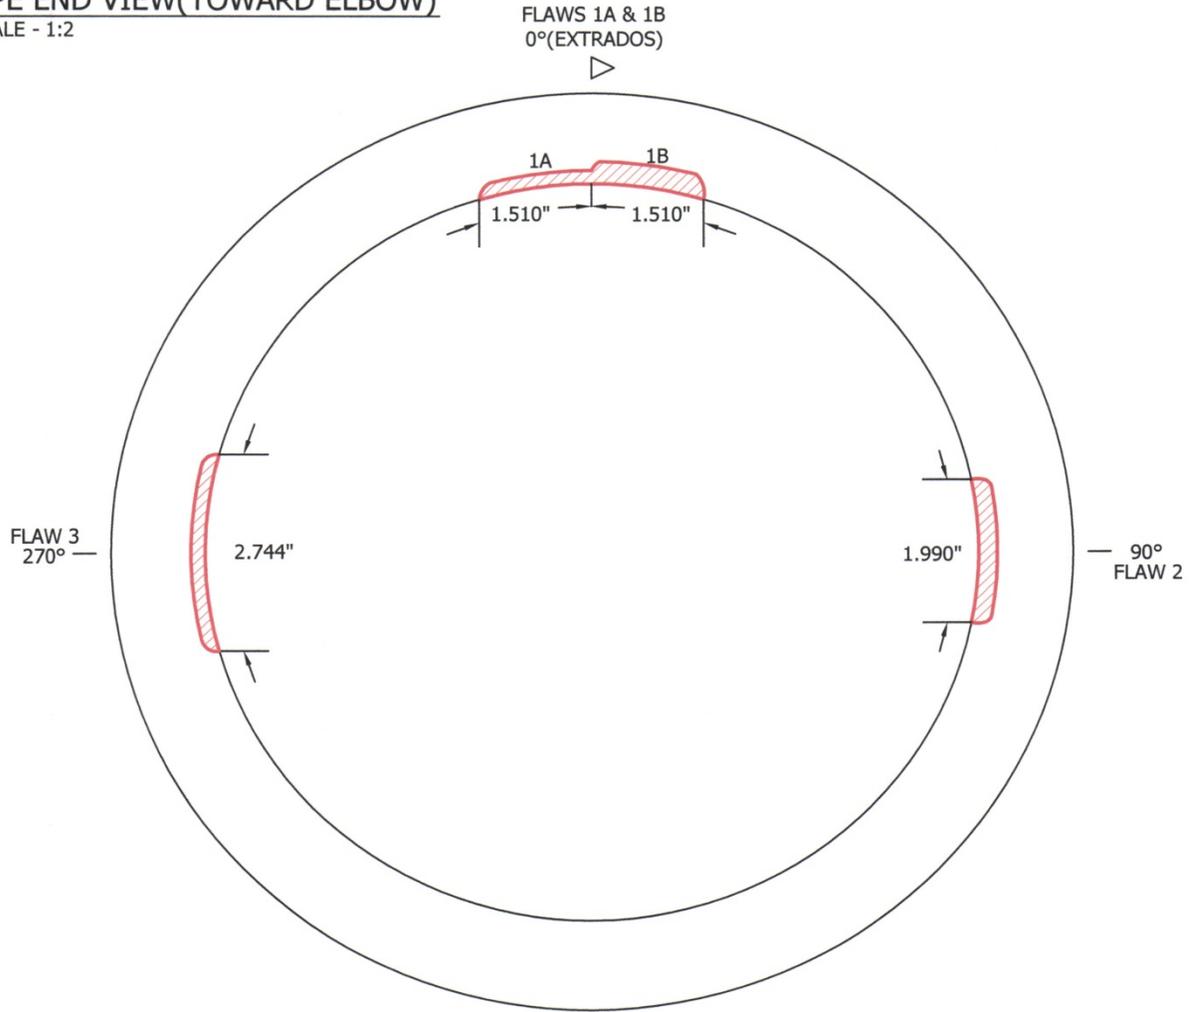
PIPE END VIEW(TOWARD ELBOW)
SCALE - 1:2

Figure 7.7 End View Illustration of All Four Thermal Fatigue Cracks Implanted into PZR CASS Specimen 9C-002 (courtesy of FlawTech, Inc.)

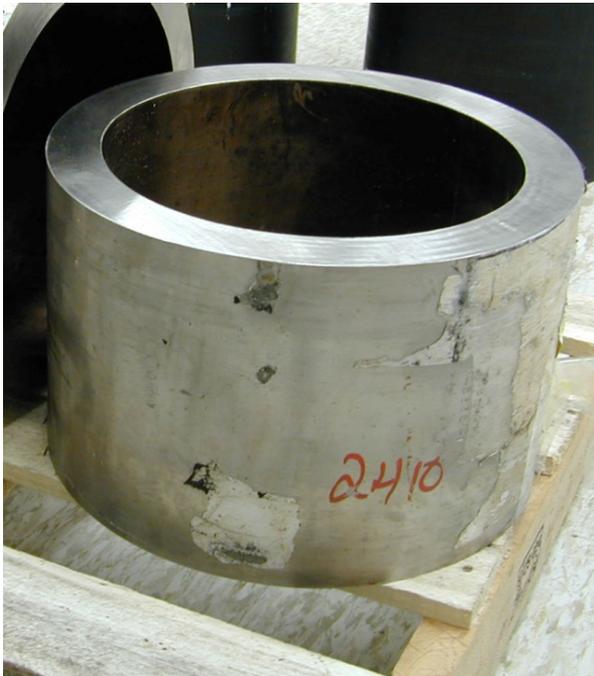
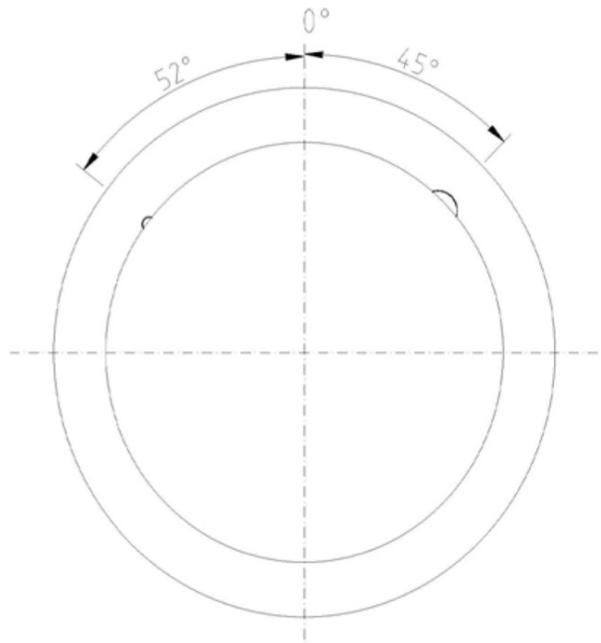
Trueflaw's process to create in-situ cracks in a mock up specimen begins with testing their proprietary and patented technique on a comparable test specimen. A 203.2 mm (8 in.) long PZR surge line pipe section (Figure 7.8) was provided by PNNL with similar metallurgical characteristics as specimen 9C-002. This specimen was cut from the same PZR surge line spool-piece material as that used to fabricate the specimens evaluated in this study. Two in-situ thermal fatigue cracks were grown in this validation specimen with different lengths and depths as a means to calibrate the crack generation process. Prior to the destructive examination (DE) of the validation specimen, PNNL collected ultrasonic phased-array data on the two cracks for nondestructive crack detection and characterization. Trueflaw correlates the destructive validation results with their thermal fatigue process parameters obtained from the validation specimen and then makes necessary process adjustments to obtain the desired flaw length and depth in the actual specimen.

Figure 7.8 CASS Validation Specimen

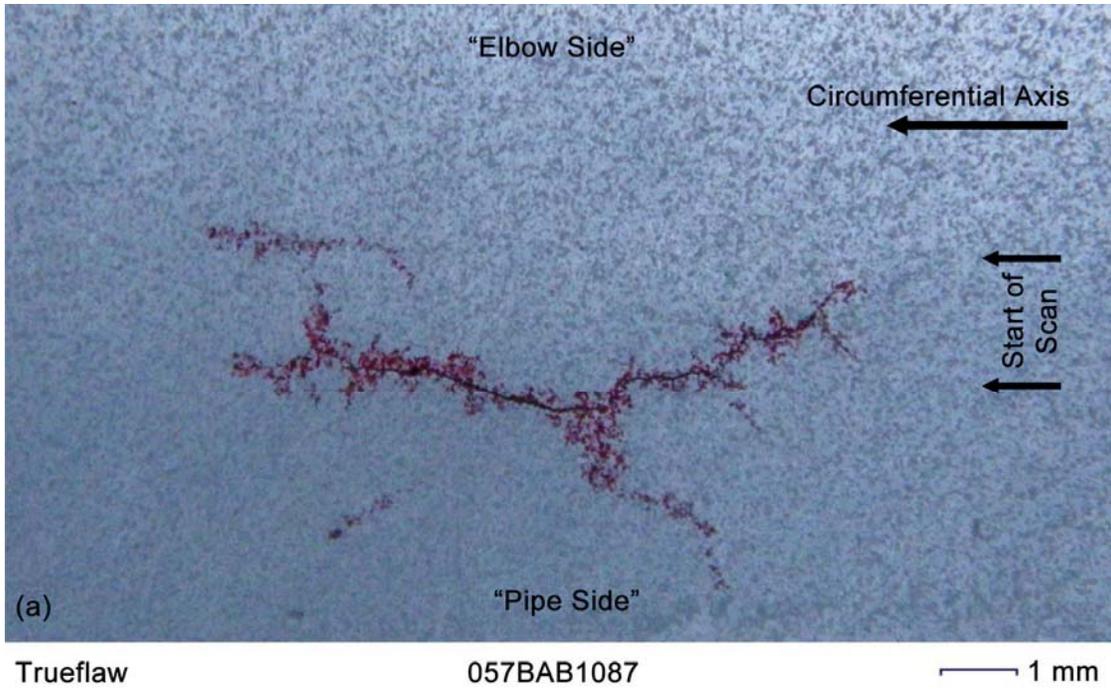
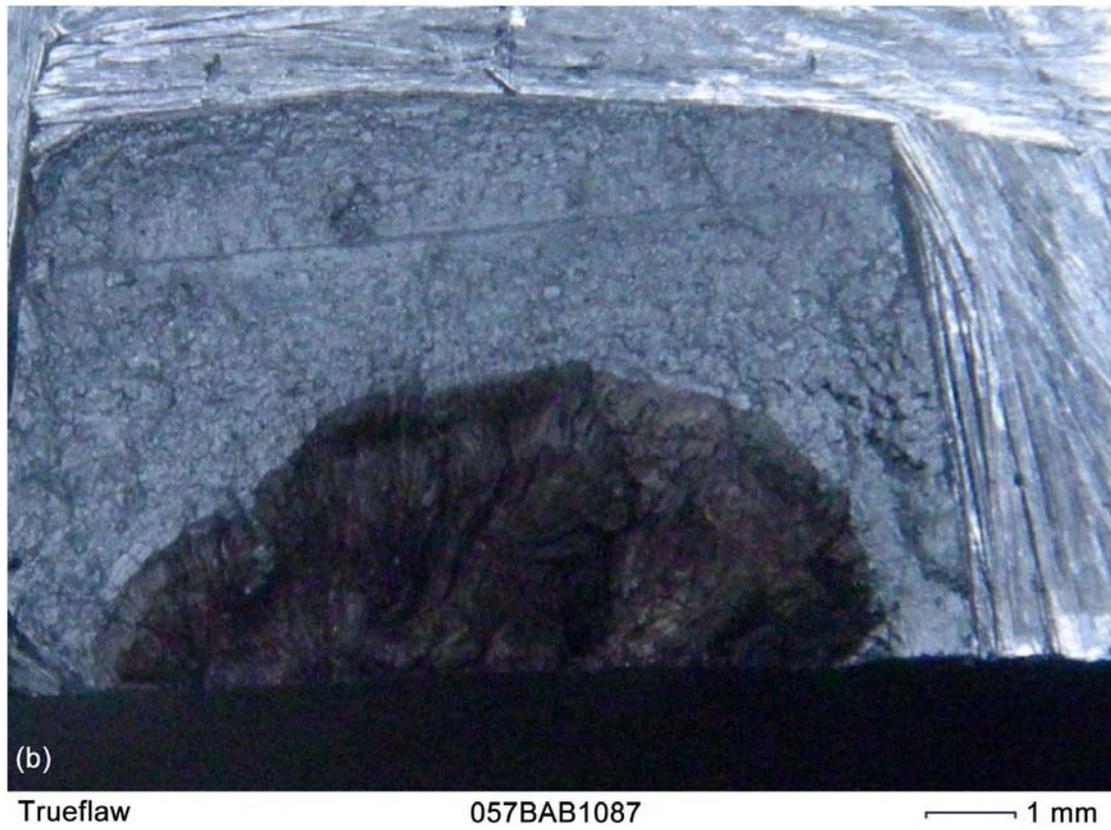
Figure 7.9 Validation Flaw 1087. (a) ID penetrant image; (b) DE fracture surface image.

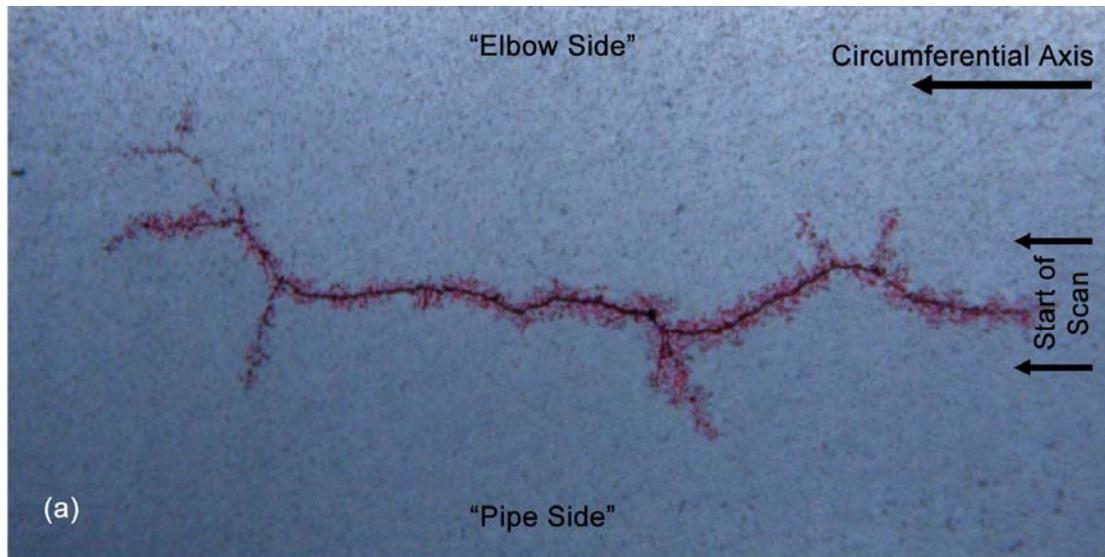
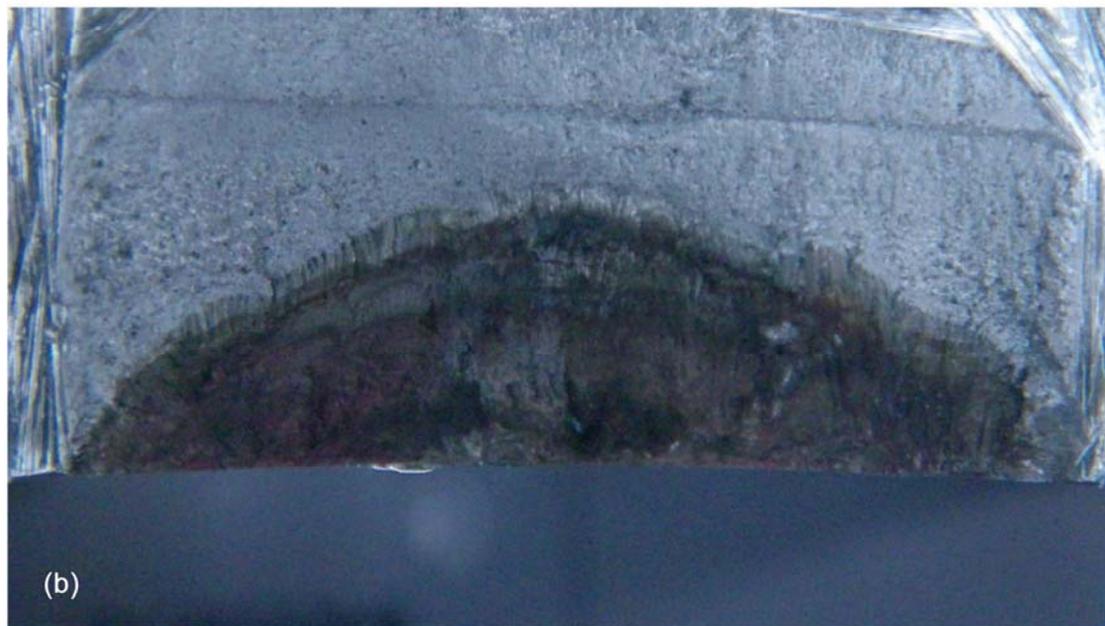
Flaw 070BAB1089 (1089) was created to have both length and depth larger than flaw 1087. Flaw 1089 has a measured length of 21.8 mm (0.86 in.) and a depth of 6.0 mm (0.24 in.) based on the ID PT and fracture surface analysis (Figure 7.10). This flaw has an average COD of 51.7 μm with six turns and five branches.

(a) Trueflaw 070BAB1089 1 mm

(b) Trueflaw 070BAB1089 1 mm

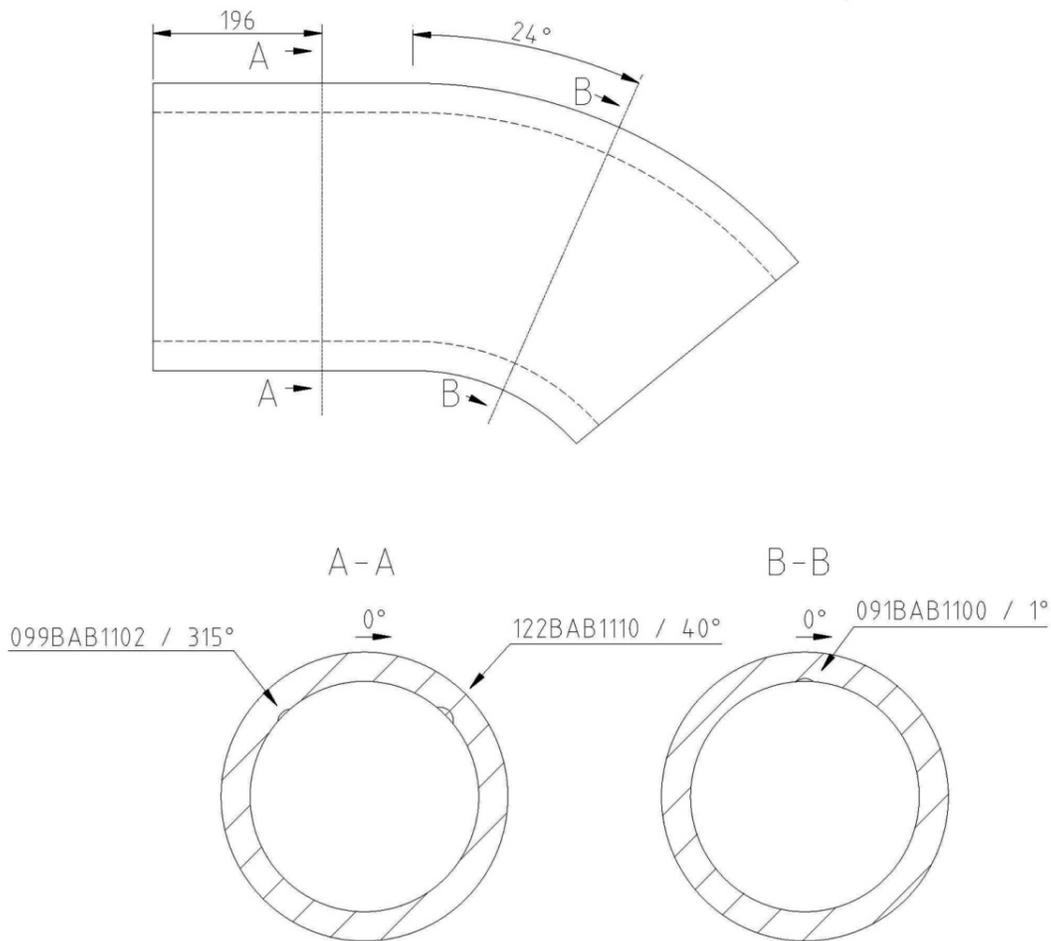
high-resolution images after liquid penetrant testing indicate that the crack is 19.3 mm (0.76 in.) long. The depth estimate is extrapolated from the validation data and is estimated at 3.4 mm (0.13 in.) yielding an approximate 10.1% through-wall extent when using 33.5 mm (1.32 in.) as the pipe wall dimension. The crack exhibits a skew angle of 86 degrees with an average and median COD of 39.9 μm and 37.8 μm (1.6×10^{-3} and 1.4×10^{-3} in.), respectively. Further, the crack has a complex morphology including three branches, six turns, and one discontinuity above the main crack on the right. Figure 7.12 shows the ID of the pipe section after PT in the crack area.

Figure 7.11 9C-002 In-situ Grown Flaw Placement Schematic

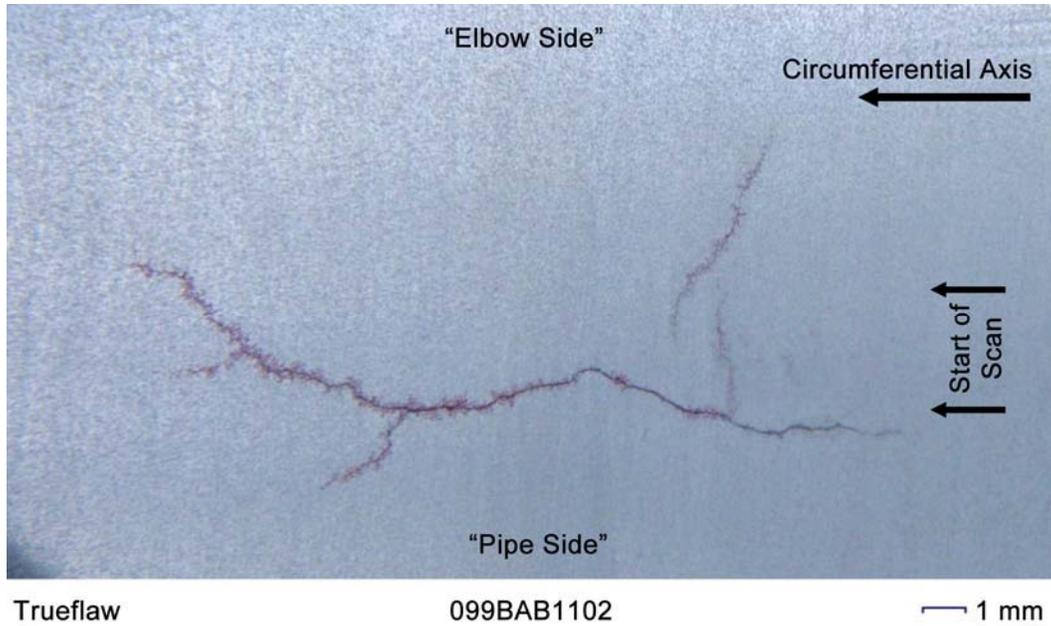
Figure 7.12 Penetrant Image of Crack 1102

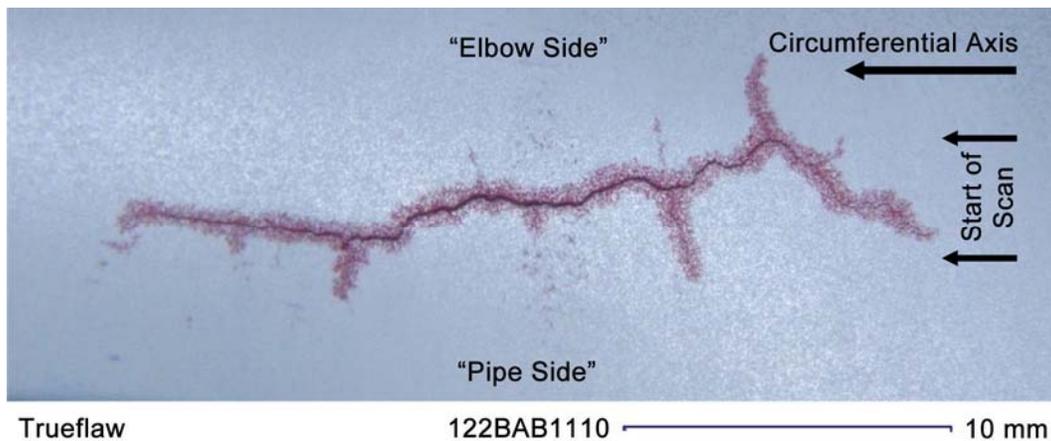
Figure 7.13 Penetrant Image of Crack 1110
