An Evaluation of Ultrasonic Phased Array Testing for Cast Austenitic Stainless Steel Pressurizer Surge Line Piping Welds

Confirmatory research is being conducted for the U.S. Nuclear Regulatory Commission at the Pacific Northwest National Laboratory to assess the effectiveness and reliability of advanced nondestructive examination methods for the inspection of primary system pressure boundary components and materials in light-water reactors. The work reported here provides a technical evaluation to assess the capabilities of phased-array (PA) ultrasonic testing (UT) methods as applied to the inspection of welds in cast austenitic stainless steel (CASS) pressurizer (PZR) surge line piping. A set of thermal fatigue cracks (TFCs) were implanted into CASS PZR surge-line specimens (pipe-to-elbow welds) salvaged from cancelled nuclear power plants that were fabricated of vintage materials formed in the 1970s. Responses from these cracks were used to evaluate detection and sizing performance of the PA-UT methods applied. Custom arrays, operating nominally at 800 kHz, 1.0 MHz, 1.5 MHz, and 2.0 MHz were employed. Raster and line-scan data were acquired as a function of probe frequency and

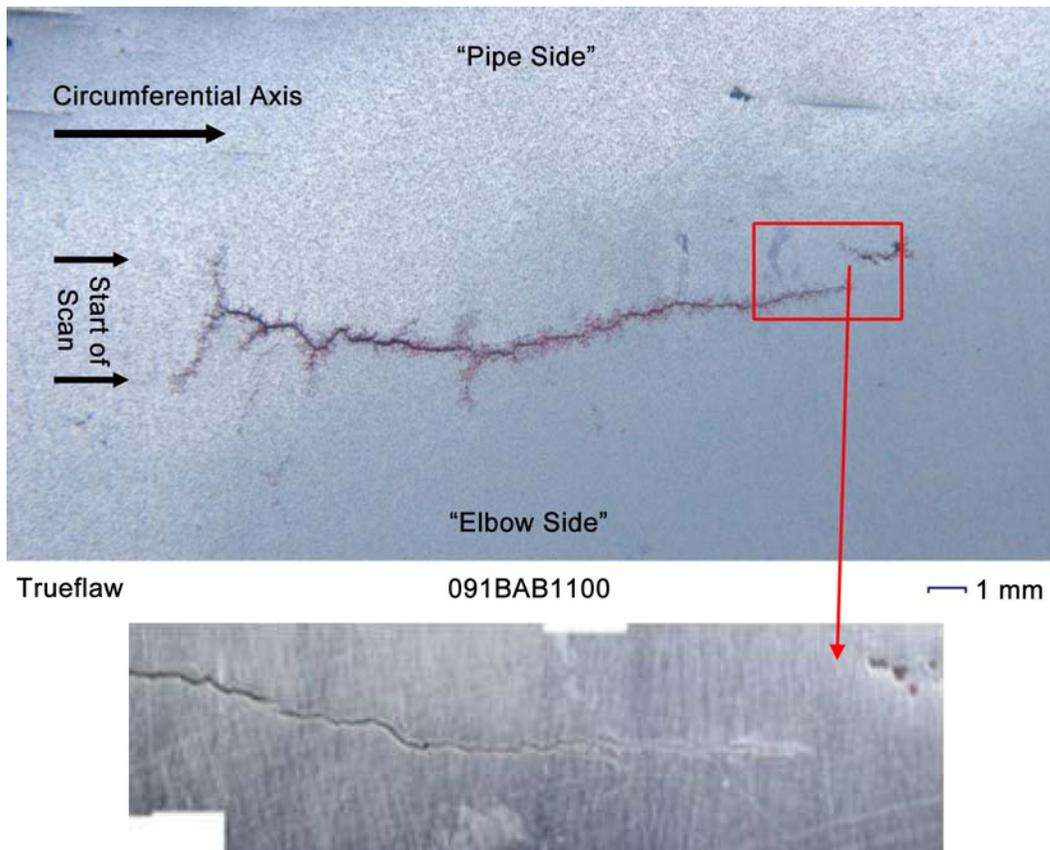
Figure 7.14 Penetrant Image of Crack 1100 in the Top and Enlarged Photograph of the Clean ID Surface in the Bottom

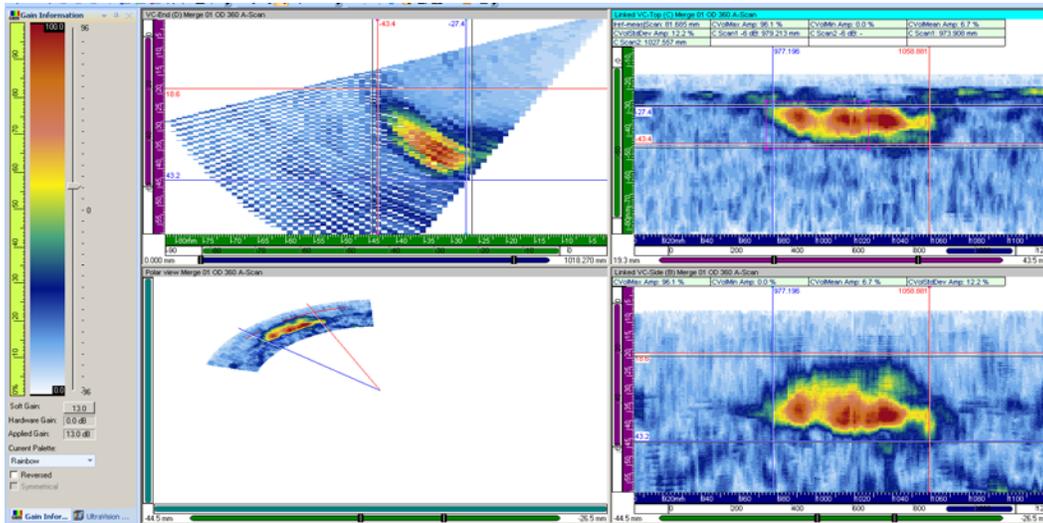
Figure 8.1 800-kHz Data on Pipe Side of 9C-002, Flaw #1, Merged Image for Length Sizing

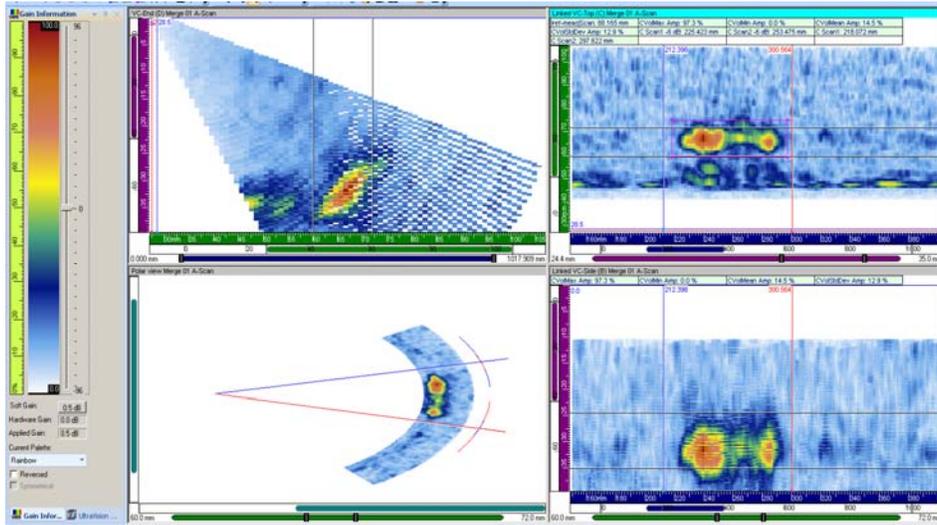
Figure 8.7 1.5 MHz Data on Pipe Side of 9C-001, Flaw #2, Merged Image for Length Sizing

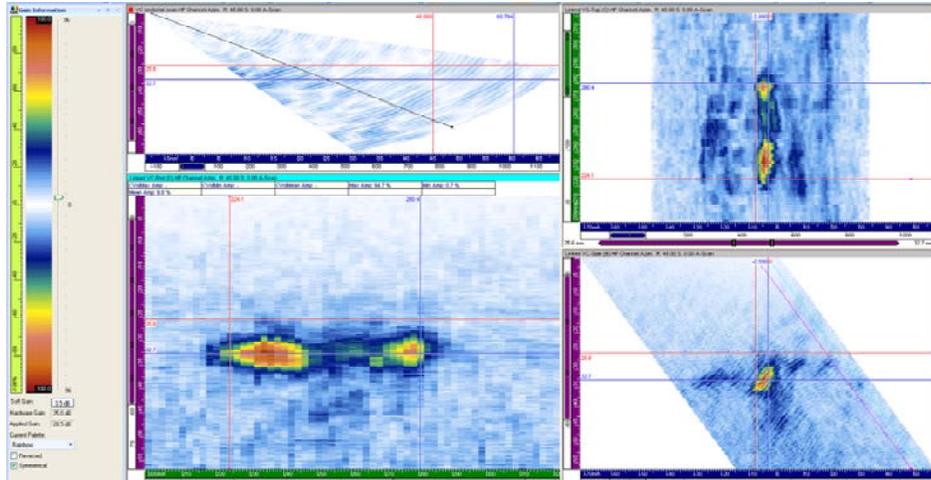
Figure 8.9 Raster Data Acquired at 1.5 MHz from the CCSS Pipe Side of the Weld on Flaw #2 in Specimen 9C-001

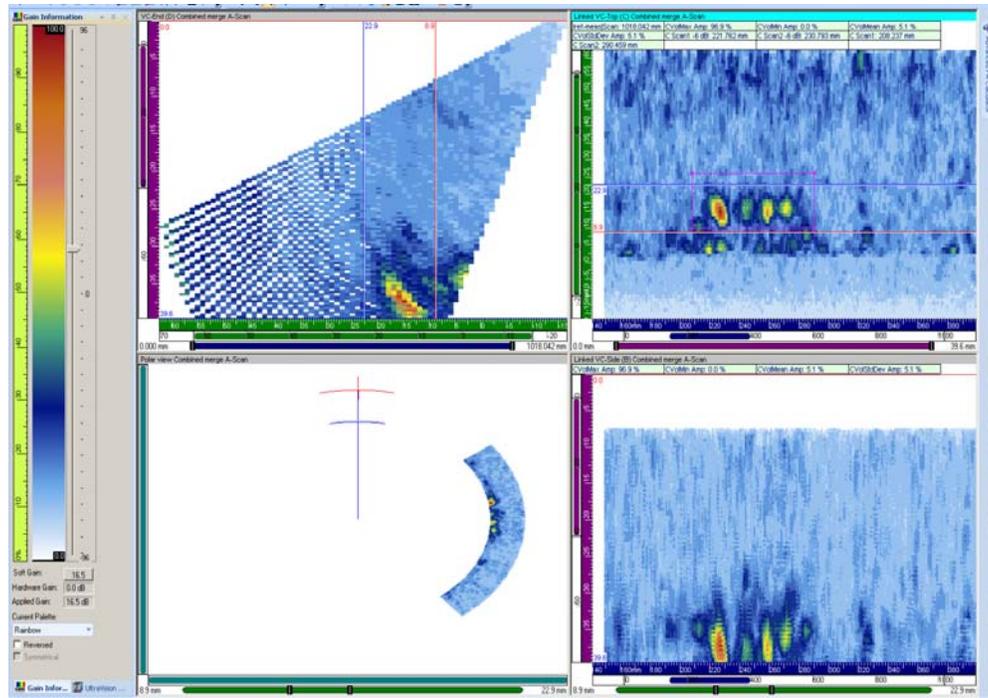
Figure 8.10 2.0-MHz Data on Pipe Side of 9C-002, Flaw #2, Merged Image for Length Sizing

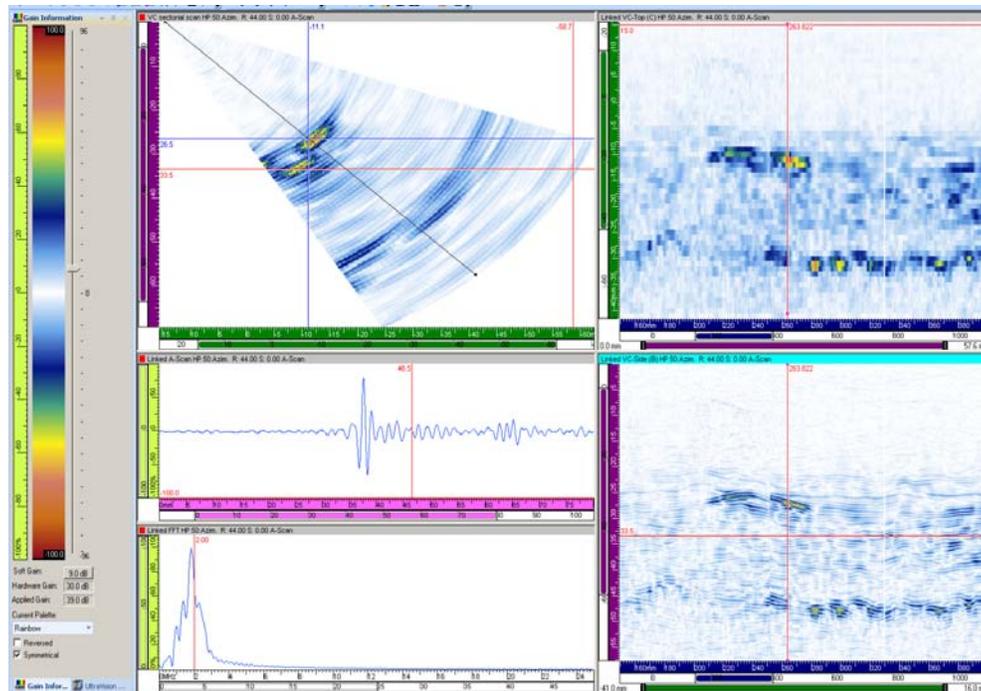
Figure 8.12 2.0-MHz Data on Elbow Side of 9C-002, Flaw #2, for Depth Sizing

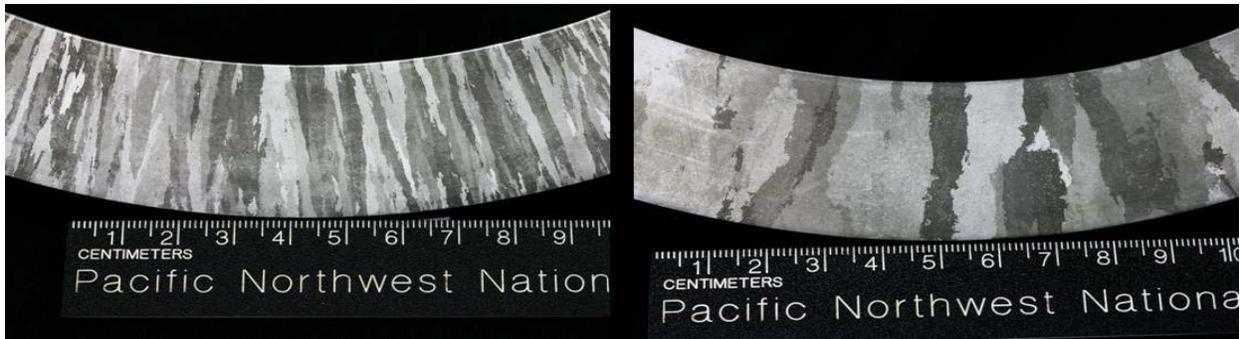
Figure 8.16 Columnar Grain Structure of Cast Specimens Examined. From left to right are the microstructures of specimens 9C-001 and 9C-002, respectively.

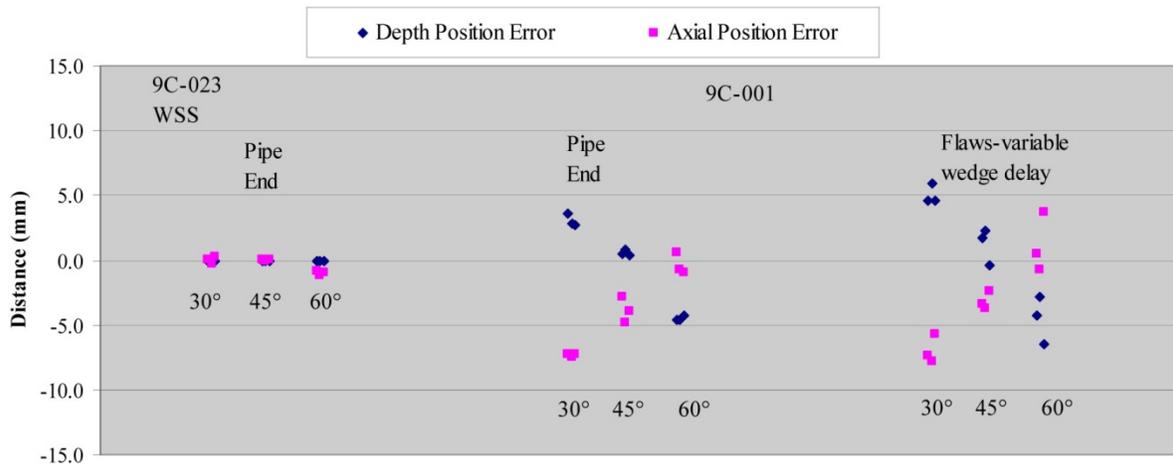
Figure 8.20 Comparison of Axial Position (and Projected Depth) Errors from the WSS Calibration Specimen and CCSS Specimen 9C-001 for Three Primary Angles. The CCSS specimen 9C-001 data includes the measurement errors from the end of pipe and flaw corner signals.

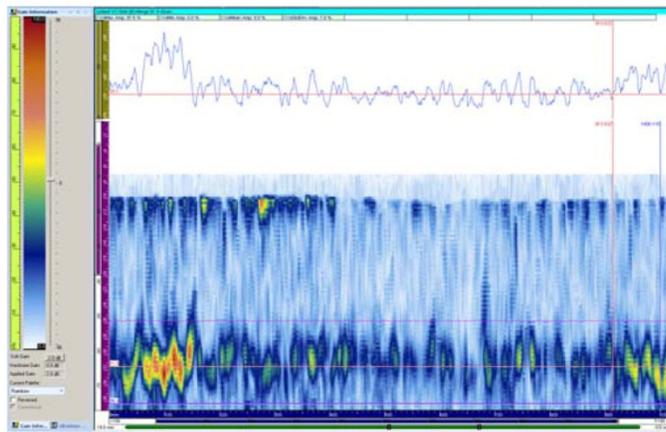
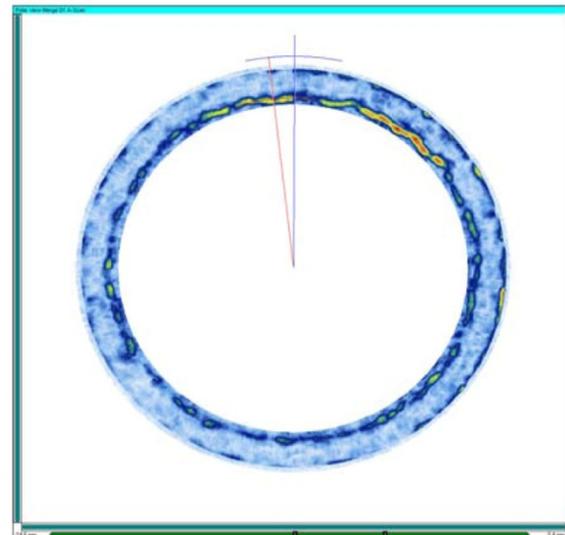
Figure 8.29 Pipe End Corner Response on 7C-059 at 1.5 MHz. The end view is the same as in Figure 8.30 but the threshold for the signal dropout measurements has been lowered to -12 db (0.25 level). A signal dropout of 31.4% is measured at the -12 dB level.

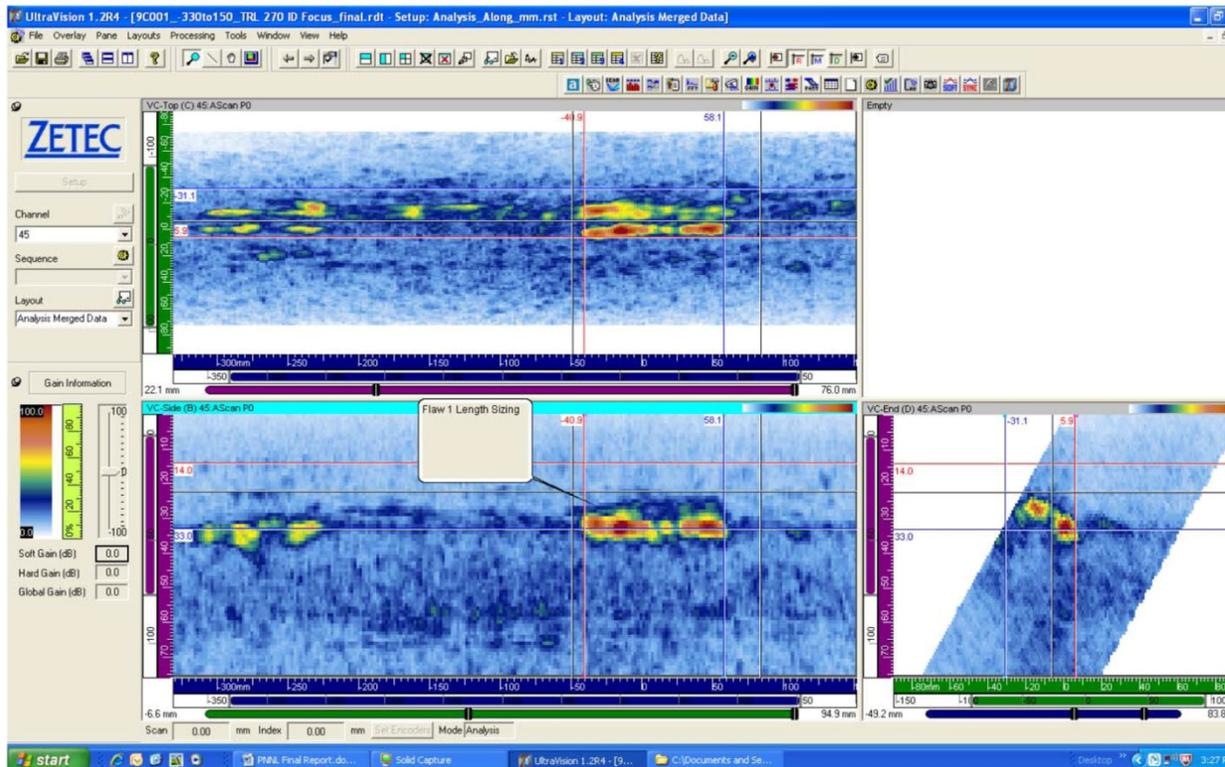
Figure 8.30 ISI Supplier, LMT, Data from Flaw 1 in Specimen 9C-001 at 270 Degree Skew, Pipe Side

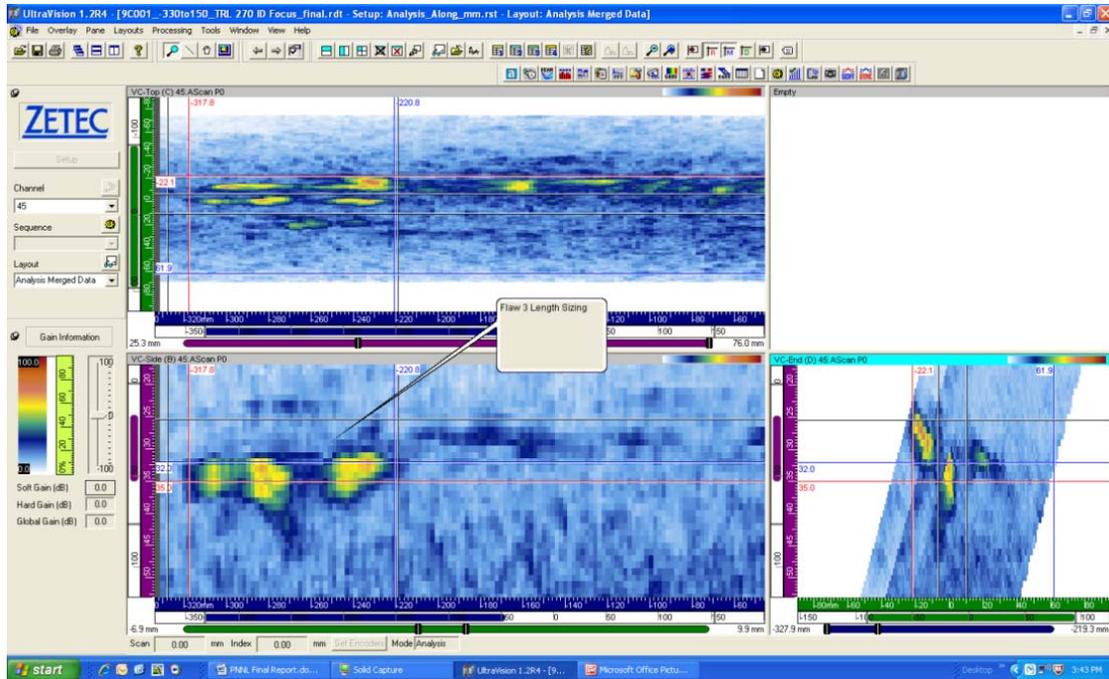
Figure 8.32 ISI Supplier data on Specimen 9C-001 Implanted Flaw 3 from the CCSS Pipe Side for Length Sizing. The D-scan end view is in the lower left.

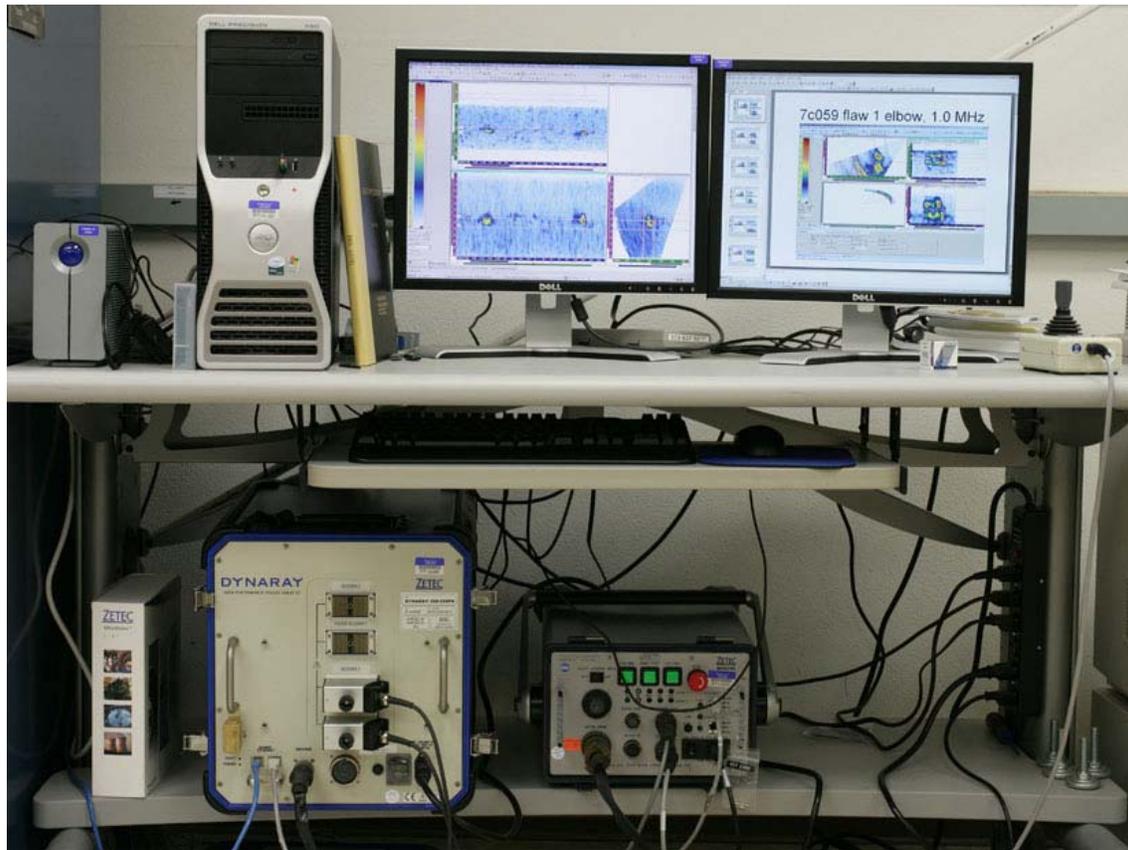
Figure 8.33 DYNARAY and Motor Control Drive Unit

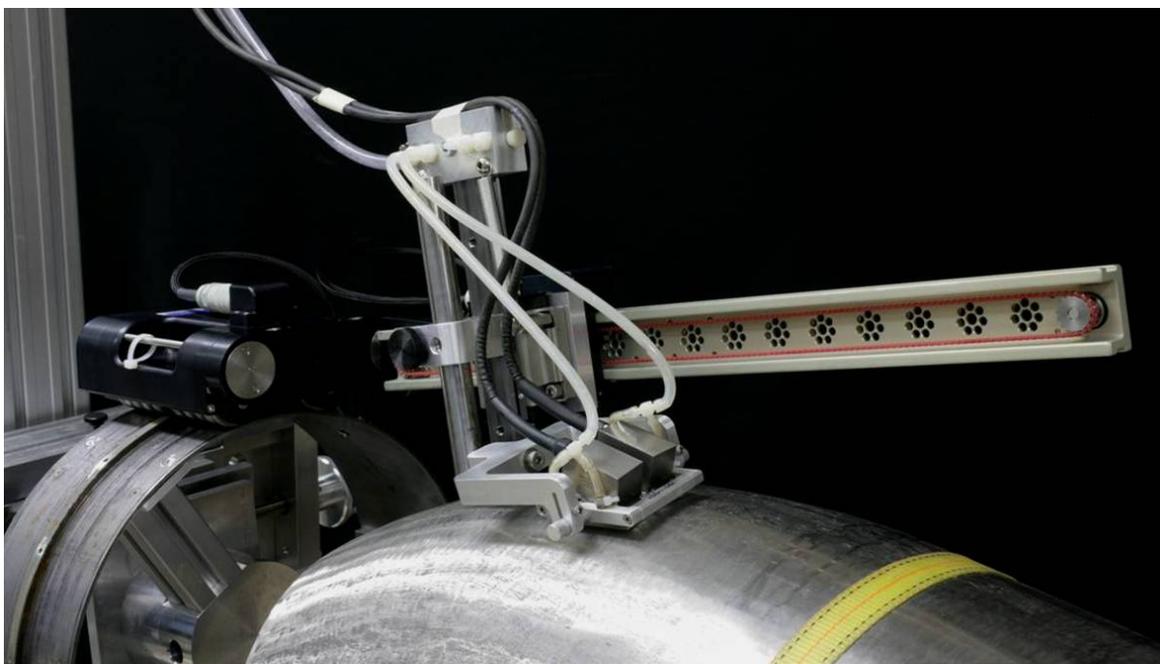
Figure 8.34 Automated Scanner and Probe System on Specimen

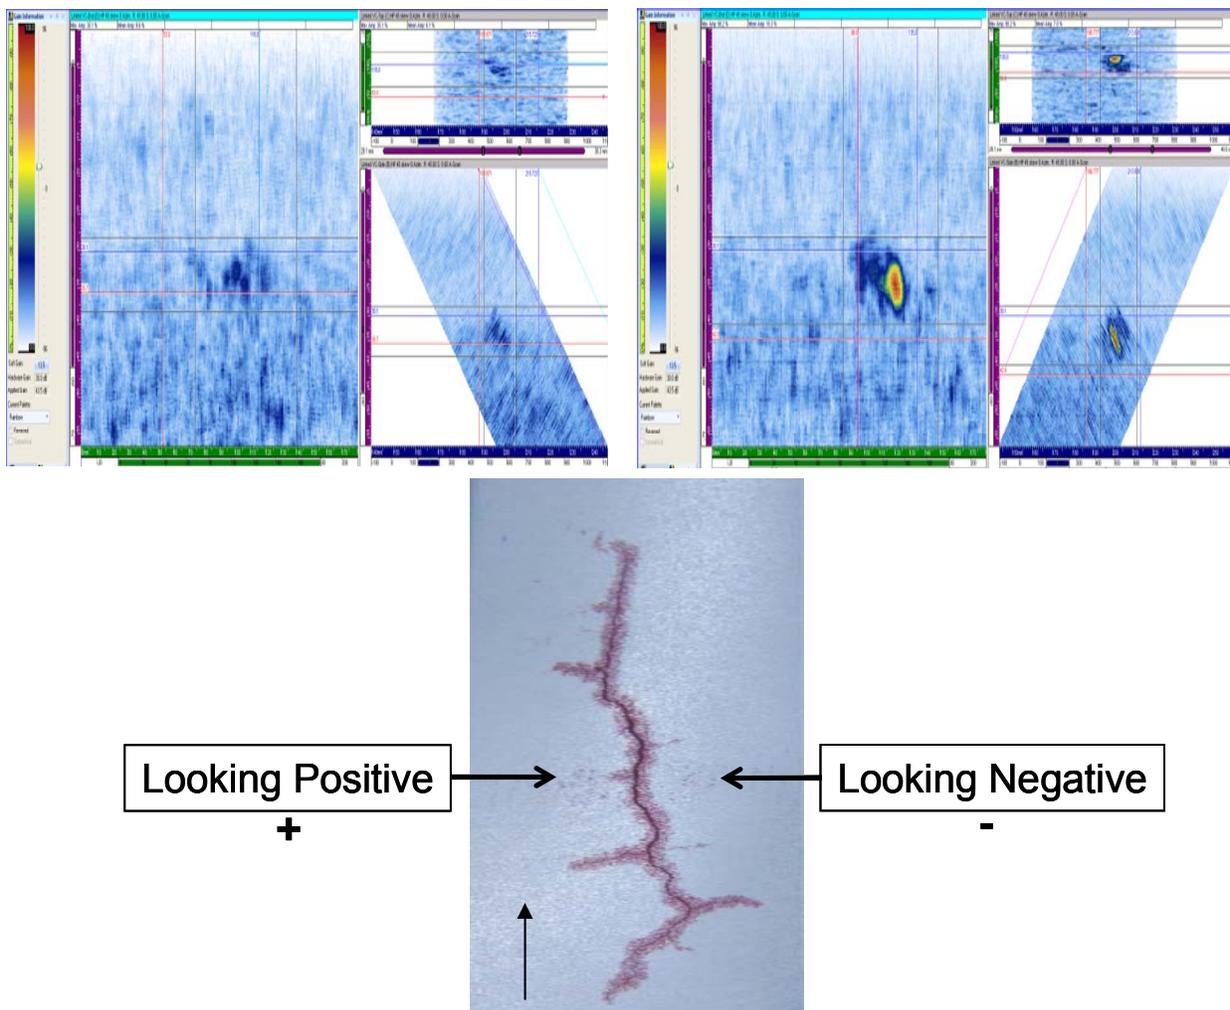
Figure 8.35 2.0 MHz Raster Data Collected from Both Sides of Flaw 1110. Left data were acquired looking positive; right data were acquired looking negative. Below is the ID liquid penetrant image of the crack with the vertical arrow showing the direction of the circumferential axis.

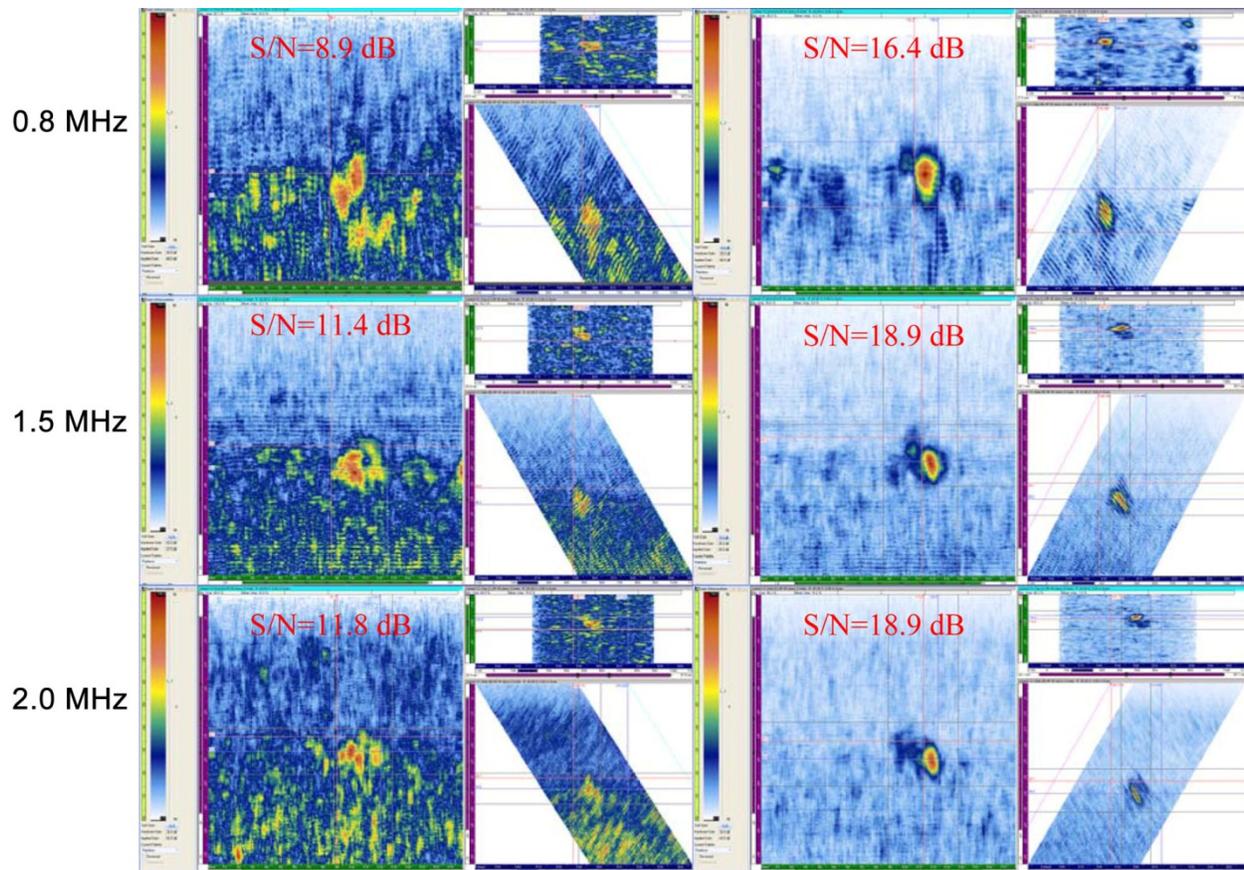
Figure 8.36 Raster Data on Flaw 1110. Left side looking positive; right side looking negative.

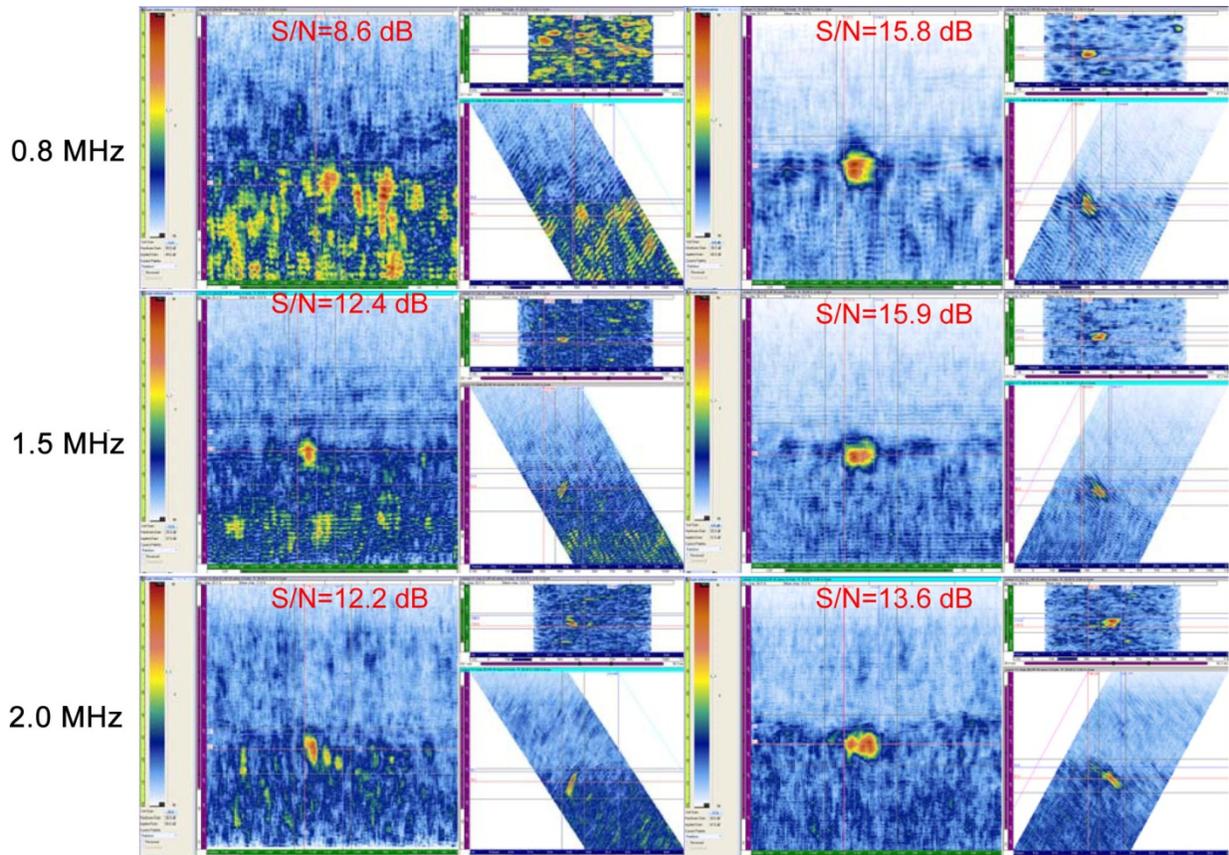
Figure 8.37 Raster Data on Flaw 1102. Left side looking positive; right side looking negative.

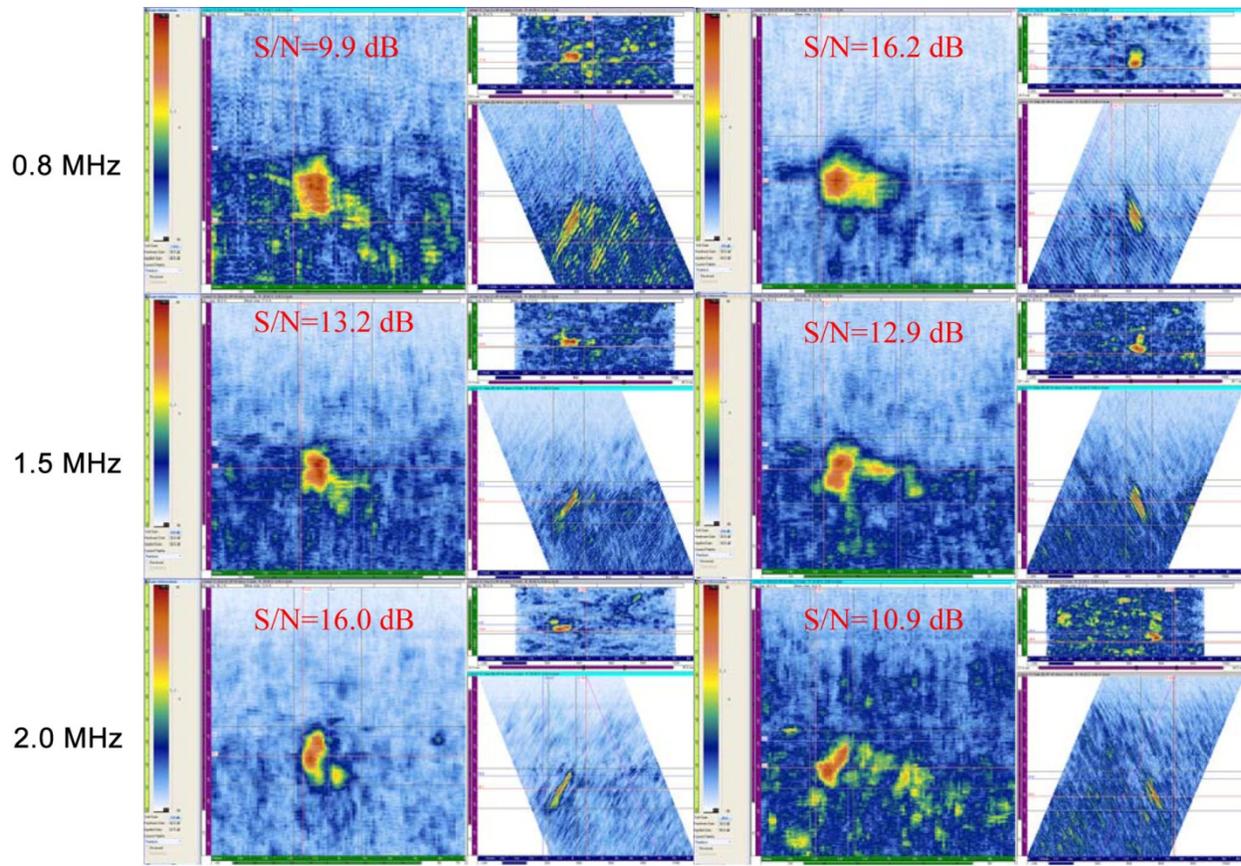
Figure 8.38 Raster Data on Flaw 1100. Left side looking positive; right side looking negative.

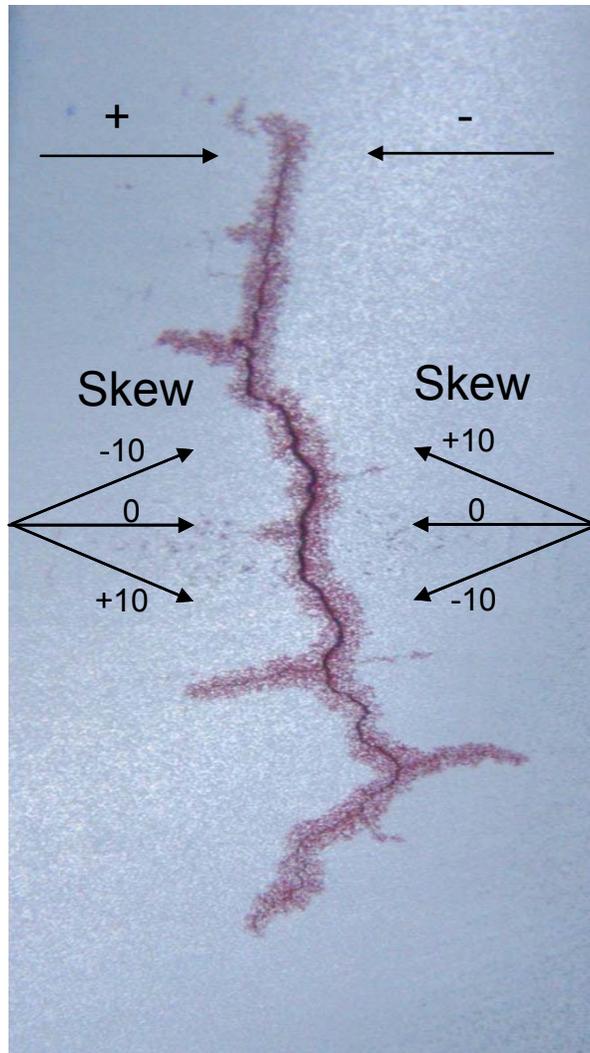
Figure 8.39 ID Penetrant Image of Flaw 1110 Using Arrows to Show the Beam Skew Directions (angles are not drawn to scale)

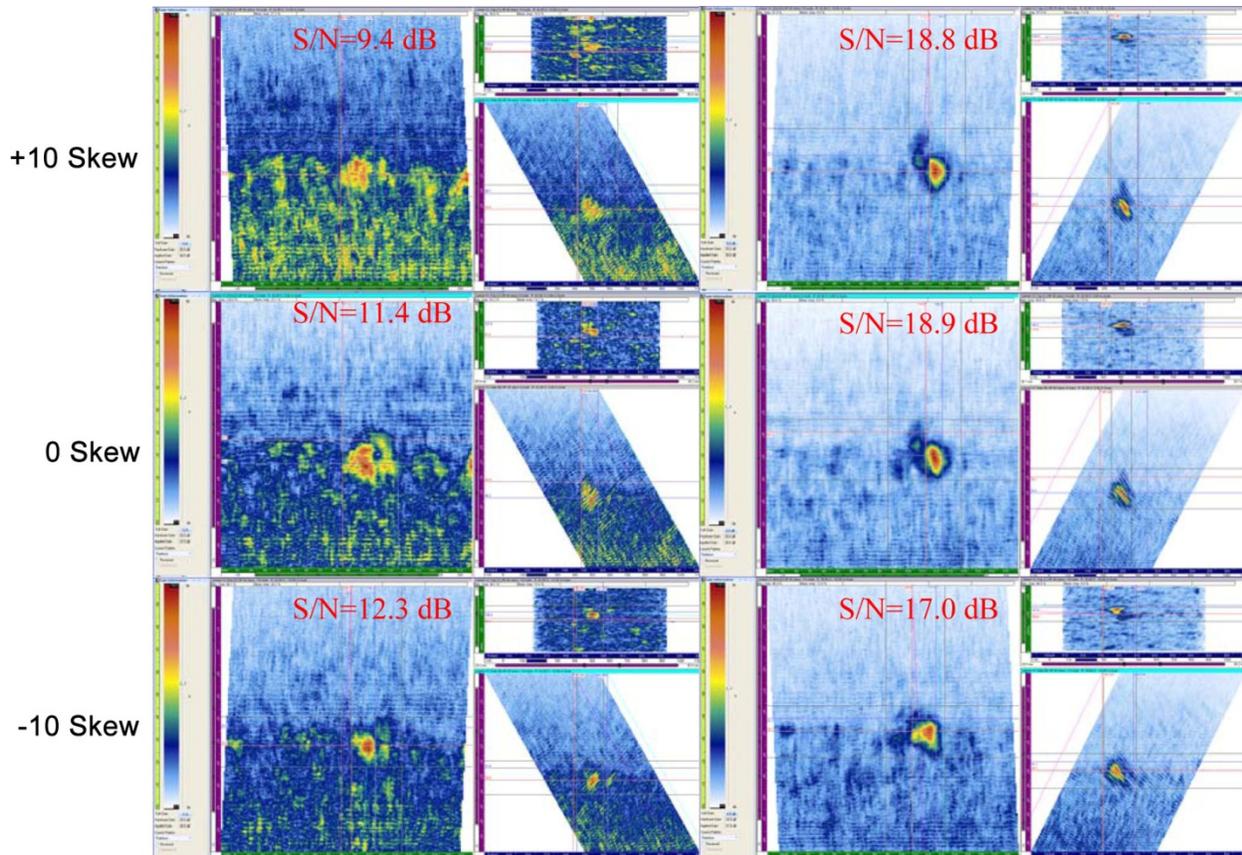
Figure 8.40 1.5 MHz Raster Data on Flaw 1110. Left side looking positive; right side looking negative.

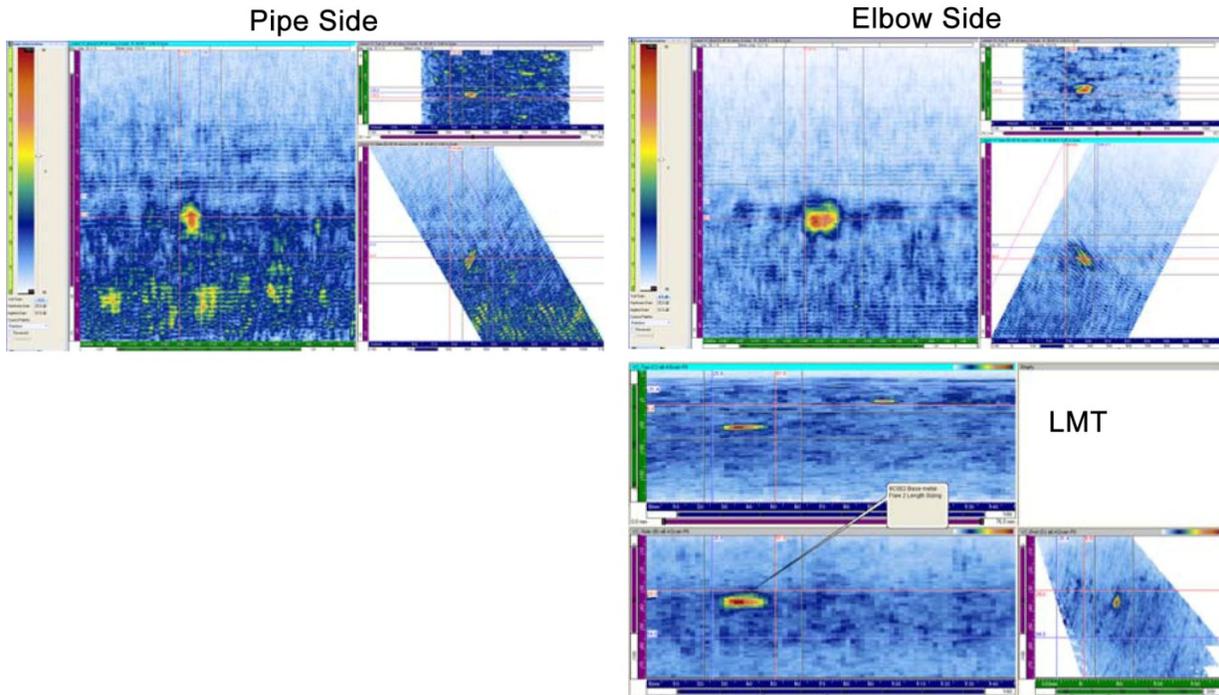
Figure 8.42 Flaw 1102 as Observed by PNNL (top two images) and LMT (bottom)

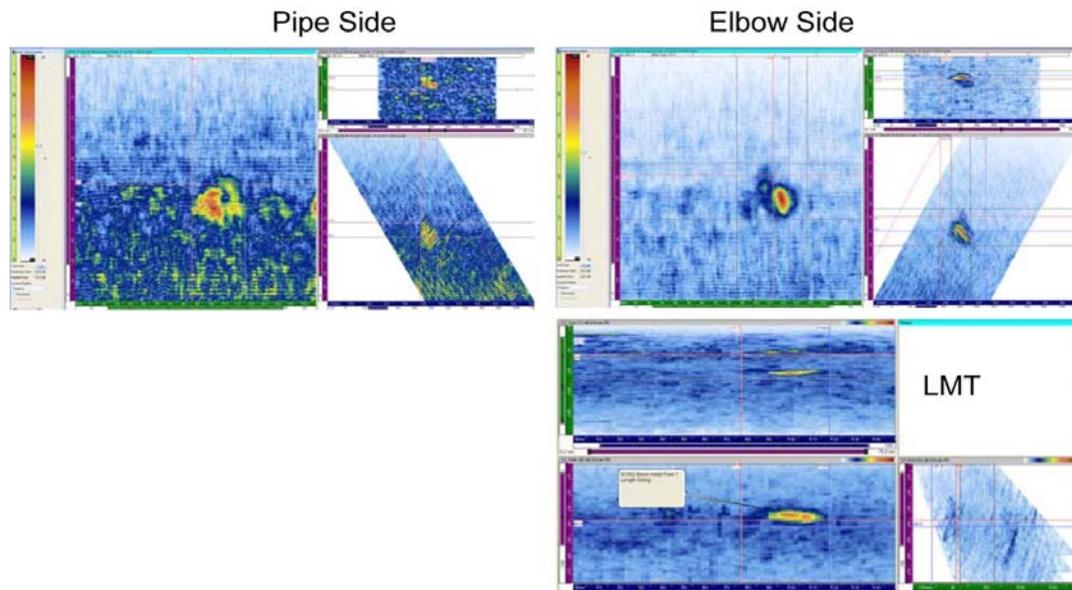
Figure 8.43 Flaw 1110 as Observed by PNNL (top two images) and LMT (bottom)

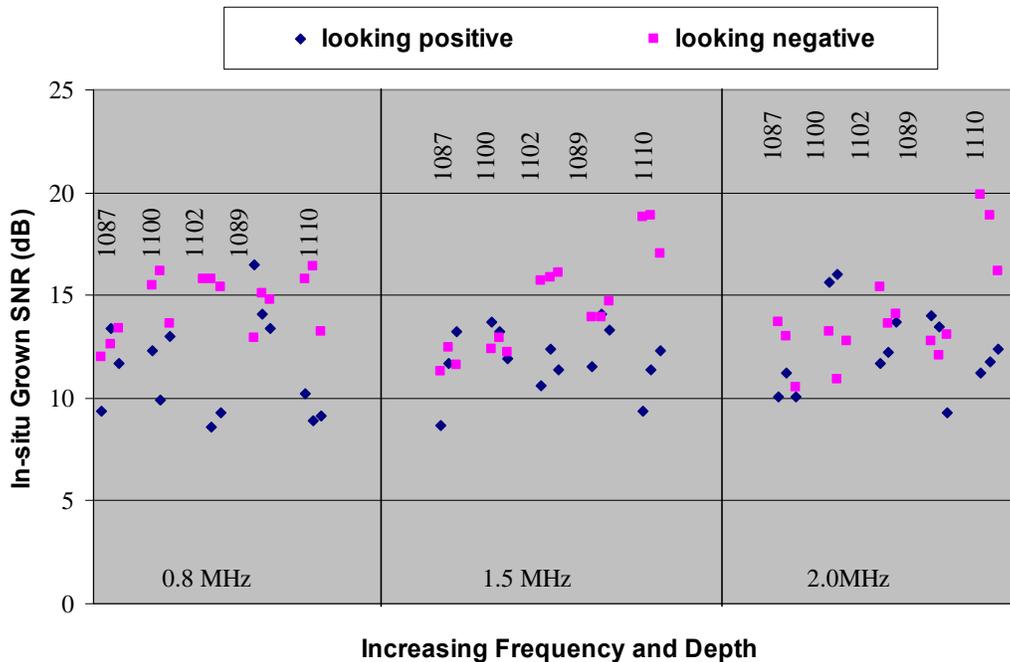
Figure 8.45 SNR Values for All In-situ Grown TFCs at Three Frequencies and Three Skews

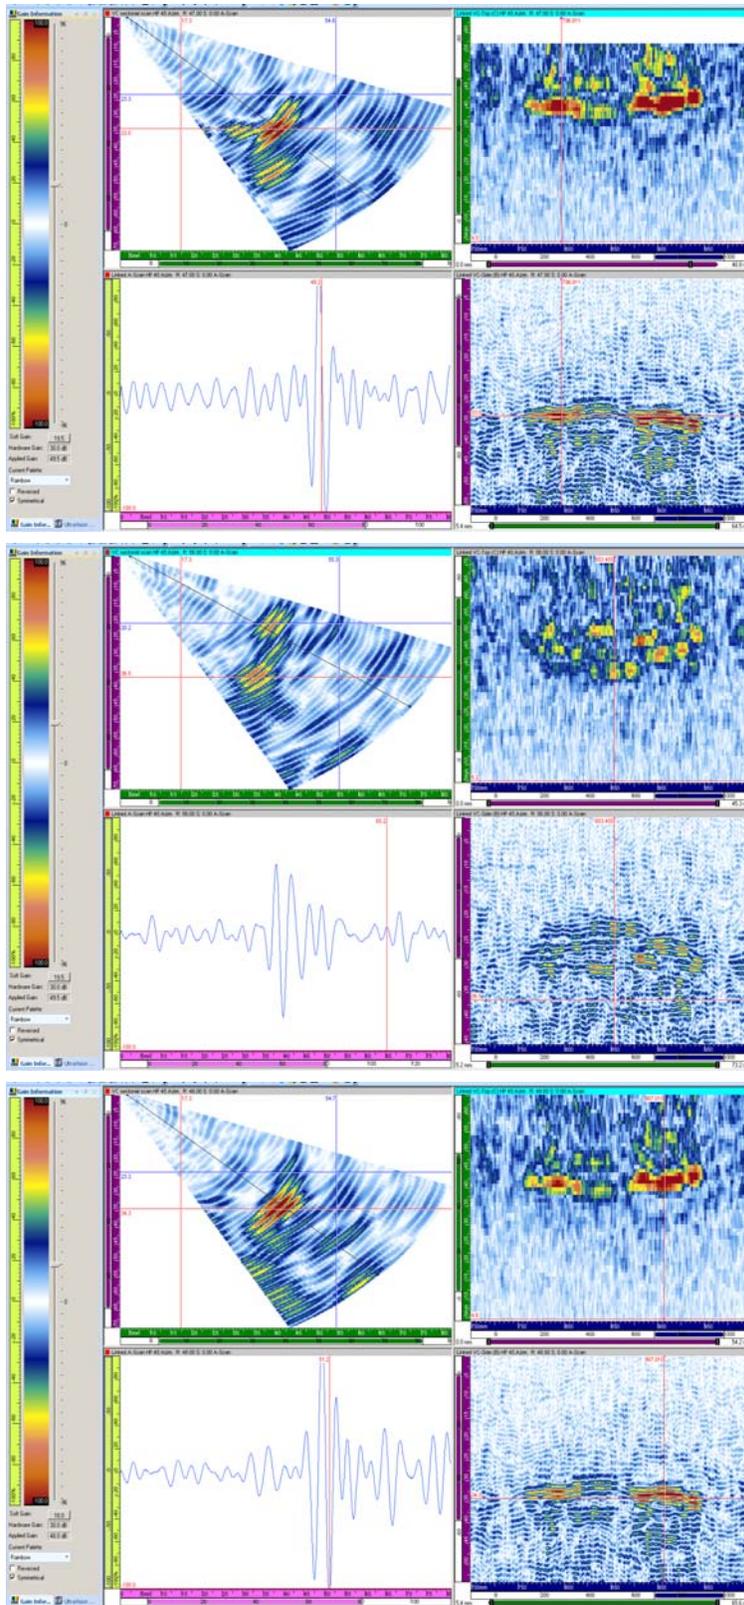
Figure A.13 800-kHz Data on Pipe Side of 7C-059, Flaw 4a, 4b, and 4c Top to Bottom for Depth Sizing

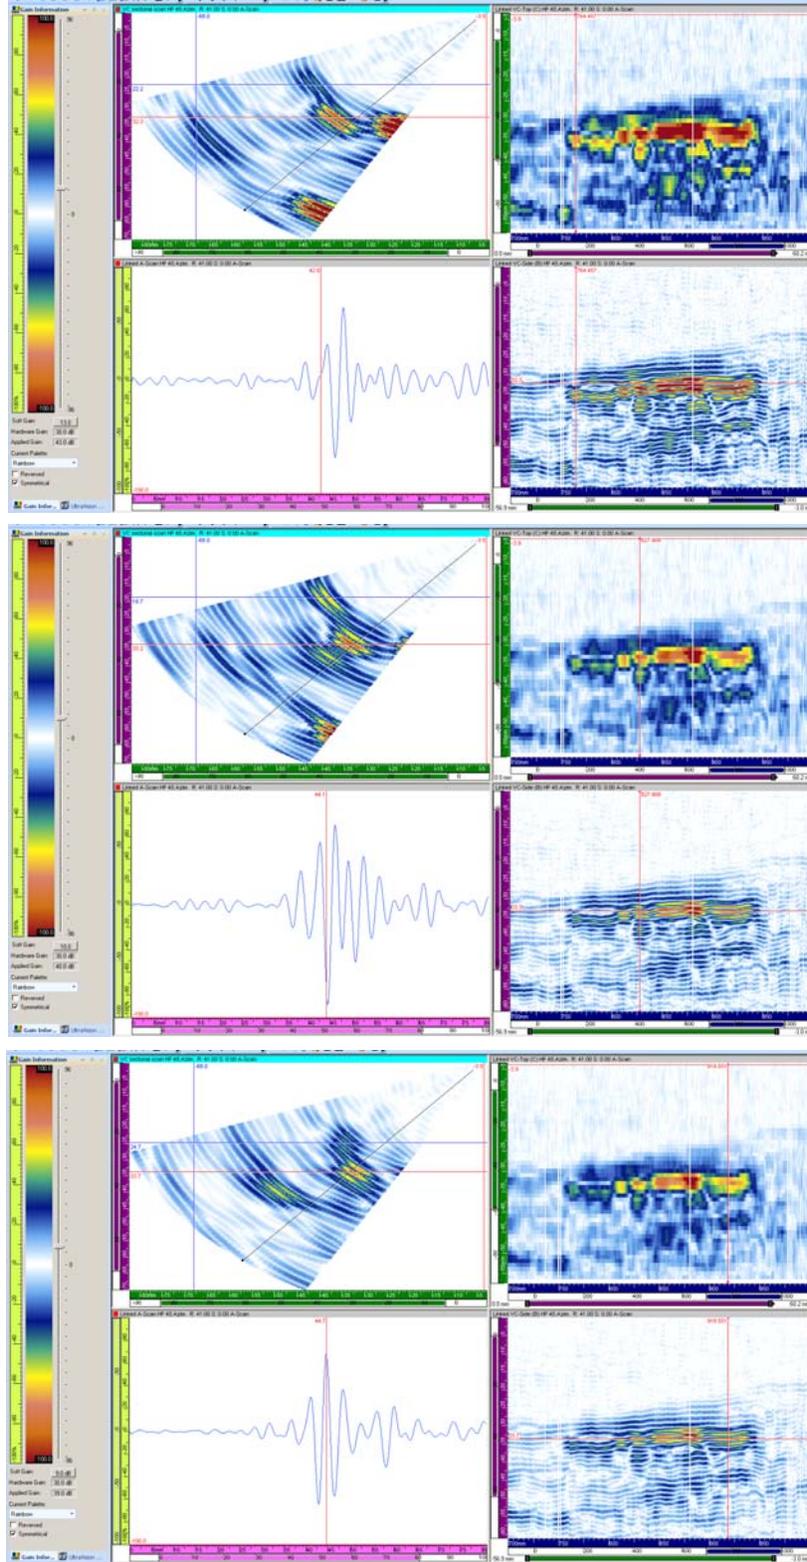
Figure A.14 800-kHz Data on Elbow Side of 7C-059, Flaw 4a, 4b, and 4c Top to Bottom for Depth Sizing

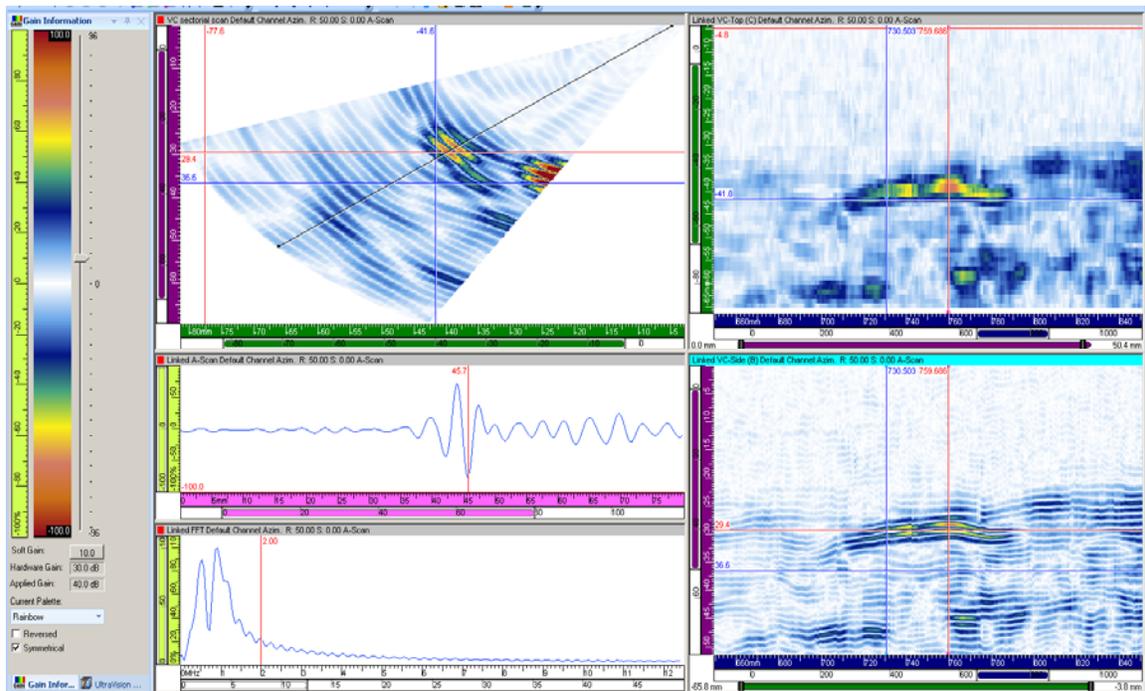
Figure A.26 800-kHz Data on Elbow Side of 9C-001, Flaw 3, for Depth Sizing

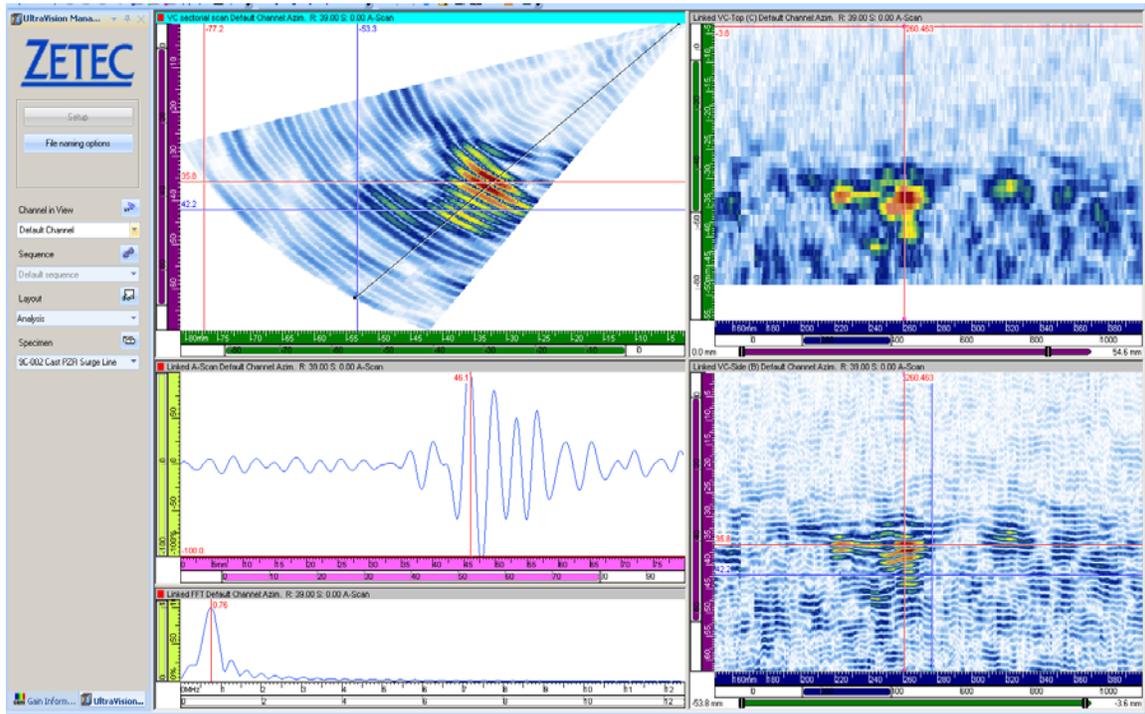
Figure A.33 800-kHz Data on Pipe Side of 9C-002, Flaw 2, for Depth Sizing

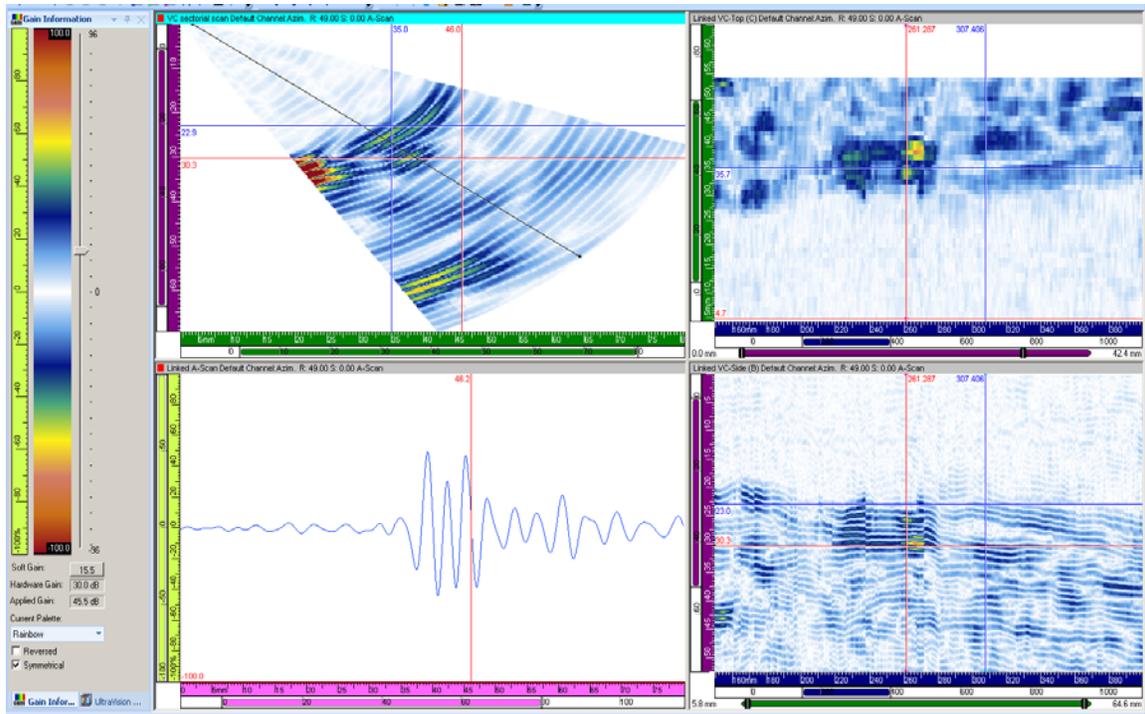
Figure A.34 800-kHz Data on Elbow Side of 9C-002, Flaw 2, for Depth Sizing
