An Evaluation of Ultrasonic Phased Array Testing for Cast Austenitic Stainless Steel Pressurizer Surge Line Piping Welds

Confirmatory research is being conducted for the U.S. Nuclear Regulatory Commission at the Pacific Northwest National Laboratory to assess the effectiveness and reliability of advanced nondestructive examination methods for the inspection of primary system pressure boundary components and materials in light-water reactors. The work reported here provides a technical evaluation to assess the capabilities of phased-array (PA) ultrasonic testing (UT) methods as applied to the inspection of welds in cast austenitic stainless steel (CASS) pressurizer (PZR) surge line piping. A set of thermal fatigue cracks (TFCs) were implanted into CASS PZR surge-line specimens (pipe-to-elbow welds) salvaged from cancelled nuclear power plants that were fabricated of vintage materials formed in the 1970s. Responses from these cracks were used to evaluate detection and sizing performance of the PA-UT methods applied. Custom arrays, operating nominally at 800 kHz, 1.0 MHz, 1.5 MHz, and 2.0 MHz were employed. Raster and line-scan data were acquired as a function of probe frequency and

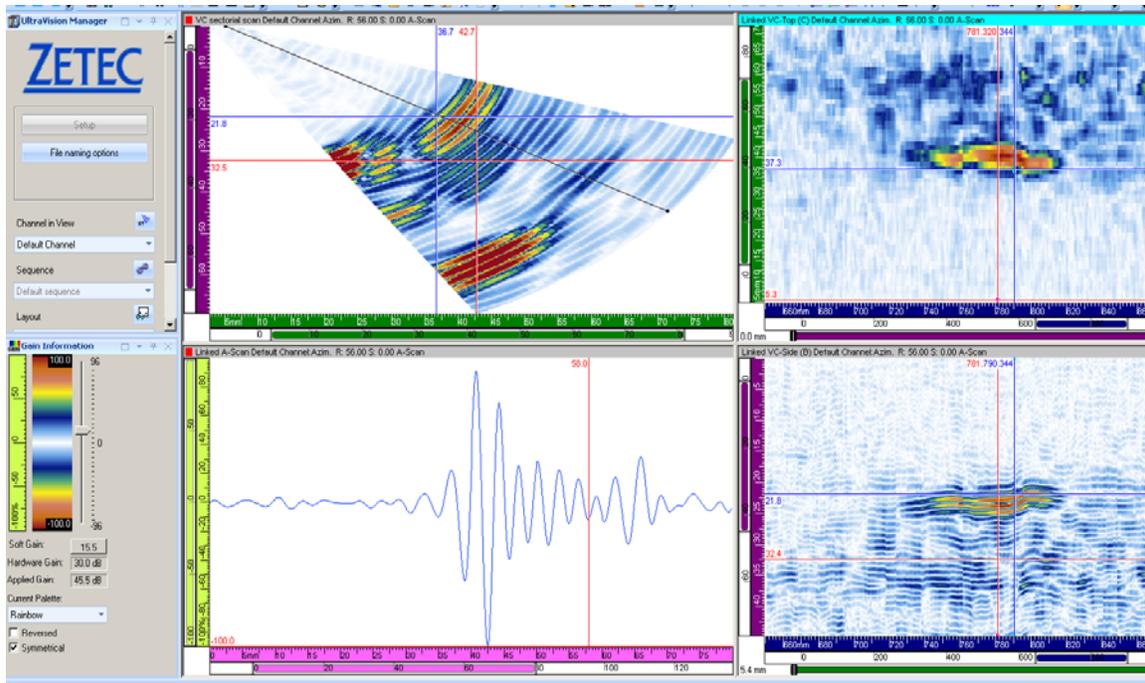
Figure A.38 800-kHz Data on Elbow Side of 9C-002, Flaw 3, for Depth Sizing

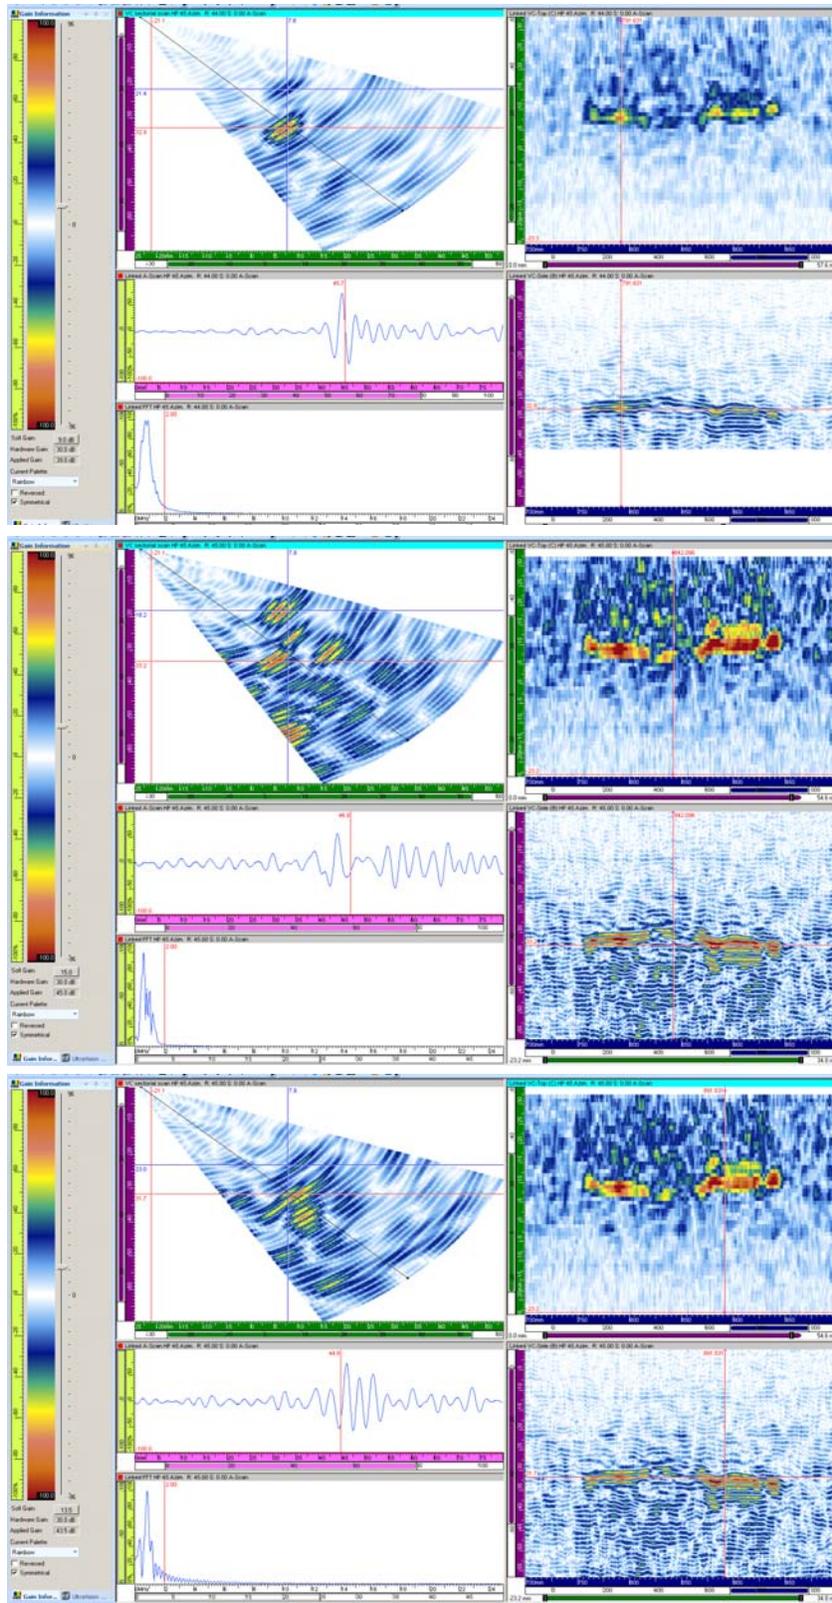
Figure B.15 1.0 MHz Data on Pipe Side of 7C-059, Flaw 4a, 4b, and 4c Top to Bottom for Depth Sizing

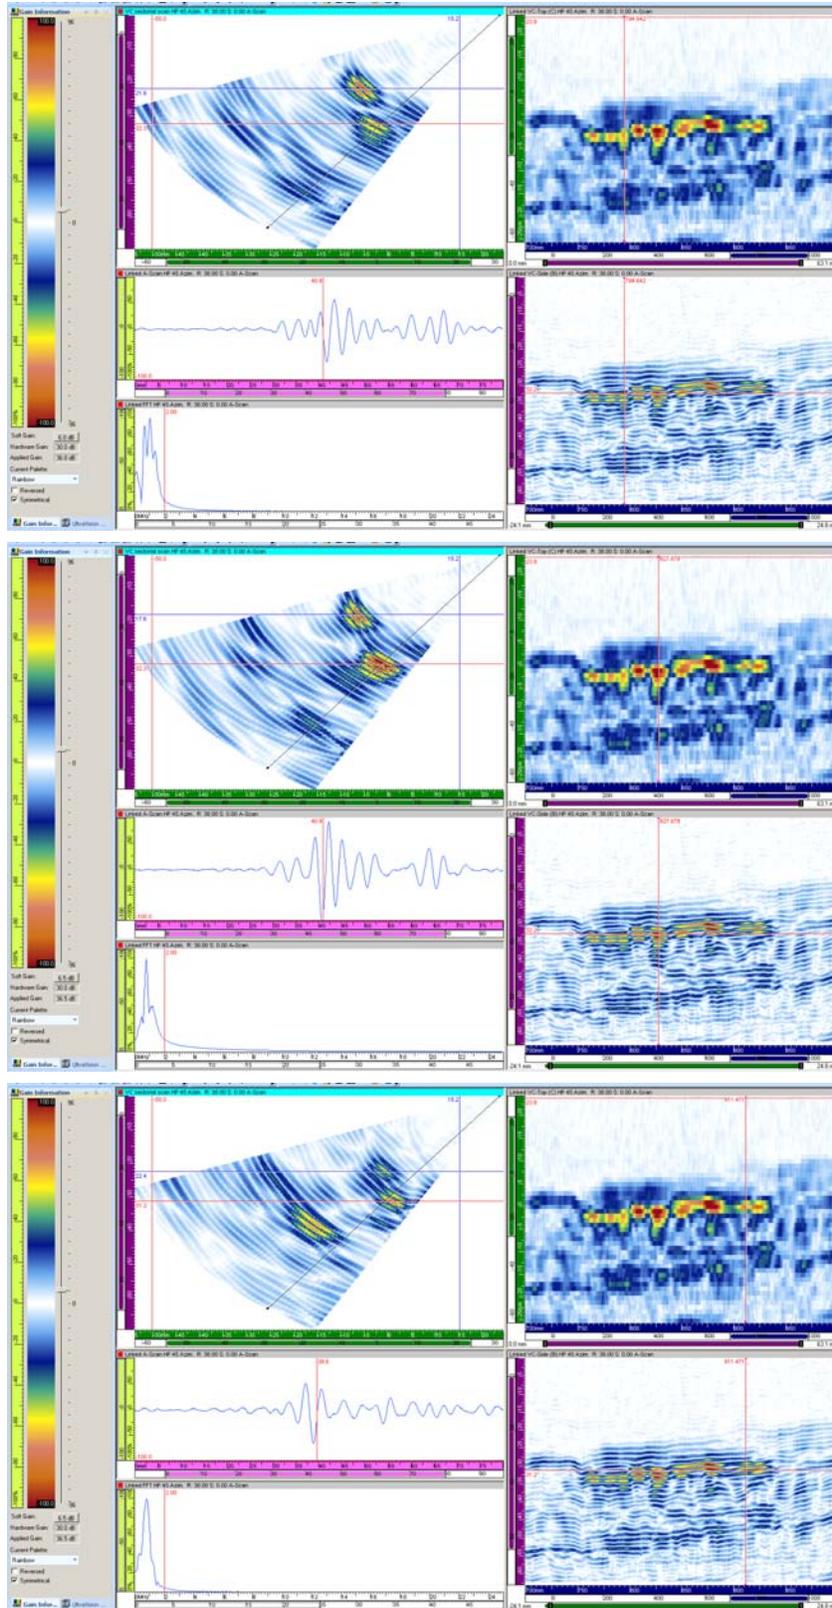
Figure B.16 1.0 MHz Data on Elbow Side of 7C-059, Flaw 4a, 4b, and 4c Top to Bottom for Depth Sizing

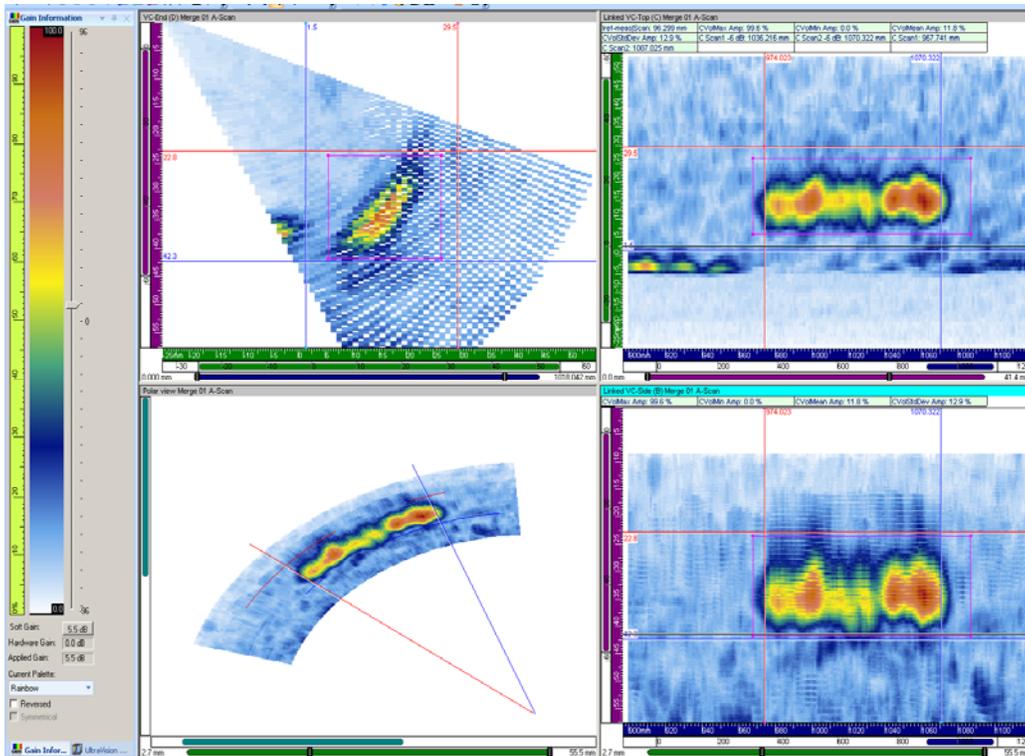
Figure B.17 1.0 MHz Data on Pipe Side of 9C-001, Flaw 1, Merged Image for Length Sizing

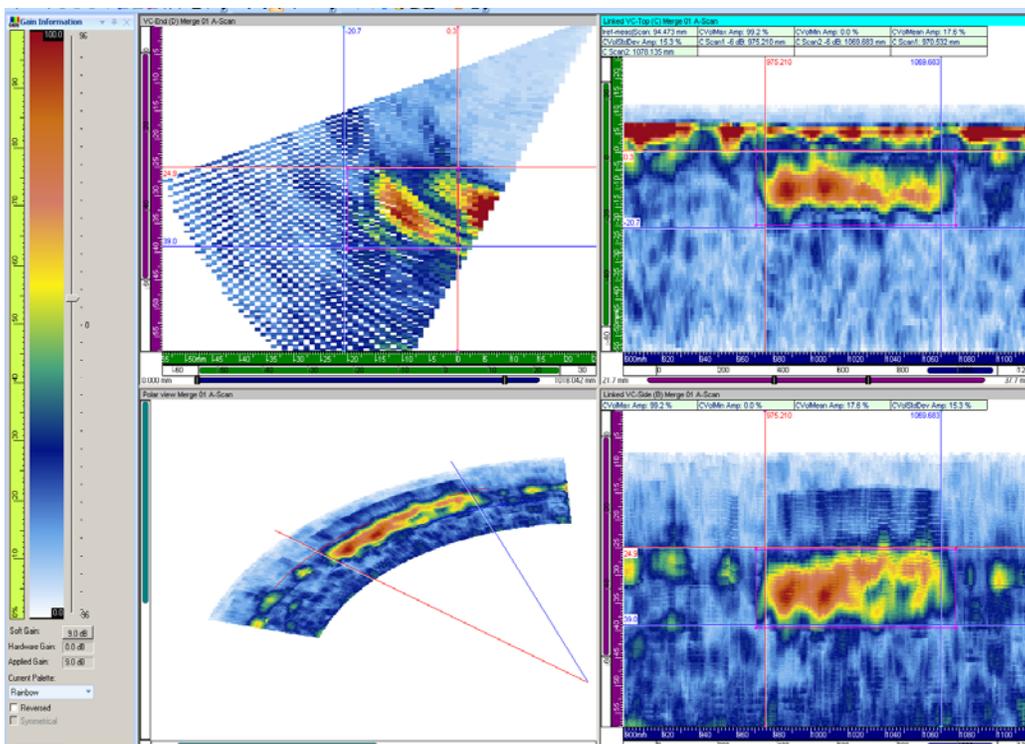
Figure B.18 1.0 MHz Data on Elbow Side of 9C-001, Flaw 1, Merged Image for Length Sizing

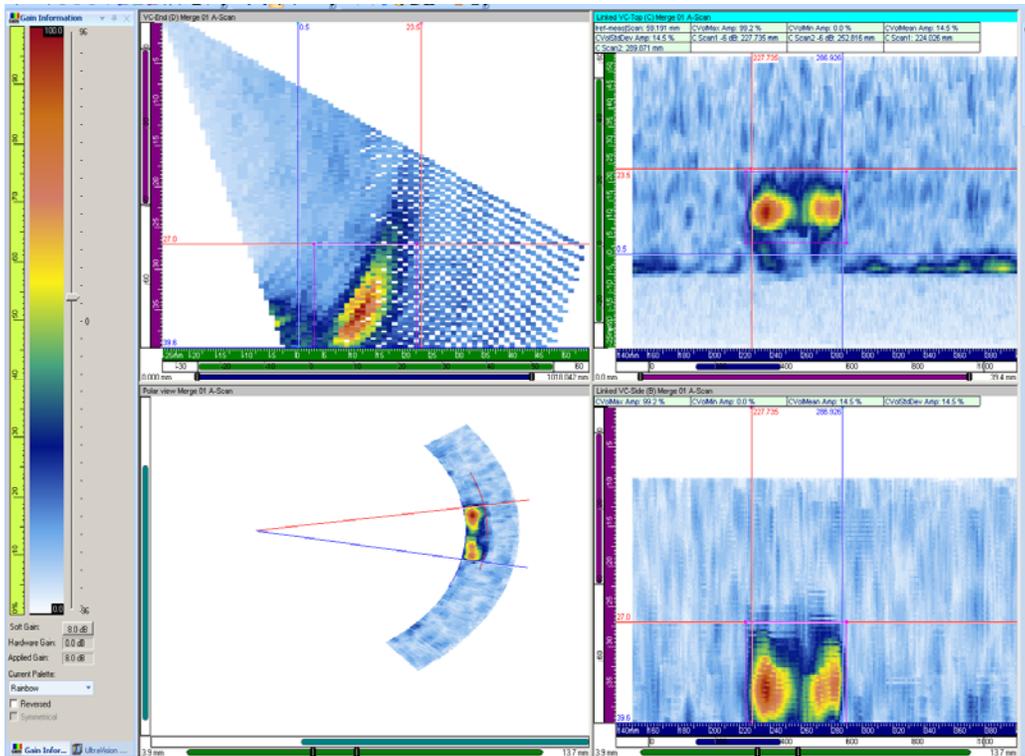
Figure B.21 1.0 MHz Data on Pipe Side of 9C-001, Flaw 2, Merged Image for Length Sizing

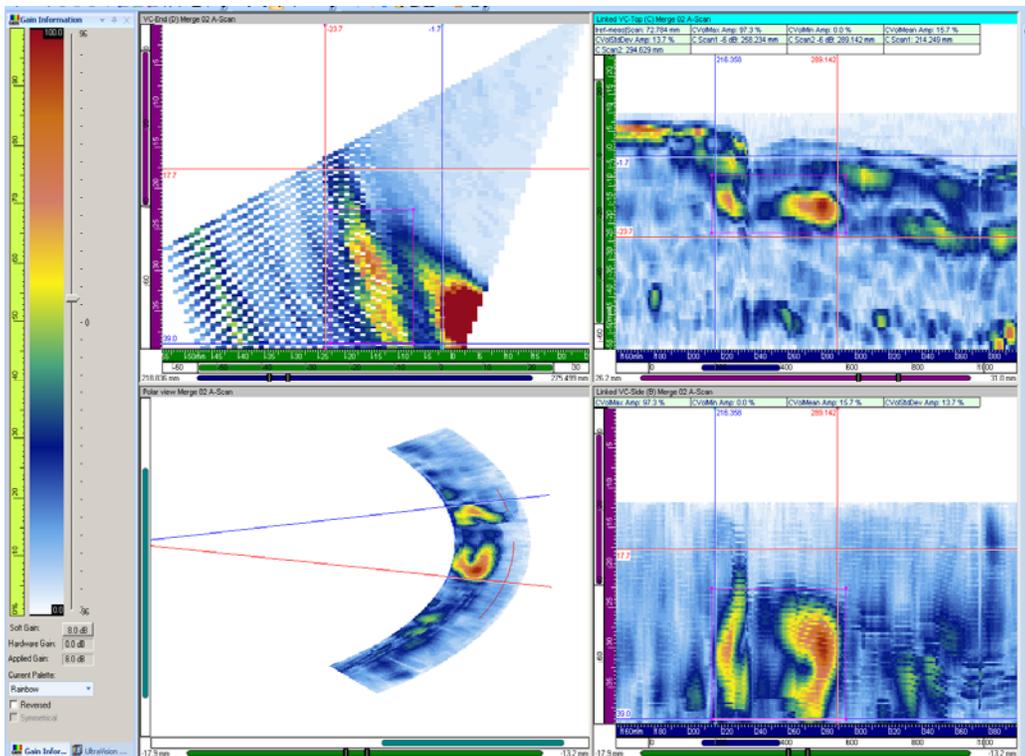
Figure B.22 1.0 MHz Data on Elbow Side of 9C-001, Flaw 2, Merged Image for Length Sizing

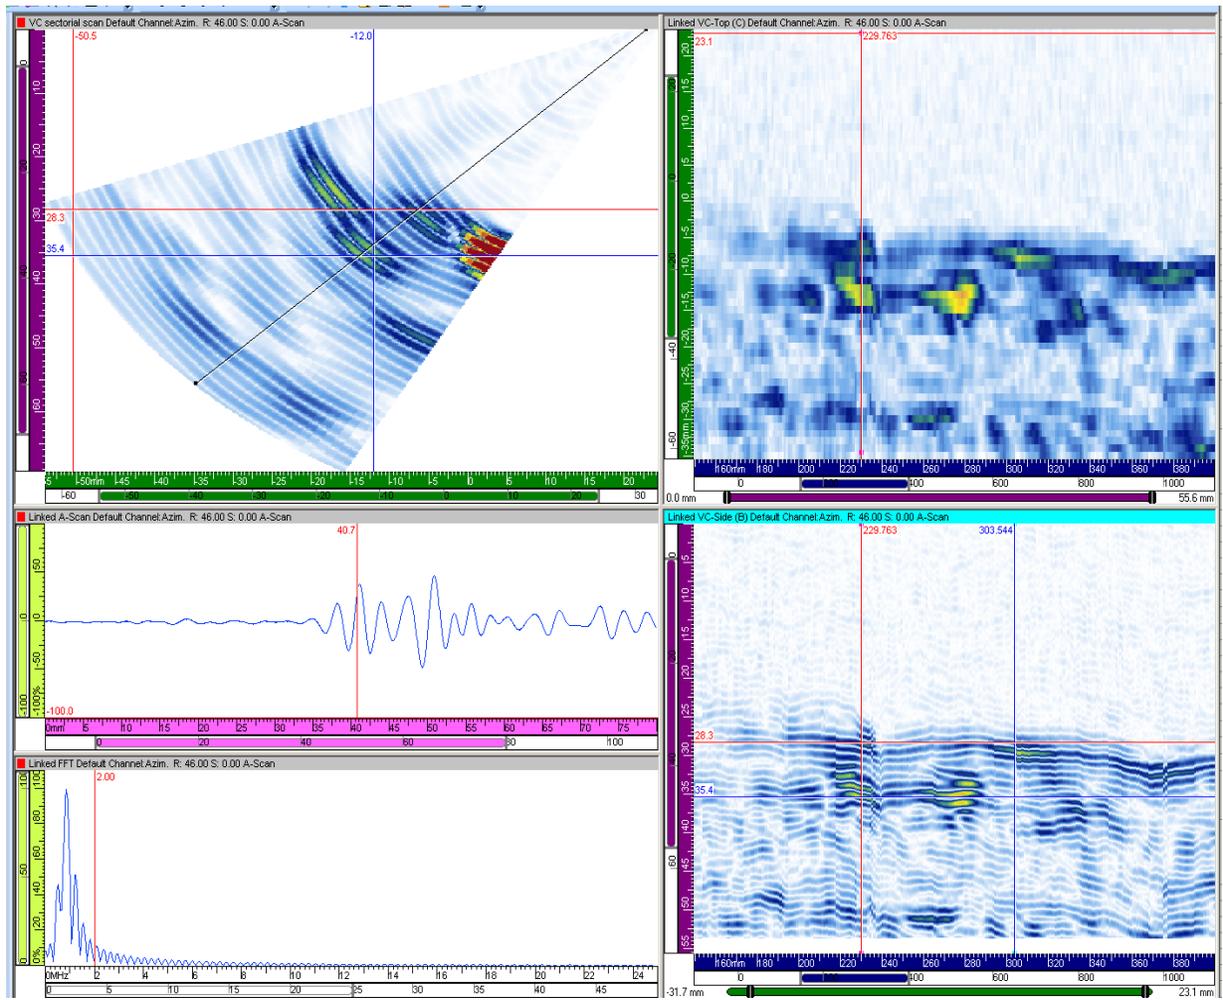
Figure B.24 1.0 MHz Data on Elbow Side of 9C-001, Flaw 2, for Depth Sizing

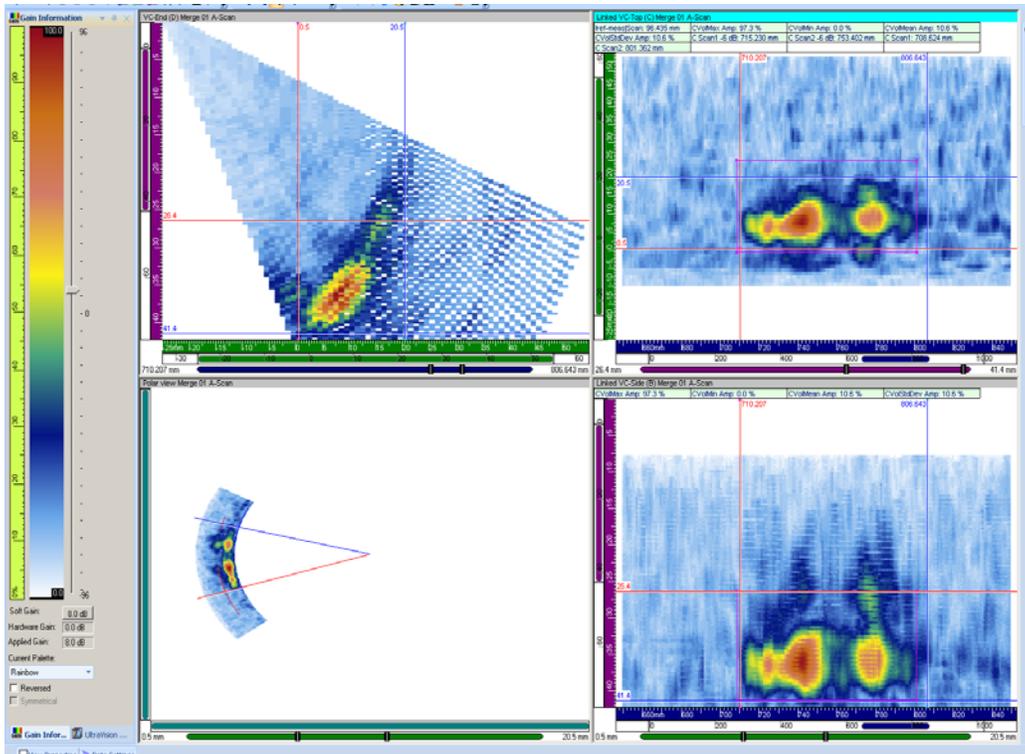
Figure B.25 1.0 MHz Data on Pipe Side of 9C-001, Flaw 3, Merged Image for Length Sizing

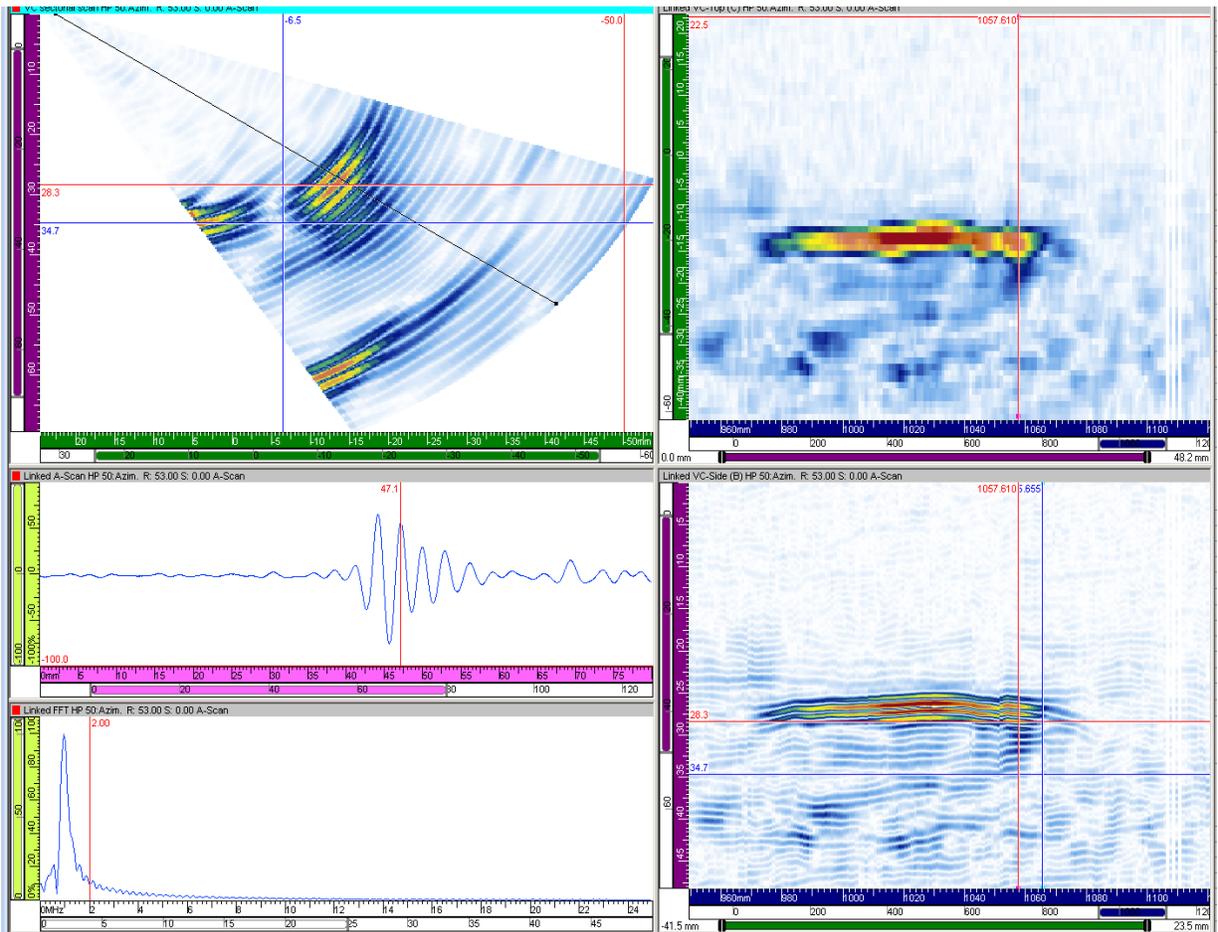
Figure B.32 1.0 MHz Data on Elbow Side of 9C-002, Flaw 1b, for Depth Sizing. The 1a portion of the flaw did not have any signal for depth sizing.

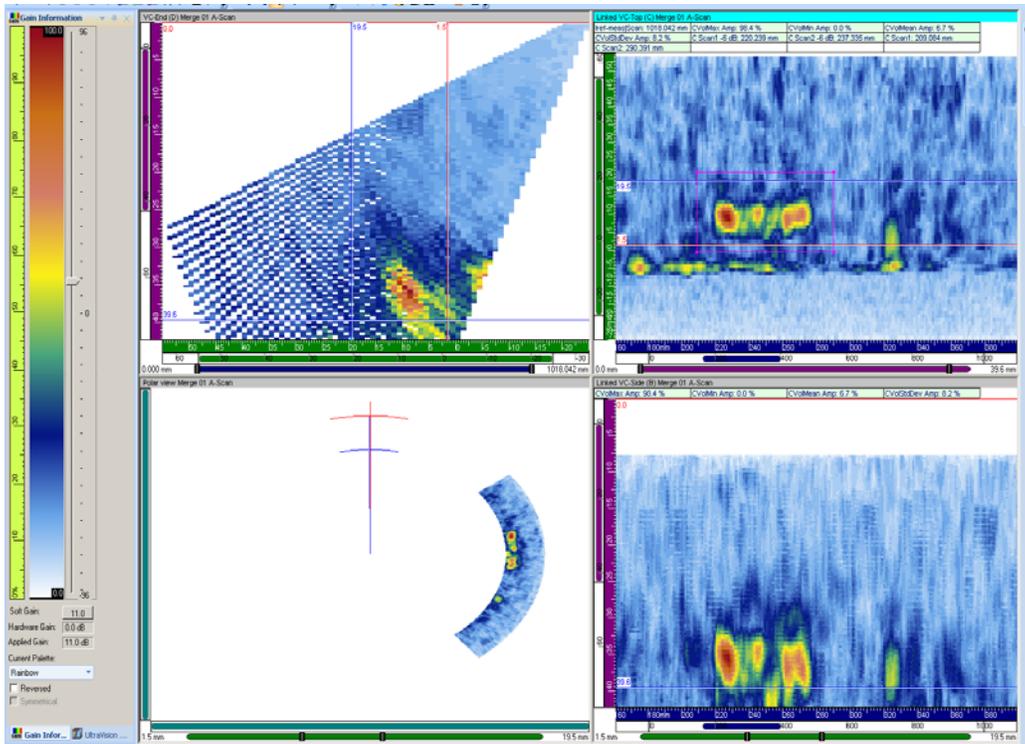
Figure B.33 1.0 MHz Data on Pipe Side of 9C-002, Flaw 2, Merged Image for Length Sizing

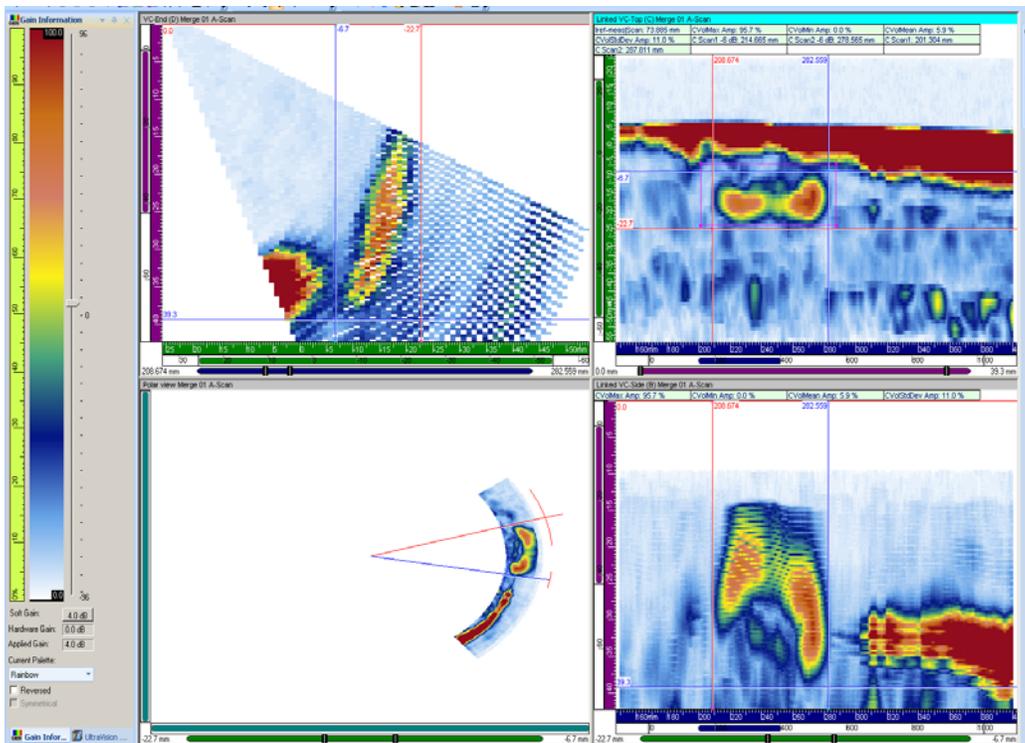
Figure B.34 1.0 MHz Data on Elbow Side of 9C-002, Flaw 2, Merged Image for Length Sizing

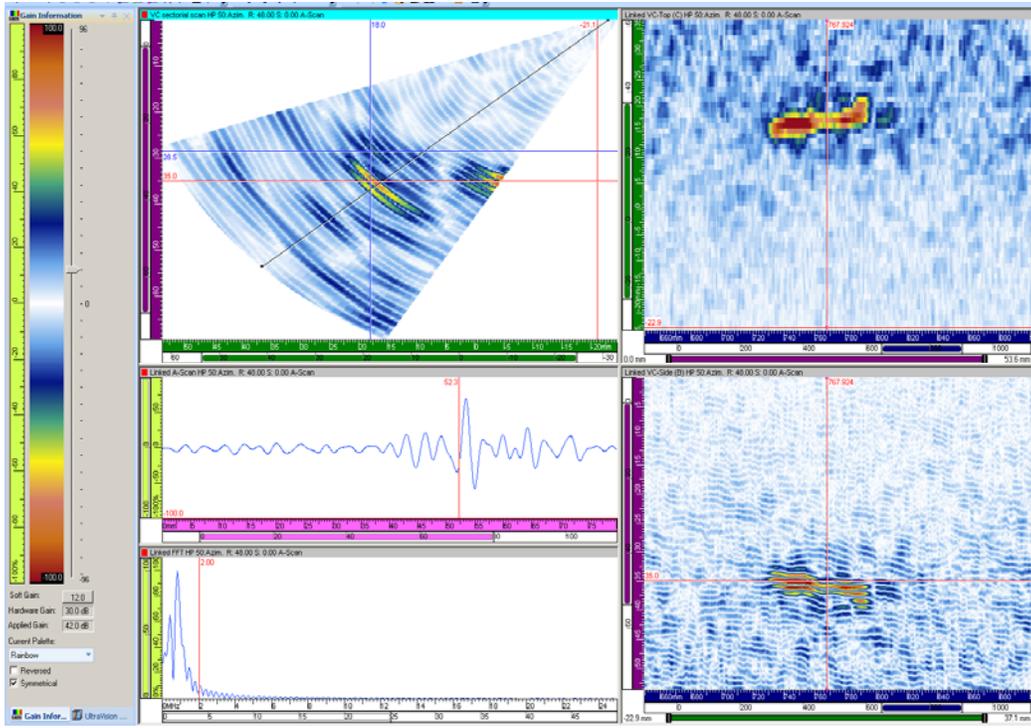
Figure B.39 1.0 MHz Data on Pipe Side of 9C-002, Flaw 3, for Depth Sizing

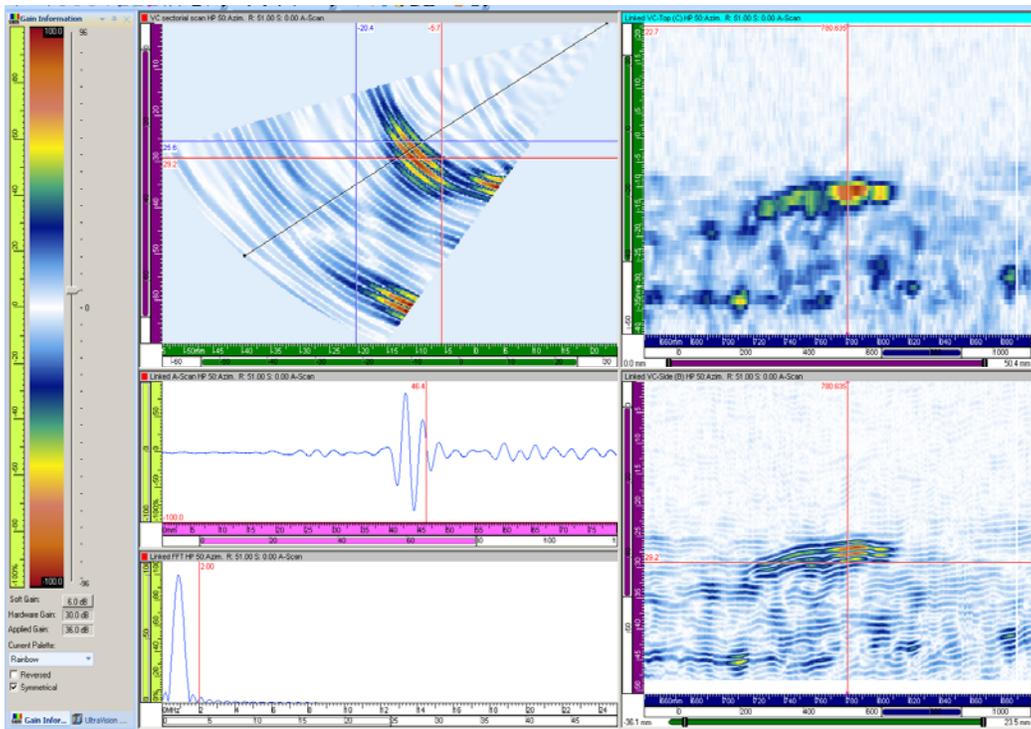
Figure B.40 1.0 MHz Data on Elbow Side of 9C-002, Flaw 3, for Depth Sizing
