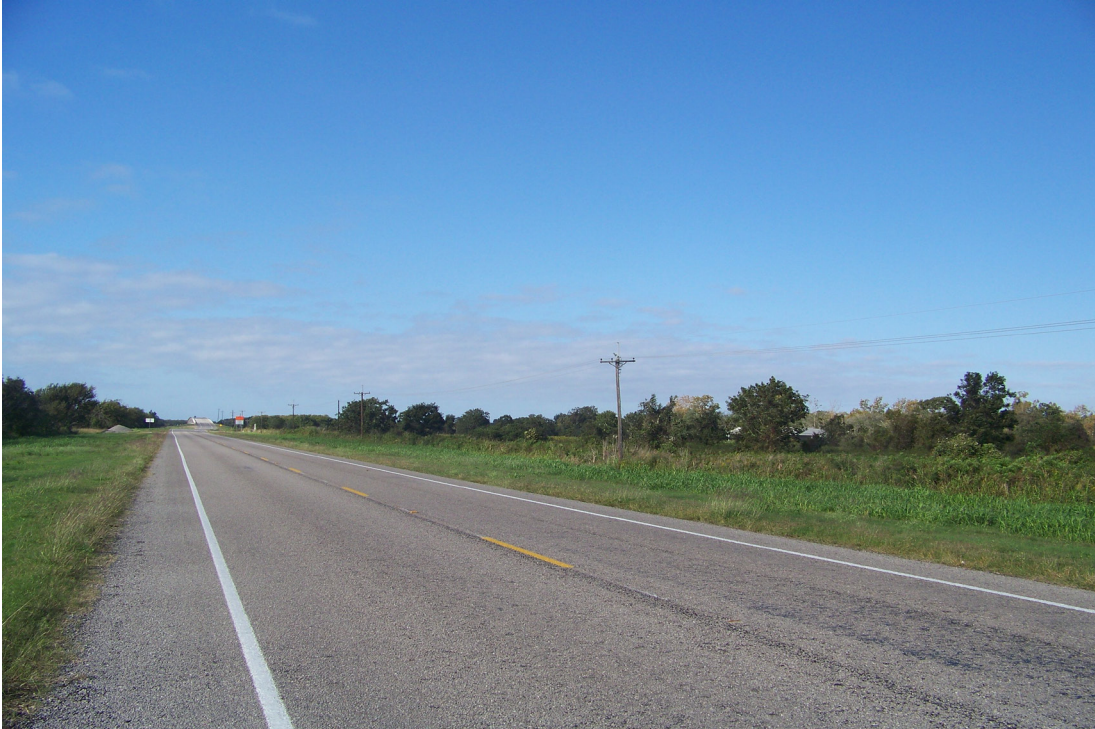
Figure 9. View toward the STP site from FM 521, looking west at a distance of 4.0 miles (Note: STP Site is not visible).

Based on the very limited visibility of the 200-foot STP site structures at approximately seven miles, and similar landscape surrounding the proposed Victoria County Station site, GMI staff concluded that an APE of 10-miles surrounding the proposed project site for the visual impact analysis would remain sufficient for a building 250 feet in height. Visibility of the proposed towers from a distance of 10 miles would be extremely limited or would not occur at all.

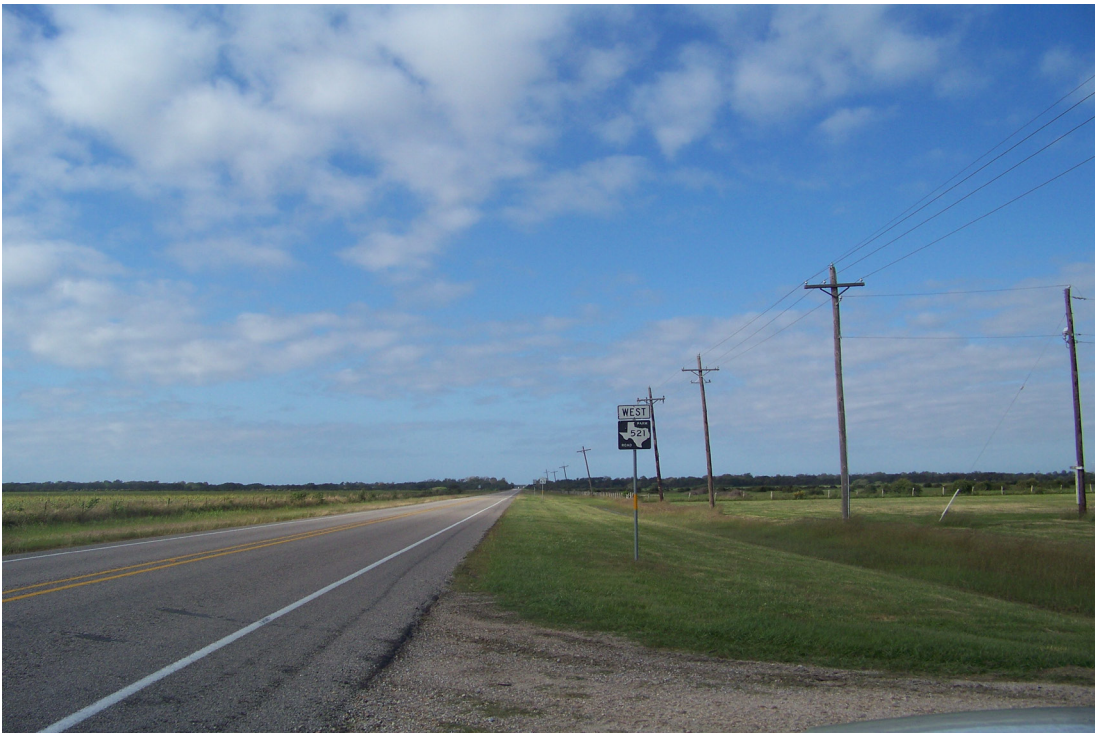
Figure 10. View toward the STP site from FM 521, looking west at a distance of 5.25 miles (Note: STP Site is not visible).

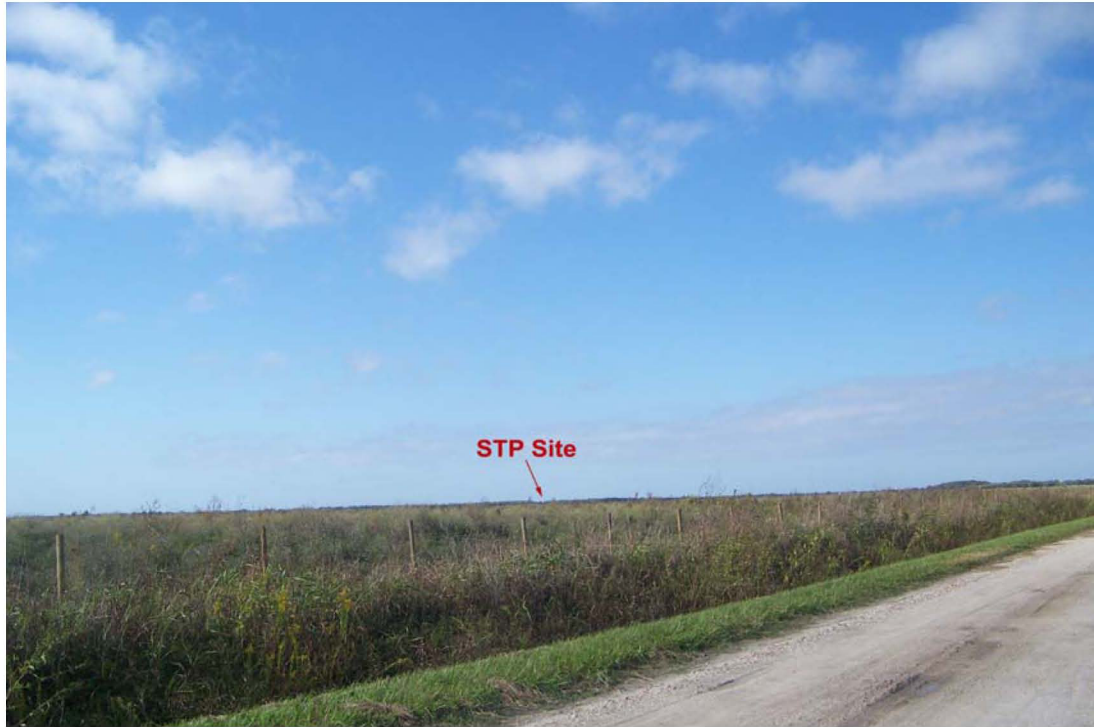
Figure 11. View toward the STP site from Gilmore Road, looking southwest at a distance of 6.7 miles.

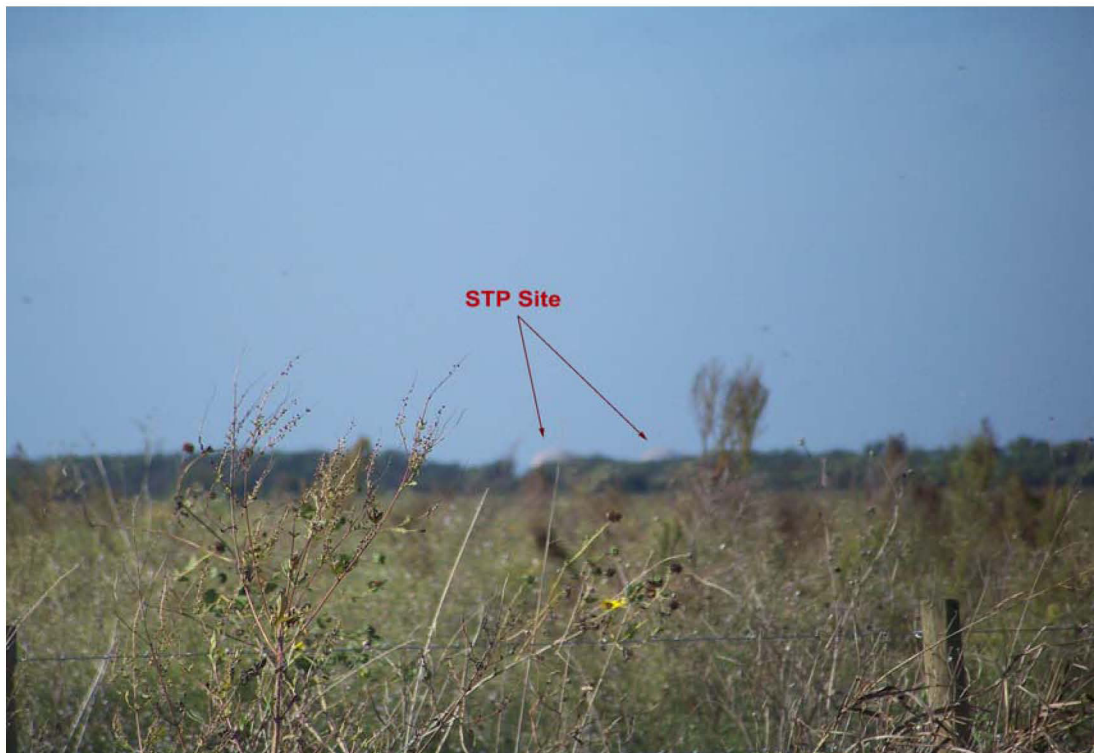
Figure 12. View toward the STP site from Gilmore Road, looking southwest at a distance of 6.7 miles, at 12x optical zoom.

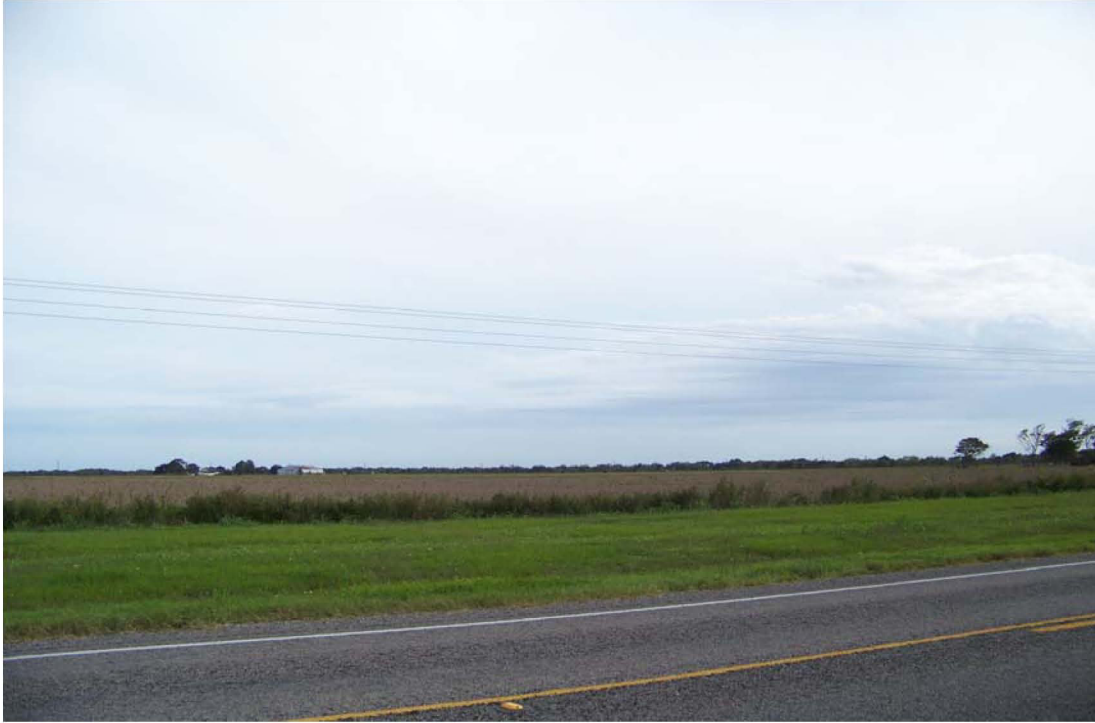
Figure 13. View toward the STP site from FM 2668, looking southwest at a distance of 11.0 miles (Note: STP Site is not visible).

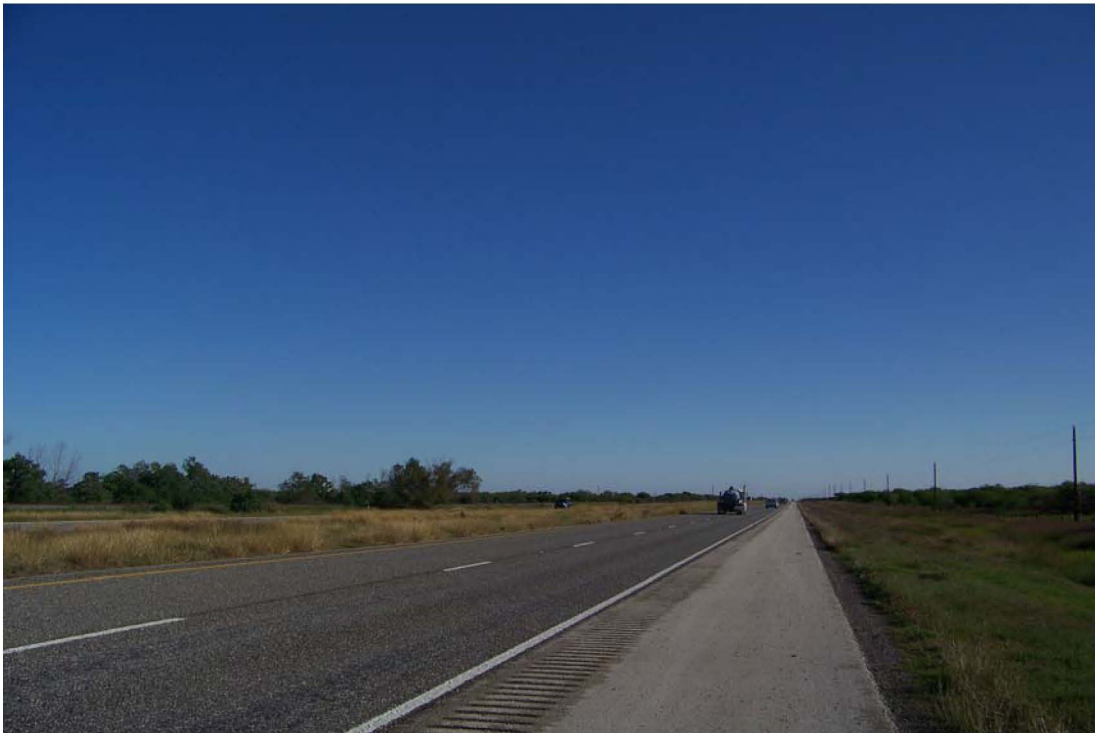
Figure 14. View toward the Victoria County Station project site from US 77, looking north-northeast at a distance of 12.8 miles.

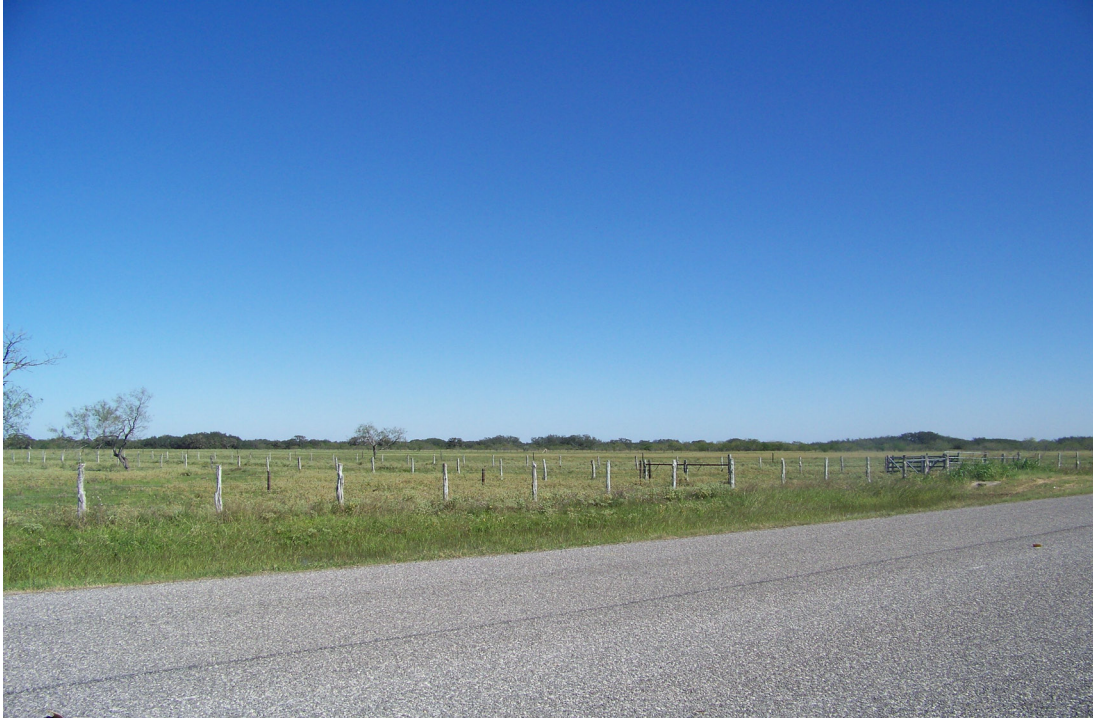
Figure 15. View toward the Victoria County Station project site from SH 239, looking northeast at a distance of 11.2 miles.

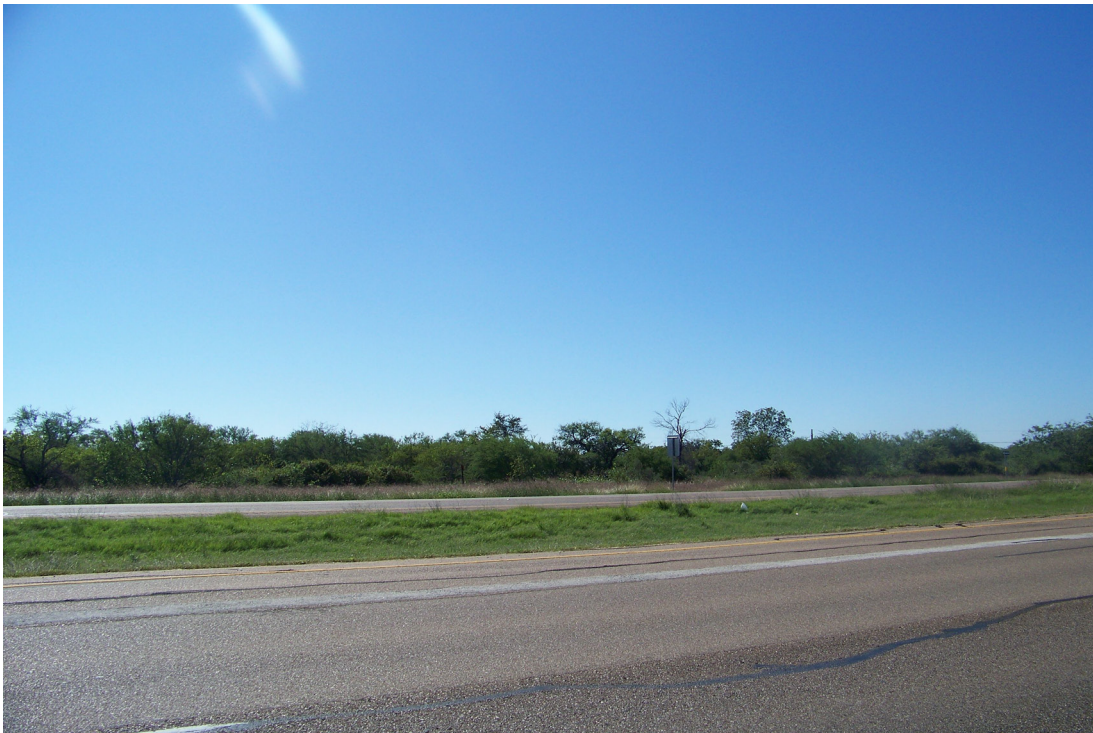
Figure 16. View toward the Victoria County Station project site from US 59 Business, looking southeast at a distance of 9.2 miles.

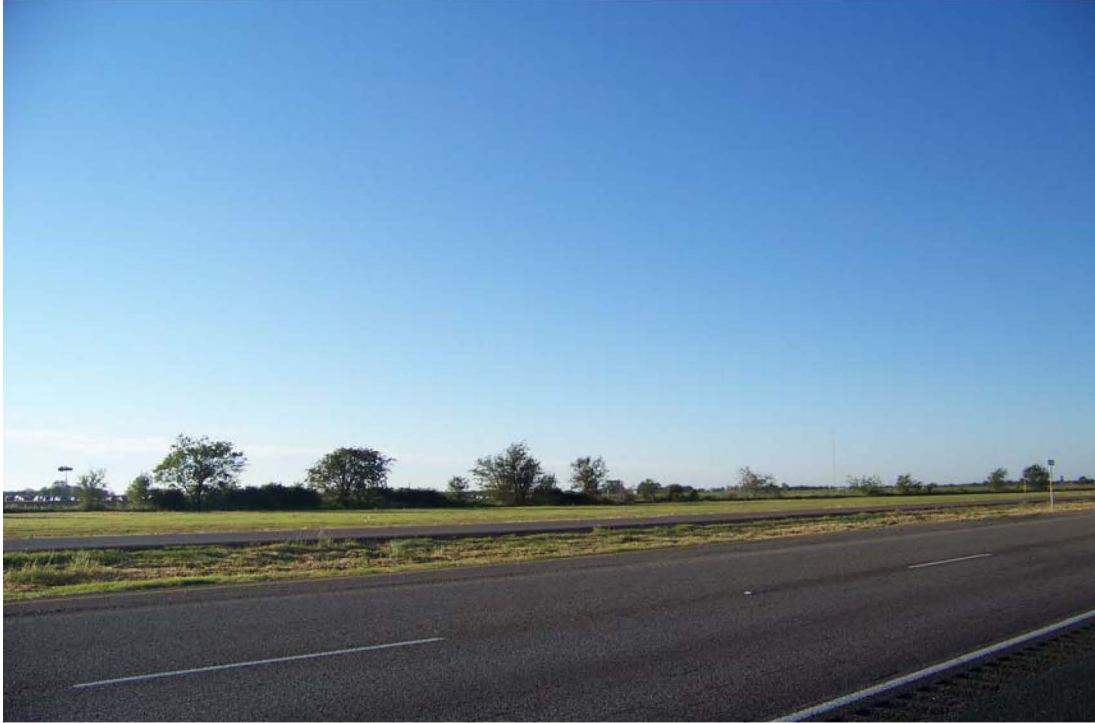
Figure 17. View toward the Victoria County Station project site from US 59, looking south-southwest at a distance of 10.8 miles.

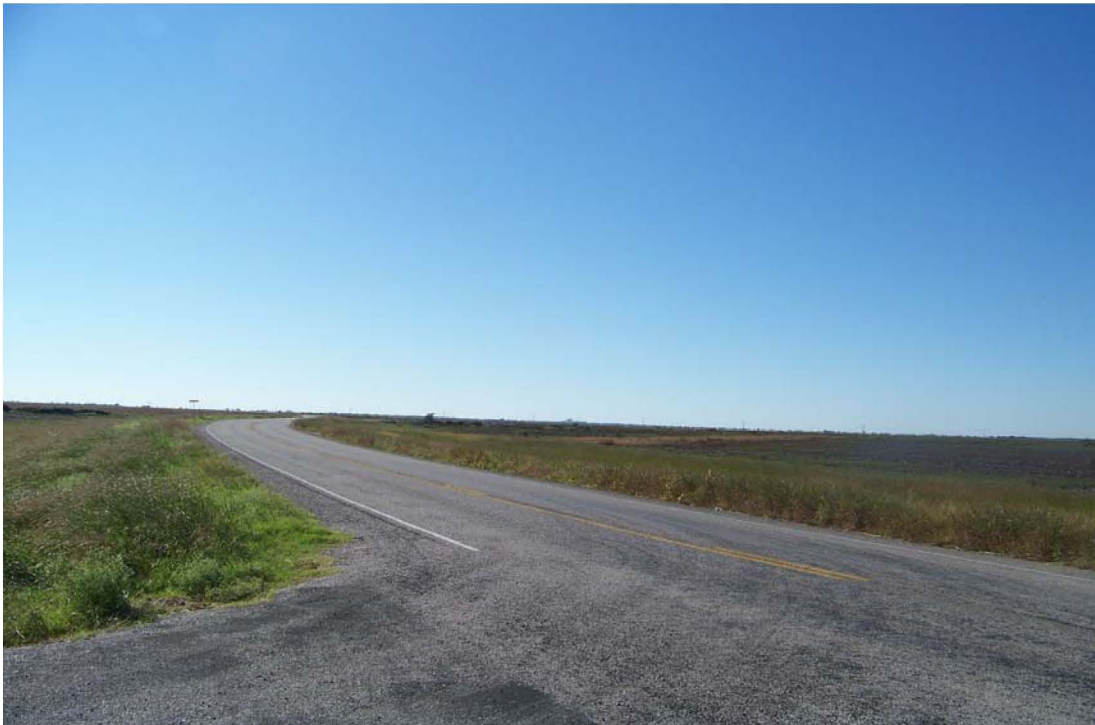
Figure 18. View toward the Victoria County Station project site from FM 1090 at Kemper Road, looking west at a distance of 13.8 miles.

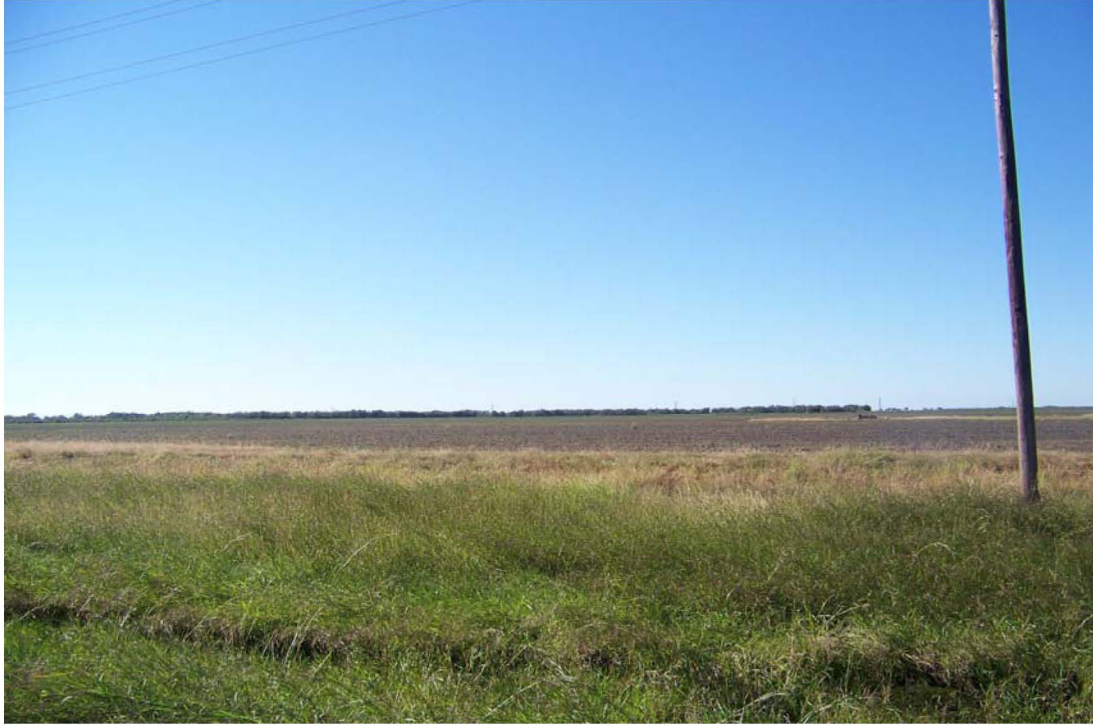
Figure 19. View toward the Victoria County Station project site from FM 2433 at SH 35, looking west-northwest at a distance of 14.9 miles.

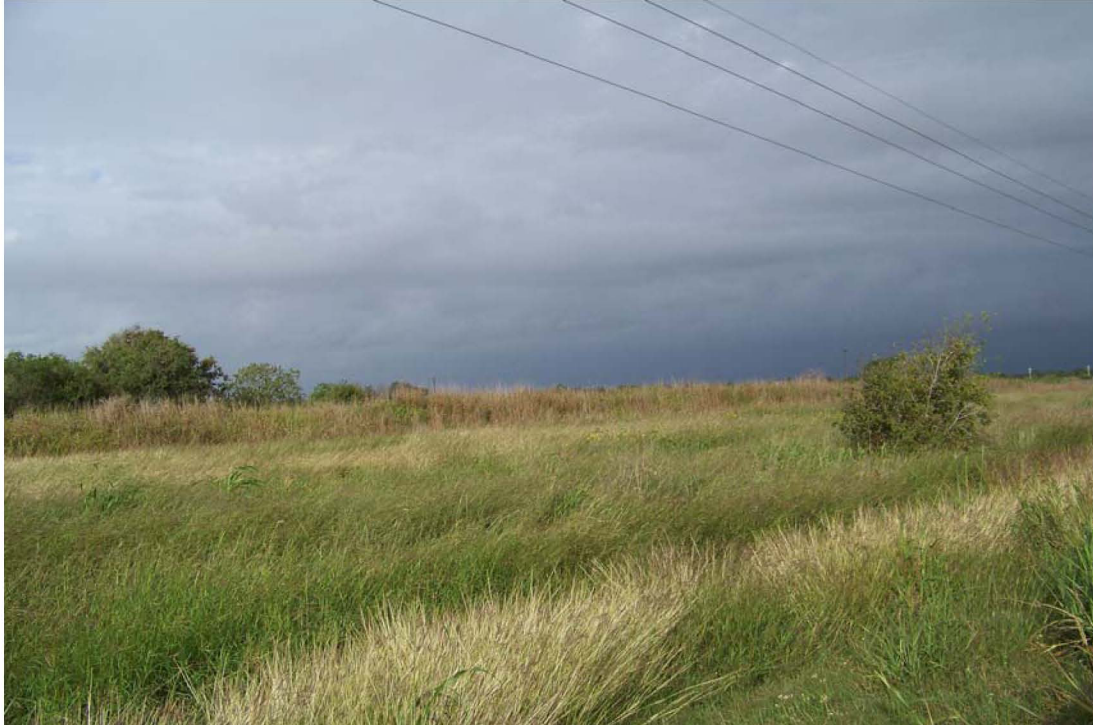
Figure 20. View toward the Victoria County Station project site from SH 185 at South Dryer Road, looking northwest at a distance of 10.6 miles.
