Pictures for potential use in NRC Report-Request to Verify No Proprietary Information

Below are 12 pictures/figures described in your site records or vendor reports related to your investigation of the Davis-Besse shield building cracking. Please confirm that none of these pictures or figures contain proprietary materials. If any are considered proprietary, please identify these so we do not incorporate them into our report. I will be out of the office next week, but please provide your E-mail response to each NRC member on my distribution for this E-mail.

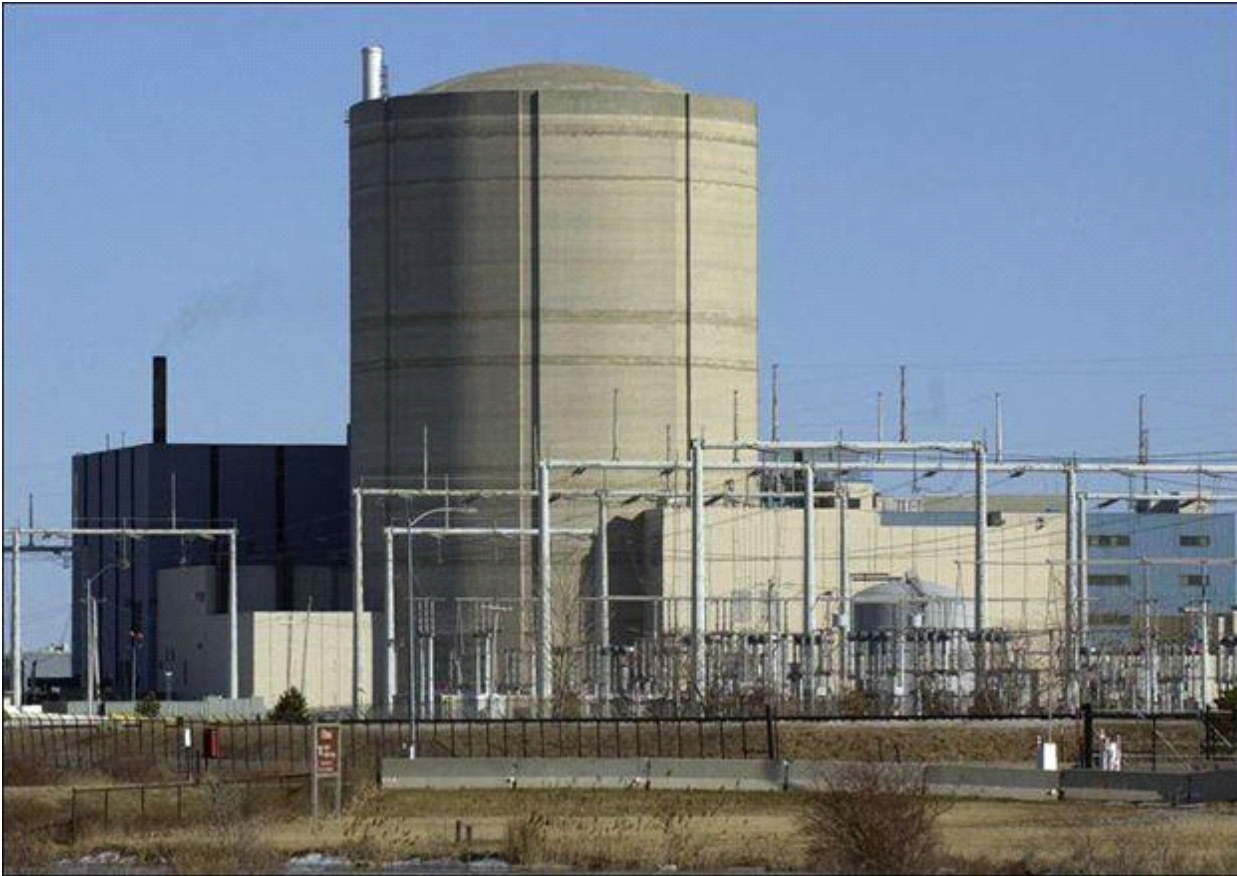
Picture No. 1 - Davis-Besse Shield Building

However, we note that Picture No. 1 appears to be the identical picture posted to the Toledo Blade Newspaper's webpage at http://www.toledoblade.com/image/2012/02/28/800x600_b1_cCM/FirstEnergy-says-that-winddriven-rain-soaked-deep-into-the-concrete.jpg (this was already brought to the attention of Jim Neurauter who is on site today).

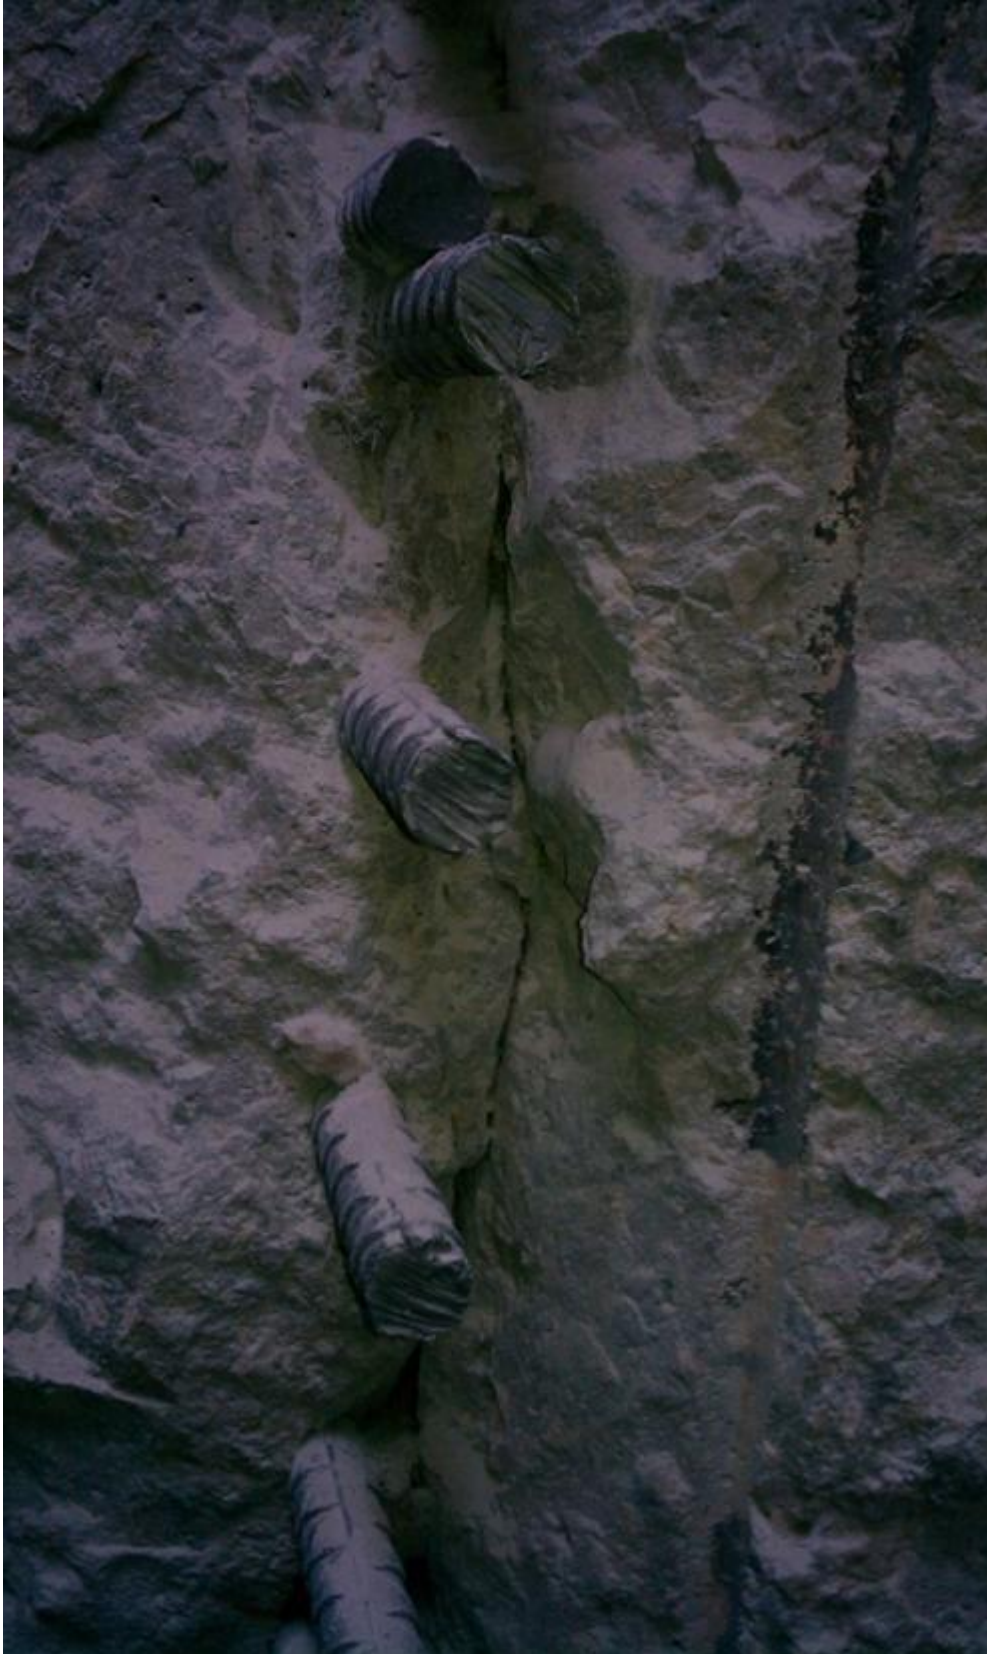
Picture No. 3 - Davis-Besse Shield Building Laminar Subsurface Cracking

As we discussed on the telephone, Picture No. 3 shows the crack that was discovered as a result of the hydro-demolition process. It should be explained with this picture that the hydro-demolition process amplified the crack opening.

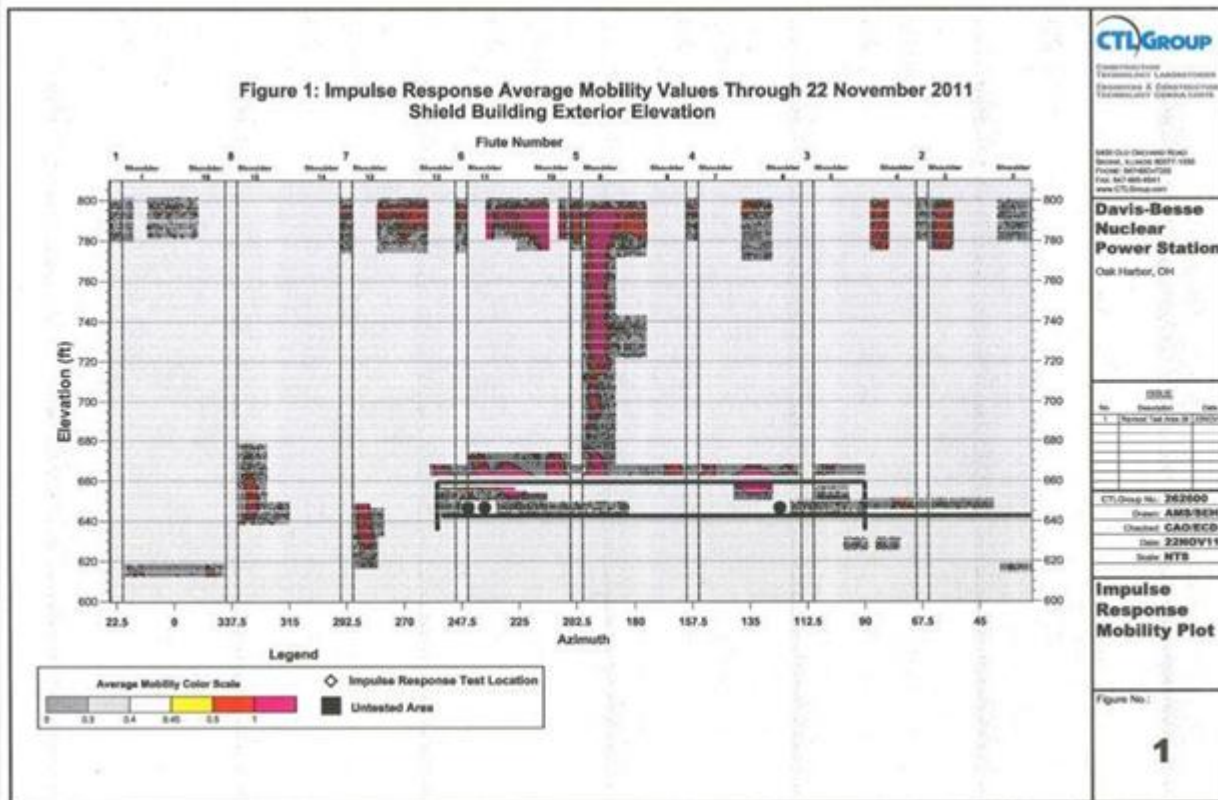
Picture No. 4- Davis-Besse Shield Building Impulse Response Testing Mobility Plot

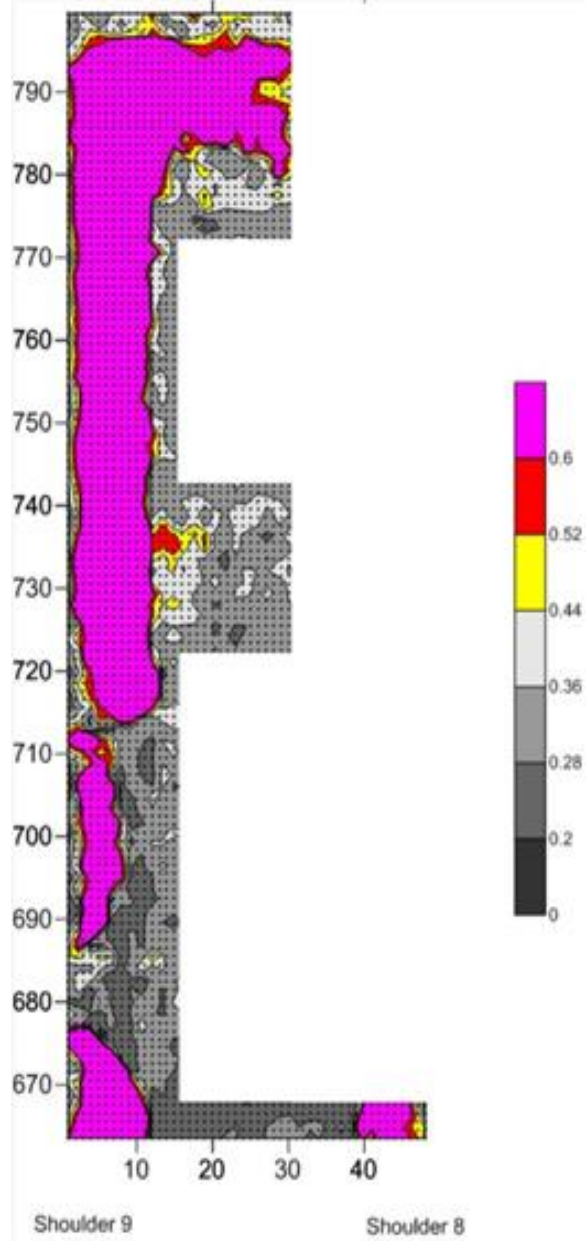
Picture No. 5- Davis-Besse Shield Building Impulse Response Testing Mobility Plot (Shoulder 9)

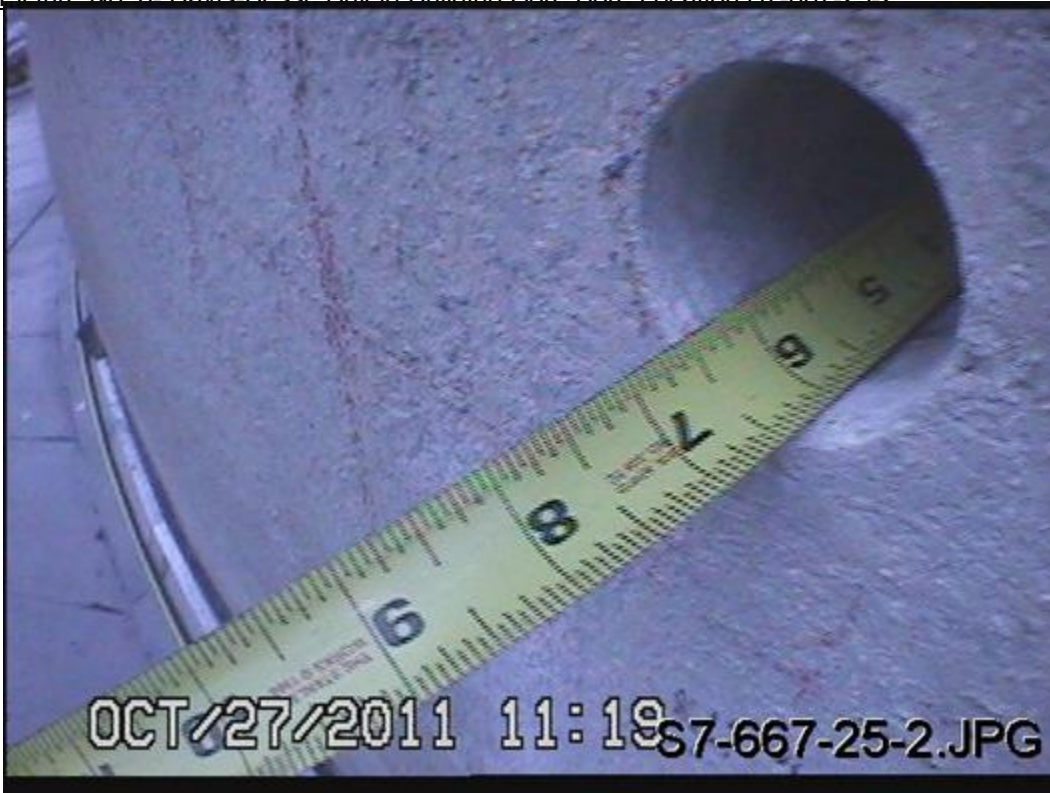
Picture No. 6- Davis-Besse Shield Building Core Bore Location S7-667-25-2

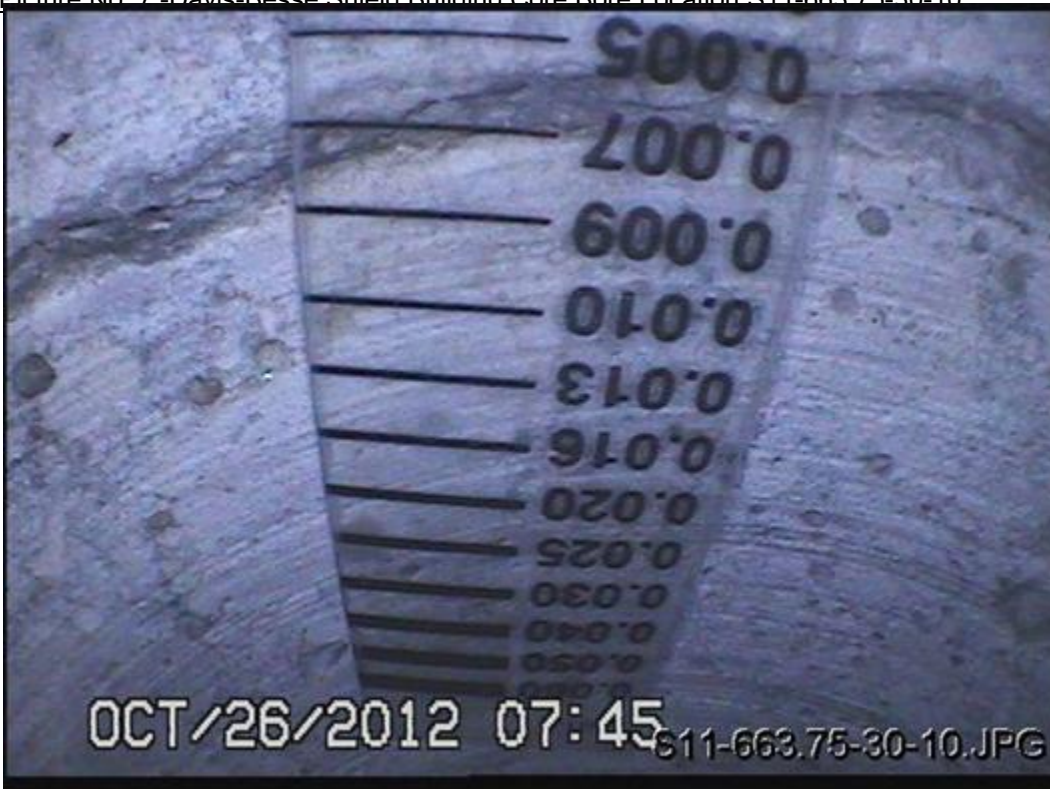
Picture No. 7 -Davis-Besse Shield Building Core Bore Location S11-663.75-30-10

Picture No. 7 contained an incorrect date stamp (shows 10/26/2012 instead of 10/26/2011). The picture immediately below (S11-663.75-30-10.jpg) has a corrected date.

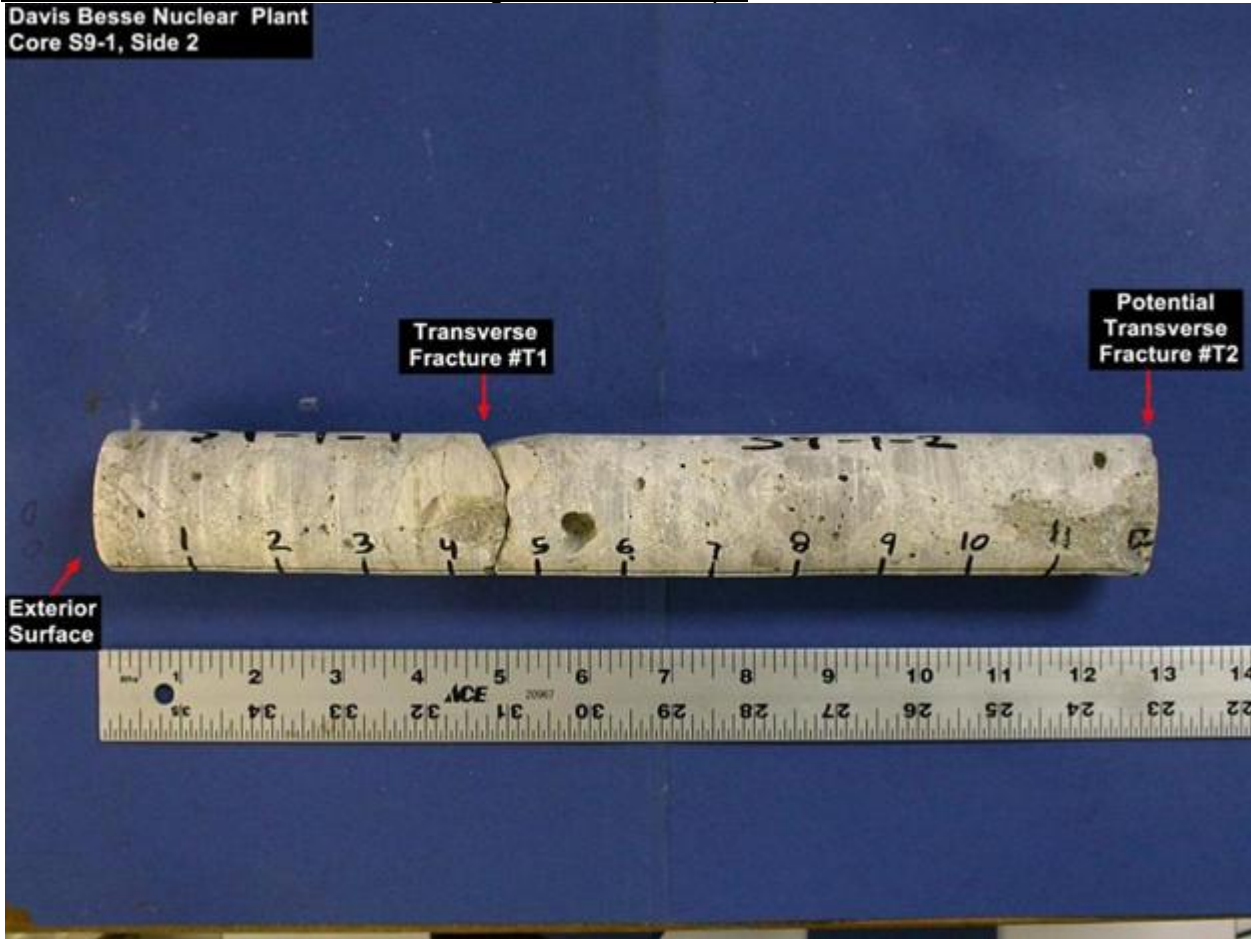
Picture No. 8 -Davis-Besse Shield Building - Core Bore Sample
