FIGURE 8. LOT 31,  
REPRESENTATIVE SHOVEL TEST PROFILES (STPs I-6 AND A-4)

BELL BEND NUCLEAR POWER PLANT  
UNISTAR NUCLEAR ENERGY, LLC.

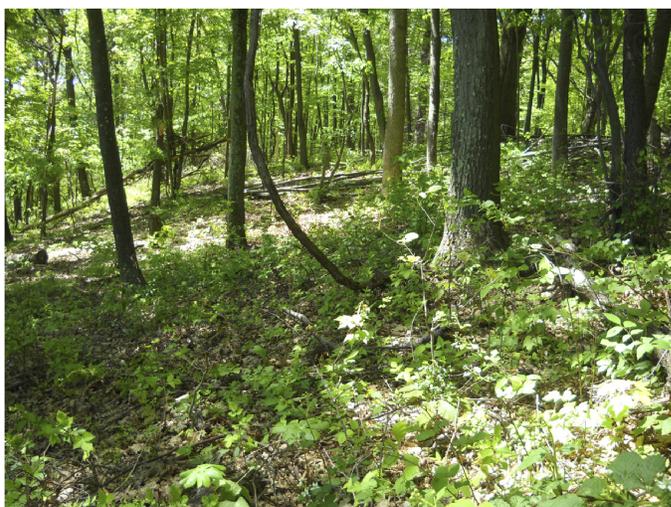
**Photograph 7. Lot 7: Wooded Upland Flat in Northwest Corner of Lot, Facing West**

Lot 7 is a wooded parcel located north of Beach Grove Road (see Figure 1). The western portion of Lot 7 lies within the previously-surveyed Switchyard 2 parcel; due to slopes in excess of 15 percent no subsurface testing was conducted within this area during GAI's initial 2008 Phase Ib survey (Munford et al. 2008, Munford et al. 2010). The remainder of Lot 7 consists largely of steep hillsides, which were excluded from subsurface testing during the current study. One line of four shovel tests was excavated at the edge of an upland flat at the northern margin of this lot (see Figure 2, Photograph 7).

Shovel testing in Lot 7 exposed an A-B soil horizon sequence, consisting of a 23-cm-thick dark yellowish-brown silt loam A horizon and a yellowish-brown clay loam B horizon (see Figure 7). No cultural materials were recovered.

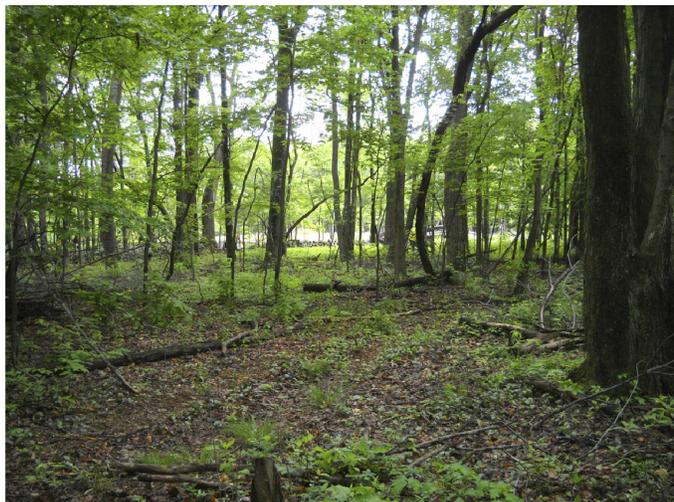
**Photograph 9. Lot 31, Section 1: Wooded Upland Flat, Facing East**

The remaining moderate to high potential portions of Lot 31 were subject to 15-meter interval shovel testing as part of the current supplemental Phase Ib survey. Two test sections were defined within this lot: Section 1 to the west of the transmission line (Photograph 9), and the smaller Section 2 to its east (see Figure 2). A residence is located in the northeast corner of Section 2. This residential property occupies a steep slope and has been disturbed by landscaping activities; accordingly, this property was excluded from shovel testing. GAI excavated 274 shovel tests within Lot 31 (217 STPs in Section 1 and 57 STPs in Section 2). Shovel test profiles typically consisted of an A-B soil horizon sequence including an approximately 29-31-cm-thick brown silt loam A horizon and a yellowish-brown sandy clay loam to silt loam B horizon (Figure 8). Shovel testing produced no cultural materials.

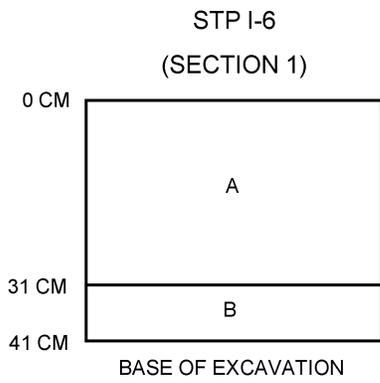
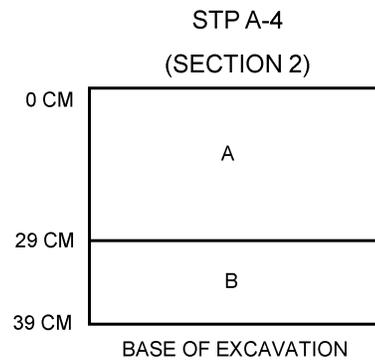
A – BROWN (10YR 4/3) SILT LOAM  
B – YELLOWISH BROWN (10YR 5/6) SANDY CLAY LOAM

A – BROWN (10YR 4/3) SILT LOAM  
B – YELLOWISH BROWN (10YR 5/6) SILT LOAM

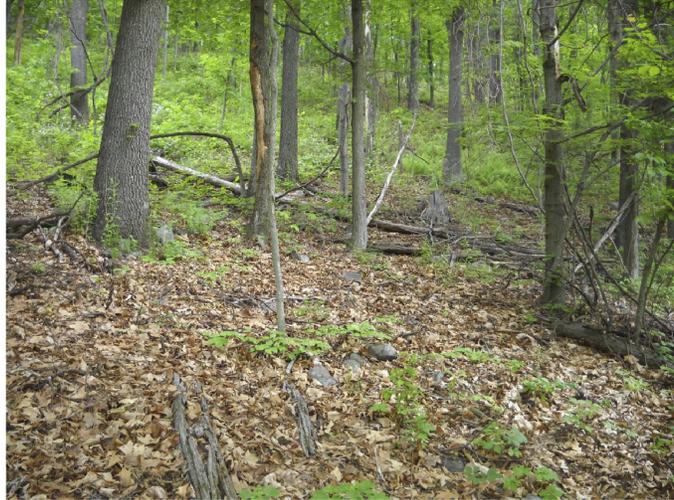
***Photograph 10. Lot 23: Steep Wooded Hillside, Facing Northeast***

The southern one-third of Lot 23 consists of a steeply sloping hillside that was excluded from subsurface testing (Photograph 10). This lot was documented with photographs; no shovel testing was required.

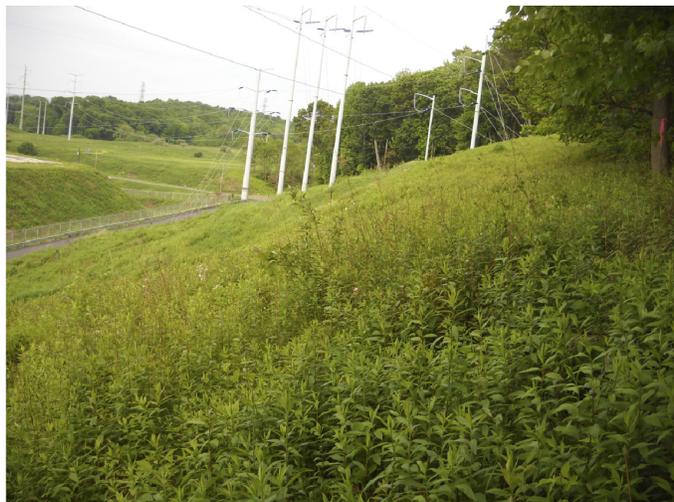
***Photograph 11. Lot 0: Transmission Corridor on Steep Hillside North of Beach Grove Road, Facing West***

Lot 0 is located north of Beach Grove Road, opposite the existing SSES facility, at the eastern edge of the project area's Northern Section (see Figures 1 and 2). The western edge of this lot, consisting of an existing northwest/southeast trending transmission line corridor, was included within the previously-surveyed Switchyard 2 parcel; the remainder of Lot 0 comprises a steeply sloping hillside that was excluded from subsurface testing (Photograph 11). In addition to transmission line disturbances, a narrow cut and fill area was documented along the edge of Beach Grove Road with this lot. This area was documented with photographs; no shovel testing was required.

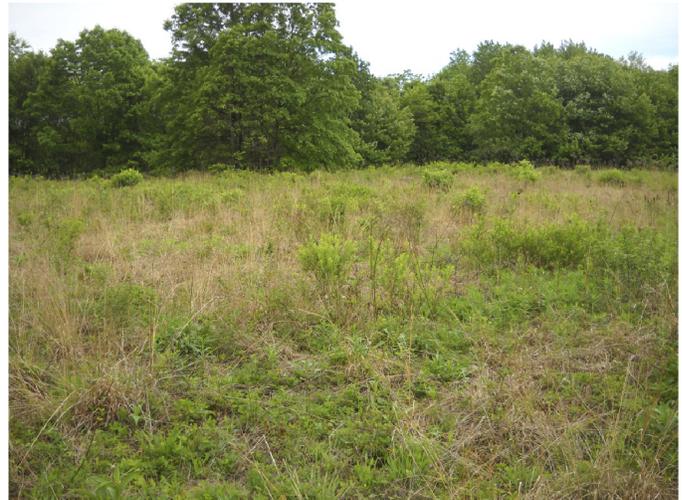
***Photograph 12. Lot 3, Section 1: Fallow Field, Facing South***

Phase Ib investigations defined two testing sections (Sections 1 and 2) within Lot 3, separated by a narrow grassy slope that was excluded from subsurface testing (see Figure 2). Section 1, located in the higher-elevation western half of Lot 3, consists of a fallow field vegetated in high grass and bounded by trees; a patch of trees also occurs in the center of this section (Photograph 12). Section 2 represents the residential property in the eastern portion of Lot 3 (Photograph 13). This property includes a house and garage, in the southeast corner, and a shed, in the west central portion. Vegetation consists of a lawn adjacent to the house and low grass throughout the remainder of the section. A wetland is delineated in the northeastern corner of the Section 2.

Shovel testing was conducted at 15-meter intervals throughout Sections 1 and 2. Shovel test profiles typically consisted of an A or Ap horizon above a B horizon. As described for STP C-3 (Section 1) and STP G-8 (Section 2), the A/Ap horizon was a 28-33 cm-thick brown silt loam while the B horizon was a yellowish-brown clay loam to silt loam (Figure 9). Shovel testing identified one prehistoric isolated find (IF 28) in Section 2. IF 28 consists of one flake fragment made from Shriver/Helderberg chert and recovered from STP G8 (A horizon), in the northwest portion of Section 2. Radial shovel tests excavated at 5-meter intervals around STP G-8 yielded no additional artifacts.

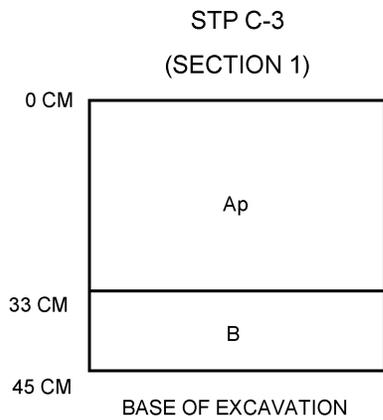
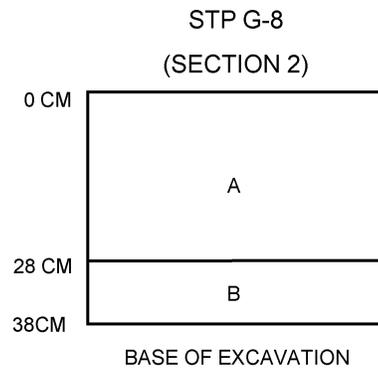
FIGURE 9. LOT 3,  
REPRESENTATIVE SHOVEL TEST PROFILES (STPs C-3 AND G-8)

Ap - BROWN (10YR 4/3) SILT LOAM  
B - YELLOWISH BROWN (10YR 5/6) CLAY LOAM

A - BROWN (10YR 4/3) SILT LOAM  
B - YELLOWISH BROWN (10YR 5/6) SILT LOAM

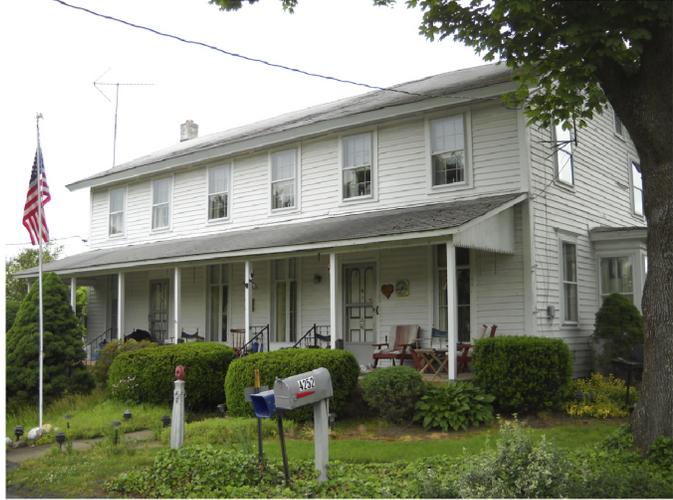
***Photograph 14. Lot 41, Section 2:  
Michaels Farm from North Market Street,  
Facing Southwest***

Lot 41, the southern of the two parcels comprising the Western Section, occupies a broad upland flat north of Walker Run, bounded in general by North Market Street to the south and west and Lot 3 to the north (see Figures 1 and 2). A man-made pond is situated to its southwest. The large majority of this lot consists of a cultivated field. A farmstead, the Michaels Farm (155063/GAI-25) (Photograph 14), recorded during GAI's previous architectural survey, lies within the southeast corner of Lot 41, inside a sharp right-angle bend in North Market Street. This property has been determined Not Eligible for listing in the NRHP (PHMC/BHP review letter, March 17, 2010) (see Appendix B). A wooded wetland is delineated in the southwest corner of the parcel, adjacent to the pond. Walker Run cuts through the southwestern tip of Lot 41 to empty into the pond.

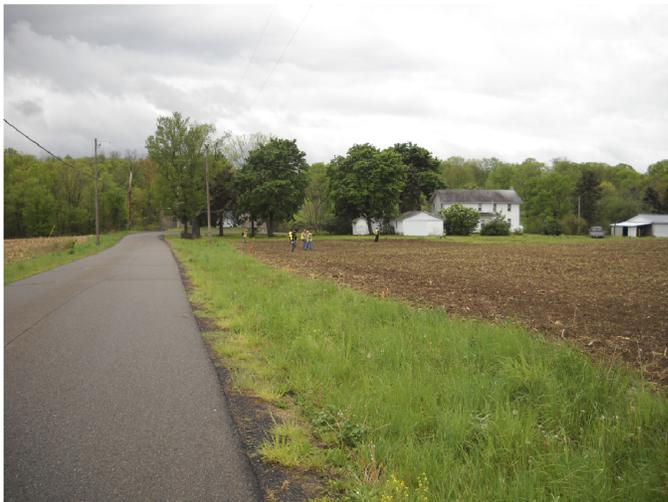
***Photograph 15. Lot 41, Section 1: View of  
Cultivated Field from Edge of North  
Market Street, showing Michaels Farm in  
Distance, Facing Southwest***

GAI defined two testing areas within Lot 41—Section 1, the cultivated field, and Section 2, the farmyard. Section 1 was investigated by pedestrian survey along transects spaced at 5-meter interval (Photograph 15). Judgmental shovel tests ( $n=12$ ) were excavated in scattered localities within the field to evaluate soil profiles. Shovel testing in Section 1 exposed an Ap-B soil horizon sequence. As described for judgmental STP J-2, soils consist of an approximately 31-cm-thick dark yellowish-brown silt loam Ap horizon and a yellowish-brown silty clay B horizon (Figure 10).

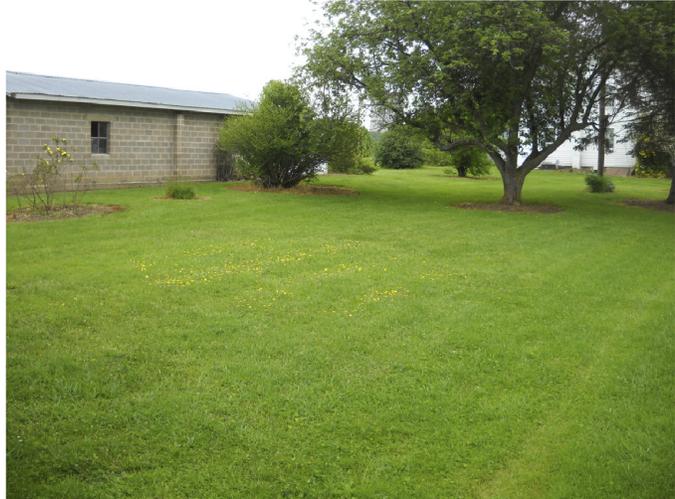
***Photograph 16. Lot 41, Section 2:  
Michaels Farm, showing Lawn,  
Residence in Background and  
Outbuilding to Left, Facing East***

Phase Ib survey of Section 2 consisted of systematic shovel testing at 15-meter intervals throughout the farmyard (Photograph 16). Twenty-one STPs were excavated within this section. Shovel testing in Section 1 revealed an A-B horizon soil sequence. As documented for STP D-1, the typical soil profile in Section 2 consisted of a 26-cm-thick dark yellowish-brown silt loam A horizon and a yellowish-brown silty clay B horizon (see Figure 10).

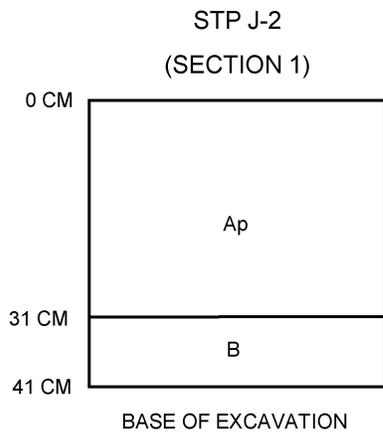
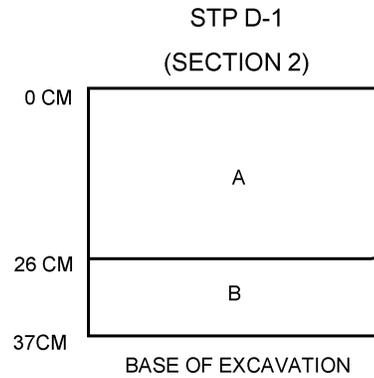
FIGURE 10. LOT 41,  
REPRESENTATIVE SHOVEL TEST PROFILES (STPs J-2 AND D-1)

Ap – DARK YELLOWISH BROWN (10YR 4/4) SILT LOAM  
B – YELLOWISH BROWN (10YR 5/6) SILTY CLAY

A – DARK YELLOWISH BROWN (10YR 4/4) SILT LOAM  
B – YELLOWISH BROWN (10YR 5/6) SILTY CLAY

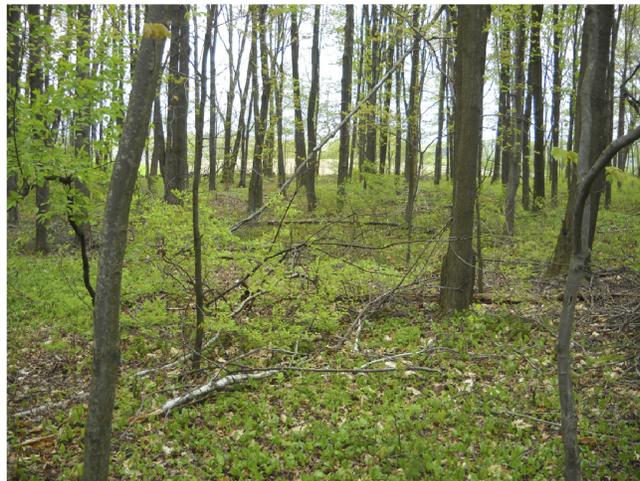
**Photograph 17. Lot 93D, Section 1: Overview of Woodland, Facing North**

Section 1 is bounded to the east and north by a low stone wall for its entire length (Photograph 17). Shovel test profiles and shallow furrows observed on the ground surface suggest that this locality has been previously cultivated. GAI excavated 445 15-meter interval shovel tests in this section. The typical STP profile, as described for STP O-4, consisted of a 28-cm-thick dark yellowish-brown silt loam A horizon above a yellowish-brown silty clay B horizon (Figure 11). Shovel testing in Section yielded not cultural materials.

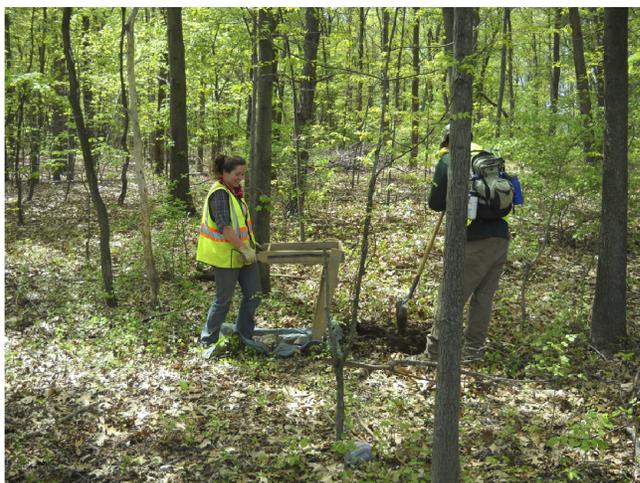
**Photograph 18. Lot 93D, Section 2: Shovel Testing in Woodland, Facing West**

Section 2 is a wooded parcel located south of US Route 11 and behind a series of residential properties bordering the roadway (Photograph 18). A field lies to its east and a steep slope to its south. This locality is relatively level, with a slight slope towards its southern edge. Disturbances associated with the existing transmission corridor and ATV trails were observed primarily in the northwestern corner. GAI excavated 251 shovel tests within Section 2. As recorded for STP G-4, shovel test profiles generally consisted of an approximately 34-cm-thick dark yellowish-brown silt loam A horizon and a yellowish-brown silt clay B horizon (see Figure 11). In areas of disturbance (e.g., STP D-1) the A horizon has been removed and the profile consists of a CA-B soil horizon

sequence. Of the 251 STPs excavated, one positive shovel test (STP C4) located in the northwest corner, produced two historic artifacts from the A horizon. These artifacts include one window glass fragment and one piece of chain link. They were concluded to represent yard scatter associated with the adjacent residential property. They do not represent an historic period archaeological site.
