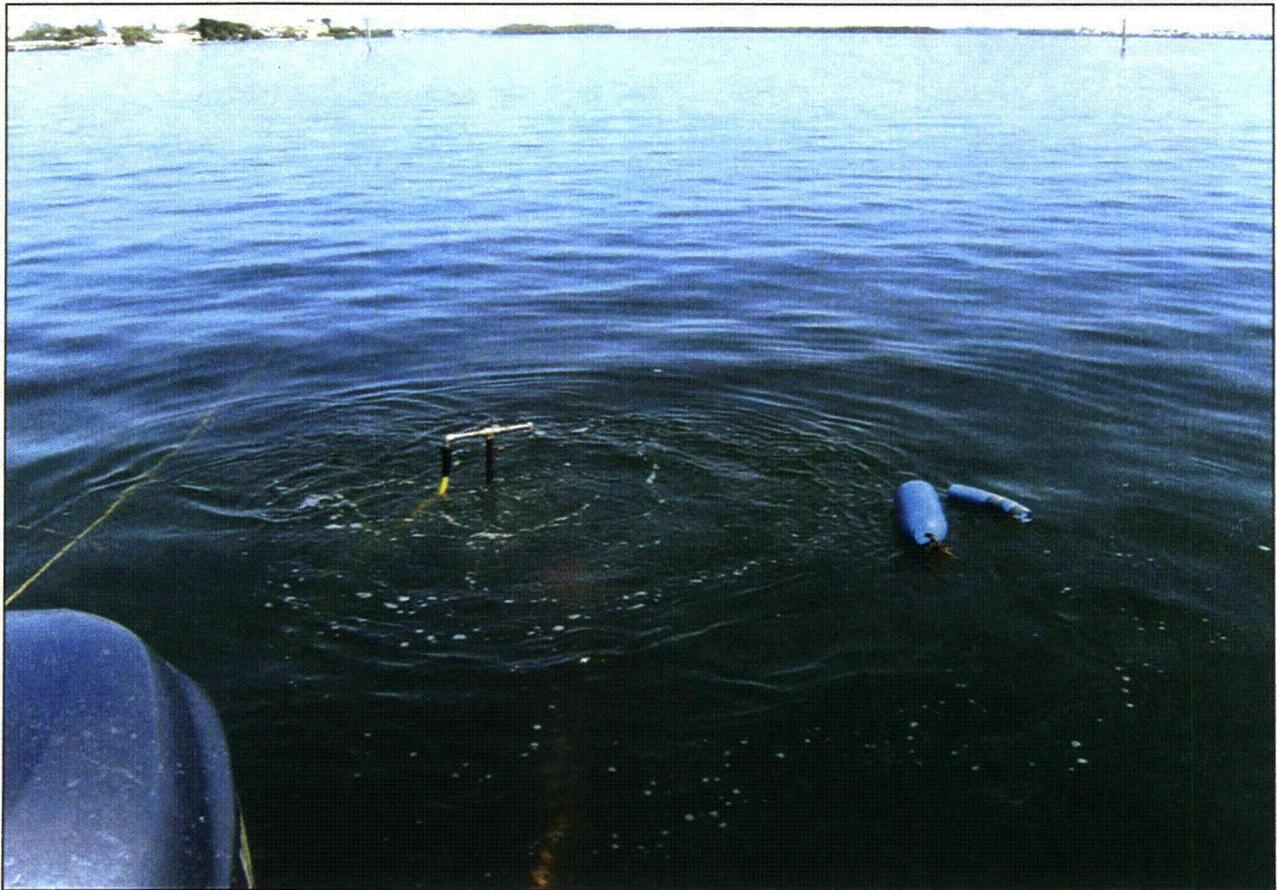
Probing of anomalies or features is an effective means of determining the spatial extent and burial depth of a given target located beneath the sea floor. The hydro-probe apparatus consists of a water pump, lengths of garden hose, and the probe, which is 0.5-inch galvanized pipe. The hose was connected to the 0.5-inch diameter steel probe by a cam-lock. The hydro-probe used for this investigation was 10 feet in length and powered by a 5-hp Honda water pump. The basic function of the hydro-probe is to aid in determining the presence or absence of buried cultural material, and, if present, the spatial extent of the material, types of overburden (i.e., sand, mud, shell), the type of cultural material, and depth of overburden. This is accomplished by forcing water through the 10-foot pipe attached to the water pump's effluent hose. The force of the water ejected from the pipe end effectively allows the probe to be inserted through sediments of varying density (e.g., sands, silts, shell hash) and depth, thereby contacting the feature if present and/or sediment layers (Figure 30).

**Figure 30. Probing was conducted at all magnetic targets, where objects were not located during diver sweeps, with a 10-foot-long hydro-probe.**

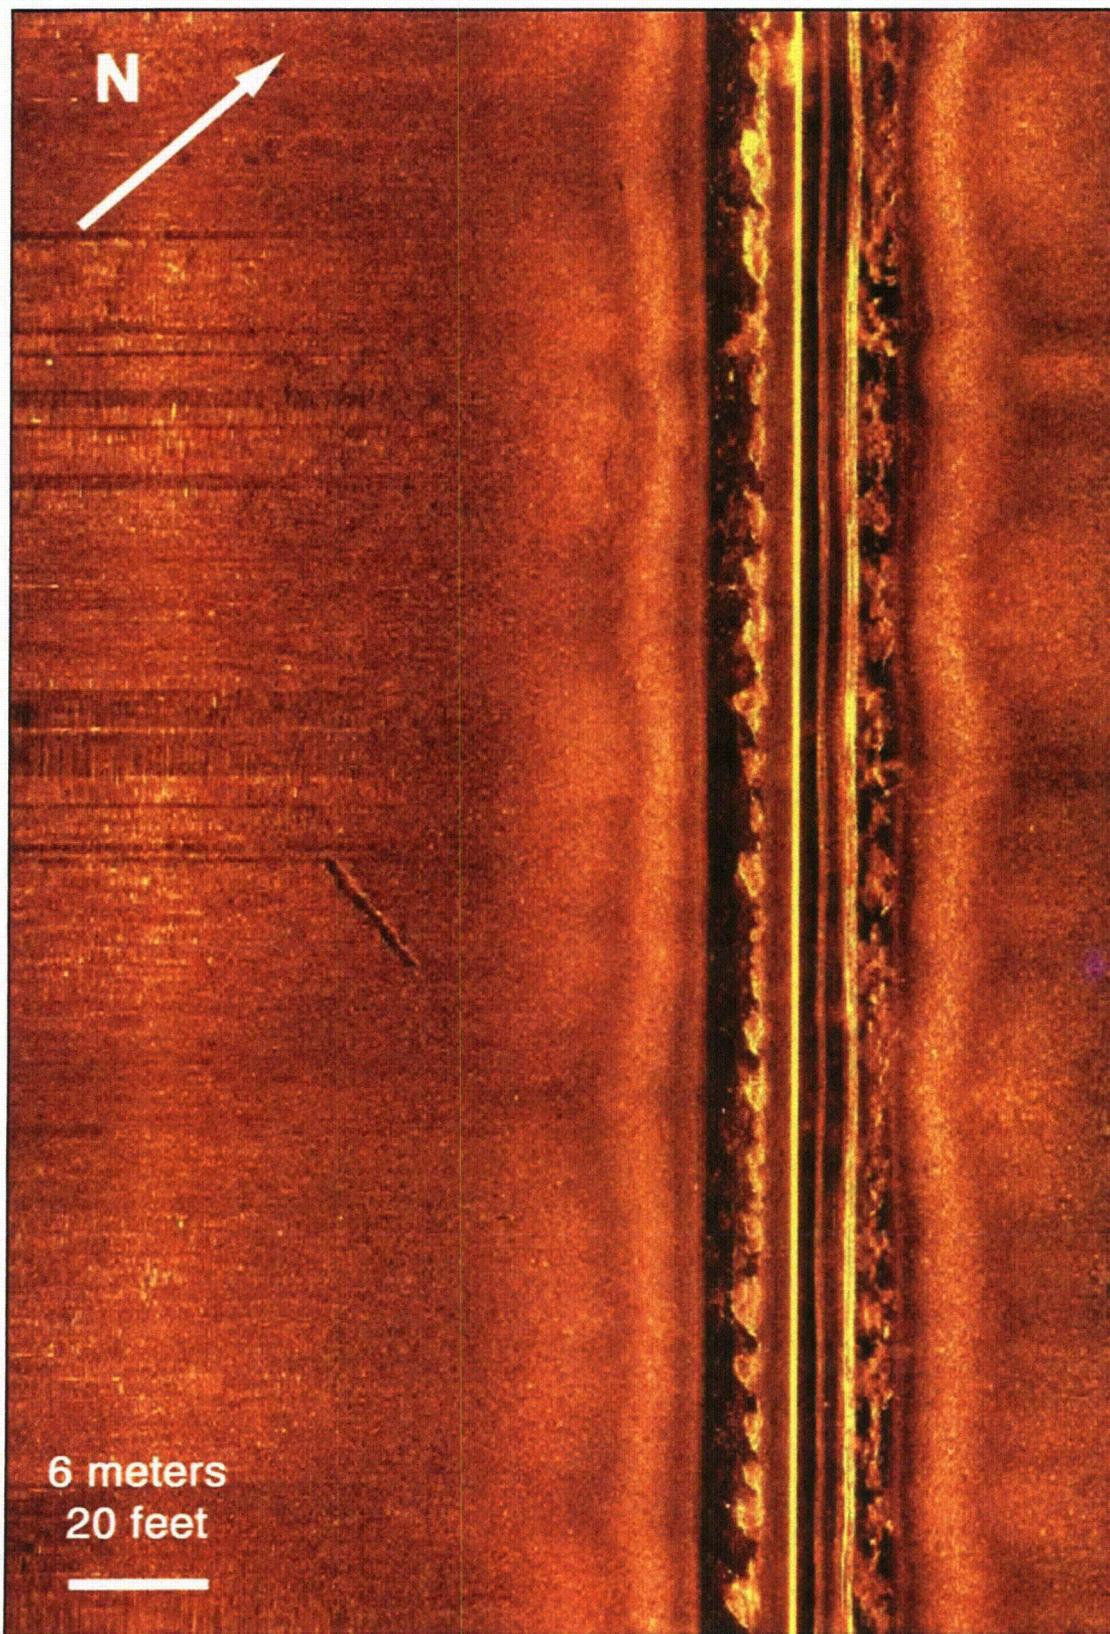
The survey data for M101 indicated the presence of a 156-nanotesla dipole anomaly with a duration of 32 meters (105 feet; Table 6; Figure 35). Examination of the sidescan sonar data indicated the presence of a possible linear object about 3 meters (10 feet) northwest of the anomaly location (Figures 49 and 50). However, a search of the bay bottom in the vicinity of the anomaly did not indicate the presence of any object (or objects) sufficient to account for the anomaly, indicating the object as seen in the sidescan data is likely the exposed rock located by the diver and discussed below. Following a search of an area of a 15-meter (50-foot) radius surrounding the target by the diver in arcs in a 3-meter (10-foot) interval with negative results, a pattern of nine hydroprobes, spaced at 3-meter (10-foot) intervals in cardinal directions (out to 6 meters [20 feet] in each direction and to a depth of 0.5 meters [2 feet]), did not locate any objects sufficient to account for the anomaly. The hydroprobes did indicate the presence of a hard layer at 0.5 meters (2 feet) below the bottom, which the probe was unable to penetrate.

Figure 49. 2011 Magnetic contour map of M101 overlaid on sidescan sonar data, showing location of hydroprobes. Data presented in Maryland State Plane, NAD83, meters.

Figure 50. Raw sidescan sonar image of area surrounding M101 collected during 2011 survey. Note linear object, confirmed by diver inspection to be a rock outcrop.

Failure to locate the object with a visual inspection and a pattern of subsurface probes, coupled with a rock layer 2 feet below the bay bottom, indicates that the source object(s) consist(s) of isolated small marine debris such as wire rope or rebar, rather than a single large object such as a shipwreck. Given the shallow depth of sediment over solid material, any object greater than 2 feet in height would extend up through the sediment and be visible in the sidescan data and by divers. This target is not considered historically significant and no further work is recommended.
