**Subject:** Response to Request of Additional Information (RAI) Concerning the Honeywell's Riprap Durability Evaluation Report of Cypress Quarry (Rip Rap Report), May 2012 Information for Surface Impoundment Decommissioning Plan (TACL32759)

## REQUESTS FOR ADDITIONAL INFORMATION REGARDING HONEYWELL'S RIPRAP DURABILITY EVALUATION: CYPRESS QUARRY (RIPRAP REPORT), May 2012

**PETROGRAPHIC EXAMINATION  
US ARMY CORPS OF ENGINEERS  
SHAWNEE STONE, CYPRESS QUARRY  
EROSION CONTROL STONE  
SAMPLES UL-FG  
(UPPER LEVEL – FINE GRAINED)**

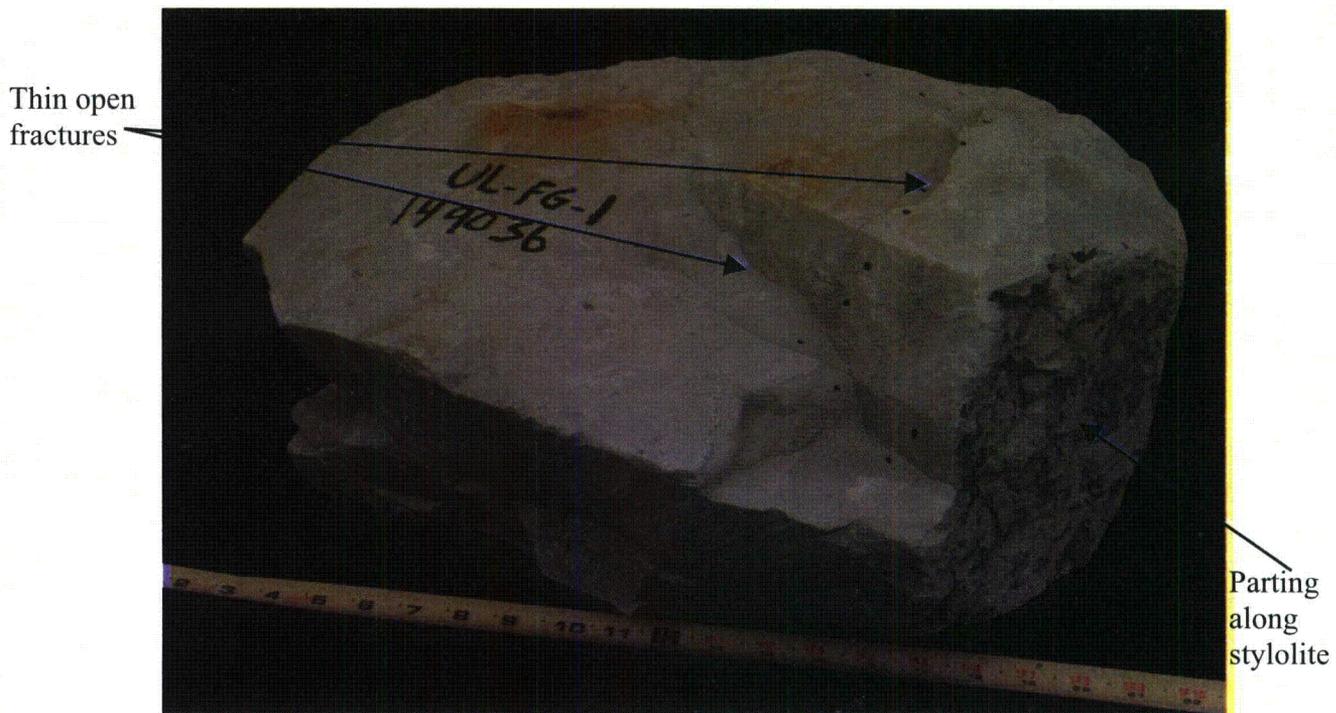
Figure 1. Shawnee Stone, Cyprus Quarry, Upper Level – Fine-Grained. UL-FG-1 as received and before washing.

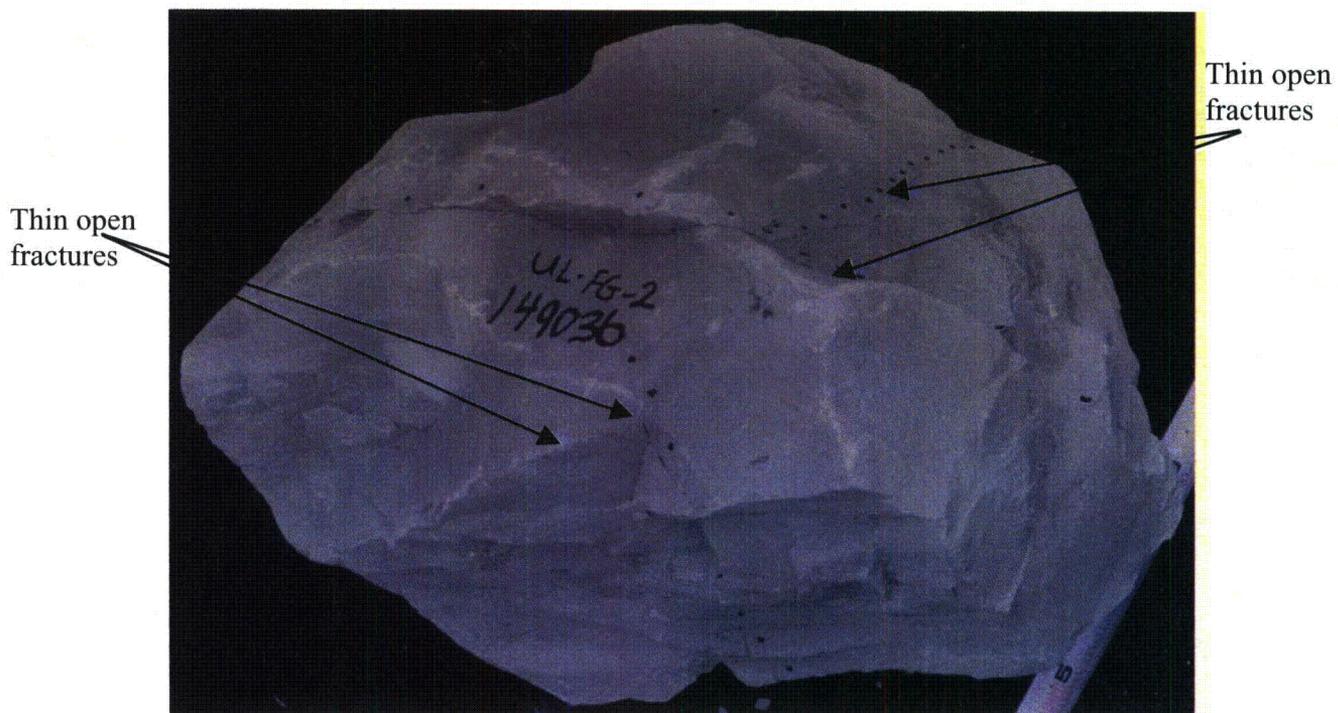
Figure 2. Shawnee Stone, Cyprus Quarry, Upper Level – Fine-Grained. UL-FG-2 as received and before washing.

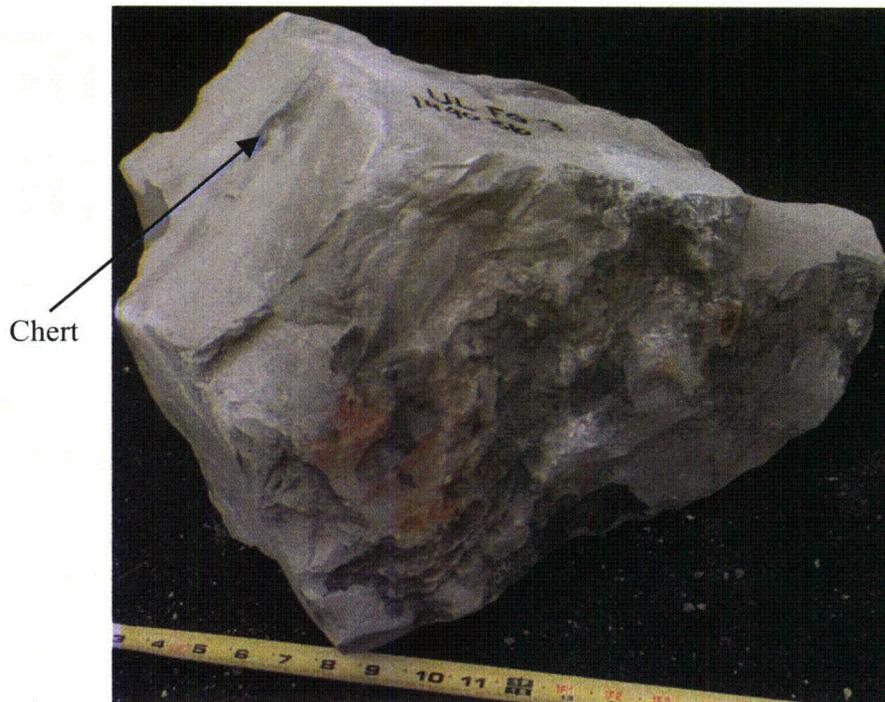
Figure 3. Shawnee Stone, Cyprus Quarry, Upper Level – Fine-Grained. UL-FG-3 as received and before washing.

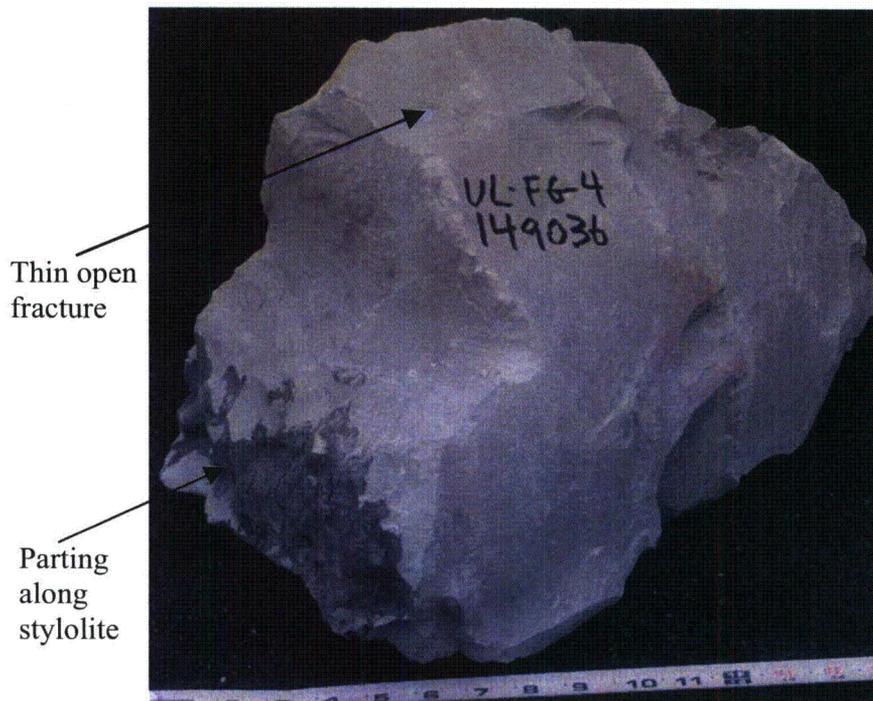
Figure 4. Shawnee Stone, Cyprus Quarry, Upper Level – Fine-Grained. UL-FG-4 as received and before washing.

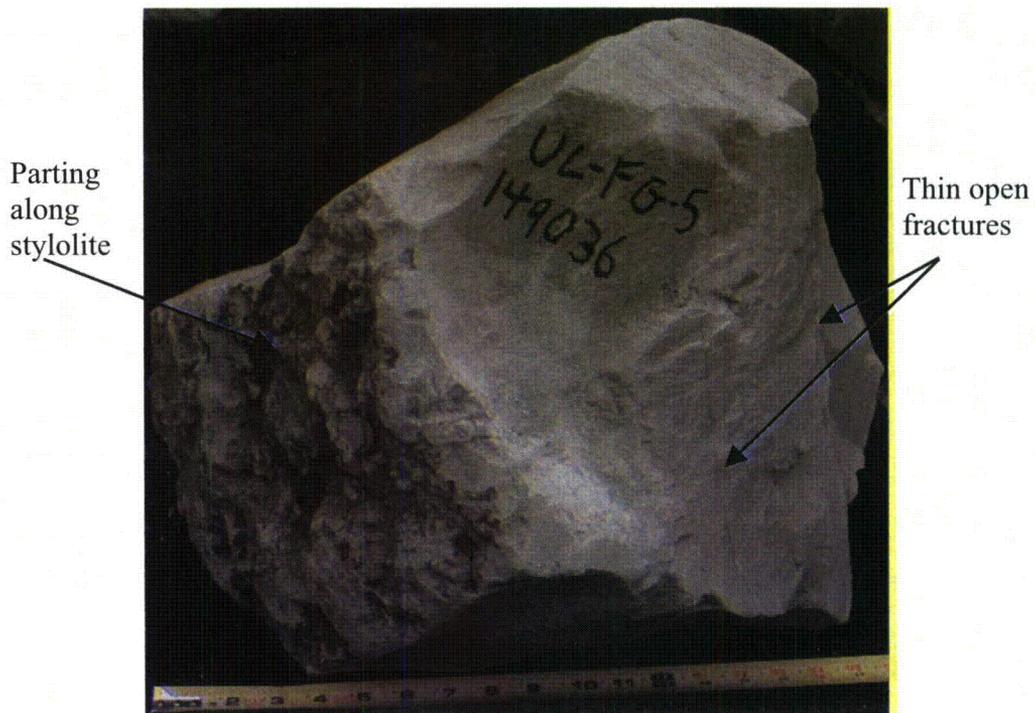
Figure 5. Shawnee Stone, Cyprus Quarry, Upper Level – Fine-Grained. UL-FG-5 as received and before washing.

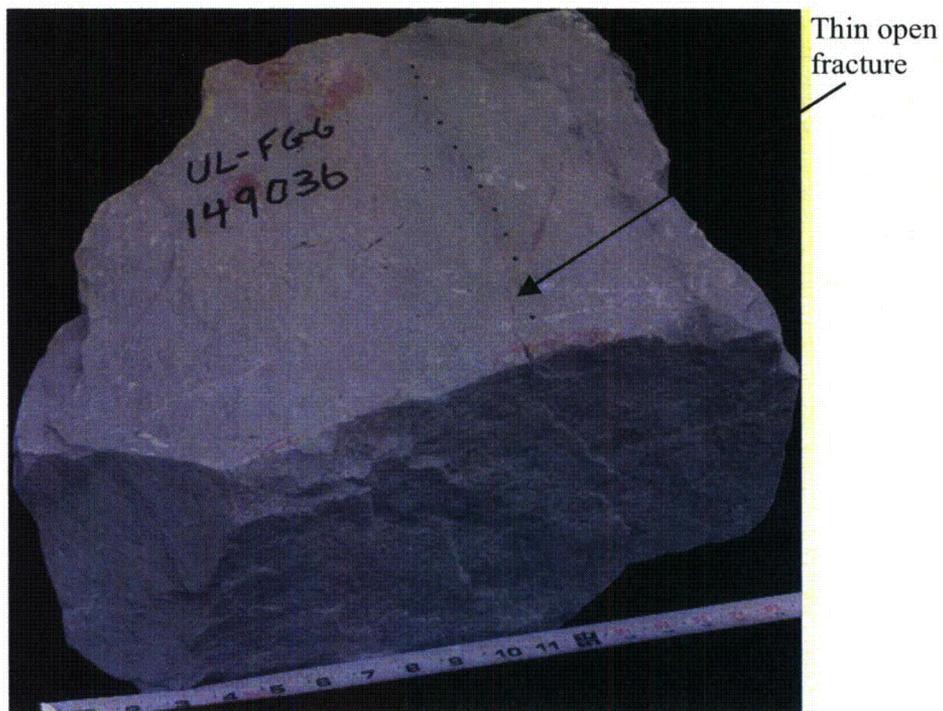
Figure 6. Shawnee Stone, Cyprus Quarry, Upper Level – Fine-Grained. UL-FG-6 as received and before washing.

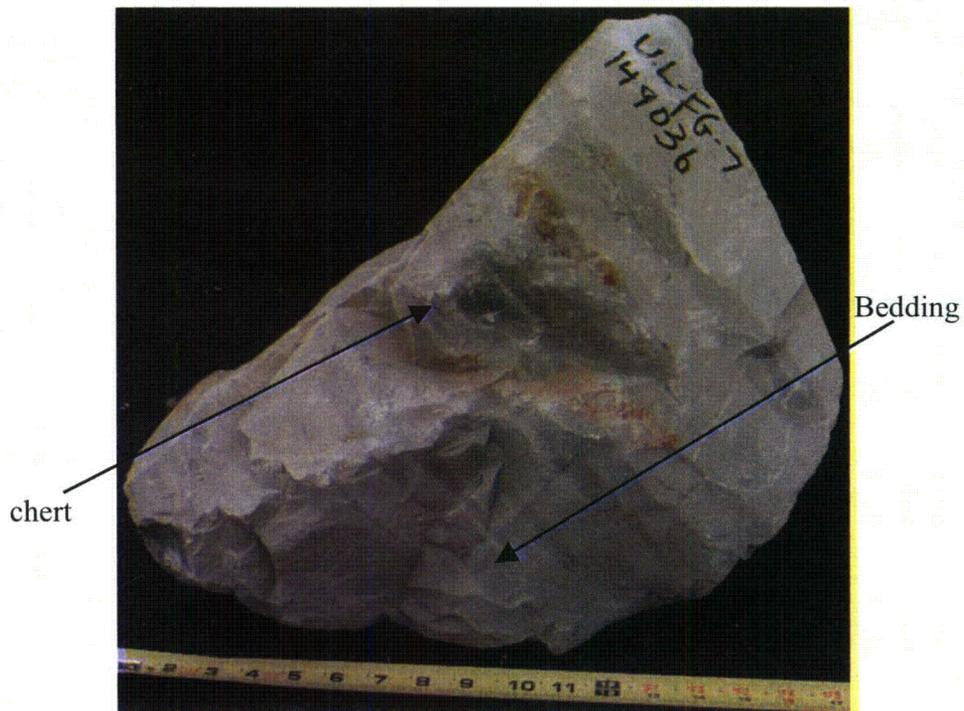
Figure 7. Shawnee Stone, Cyprus Quarry, Upper Level – Fine-Grained. UL-FG-7 as received and before washing.

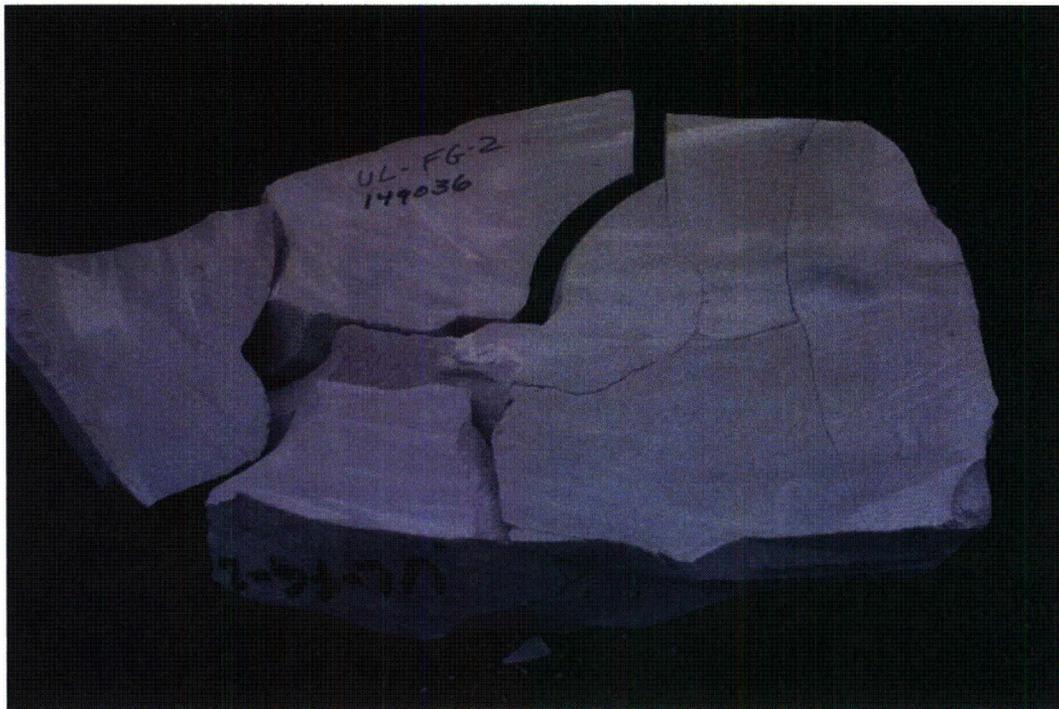
Figure 8. Shawnee Stone, Cyprus Quarry, Upper Level – Fine-Grained. UL-FG-2 broke into several pieces during attempt at sawing.

but no stylolites bounded on each side by argillaceous dolomitic limestone were seen in the samples. The samples obviously have a tendency to part along pre-existing fractures and stylolites and this tendency could present problems maintaining gradation. The samples possess a uniform lithology and composition and are moderately soft, porous, rough, and durable to non-durable.

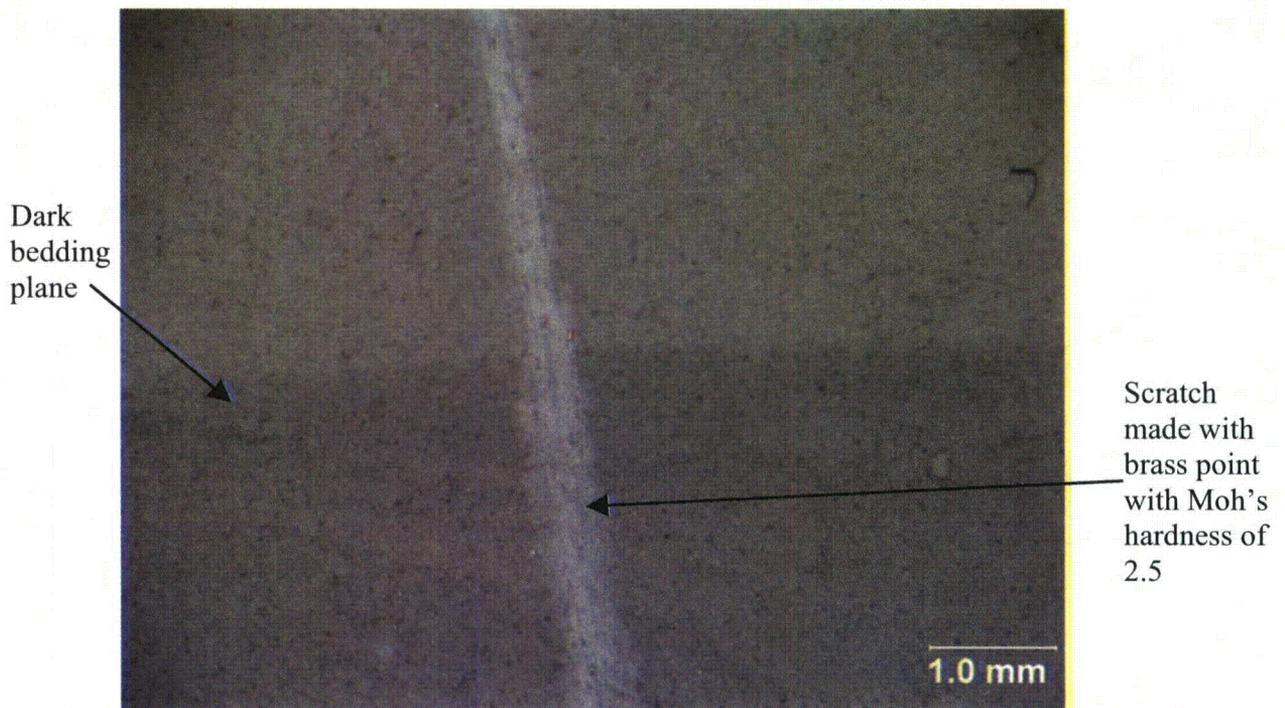
Figure 9. Shawnee Stone, Cyprus Quarry, Upper Level – Fine-Grained. Microphotograph of typical argillaceous dolomitic limestone (UL-FG-5). Photographed at 10X magnification.

Medium bedding with bedding defined by slightly darker bands (Figure 9). Finely crystalline, argillaceous and moderately soft, easily scratched with brass pen with Moh's hardness of 2.5 (Figure 9). Numerous thin open fractures, many occurring as closely-spaced (< 1.0 mm) parallel fractures (Figure 10), the fractures presented difficulties during sawing, sample UL-FG-2 was not tested because sample broke into multiple pieces along pre-existing fractures during sawing (Figure 8); sample UL-FG-3 broke into four pieces during sawing; sample UL-FG-4 separated along one edge into 2 pieces during sawing; sample UL-FG-6 separated along pre-existing fractures into three pieces and began to separate along fourth fracture during sawing; and sample UL-FG-7 separated along pre-existing fractures into six pieces during sawing; samples UL-FG-1 and UL-FG-5 were the only two samples that did not break along existing fractures during sawing. Several faces on the samples appear to have been created by breakage along stylolites

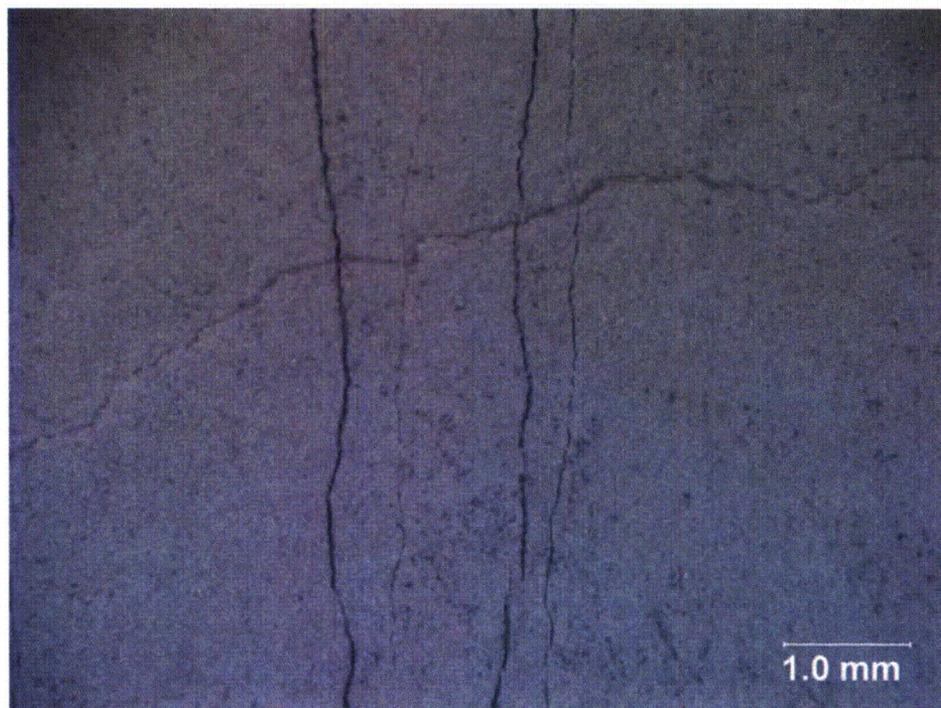
Figure 10. Shawnee Stone, Cyprus Quarry, Upper Level – Fine-Grained. Microphotograph of thin closely-spaced, intersecting open fractures (UL-FG-1). Photographed at 10X magnification.

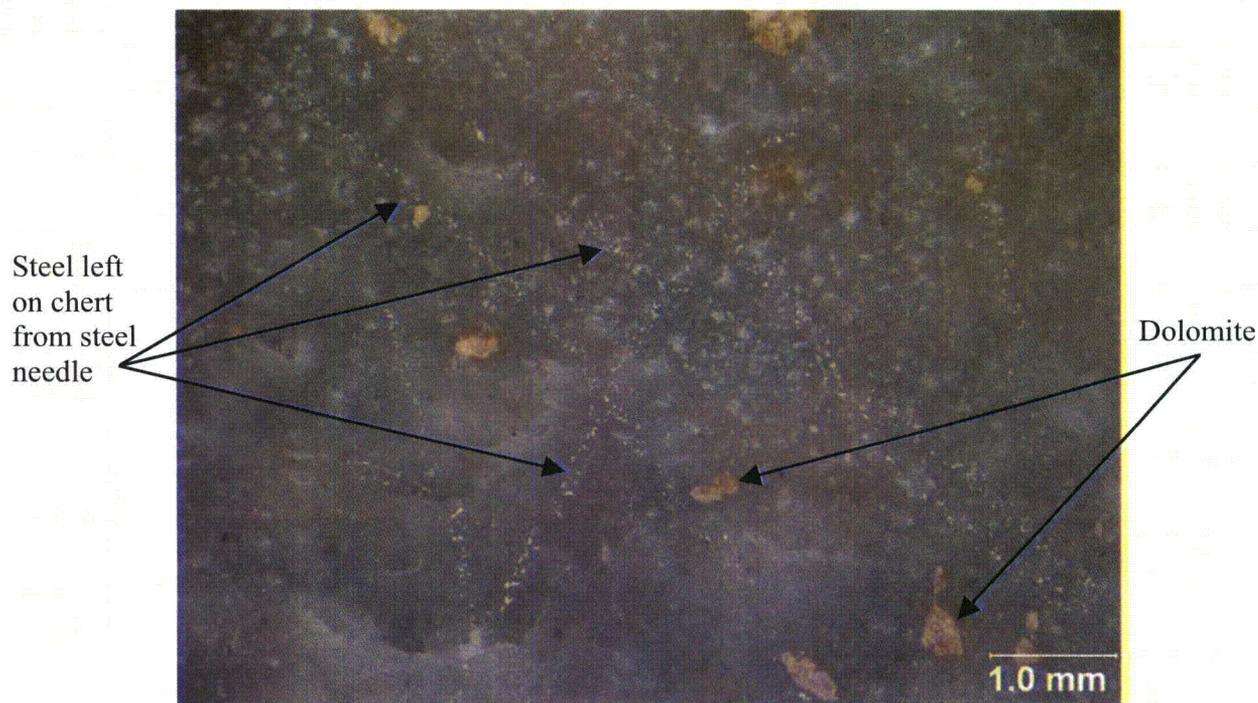
Figure 11. Shawnee Stone, Cyprus Quarry, Upper Level – Fine-Grained. Microphotograph of chert nodule (UL-FG-7). Photographed at 10 X magnification.

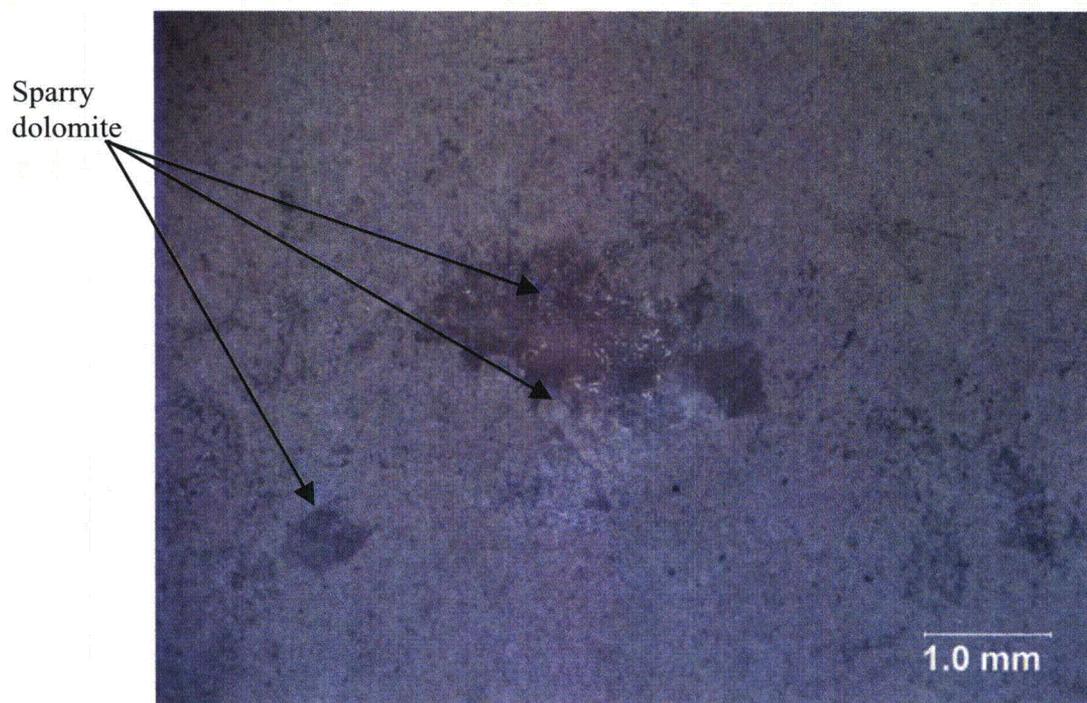
Figure 12. Shawnee Stone, Cyprus Quarry, Upper Level – Fine-Grained. Microphotograph of sparry dolomite (UL-FG-1). Photographed at 10X magnification.

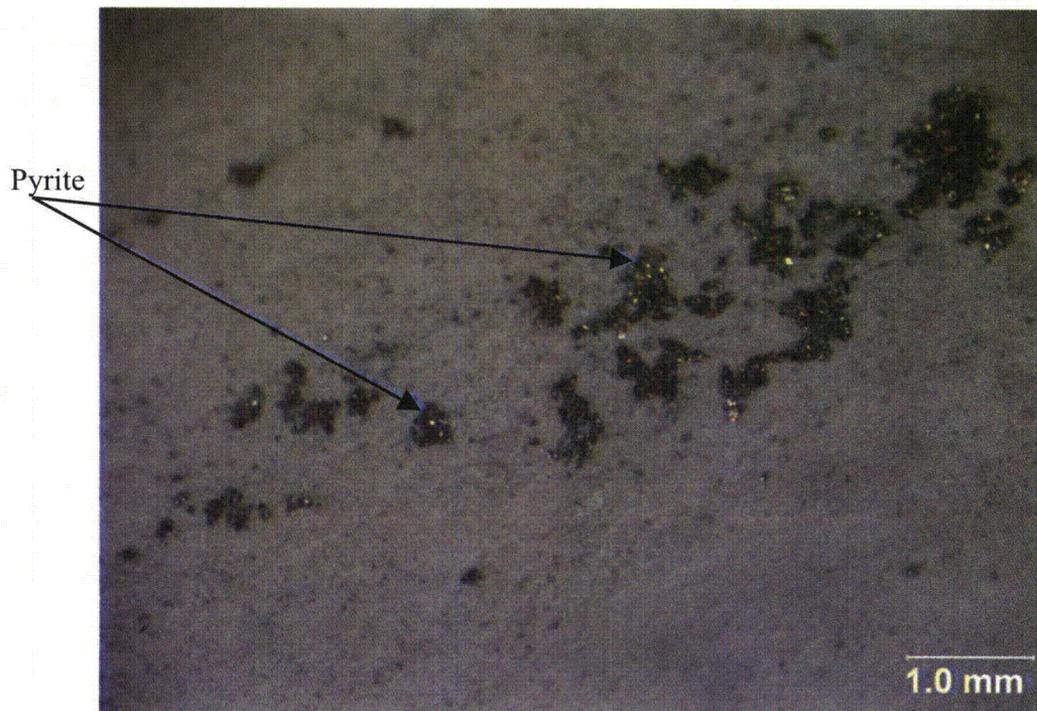
Figure 13. Shawnee Stone, Cyprus Quarry, Upper Level – Fine-Grained. Microphotograph of pyrite in argillaceous dolomitic limestone (UL-FG-7). Photographed at 10X magnification.
