WILDLIFE SURVEY REPORT: 23-26 JULY 2007

PROPOSED EXELON NUCLEAR POWER PLANT SITE MATAGORDA COUNTY, TEXAS

**Prepared By:
Tetra Tech NUS, Inc.
900 Trail Ridge Road
Aiken, SC 29803**

22 August 2007

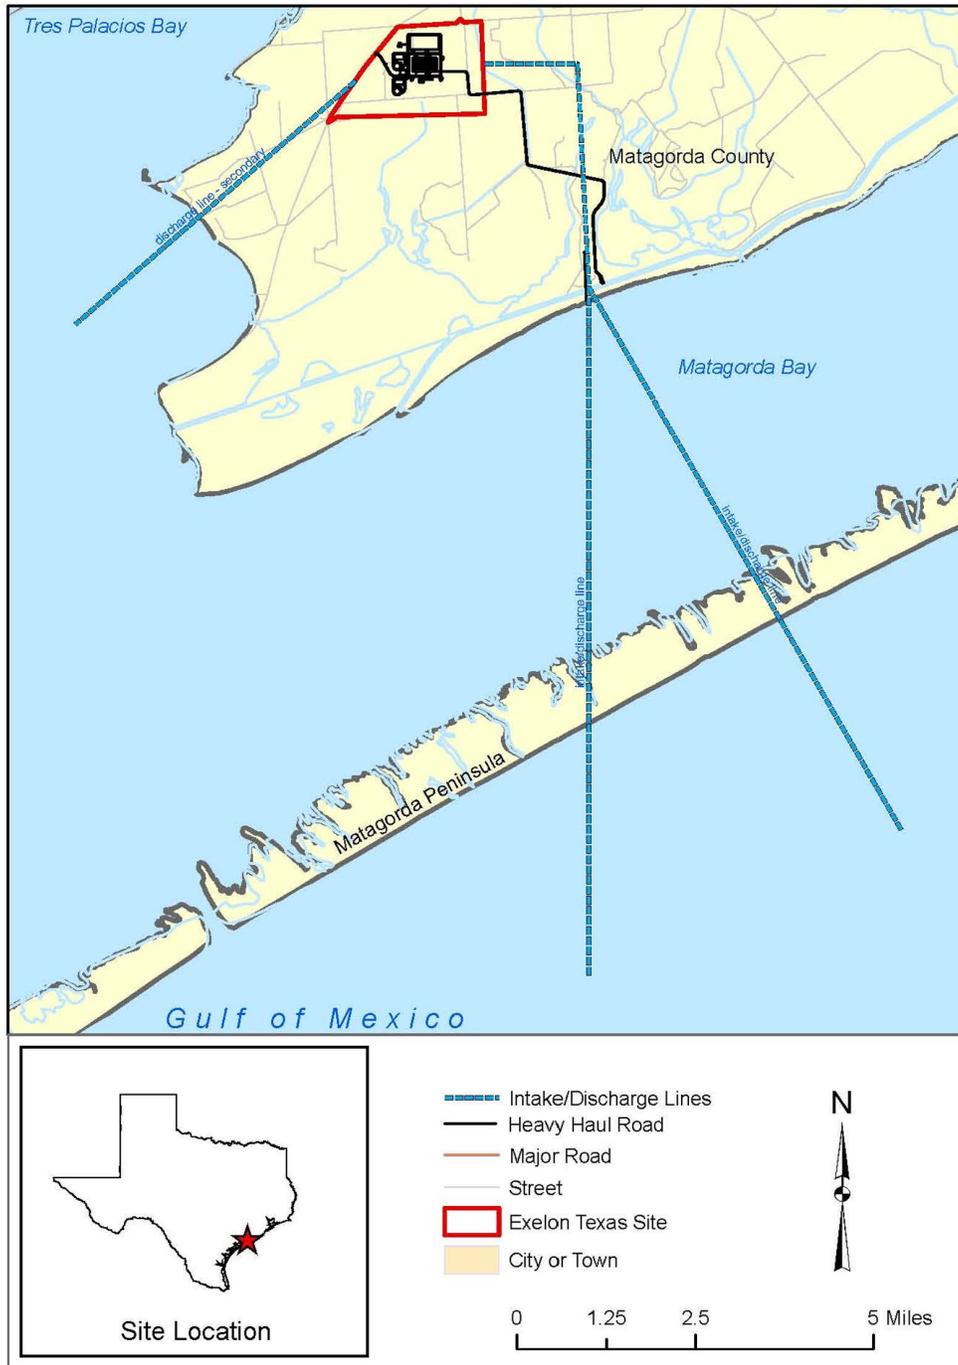
Figure 1. Site Layout

Figure 1. Map of the Exelon Site in Matagorda County, Texas, and Associated Intake/Discharge Corridors and Heavy Haul Road.

The heavy haul road, GIWW intake, and GOM intake/discharge corridors exit the east side of the site before turning south to the GIWW (Figure 1). The last 1.5 miles of these corridors occur on an upland strip of land (rice fields and pasture) bordered by brackish marsh. The mainland shore of the GIWW is stabilized by rip-rap, with no transitional wetland areas between the upland and the GIWW. Vegetation on the upland edge of the shore is characterized by Bermuda grass and honey mesquite (*Prosopis glandulosa*).

¹Gulf of Mexico (GOM) intake/discharge and heavy haul (HH) road corridor (see Figure 1)
