## Tuba City, Arizona, Disposal Site

## 19.0 Tuba City, Arizona, Disposal Site

SUBJECT: TUBA CITY DISPOSAL SITE  
OBSERVATIONAL SITE VISIT

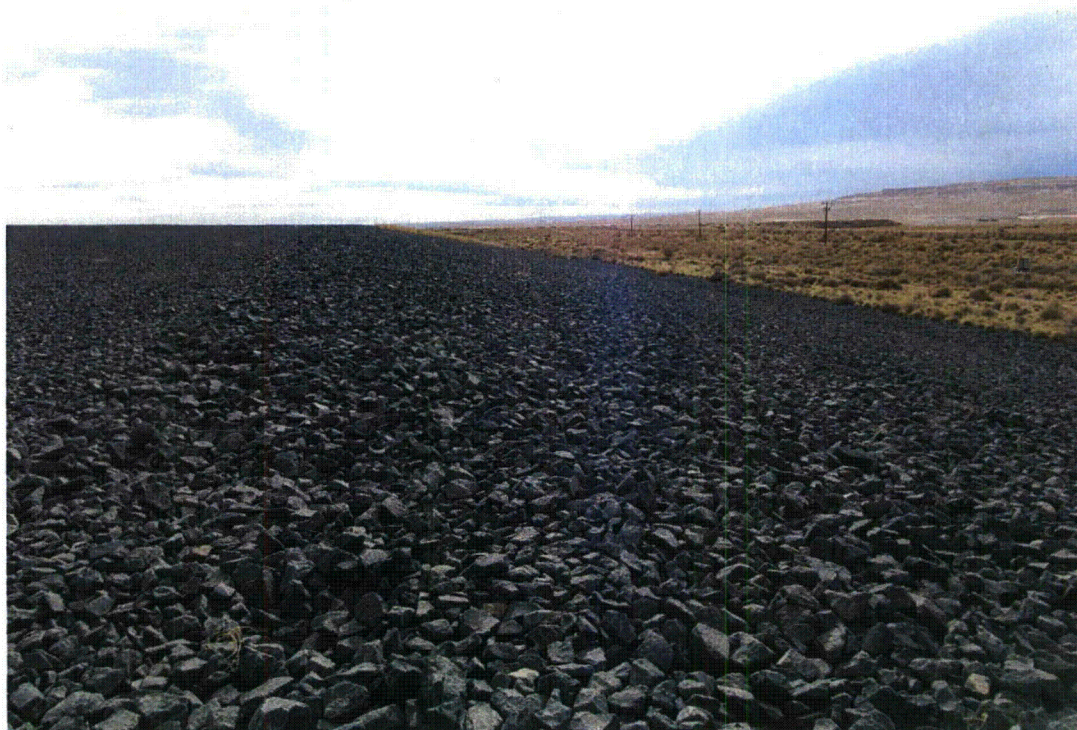
**Disposal Cell**—The disposal cell is covered with riprap to control erosion. The rock cover material was in excellent condition and showed no signs of deterioration. No evidence of differential settlement or slumping was observed, and all visible components of the disposal cell and cover were in excellent condition (PL-1 and PL-2).

*TUB 4/2011. PL-2. South side slope of the disposal cell cover.*

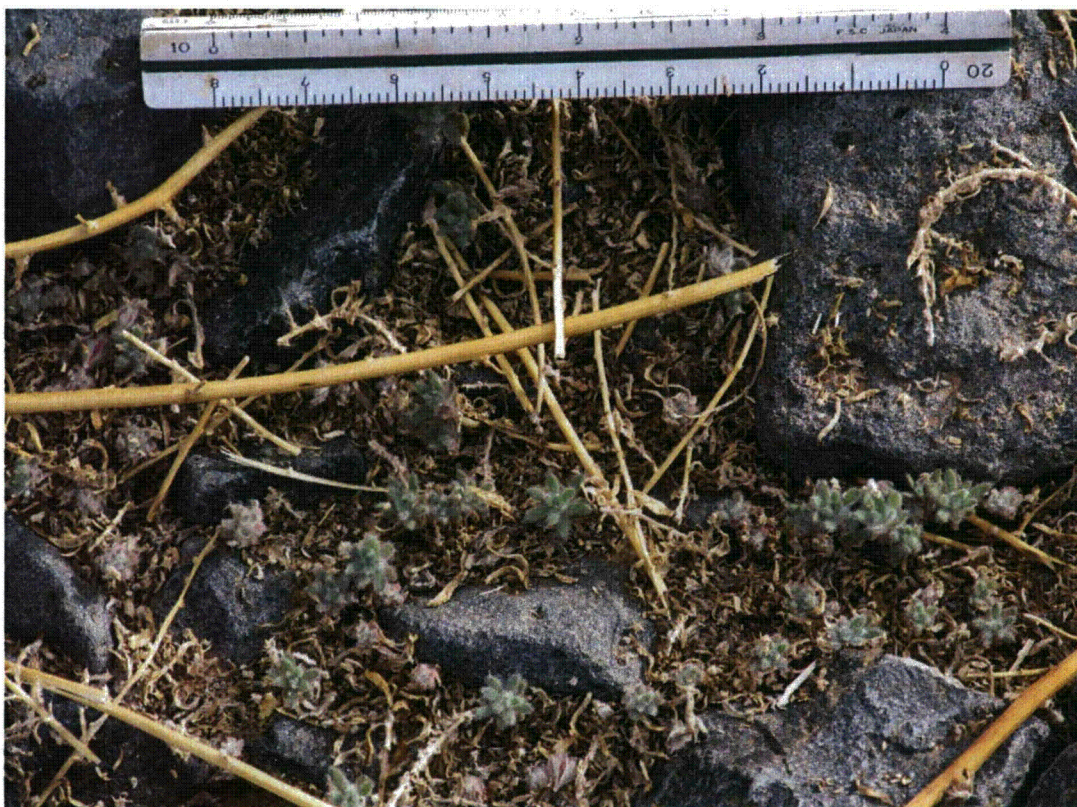
In accordance with the LTSP, deep-rooted vegetation, primarily saltbush, is removed or controlled to prevent potential penetration of the radon barrier. The most recent removal effort occurred in 2004. Since then, periodic application of herbicide has been very effective in controlling deep-rooted vegetation growth on the cell cover. All shrubs on the disposal cell were treated with herbicide during the 2010 inspection; only a few small shrubs were noted during the 2011 inspection. Scattered patches of grass and annual weeds also grow on the cell top and side slopes; however, these shallow-rooted plants are not a concern. Windblown sand continues to accumulate on the rock-covered surfaces, providing a favorable environment for plant growth (PL-3).

*TUB 4/2011. PL-3. Windblown sand accumulation on the disposal cell cover.*

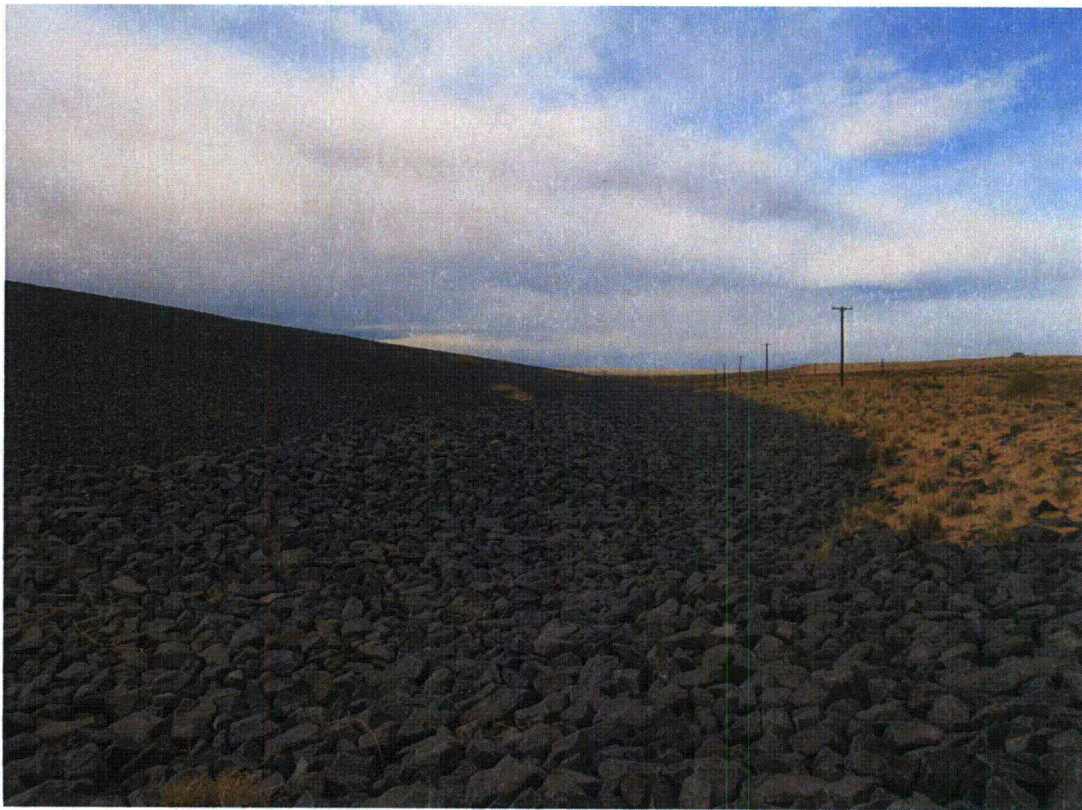
**Area Between the Disposal Cell and the Site Boundary**—The apron drainage ditch at the base of the disposal cell (PL-5) and the diversion channel (PL-6), both located along the north and northwest sides of the cell, are in good condition. Windblown sand deposition continues to be monitored at the site because unstable dunes in outlying areas can contribute to sand accumulation along fence lines, in diversion channels, and in the rock cover of the disposal cell. Sand accretion and vegetation encroachment have been checked annually since 2001 in the diversion channel and apron drainage ditch on the north and northwest sides of the cell. The sand tends to periodically accumulate and scour but, overall, sand accretion and concomitant new vegetation growth continues to increase (PL-7). However, these accumulations are not adversely affecting the performance of these features.

*TUB 4/2011. PL-5. Northwest side slope and apron ditch of the disposal cell.*

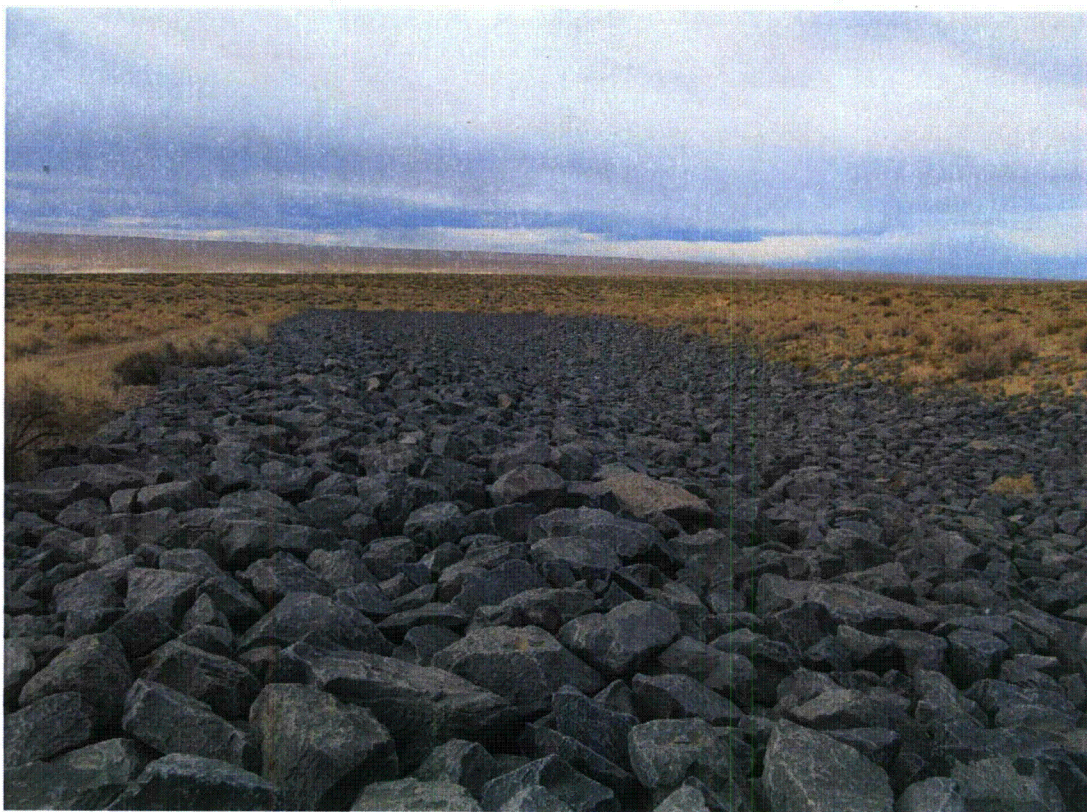
*TUB 4/2011. PL-6. Diversion channel on the west side of the site.*

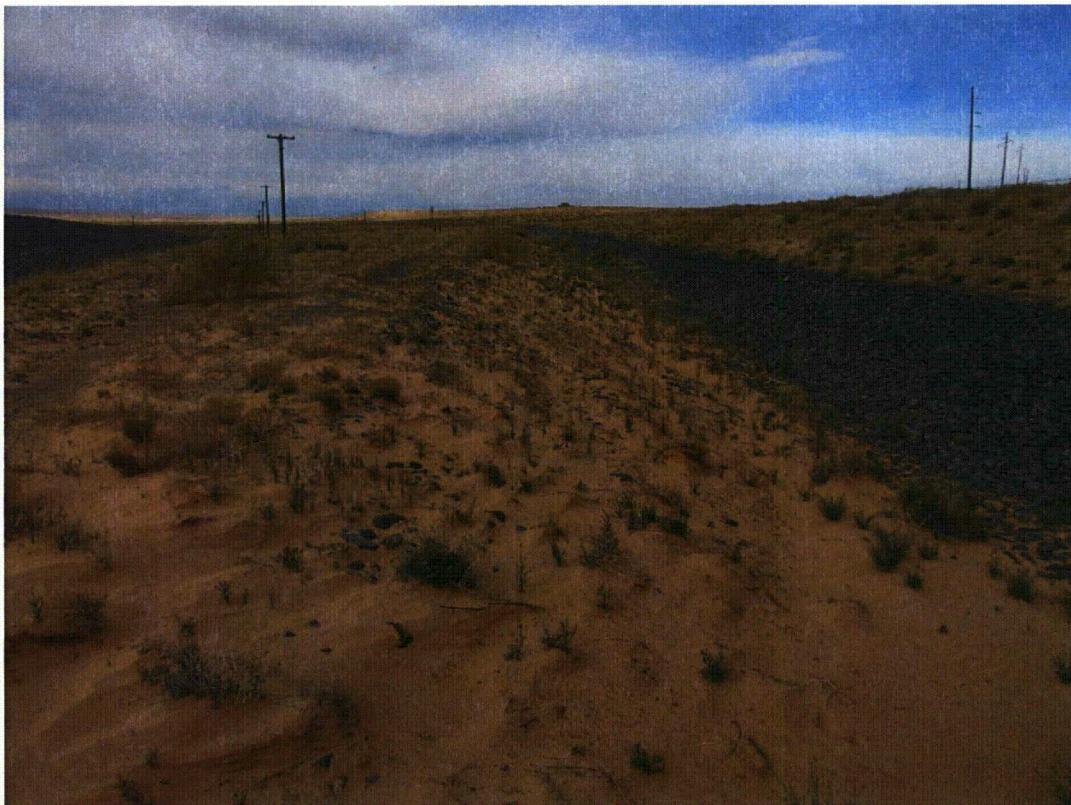
*TUB 4/2011. PL-7. Windblown sand deposition on the south bank of the diversion channel.*

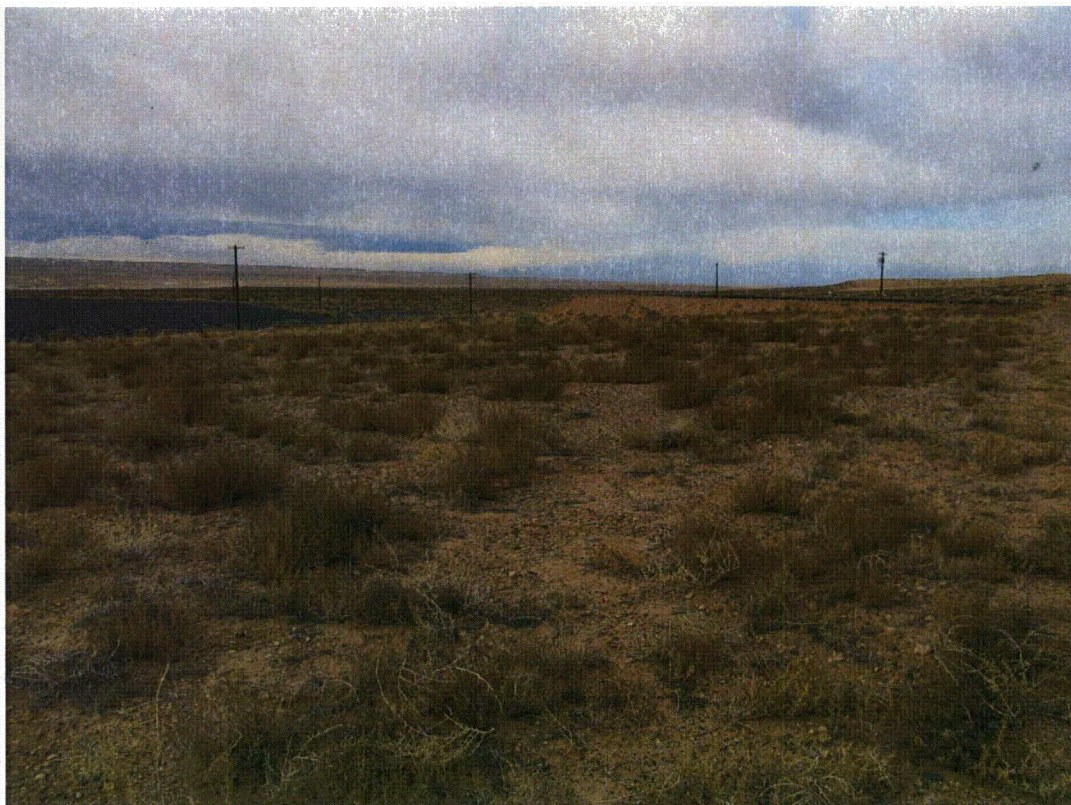
In 2007, two of the three evaporation ponds located near the northwest side of the disposal cell were removed, and the area was reclaimed and seeded with a native vegetation seed mix. Although the area is scoured by wind, perennial vegetation continues to establish (PL-8). The

*TUB 4/2011. PL-8. Reclaimed area of former evaporation ponds.*

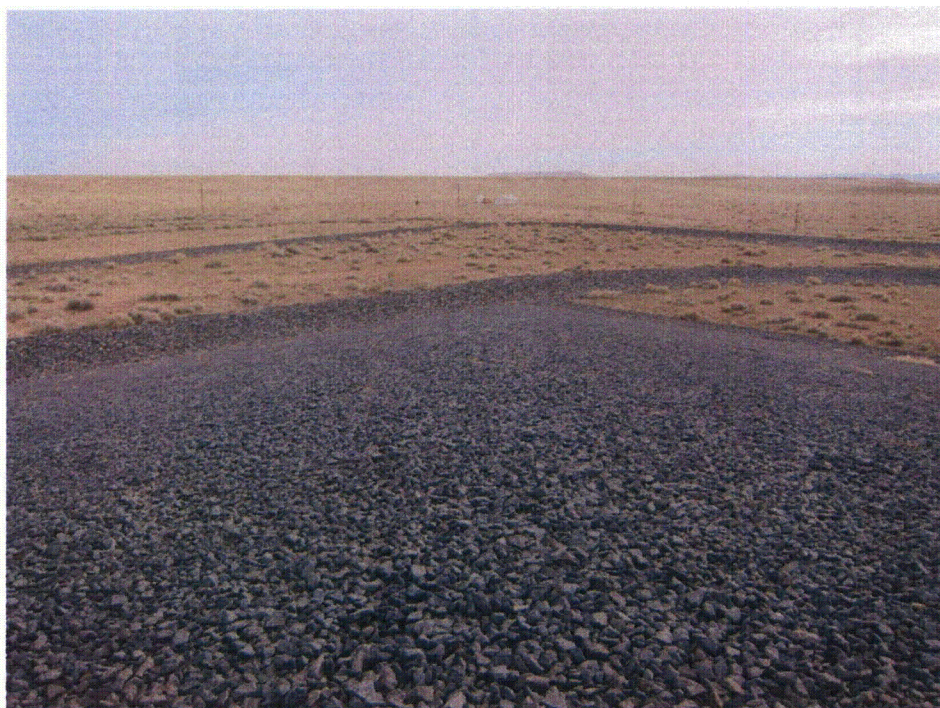
Figure 2: Diversion Ditches as Seen from Top of Impoundment
