SUBJECT: OBSERVATIONAL SITE VISIT AT BLUEWATER DISPOSAL SITE

Report: 040-08902/12-001

Facility: Bluewater Disposal Site

Location: Village of Bluewater, Cibola County, New Mexico

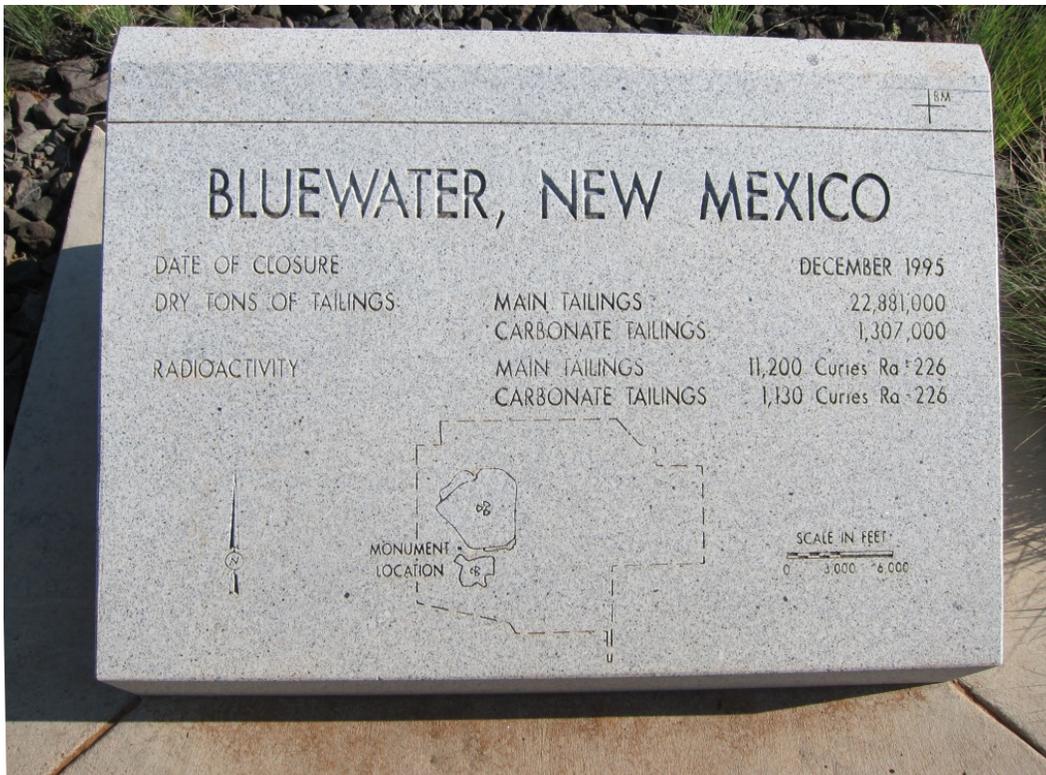
Figure 1: Bluewater disposal site monument

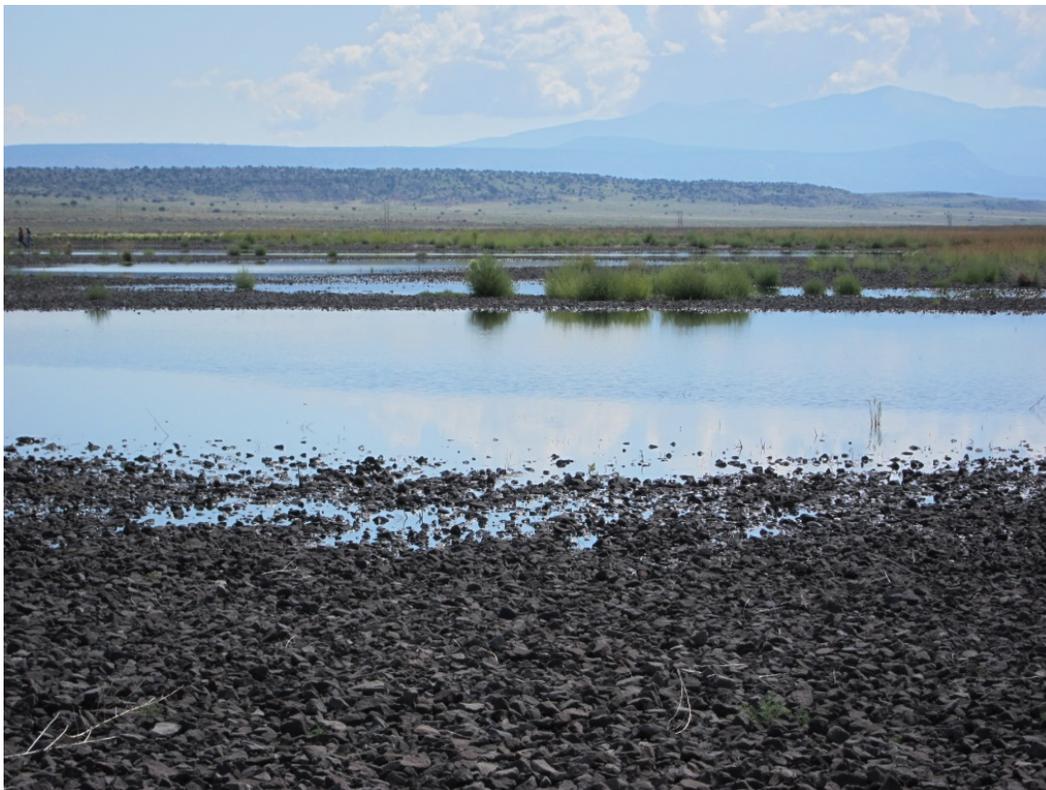
The DOE inspectors checked the tailings cells for quality of the cover rock, signs of settlement and erosion, evidence of ponding, and evidence of deep-rooted shrubs and trees. Overall, the main tailings disposal cell cover appeared to be in good condition, although pooled water was observed at the northern end of the cell. The pooled water may be indicative of slight subsidence on this end of the disposal cell. As discussed earlier, the DOE has started a cell performance study, in part, to determine if the cell cover is still effective at encapsulating the tailings material.

Figure 2: Shallow depression in northern end of main tailings disposal area

In response to the shallow depressions on the main tailings disposal cell and the elevated uranium concentrations in point-of-compliance Well T(M), the DOE implemented a cell performance study and developed a proposed work plan. The DOE presented the details about the study and work plan to the NRC in its letters dated August 31, 2011, and June 27, 2012. In summary, the DOE plans to review cover design documents and completion reports, determine what information is needed to complete the evaluation, characterize and analyze the cell covers, and implement changes as necessary based on the evaluation results.

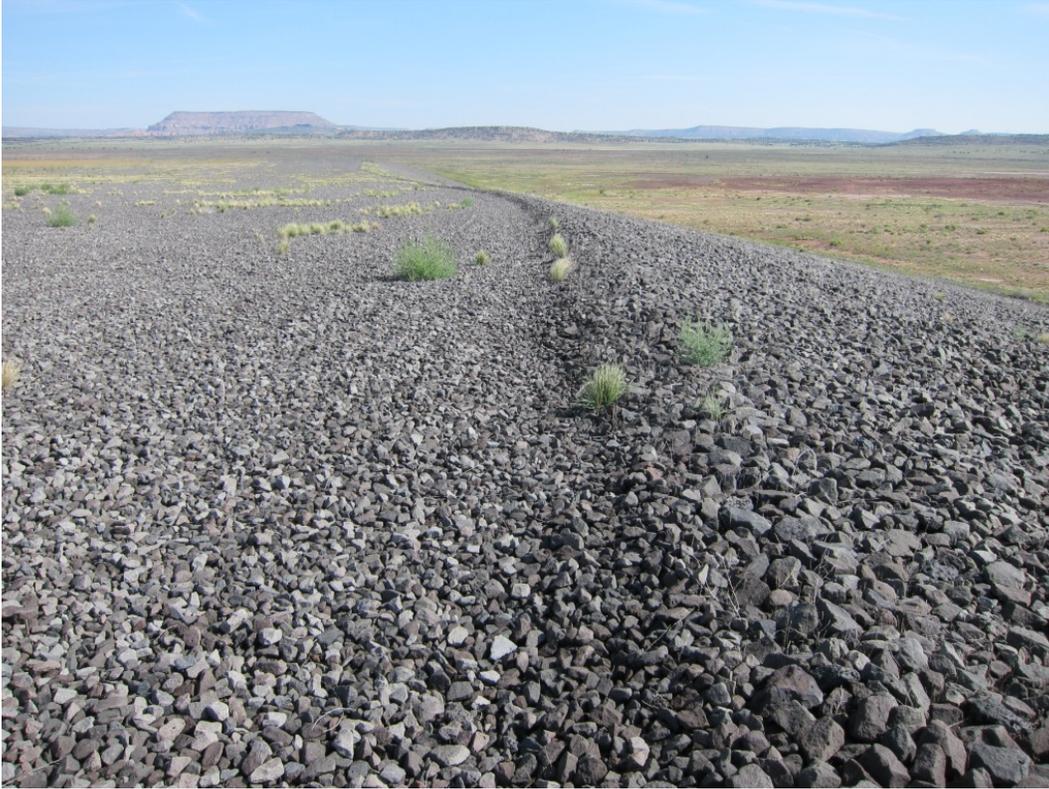
Figure 3: Western edge of main tailings disposal cell (looking north)

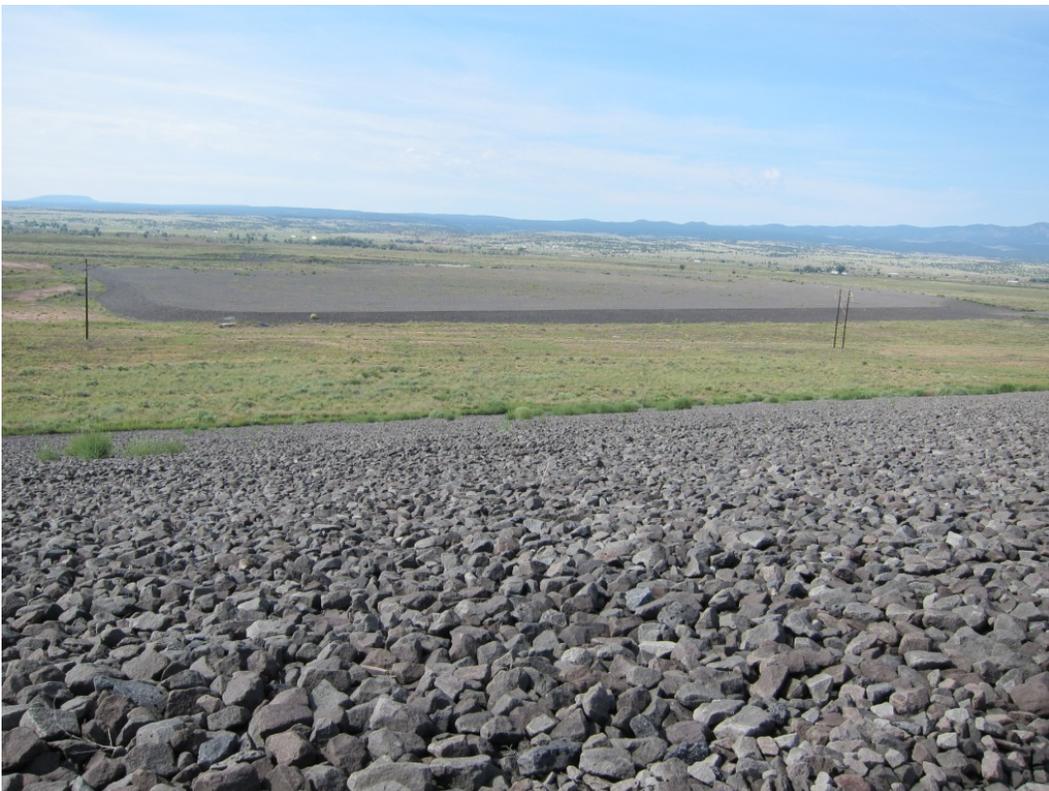
The carbonate tailings disposal cell also appeared to be in good condition with no standing water, surface ripples, or deep-rooted vegetation on the cover. In addition, the surface covers for the asbestos disposal area, PCB disposal area, and landfills appeared in good condition.

Figure 4: Carbonate tailings disposal cell (as seen from main tailings disposal cell)
