**Prototype SAFKEG HS 3977A/0002**  
**NCT and HAC Regulatory Test Report**

Title	Prototype Safkeg HS 3977A/0002 NCT and HAC Regulatory Test Report	Number	CTR 2010/02
		Issue	A
		File Ref	CTR 2010-02-A-v1-SAFKEG 3977A-Regulatory Test Report
Compiled

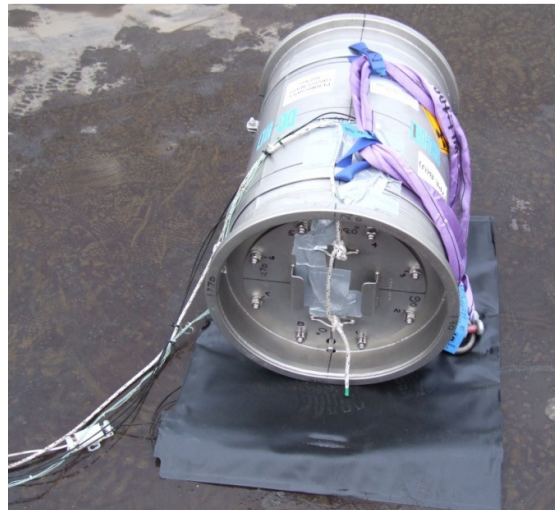
**Photograph 7 - Rest position after 1.2m side drop**

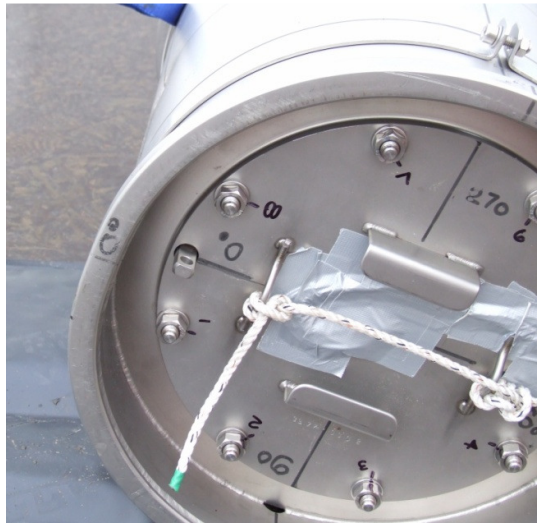
**Photograph 8 - Top Rim Damage**

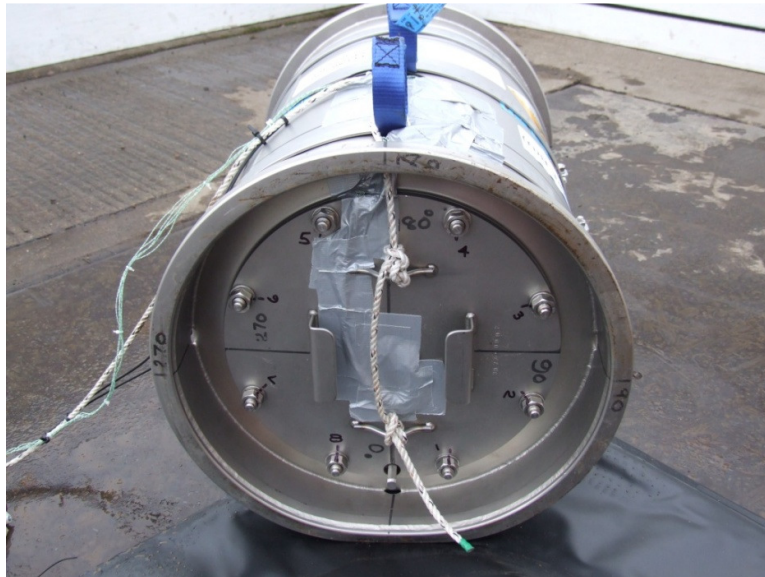
**Photograph 12 - Damage to the keg from the 1.2 m drop over top**

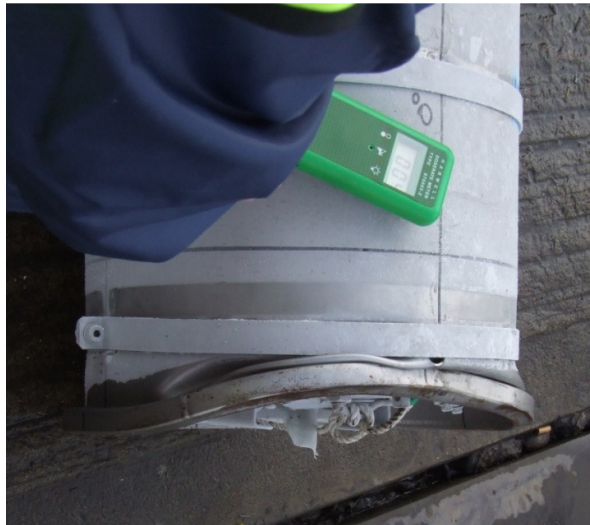
**Photograph 16 - Damage to package caused by 10.2m drop on top rim**

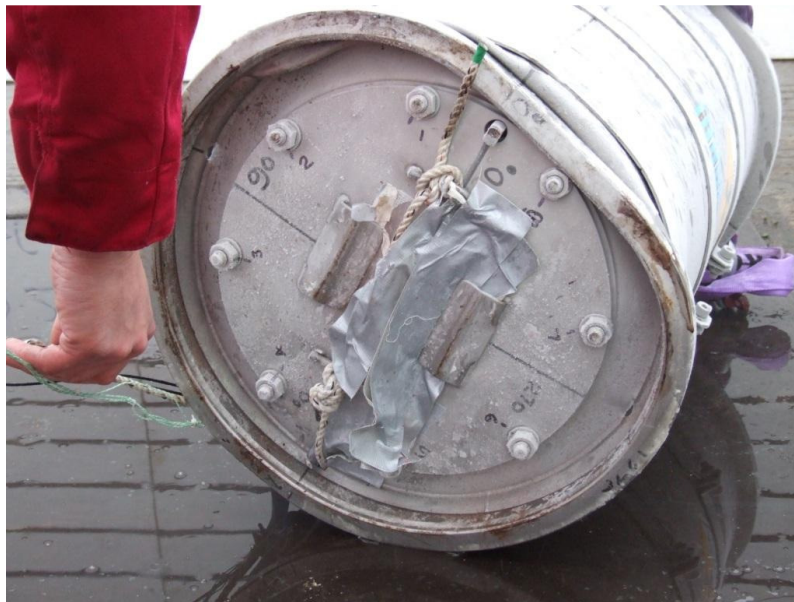
**Photograph 18 - Damage caused to keg from 10.2m drop on top**

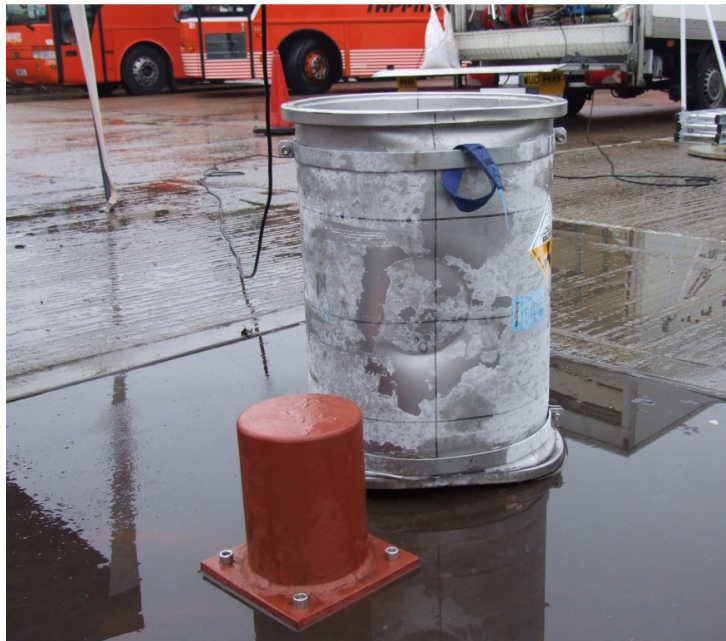
**Photograph 20 - Damage from 1 m Puncture Test**

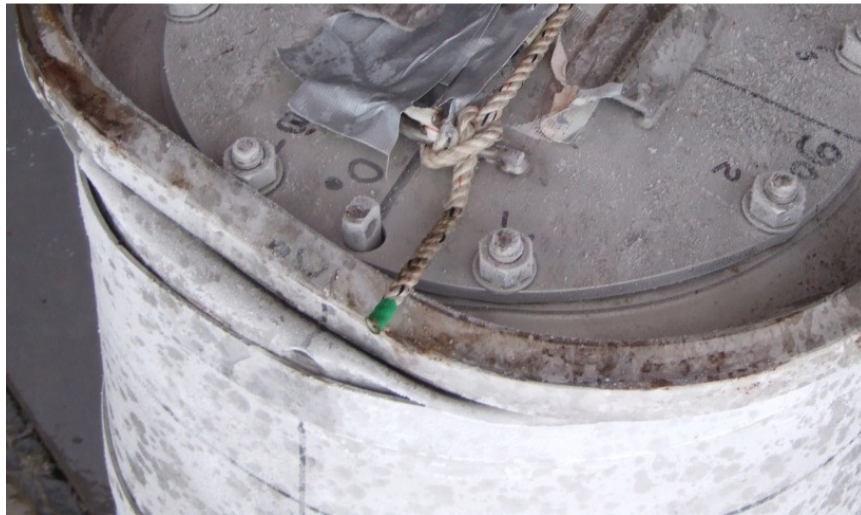
**Photograph 22 - Damage prior to 1m puncture test on top rim**

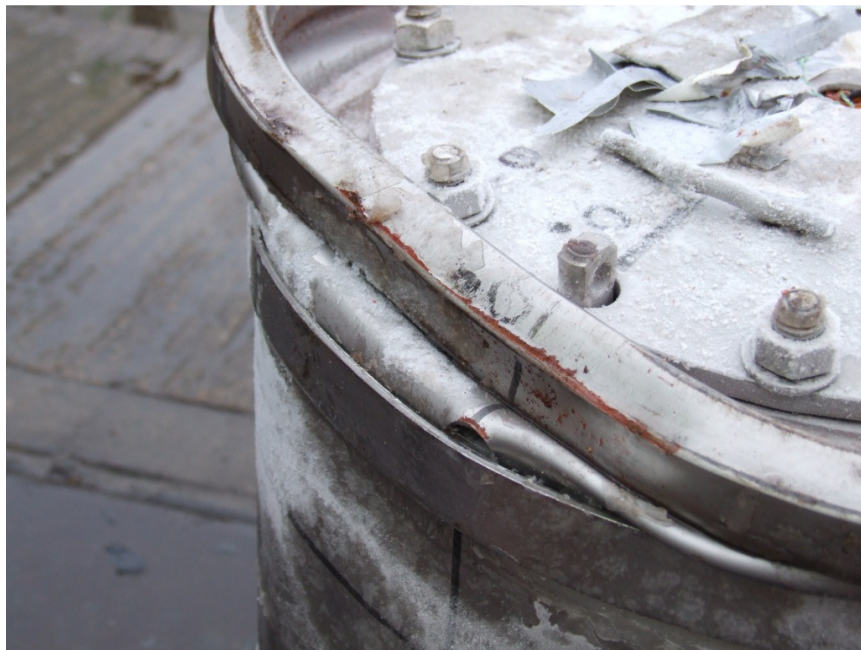
**Photograph 23 - Damage caused by 1m puncture test on top rim**

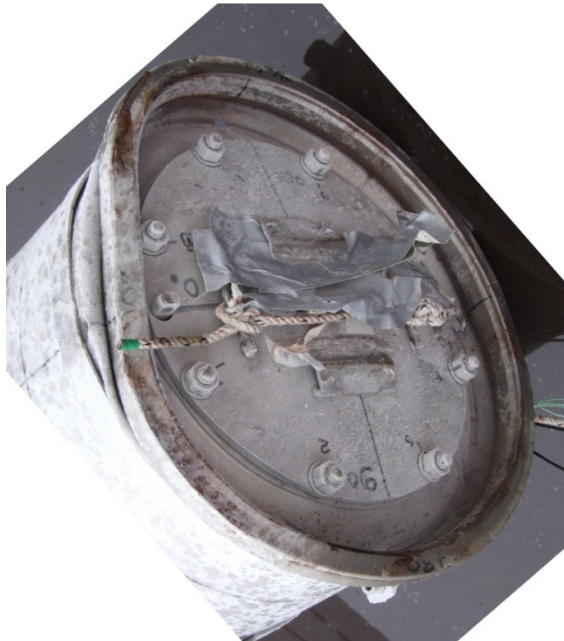
**Photograph 25 - Damage to keg prior to 1m puncture test on top of package**

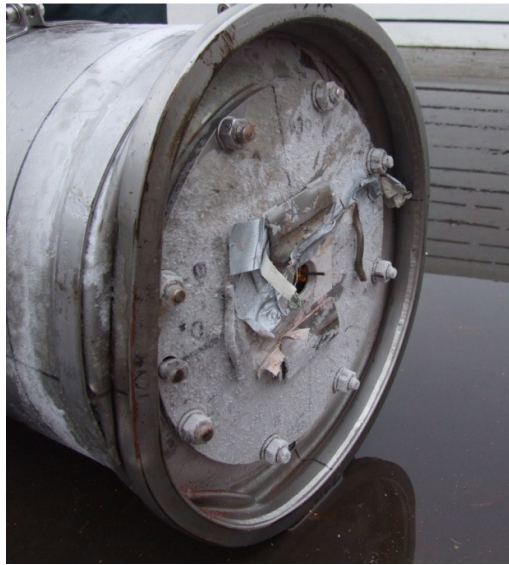
**Photograph 26 - Damage caused to package by 1m puncture test on the top of package**

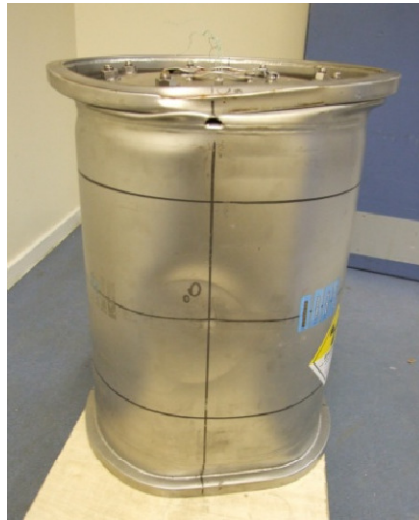
**Photograph 27 - Damaged package after testing**

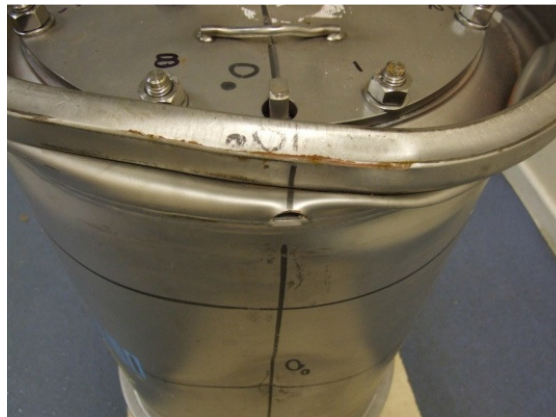
**Photograph 28 - Keg damage at main impact point**

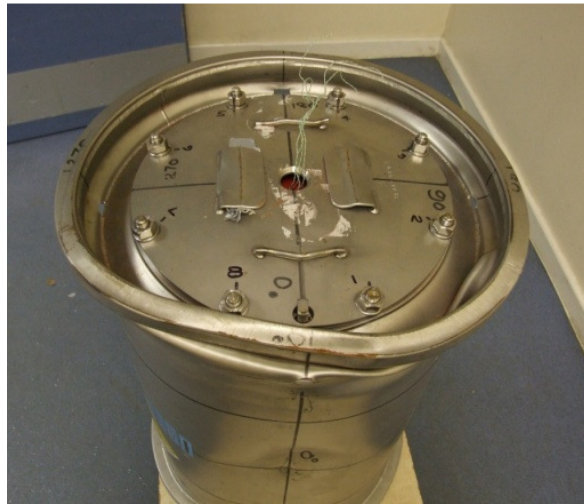
**Photograph 29 - Damage to top of package**

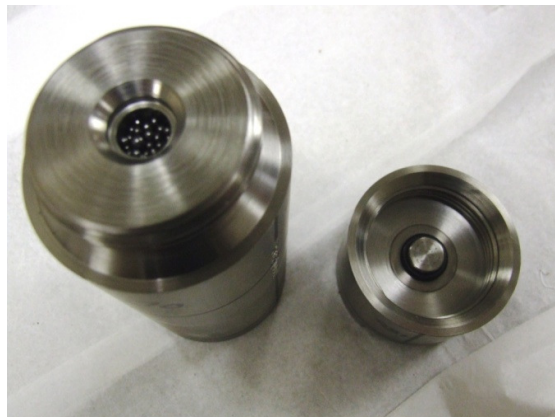
**Photograph 35 - Opened insert after testing**
