**Seismic Walkdown Checklist (SWC) SWEL1-025**

Equipment ID No. CV-0736A Equip. Class<sup>1</sup> 7 - PNEUMATIC-OPERATED VALVES

Equipment Description E-50B FLOW CONTROL

SEISMIC WALKDOWN CHECKLIST FORM

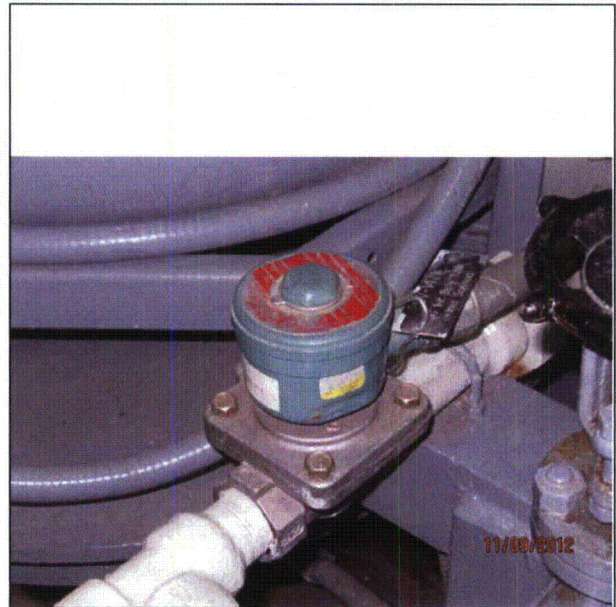
**Note:** SV-1471

**Note:** Close up of mounting.

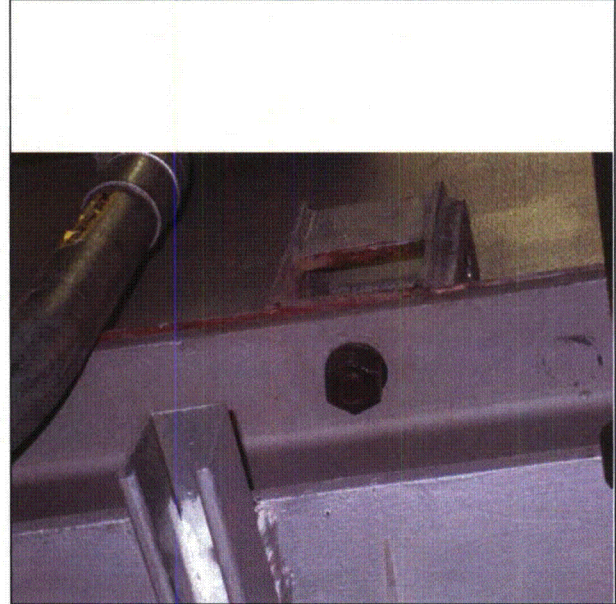
**Note:** Equipment view on top of steel platform looking west.

**Note:** View of anchorage beneath platform looking up.

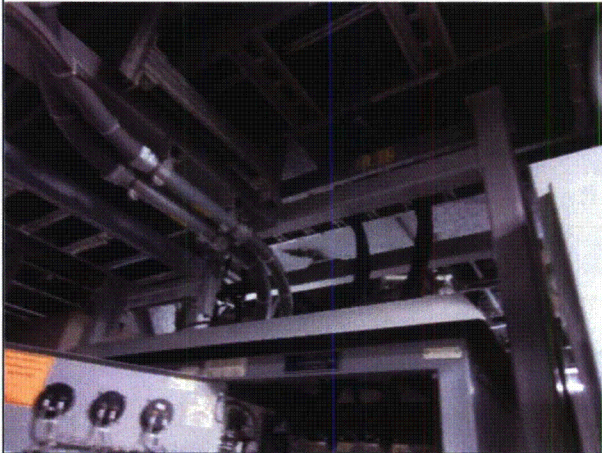
Equipment ID No. ED-06 Equip. Class<sup>1</sup> 16, BATTERY CHARGERS AND INVERTERS

**Note:** *Small gap noted between cable tray support structure column and side of cabinet near top of cabinet.*

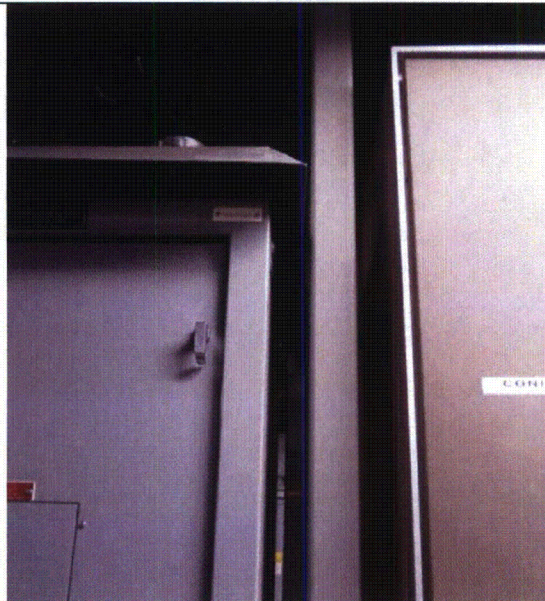
Equipment ID No. ED-08 Equip. Class<sup>1</sup> 16, BATTERY CHARGERS AND INVERTERS

**Note:** *Small gap noted between cable tray support structure column and side of cabinet near top of cabinet.*

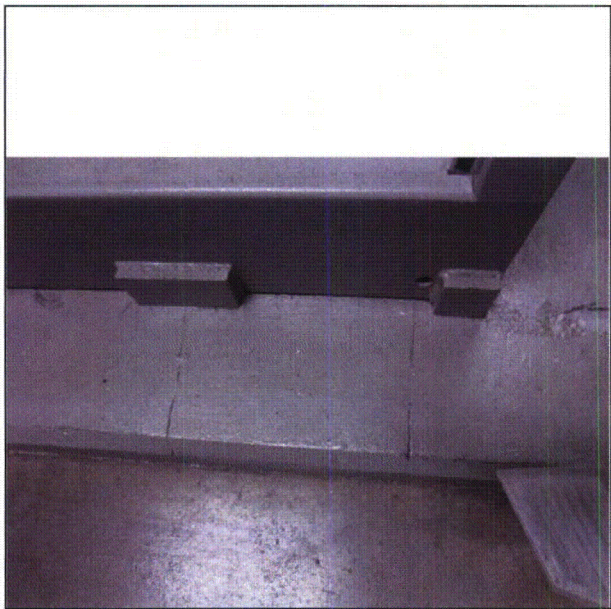
Equipment ID No. ED-17 Equip. Class<sup>1</sup> 16, BATTERY CHARGERS AND INVERTERS

**Note:** Cracks noted in pedestal.

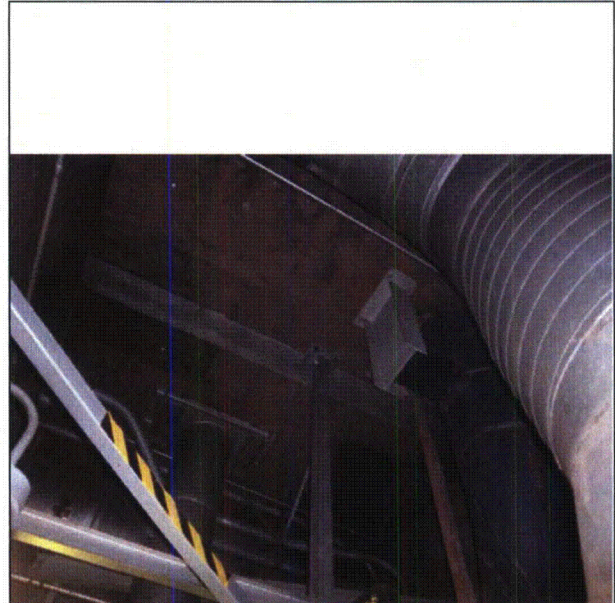
**Note:** *Missing bolts in overhead support, however, welding is evident to embed in lieu of bolts. Photo is from stairwell to Room 147 in northwest corner of room looking up.*

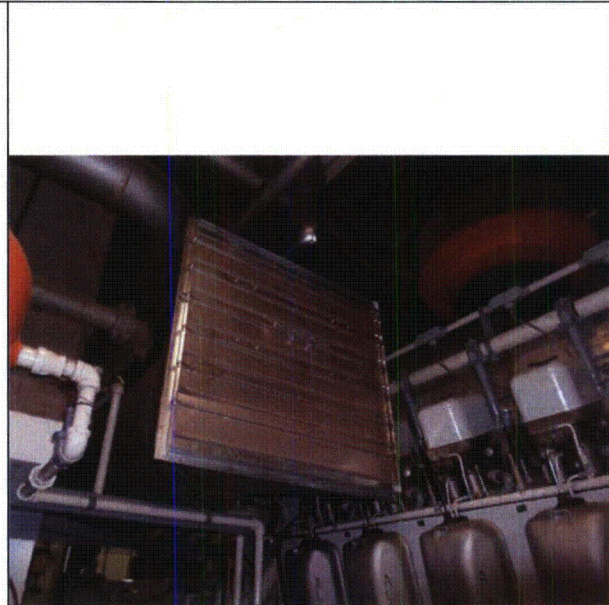
**Note:** Credible interaction between V24D ventilation duct, D-29 damper and K-6B. Photo is looking north, west side of K-6B.

**Note:** Credible interaction between V24D ventilation duct, D-29 damper and K-6B. Photo is looking northeast, west side of K-6B.

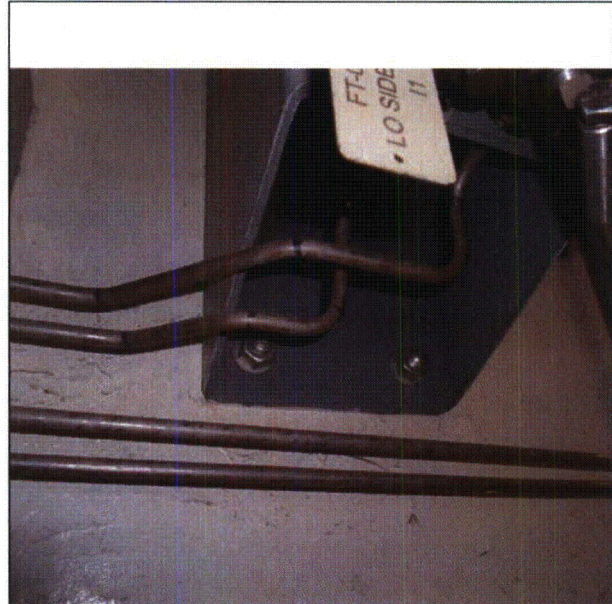
**Note:** Anchorage of HSS to wall at the top of the component.

**Note:** Anchorage of HSS to wall at the bottom of the component.

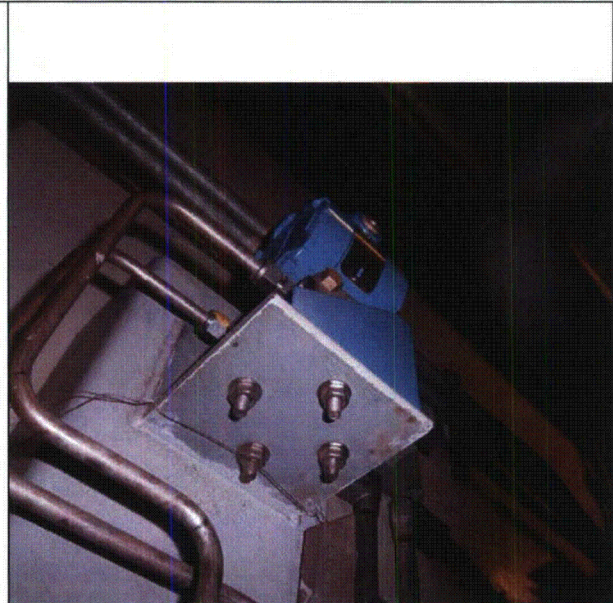
**Note:** Anchorage of equipment to shelf angle and weld of angle to HSS section.

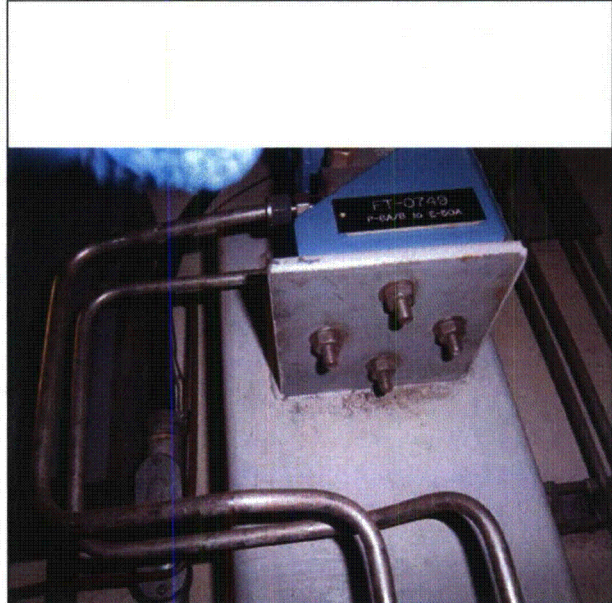
**Note:** Anchorage of equipment to shelf angle.

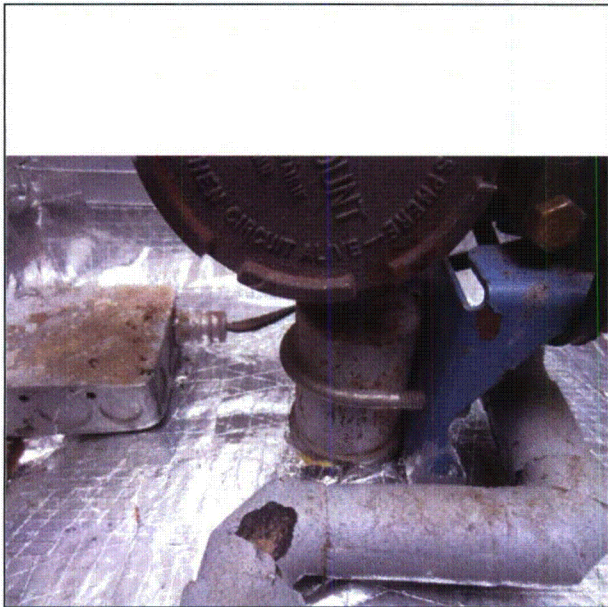
Equipment ID No. LT-2021 Equip. Class<sup>1</sup> 18, INSTRUMENT RACKS

**Note:** View of u-bolt anchorage. Vendor installation manual calls for two u-bolts. Only one u-bolt is installed.

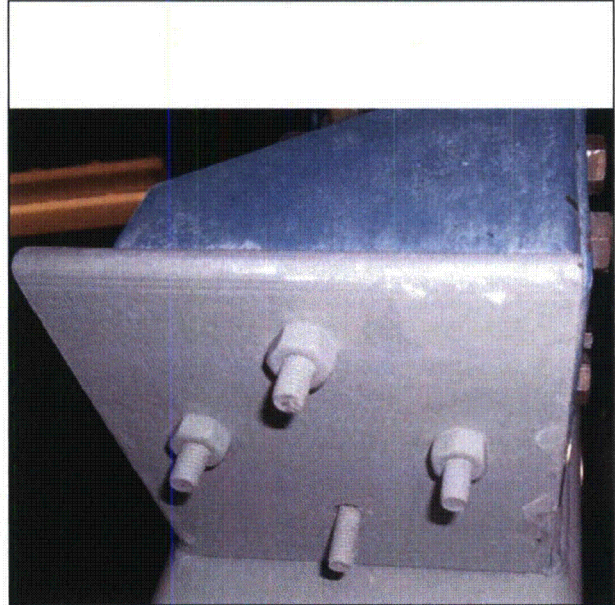
**Note:** Missing Nut from Anchorage to Steel Shelf Angle

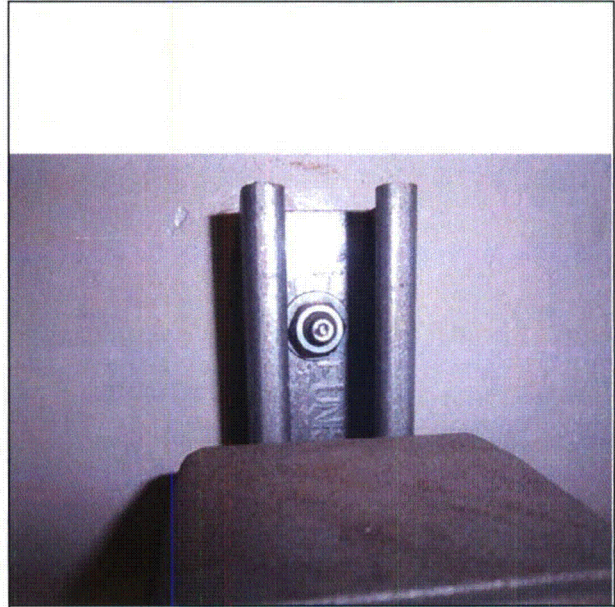
**Note:** Unistrut anchorage to concrete wall (1 of 2 anchors shown).

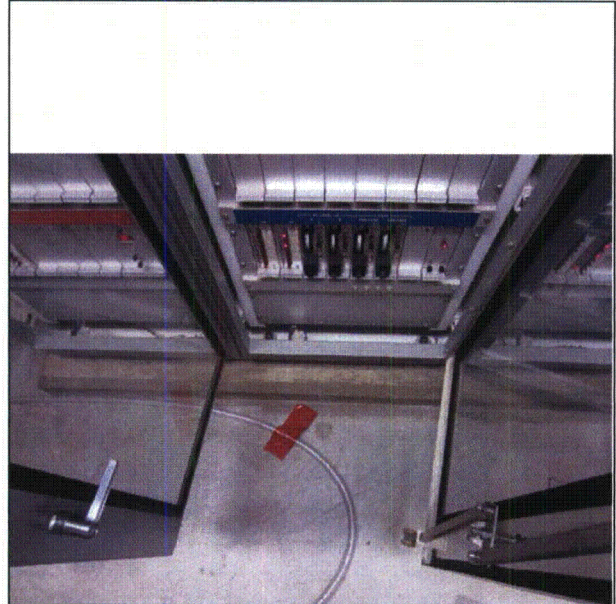
**Note:** *Anchorage of equipment base to inverted channel skid.*

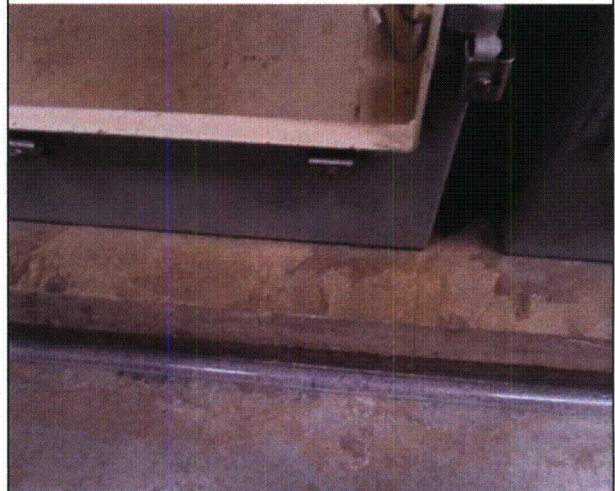
**Note:** Micro Cracks in Concrete
