Void Swelling and Microstructure of Austenitic Stainless Steels Irradiated in the BOR-60 Reactor

NRC Job Code N6519

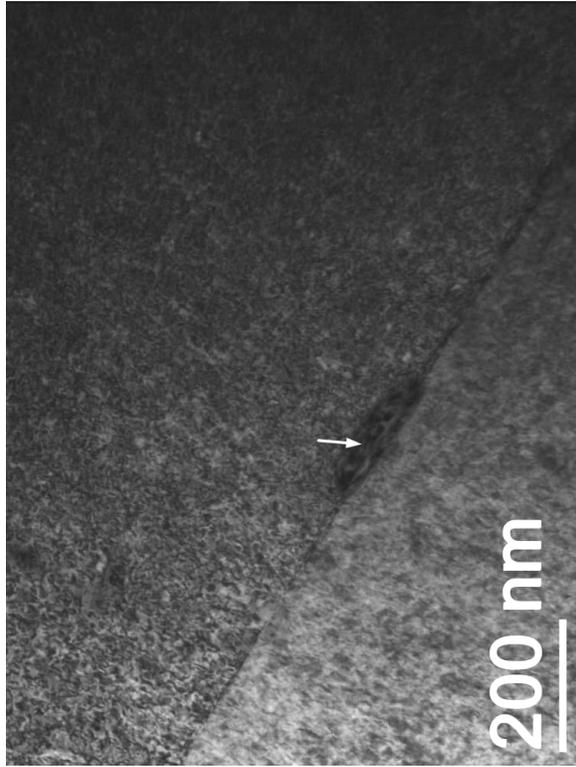
Figure 11. Irradiated microstructure of SA Type 347 SS (Mat. D1) at 45 dpa: (a) BF image, (b) relrod DF image, and (c, d) precipitates at a grain boundary and within a grain.

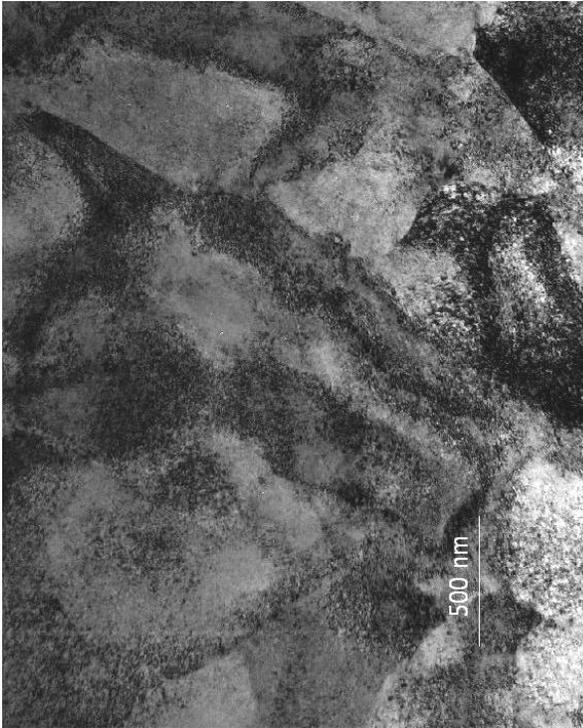
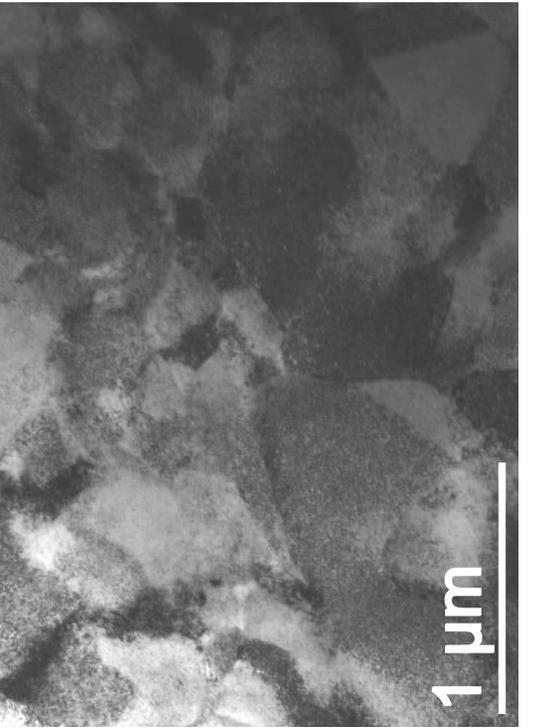
Figure 13. Irradiated microstructure of Type 316LN SS (Mat. B3): (a, b) 24.5 dpa and (c, d) 45.0 dpa.

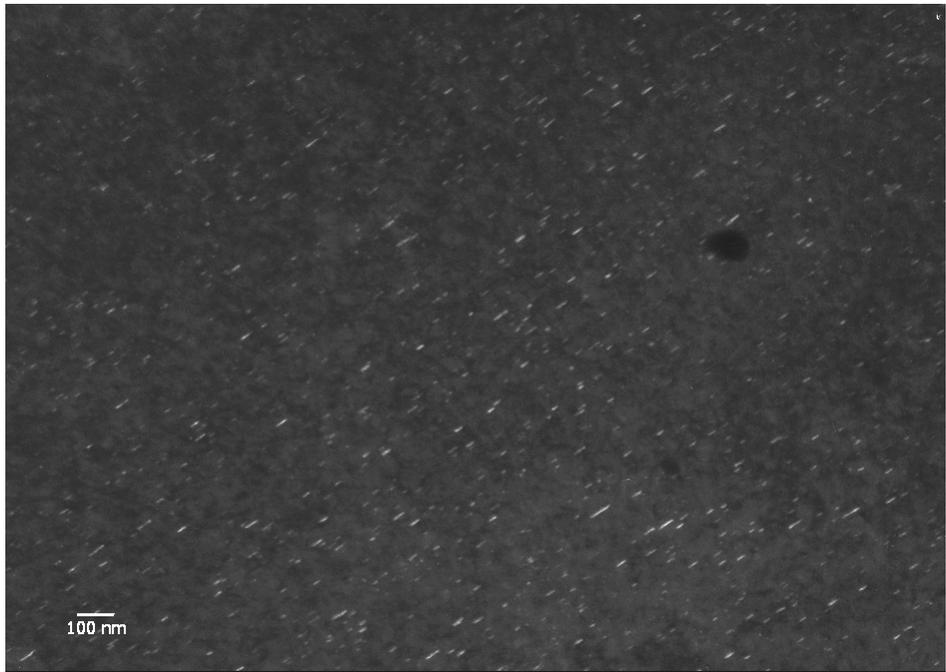
Figure 24. Irradiated microstructure of Alloy 690 (Mat. E2) at 24.5 dpa: (a) precipitates and cavities, (b) BF image of irradiation defects, and (c) relrod DF image of dislocation loops.
