Document No: CHLE-015	Revision: 2	Page 1 of 42
Title: Volume 3.6 – GSI-191 License Submittal Documentation for Chemical Effects at STP		
Project: Corrosion/Head Loss Experiment (CHLE) Program		Date: 26 Nov 2012
Client: South Texas Project Nuclear Operating Company

Corrosion/Head Loss Experiment (CHLE) tests were performed to support the risk-informed resolution of GSI-191 at the South Texas Project Nuclear Operating Company (STP). This document presents the results of testing, calculations, and analysis conducted during 2012 to evaluate the extent to which chemical precipitates may contribute to additional blockage on emergency core cooling system (ECCS) strainers beyond what is caused by non-chemical debris.

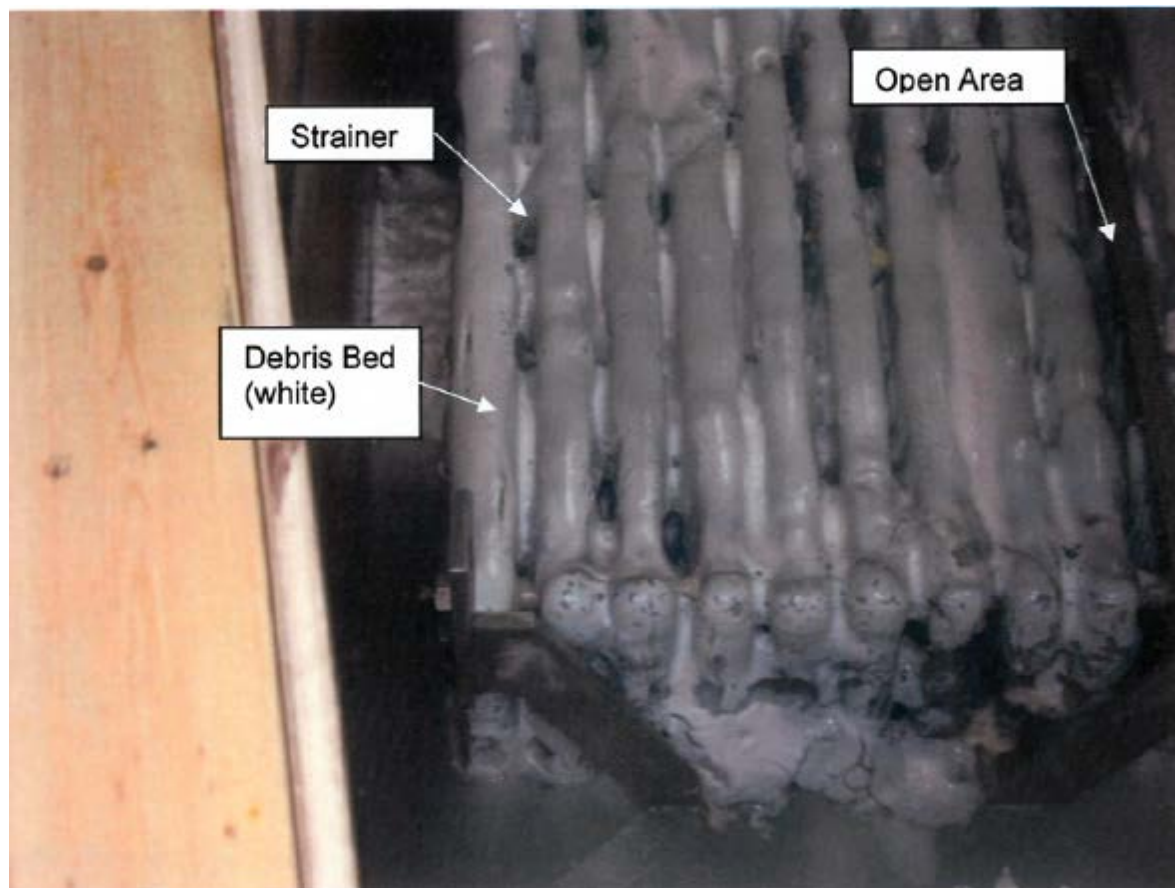
Figure 1 – Precipitates covering a PCI Sure-Flow™ strainer module after testing for a design basis LOCA at the STP. In this test, the loading rate on the strainer was 990 g/m² for aluminum and 190 g/m² for calcium (reproduced from [4]).

To compare the results of experimental testing programs to full-scale performance, the chemical quantities can be scaled based on either pool volume and strainer area. Dividing chemical quantities by pool volume defines the concentration of chemicals in solution, which is relevant because the quantity of precipitates that form is affected by the relationship between actual concentration and the solubility limitations of the relevant precipitates. Dividing chemical quantities by the screen area is relevant because the head loss will be influenced by the actual precipitate loading on the screen. Based on pool volume, the chemical additions in the Alden test resulted in an aluminum concentration of 1,220 mg/L as Al and a calcium concentration of 240 mg/L as Ca. Based on screen loading, the chemical quantities resulted in a screen loading of 990 g/m² of Al and of 190 g/m² of Ca.

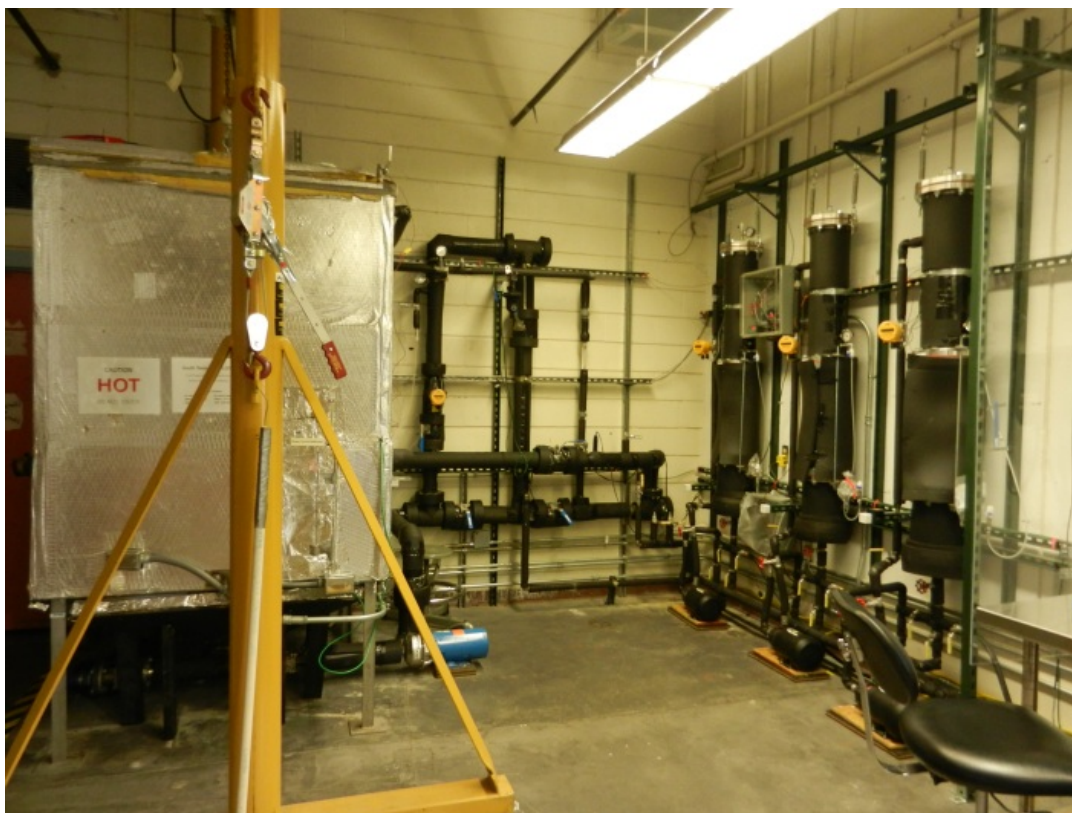
Figure 3 – CHLE tank.

The CHLE test equipment for the 30-day tests consists of a material corrosion tank and three vertical head loss modules. The 304 stainless steel tank, as shown on the left in Figure 3, is nominally 4 ft x 4 ft x 6.6 ft and has a bottom that slopes to a centrally-located discharge port. Although the inside of the tank is not physically divided into different compartments, the tank can be visualized as containing upper and lower sections. The upper section of the tank is designed to accommodate all vapor space materials in containment that contribute to chemical effects through exposure to containment sprays. The lower section of the tank is designed to accommodate solution and materials that may be submerged in containment. A removable cover and gantry crane allow for placing and removing samples into the desired areas of the tank. The tank is not pressurized and is therefore limited to testing below the normal boiling point of water.

The tank is insulated and contains two titanium-jacketed 3.5-kW rod-type heaters in the tank pool to maintain the temperature of the solution at a maximum of 185 °F (85 °C) \pm 5 °F. Solution can enter the tank through injection headers in the lower portion of the tank (submerged area) and/or through spray nozzles in the upper portion of the tank (non-submerged area). Additional details of the experimental equipment are described in [12].

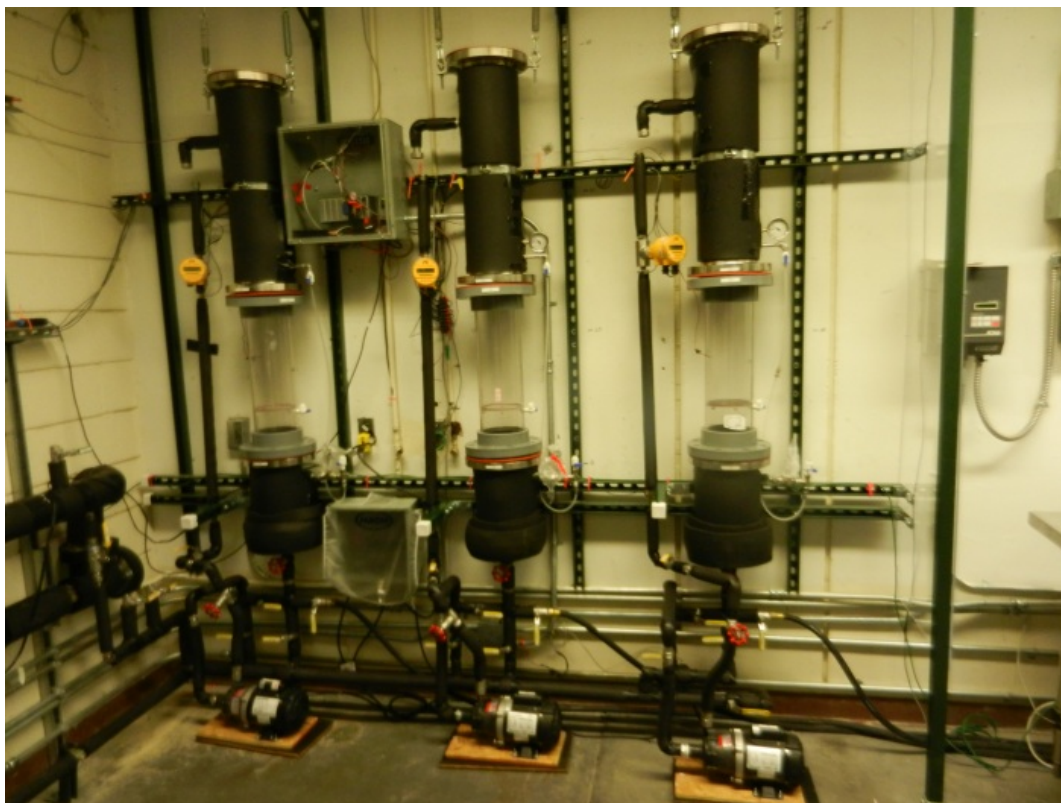
Figure 4 – CHLE Head Loss Columns.

The three identical vertical head loss modules, as shown in Figure 4, are designed to operate in parallel when connected to the corrosion tank or individually when isolated from the corrosion tank. Each has an independent pump so that the flow rate to each column and velocity to the screen area can be separately controlled. The nominal velocity through the screen area during testing was 0.01 ft/s. The upper and lower portions of the 6-in diameter vertical head loss modules are constructed of stainless steel and are sealed at the top with a blind flange. The blind flanges can be removed to introduce debris into the head loss assembly. The upper section of piping also has an air vent to allow gas to be vented from the head loss assembly, if necessary. The middle section of the assembly is constructed of 1/4-in thick polycarbonate to allow view of the debris bed (6 inches below and 16 inches above) with a perforated plate supported by a ring located 6-in from the bottom. The perforated plate is constructed of stainless steel and contains 0.094-inch holes in the same pattern as on the STP strainers. There are vents above and below the screen support to assist in post-test activities. A differential pressure (DP) transducer is piped to ports above and below the screen support to measure the pressure loss through the debris bed. Each module has a dedicated flow meter to monitor flow to the column.

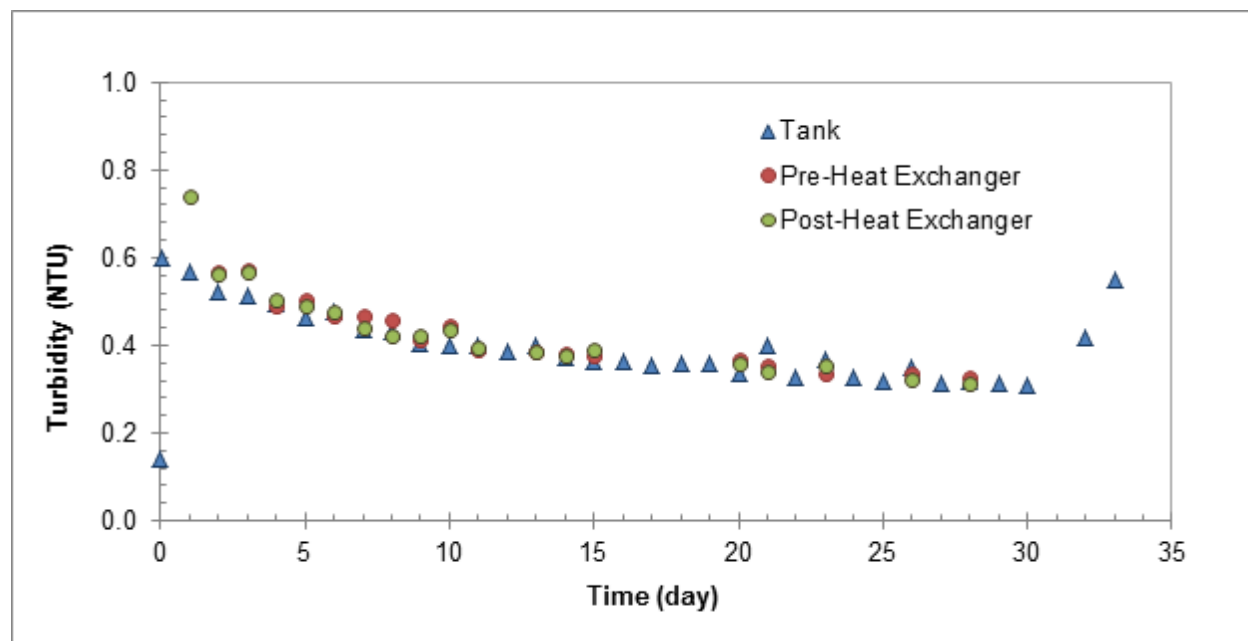
Figure 8 – Turbidity over the duration of the 30-day MBLOCA CHLE test.

Several parameters were measured to determine whether precipitates formed in solution. First, turbidity of the pool water was measured on a daily basis. The trend over the course of the test is shown in Figure 8. The turbidity was the highest, ~0.6 NTU, on the first day of testing and gradually decreased over the thirty days of testing. This trend is similar to tests that did not contain corrosion specimens in the tank. The turbidity increased when the blender-prepared debris beds were linked to the tank on Day 32 of the test, likely due to fiber shedding from the new debris beds. Previous testing showed a good correlation between turbidity and aluminum hydroxide precipitates, as shown in Figure 9. The lack of increase in turbidity over the test suggests that precipitates did not form in the solution.

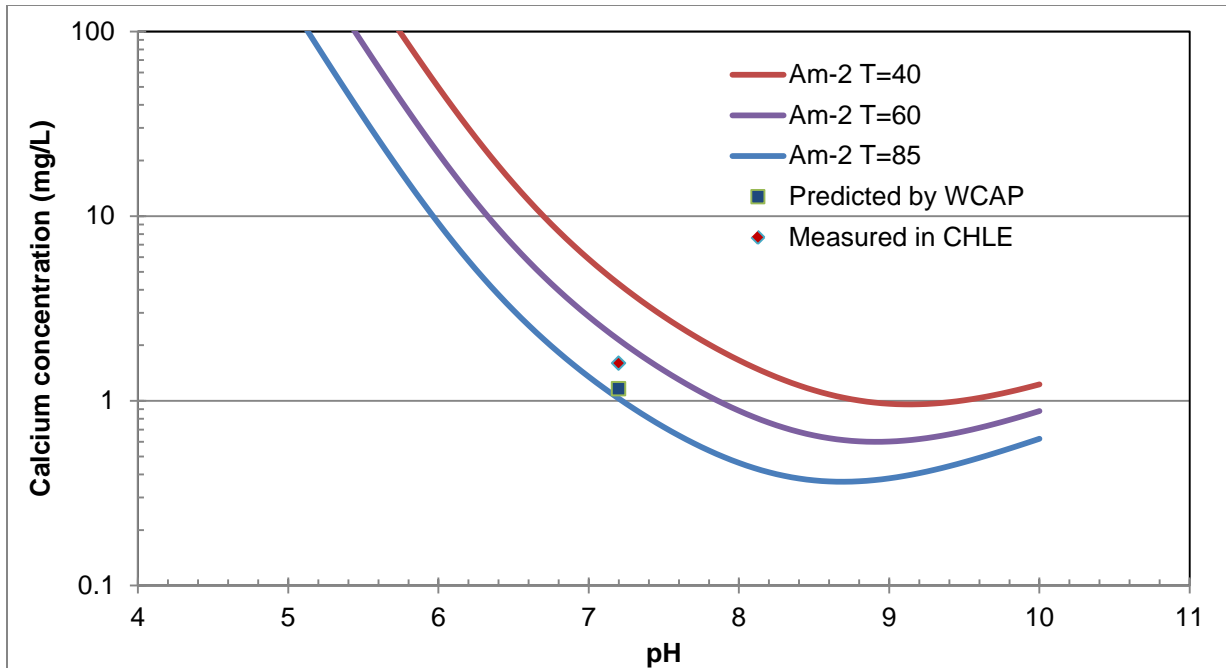
Figure 16 – Equilibrium saturation concentration of calcium for the formation of calcium phosphate $[Ca_3(PO_4)_2]$ as a function of pH. Values given for WCAP and CHLE are the concentrations in solution at the end of a 30-day event as a result of corrosion.

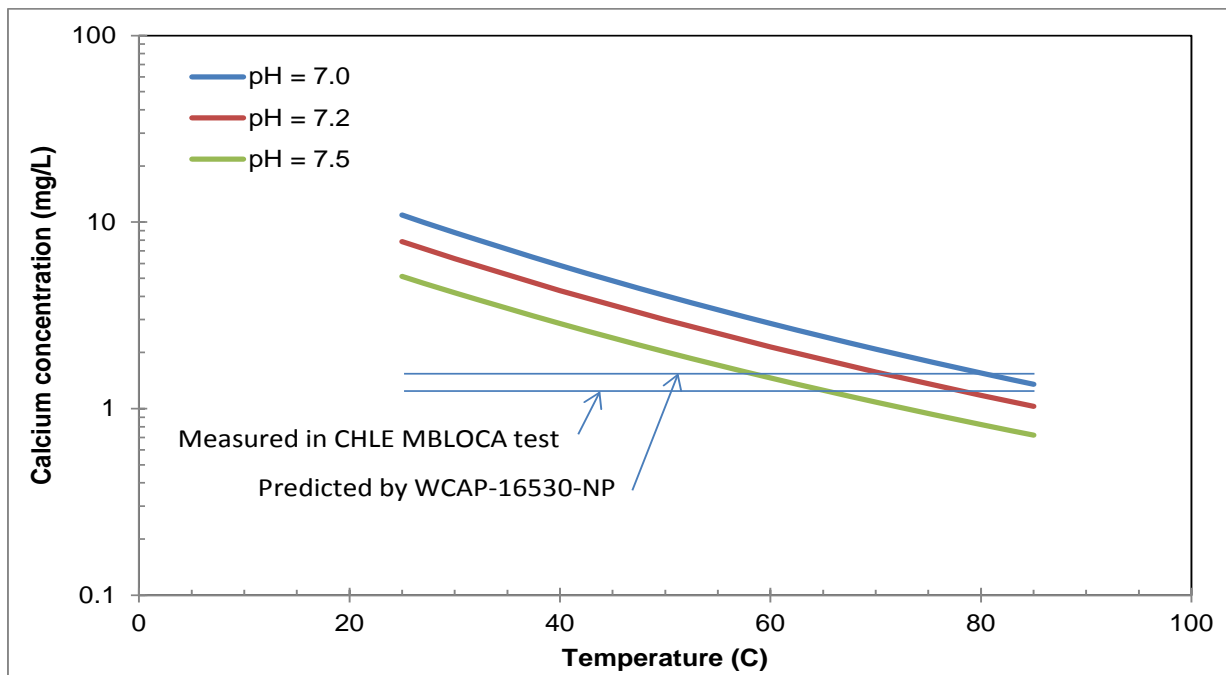
Figure 17 – Equilibrium saturation concentration of calcium for the formation of calcium phosphate $[Ca_3(PO_4)_2]$ as a function of temperature. Values given for WCAP and CHLE are the concentrations in solution at the end of a 30-day event as a result of corrosion (temperature varies during the event).

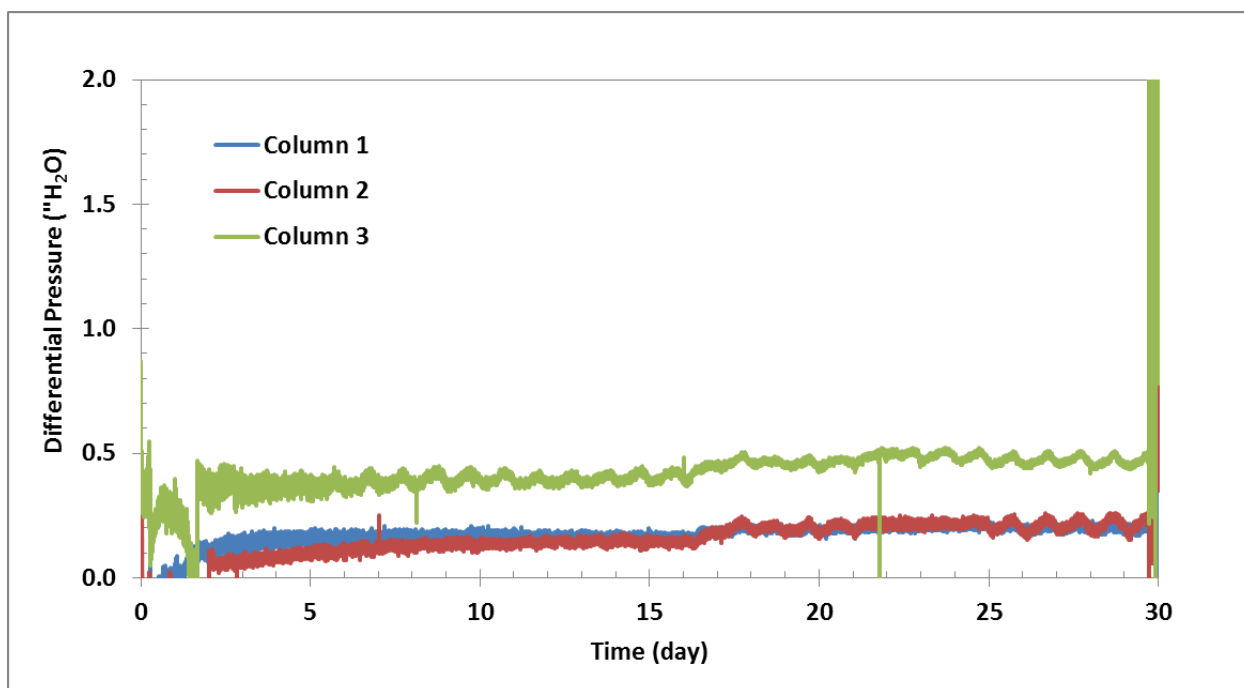
Figure 18 –Normalized head loss through NEI pressure-washed debris beds during the 30-day MBLOCA CHLE test.

The ability for the available aluminum to cause head loss in a debris bed can be assessed by comparing the results of this test to previous head loss testing. Based on the measured aluminum concentration of 0.28 mg/L, the maximum loading that would occur on the CHLE strainers would be 5.8 g/m² as Al. As noted earlier, the CHLE strainers were designed with less surface area than would be proportional to the STP plant to ensure a conservative loading rate. If the corresponding concentration were applied to the STP strainers, the loading rate would 1.7 g/m² as Al.

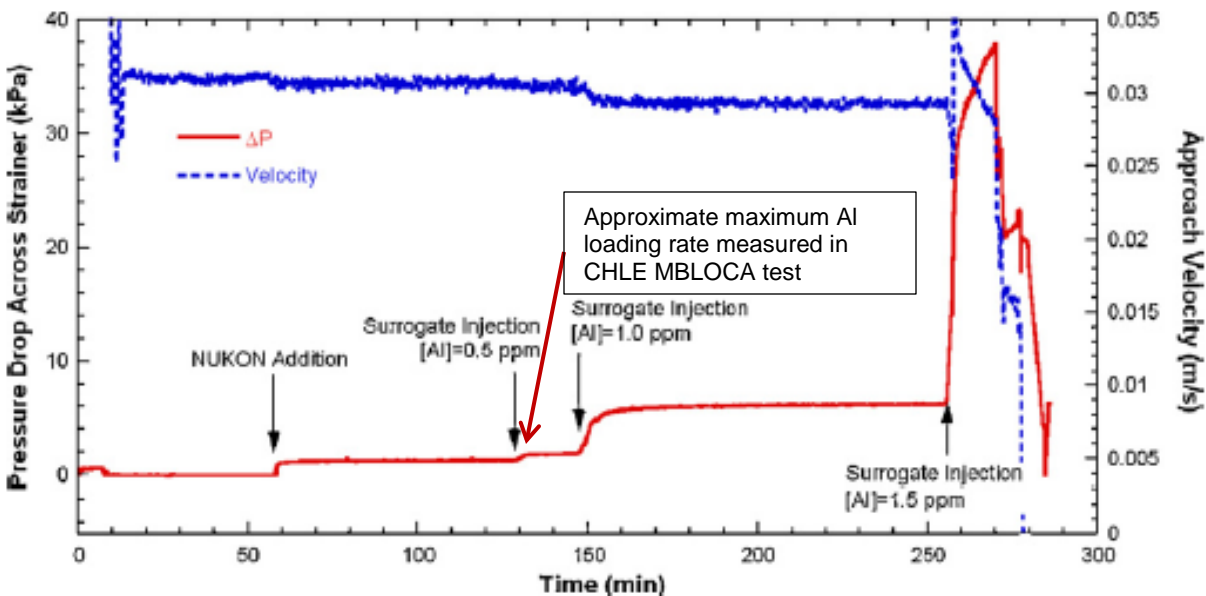
Figure 19 – “Pressure drop and screen approach velocity versus time history in a loop test using the WCAP aluminum hydroxide surrogates” reproduced from Bahn et al, 2009 [20]. The quantity marked with the arrow represents approximately the maximum loading rate that can be achieved in a MBLOCA at the STP plant, using either the measured corrosion quantities in the CHLE test or the calculated corrosion quantities in the WCAP protocol.

This loading rate can be put in context by comparing it to tests conducted at ANL. Results from the ANL testing are reproduced in Figure 19. The point on the graph labeled as 0.5 ppm corresponds to a loading rate of 4.4 g/m^2 as Al. Rapid head loss did not occur until the loading rate reached 13.3 g/m^2 as Al. Similarly, in small-scale chemical effect testing described in NUREG/CR-6868, additional head loss due to chemical precipitates did not begin to occur until the aluminum concentration was 2.7 mg/L and the loading rate was 3.5 g/m^2 as Al [22]. Thus, the loading rate, even if all aluminum measured in these tests were to have precipitated, would be below the quantities that were necessary to cause significant head loss in previous testing with blender-prepared fiber debris beds.

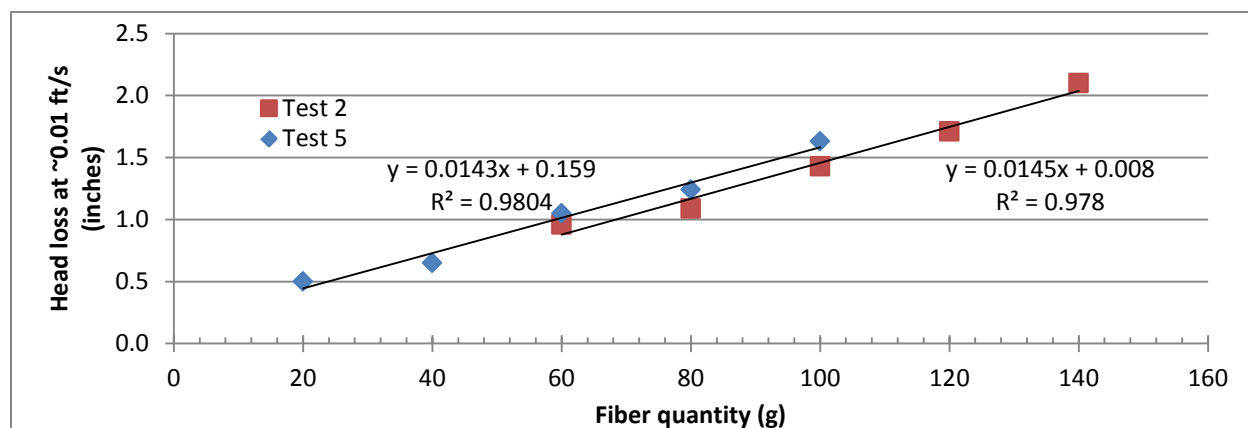
Figure 27 – Head loss through NEI pressure-washed debris beds at approach velocity of 0.01 ft/s in Tests 2 and 5.

Testing found that the NEI fiber preparation method resulted in very consistent debris beds. Incremental additions of fiber resulted in a linear increase in bed thickness and head loss. Repeated tests resulted in similar increases in bed thickness and head loss, as shown in Figures 26, 27, and 28. The blender method resulted in less consistent debris beds. The increase in head loss with additions of fiber was non-linear. In addition, changing the approach velocity and returning it to the original velocity resulted in significant increases in head loss. After a threshold quantity of fiber was introduced into the column, the head loss through the fiber-only bed increased rapidly to over 50 inches at both 0.1 and 0.01 ft/s, as shown in Figures 29 and 30. The increase in head loss caused by cycling the velocity low and high was as much as 80 percent, as shown in Figure 31.

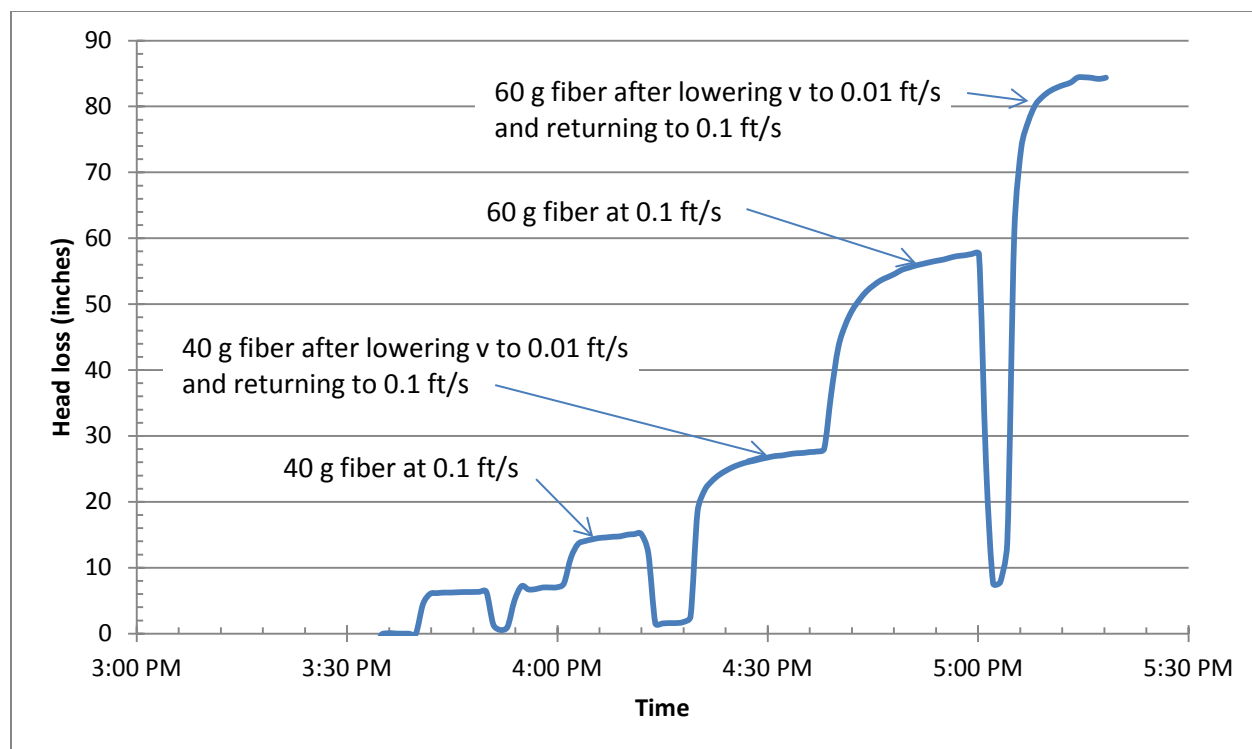
Figure 31 – Head loss through a blender-prepared fiber debris bed in Test 10.

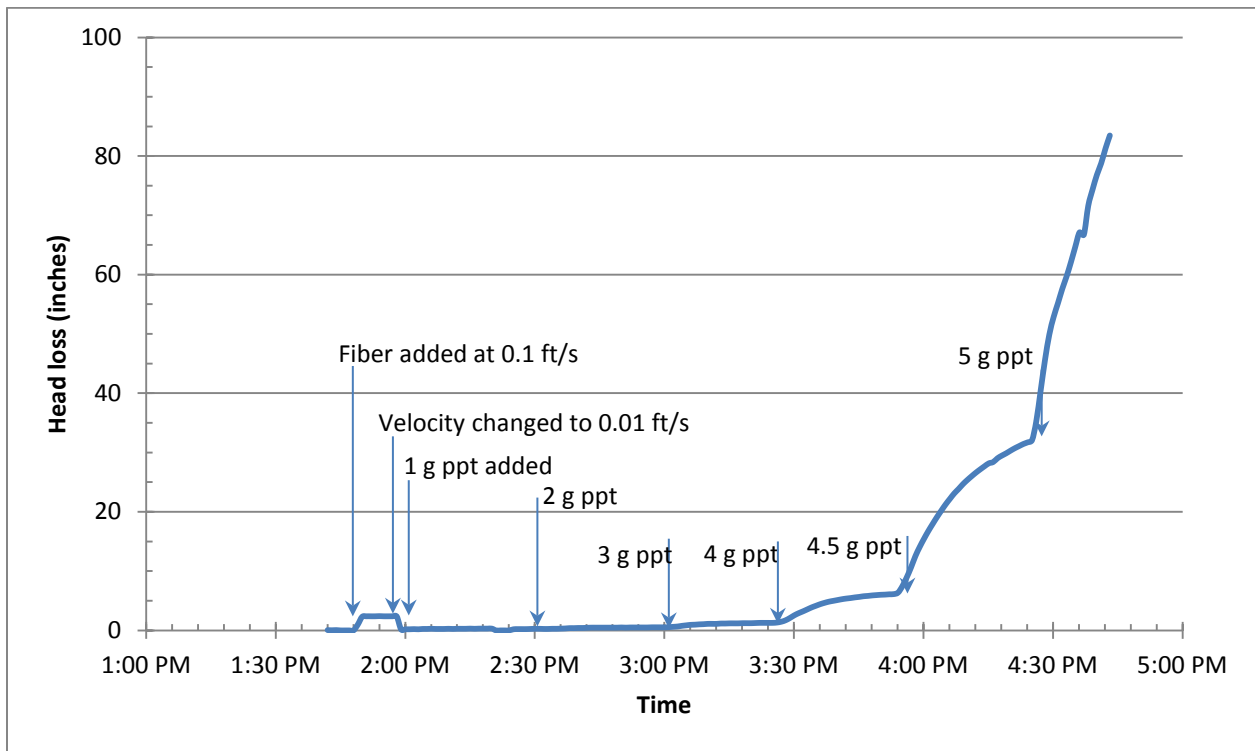
Figure 32 – Head loss after addition of 1 g increments of WCAP precipitate introduced into a NEI pressure-washed debris bed (Test 6). Quantities refer to amount of AIOOH precipitate prepared according to the WCAP recipe.

For both debris beds, the WCAP precipitates were added in batches corresponding to 0.45 g of Al directly to the recirculating head loss column, which resulted in a bed loading rate of 24.7 g/m² as Al for each batch. As shown in Figure 32 for the NEI bed, 4 batches of WCAP precipitate were added with only marginal increases in head loss, resulting in an aluminum loading rate into the bed of 98.8 g/m² as Al. An additional loading of 12.3 g/m² as Al for a total loading of 111 g/m² as Al, resulted in a rapid increase in head loss. As is demonstrated in Figure 33, these results were reproducible over multiple tests.

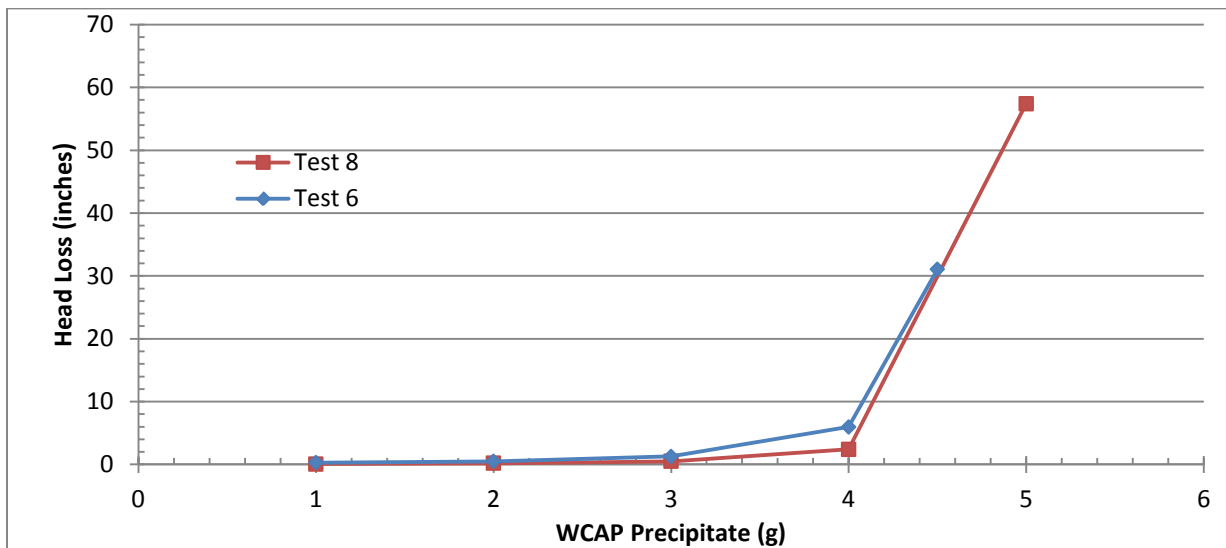
Figure 33 – Comparison of head loss after addition of WCAP precipitate introduced into a NEI pressure-washed debris bed in Tests 6 and 8.

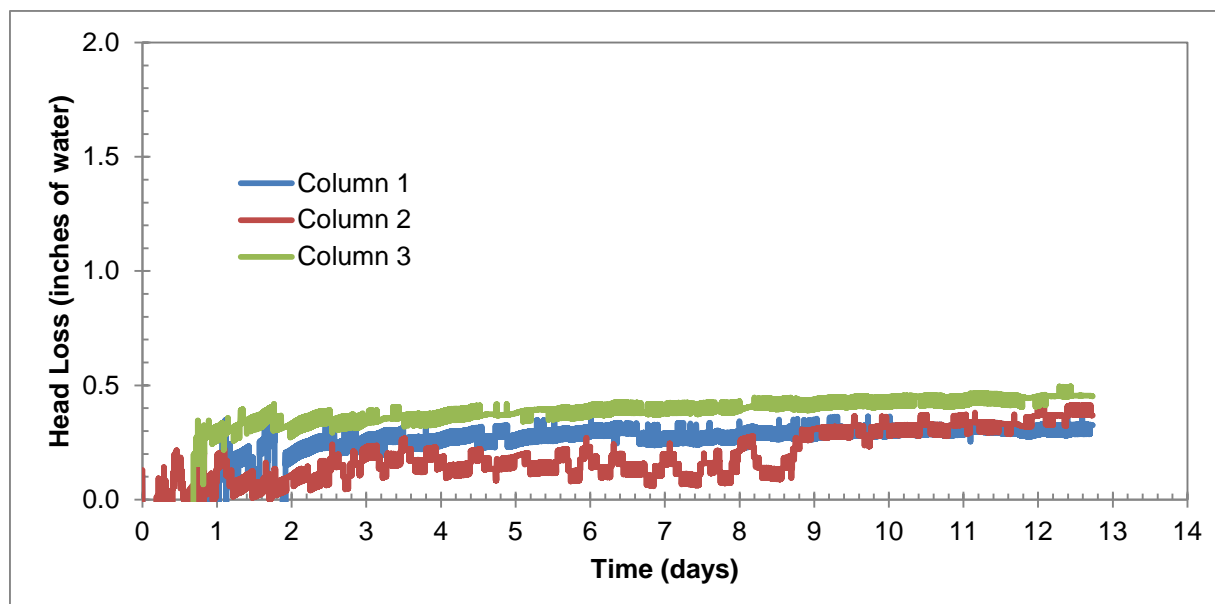
Figure 36 – Normalized head loss through fiberglass debris beds prepared using the NEI pressure-washing method (normalized to 20 °C).

The fiber beds prepared with the NEI pressure-washing method were reproducible between columns. After 6 days of operation, the normalized head loss remained less than 0.5 inches of water, as shown in Figure 30. Similar behavior continued until the test was terminated after 12 days. The fiber beds prepared with the NEI pressure-washing method did not form the dense nodules of fiber that were observed with the blended fiber beds. The absence of these nodules and the reproducible behavior of the NEI beds lends further credibility to the conclusion that these nodules were responsible for the non-reproducible behavior of the blended fiber beds.
