Seismic Walkdown Checklist (SWC)

Equipment ID No.: 0VC01JB

Equipment Description: CONTROL ROOM HVAC SYST LOCAL CONT PANEL ASMBLY

Project: Braidwood 2 SWEL

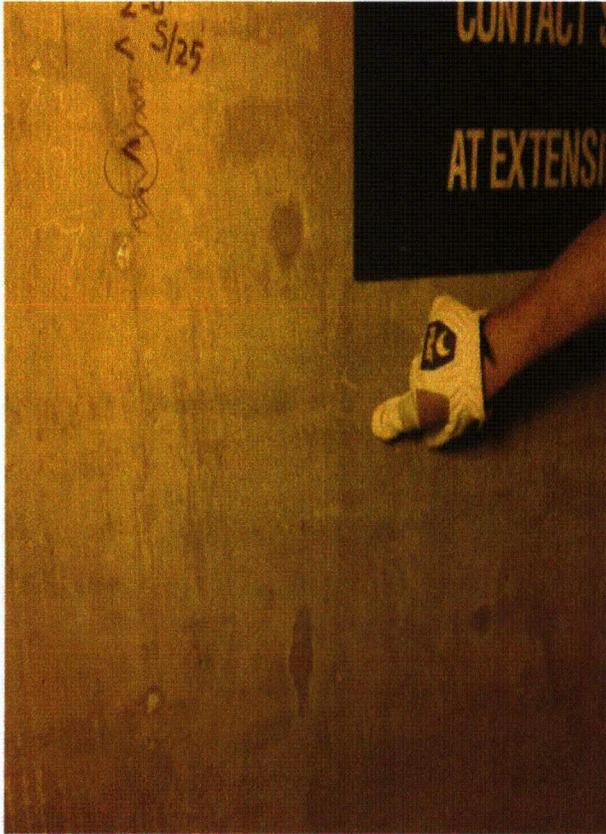
0VC16J (NP-6695) 7-31-12 029

6. Based on the above anchorage evaluations, is the anchorage free of potentially adverse seismic conditions? Yes
Instrument is mounted on rack 2PL84JB which is well-anchored

7. Are soft targets free from impact by nearby equipment or structures? Yes
Adequate clearance with adjacent valves
8. Are overhead equipment, distribution systems, ceiling tiles and lighting, and masonry block walls not likely to collapse onto the equipment? Yes
9. Do attached lines have adequate flexibility to avoid damage? Yes
10. Based on the above seismic interaction evaluations, is equipment free of potentially adverse seismic interaction effects? Yes

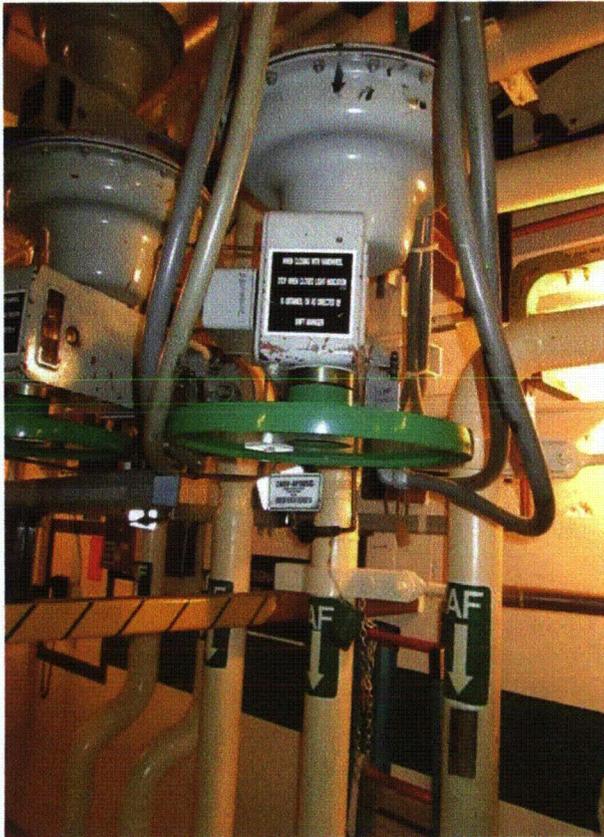
2AF005C 8-1-12 AM 038

*Handwheel for valve 2AF005H is less than 1/8" from the actuator of valve 2AF005G. Piping is observed to be well-supported (lateral movement is limited and impact would be to rugged part of valve).
IR 1396037 written documenting engineering review of the seismic movements. Due to the relatively small displacements and the nature of the contact (hand wheel to air actuator) such contact will not result in valve assembly distortion that will challenge the function of the valve to open.*

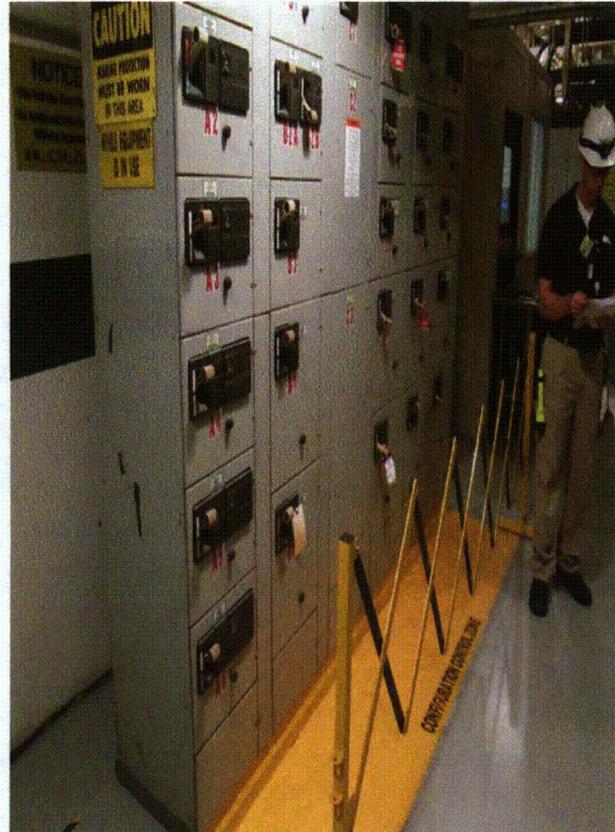
2AP22E 8-1-12 AM 044

Drawing specified weld of 1 1/2" at 8 while actual weld is 2" at 9. The percentage of weld required per the drawing equals $1.5/8 \times 100\% = 18.75\%$. The percentage of actual weld equals $2/9 \times 100\% = 22.22\%$ which is larger than the amount required per the drawing therefore it is acceptable.
6. Based on the above anchorage evaluations, is the anchorage free of potentially adverse seismic conditions? Yes

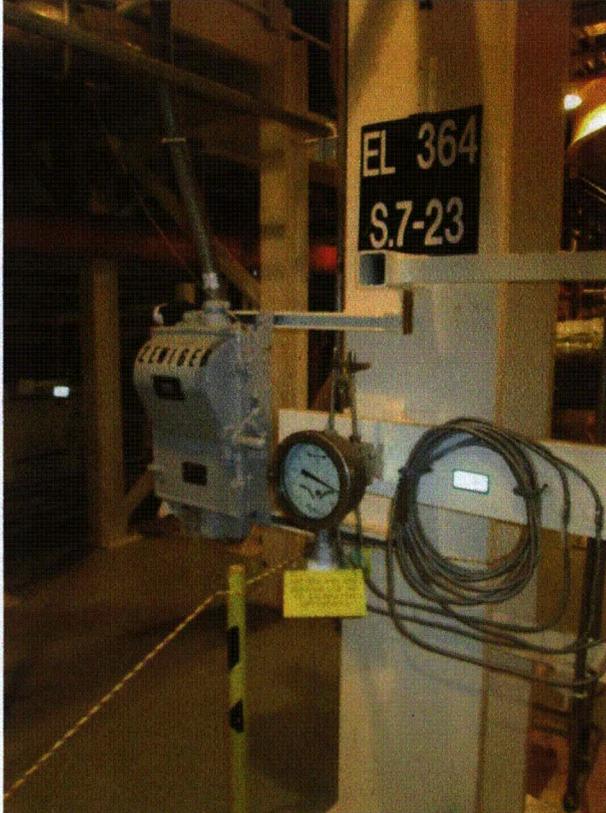
2CV112E (AWB - STANCHION) 7-30-12 AM 051

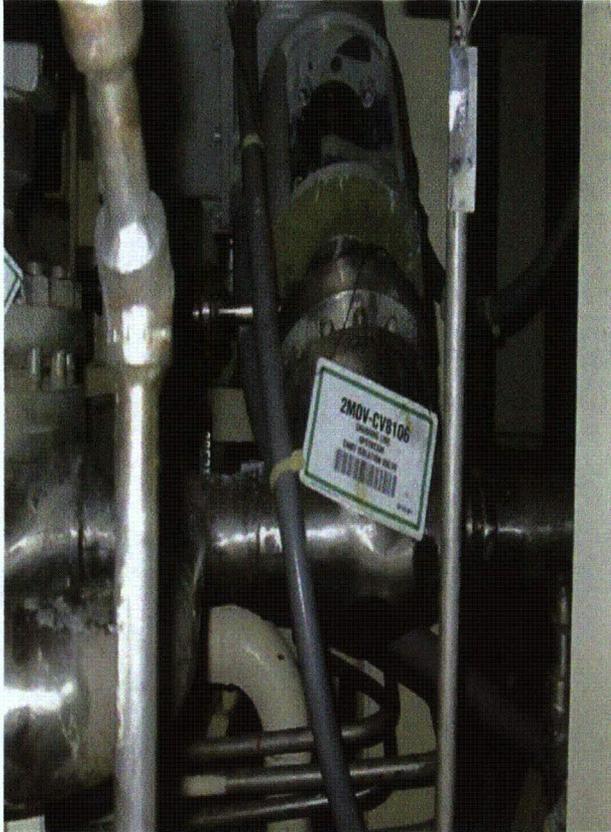
2CV8106 8-2-12 021

Equipment Description: CHG LINE CNMT ISOL VLV C/S AT 2PM05J ASMBLY

11. Have you looked for and found no adverse seismic conditions that could adversely affect the safety functions of the equipment?
well-supported pipe Yes

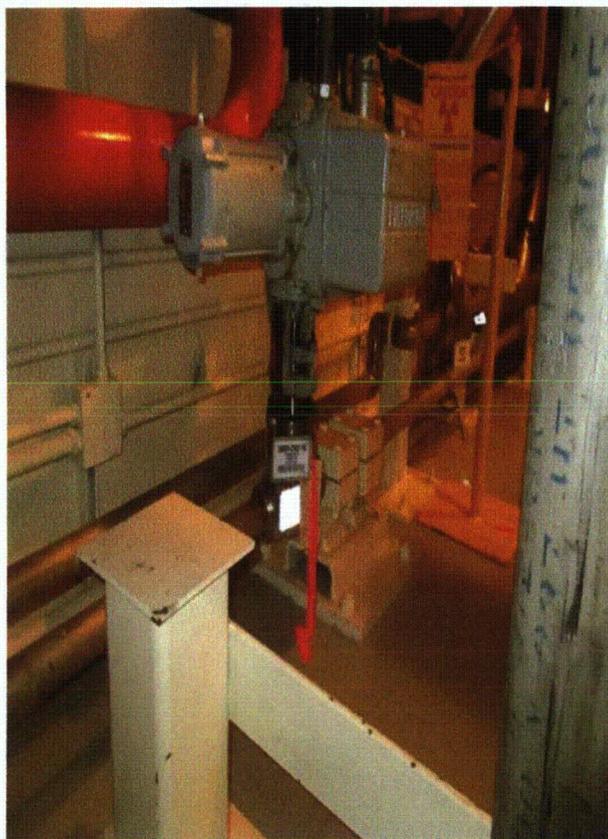
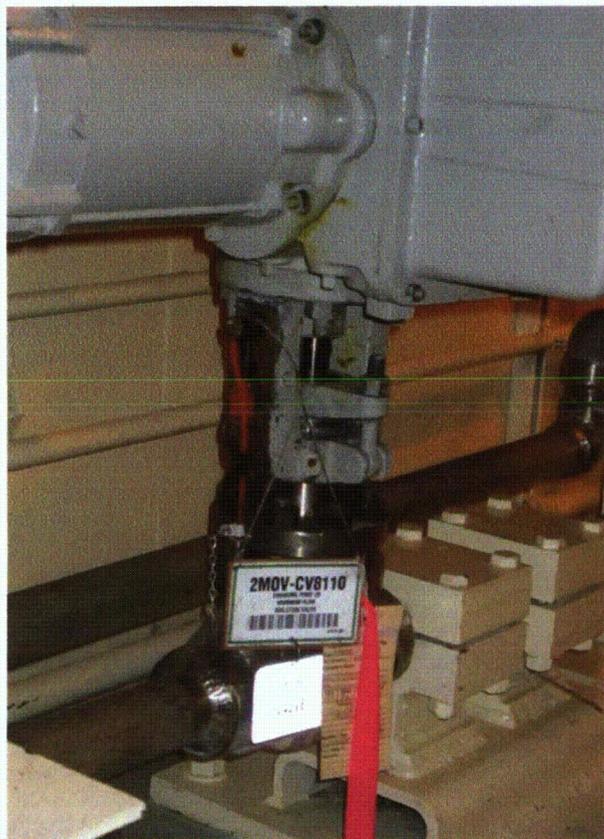
2CV8110 7-30-12 AM 042

Equipment Description: CV PMP MINIFLOW ISOL VLV C/S AT 2PM05J ASMBLY

11. Have you looked for and found no adverse seismic conditions that could adversely affect the safety functions of the equipment? Yes
Well-supported pipe

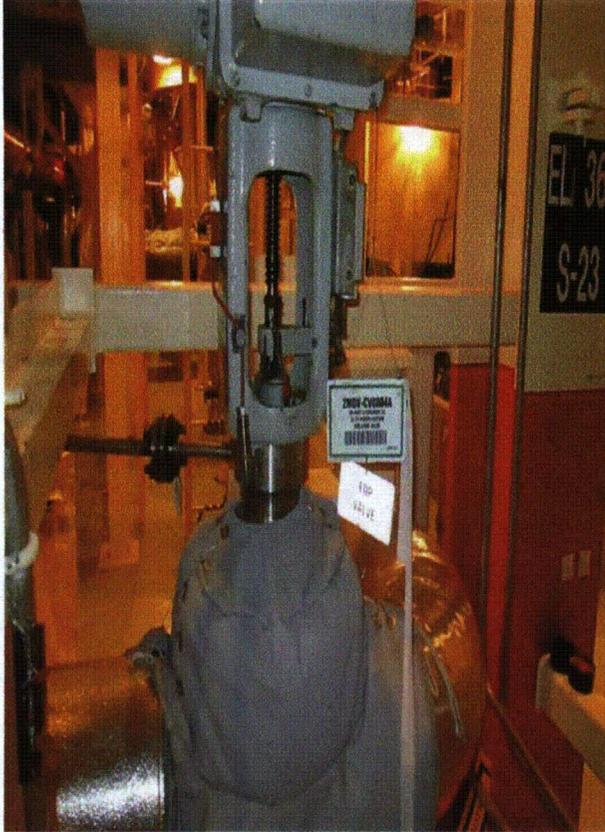
2CV8804A 7-30-12 AM 039

Equipment Description: RH HX 2A TO CV PMP SUCT ISOL VLV; C/S AT 2PM06J ASMBLY

7. Are soft targets free from impact by nearby equipment or structures? Yes
8. Are overhead equipment, distribution systems, ceiling tiles and lighting, and masonry block walls not likely to collapse onto the equipment? Yes
*Seismic block walls in area,
Open S-hook on one chain for east-west light fixture just inside the room. IR 1395456 was written. Other chain does not have open hook so light would not fall.*
9. Do attached lines have adequate flexibility to avoid damage? Yes
10. Based on the above seismic interaction evaluations, is equipment free of potentially adverse seismic interaction effects? Yes
