Seismic Walkdown Checklist (SWC)

Equipment ID No.: 2DC03E

Equipment Description: BATTERY CHARGER 211 DIV. 21

Project: Braidwood 2 SWEL

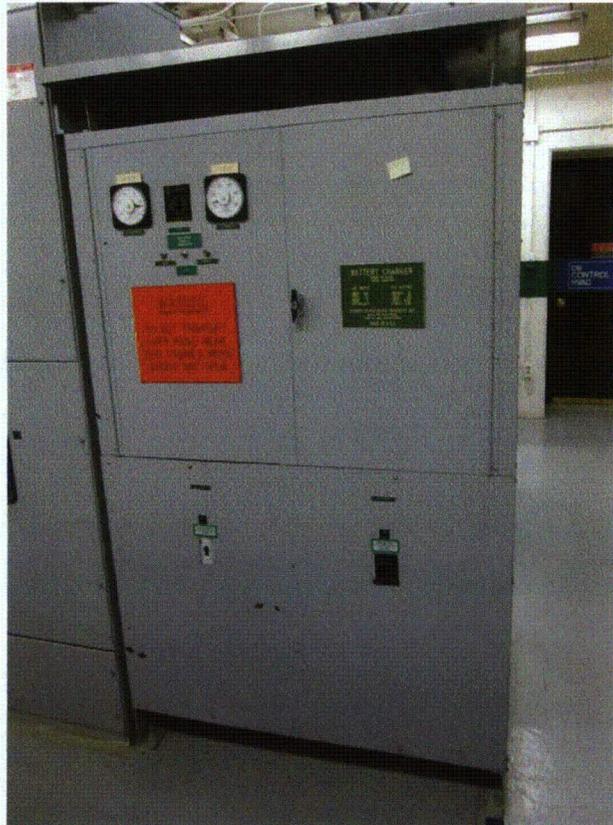
2DC03E 7-30-12 PM 039

3. Is the anchorage free of corrosion that is more than mild surface oxidation? Yes
Mild corrosion / rust. No structural/seismic impact.

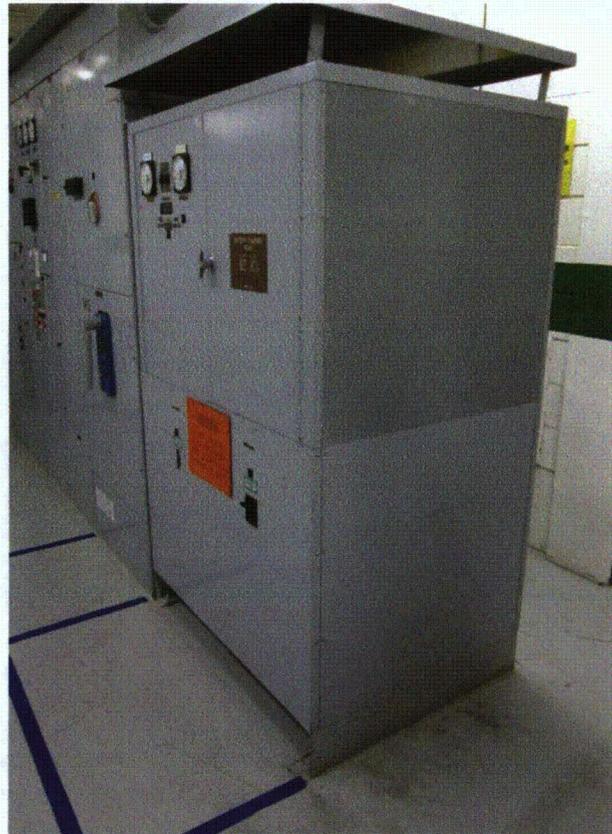
2DC04E 7-31-12 007

2. Is the anchorage free of bent, broken, missing or loose hardware? Yes
Welded anchorage.

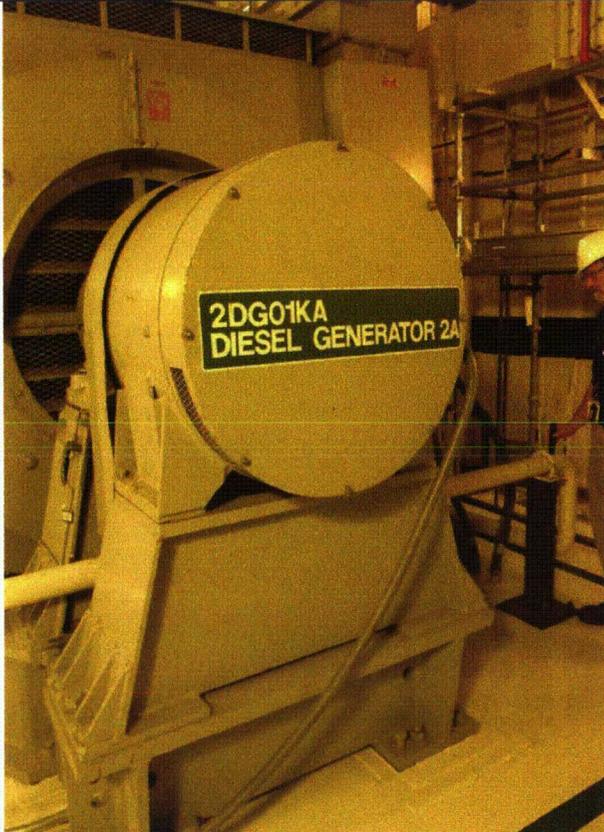
2DG01KA7-31-12 093

6. Based on the above anchorage evaluations, is the anchorage free of potentially adverse seismic conditions? Yes
Note that anchorage is internal to box but no cracking in concrete was visible and since the box is on the wall, there is no corrosion possible. Washer plates verified. Anchorage is acceptable.
