# Seismic Walkdown Checklist (SWC)

Limerick Generating Station Unit 1 MPR-3796, Revision 1 Correspondence No : RS-12-171

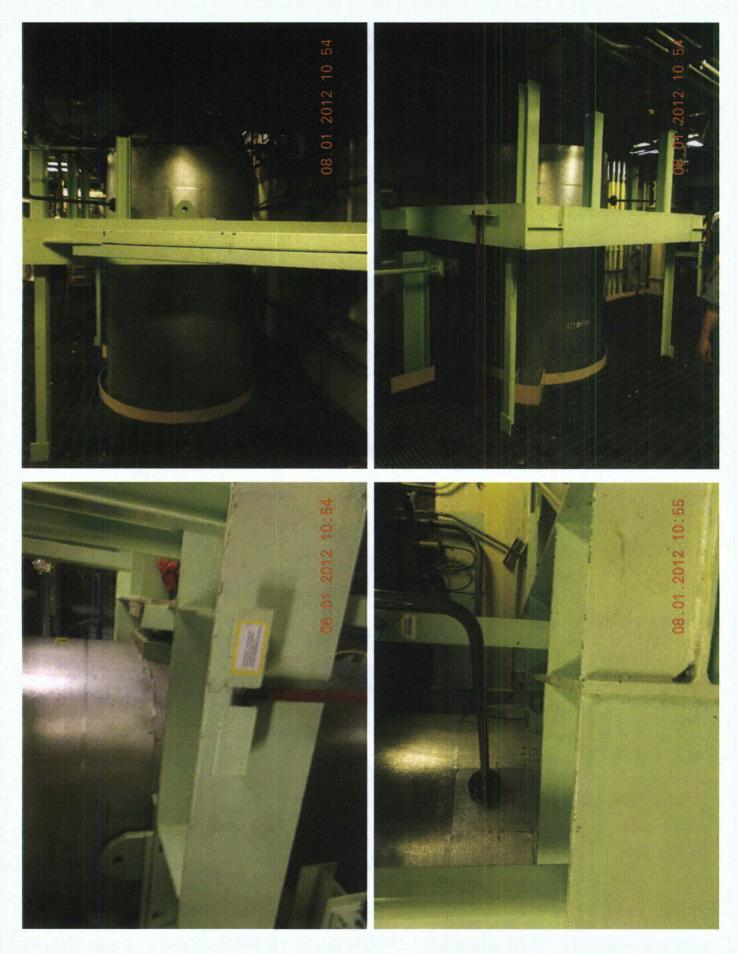
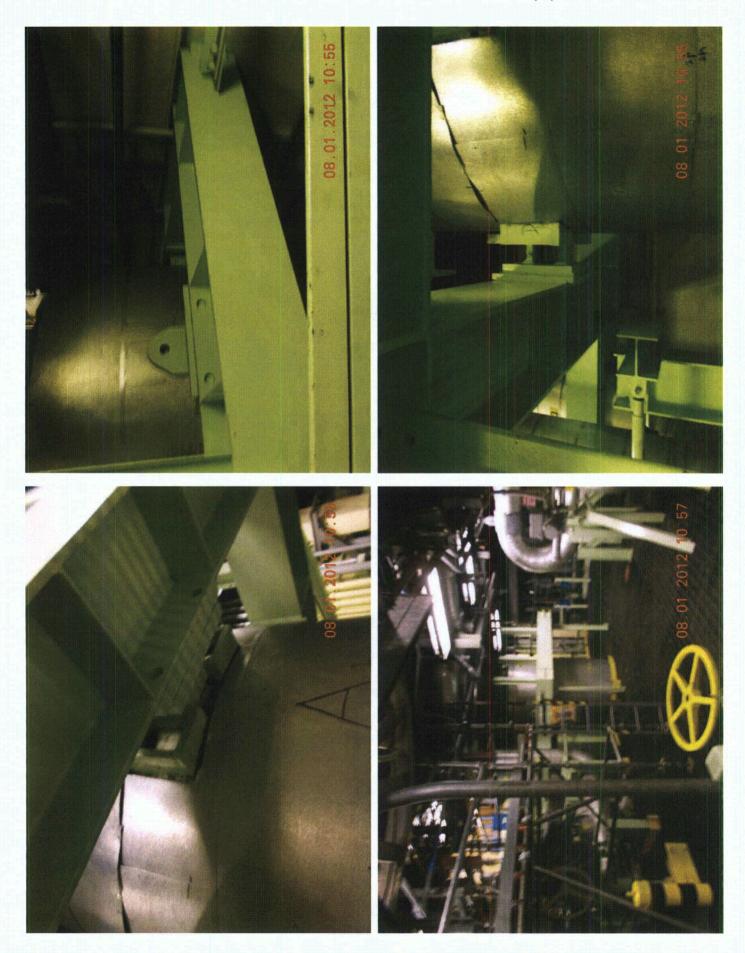
Equipment ID No. <u>1AE205</u> Equip. Class <sup>12</sup> (19) Vertical Tanks of	or Heat Exchangers
Equipment Description Residual Heat Removal Heat Exchanger	
Location: Bldg. <u>Reactor</u> Floor El. <u>177</u> Room, Area <u>Room 102</u> <u>Enclosure</u>	
Manufacturer, Model, Etc. (optional but recommended)	
Instructions for Completing Checklist	
This checklist may be used to document the results of the Seismic Walkdown of SWEL. The space below each of the following questions may be used to record the findings. Additional space is provided at the end of this checklist for documenting the space of the space is provided at the end of the space space.	the results of judgments and
Anchorage

11. Have you looked for and found no other seismic conditions that could adversely affect the safety functions of the equipment?	ҮҲ҈( и⊡ и⊡
<u><b>Comments</b></u> (Additional pages may be added as necessary)	
N/A	
Evaluated by: James Wiggin	Date: <u>8/3/2012</u>
Juni	8/3/2012

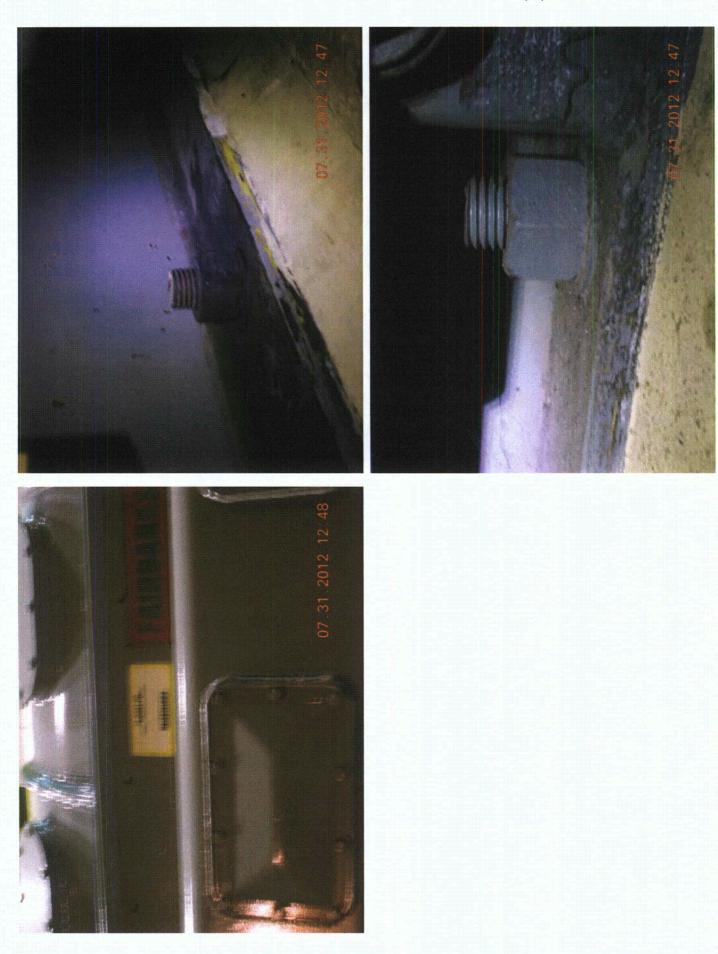
Equipment ID: 1AG501

- 7. Are soft targets free from impact by nearby equipment or structures? YEN UNANA
   Overhead in Candes can't light bolbs coold fall. No soft targets identified in path. Judged to be accepteble.
   Fixtures are adequately restrained.
   8. Are overhead equipment, distribution systems, ceiling tiles and lighting, YEN UNANA
- and masonry block walls not likely to collapse onto the equipment? Sex above for lighting. Confirm Overhead crane is designed for II over I. <u>Per Limerick</u> calculation 042.002.003, Rev.: the EOG enclosure crane is designed for seismic loading. 9. Do attached lines have adequate flexibility to avoid damage? YX NU UNAL
- 10. Based on the above seismic interaction evaluations, is equipment free of potentially adverse seismic interaction effects?

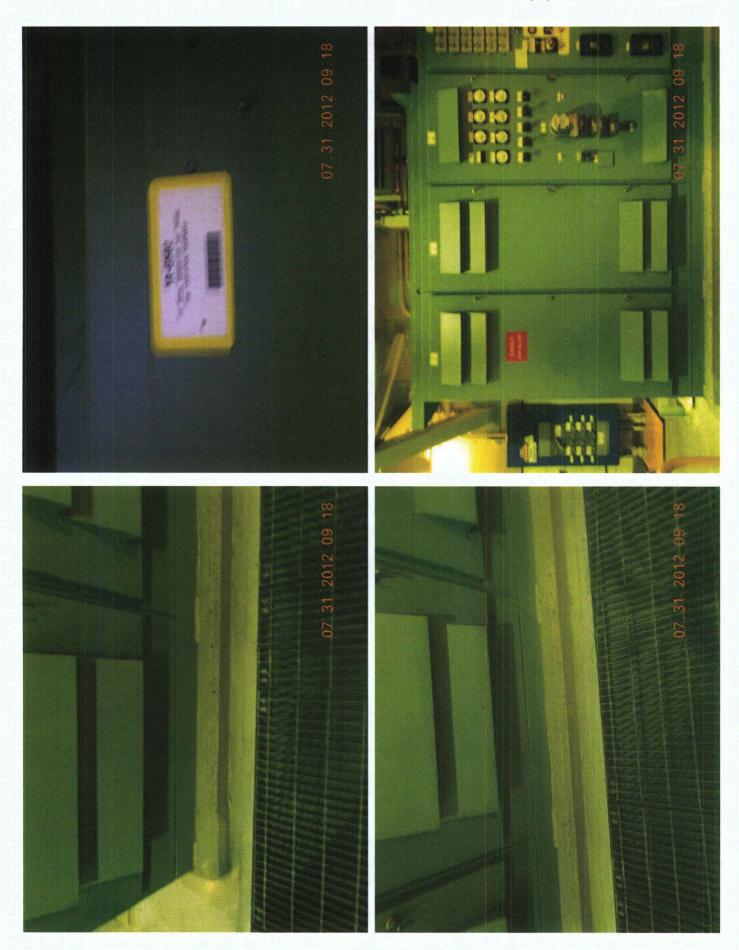
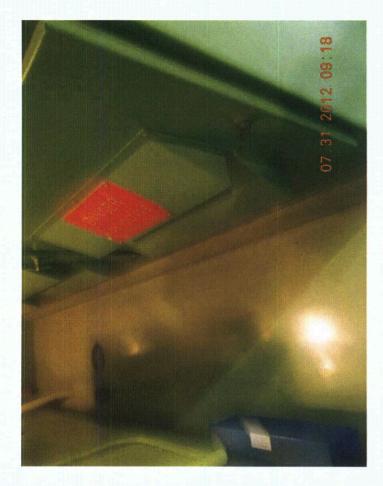
Equipment ID: 1AG502

7. Are soft targets free from impact by nearby equipment or structures? Y' N UNAL there is an overhead with bould in thigh ceiling. if that falls, and falts, the cabinet with soft instruments, there is a vent head on the top of Cabinet on the path to hit (see comments) that will give it a parabola path that will prevent it from hitting those loft target. 8. Are overhead equipment, distribution systems, ceiling tiles and lighting, YUNUN/A and masonary block walls not likely to collapse onto the equipment? no masonary block walls. HVAC line is the fill of the solution of the solu 9. Do attached lines have adequate flexibility to avoid damage? YZ NO UO N/AO 10. Based on the above seismic interaction evaluations, is equipment free of potentially adverse seismic interaction effects? **Other Adverse Conditions** YD NTI UTI 11. Have you looked for and found no other seismic conditions that could adversely affect the safety functions of the equipment? Comments (Additional pages may be added as necessary) falling path- of fluorescent Soft targets are not in potential bulbe. Evaluated by: Date:

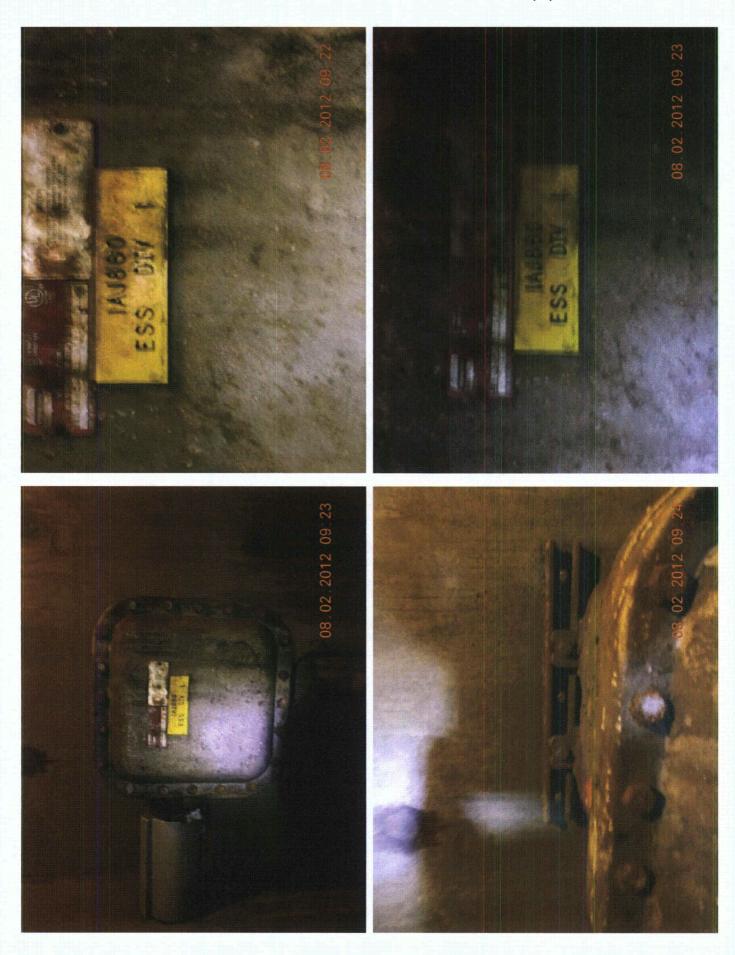
Equipment ID: 1AJ860

3. Is the anchorage free of corrosion that is more than mild surface oxidation? .Mild to moderate surface corrosion doomed accept	YX NO UO N/AO Table
4. Is the anchorage free of visible cracks in the concrete near the anchors?	Y∑ N□ U□ N/A□

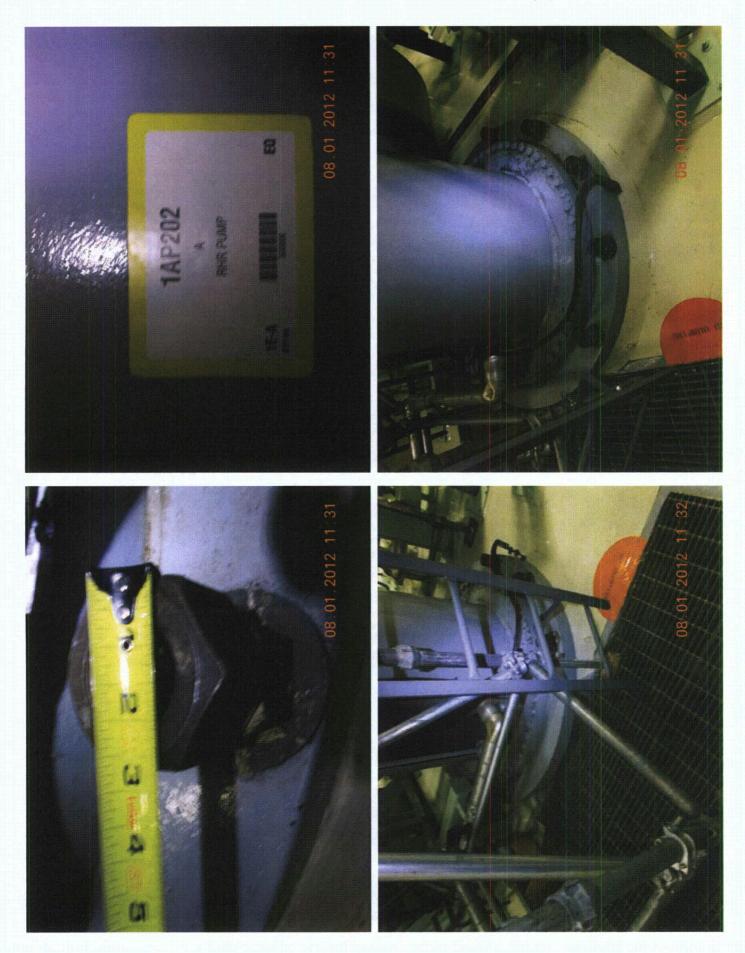
1. Is the anchorage configuration verification required (i.e., is the item one of the 50% of SWEL items requiring such verification)?	Y ND
2. Is the anchorage free of bent, broken, missing or loose hardware? Anchors double - nutled with top nots not fully nut used as a lock washer, not for structural	MAND UD N/AD engaged; top support

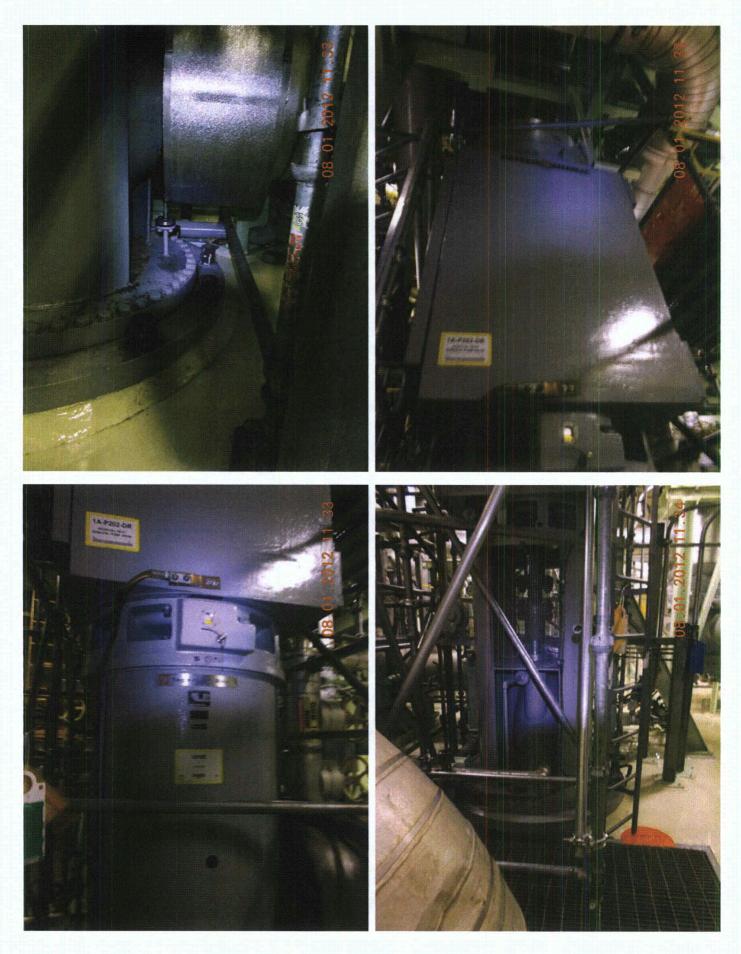
Equipment ID No. <u>1AP202</u> Equip. Class <sup>12</sup> (04) Vertical Pumps	
Equipment Description <u>RHR Pump</u>	
Location: Bldg. <u>Reactor</u> Floor El. <u>177</u> Room, Area <u>Room 102</u> <u>Enclosure</u>	
Manufacturer, Model, Etc. (optional but recommended)	
Instructions for Completing Checklist	
This checklist may be used to document the results of the Seismic Walkdown of a SWEL. The space below each of the following questions may be used to record t findings. Additional space is provided at the end of this checklist for documentin	he results of judgments and
Anchorage	,

3. Is the anchorage free of corrosion that is more than mild surface oxidation?	
4. Is the anchorage free of visible cracks in the concrete near the anchors?	YAD UD N/AD
<ol> <li>Is the anchorage configuration consistent with plant documentation? (Note: This question only applies if the item is one of the 50% for which an anchorage configuration verification is required.)</li> </ol>	
Motches Dwg. # 8031-M-1-E11-COO2-C-5.4	t, Rev. 8

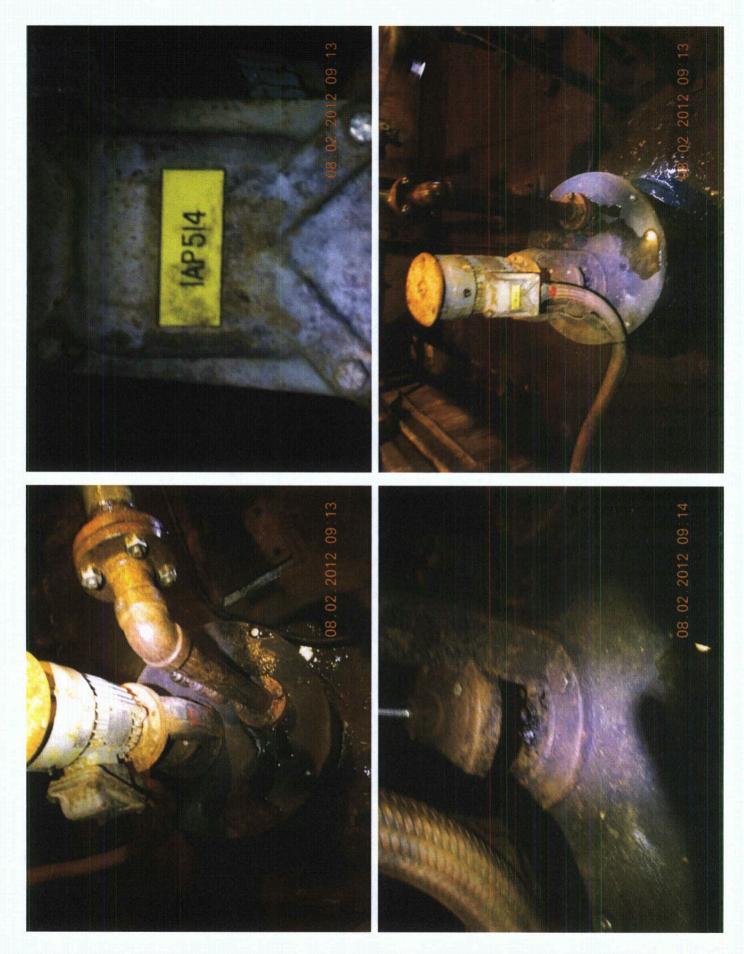
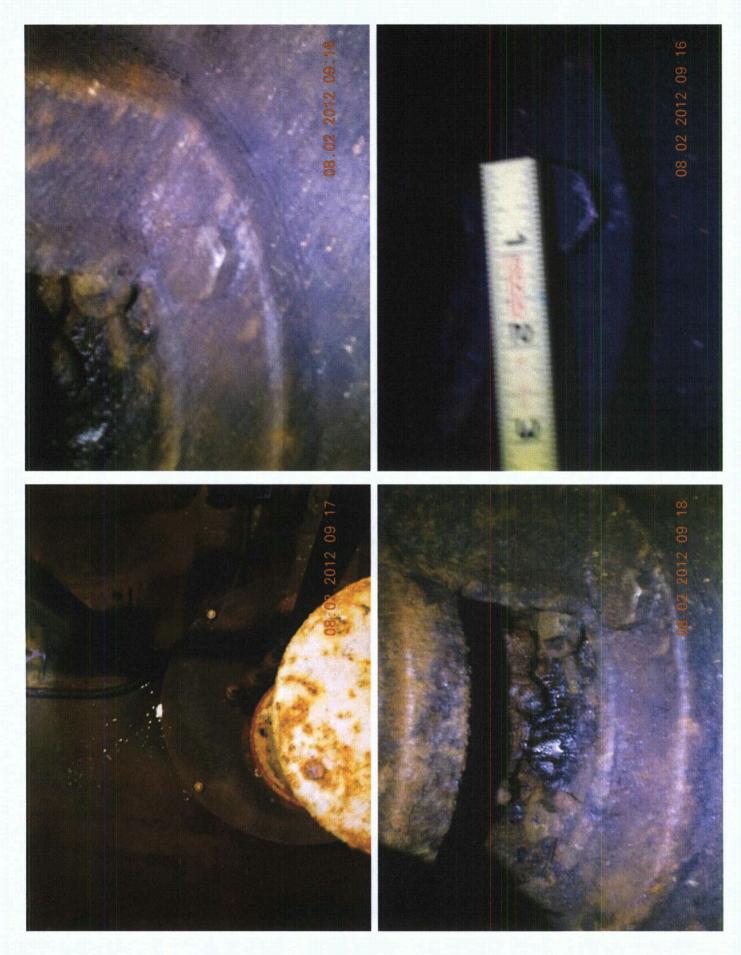
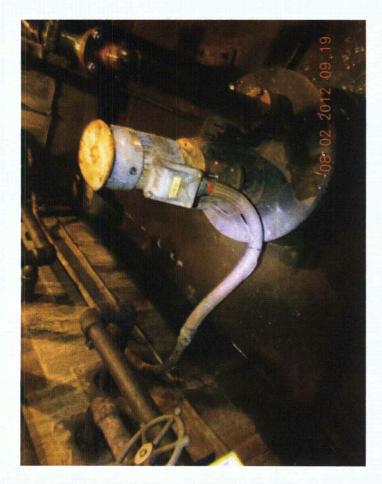
3. Is the anchorage free of corrosion that is more than mild surface oxidation? Mild to moderate surface corrosion deemed acce	YX NO UO N/AO ptoble
4. Is the anchorage free of visible cracks in the concrete near the anchors? Anchored to tank, tank encased in concrete free	YX N□ U□ N/A□ off cracks
