**SEQUOYAH NUCLEAR PLANT, UNIT 1  
FUKUSHIMA NEAR-TERM TASK FORCE  
RECOMMENDATION 2.3: SEISMIC RESPONSE REPORT**

# **SEQUOYAH NUCLEAR PLANT – UNIT 2 FUKUSHIMA NEAR-TERM TASK FORCE RECOMMENDATION 2.3: SEISMIC RESPONSE REPORT**

12-November-2012

REV	DESCRIPTION	ORIG	REVIEW	WORLEY- PARSONS APPROVAL	DATE	CLIENT APPROVAL	DATE
0	SQN Unit 2 Seismic Walkdown Report

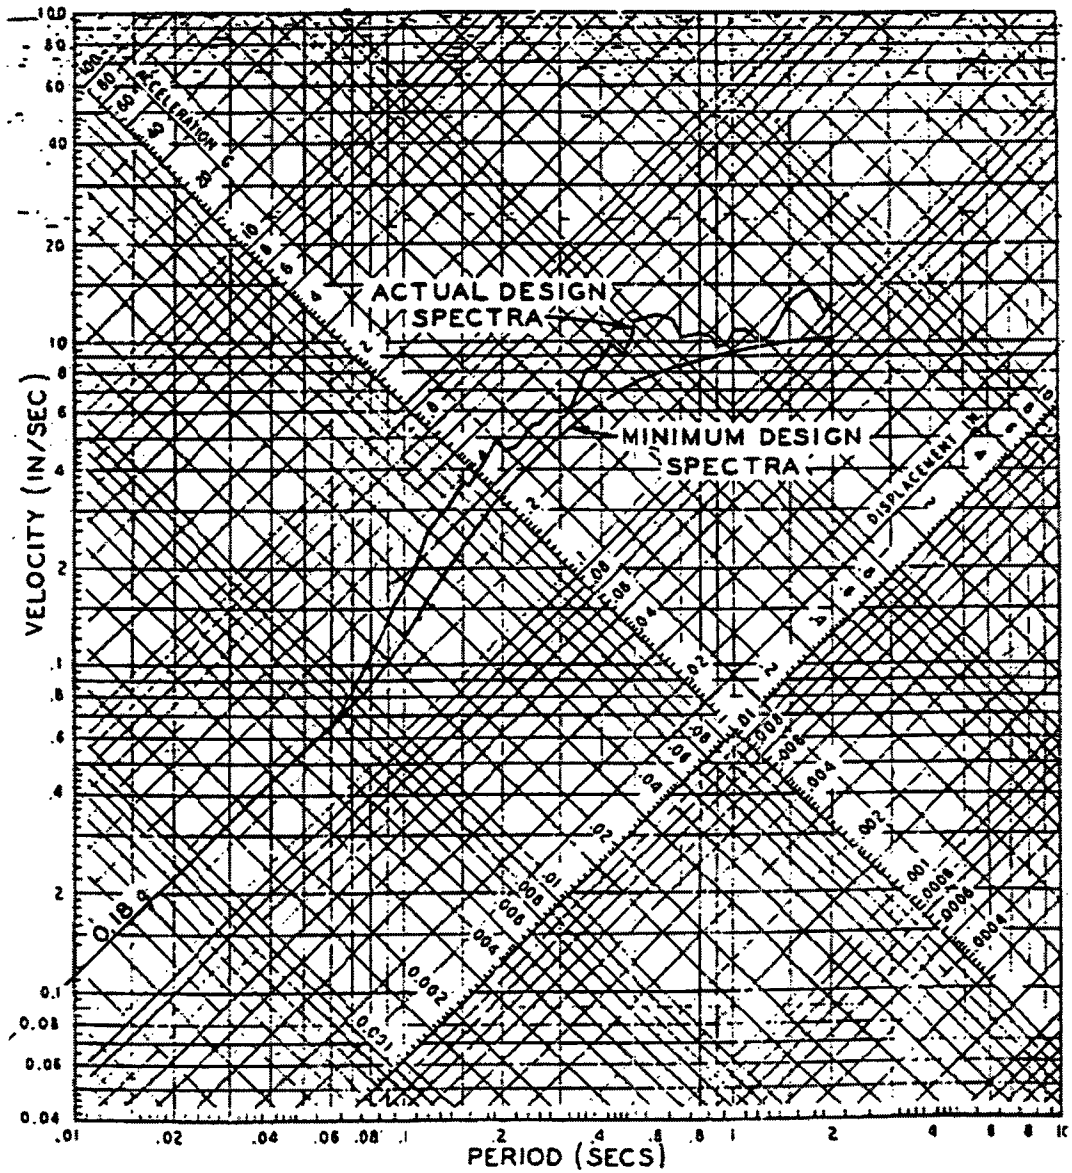
Figure 1 – Comparison of Response Spectra for Safe Shutdown Earthquake, 5% damping

The seismic design basis for Sequoyah Nuclear Power Plant is the 0.18g horizontal peak ground acceleration represented by the modified Housner-shape spectrum for Safe Shutdown Earthquake (SSE). Operating Basis Earthquake (OBE) is one-half of SSE ground acceleration. Vertical ground acceleration is two-thirds of the horizontal ground acceleration.

Figure 1 illustrates the relationship between the 5% damped minimum design response spectra and the actual site seismic design response spectra for the SSE used in the design of rock-supported structures.
