Status: ☒ Y ☐ N ☐ U**Seismic Walkdown Checklist (SWC)**

Equipment ID No.: LFFV0096

Equipment Class: (7) Fluid-Operated Valves

Equipment Description: CTMT NOR SUMPS TO FLR DRN TK OUTSIDE CTMT ISO

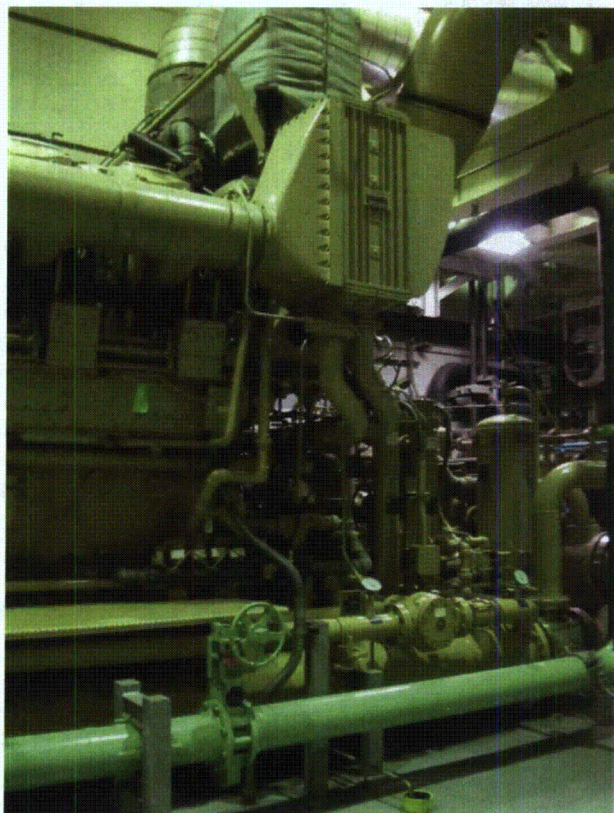
NE002 9-17 003

2. Is the anchorage free of bent, broken, missing or loose hardware? Yes
Item shares common skid with KKJ01B.

5. Is the anchorage configuration consistent with plant documentation? (Note: This question only applies if the item is one of the 50% for which an anchorage configuration verification is required.) Yes
Item shares common skid with KKJ01B. Refer to Note 5 for KKJ01B. No hazard.

Noted ruggedly-supported crane overhead with hoist chains tied off. Fall protection yo-yos above also well-secured. No hazards.

Noted minor surface oxidation on heat exchanger bolts, but no indication of strength loss. Therefore no seismic concern.

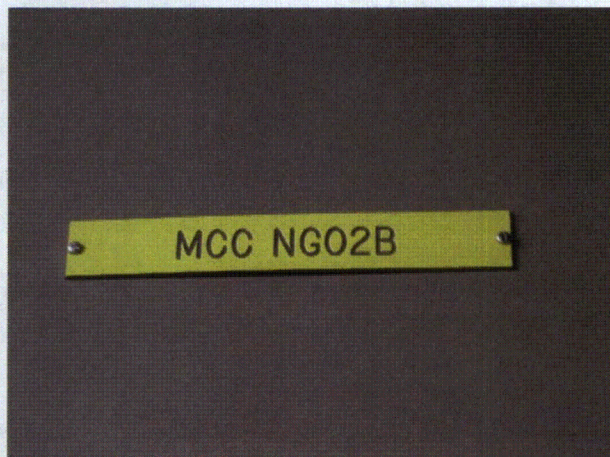
NG002B 9-20 072

Observed 1-7/8" clearance from back of MCC (drip shield) to concrete wall. There is concern that the MCC could close the gap in SSE event and cause equipment to malfunction. Verification needed to ensure gap is sufficient given MCC flexibility (gap oriented in weak direction) and high elevation of the Aux Building (2047.5').

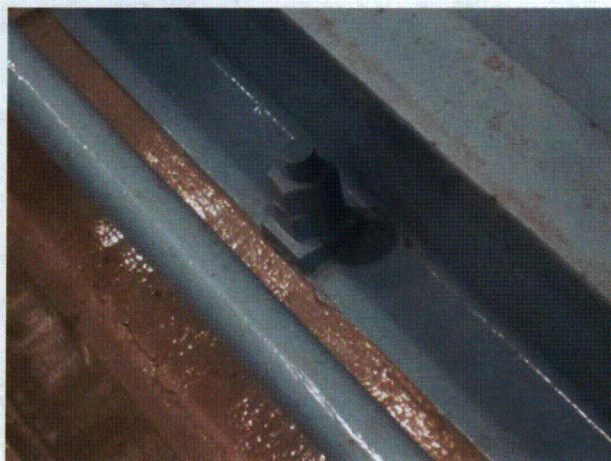
PAL01B 9-19 308

3. Is the anchorage free of corrosion that is more than mild surface oxidation? Yes
Minor surface oxidation noted but no indication of strength loss. Therefore no hazard.

11. Have you looked for and found no adverse seismic conditions that could adversely affect the safety functions of the equipment? Yes
Noted leveling bolts missing on N end. Large anchors are adjacent at 4 corners; therefore no adverse seismic condition. WCNOG is checking on bolt.

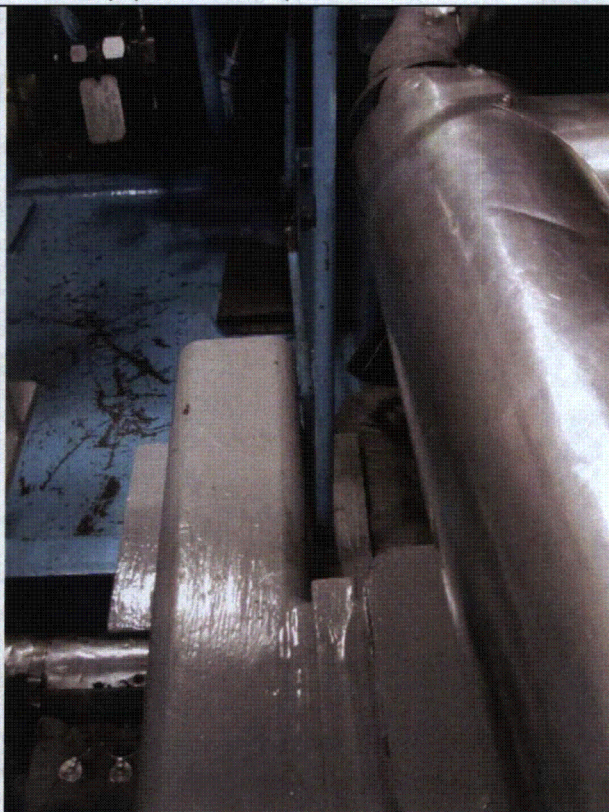
PAL02 9-19 264

4. Is the anchorage free of visible cracks in the concrete near the anchors? Yes
Minor grout cracks noted but no concrete cracks in pump pedestal. No adverse concern.

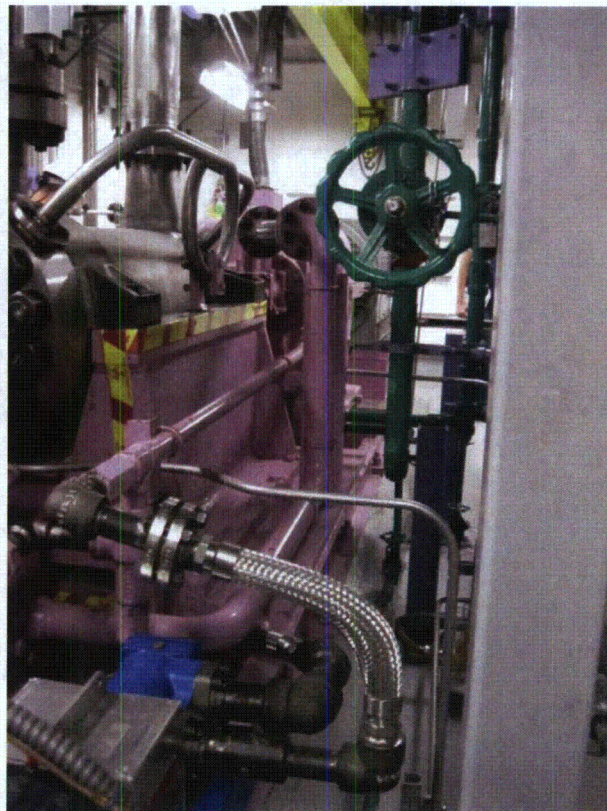
PBG05B 9-19 009

Noted scaffolding near air tubing running to pump. Scaffolding is well-supported, well-braced and has adequate clearance. Fall protection harness mounted on scaffold but far enough away not to be in zone of influence of the tubing. No hazards.

Overhead hoist noted to be well-supported with chains tied off. No hazard.

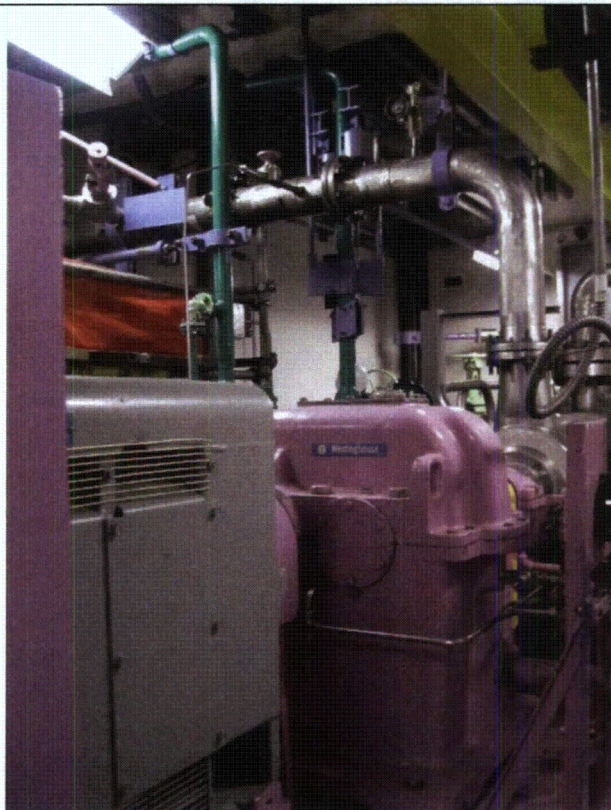
PBG05B 9-19 014

7. Are soft targets free from impact by nearby equipment or structures? Yes
Hoist overhead, well supported and hoist chains tied off at south end away from pump. Good practice noted; no hazard.
8. Are overhead equipment, distribution systems, ceiling tiles and lighting, and masonry block walls not likely to collapse onto the equipment? Yes
9. Do attached lines have adequate flexibility to avoid damage? Yes
10. Based on the above seismic interaction evaluations, is equipment free of potentially adverse seismic interaction effects? Yes

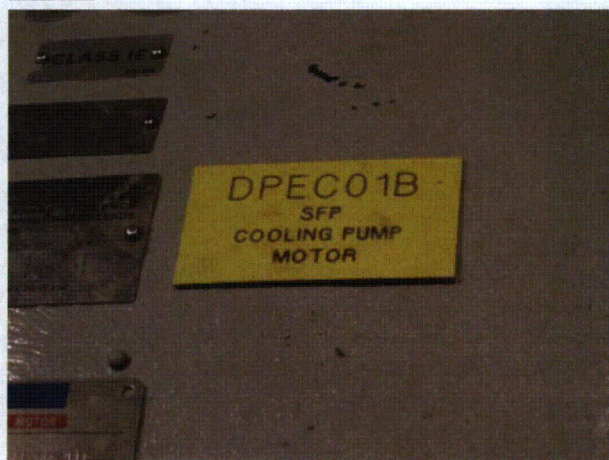
PECO1B 9-18 230

Scaffolding and overhead hoist are well-supported and properly braced. Hoist rig is in safe position with chains tied off. No hazards.
