Seismic Walkdown Checklist (SWC)

Equipment ID No.: EGHV101

Equipment Description: CCW TO RHR HX A ISO

Project: Callaway SWEL

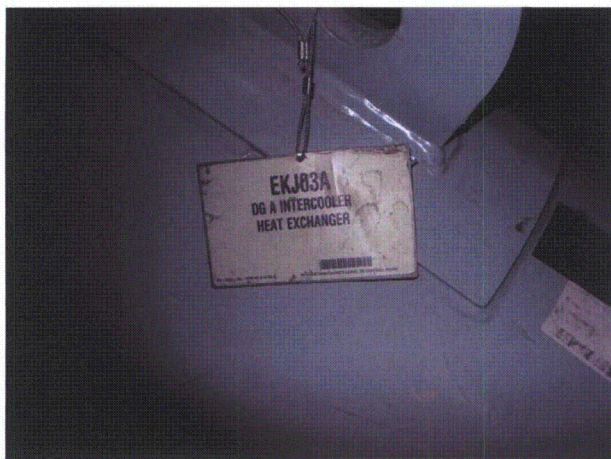
EKJ03A0189

2. Is the anchorage free of bent, broken, missing or loose hardware? Yes
Mounted on Diesel skid (welded).

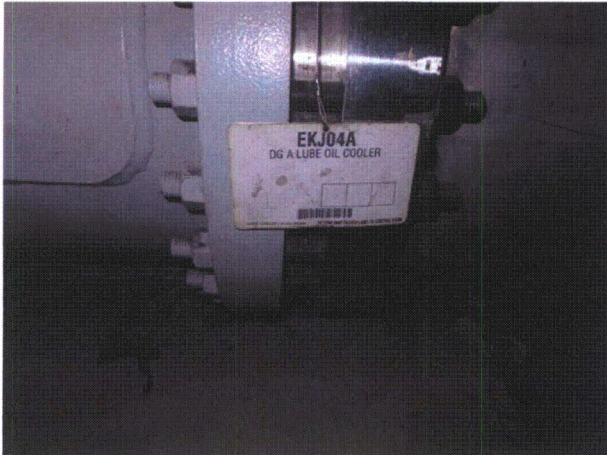
EKJ04A0157

2. Is the anchorage free of bent, broken, missing or loose hardware? Yes
One bolt is threaded less than flush, no concern.

7. Are soft targets free from impact by nearby equipment or structures? Yes
Up against a support leg but it is very rigid to move, not a seismic concern.
8. Are overhead equipment, distribution systems, ceiling tiles and lighting, and masonry block walls not likely to collapse onto the equipment? Yes
9. Do attached lines have adequate flexibility to avoid damage? Yes
10. Based on the above seismic interaction evaluations, is equipment free of potentially adverse seismic interaction effects? Yes

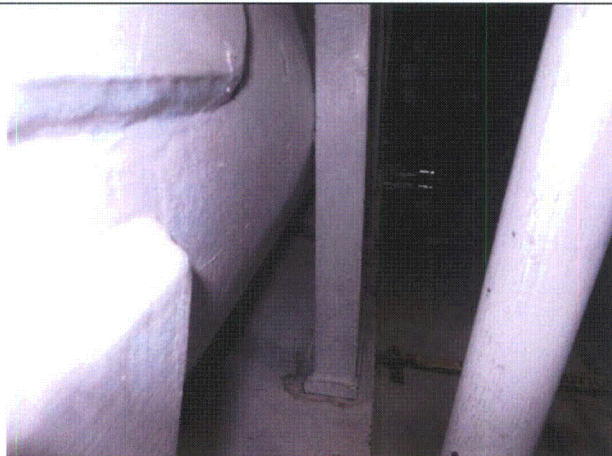
EKJ06A0156

7. Are soft targets free from impact by nearby equipment or structures? Yes
Nearby pipe with adequate gap.
8. Are overhead equipment, distribution systems, ceiling tiles and lighting, and masonry block walls not likely to collapse onto the equipment? Yes
Overhead emergency light is adequately anchored to wall.
9. Do attached lines have adequate flexibility to avoid damage? Yes
Flex conduit and tubing attached to some mounting structure.
10. Based on the above seismic interaction evaluations, is equipment free of potentially adverse seismic interaction effects? Yes

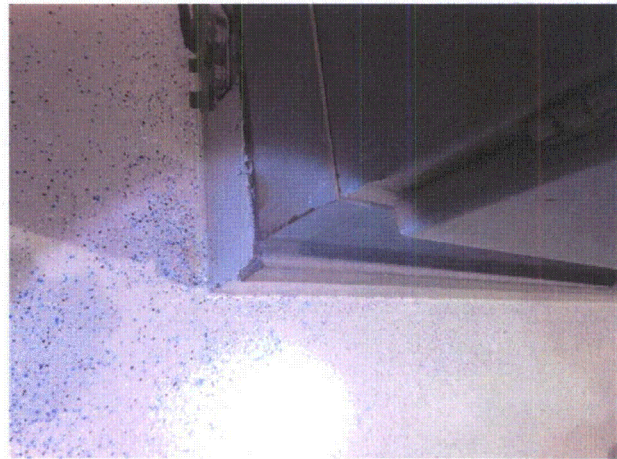
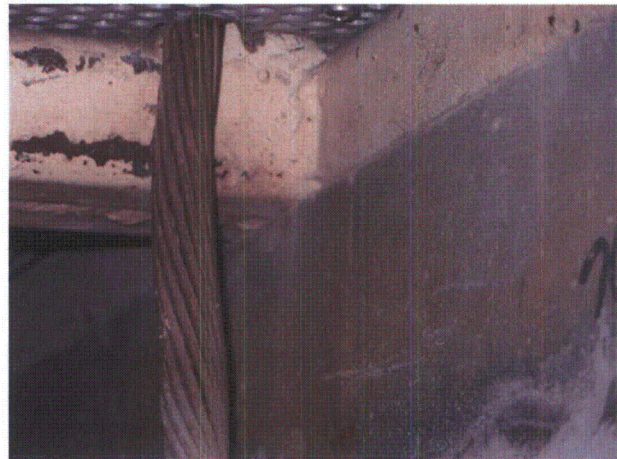
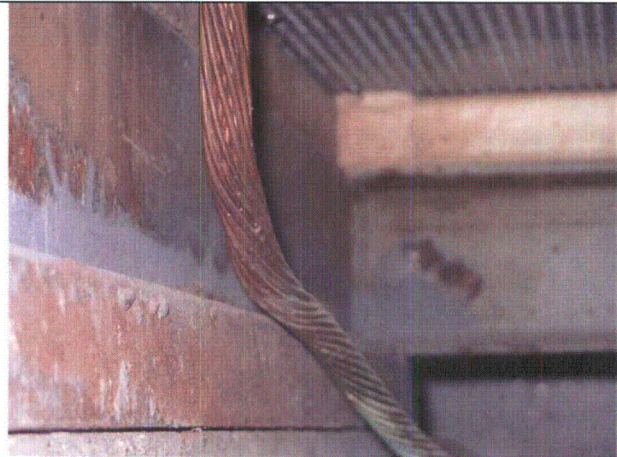
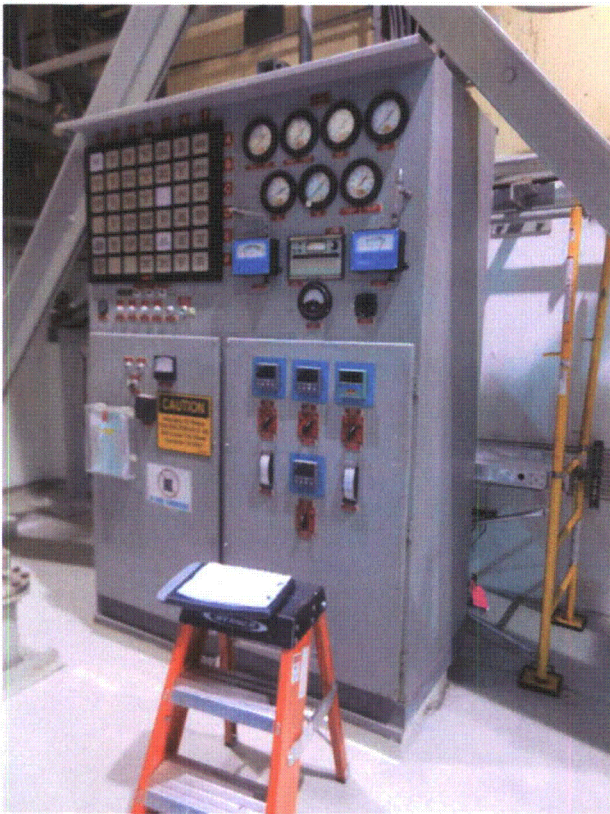
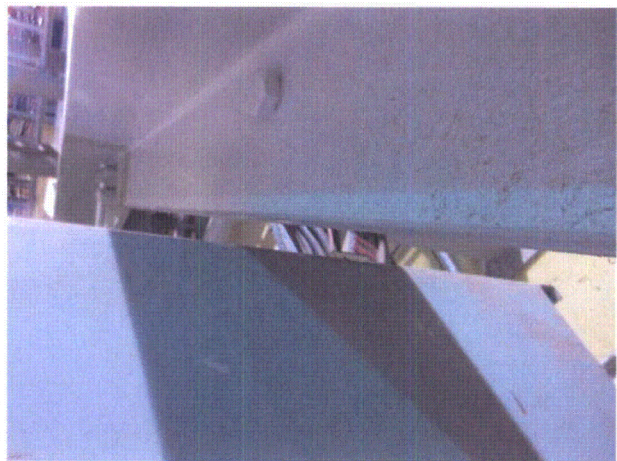
KJ1210140

7. Are soft targets free from impact by nearby equipment or structures? Yes
*Bracing members are 1-1/8" away, no concern.
Seismic scaffold stored 2" behind cabinet, no concern.*
8. Are overhead equipment, distribution systems, ceiling tiles and lighting, and masonry block walls not likely to collapse onto the equipment? Yes
Overhead fan is well supported.
9. Do attached lines have adequate flexibility to avoid damage? Yes
10. Based on the above seismic interaction evaluations, is equipment free of potentially adverse seismic interaction effects? Yes

11. Have you looked for and found no adverse seismic conditions that could adversely affect the safety functions of the equipment? Unknown
*Cabinet internals could not be accessed during at-power walkdowns.
Internals will be inspected during next bus outage.*
