**ATTACHMENT 3**  
**WALKDOWN CHECKLISTS**

**Seismic Walkdown Checklist (SWC)**

Project: CCNPP 1 SWEL

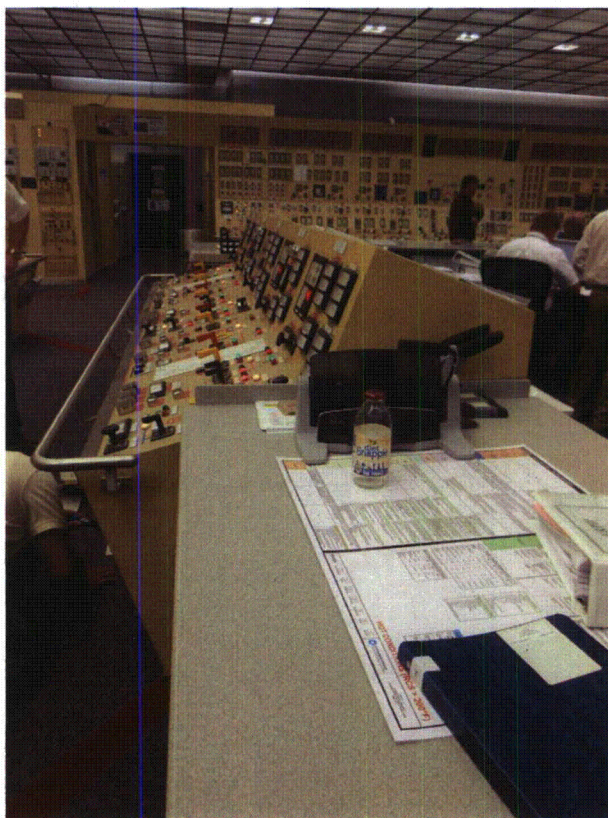
1PNL1C18A 8-14-12 132

*SWE opened the front of the cabinet lineup and only C18A of the rear, because there are anchored bookcase that need to be unanchored and moved out of the way. The only anchorage observed was one ½" CEA in the front and rear of C18A and one in the rear of C18B. No other anchor bolts were observed due to interferences with cables and the inaccessibility of the rear.*

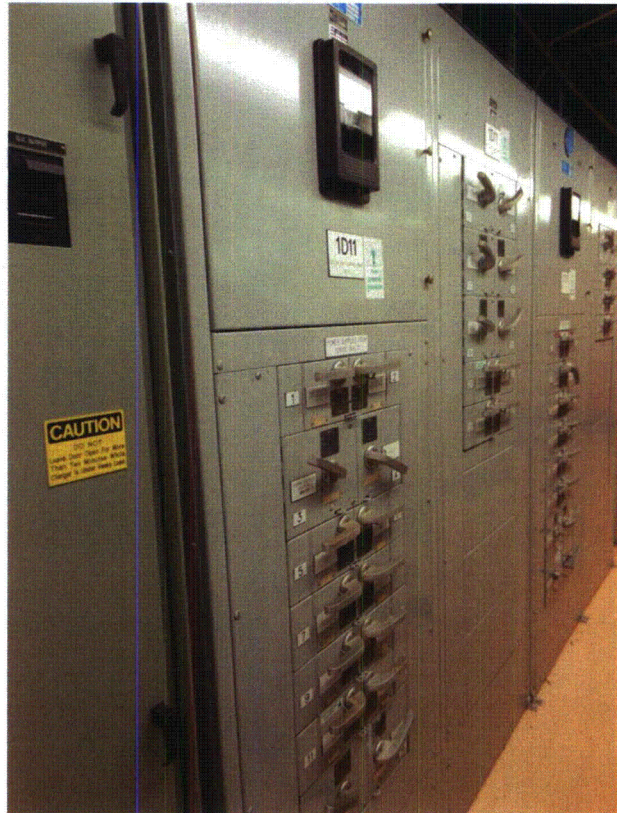
1PNL1D11 8-14-12 086

*Observed a 3/8" clearance to 1D01 that is behind 1D11 and 3/8" to 1B13 adjacent to 1D11. This cabinet 1D11 is 14.5"x64"x90" high. Evaluated this condition using 8Hz and 2% damping. The resulting displacement is 0.147", which is less than 3/8", therefore the gap is acceptable.*

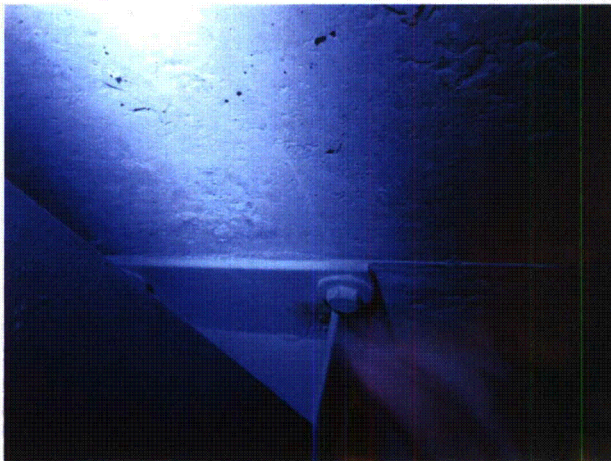
1PT5313A 8-8-12 102

3. Is the anchorage free of corrosion that is more than mild surface oxidation? Yes  
*There is some surface oxidation on wall plate < 1/32" and it is not near weld. The plate stresses in the vicinity of the oxidation are judged to be small, therefore not a seismic concern.*

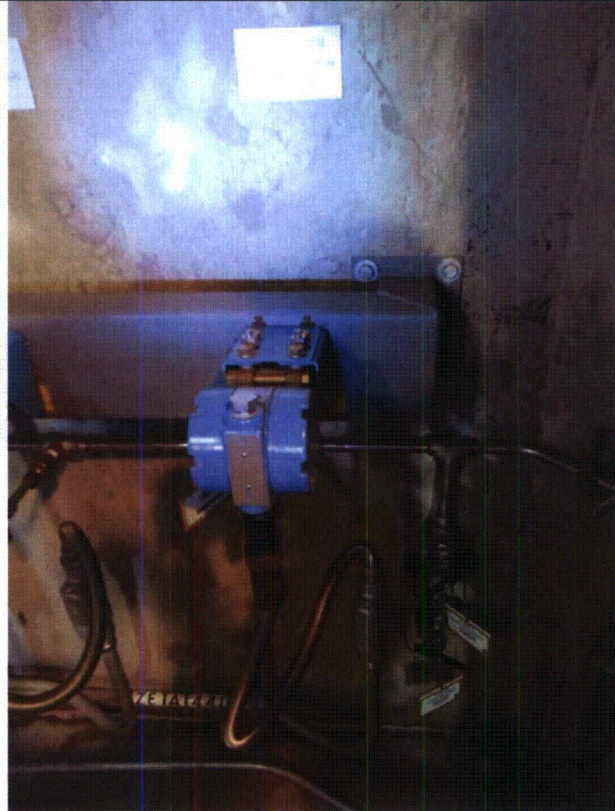
1PT5313B 8-8-12 092

2. Is the anchorage free of bent, broken, missing or loose hardware? No  
*The upper left anchor bolt on the left side of the anchor plate is missing. CR-2012-009320 & CR-2012-009333*
