**ATTACHMENT 3**  
**WALKDOWN CHECKLISTS**

**Seismic Walkdown Checklist (SWC)**

Project: CCNPP 1 SWEL

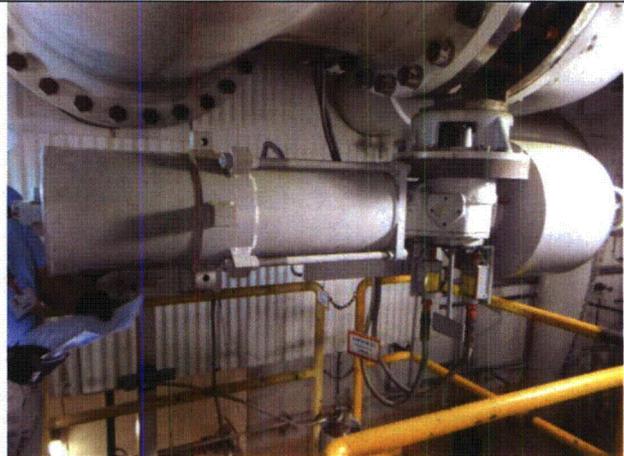
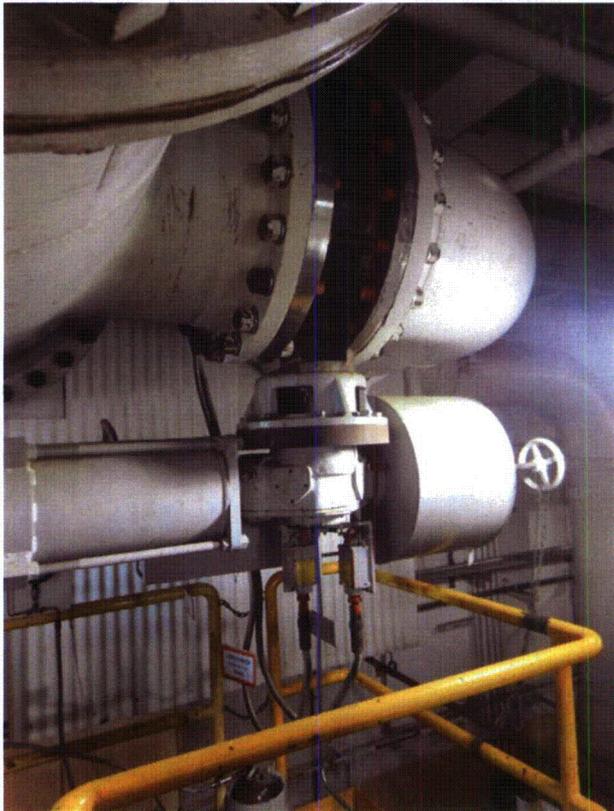
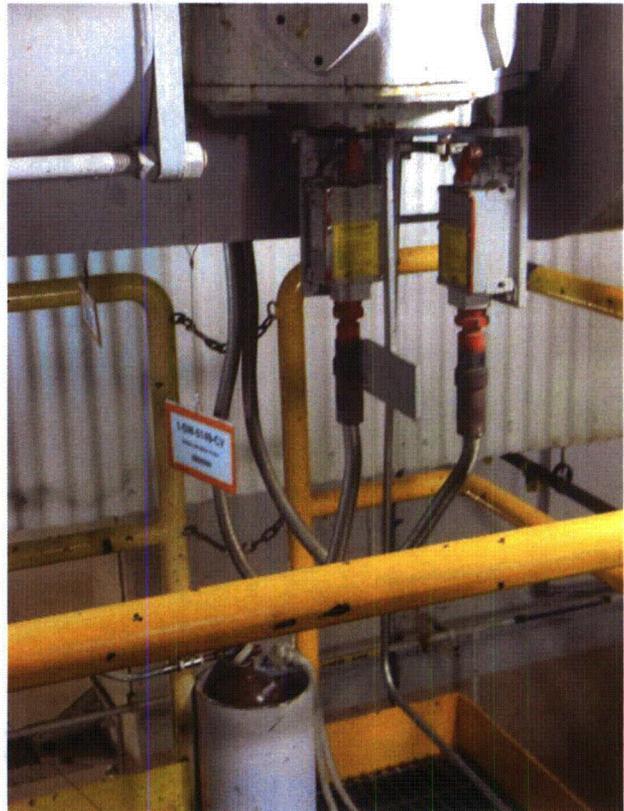
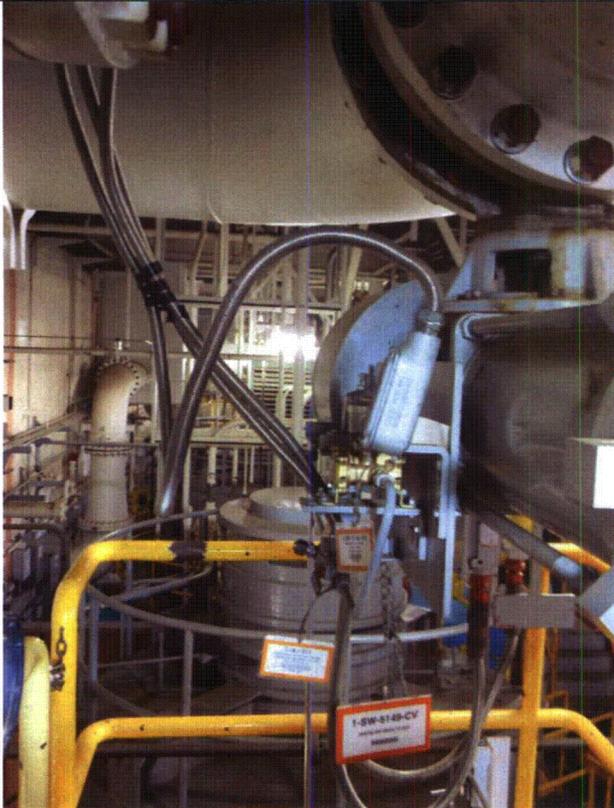
| 1. Is anchorage configuration verification required (i.e., is the item one of the 50% of SWEL items requiring such verification)?<br><i>Solenoid for 1CV5149 and mounted directly on 1CV5149.</i> | No |

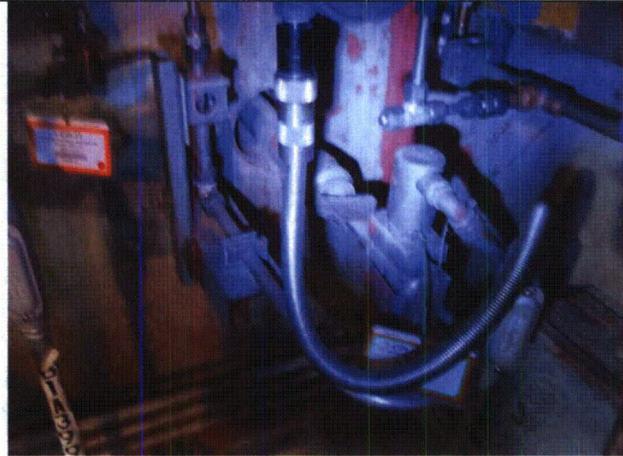
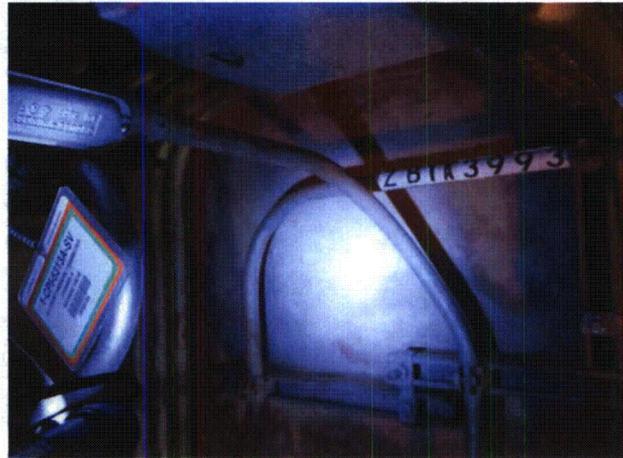
*Valve tubing is 1/8" away from PT's conduit. Conduit is flexible and not considered a hard target therefore judged not to be an adversely seismic concern for the SV.*

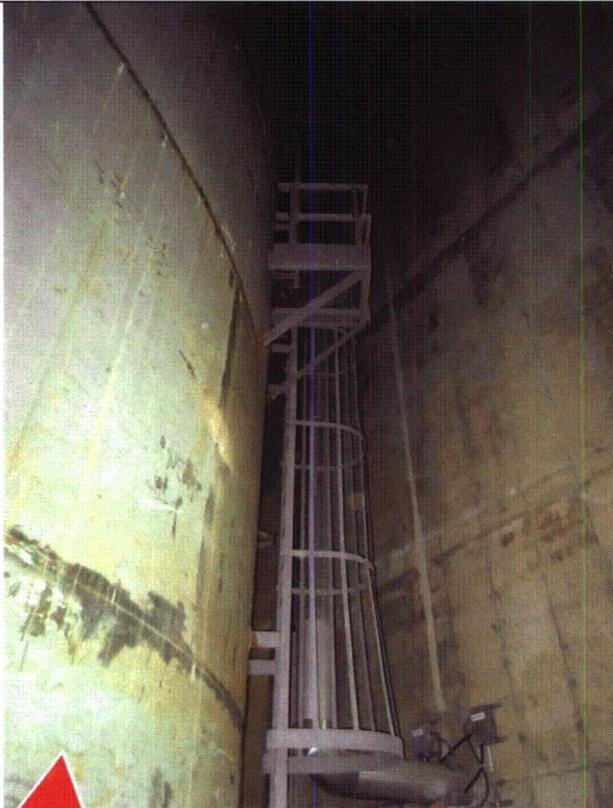
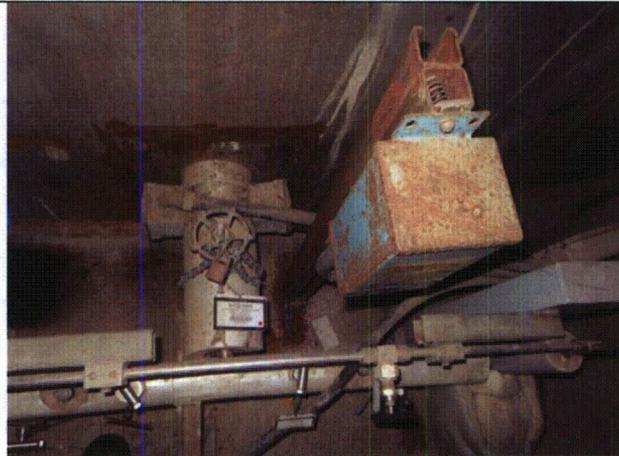
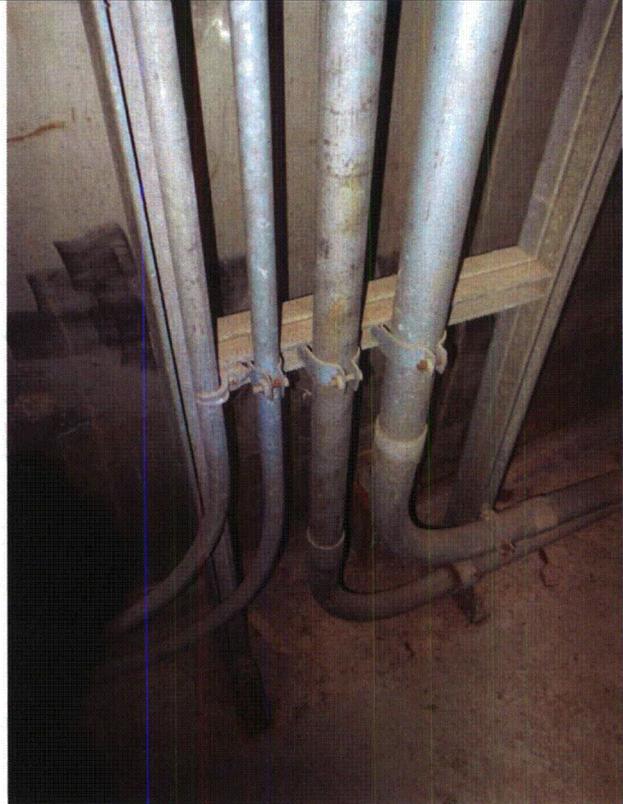
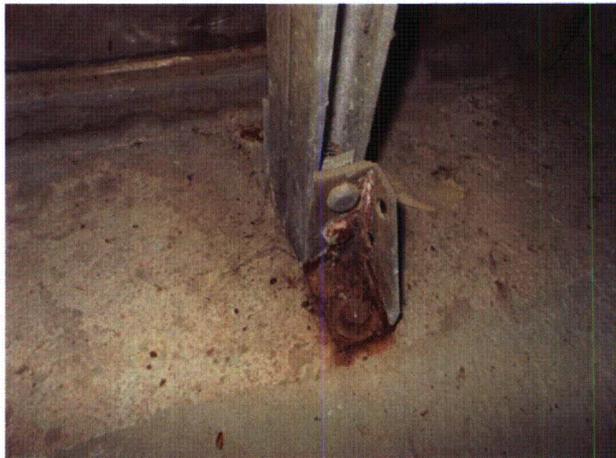
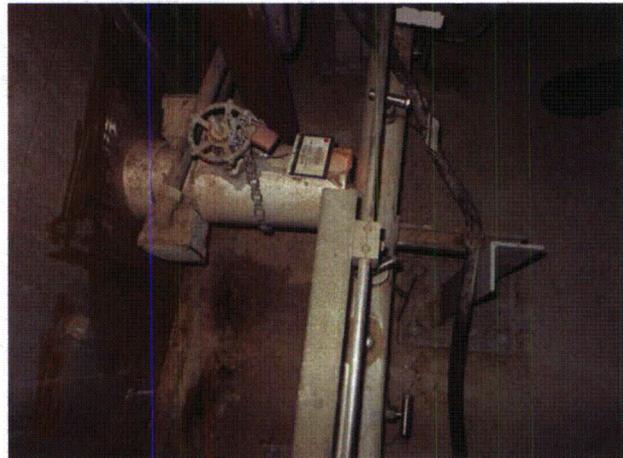
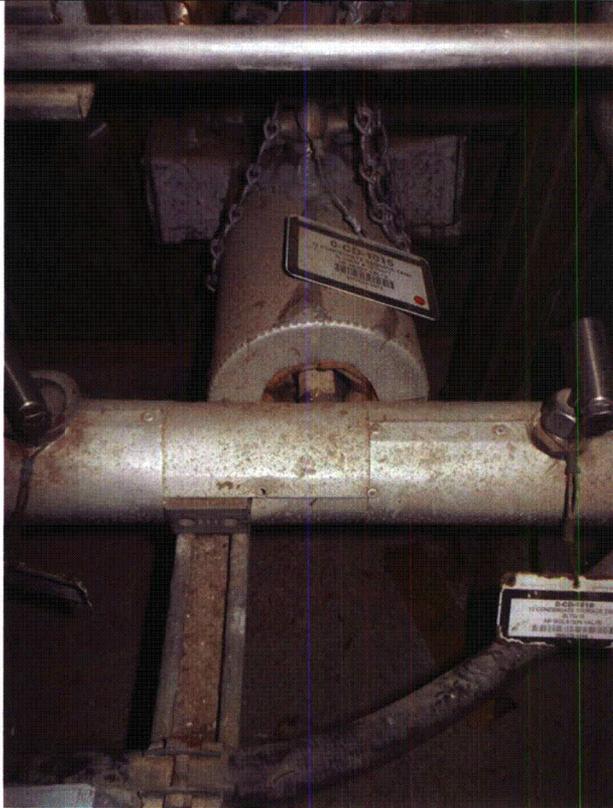
3. Is the anchorage free of corrosion that is more than mild surface oxidation? Yes  
*Only surface oxidation is present, therefore not a concern.*

4. Is the anchorage free of visible cracks in the concrete near the anchors? Yes  
*Minor surface finish concrete hairline cracks approximately 1" to 3" long, therefore not a concern.*

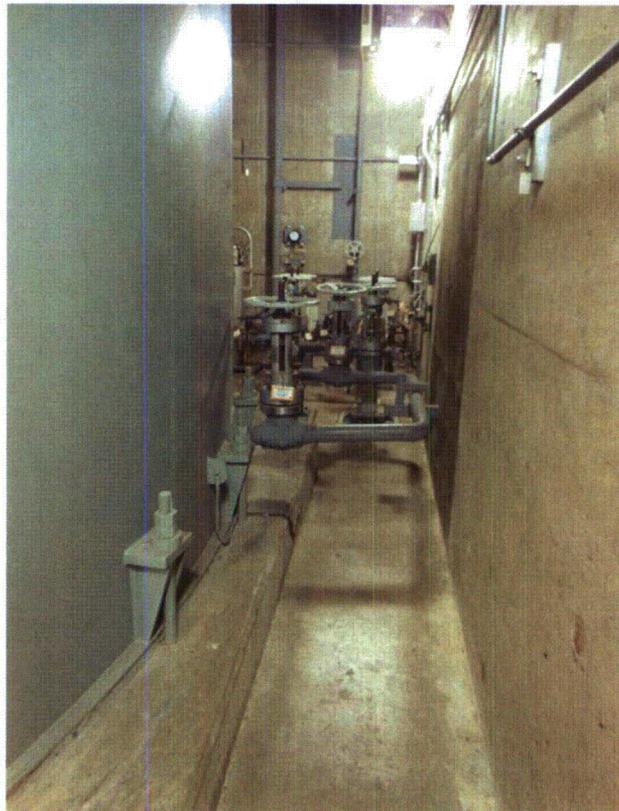
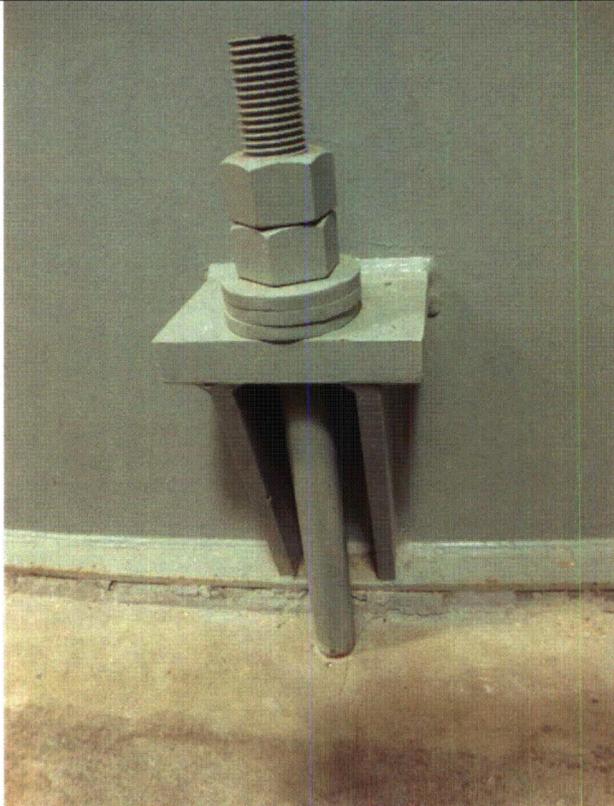
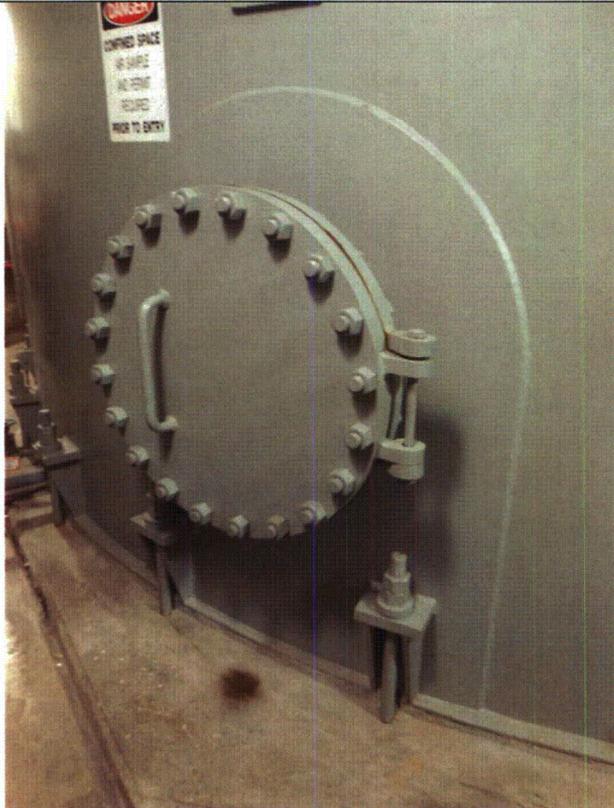
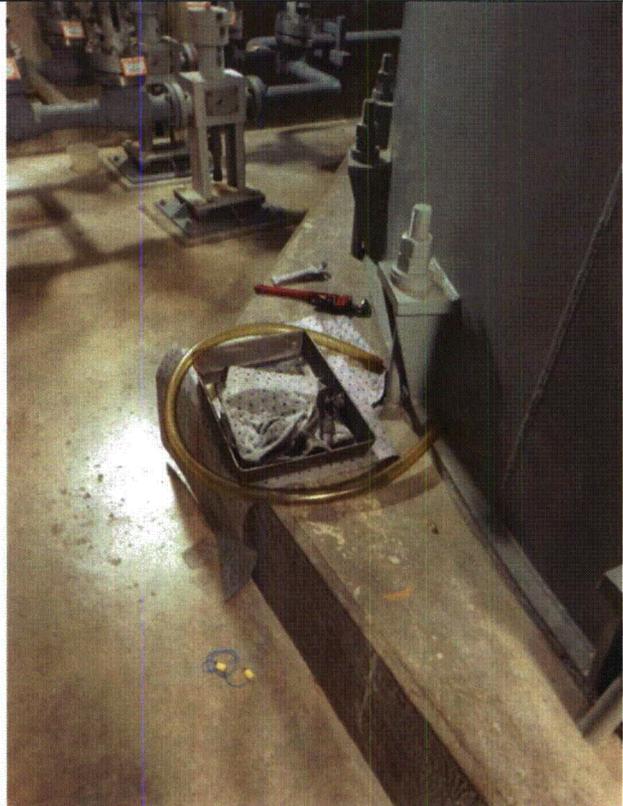
3. Is the anchorage free of corrosion that is more than mild surface oxidation? No  
*There is corrosion at the base of some anchor bolts, one bolt has extensive corrosion. CR-2012-008384*

4. Is the anchorage free of visible cracks in the concrete near the anchors? No  
*Cracking in the concrete pad was observed near, at least, 3 anchor bolts. CR-2012-010257*

6. Based on the above anchorage evaluations, is the anchorage free of potentially adverse seismic conditions? No

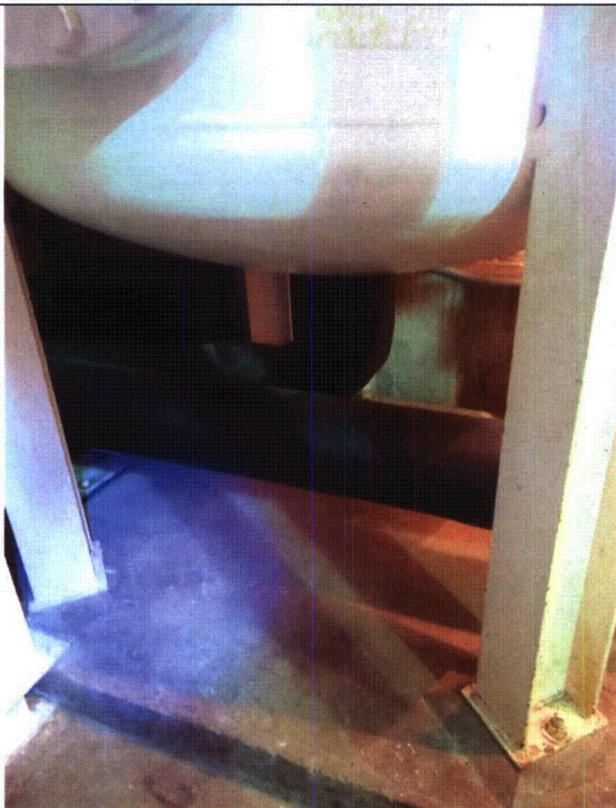
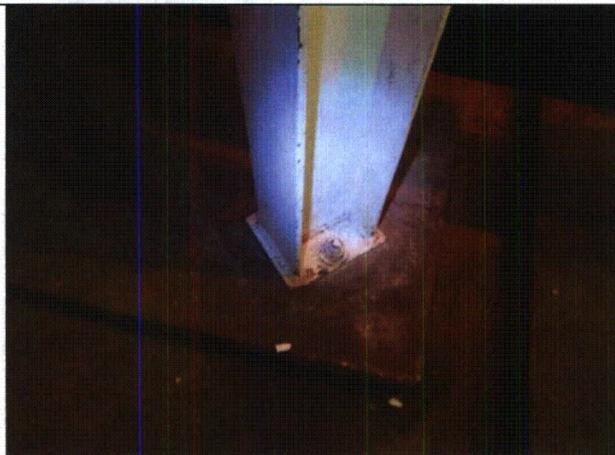
1TKSRWHD11 8-10-12 095

Equipment Description: SERVICE WATER HEAD TANK 11

2. Is the anchorage free of bent, broken, missing or loose hardware? Yes

3. Is the anchorage free of corrosion that is more than mild surface oxidation? Yes

4. Is the anchorage free of visible cracks in the concrete near the anchors? Yes

6. Based on the above anchorage evaluations, is the anchorage free of potentially adverse seismic conditions? Yes

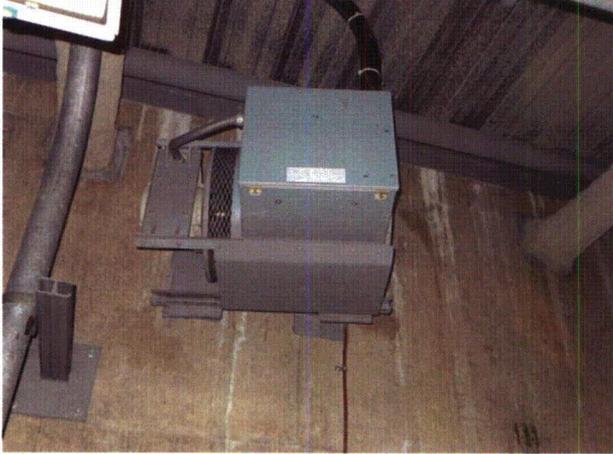
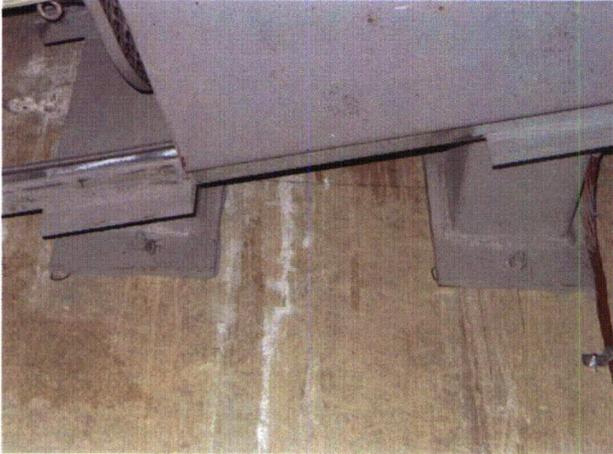
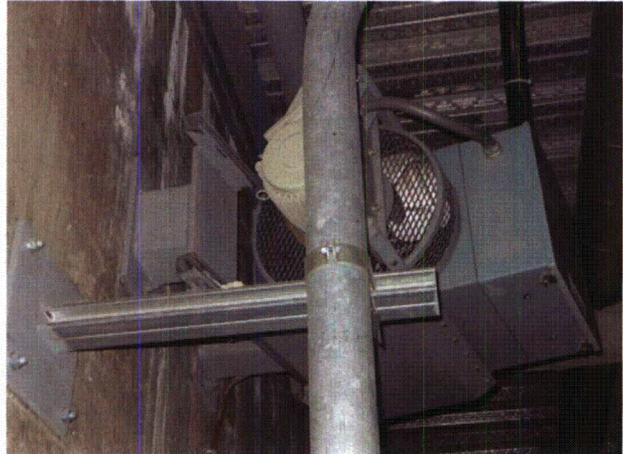
1U2311A 8-15-12 082

Equipment Description: BATTERY RM UH (UH-19); 480V 15KW

6. Based on the above anchorage evaluations, is the anchorage free of potentially adverse seismic conditions? Yes  
*The equipment is in-line with duct work.*

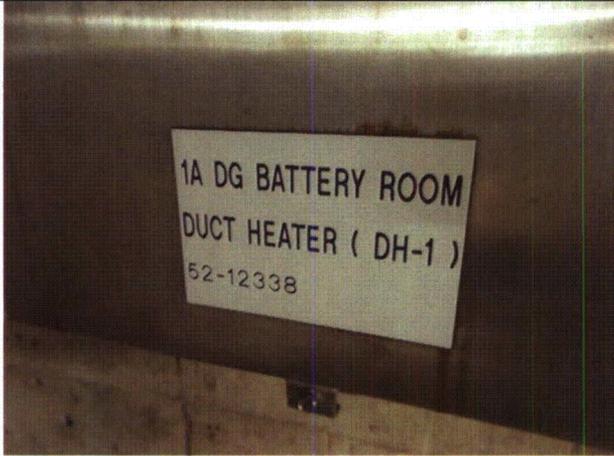
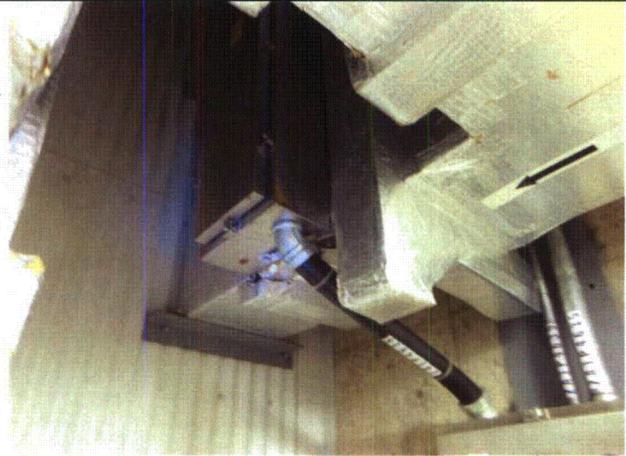
1U2338 8-15-12 077

Equipment Description: BATTERY RM DUCT HTR (DH-1)

2. Is the anchorage free of bent, broken, missing or loose hardware? No  
*Anchorage is inaccessible.*

3. Is the anchorage free of corrosion that is more than mild surface oxidation? No  
*Anchorage is inaccessible.*

4. Is the anchorage free of visible cracks in the concrete near the anchors? No  
*Anchorage is inaccessible.*

6. Based on the above anchorage evaluations, is the anchorage free of potentially adverse seismic conditions? No  
*Anchorage is inaccessible.*

11. Have you looked for and found no adverse seismic conditions that could adversely affect the safety functions of the equipment? No

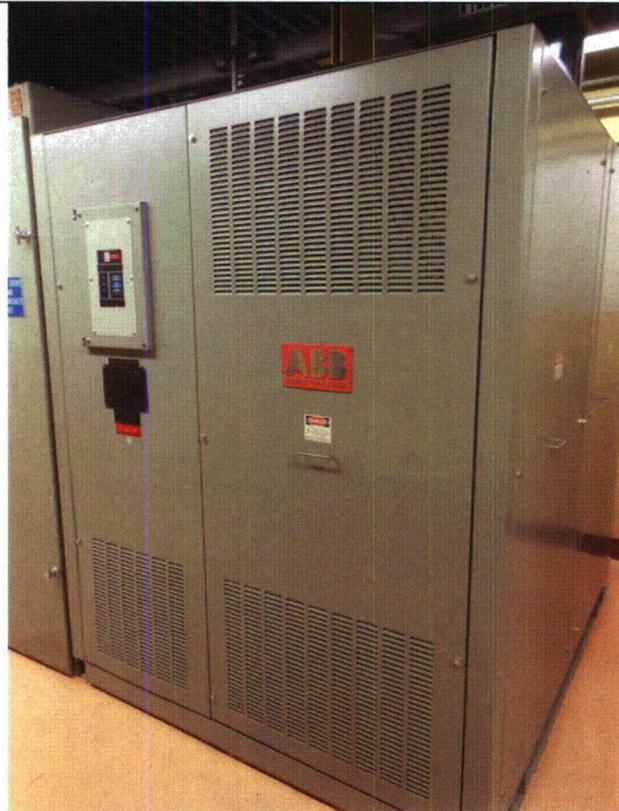
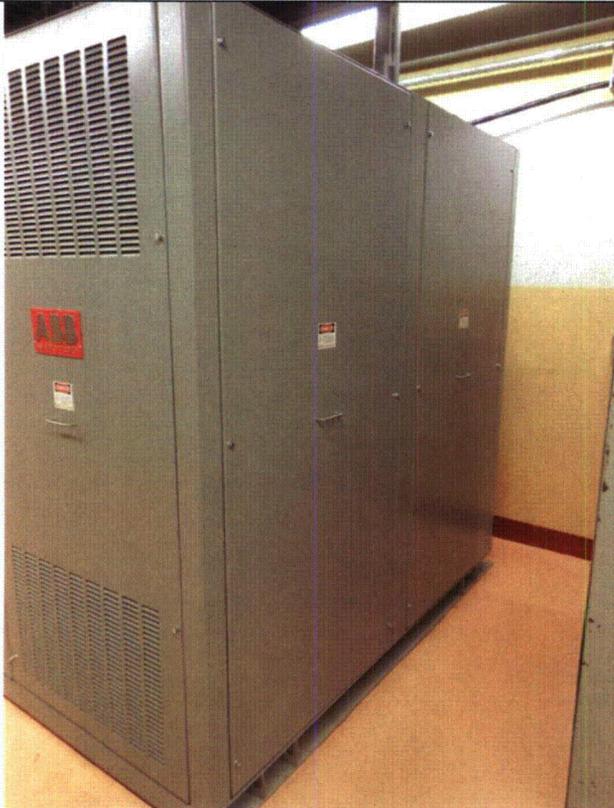
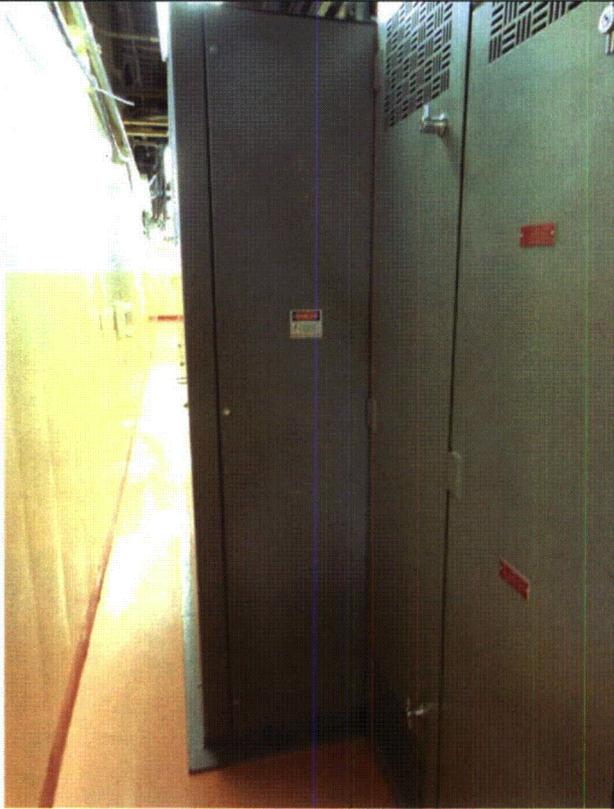
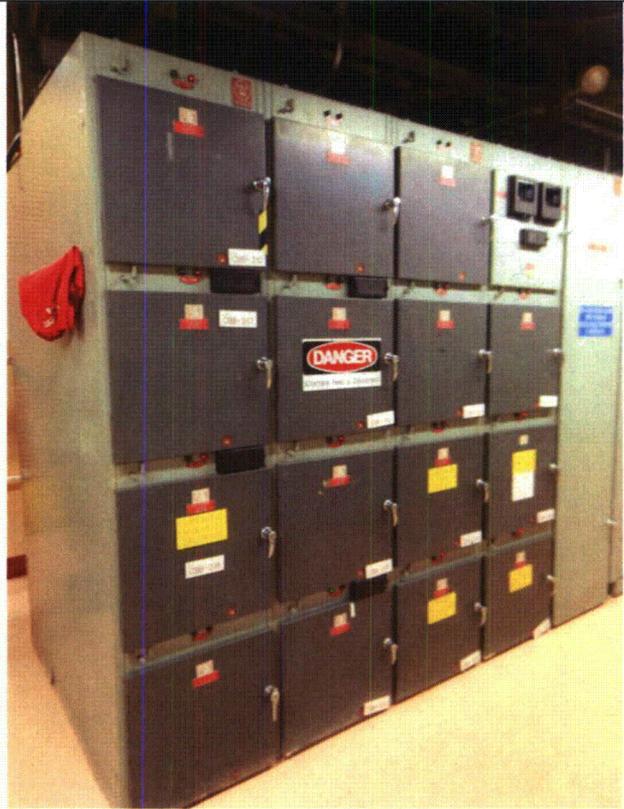
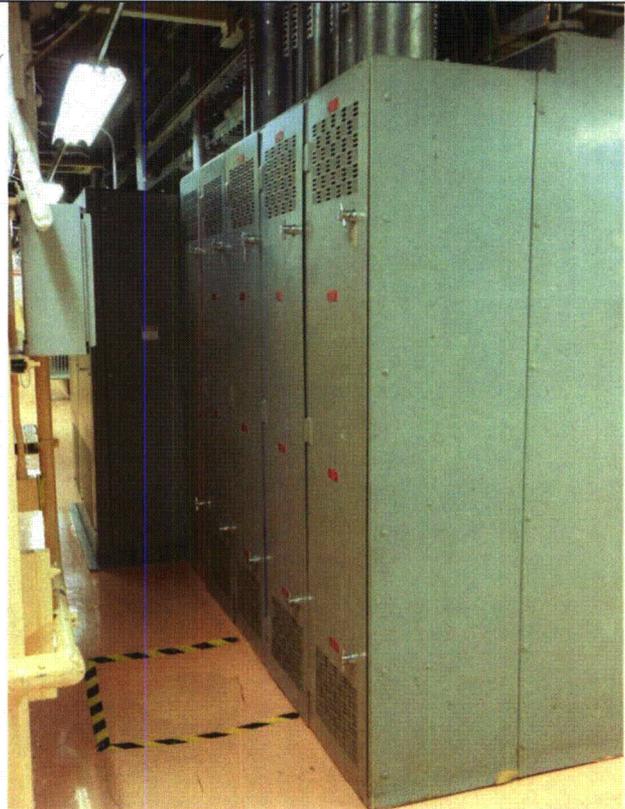
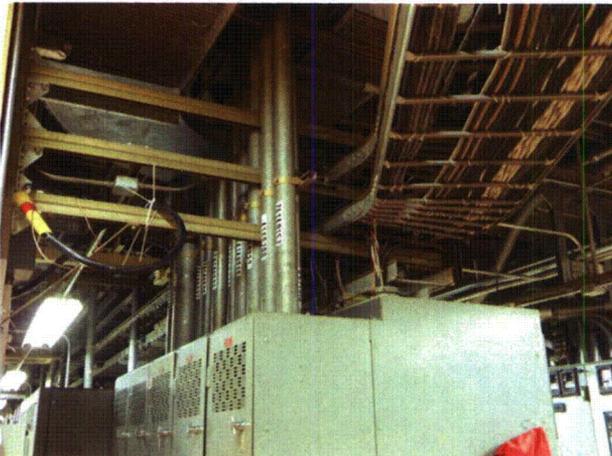
1XU-440-11A 8-15-12 177

Equipment Description: 480V XFMR U-440-11A
