ASME and NRC Discussion on Code Case N-766 Weld Inlay/Onlay Mitigation or Repair

Goals of the Meeting

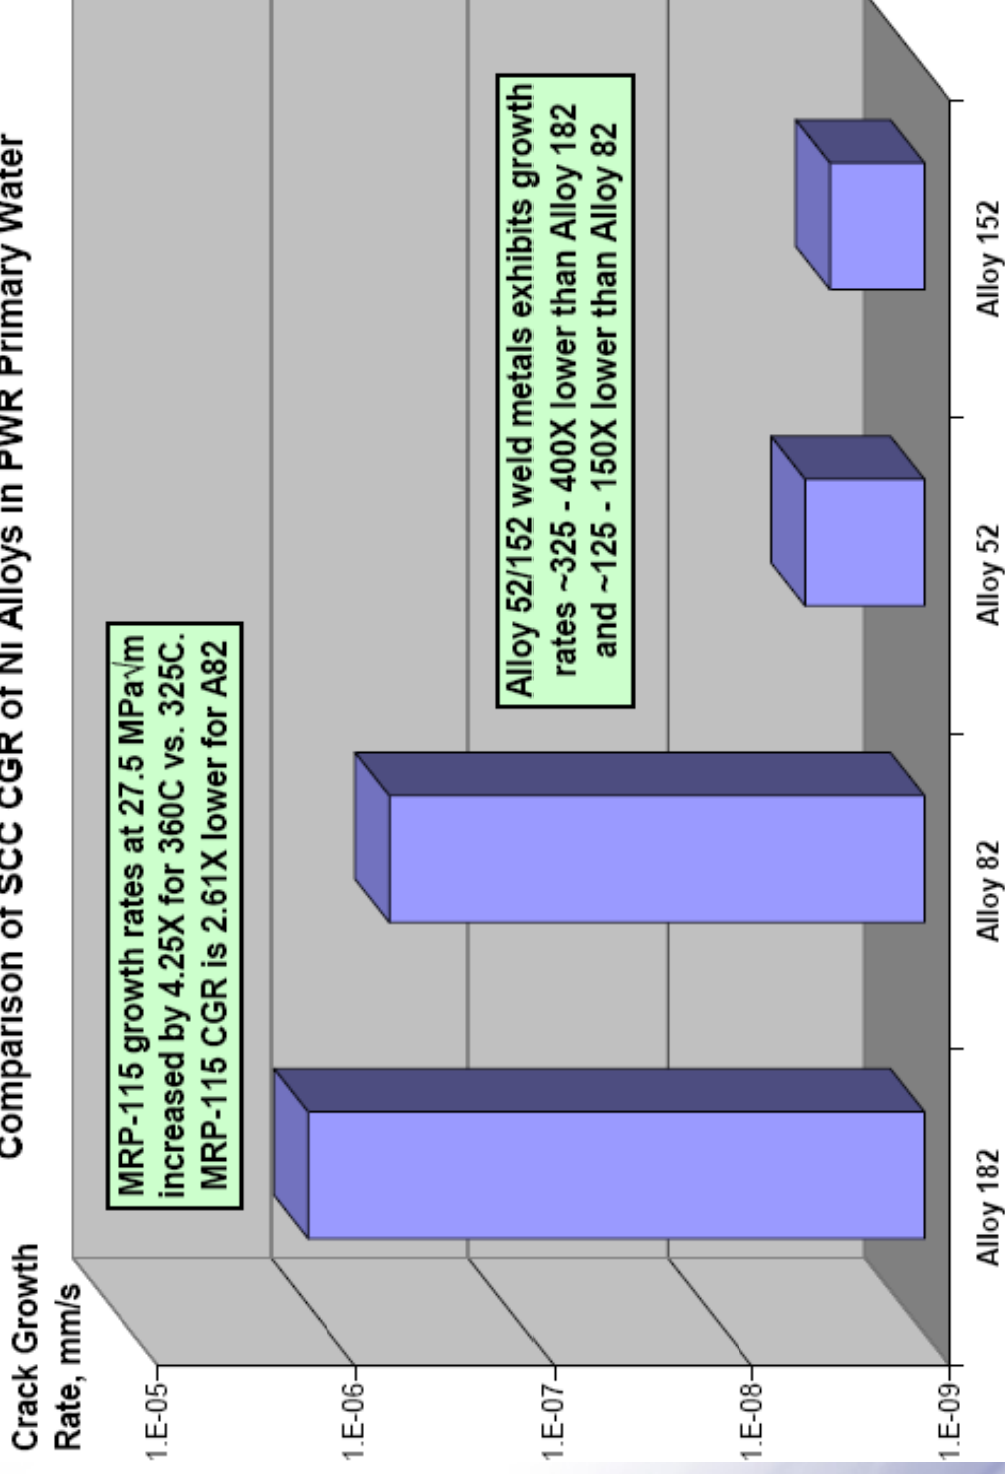
Recent GE/MRP Data suggests PWSCC rates are lower than used in NRC analysis

Comparison of SCC CGR of Ni Alloys in PWR Primary Water

MRP/GE
Data

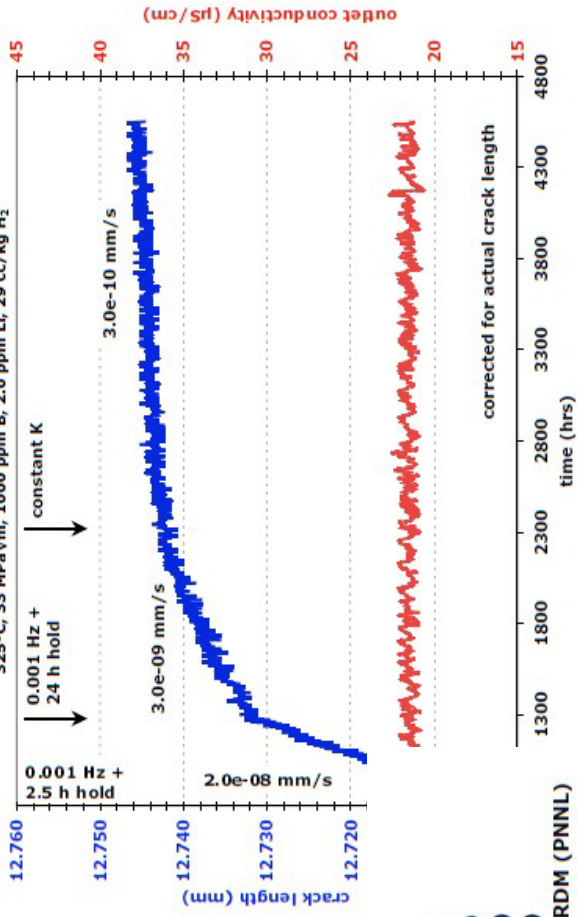
Recent PNNL Data suggests PWSCC rates are lower than used in NRC analysis

CT013 CGR, 0.5TCT MHI Kewaunee 152 mockup, sample NRC 152-C
325°C, 33 MPaV/m, 1000 ppm B, 2.0 ppm Li, 29 cc/kg H₂

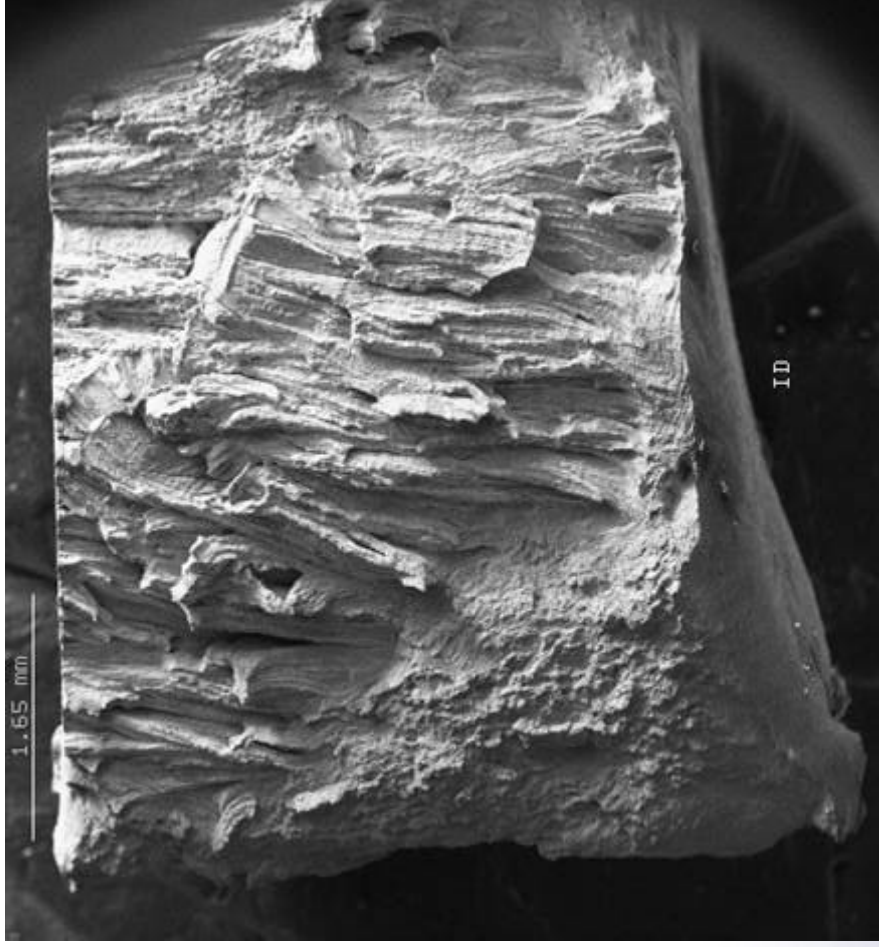
Surface and Subsurface PWSCC detected by Eddy Current Testing

- Volumetric (UT) and surface (ET and PT) examinations insure that surface and subsurface flaws are detected prior to inlay
- Volumetric and surface examination of the excavation so that unacceptable flaws are detected and removed or seal welded
- Eddy current has been demonstrated to reliably detect flaws smaller than 1/16 inch in size (0.060” long, up to 0.014” deep, and 0.002” wide)

- Successful field inspection confirmed with destructive metalography on VC Summer nozzle (Alloy 600 class materials). Detected axial and circumferential cracks in initiation and developed stages, including surface and subsurface ligaments.
- NUREG/CR6996, conclusions from this report have confirmed that the eddy current testing was the most useful technique for finding PWSCC on the J-groove weld (Alloy 600) and showed much higher sensitivity than any of the other techniques.
- Extensive laboratory testing on authentic samples representing fusion zones along DMW, excavated inlay cavities, and welded inlays have confirmed adequate signal-to-noise ratios when detecting short surface indications (1/16" long)

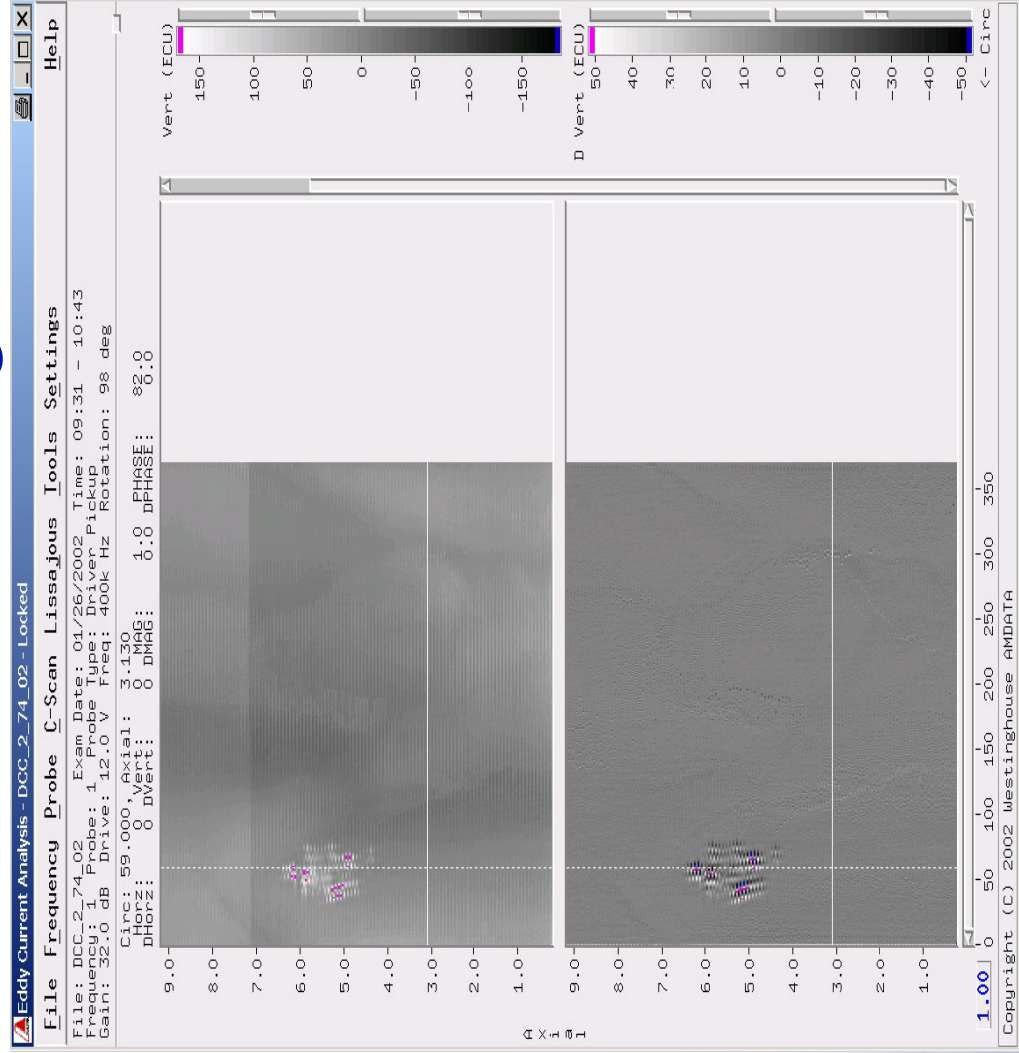
Sample ECT View: Craze Cracking
