Status: Y ☒ N ☐ U ☐**Seismic Walkdown Checklist (SWC)**Equipment ID No. 1R43-C001A Equip. Class<sup>1</sup> 12Equipment Description DG 1A AIR COMPRESSOR 1A1Location: Bldg. DIESEL Floor El. 130 Room, Area DIESEL GENERATOR ROOM 1A

Status: Y ☒ N ☐ U ☐**Seismic Walkdown Checklist (SWC)**Equipment ID No. 1R43-C001A Equip. Class<sup>1</sup> 12Equipment Description DG 1A AIR COMPRESSOR 1A1**Photographs**

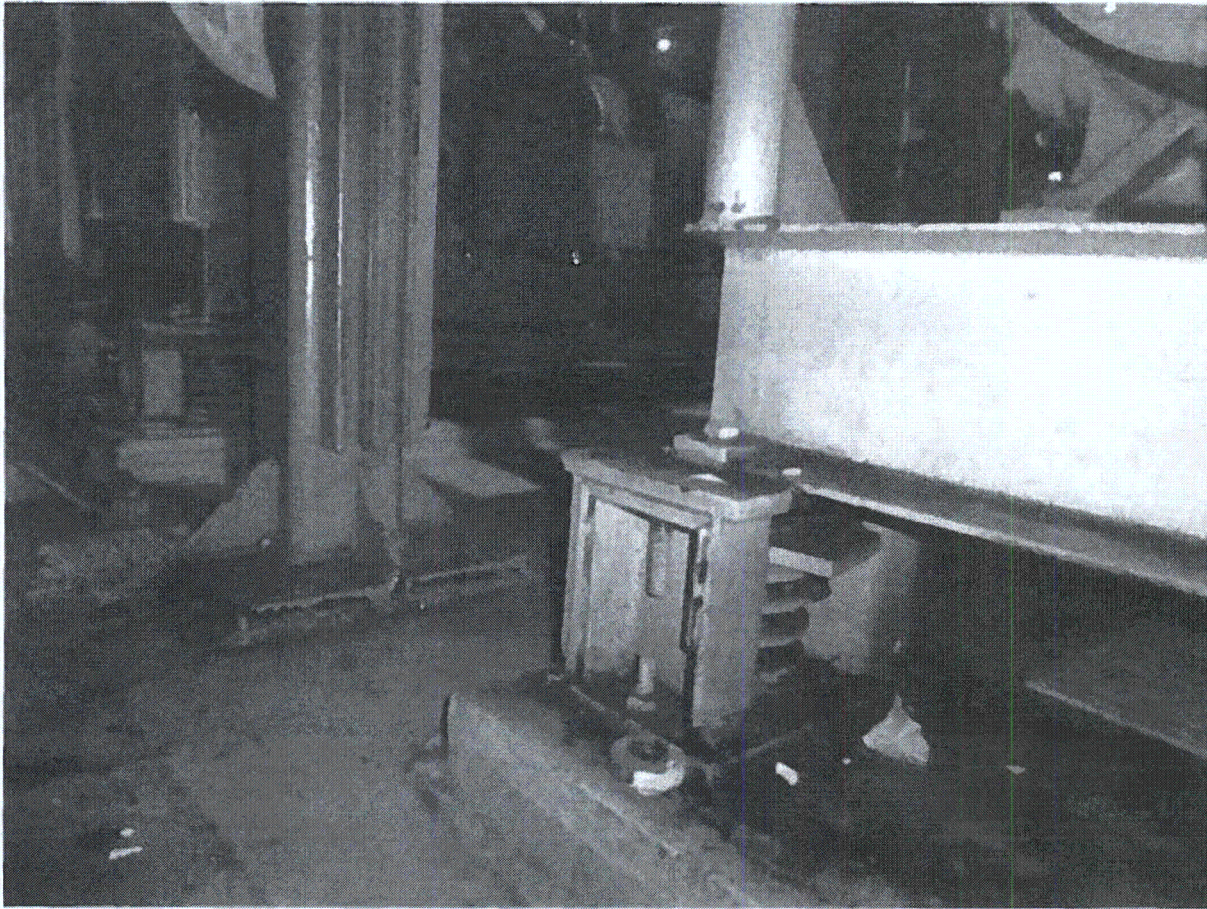
3: Southwest Support Missing Hardware (1Z41-B008A)

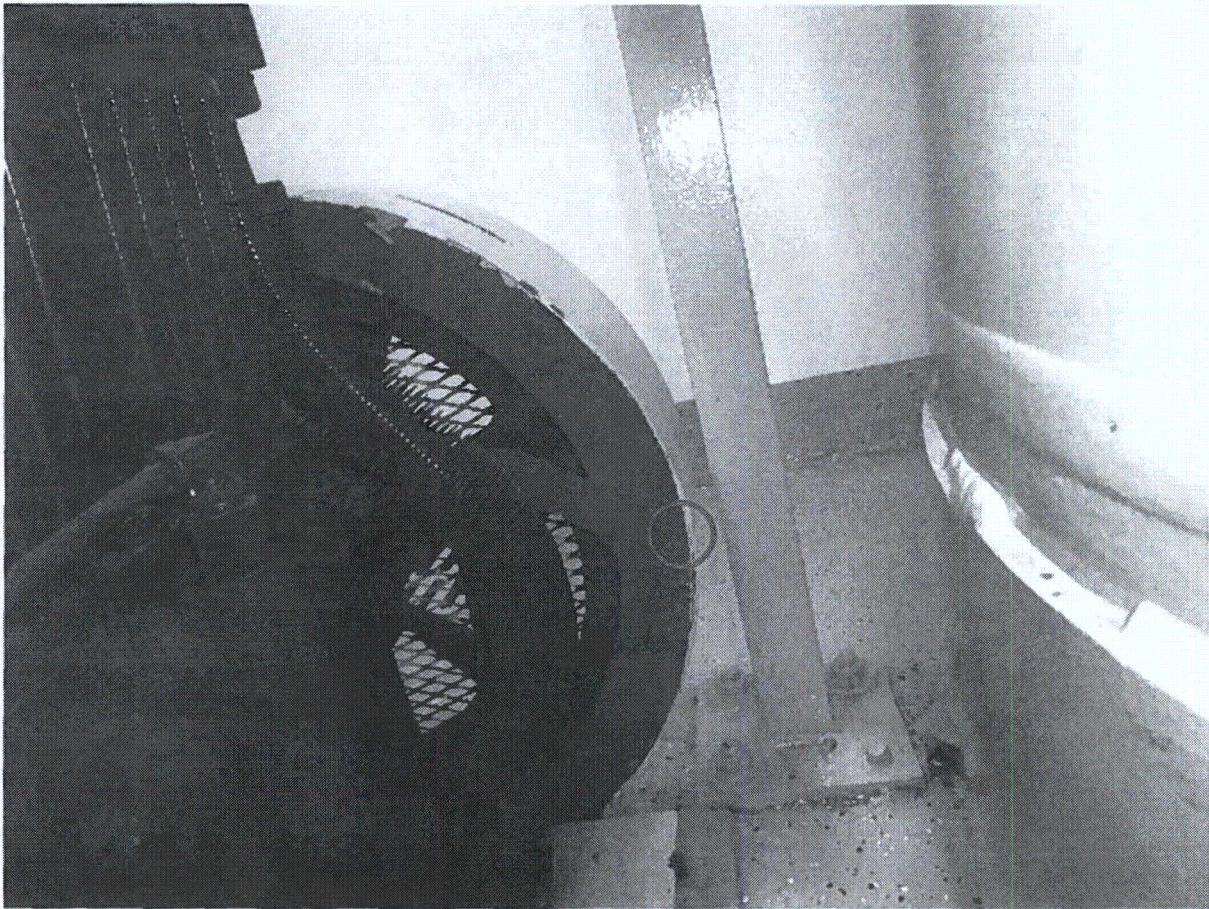
11. Have you looked for and found no other seismic conditions that could adversely affect the safety functions of the equipment? Y ☒ N ☐ U ☐  
*There is a missing screw on the fan belt housing cover plate for 1R43-C001A (see photograph 5). There are 7 other screws which are determined to be adequate to secure the cover plate. It is judged to be seismically adequate. CR 524556 has been written to install the missing screw.*

5: Missing Screw in Fan Belt Housing Enclosure (1R43-C001A)

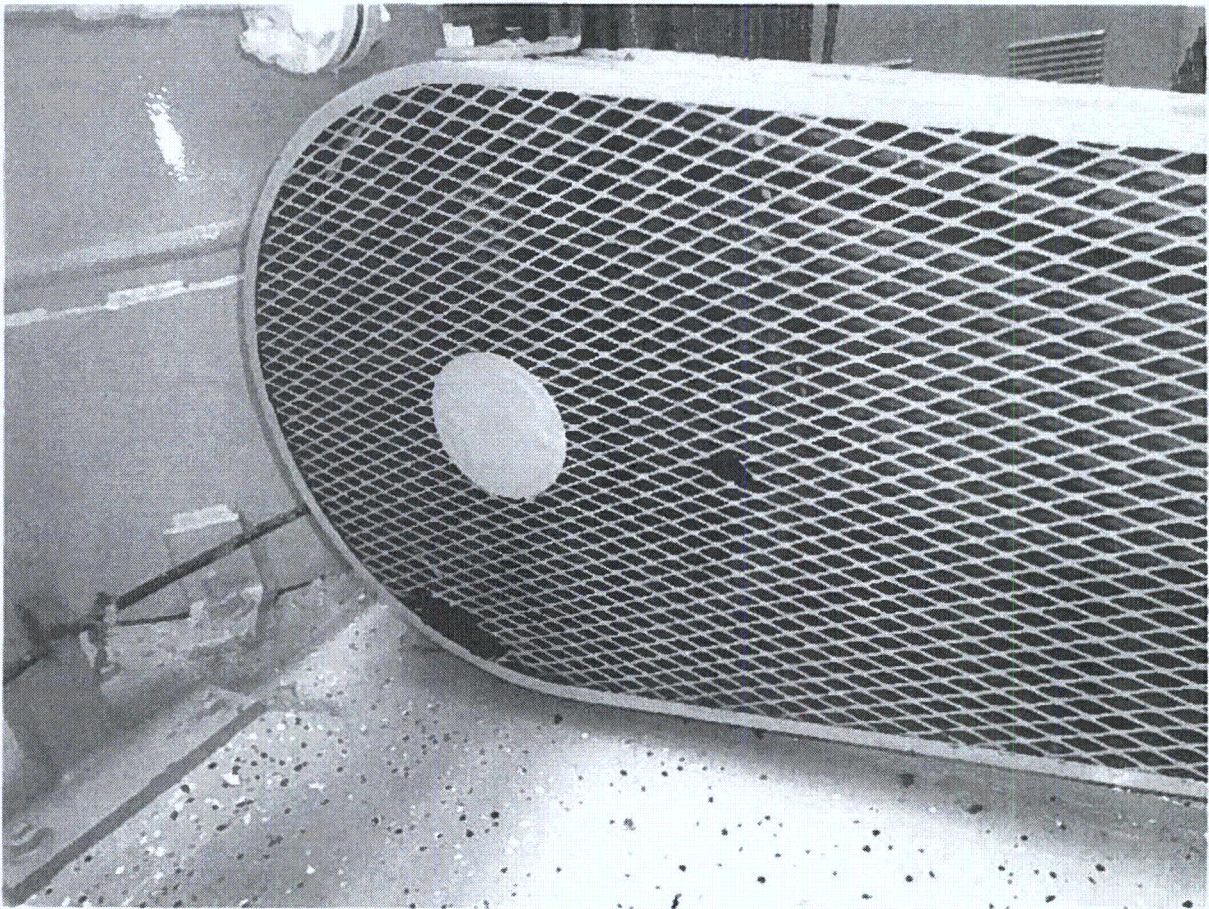
3: Fan Belt Enclosure Damage (1R43-C010B)

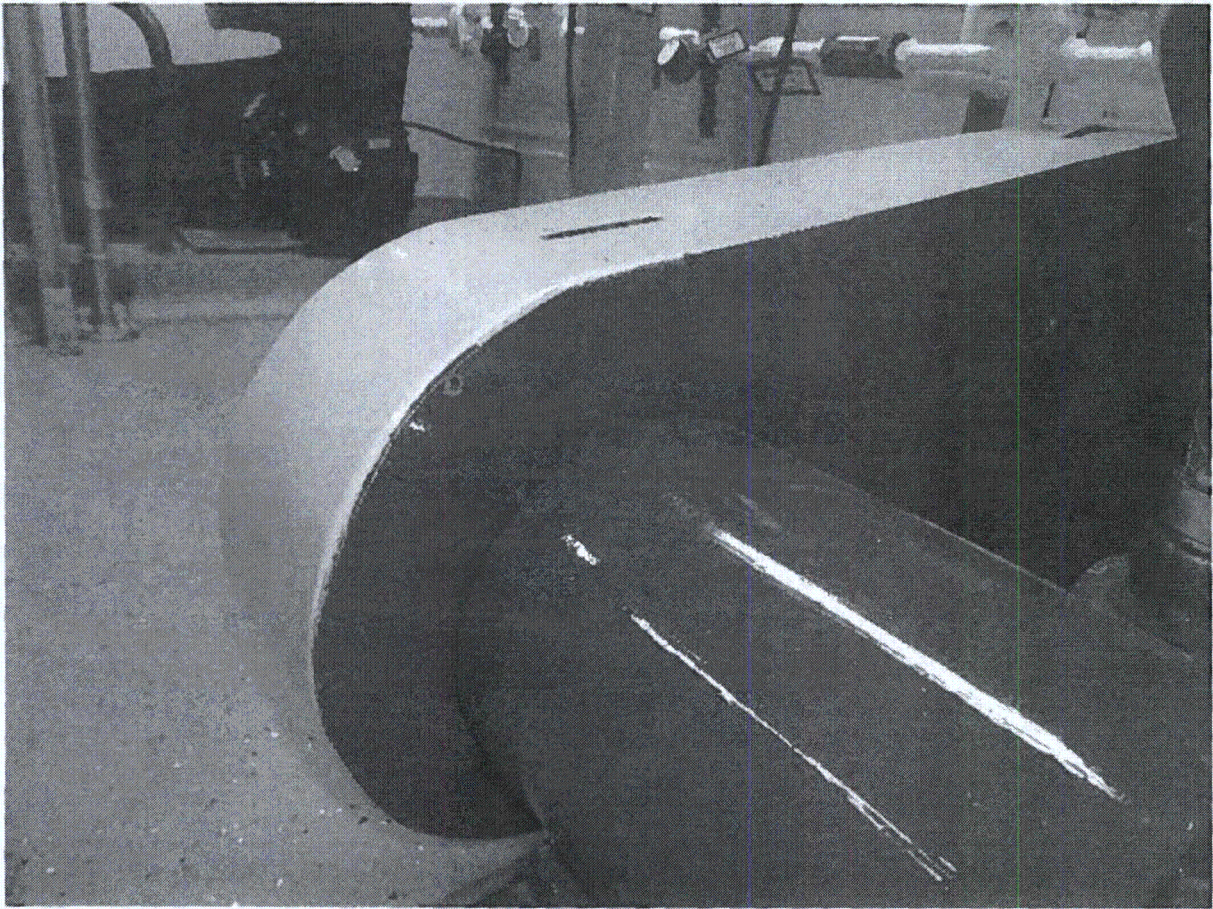
3: Fan Belt Enclosure Missing Screws (1R43-C010C)

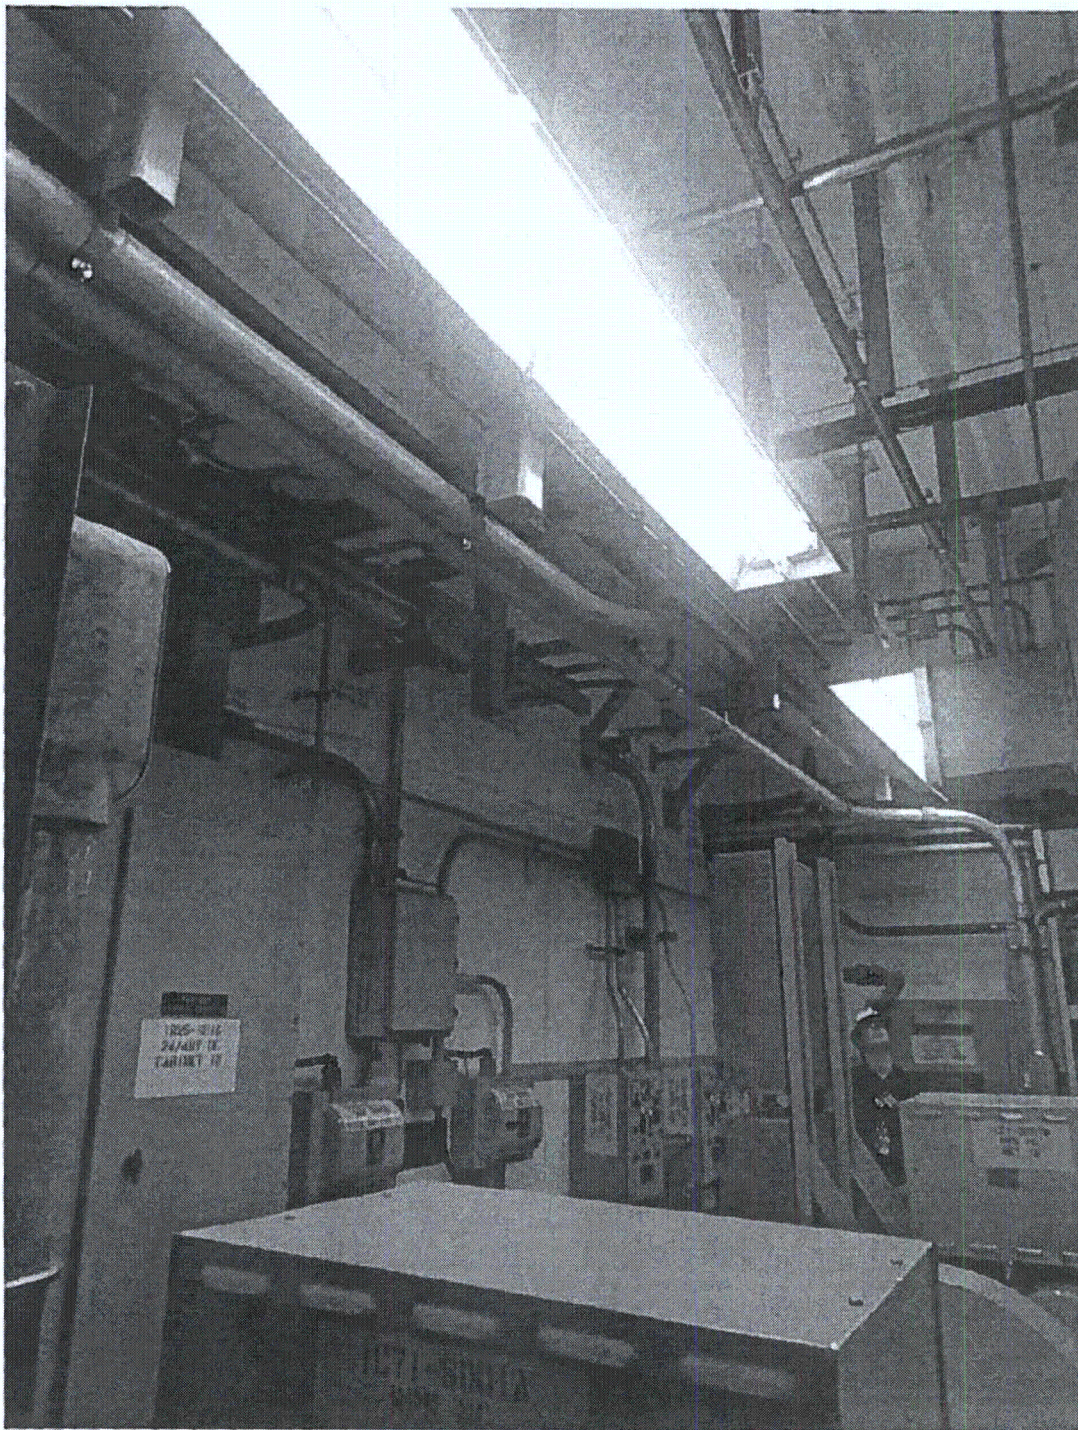
7. Are soft targets free from impact by nearby equipment or structures? Y ☒ N ☐ U ☐ N/A ☐
8. Are overhead equipment, distribution systems, ceiling tiles and lighting, and masonry block walls not likely to collapse onto the equipment? Y ☒ N ☐ U ☐ N/A ☐  
*The seismic capacity of the Concrete Block Walls C130-47E, C130-50B, C130-51A and C130-54A surrounding the Motor Generator were verified using Drawing H-40383 Rev. 2 and Hatch Unit 2 UFSAR Table 3.8-20.*  
*There is a fluorescent light fixture without a cover located over the component. The light is tied to the ceiling, so during a seismic event, only the bulb could fall. The motor generator is very rugged and is judged to have sufficient strength as to make a possible impact between the motor generator and the bulb will be insignificant. Therefore, it is judged to be seismically adequate.*

Figure 3 – Light Fixture over Motor Generator (1C71-S001A)

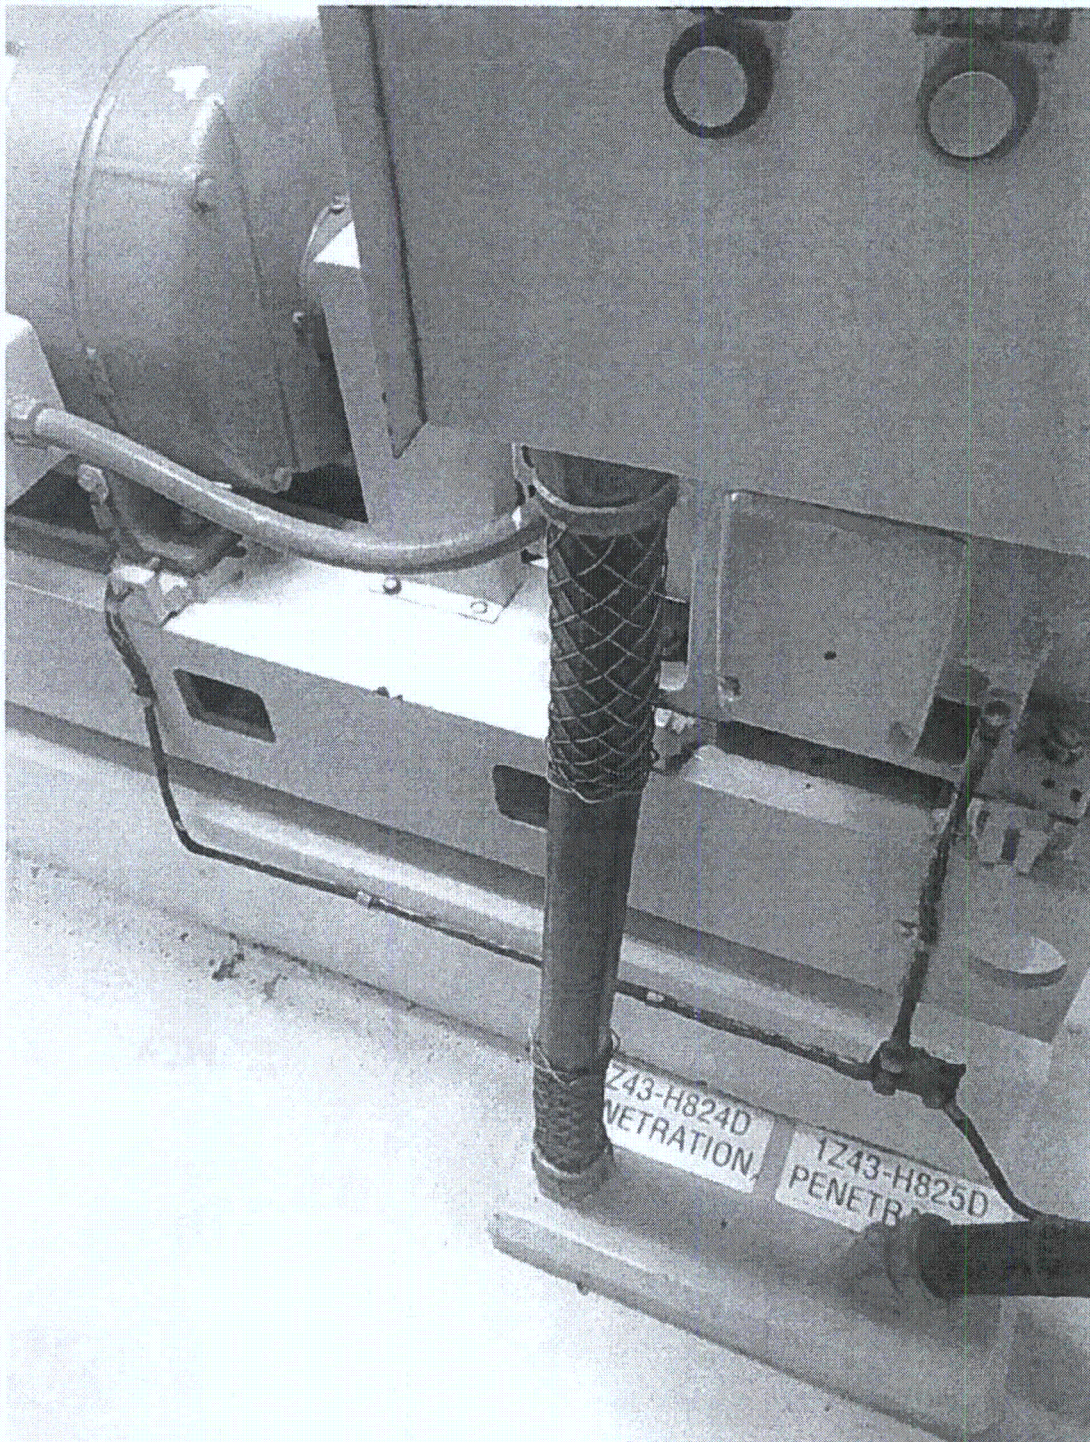
9. Do attached lines have adequate flexibility to avoid damage? Y ☒ N ☐ U ☐ N/A ☐  
*There is a section of flex conduit between the motor generator and a conduit support with limited slack. The motor generator is rigidly attached to the floor and has a low center of gravity, and the conduit support is rigidly attached to the floor. Therefore, there will not be much differential movement between the two ends of the flex conduit. The existing slack is judge to be sufficient for the very small differential movement, so there is no potentially adverse seismic condition.*

Figure 4 – Flex Conduit with Limited Slack (1C71-S001A)

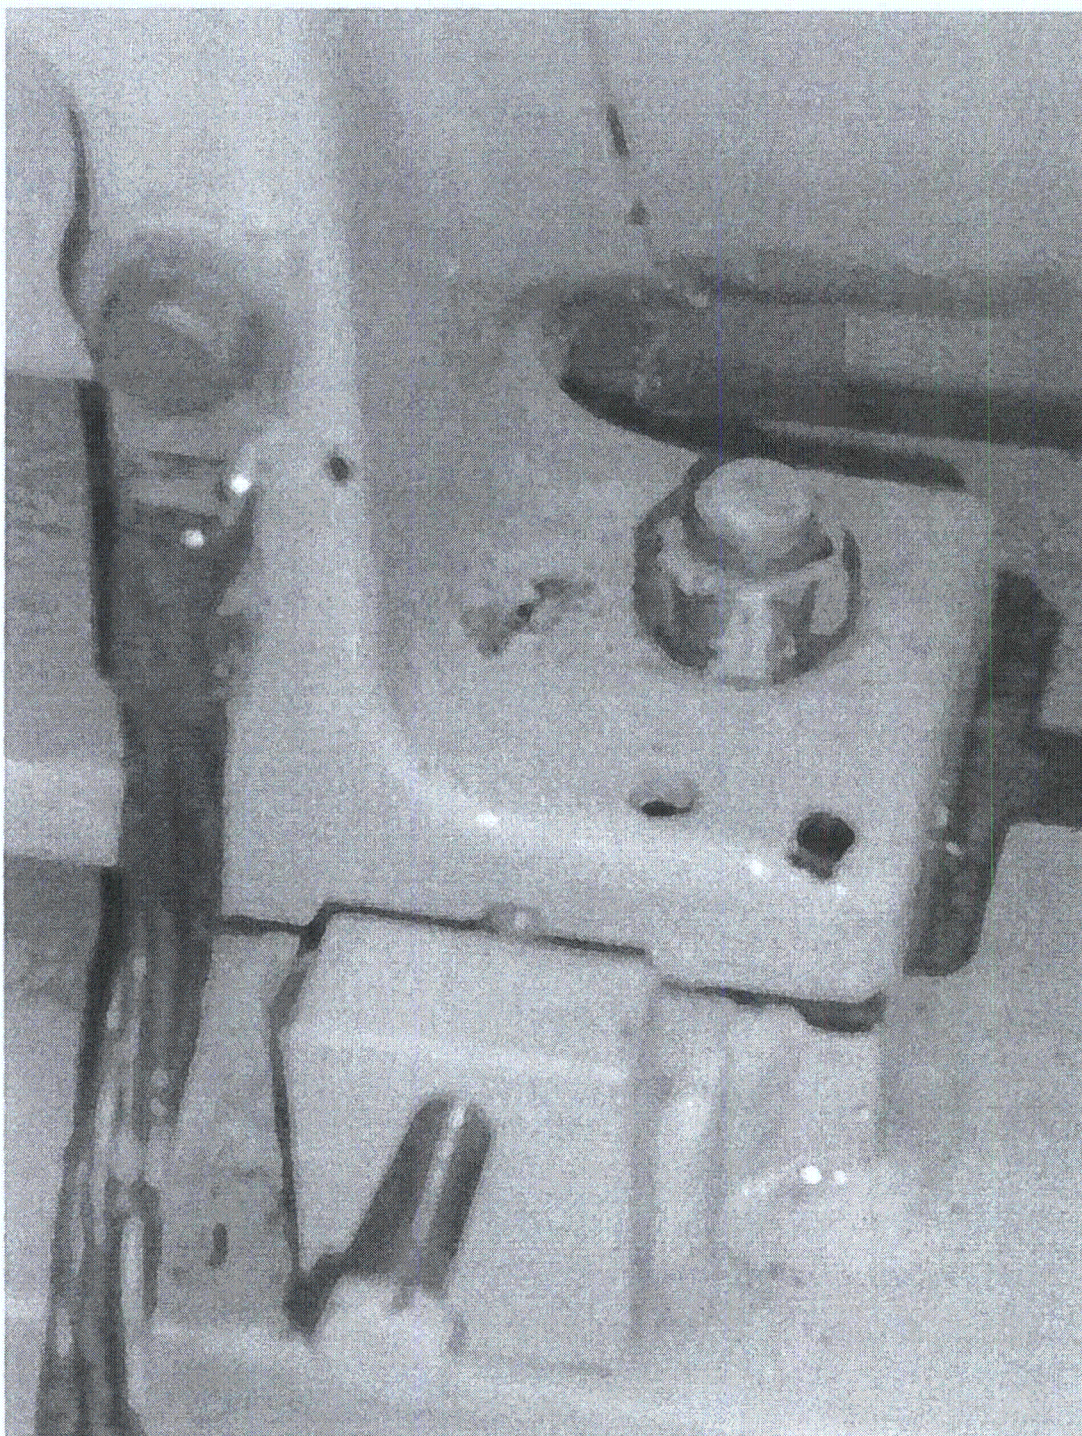
11. Have you looked for and found no other seismic conditions that could adversely affect the safety functions of the equipment? Y ☒ N ☐ U ☐  
*There are a number of drilled holes in the casing of the motor, particularly at anchorage locations. These holes appear to have been drilled to alter the balance of the motor and are clearly unrelated to component anchorage. Their presence does not indicate missing anchors or screws. Therefore, there is no potentially adverse seismic condition.*

Figure 5 – Stability Holes Drilled in Motor Generator Casing (1C71-S001A)

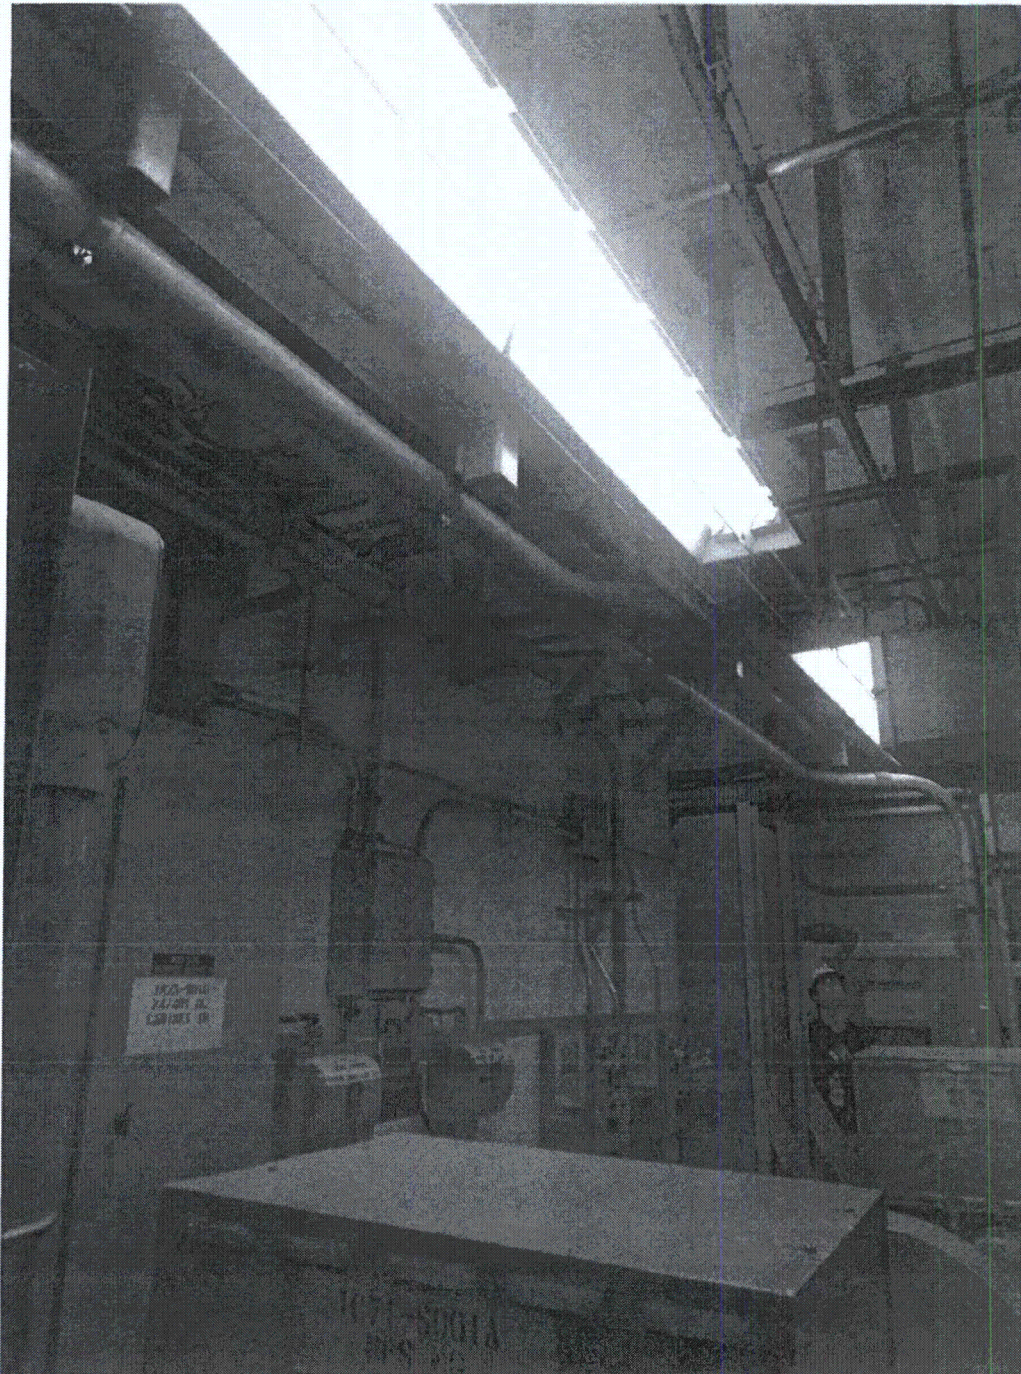
*There is a fluorescent light fixture without a cover located over the component. The light is tied to the ceiling, so during a seismic event, only the bulb could fall. The motor generator is very rugged and is judged to have sufficient strength as to make a possible impact between the motor generator and the bulb insignificant. Therefore, it is judged to be seismically adequate.*

Figure 3 – Fluorescent Light over Equipment (1C71-S001B)

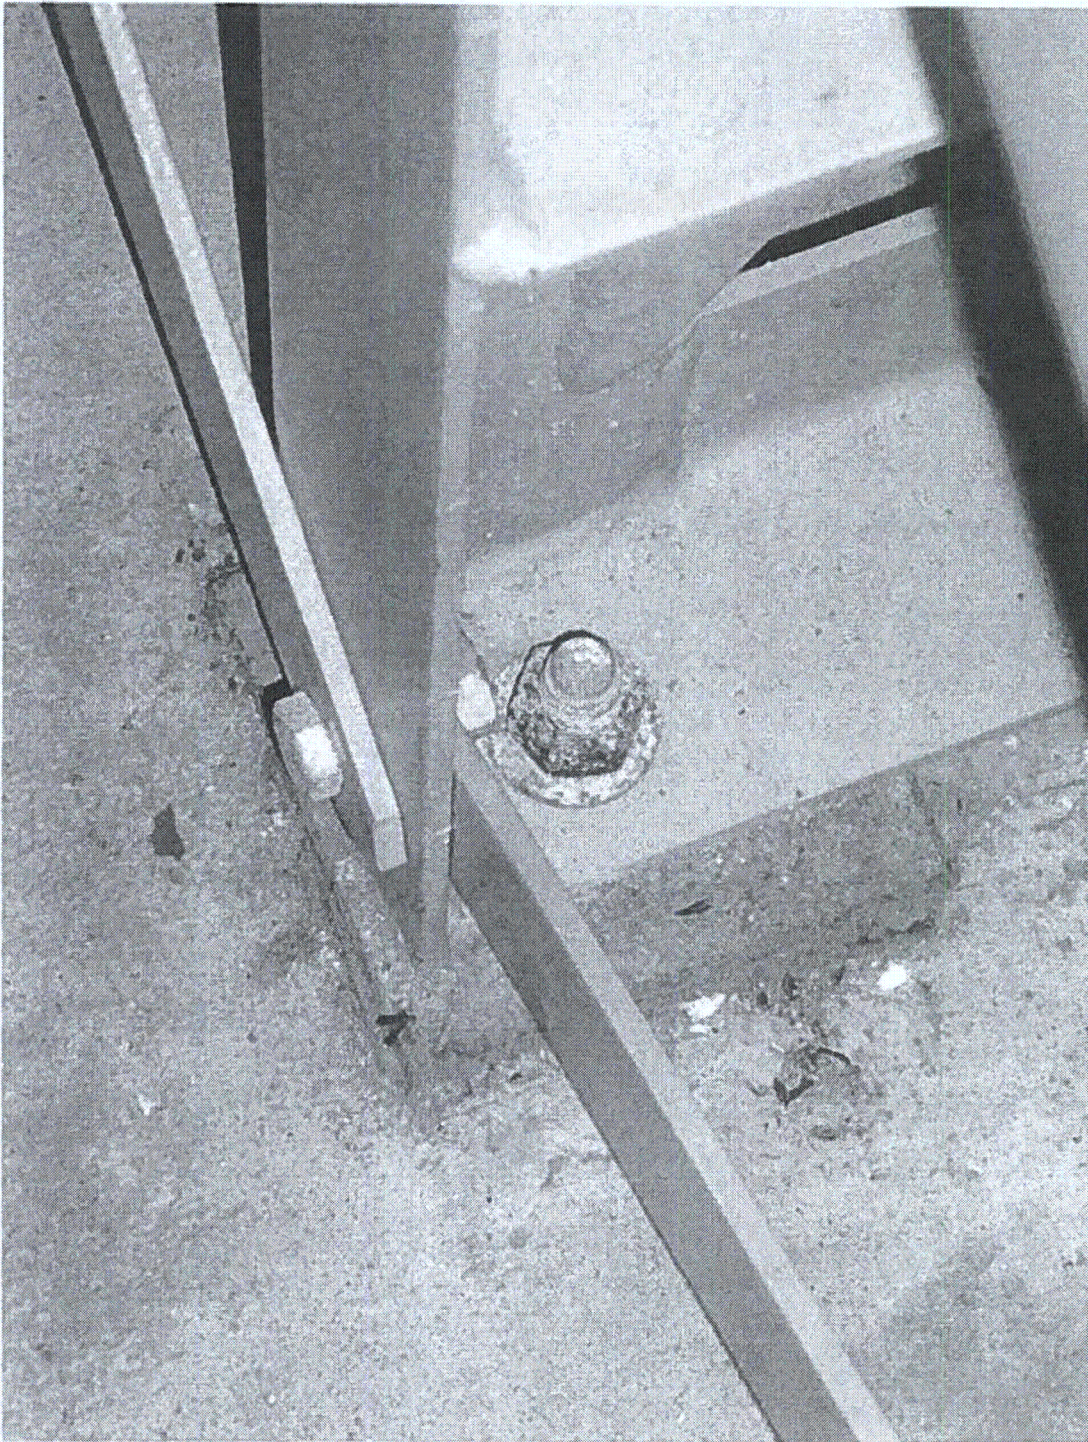
3. Is the anchorage free of corrosion that is more than mild surface oxidation? Y ☒ N ☐ U ☐ N/A ☐  
*There is mild surface oxidation on one of the anchor bolts. Since oxidation is only on the surface, the bolts are not degraded. Therefore, judged not to be a concern.*

Figure 3 – Surface Oxidation on Anchor Bolt (1R42-S002B)
