Seismic Walkdown Checklist (SWC)

Equipment ID No.: 2-XPC-211

Project: DC Cook 2 SWEL

Area Walk-by Checklists (AWCs)

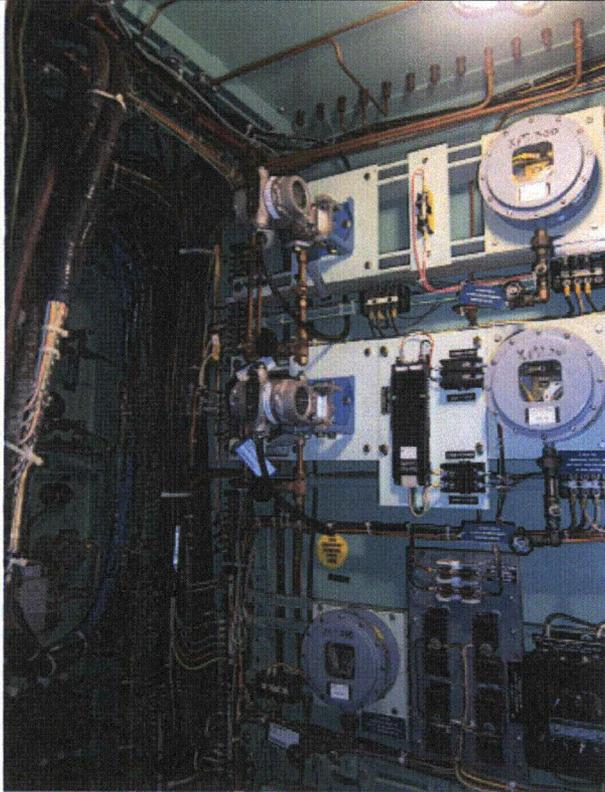
P9130465

Equipment Description: XMTR

4. Is the anchorage free of visible cracks in the concrete near the anchors? Not Applicable
Unistrut mounted to bracket/moount

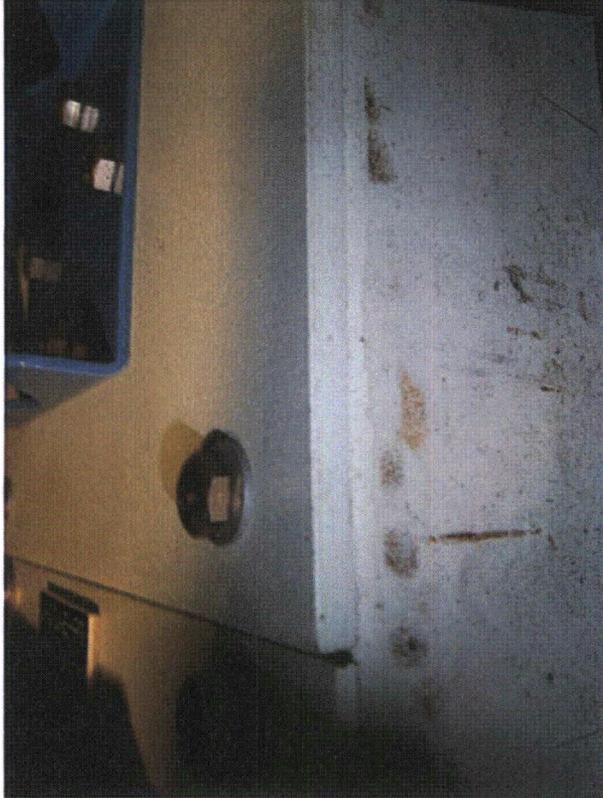
P9130467

Equipment Description: AB EMER DIESEL STARTING AIR RECEIVER QT-141-AB1 PRESSURE
XMTR

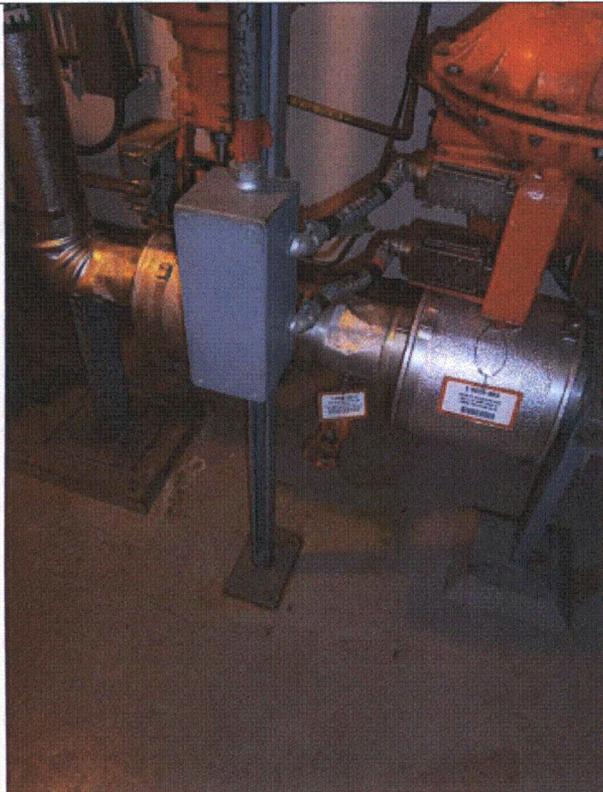
P9100271

5. Does it appear that the area is free of potentially adverse seismic interactions that could cause flooding or spray in the area? No
Fire protection - wet - threaded rod hung pipe - AR 2012-11738 was issued.
