**Seismic Walkdown Checklist (SWC)**

**Table C-2. Unit 0 Seismic Walkdown Checklists (SWCs)**

Peach Bottom Atomic Power Station Unit 2  
MPR-3815, Revision 3  
Correspondence No. RS-12-173

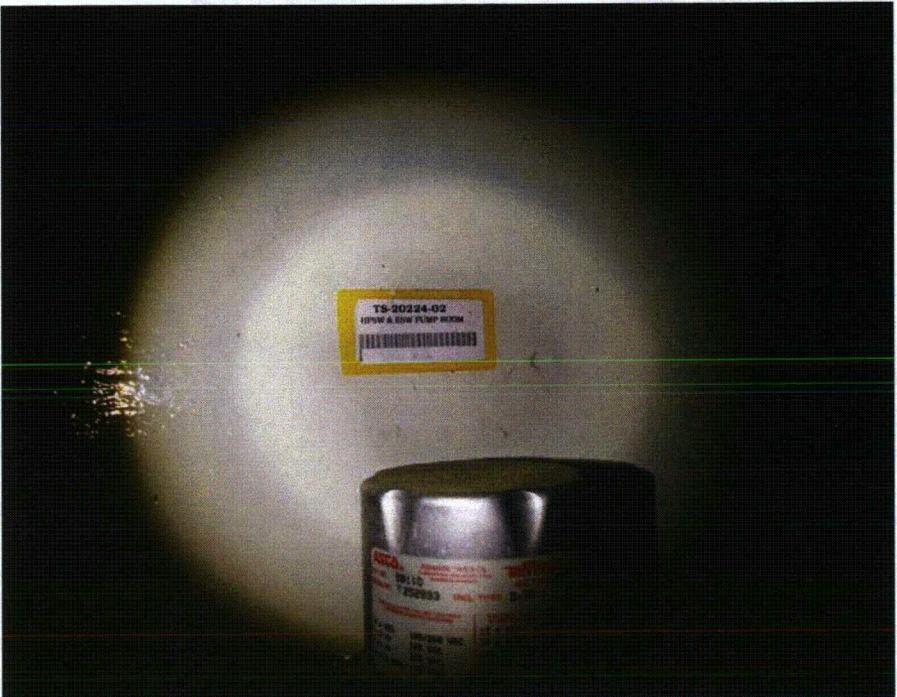
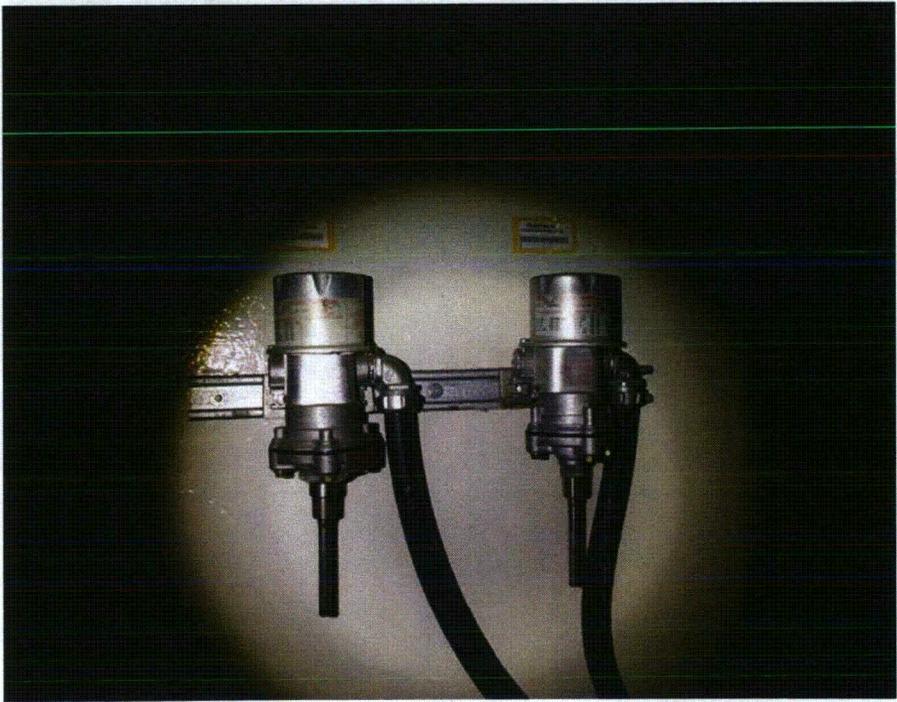
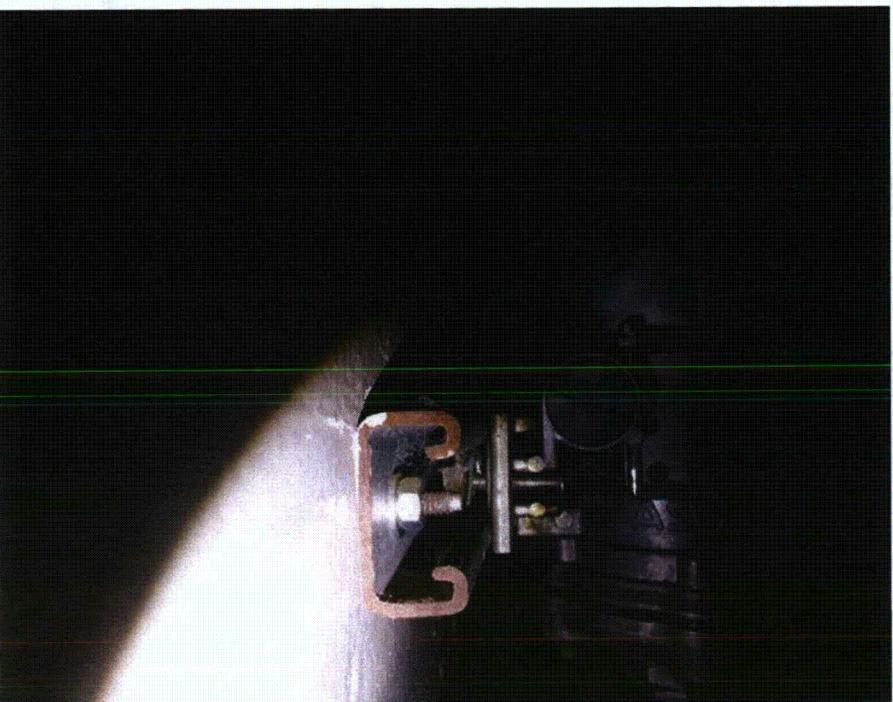
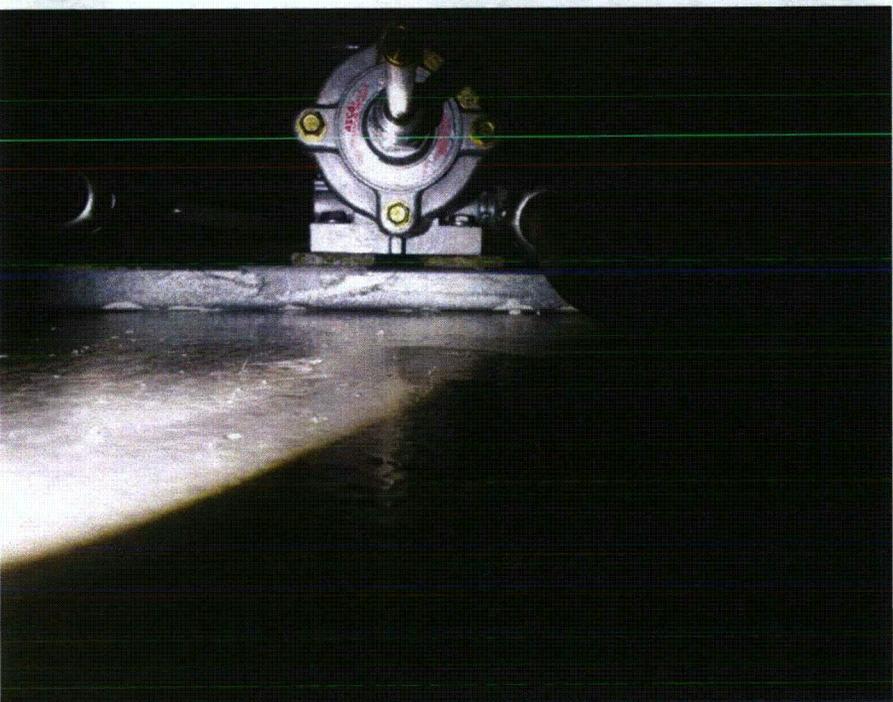
2. Is the anchorage free of bent, broken, missing or loose hardware?  Y  N  U  N/A  
*Anchorage is in good condition.*

*No II/I issues identified.*

*Adjacent scaffolding is secure.*

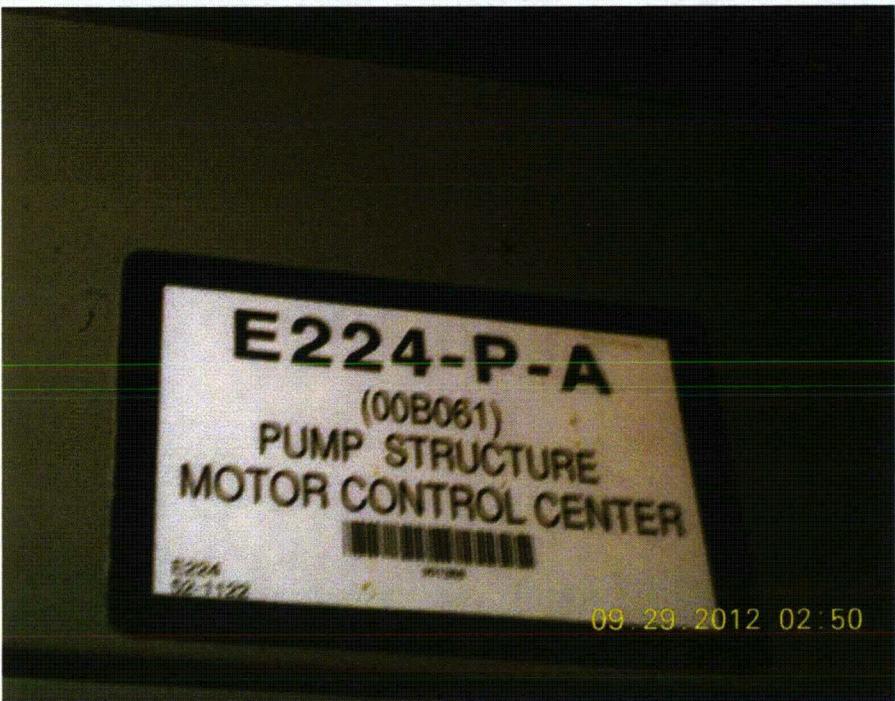
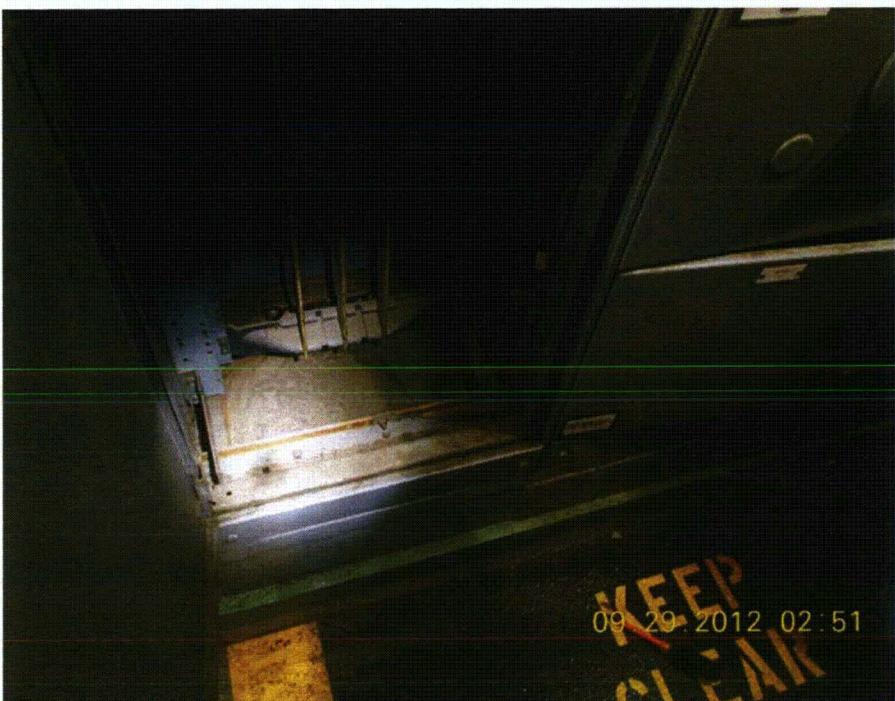
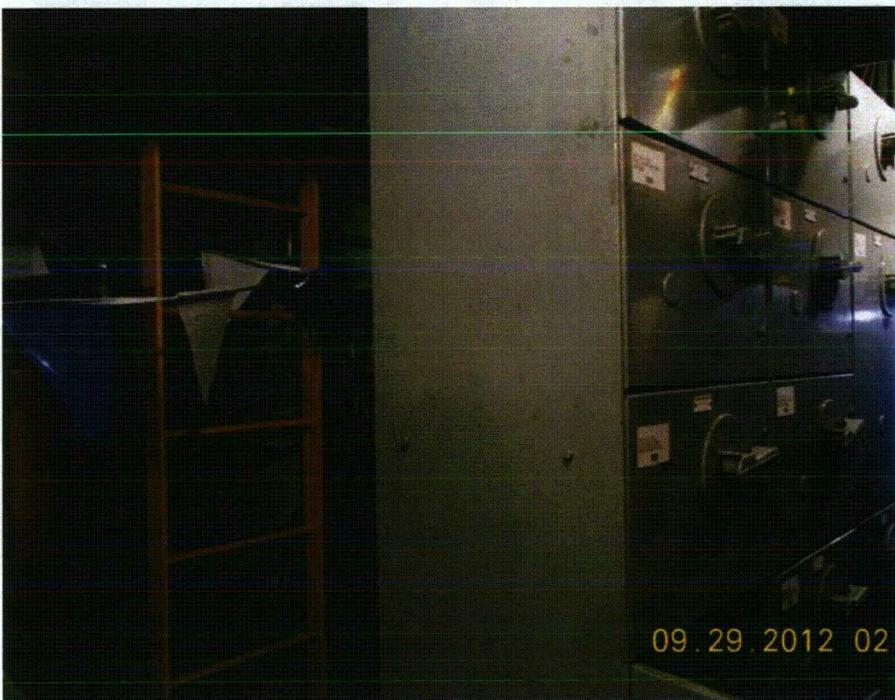
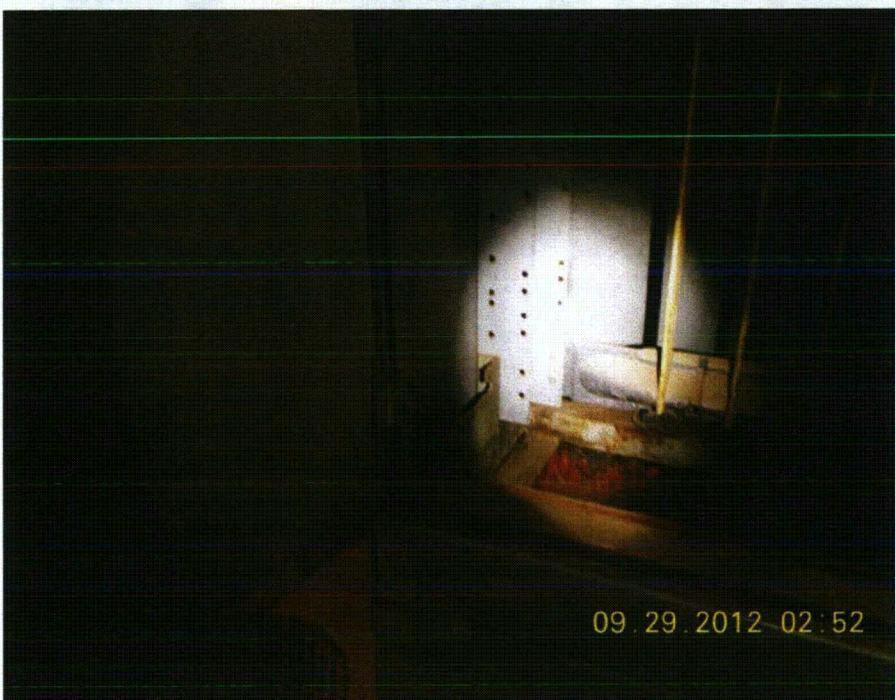
Equipment ID: 00B061

2. Is the anchorage free of bent, broken, missing or loose hardware?  Y  N  U  N/A  
*Anchorage in good condition*

3. Is the anchorage free of corrosion that is more than mild surface oxidation?  Y  N  U  N/A  
*Mild corrosion deemed acceptable.*

*No I/I issues identified.*

*Scaffolding + temporary outage related equipment secure*

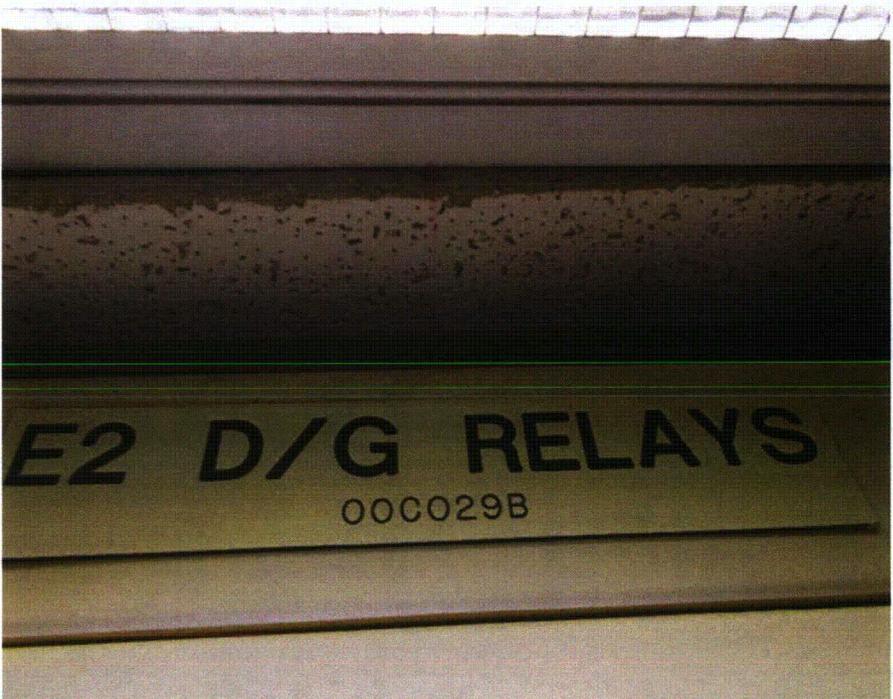
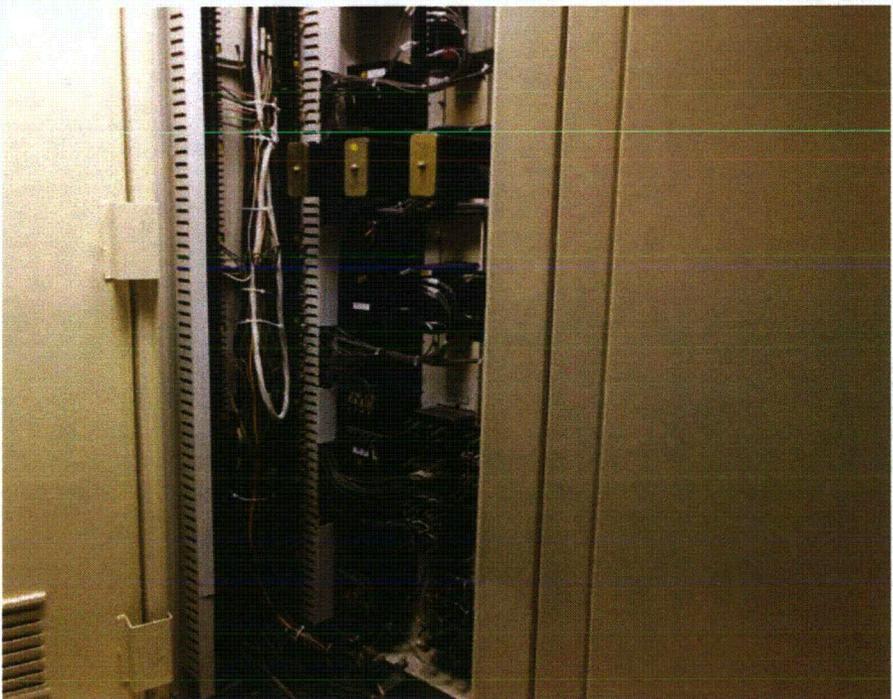
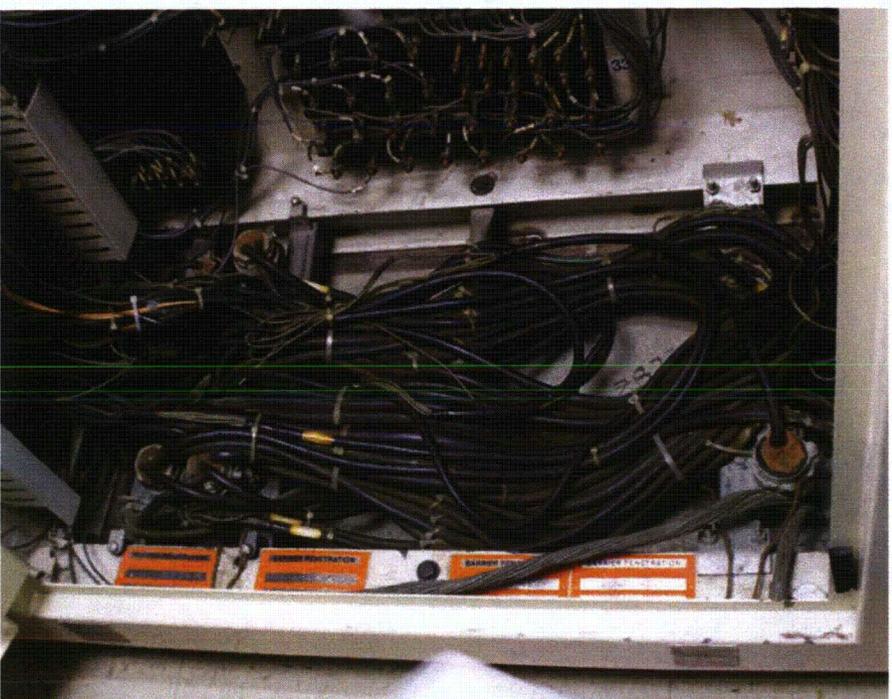
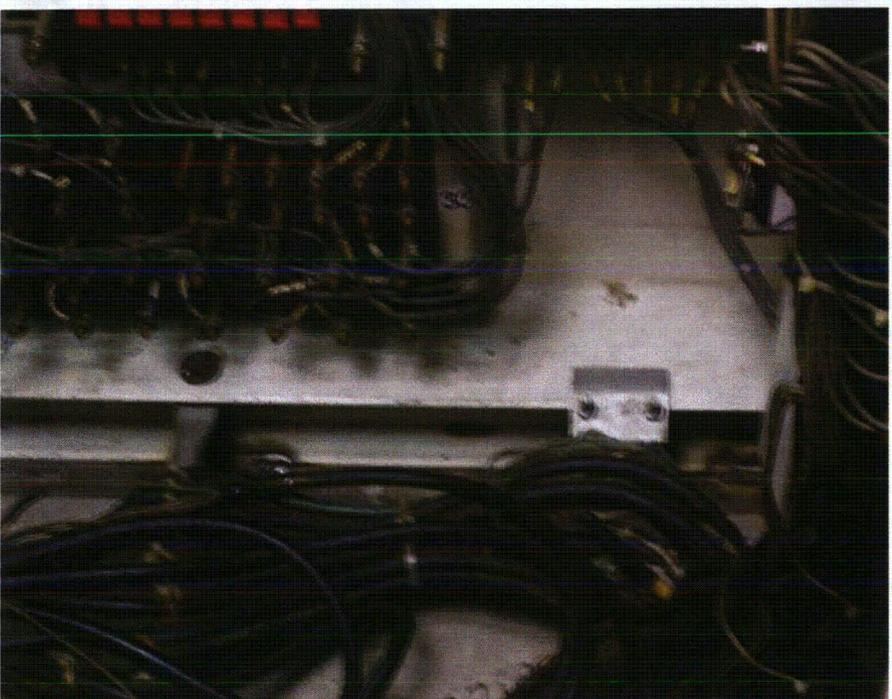
Equipment ID: 00C029B

4. Is the anchorage free of visible cracks in the concrete near the anchors?  
*embedded channel in concrete. No cracks around embedded channel.*  Y  N  U  N/A

5. Is the anchorage configuration consistent with plant documentation?  
 (Note: This question only applies if the item is one of the 50% for which an anchorage configuration verification is required.)  
*- Cabinet bolted to adjacent cabinets.*  Y  N  U  N/A

6. Based on the above anchorage evaluations, is the anchorage free of potentially adverse seismic conditions?  
*- Anchorage confirmed per ~~6880-S~~ <sup>SAC 9/25/12</sup> S-1197 sheet 1 of 3, Rev 0, and sheet 2 of 3, Rev 0.*  Y  N  U

7. Are soft targets free from impact by nearby equipment or structures?  Y  N  U  N/A  
*No soft targets outside of panel*
8. Are overhead equipment, distribution systems, ceiling tiles and lighting, and masonry block walls not likely to collapse onto the equipment?  Y  N  U  N/A  
*2'x2' ceiling tiles. Damage not credible from falling tiles*
9. Do attached lines have adequate flexibility to avoid damage?  Y  N  U  N/A  
*No attached lines*
10. Based on the above seismic interaction evaluations, is equipment free of potentially adverse seismic interaction effects?  Y  N  U

*IPEEE - Items will be removed or restrained (housekeeping).  
 - No housekeeping issues observed.*

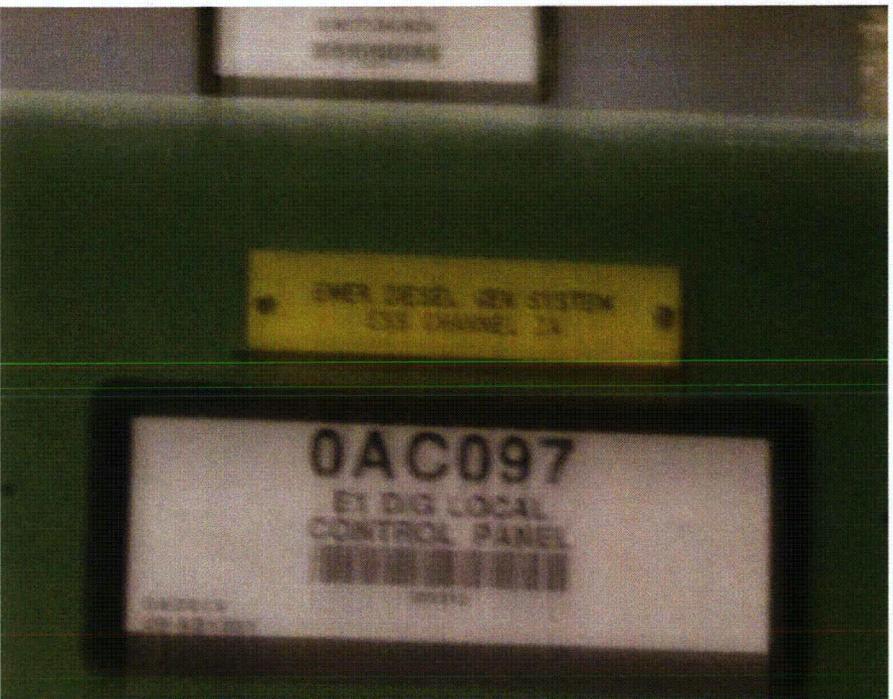
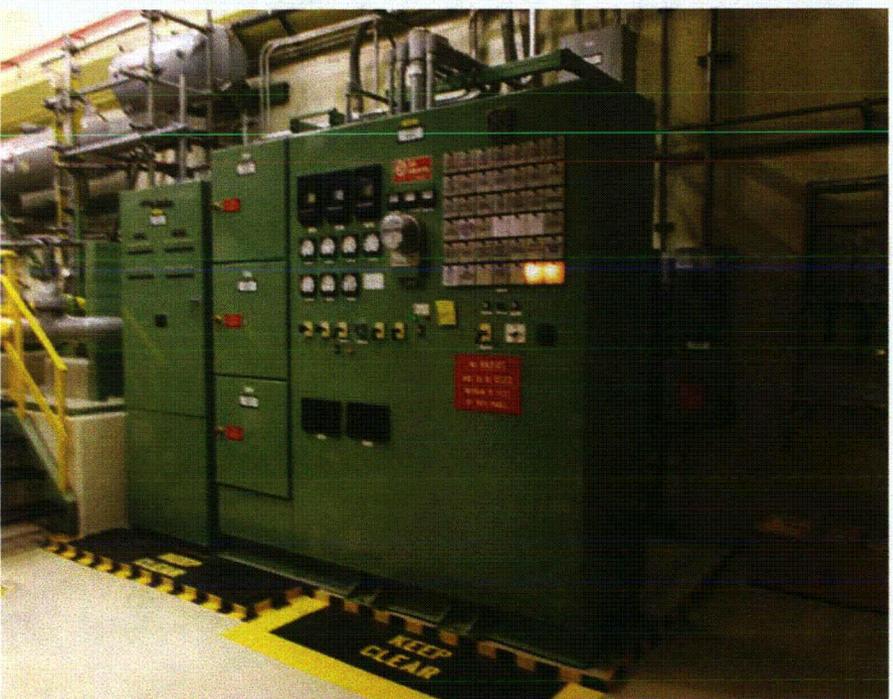
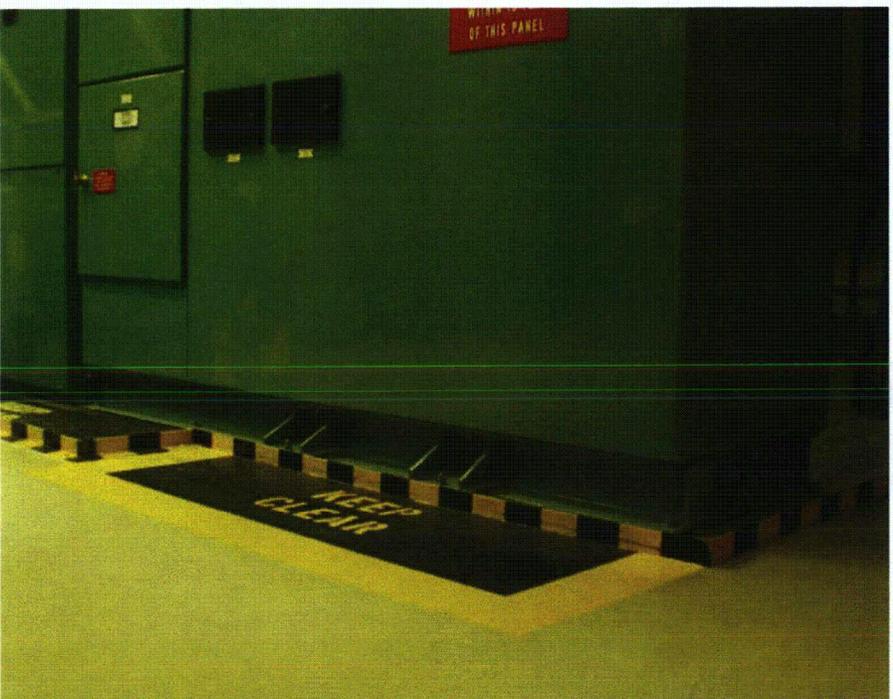
Equipment ID: 0AC097

5. Is the anchorage configuration consistent with plant documentation?  
 (Note: This question only applies if the item is one of the 50% for which an anchorage configuration verification is required.)  
*Anchorage confirmed to PBABS drawing S-1199 Revision 0.*  Y  N  U  N/A

7. Are soft targets free from impact by nearby equipment or structures?  Y  N  U  N/A  
*Component contains soft targets. No potential for impact from nearby equipment.*
8. Are overhead equipment, distribution systems, ceiling tiles and lighting, and masonry block walls not likely to collapse onto the equipment?  Y  N  U  N/A  
*No seismic 2/1 concerns.*
9. Do attached lines have adequate flexibility to avoid damage?  Y  N  U  N/A
10. Based on the above seismic interaction evaluations, is equipment free of potentially adverse seismic interaction effects?  Y  N  U

*IPEEE - Crane Controller securely mounted to the wall. MO  
 10/10/2012*

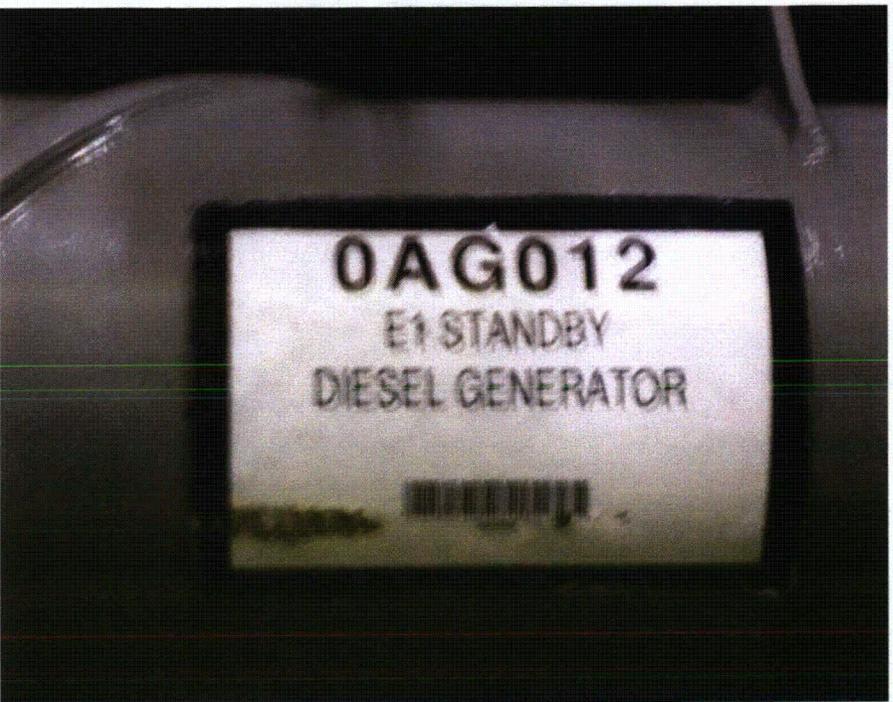
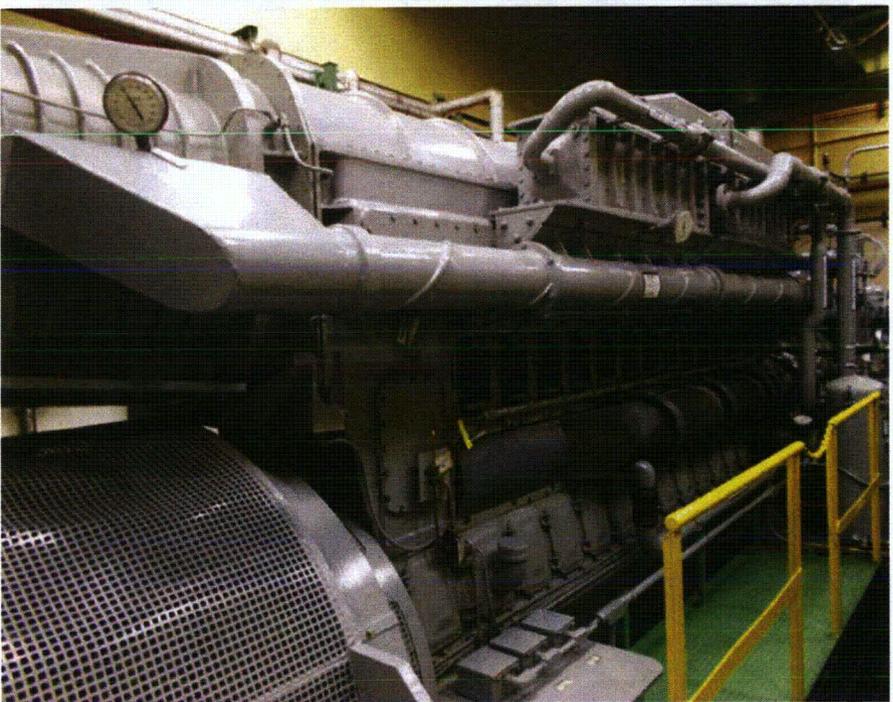
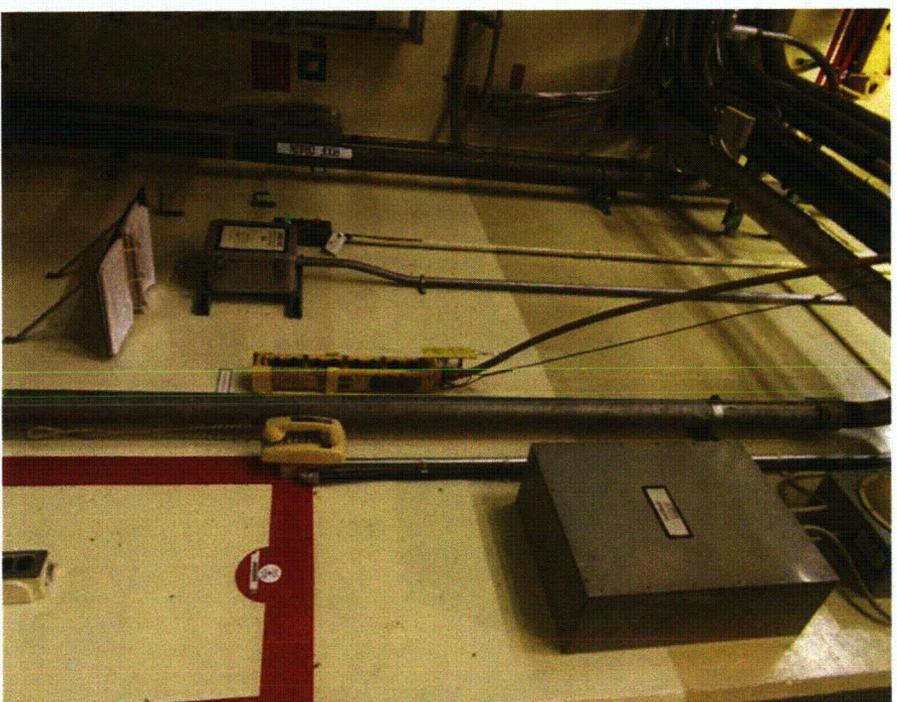
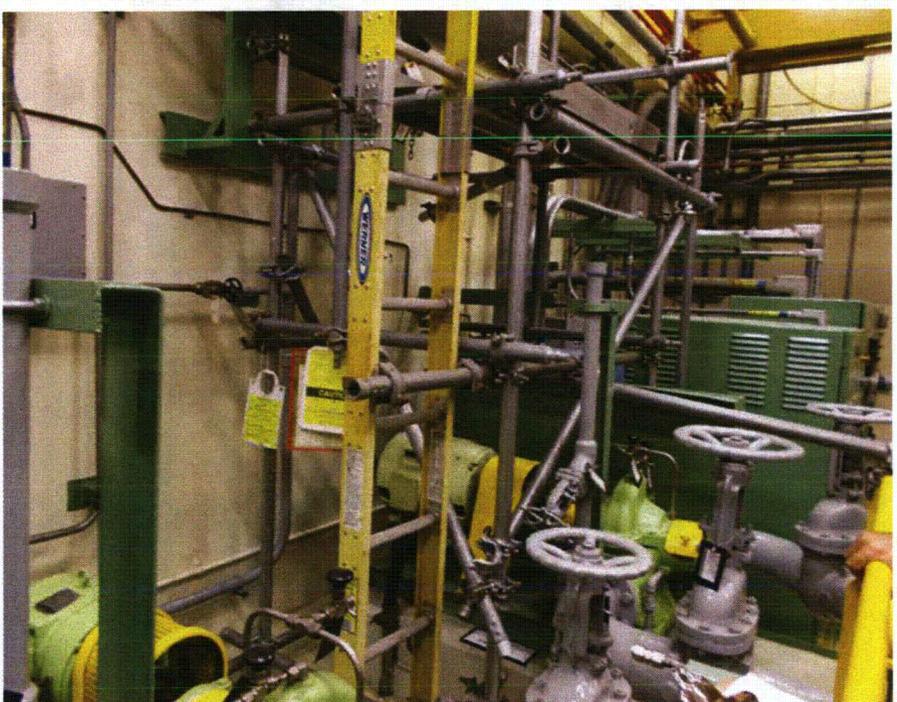
Equipment ID: 0AG012

3. Is the anchorage free of corrosion that is more than mild surface oxidation?  Y  N  U  N/A  
*Mild surface oxidation noticed on support beam at north east corner of diesel.*

6. Based on the above anchorage evaluations, is the anchorage free of potentially adverse seismic conditions?  Y  N  U  
*Calc ES-155-1 (Rev 1) indicates 1 1/4" anchor bolts. Actual anchor bolts are 1" Anchor bolt size discrepancy documented in IR# 01438055. BMF 11/9/12*

7. Are soft targets free from impact by nearby equipment or structures?  Y  N  U  N/A  
*Component contains soft targets. No potential impacts from nearby equipment*
8. Are overhead equipment, distribution systems, ceiling tiles and lighting, and masonry block walls not likely to collapse onto the equipment?  Y  N  U  N/A  
*It is not credible for falling fluorescent bulbs to damage equipment. No ceiling tiles or masonry blocks.*
9. Do attached lines have adequate flexibility to avoid damage?  Y  N  U  N/A
10. Based on the above seismic interaction evaluations, is equipment free of potentially adverse seismic interaction effects?  Y  N  U

*IPEEE - Crane controller securely mounted to the wall.  
 Seismic restraints have been added to the mounting of the diesel instrumentation panel next to the vibration isolators.*

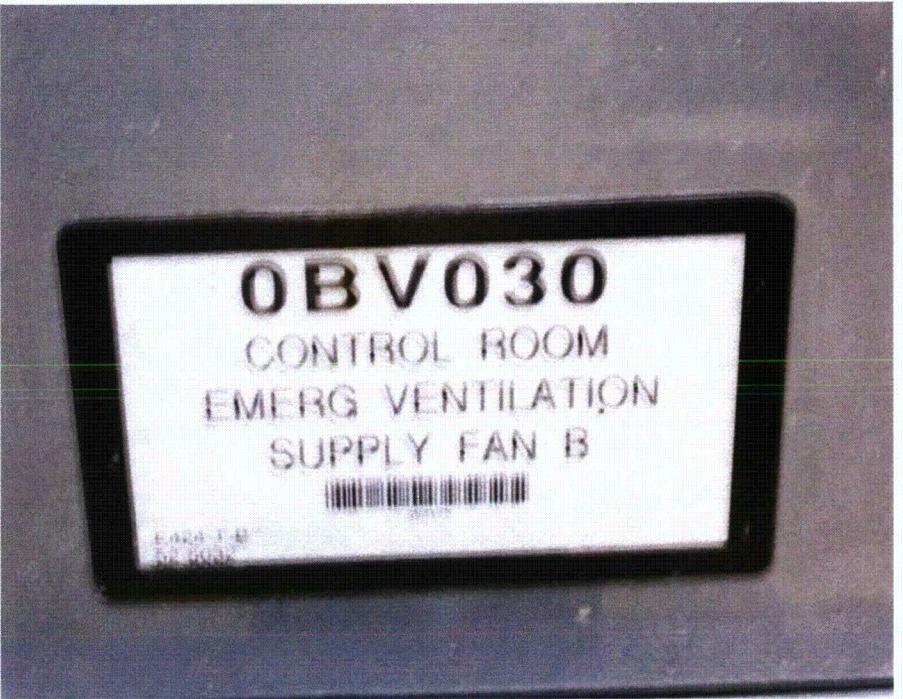
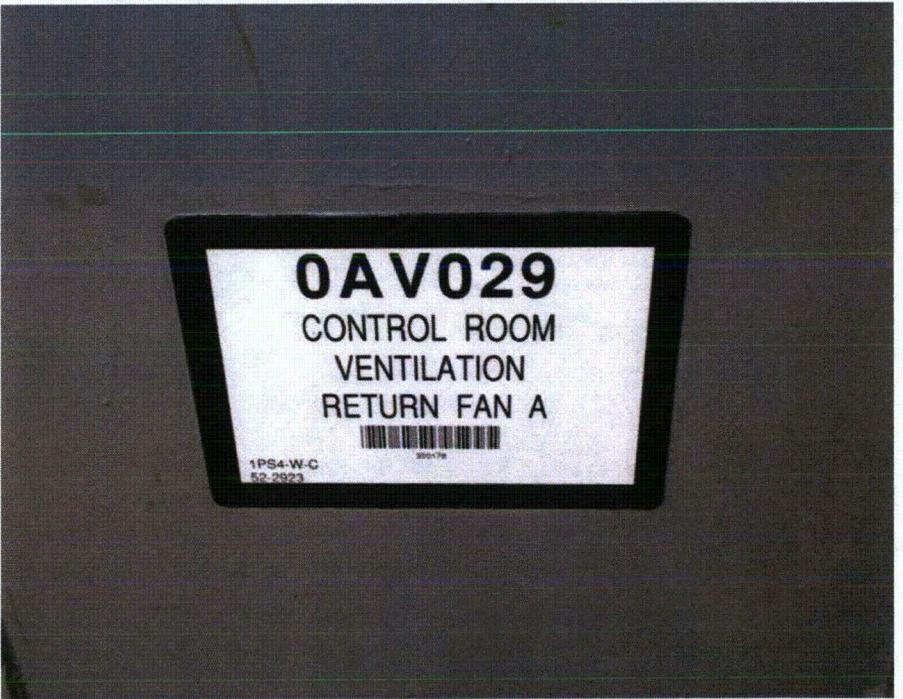
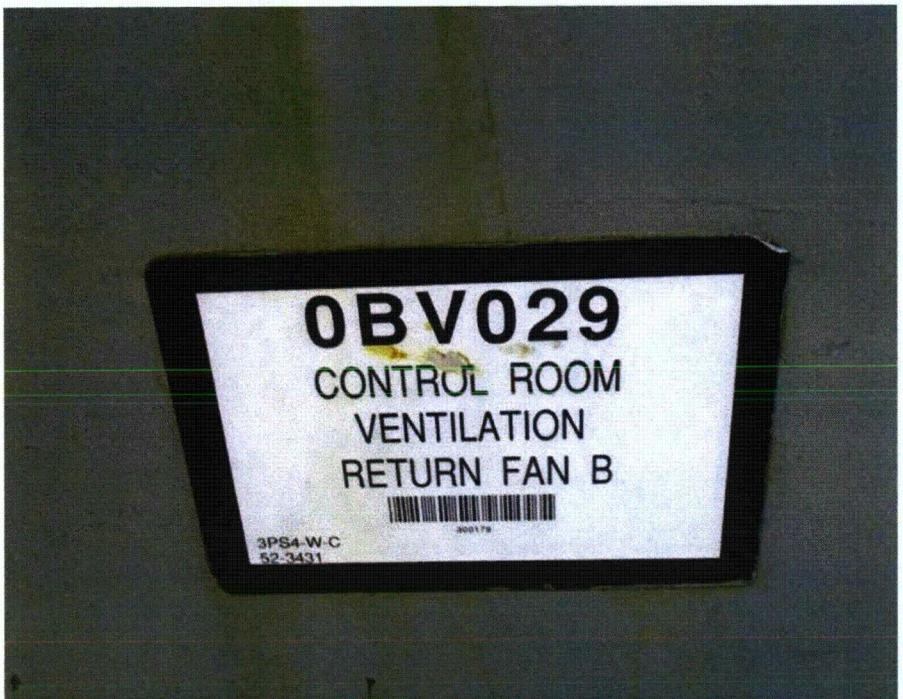
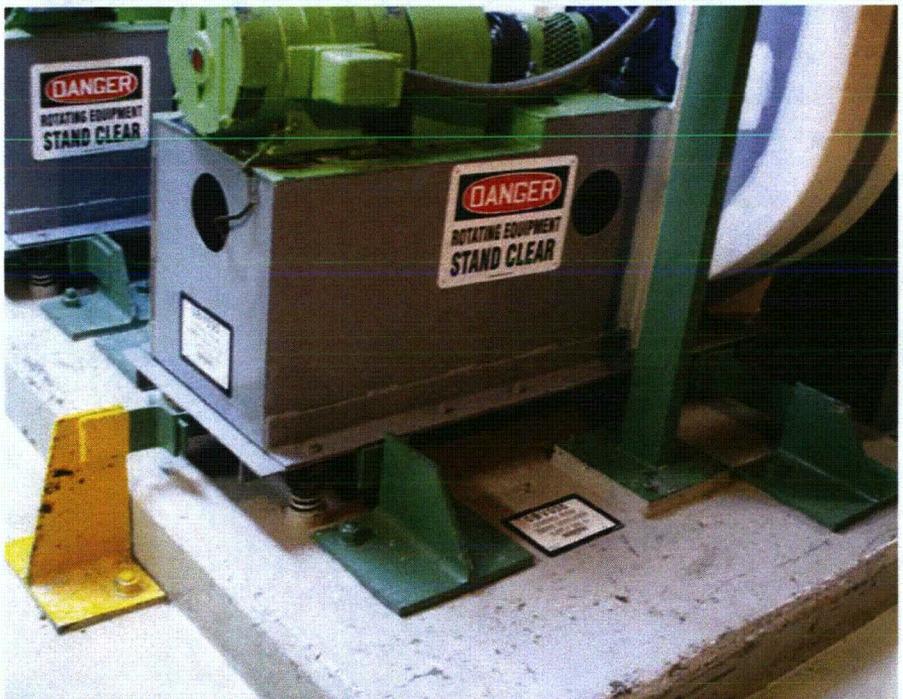
Equipment ID: OBV030

8. Are overhead equipment, distribution systems, ceiling tiles and lighting, and masonry block walls not likely to collapse onto the equipment?  Y  N  U  N/A  
*No ceiling tiles, no masonry walls nearby.  
 Nearby Fluorescent light fixture has closed S-hooks, Damage due to falling fluorescent bulb not credible.*

*The structural support for Flow switch FS-0760A is approx 1/2 inch from fan housing. The structural support is mounted to the same floor slab as the Fan. It is not credible for damage to occur due to relative motion.*
