Seismic Walkdown Checklist (SWC)

Equipment ID No. 3AD01 *B gnr 9/12/2012* Equip. Class¹² (15) Batteries & Racks
 Equipment Description 125 VDC Battery 3A B *gnr 9/12/2012*
 Location: Bldg. Turbine Floor El. 135 Room, Area T3-70 169 *gnr 9/12/2012*
 Manufacturer, Model, Etc. (optional but recommended) _____

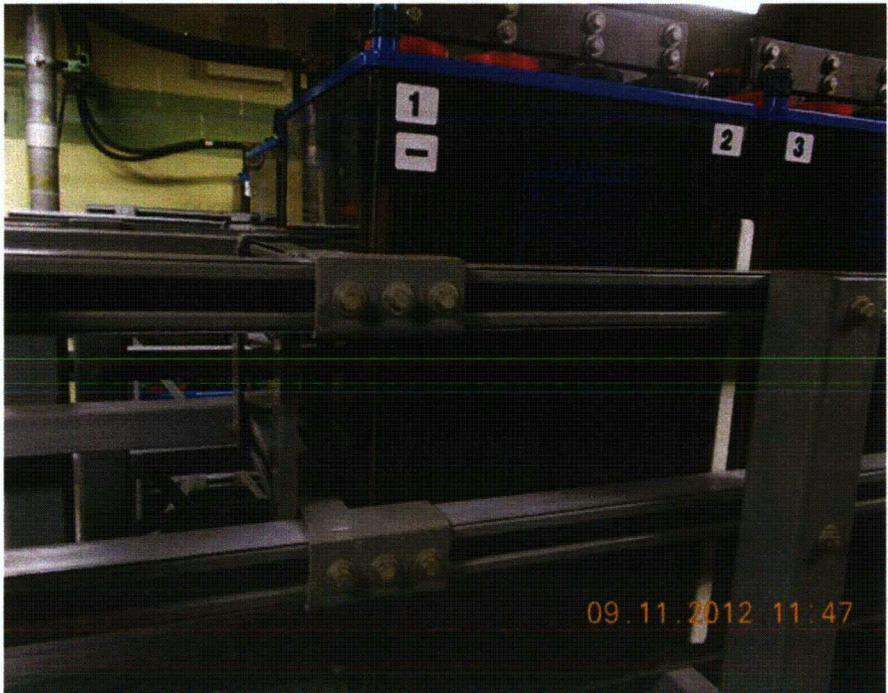
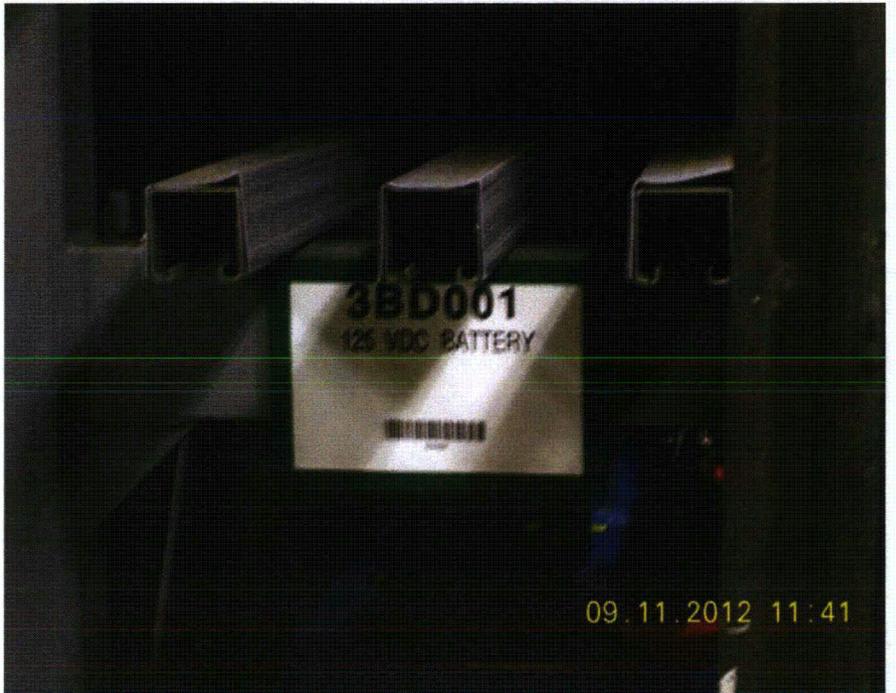
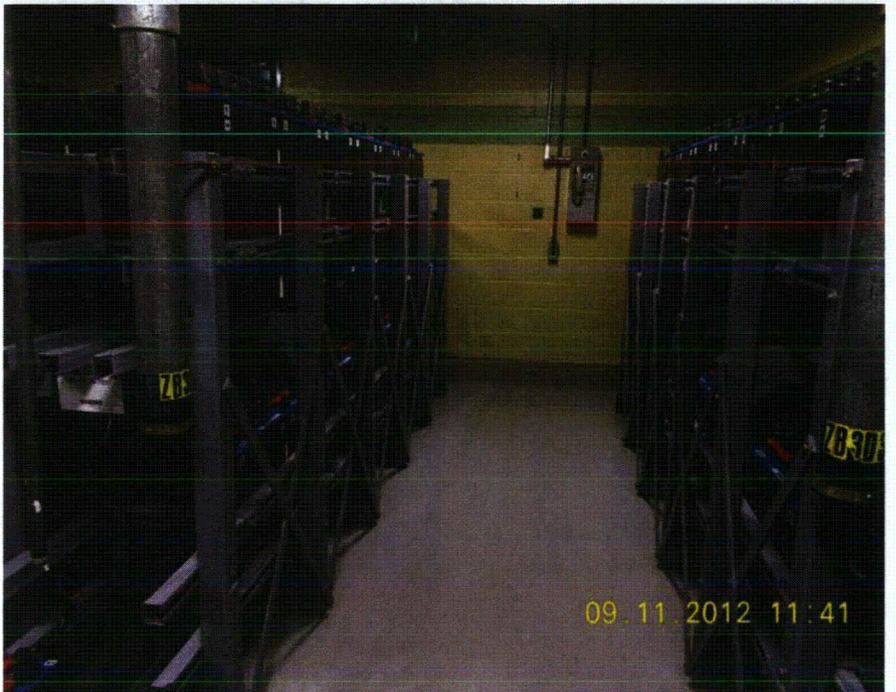
Equipment ID: 3BD001

IPEEE: Overhead light S-hooks have been closed and end rails have been snugged up against batteries

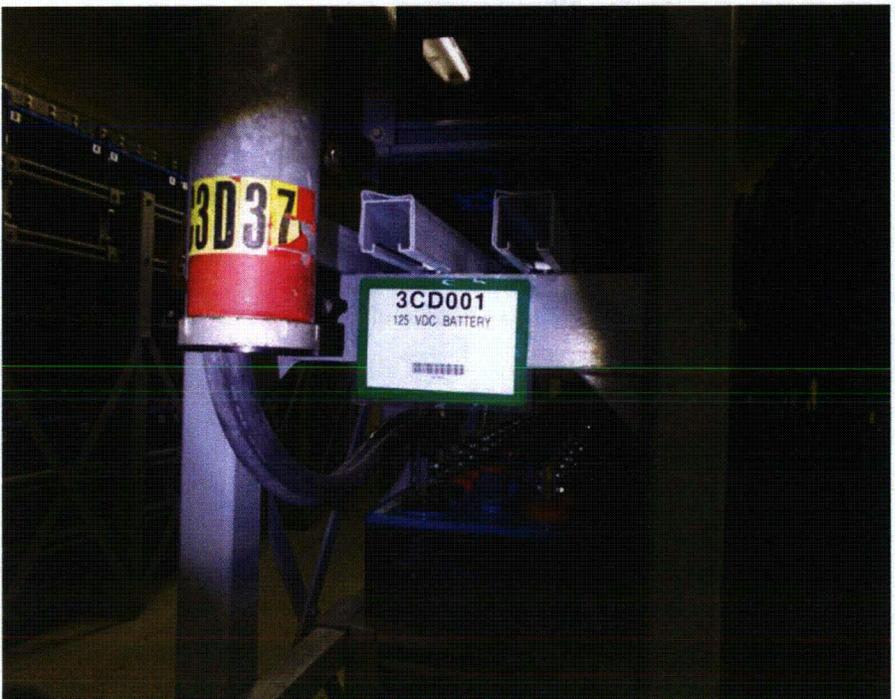
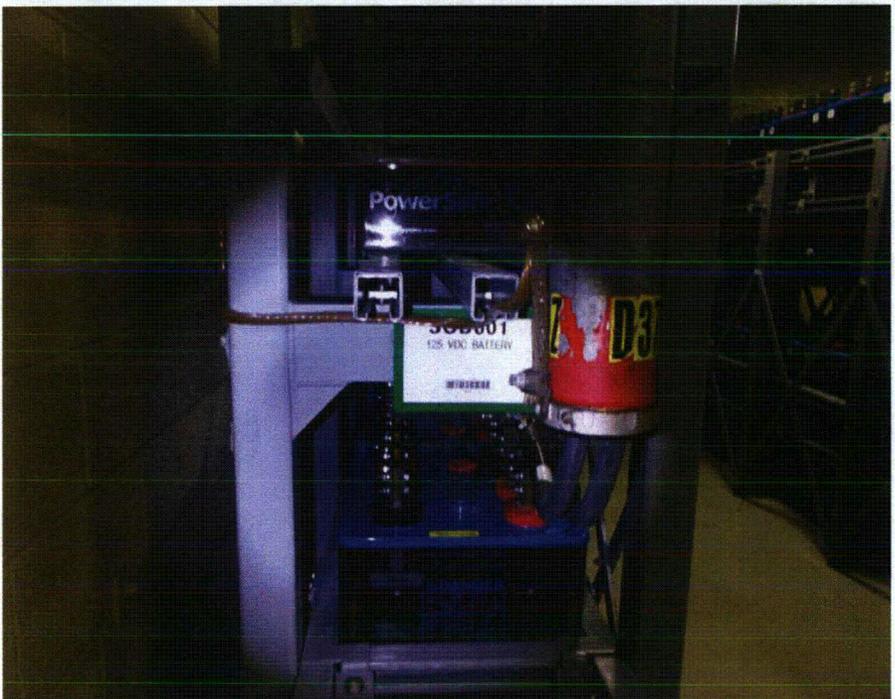
Equipment ID: 3CD001

3. Is the anchorage free of corrosion that is more than mild surface oxidation?
 MILD OXIDATION ON N. RACK, 2ND
 SUPPORT FROM E., BACK BOLT Y N U N/A

Component near masonry walls 40-6 and 40-21 per S-40 Rev 26. The walls are safety related per code specification M-701 Rev 1.
BMF
9/13/12

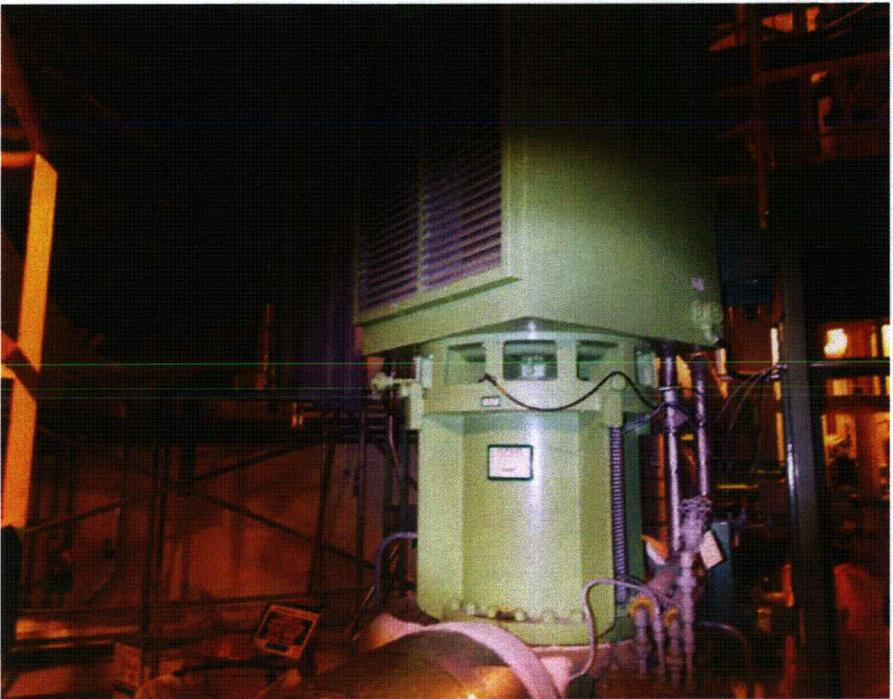
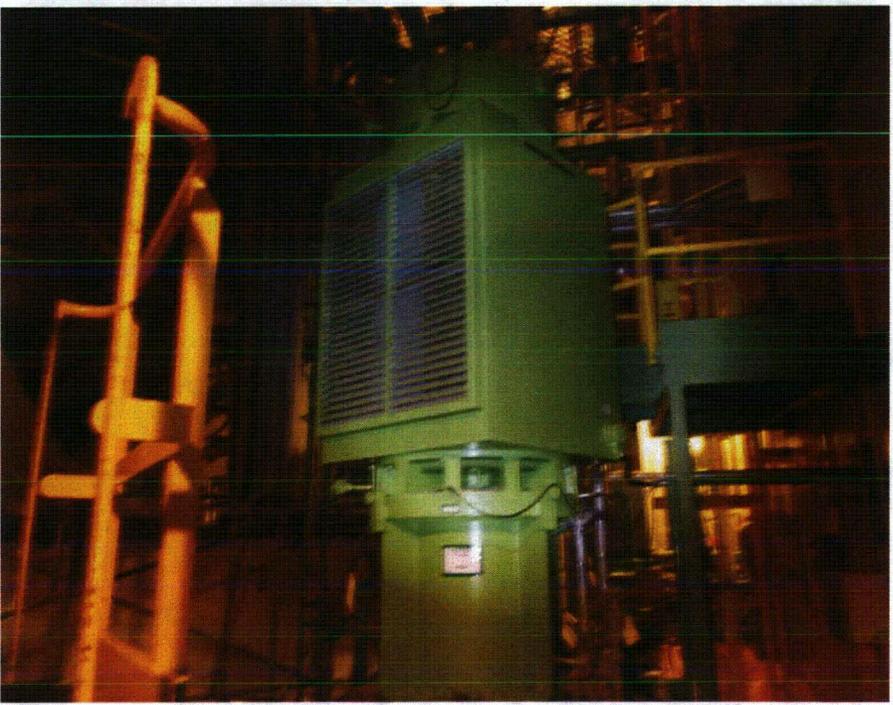
Equipment ID: 3CP035

1. Is the anchorage configuration verification required (i.e., is the item one of the 50% of SWEL items requiring such verification)? Y N
*Per Reg. 6280-5-1150, Rev. 0
 1152 cas 9/11/12*
2. Is the anchorage free of bent, broken, missing or loose hardware? Y N U N/A
3. Is the anchorage free of corrosion that is more than mild surface oxidation? Y N U N/A
4. Is the anchorage free of visible cracks in the concrete near the anchors? Y N U N/A
5. Is the anchorage configuration consistent with plant documentation? Y N U N/A
 (Note: This question only applies if the item is one of the 50% for which an anchorage configuration verification is required.)
6. Based on the above anchorage evaluations, is the anchorage free of potentially adverse seismic conditions? Y N U

- 7. Are soft targets free from impact by nearby equipment or structures? Y N U N/A
No soft targets identified
- 8. Are overhead equipment, distribution systems, ceiling tiles and lighting, and masonry block walls not likely to collapse onto the equipment? Y N U N/A
- 9. Do attached lines have adequate flexibility to avoid damage? Y N U N/A
- 10. Based on the above seismic interaction evaluations, is equipment free of potentially adverse seismic interaction effects? Y N U

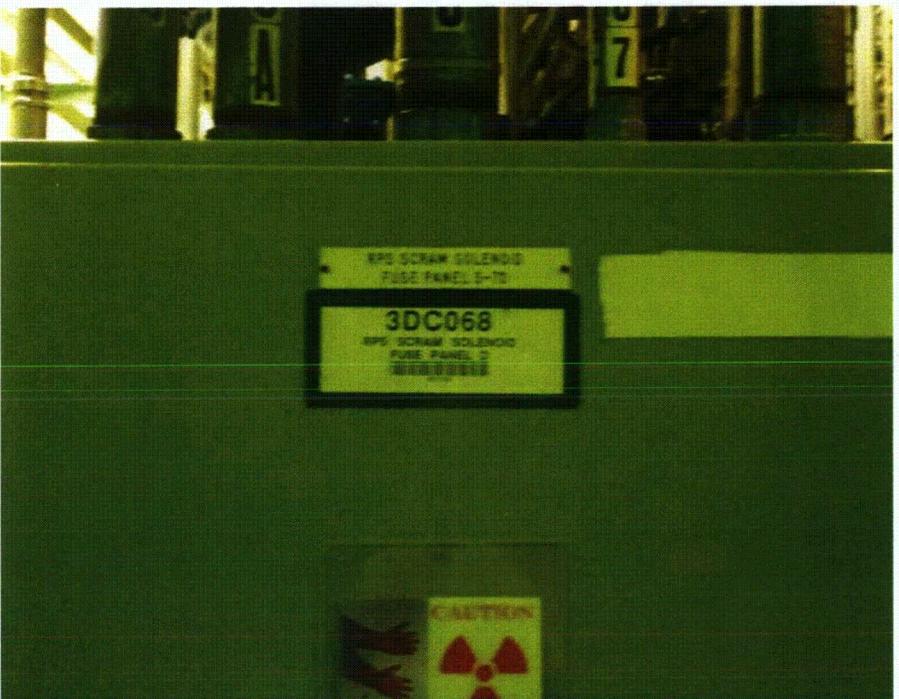
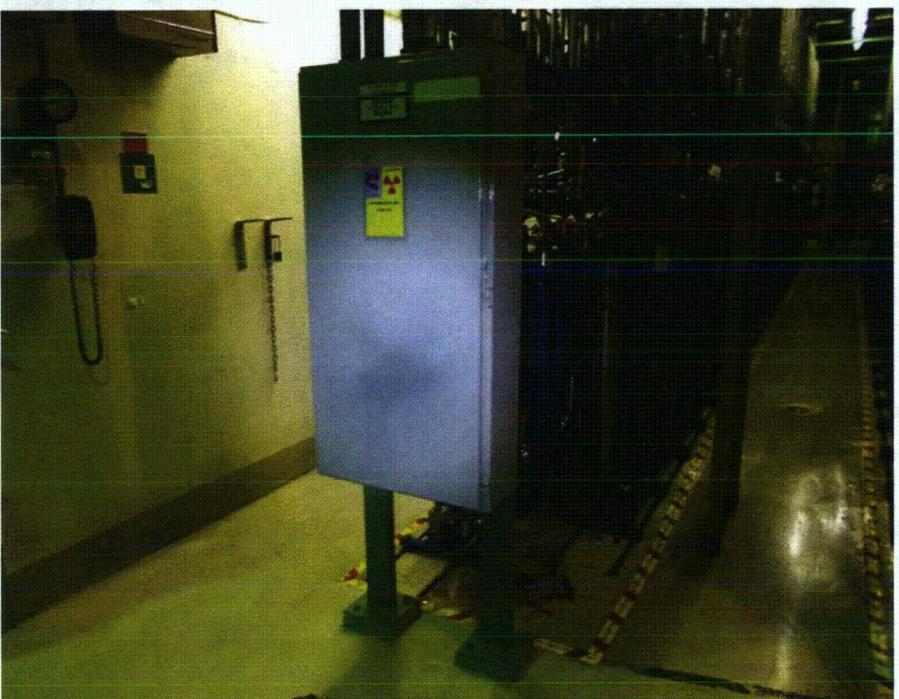
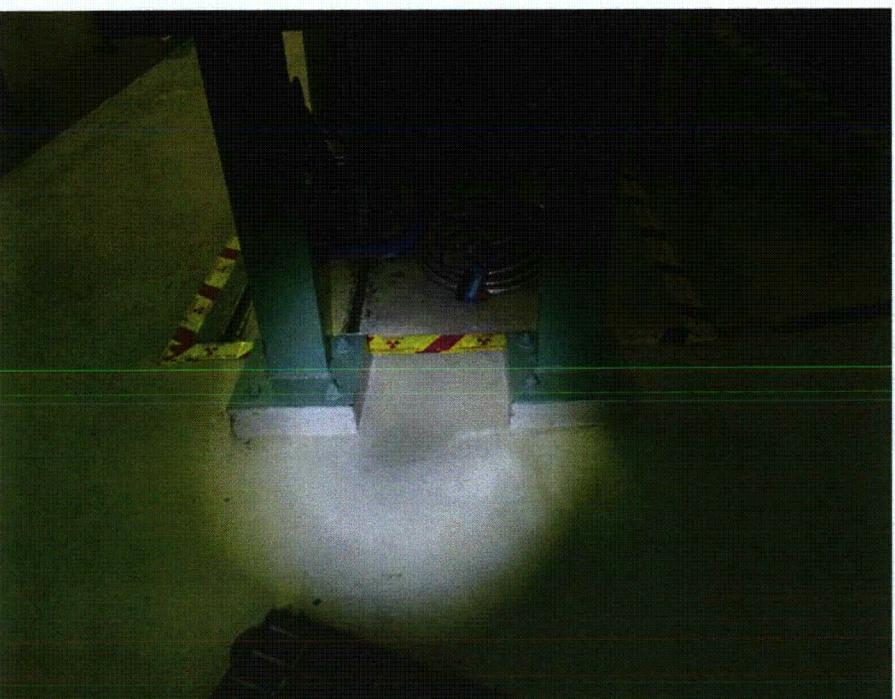
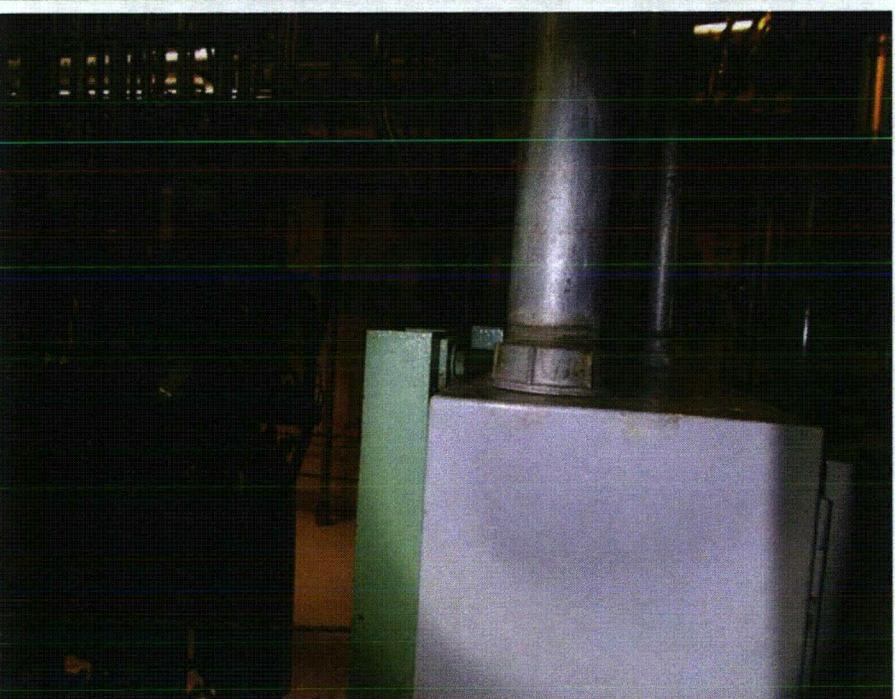
Equipment ID: 3DC068

4. Is the anchorage free of visible cracks in the concrete near the anchors? Y N U N/A
Minor chipping near corner is no issue.

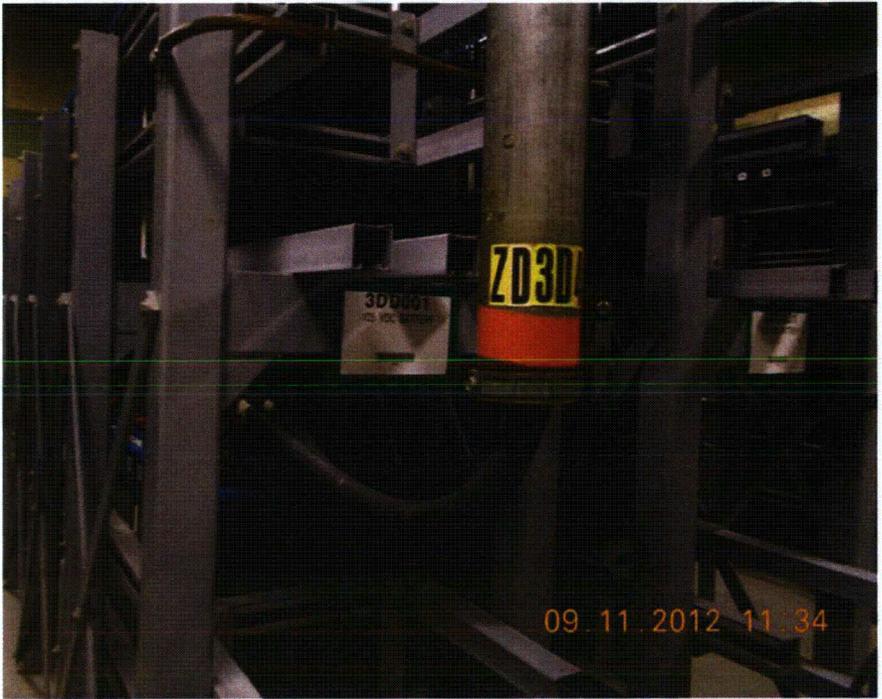
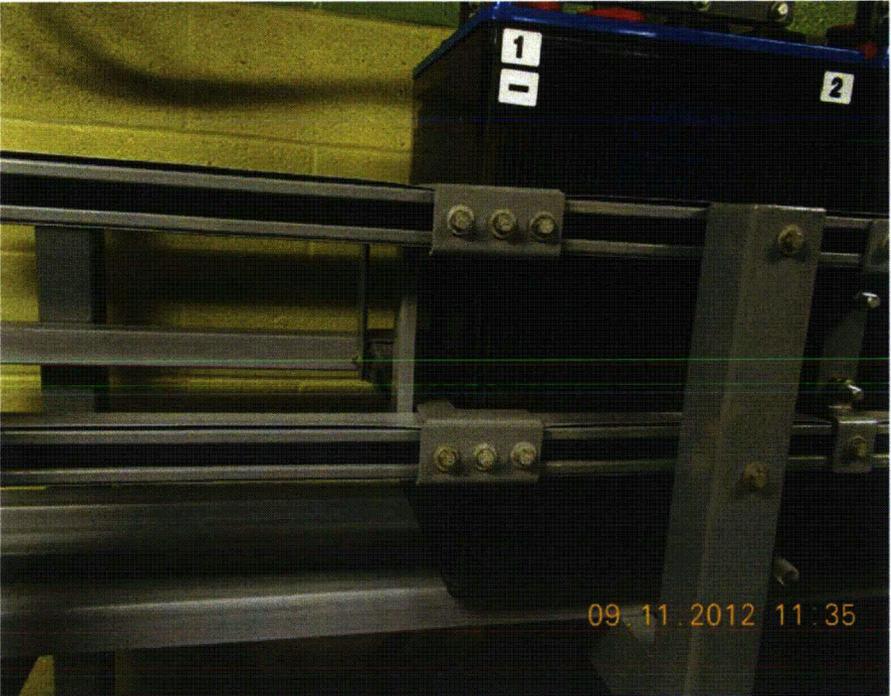
Equipment ID: 3DD001

IPEEE: Overhead light S-hooks have been closed and end rails have been snugged up to the batteries

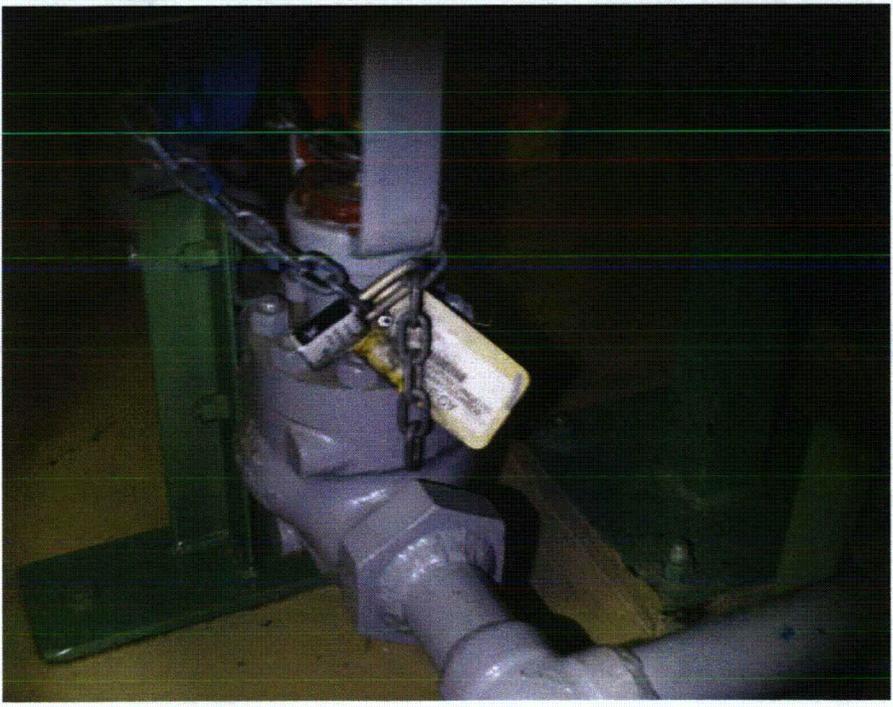
Equipment ID: A0-3-03-036

No Line mounted
2. Is the anchorage free of bent, broken, missing or loose hardware? Y N U N/A
3. Is the anchorage free of corrosion that is more than mild surface oxidation? Y N U N/A
4. Is the anchorage free of visible cracks in the concrete near the anchors? Y N U N/A
5. Is the anchorage configuration consistent with plant documentation? Y N U N/A

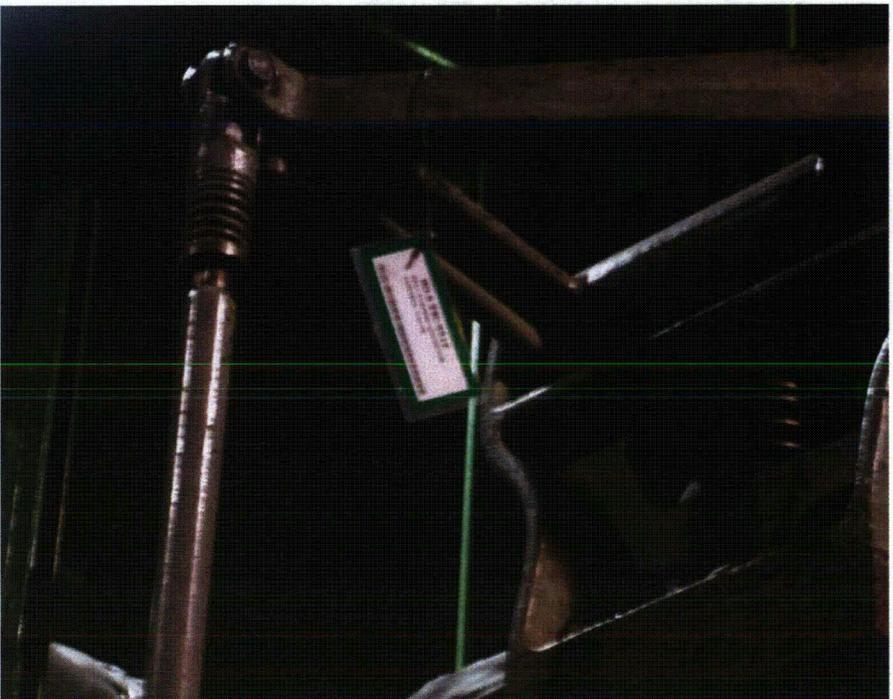
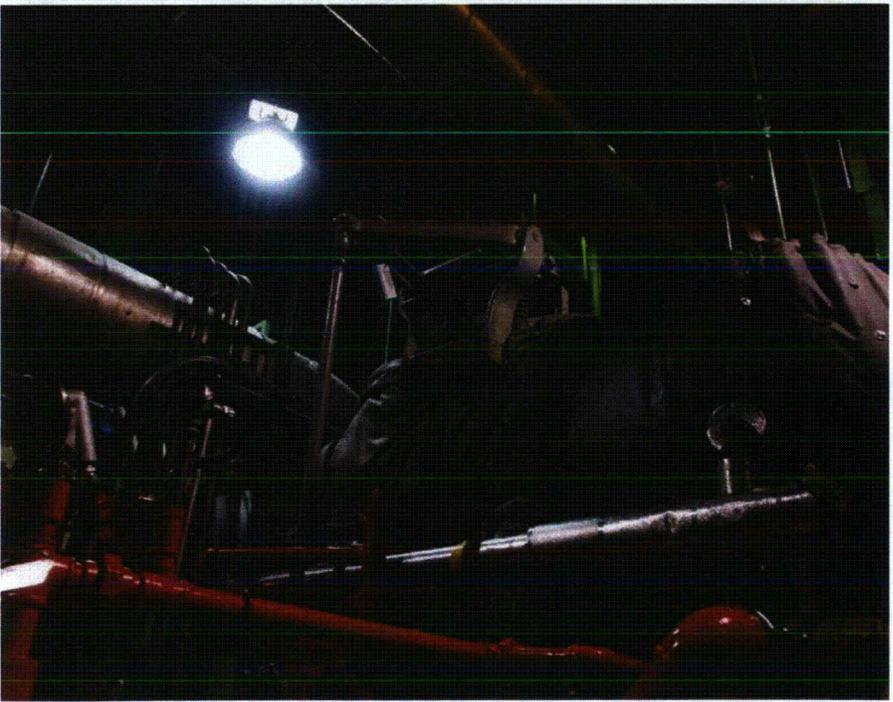
Equipment ID: H03-23C-5512

1. Is the anchorage configuration verification required (i.e., is the item one of the 50% of SWEL items requiring such verification)? Y N U
Verified per Dwg 6280-M-1-D-14 Rev. 2
2. Is the anchorage free of bent, broken, missing or loose hardware? Y N U N/A
3. Is the anchorage free of corrosion that is more than mild surface oxidation? Y N U N/A
Debris in unistrut has accumulated but is not corrosion nor is it an issue.
4. Is the anchorage free of visible cracks in the concrete near the anchors? Y N U N/A
5. Is the anchorage configuration consistent with plant documentation? Y N U N/A
 (Note: This question only applies if the item is one of the 50% for which an anchorage configuration verification is required.)
6. Based on the above anchorage evaluations, is the anchorage free of potentially adverse seismic conditions? Y N U

IPEEG - Unistat bracing installed for overhead conduit on HCU's.

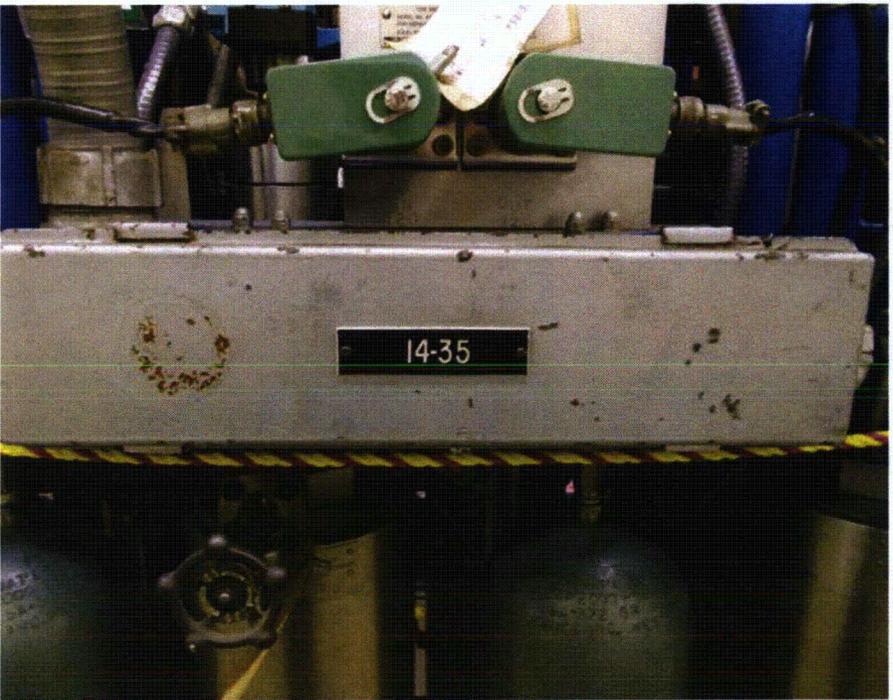
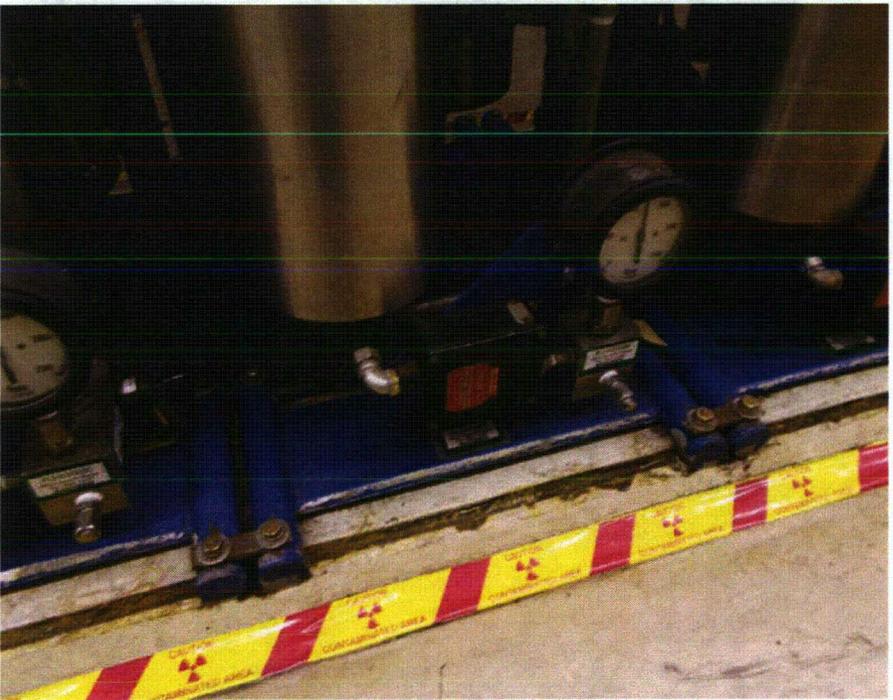
Equipment ID: HCU 14-35

1. Is the anchorage configuration verification required (i.e., is the item one of the 50% of SWEL items requiring such verification)? Y N U
 Verified per Dwg. 6280-M-1-D-14 Rev. 2
2. Is the anchorage free of bent, broken, missing or loose hardware? Y N U N/A
3. Is the anchorage free of corrosion that is more than mild surface oxidation? Y N U N/A
4. Is the anchorage free of visible cracks in the concrete near the anchors? Y N U N/A
5. Is the anchorage configuration consistent with plant documentation? (Note: This question only applies if the item is one of the 50% for which an anchorage configuration verification is required.) Y N U N/A
6. Based on the above anchorage evaluations, is the anchorage free of potentially adverse seismic conditions? Y N U

1 PEE - Unistrut bracing installed for overhead conduit on HCU's.

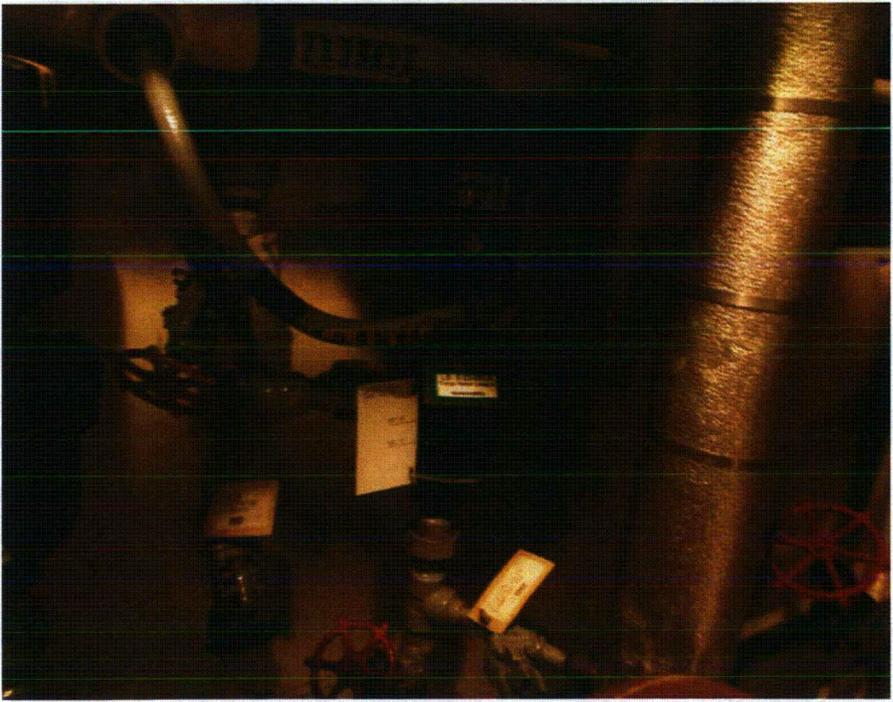
Equipment ID: LS-3-23-091A

1. Is the anchorage configuration verification required (i.e., is the item one of the 50% of SWEL items requiring such verification)? Y N
2. Is the anchorage free of bent, broken, missing or loose hardware? Y N U N/A
 Line-mounted
3. Is the anchorage free of corrosion that is more than mild surface oxidation? Y N U N/A
4. Is the anchorage free of visible cracks in the concrete near the anchors? Y N U N/A
5. Is the anchorage configuration consistent with plant documentation? Y N U N/A
 (Note: This question only applies if the item is one of the 50% for which an anchorage configuration verification is required.)
6. Based on the above anchorage evaluations, is the anchorage free of potentially adverse seismic conditions? Y N U

- 7. Are soft targets free from impact by nearby equipment or structures? Y N U N/A
Small clearance between upper component housing and pipe support but not significant threat (rigid mounting will also reduce likelihood of interaction) judged credible
- 8. Are overhead equipment, distribution systems, ceiling tiles and lighting, and masonry block walls not likely to collapse onto the equipment? Y N U N/A
- 9. Do attached lines have adequate flexibility to avoid damage? Y N U N/A
- 10. Based on the above seismic interaction evaluations, is equipment free of potentially adverse seismic interaction effects? Y N U
