Technical Considerations Affecting Preparation of Ion-Exchange Resins for Disposal

Prepared by B. S. Bowerman, P. L. Piciulo

Brookhaven National Laboratory

Prepared for
U.S. Nuclear Regulatory
Commission

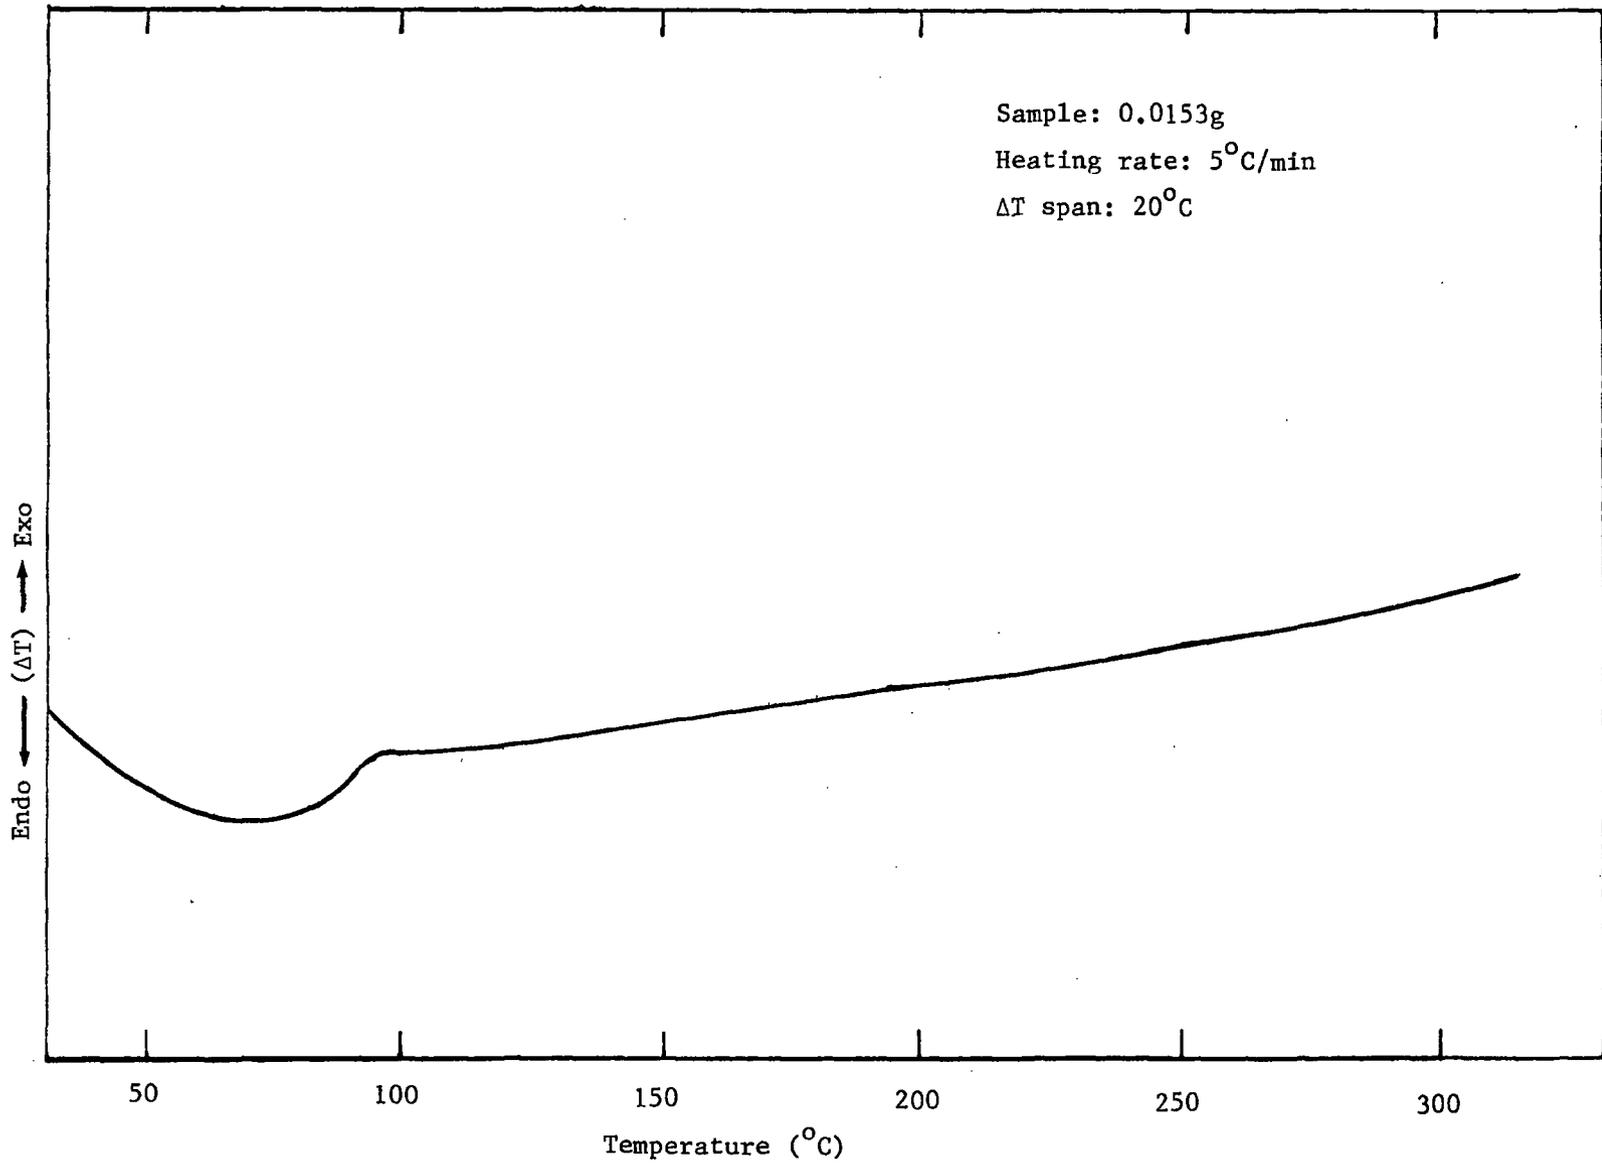
Figure 4.1 DTA curve for ANO sample AII-2.

Confirmatory thermal stability tests were run on several samples from Casks A and B, as well as on new resins of the type used in the LRWCS at ANO. The results were essentially the same as those found at BPNL. For resin samples AI, BI, and AII-2, no evidence of exothermic behavior on heating in air was seen below 300°C. (Endotherms, i.e., processes which absorb heat, are indicated by dips in the DTA curve toward the bottom of the figure, while exotherms, or energy-releasing processes, are characterized by peaks in the DTA curve above the baseline.) One point worth noting is that these samples were dried to the extent that no surface moisture remained on the resin beads. Consequently, the endotherm below $\approx 100^\circ\text{C}$ corresponding to the loss of water from the resins is reduced. Figure 4.1 illustrates the DTA curve for sample AII-2 up to 320°C.

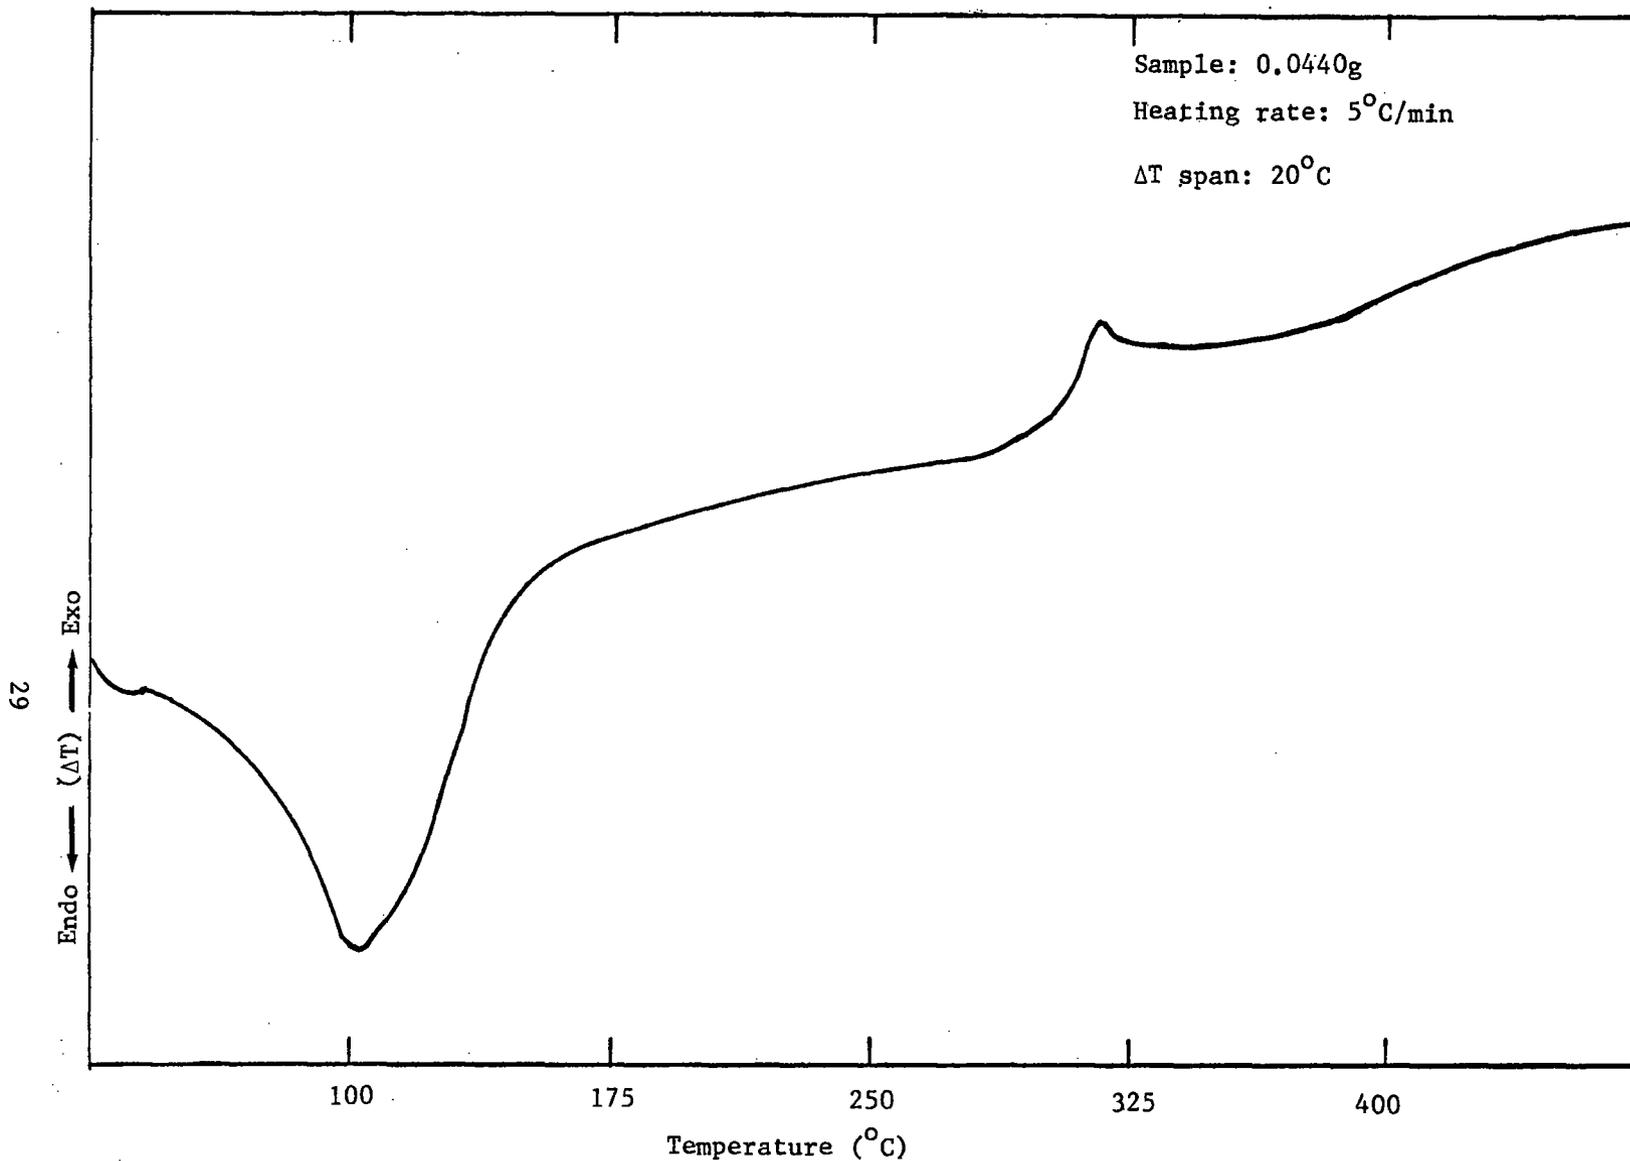
Figure 4.2 DTA curve for damp resins: Duolite ARC-9358 and AR A-9371 resins mixed 1:1 by weight in deionized water and dewatered by vacuum filtration for ≈ 5 minutes.

It was realized that the thermal stability experiments by BPNL were somewhat limited, at least with respect to the tests on new resins. BPNL's DSC tests of new resins involved heating cation and anion resins separately; however, the resin wastes in which the exotherm occurred probably consisted of mixed anion and cation resins. BPNL's approach to the problem apparently was based on the assumption that one particular factor could be singled out as the cause of the exotherm, rather than a combination of factors. Because the BPNL study indicated that the presence of Cu^{2+} on ARA-9371, resin resulted in the appearance of an exotherm at $\approx 210^\circ\text{C}$ compared to 300°C for untreated ARA-9371, it was decided to try to simulate the Cask A resins as closely as possible to determine whether a mixture of ARA-9358 and ARA-9371 loaded with all the anions and cations found in the Cask A resin waste would lower even further the temperature at which an exotherm could occur. It was also realized that the moisture content of the resin samples could significantly influence the thermal behavior of the resins. This is illustrated in Figures 4.2 and 4.3, in which new anion (ARA-9371) and cation (ARA-9358) resins were mixed one-to-one by weight, slurried in deionized water, and dewatered by vacuum filtration prior to the DTA analysis. Figure 4.2 shows the behavior of damp resins immediately after dewatering for ≈ 5 minutes, while in Figure 4.3, the same resin mixture after 24 hours drying in air, is markedly different, particularly in the neighborhood of the exotherm near 300°C and in the range less than 100°C . The latter endothermic peak is significantly reduced.

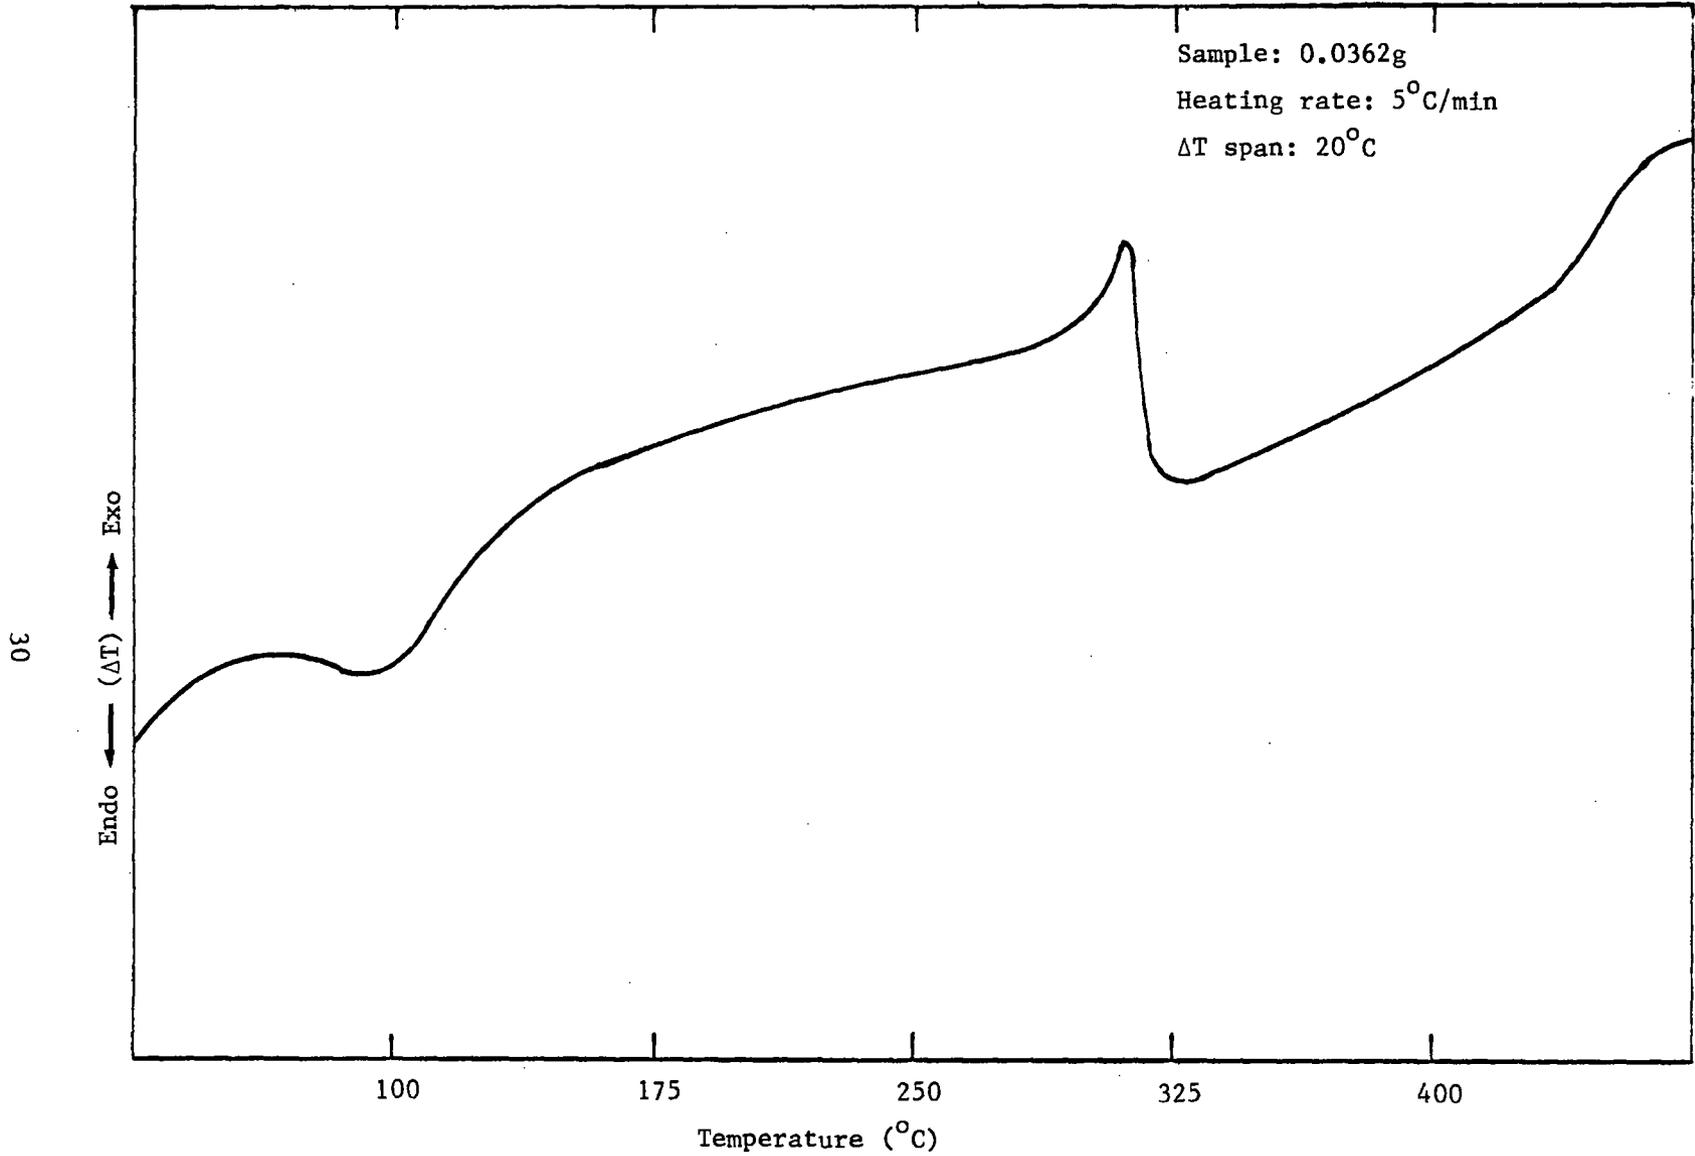
Figure 4.3 DTA curve for damp resins: Duolite ARC-9358 and ARA-9371 resins mixed 1:1 by weight in deionized water, dewatered for ≈5 minutes and dried in air for 24 hours.

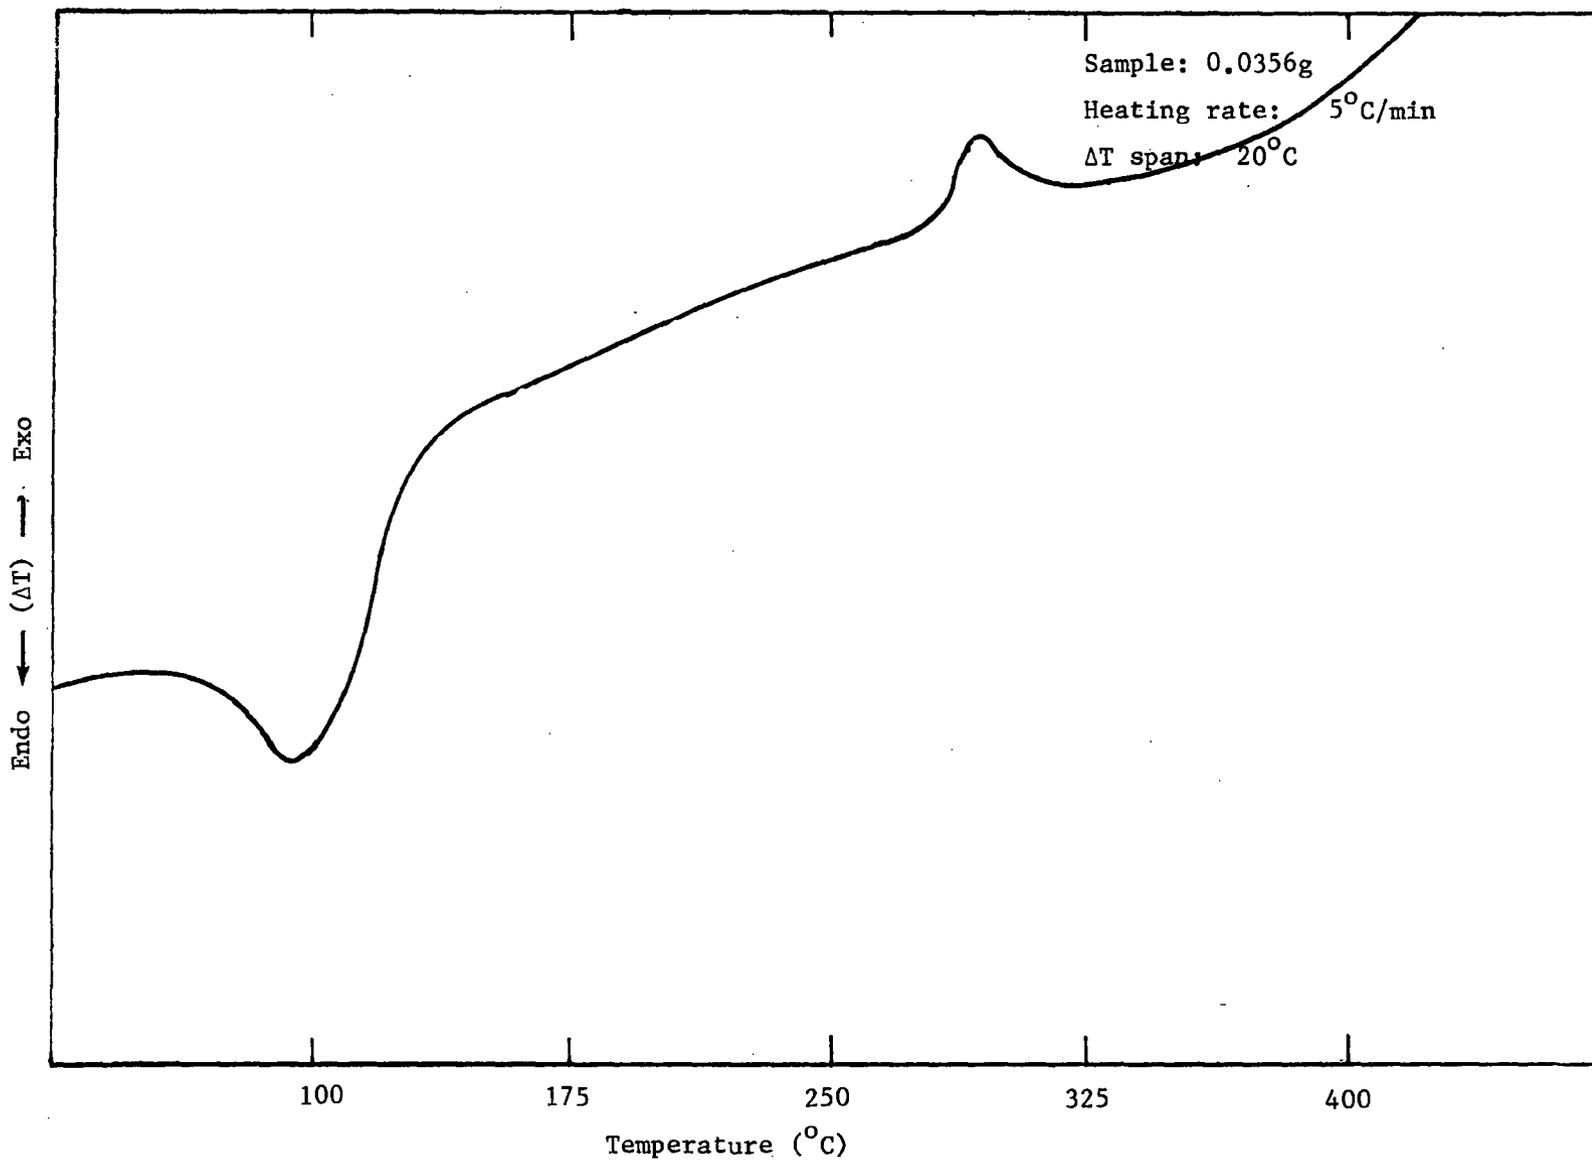
Figure 4.4 DTA curve for damp resins: Duolite ARC-9358 and ARA-9371 mixed 1:1 by weight, equilibrated with mixed-ion solution as described in text, and dewatered ~30 minutes.

Samples of new ARA-9371 and ARA-9358 resins were mixed one-to-one by weight and equilibrated with a solution containing a mixture of cations and anions reported in the BPNL study as being present in the Cask A resins. The equilibrium period was five days, and the conductivity of the liquid-resin mixture dropped from 3,300 μmho to $<10 \mu\text{mho}$; final pH was 4.6. The mixture included iron, copper, zinc, manganese, ammonium, calcium and sodium cations and chloride, bromide, sulfate, nitrite, nitrate, and borate anions. The results of several DTA tests on these samples are shown in Figures 4.4 to 4.6. The resins were dewatered approximately 30 minutes prior to the test corresponding to the DTA shown in Figure 4.4. One hour of vacuum filtration followed by three hours of standing in air gave the results depicted in Figure 4.5 in which it appears that a small exotherm begins at 100°C and continues up to $\approx 300^\circ\text{C}$. Comparison with Figure 4.3 indicates that what appears to be the baseline from 30°C to $\approx 80^\circ\text{C}$ or just before the appearance of the exotherm at $\approx 100^\circ\text{C}$ could well be a smaller water loss endotherm. A test of the same dewatered and air-dried resins utilizing the "scanning autozero" function on the DTA apparatus seems to confirm that there is a small endotherm extending up to $\approx 140^\circ\text{C}$. (See Figure 4.6.) Above this point, at $\approx 170^\circ\text{C}$, the DTA curve begins to increase slowly. This could be an indication of a small and continuous release of heat up to $\approx 300^\circ\text{C}$, at which point a strong exothermic peak occurs. Attributing the small and slow increase in the DTA curve to an exotherm must be based on the assumption that the scanning autozero function used in this test provides a straight flat baseline. From the discussion given earlier on the limitations of the DTA apparatus used, this assumption may not be valid.

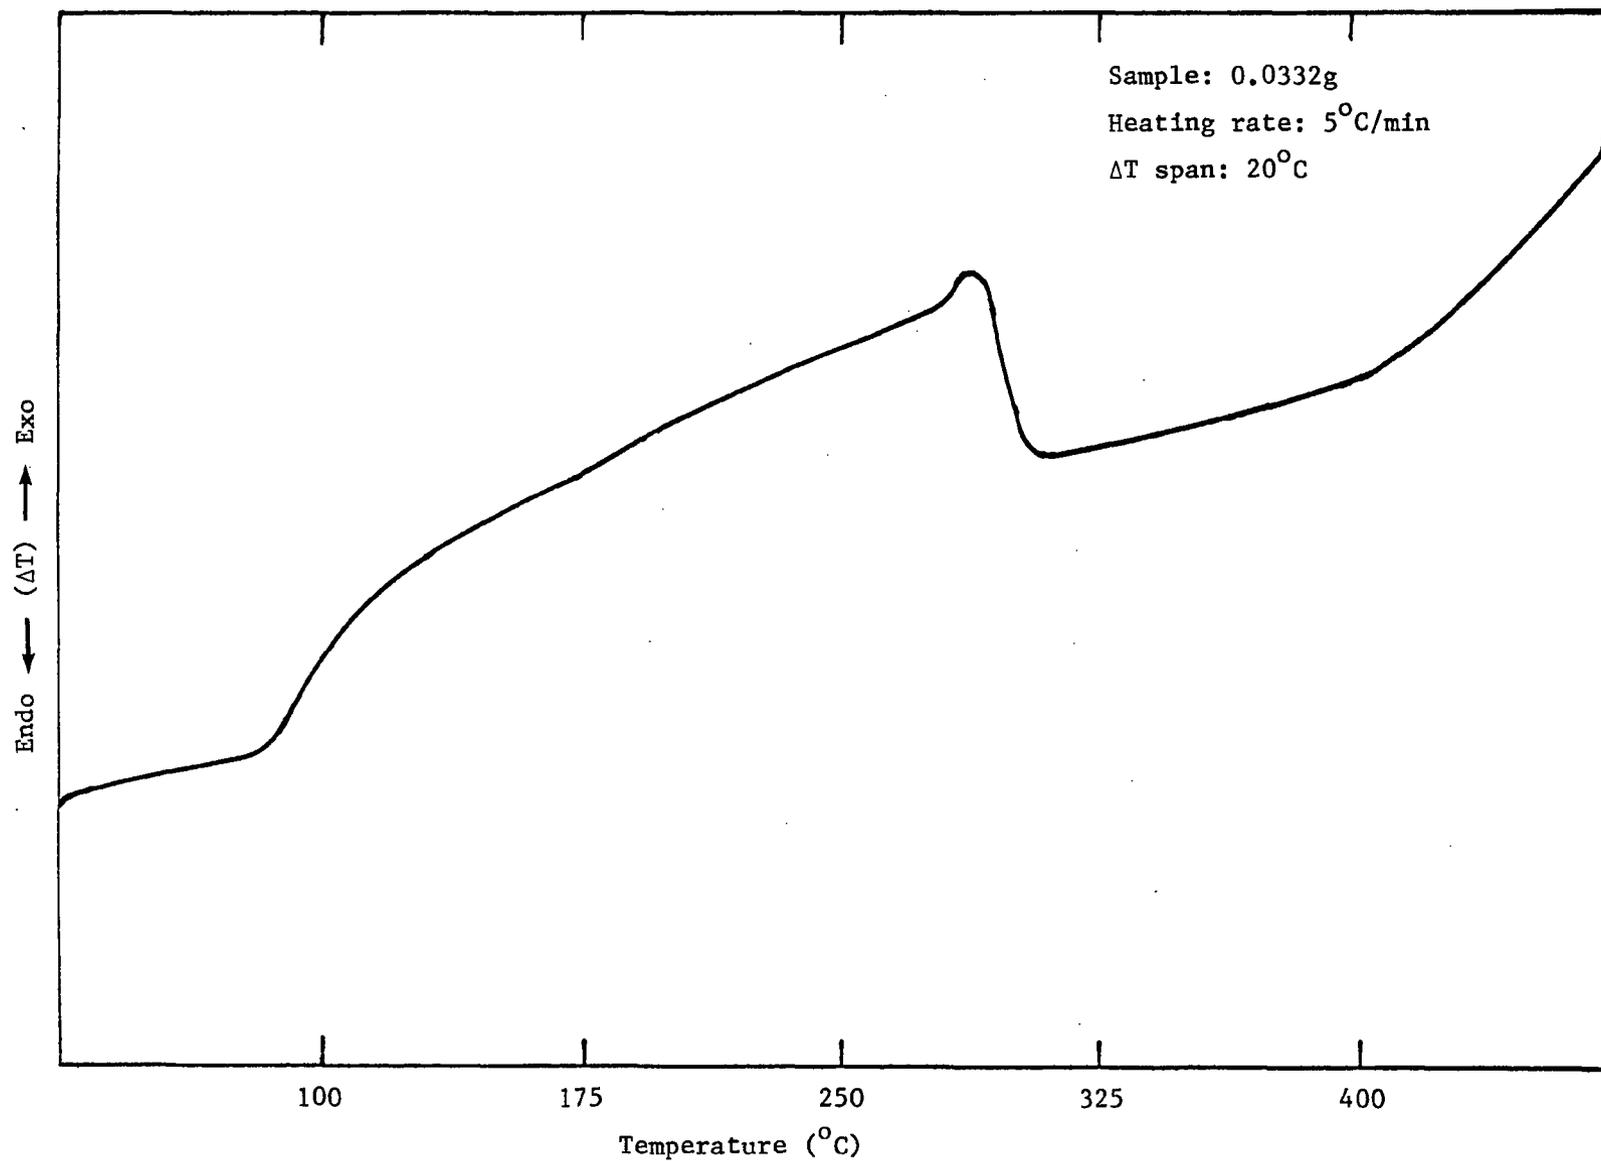
Figure 4.5 DTA curve for dried resins: Duolite ARC-9358 and ARA-9371 mixed 1:1 by weight, equilibrated with mixed-ion solution as described in text, dewatered for ~1 h and dried in air for 3 h.

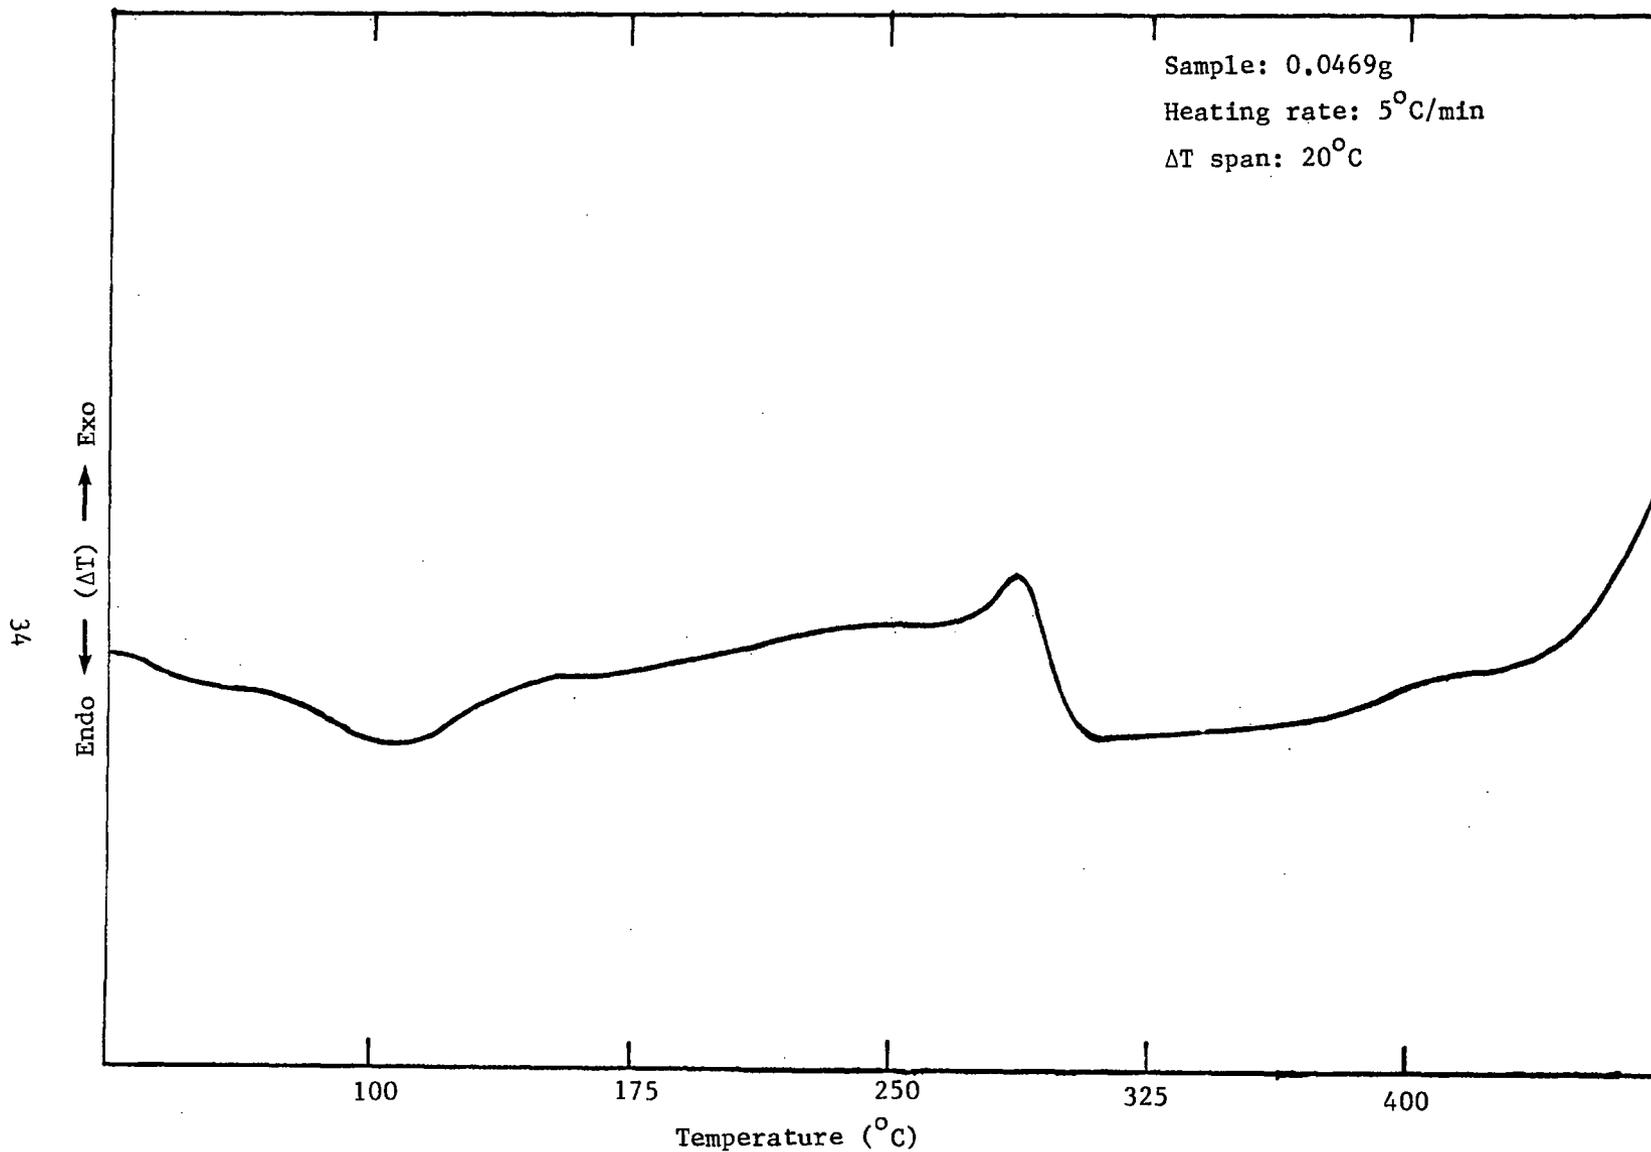
Figure 4.6 DTA curve for dried resins: Duolite ARC-9358 and ARA-9371 mixed 1:1 by weight, equilibrated with mixed-ion solution as described in text, dewatered for ≈1 h, and dried in air for 24 h, run with "scanning autozero".

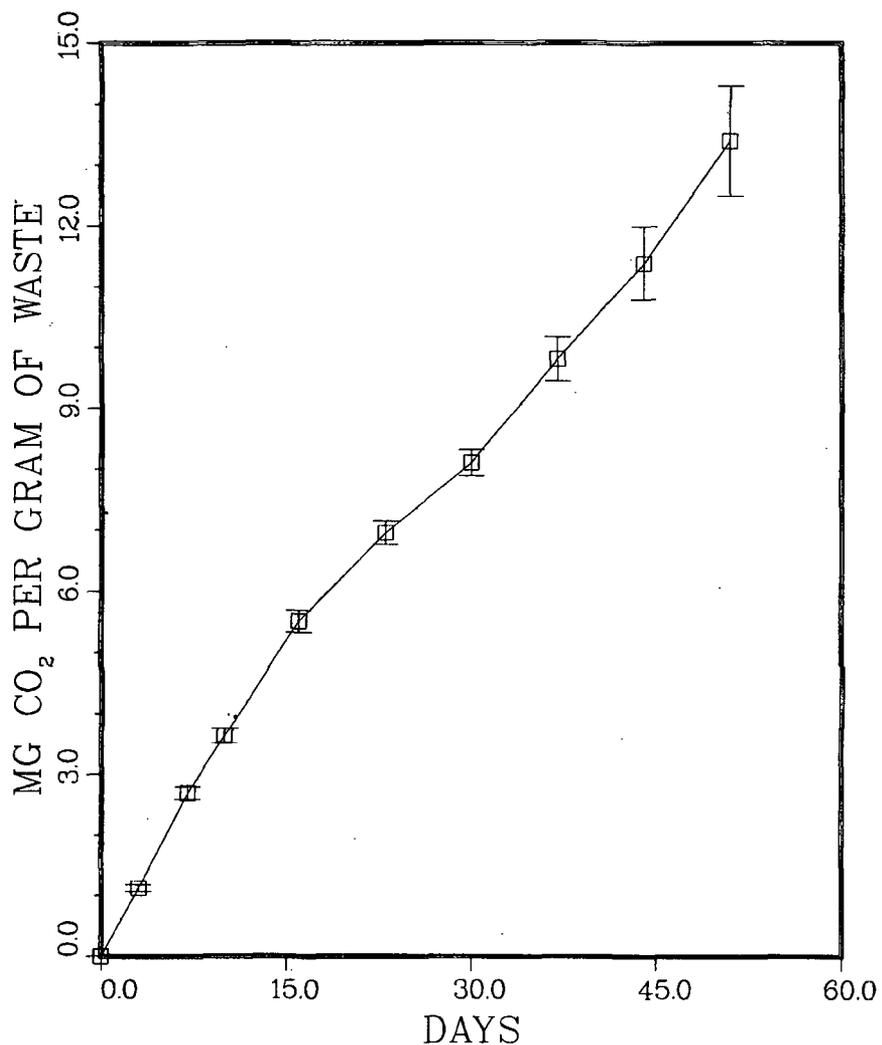
Figure 6.1 Cumulative production of CO₂ from FNPP resin samples.

Carbon dioxide produced by the waste sample indicates that active viable microorganisms are present. A rate of CO₂ gas generation from the resins was estimated based on a linear least squares fit of the data. Listed in Table 6.4 are rates of CO₂ production calculated using different portions of the cumulative gas generation data. The rate was greatest during the first 16 days of the experiments and decreased to about two-thirds the initial rate during the last 5 weeks of testing.

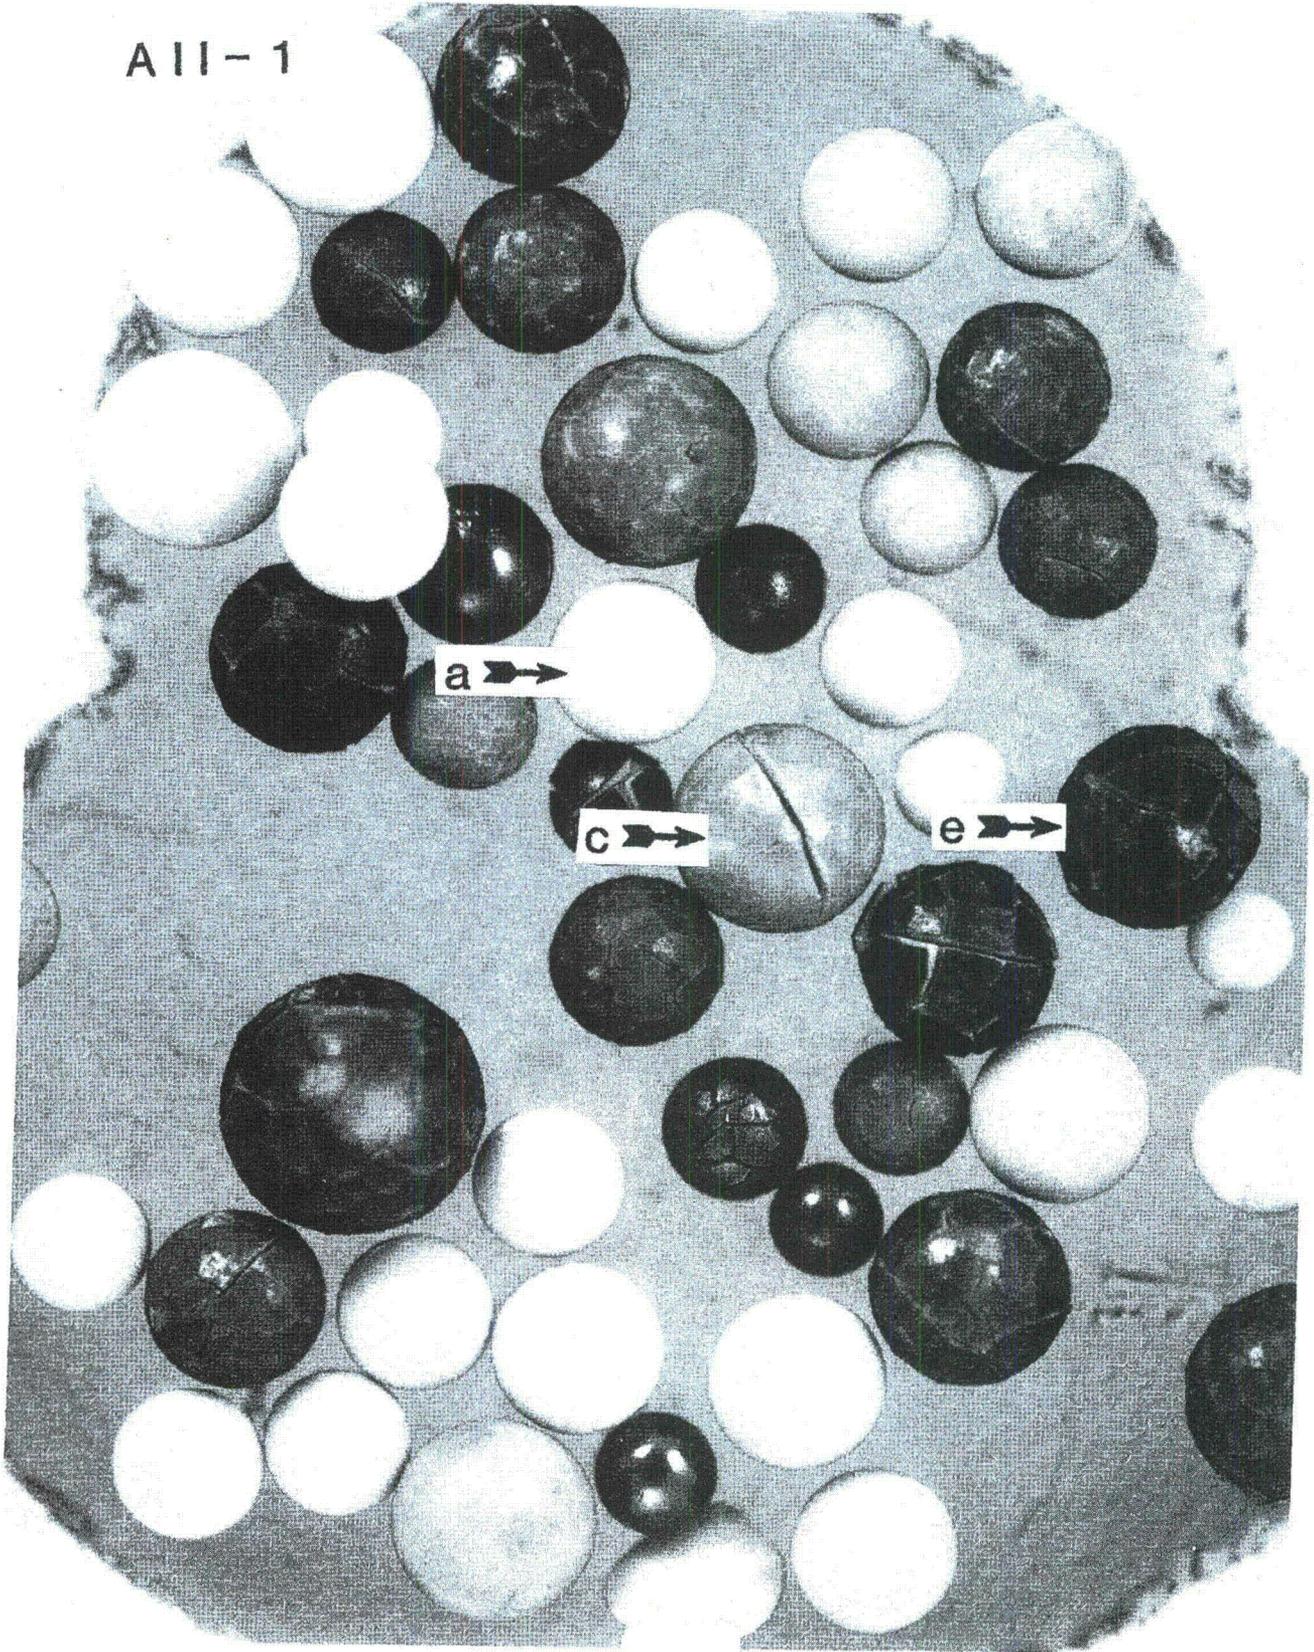
Label	Description	Sampling Location
a	undamaged macroporous (opaque) bead	AII-1
b	undamaged gel-type (translucent) bead	B-1,C
c	cracked macroporous bead	AII-1, AII-3
d	charred macroporous bead	AII-2, AII-3
e	cracked and charred macroporous beads	AII-1, AII-3
