# Doel 3 – Tihange 2 Reactor Pressure Vessel Assessment

WGIAGE  
April 2013

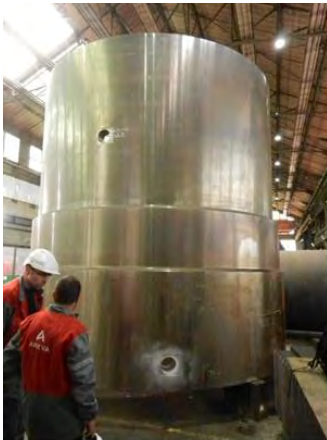
- Sample 500x500 mm taken from rejected AREVA SG shell VB395 containing hydrogen flakes
- Sample machined to 200 mm thickness (as RPV); no cladding
- UT flaw detection and sizing capability validated through destructive examination of 18 representative flaws in terms of size, location and slope

- Conclusions of UT validation on the VB395/1 block:
  - No flaw missed by UT inspection
  - UT slightly overestimates the size of flaws and hence slightly underestimates the ligaments between neighbouring flaws
  - Between neighbouring flaws there is a ligament composed of sound material
  - Use of angle beams up to 20° does not improve the UT flaw detection and sizing capability
- MIS-B qualification to be done:
  - Based on 2nd sample of VB395 shell (1800x1400x200mm)
  - Quality heat treatment and stainless steel cladding to be applied
  - Non-destructive examination by MIS-B
  - Destructive examination

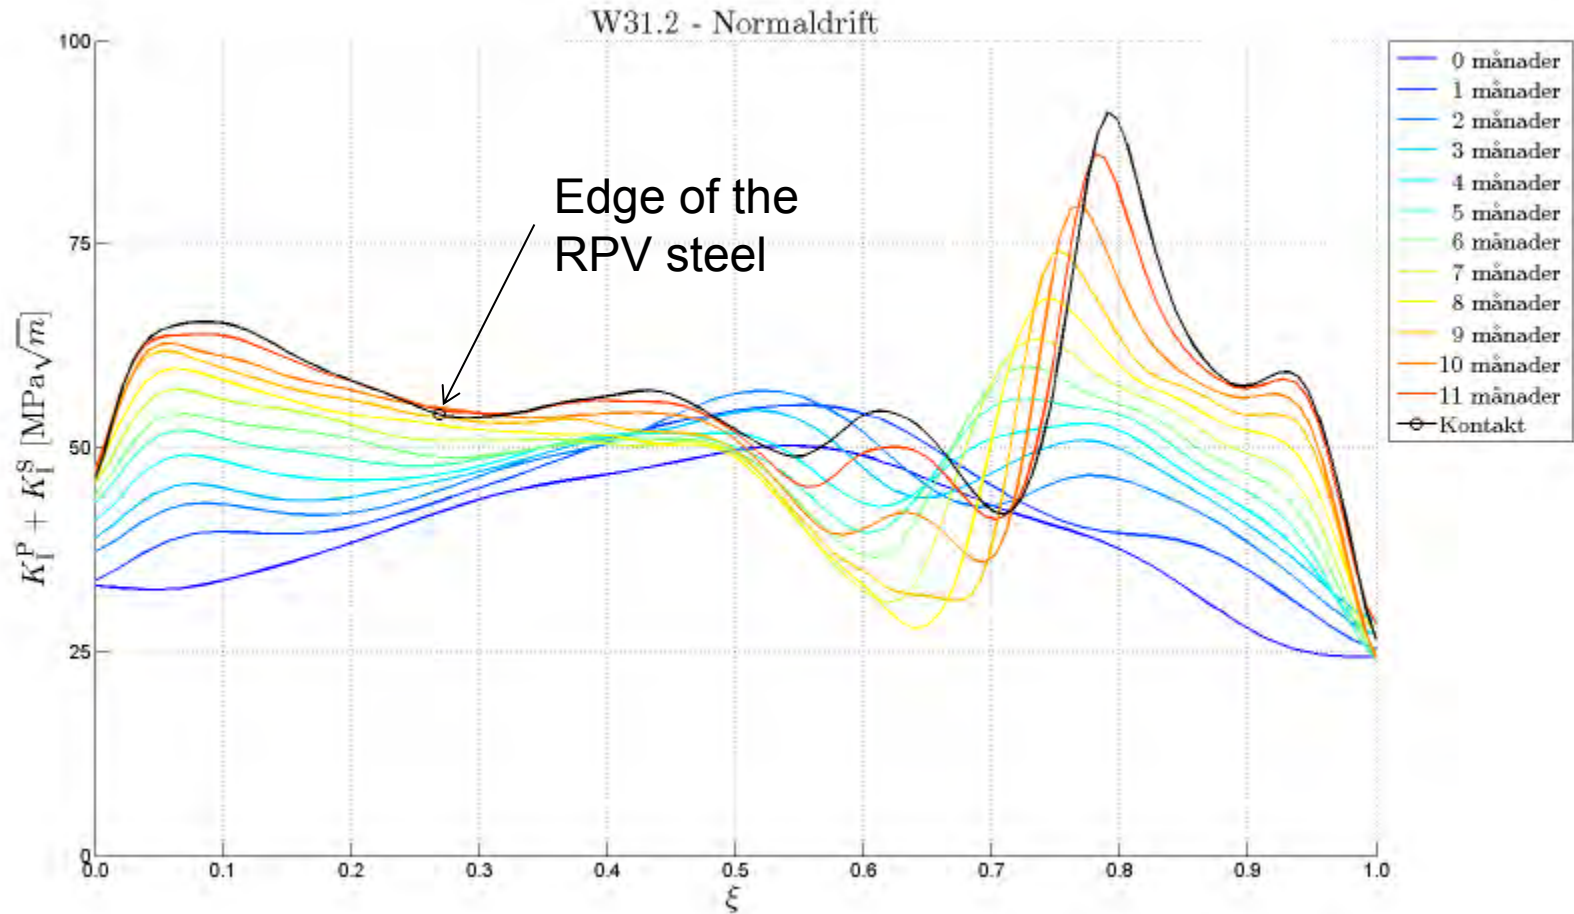
# Total stress intensity factor along the crack front at normal operation as function of time

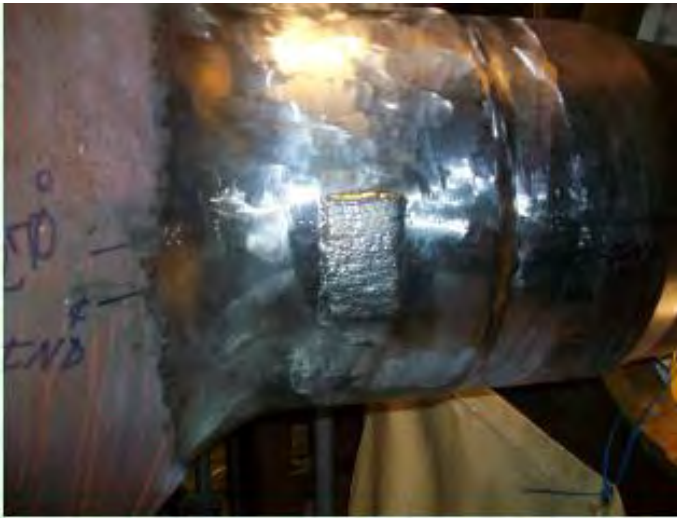
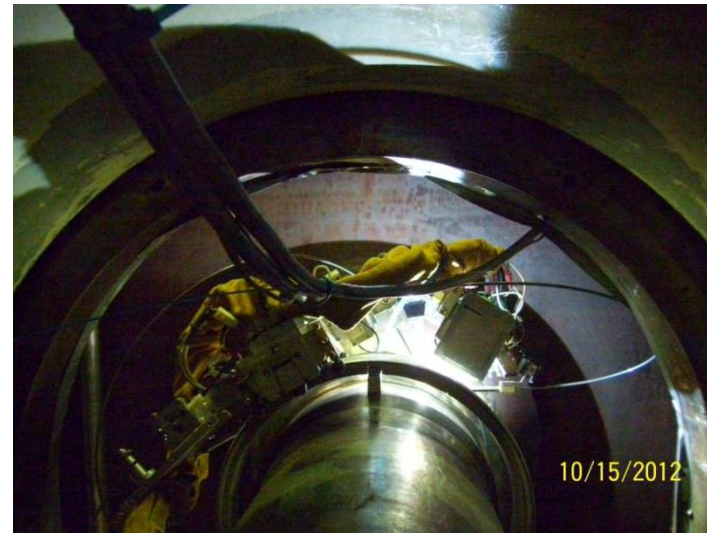
# Decision for FSWOL-Repair of Crack

- **Full structural weld overlay (FSWOL)**
- Code Case ASME N-740-2
- Local repair 2 layers (52M)
- 7 layers (52M) FSWOL
- FSWOL approved by ENSI as temporary repair measure (until 2015)

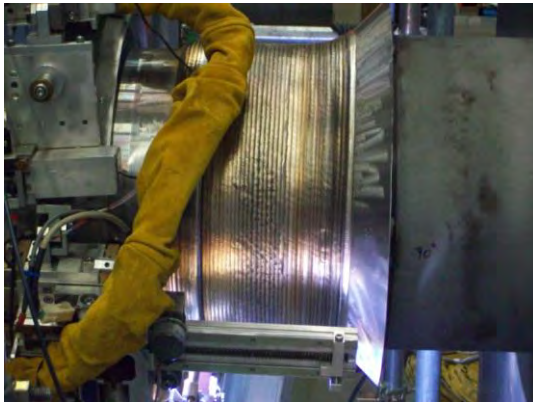
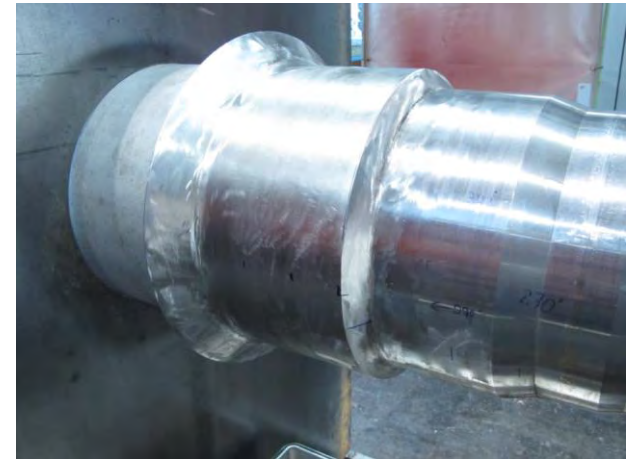
Full size mock-up for welding, acceptance NDE, and PSI/ISI demonstration

- Machined CS round bar with same nominal ID and OD dimensions as N-5 DMW including all tapers and transitions
- Mock-up was water backed

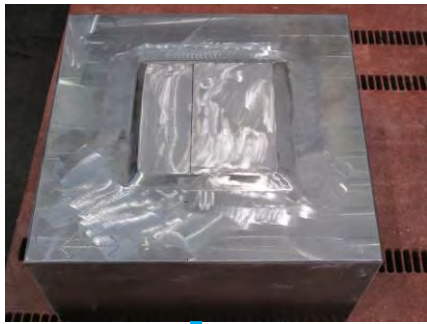
# Mockup for metallography and mech. testing

- Purpose was to demonstrate temperbead welding ( 4 layers of 52M deposited by temperbead process
- Sections cut out and removed for metallography and mechanical testing

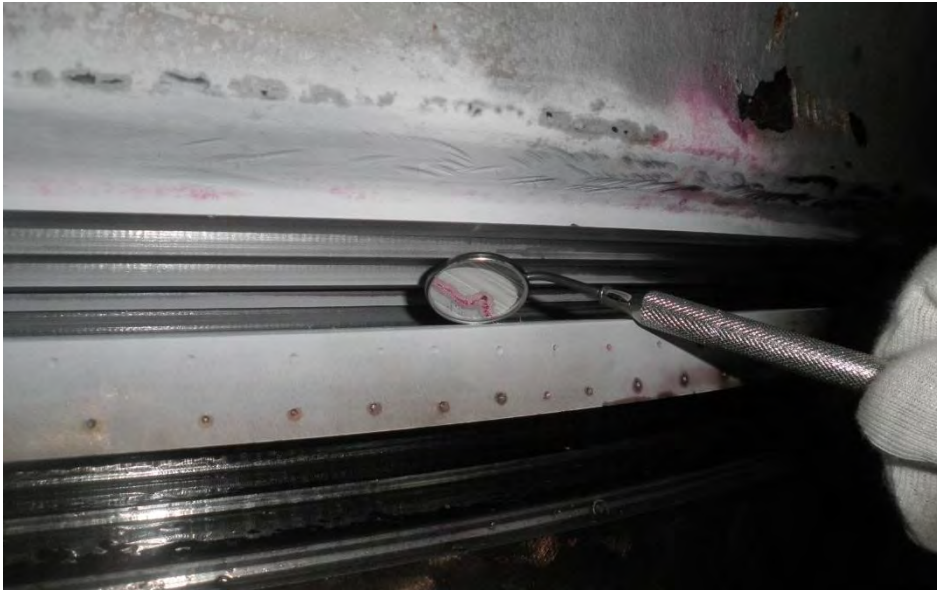
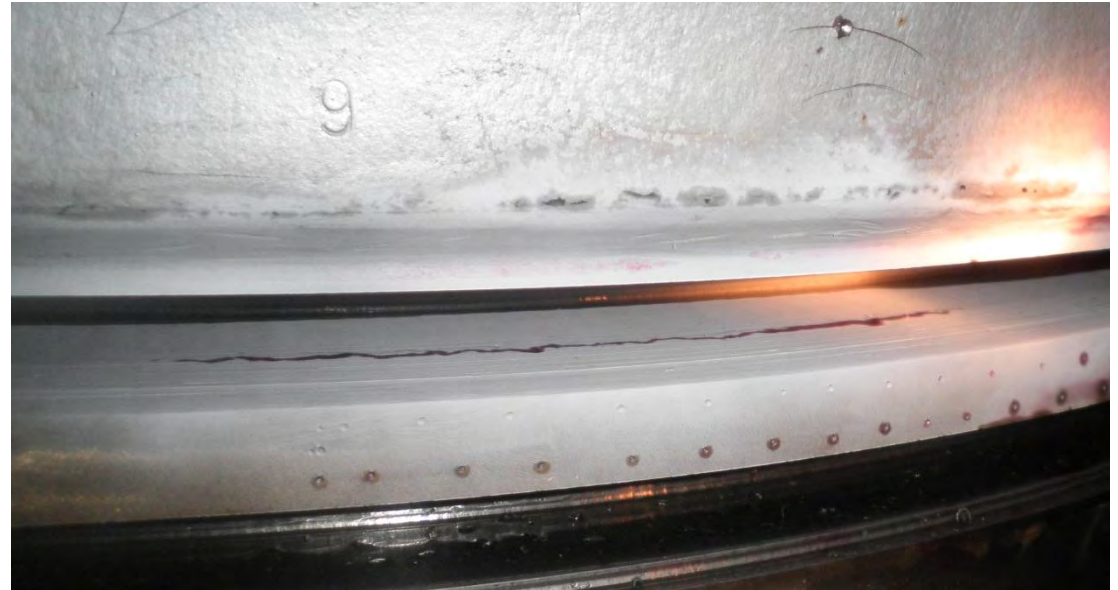
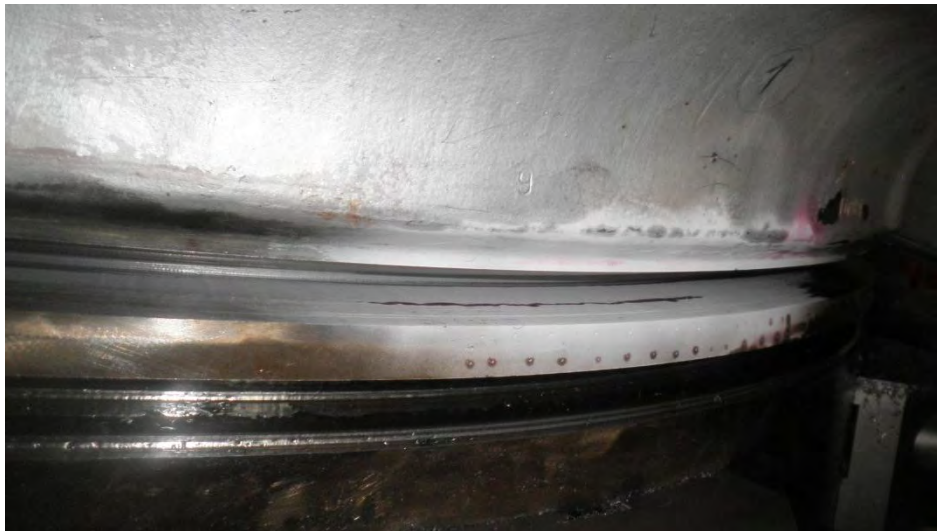
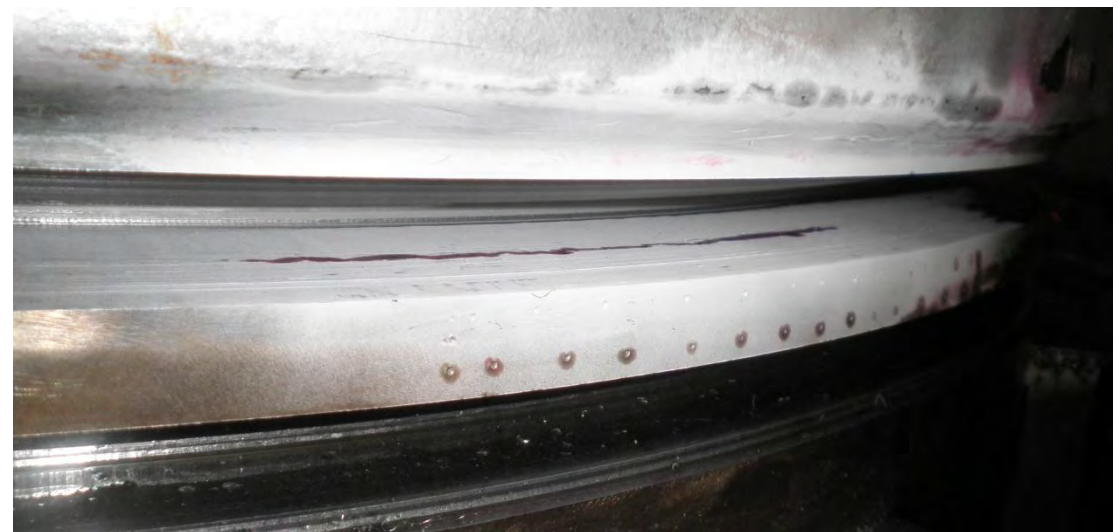
# Confirmation of Indication

Depth will be confirmed on SG21

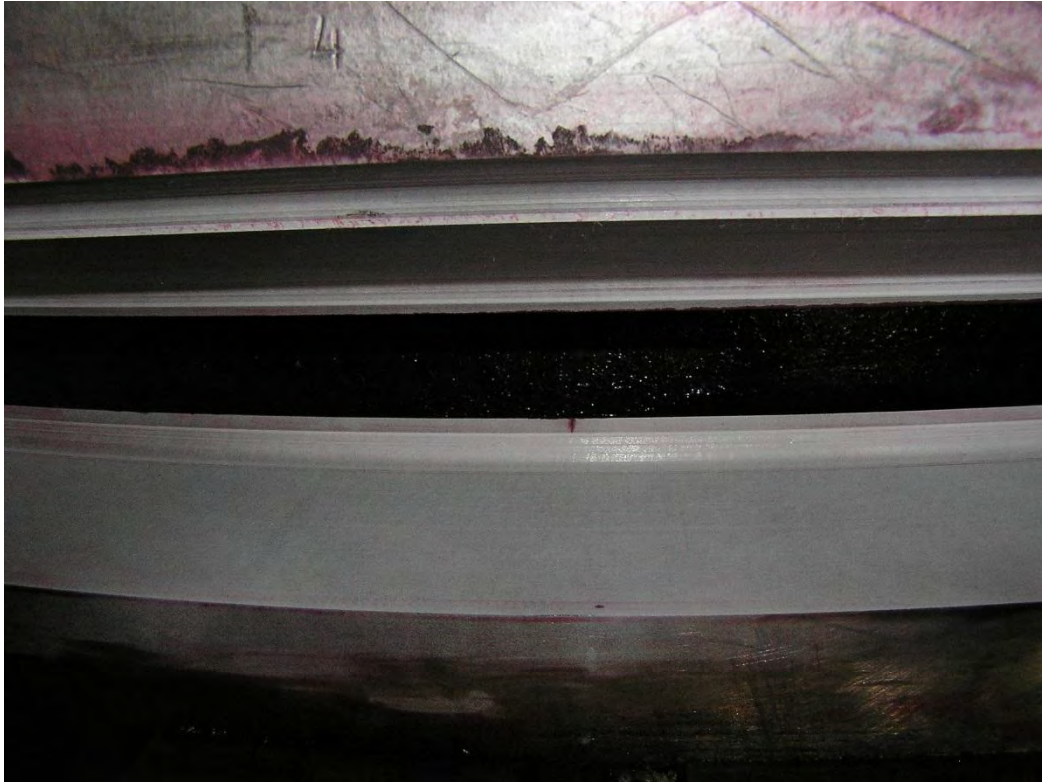
## New weld area

# Before welding

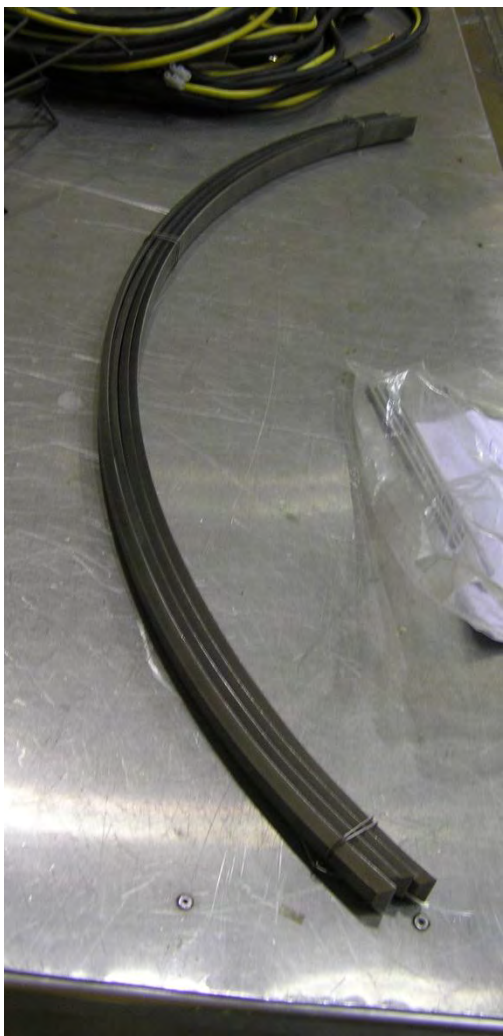
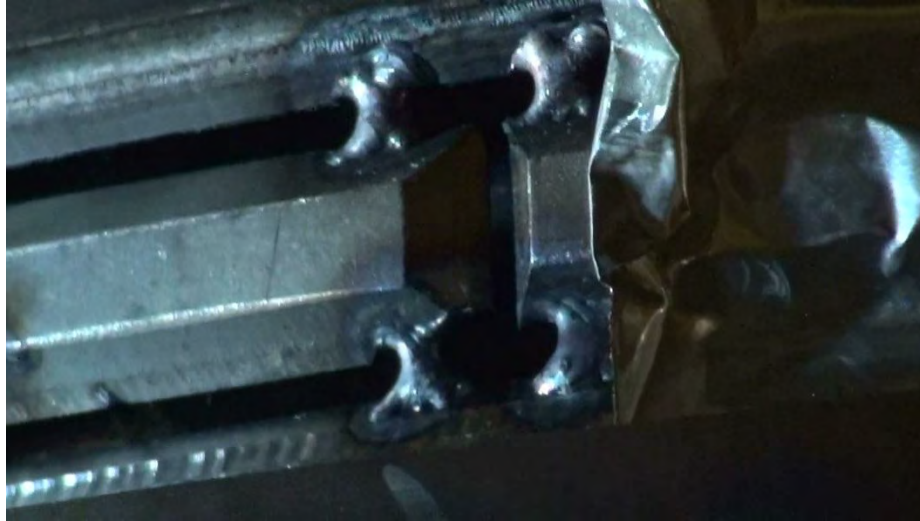
# New root of DMW weld

Material with 25Cr, 12Ni (SS 321) instead 25Ni, 12Cr

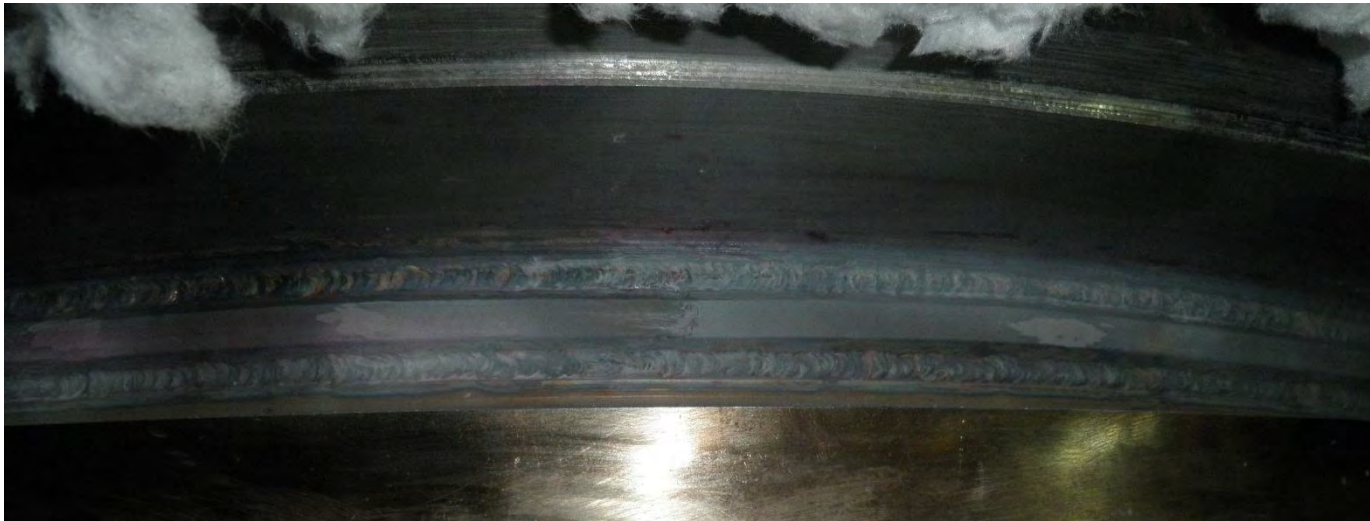
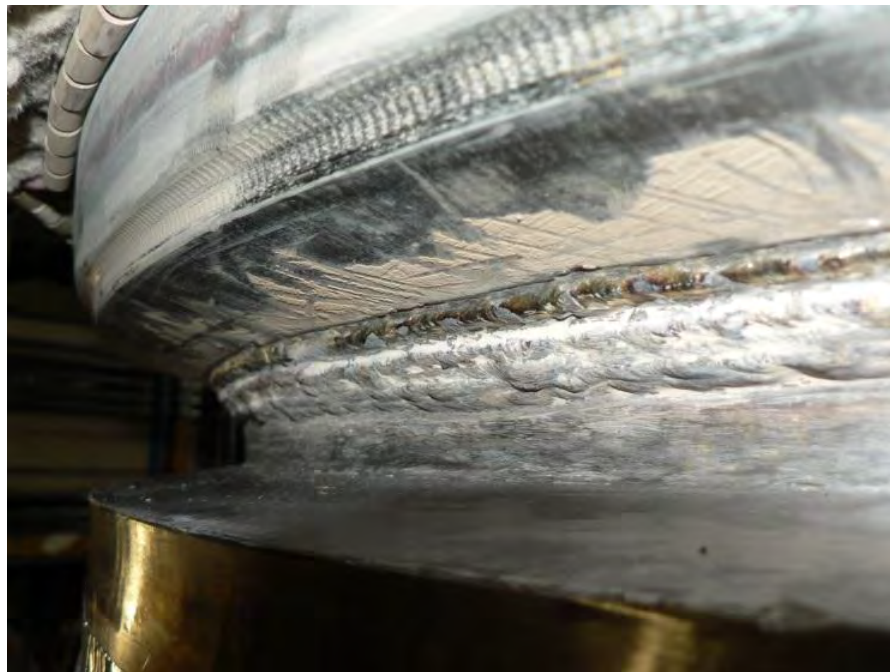
# New root of DMW weld

**SS - 25Cr, 12Ni**

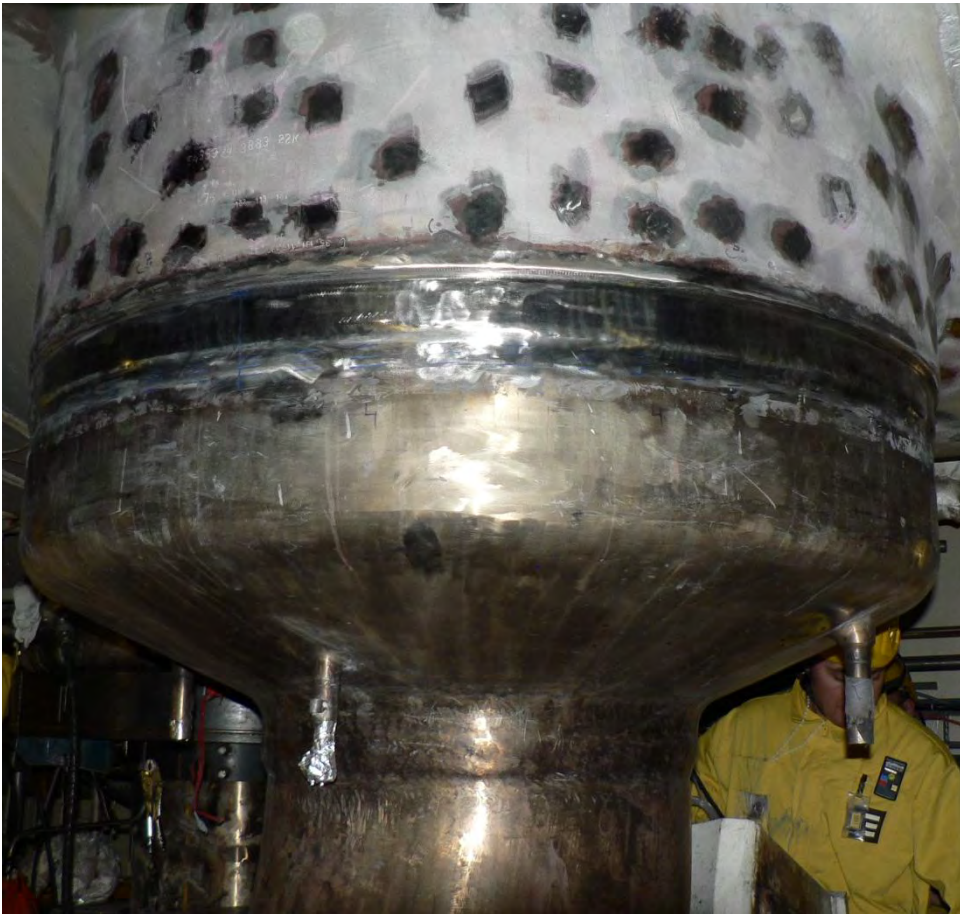
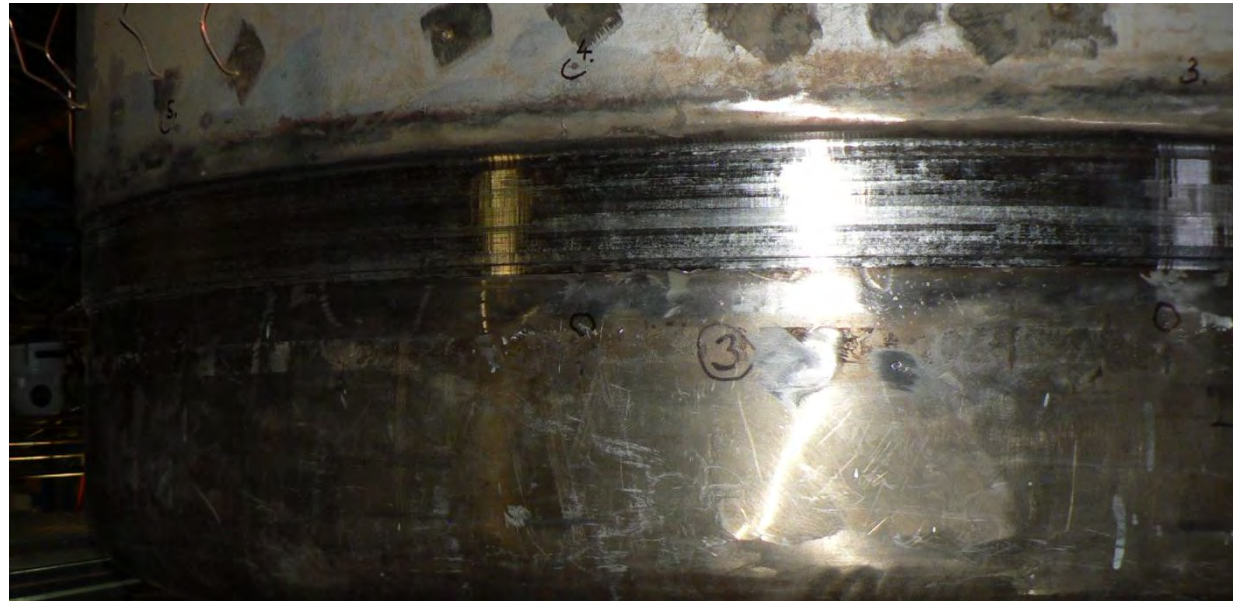
# New SG DMW after Repair

## New DMW

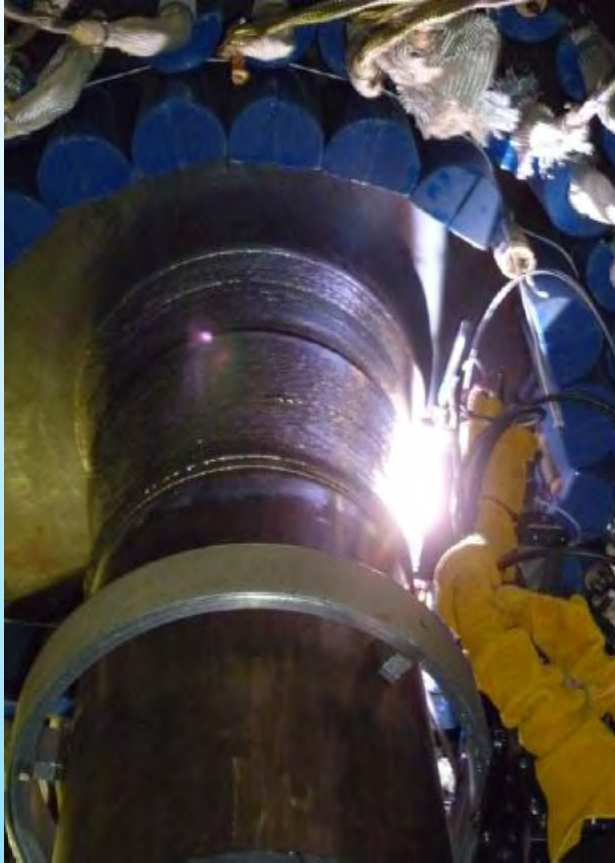
- ✓ Dual wire process

Weld overlay in progress

- Pressurizer nozzle-to-spray line weld (4"), nozzle-to-safety valve lines weld (6") and nozzle-to-discharge line weld (6")
  - ✓ FSWOL selected for mitigation in Tihange 2 and Doel 3&4
  - ✓ Qualification in 2012-2013
  - ✓ Application
    - in 2014 in Tihange 2/Doel 3
    - In 2015 in Doel 4

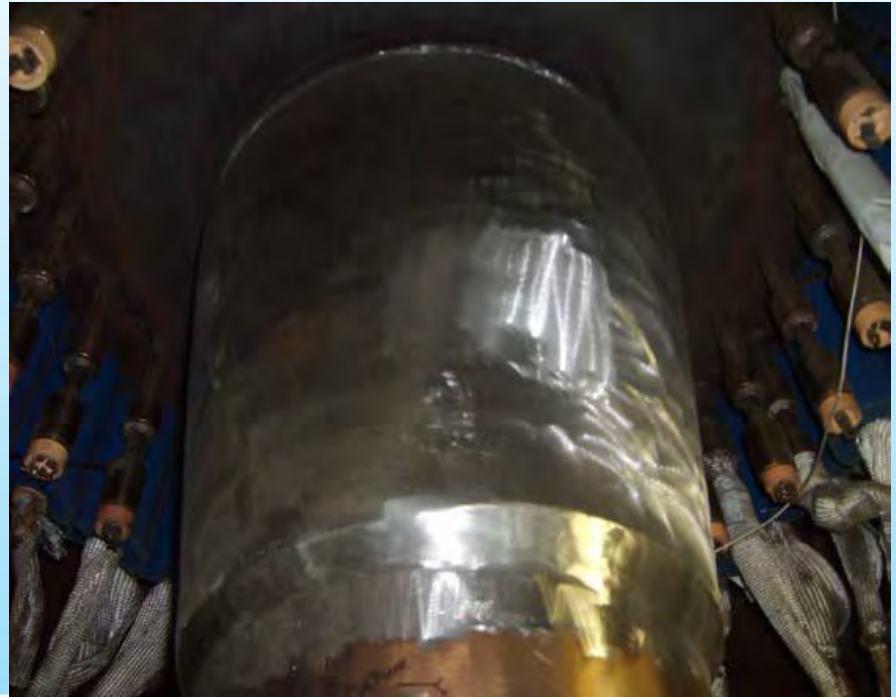
Final aspect

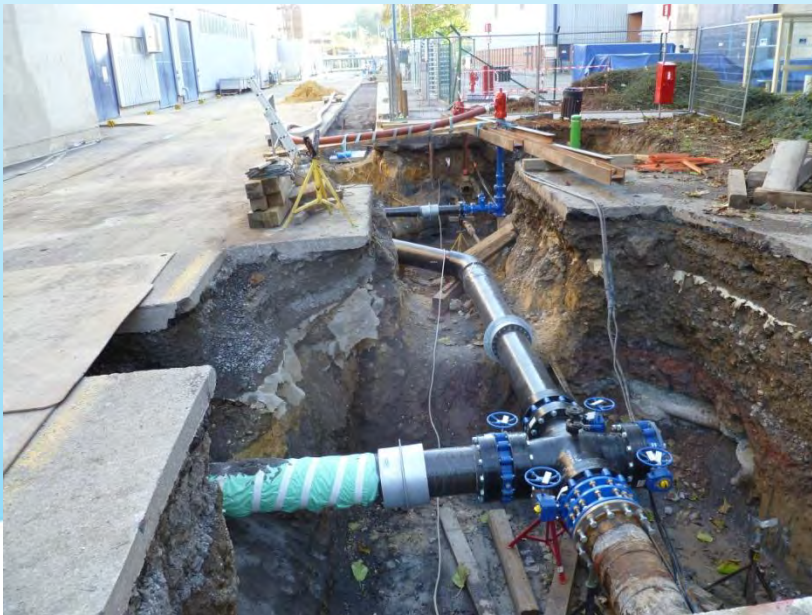
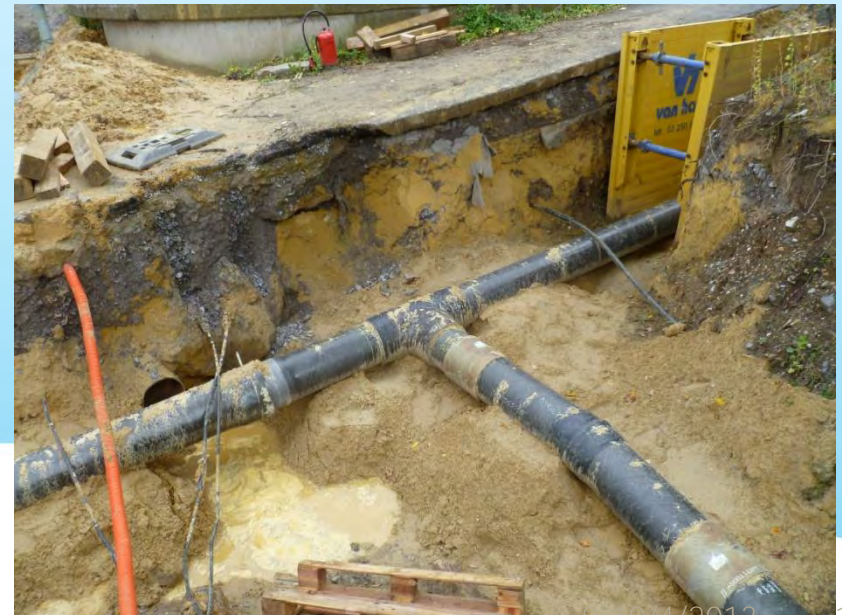
# REPLACEMENT OF FIRE WATER LOOP

- Buried piping of the fire water loops in Tihange
  - ✓ Carbon steel and cast iron piping currently being replaced by piping in glass-fiber reinforced epoxy (GRE) in Tihange 2 and 3
  - ✓ Approximately 5000 m to be replaced (until 08/2013)
  - ✓ **12", non ASME**
  - ✓ Linear parts attached by Key-Lock male and female mechanical joints
  - ✓ Elbows attached by male and female adhesive-bonded joints

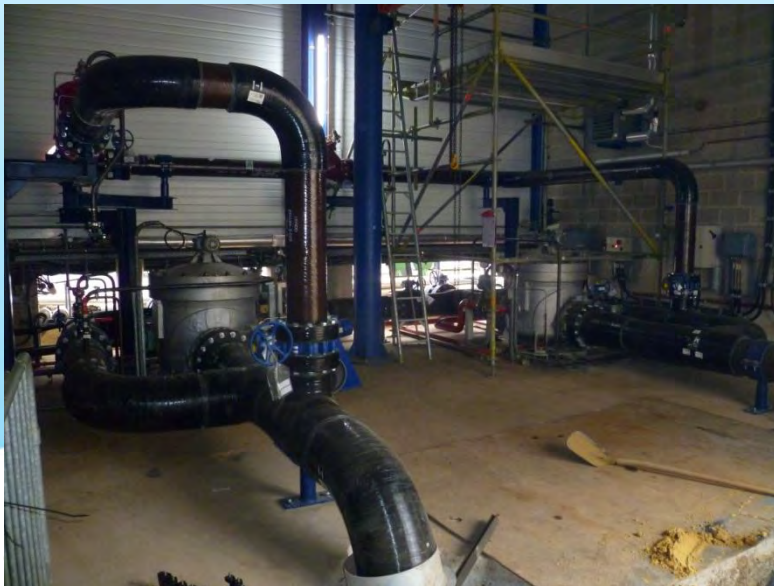
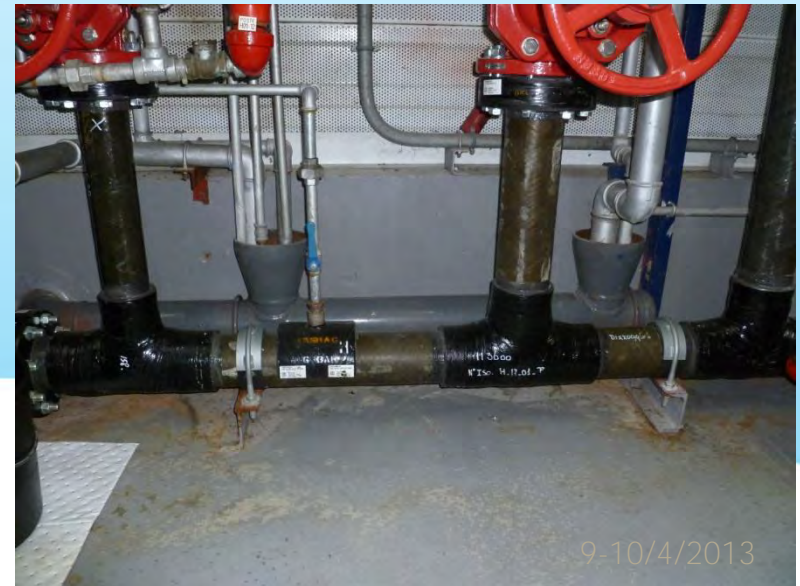
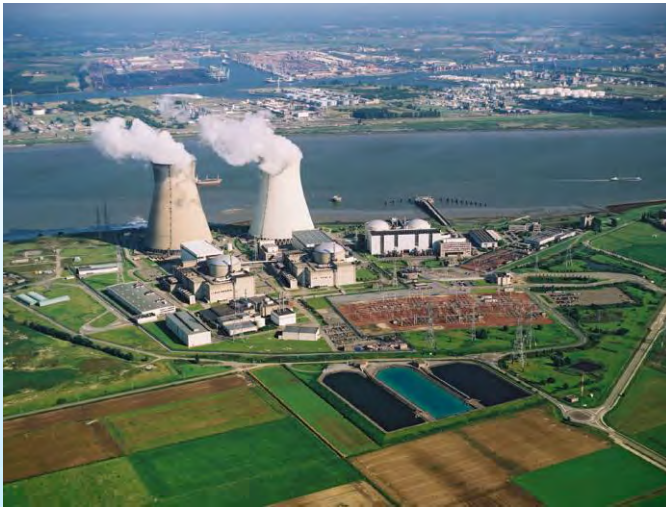
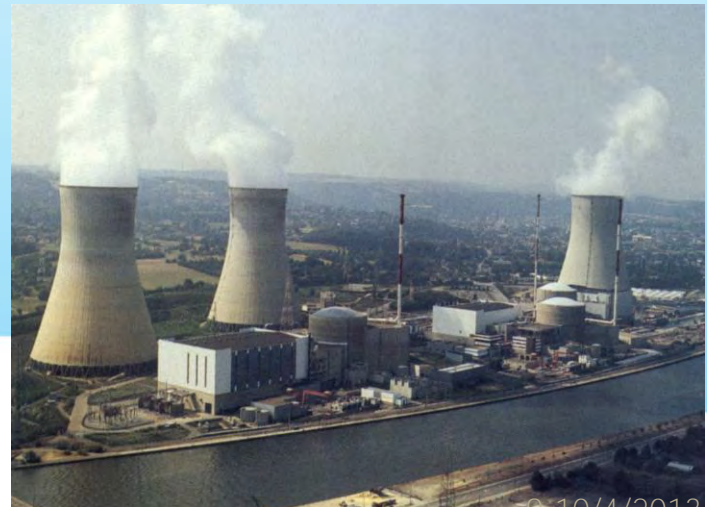
- Inside piping of the fire water loops in Tihange
  - ✓ Reactor building
    - ASME part, piping replaced by steel
  - ✓ Other buildings
    - Non ASME part, replacement by piping in GRE
    - 12km to be replaced in Tihange 1, 2 & 3
    - Linear parts and elbows attached by Key-Lock mechanical joints
    - Work planned until 2016

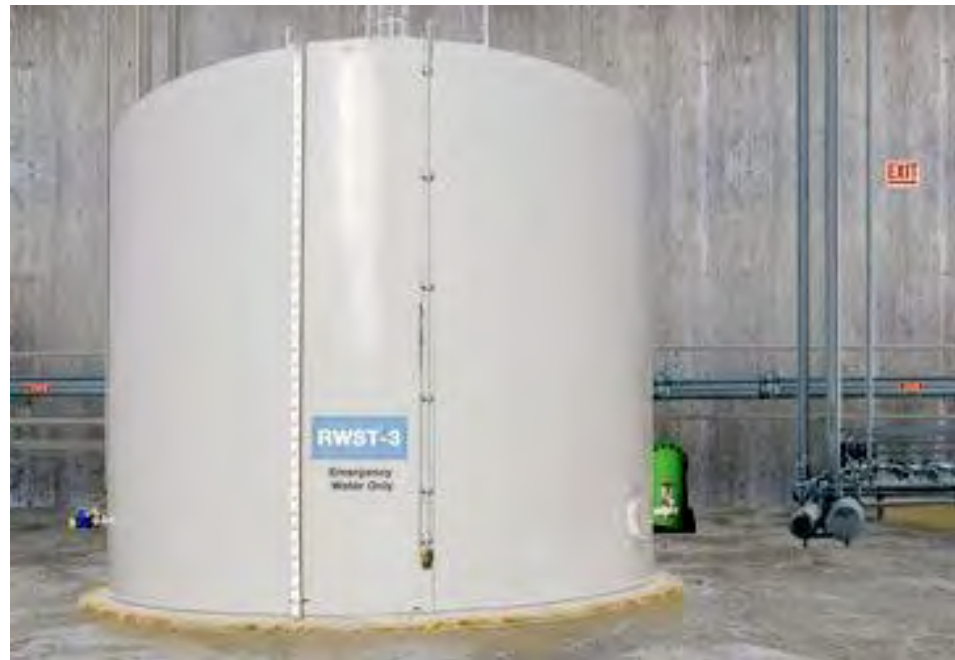
# Refueling Water Storage Tanks

- 3 recent instances of cracking
- At least 1 SCC

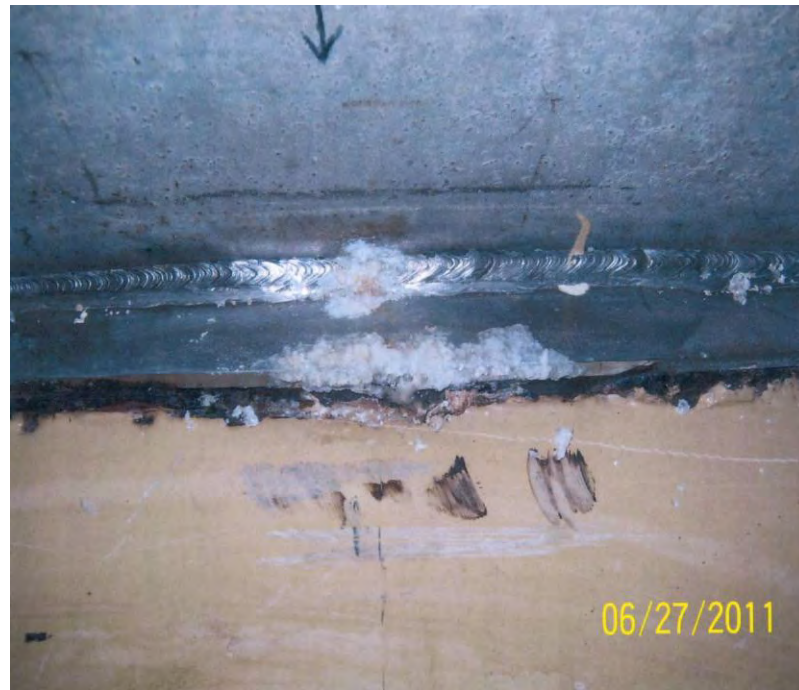
- Chloride SCC
  - Near tank bottom
  - OD originated
    - Consider
      - Ground Water
      - Deicing salt
  - Temp < traditional Chloride SCC limit

- Resolution
  - Tanks repaired
  - Information Notice being prepared

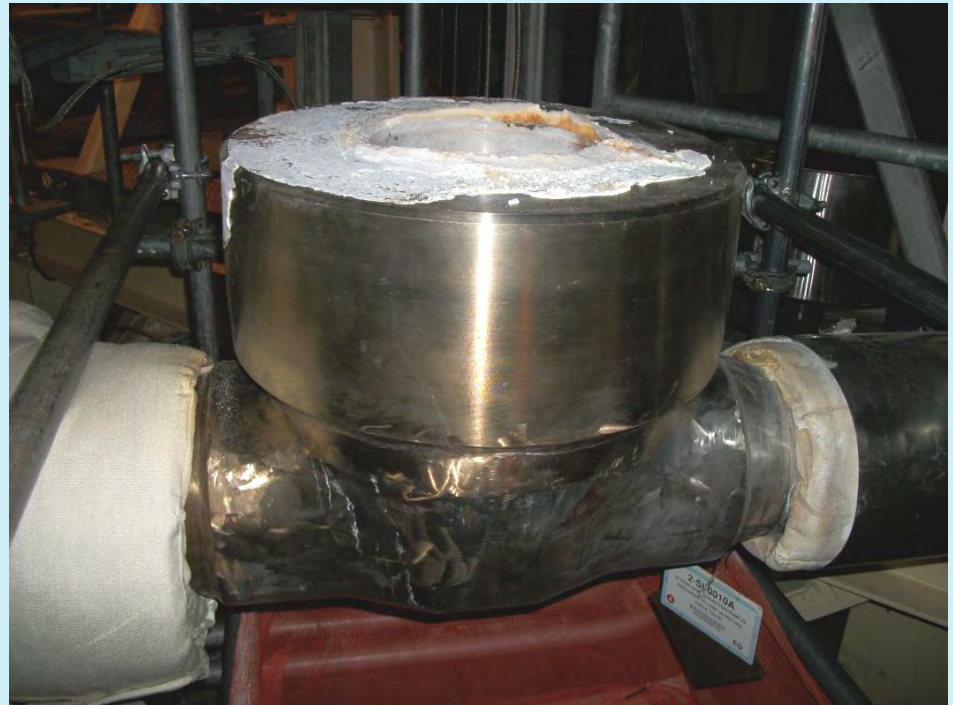
- Seal Cap Enclosure #2 (Plant B) (cont.)
  - Boric acid observed
  - Seal weld repaired

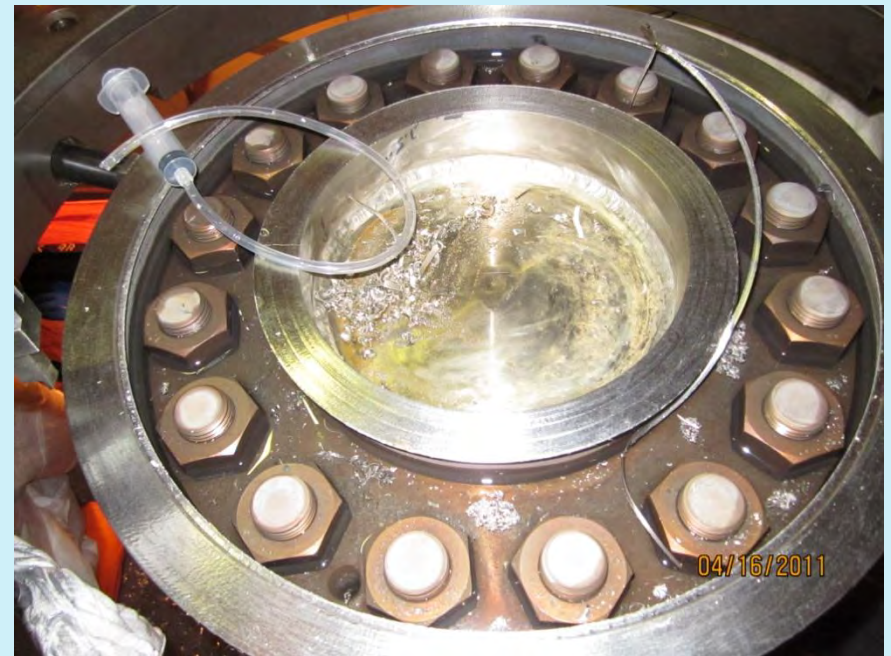
- Seal Cap Enclosure #2 (Plant B) (cont.)
  - 2012 more boric acid
    - Enclosure top removed
    - Bolts inspected
      - UT/Torque
      - No degradation
    - Enclosure reinstalled

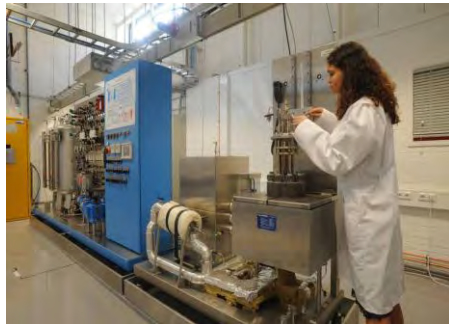
3 recirculation loops with full water chemistry control, equipped for environmental mechanical tests at  $p_{\max} = 360 \text{ bar}$ ,  $T_{\max} = 650^\circ \text{ C}$ :  
 ⇒ BWR, PWR, SCWR conditions

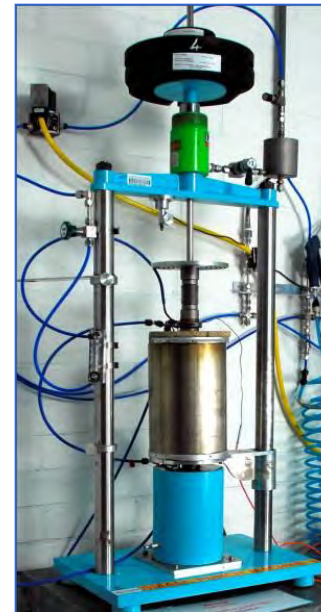
- Low alloy ferritic steel 22NiMoCr3-7 (similar to ASTM A508, Cl. 2)
    - Austenitic SS X6CrNiNb18-10 and X10CrNiNb18-9 (similar to ASTM TP347)
    - Austenitic SS X10CrNiTi18-9 (similar to ASTM TP321)

- **LCF tests in air environment at room temperature (RT)**  
**- austenitic stainless steel**
