**Seismic Walkdown Checklist (SWC)**

Equipment ID No.: D03-5203-----P30

Equipment Description: DIESEL GENERATOR/ Fuel Oil Transfer Pump

Project: Dresden 3 SWEL

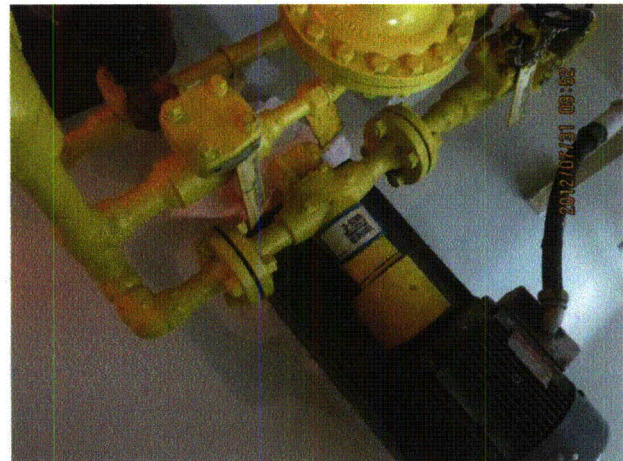
20120731-Dresden-3 132

| 4. | Is the anchorage free of visible cracks in the concrete near the anchors?<br><i>Minor crack in grout pad judged to be acceptable.</i> | Yes |

Small transfer pump anchored by four 3/8" cast-in-place anchors.

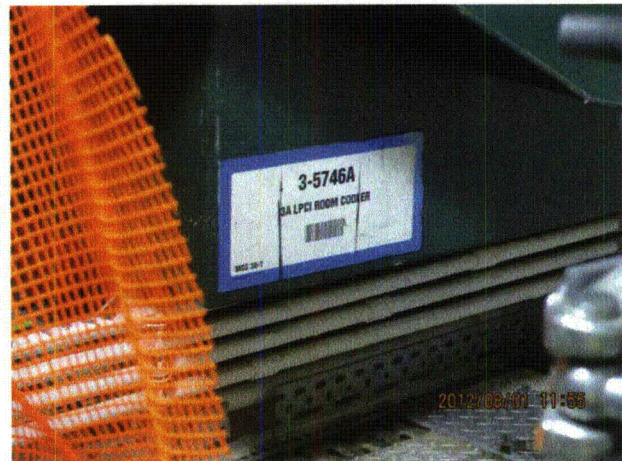
20120801-Dresden-3 237

1. Is anchorage configuration verification required (i.e., is the item one of the 50% of SWEL items requiring such verification)? Yes
2. Is the anchorage free of bent, broken, missing or loose hardware? Yes  
*Abandoned anchor hole located at least 2 anchor diameters away from one rod support in accordance with station procedures. Judged to be acceptable.*

3. Is the anchorage free of corrosion that is more than mild surface oxidation? Yes
4. Is the anchorage free of visible cracks in the concrete near the anchors? Yes  
*Minor shrinkage cracks in underside of ceiling slab judged to be acceptable.*

Air cooler is hung from the ceiling with six 1/2" diameter rod hangers (3 on each side).

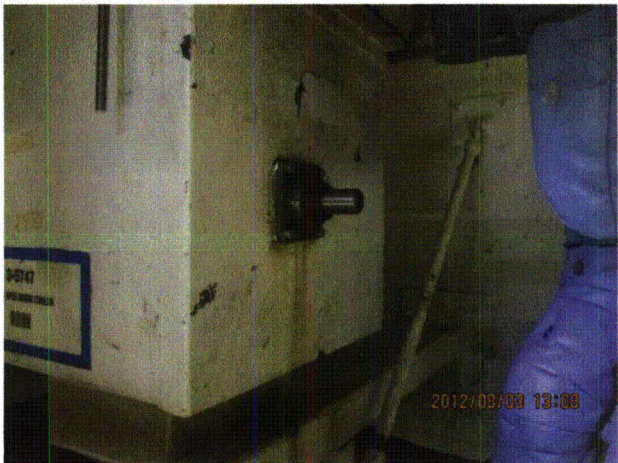
20120803-Dresden-3 171

4. Is the anchorage free of visible cracks in the concrete near the anchors? Yes  
*Minor shrinkage cracks in ceiling judged to be acceptable.*

*Potential interaction between cooler and channel support of HVAC duct judged to be non-damaging and acceptable.*

*Insulated pipe for cooler touching duct judged to be acceptable.*

Air cooler is hung from the ceiling with six 1/2" diameter rod hangers (3 on each side).

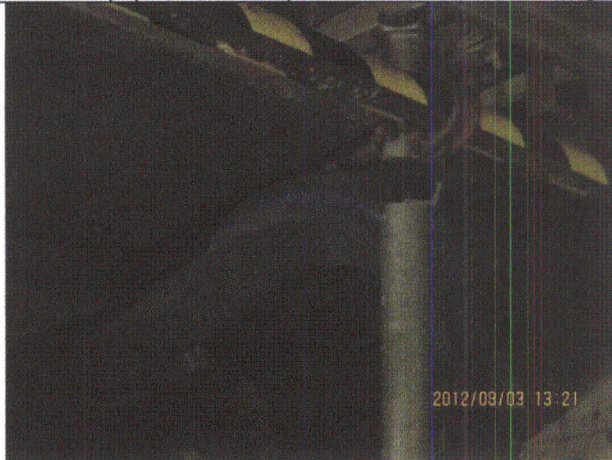
20120803-Dresden-3 209

Equipment Class: (10) Air Handlers

Equipment Description: HPCI/ HPCI Emergency Air Cooler

4. Is the anchorage free of visible cracks in the concrete near the anchors? Yes  
*Minor shrinkage cracks in floor judged to be acceptable.*

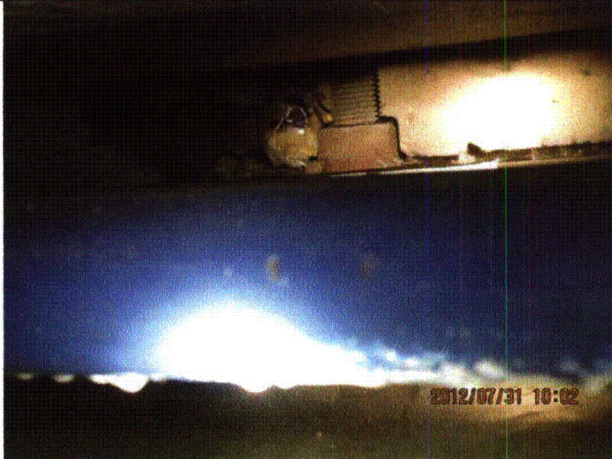
20120731-Dresden-3 153

Equipment Class: (17) Engine-Generators

Equipment Description: DIESEL GENERATOR/ Diesel Engine Driven Generator

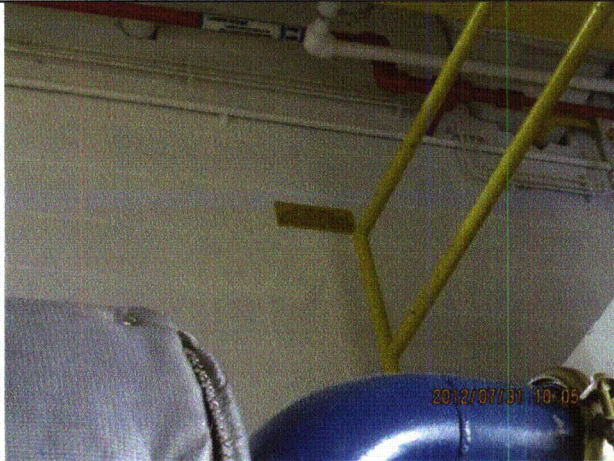
20120731-Dresden-3 161

Equipment Class: (17) Engine-Generators

Equipment Description: DIESEL GENERATOR/ Diesel Engine Driven Generator

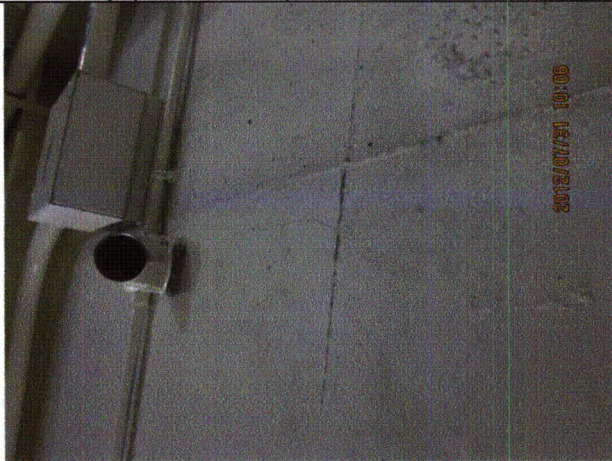
20120731-Dresden-3 165

Equipment Class: (17) Engine-Generators

Equipment Description: DIESEL GENERATOR/ Diesel Engine Driven Generator

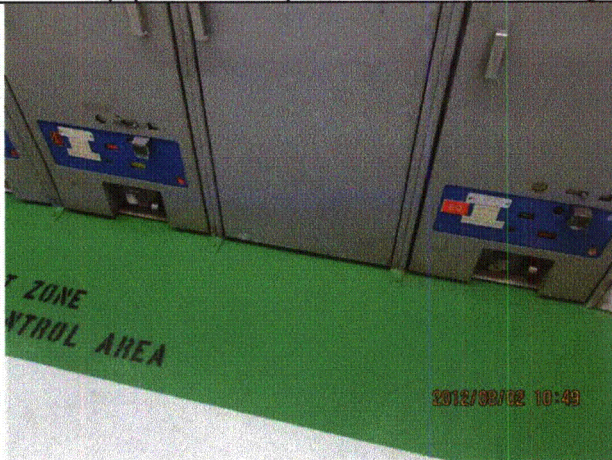
20120802-Dresden-3 138

Equipment Class: (3) Medium Voltage Switchgear

Equipment Description: 4160V AC/ Switchgear 34-1

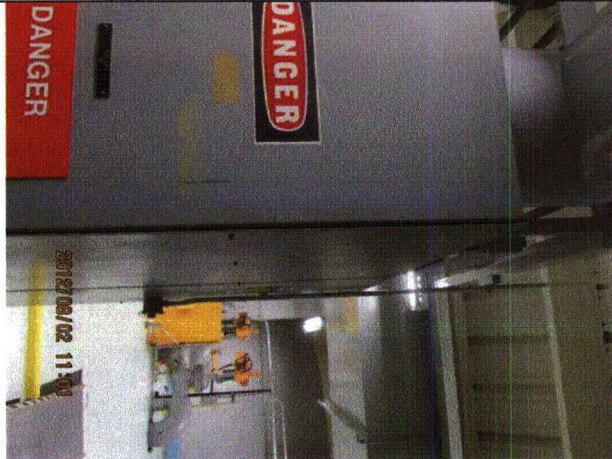
20120802-Dresden-3 158

Equipment Class: (3) Medium Voltage Switchgear

Equipment Description: 4160V AC/ Switchgear 34-1

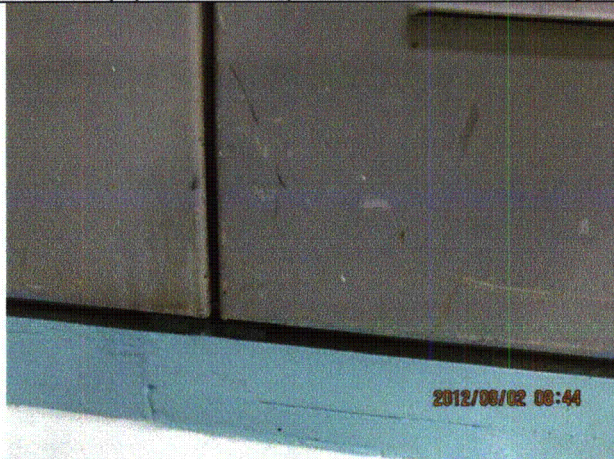
20120802-Dresden-3 036

*During Fukushima seismic walkdowns, two movable trolley hoists mounted on top of SWGR 38 and one movable trolley hoist mounted on top of SWGR 39 were found unrestrained against horizontal movement due to the restraining pin for each hoist not being installed while each hoist was in the stored position. The switchgears are located at U3, N-47, EL. 570.*

Equipment Class: (2) Low Voltage Switchgear

Equipment Description: 480V AC/ Switchgear 38

*Unit supervisor and shift manager were informed of the condition and station personnel installed the pins for the trolley hoists. Therefore, hoists are judged acceptable.*

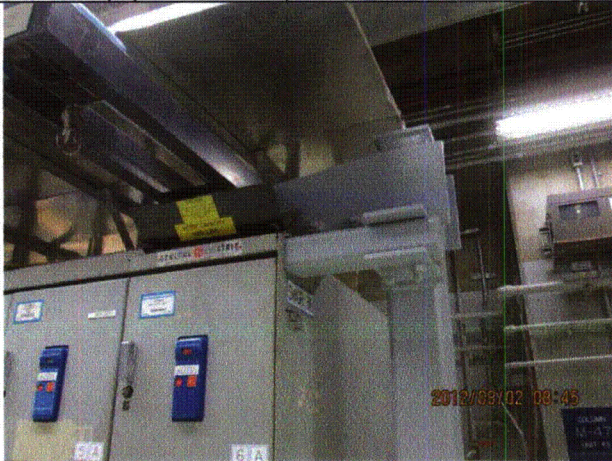
20120802-Dresden-3 040

Equipment Class: (2) Low Voltage Switchgear

Equipment Description: 480V AC/ Switchgear 38

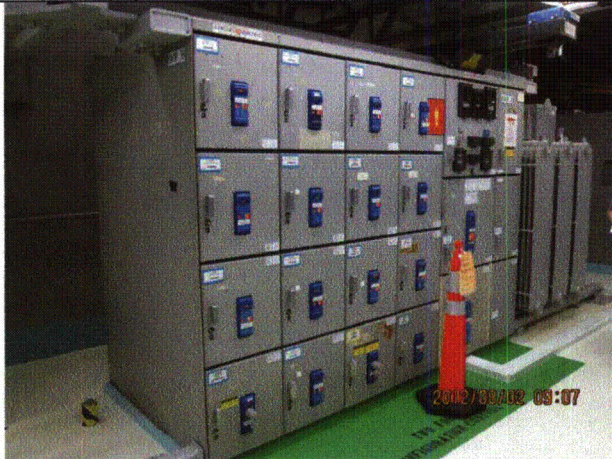
20120802-Dresden-3 059

*During Fukushima seismic walkdowns, two movable trolley hoists mounted on top of SWGR 38 and one movable trolley hoist mounted on top of SWGR 39 were found unrestrained against horizontal movement due to the restraining pin for each hoist not being installed while each hoist was in the stored position. The switchgears are located at U3, N-47, EL. 570.*

Equipment Class: (2) Low Voltage Switchgear

Equipment Description: 480V AC/ 480V Switchgear 39

*Unit supervisor and shift manager were informed of the condition and station personnel installed the pins for the trolley hoists. Therefore, hoists are judged acceptable.*
