Stress Corrosion Crack Growth Response of Alloy 152/52-Carbon Steel Dissimilar Metal Welds in PWR Primary Water

*Mychailo Toloczko, Matt Olszta, Nicole
Overman and Steve Bruemmer
Pacific Northwest National Laboratory*

2013 ICG-EAC Meeting
May 20-24, 2013 Karuizawa, Japan

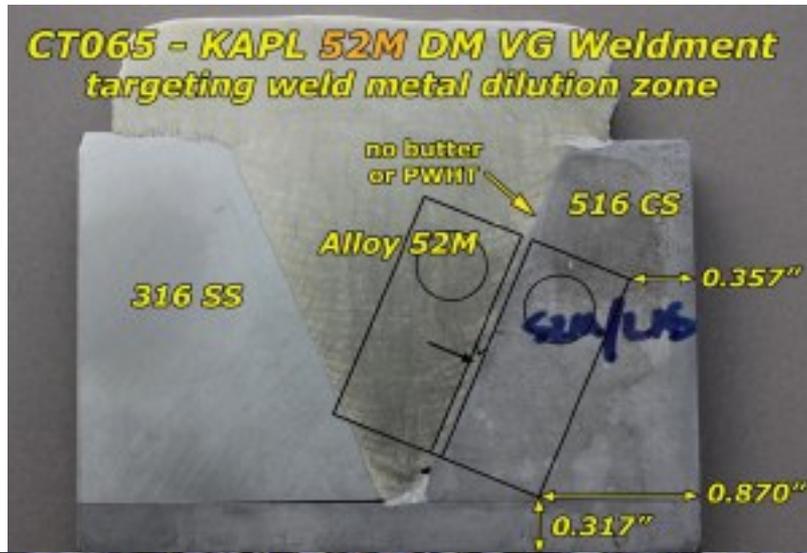
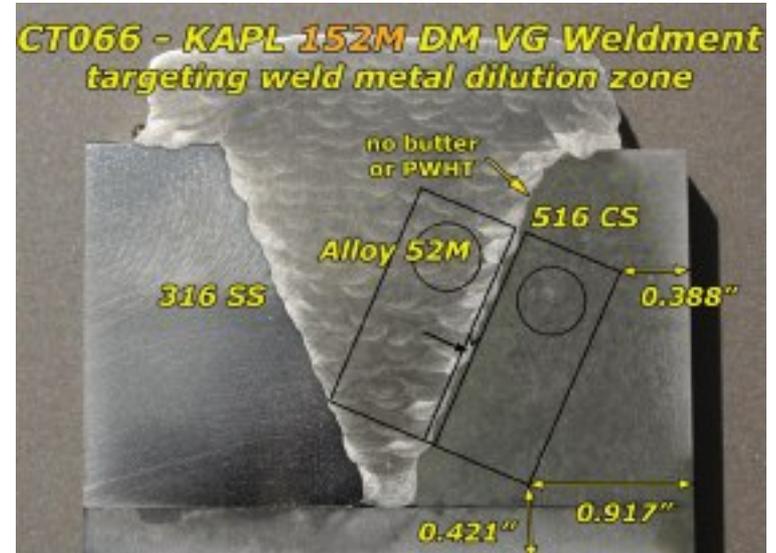
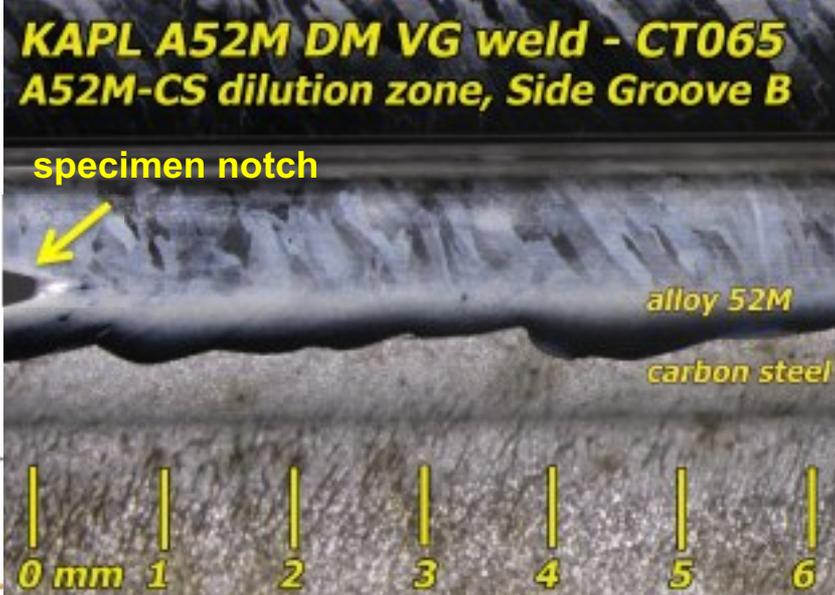
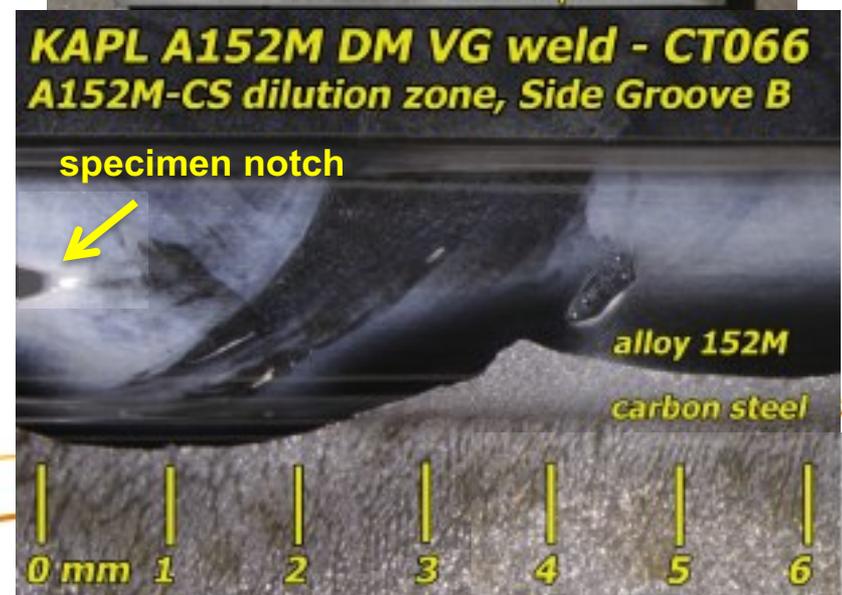
KAPL 52M/CS (CT065) and 152M/CS (CT066) Dilution Zone Specimens

Goal was to measure weld dilution zone response. ~0.5-1 mm from fusion line.

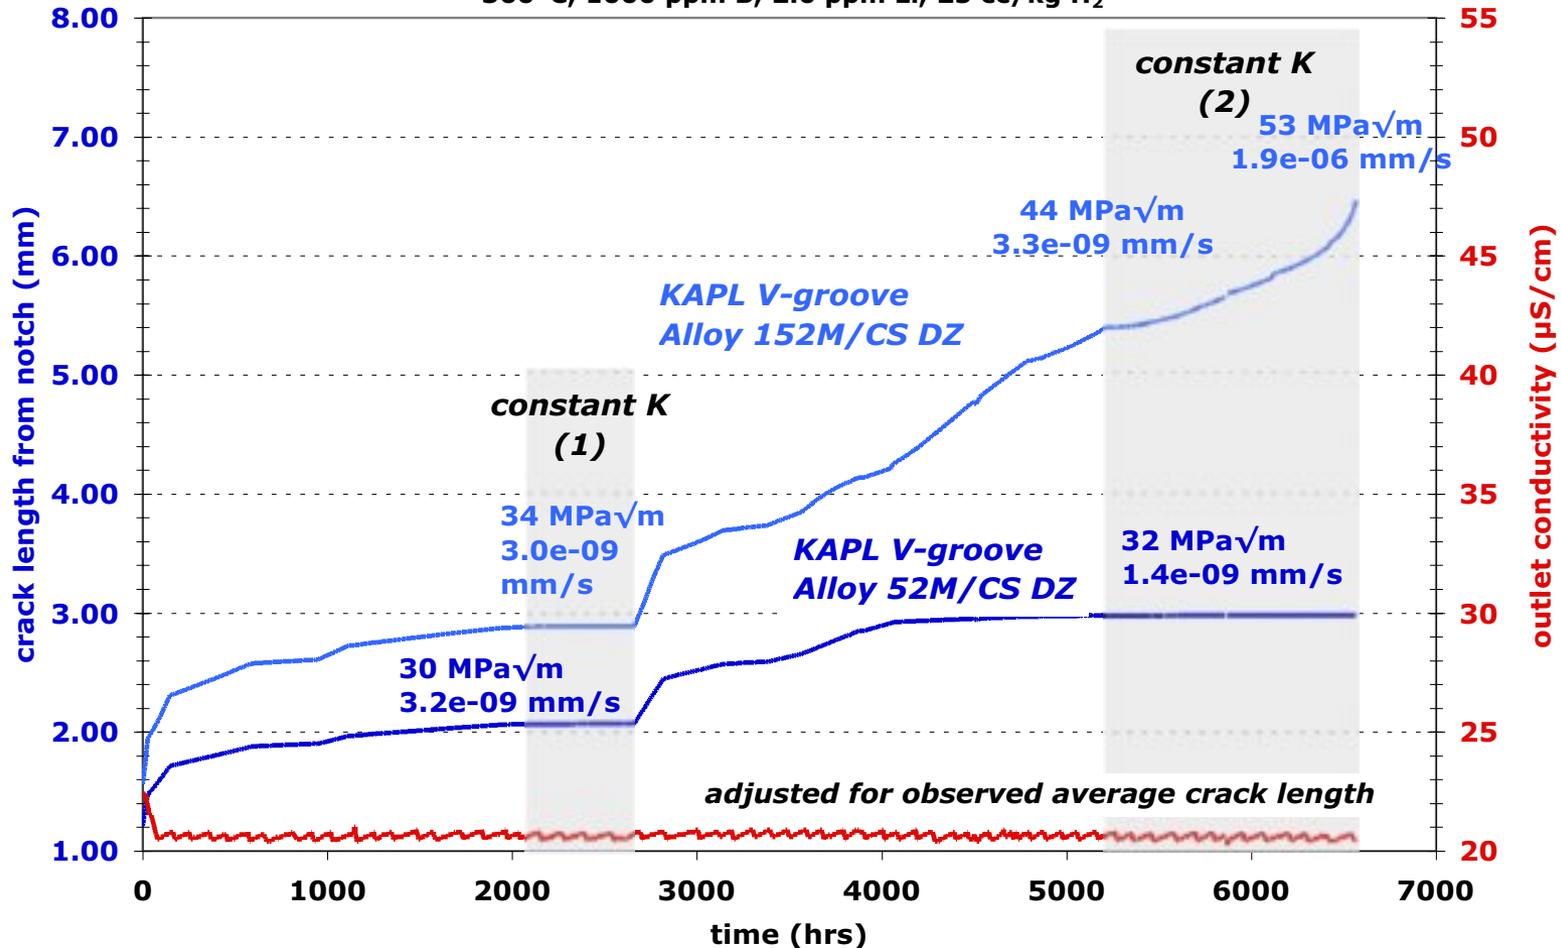
Overview of Crack Growth Test for KAPL 152M/CS and 52M/CS Specimens

CT065&66 - 0.5T CT KAPL VG A52M/CS DZ and KAPL VG A152M/CS DZ
360°C, 1000 ppm B, 2.0 ppm Li, 25 cc/kg H₂

Constant *K* response measured twice for the dilution zone specimens with high SCC rates seen for the alloy 152M/CS specimen at high *K* levels.

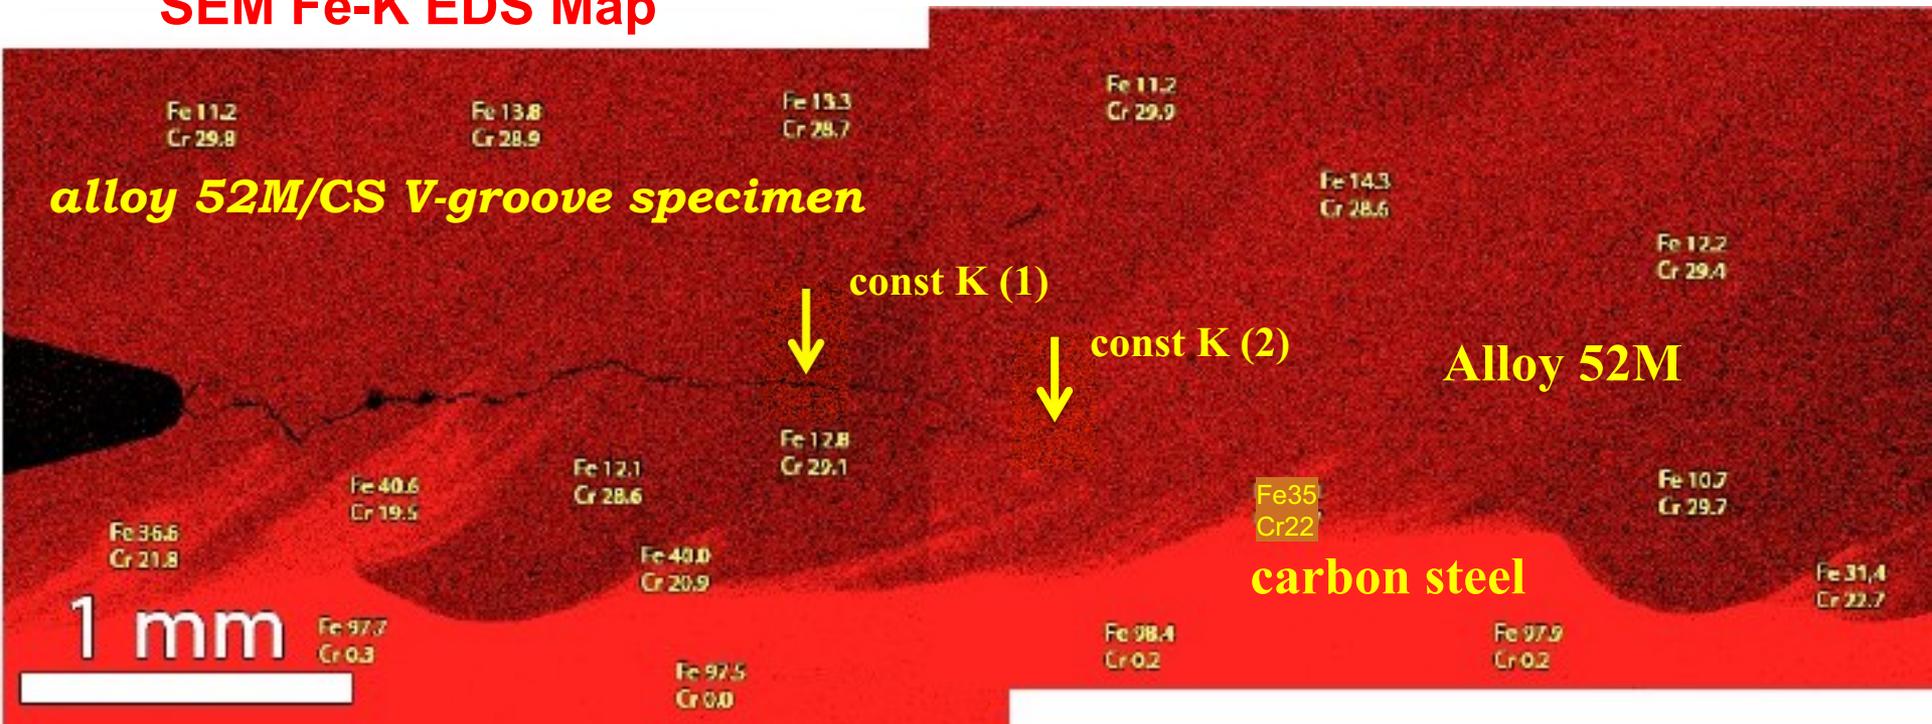
KAPL Alloy 52M/CS Dilution Zone Specimen CT065: Cross-Section

- **First** and **second** constant K in 52M/CS take place in regions of little or no chromium dilution.

SEM Fe-K EDS Map

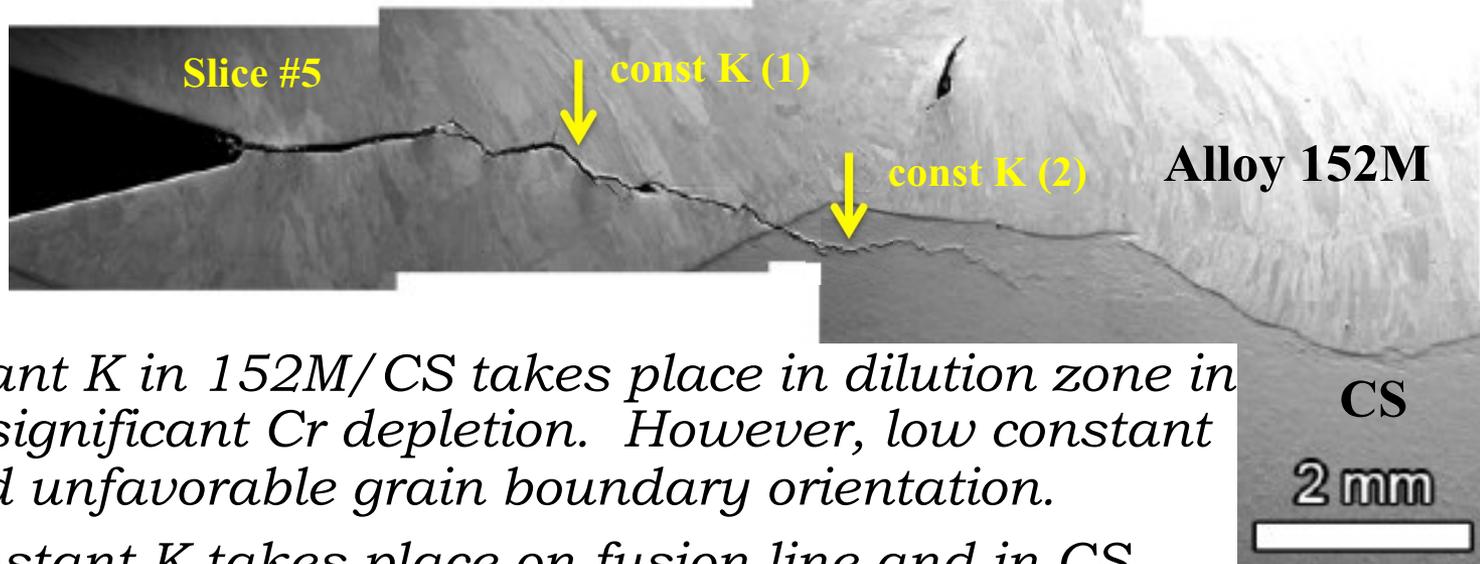
KAPL Alloy 152M/CS Dilution Zone Specimen CT066: Cross-Section

SEM BSE Image

- ▶ **First** constant K in 152M/CS takes place in dilution zone in a region of significant Cr depletion. However, low constant K CGRs and unfavorable grain boundary orientation.
- ▶ **Second** constant K takes place on fusion line and in CS HAZ (depending on location in the specimen.)

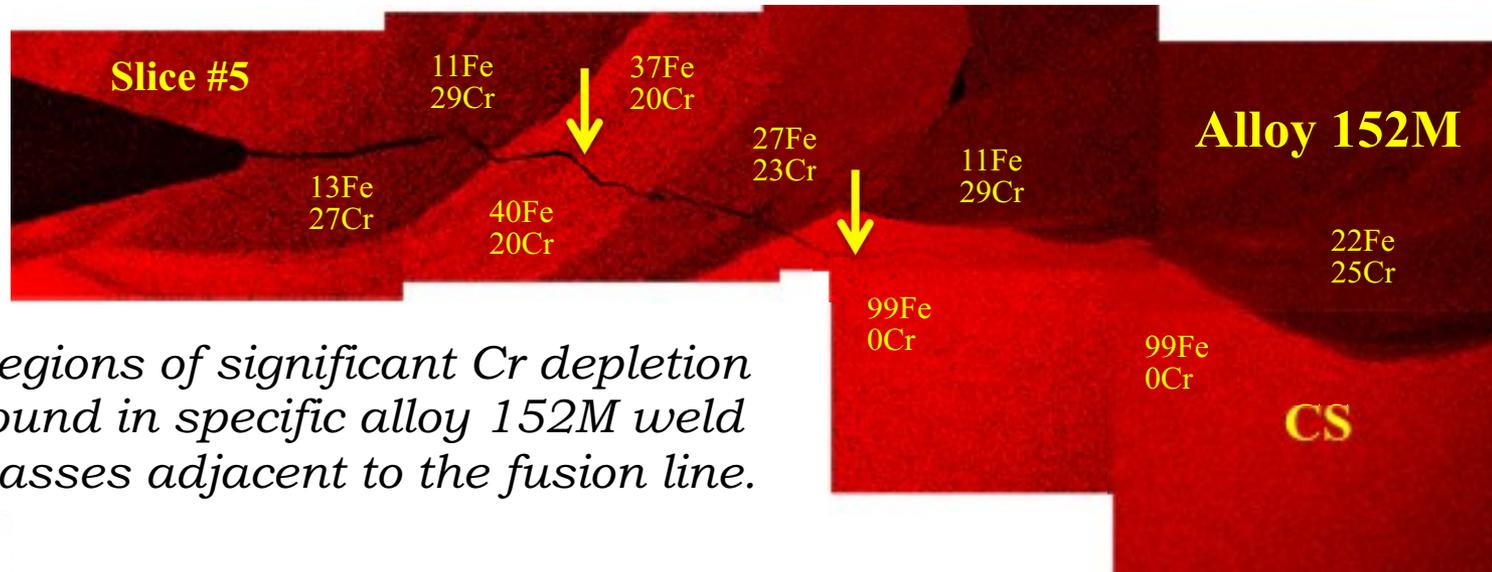
SEM Fe-K EDS Map

Regions of significant Cr depletion found in specific alloy 152M weld passes adjacent to the fusion line.

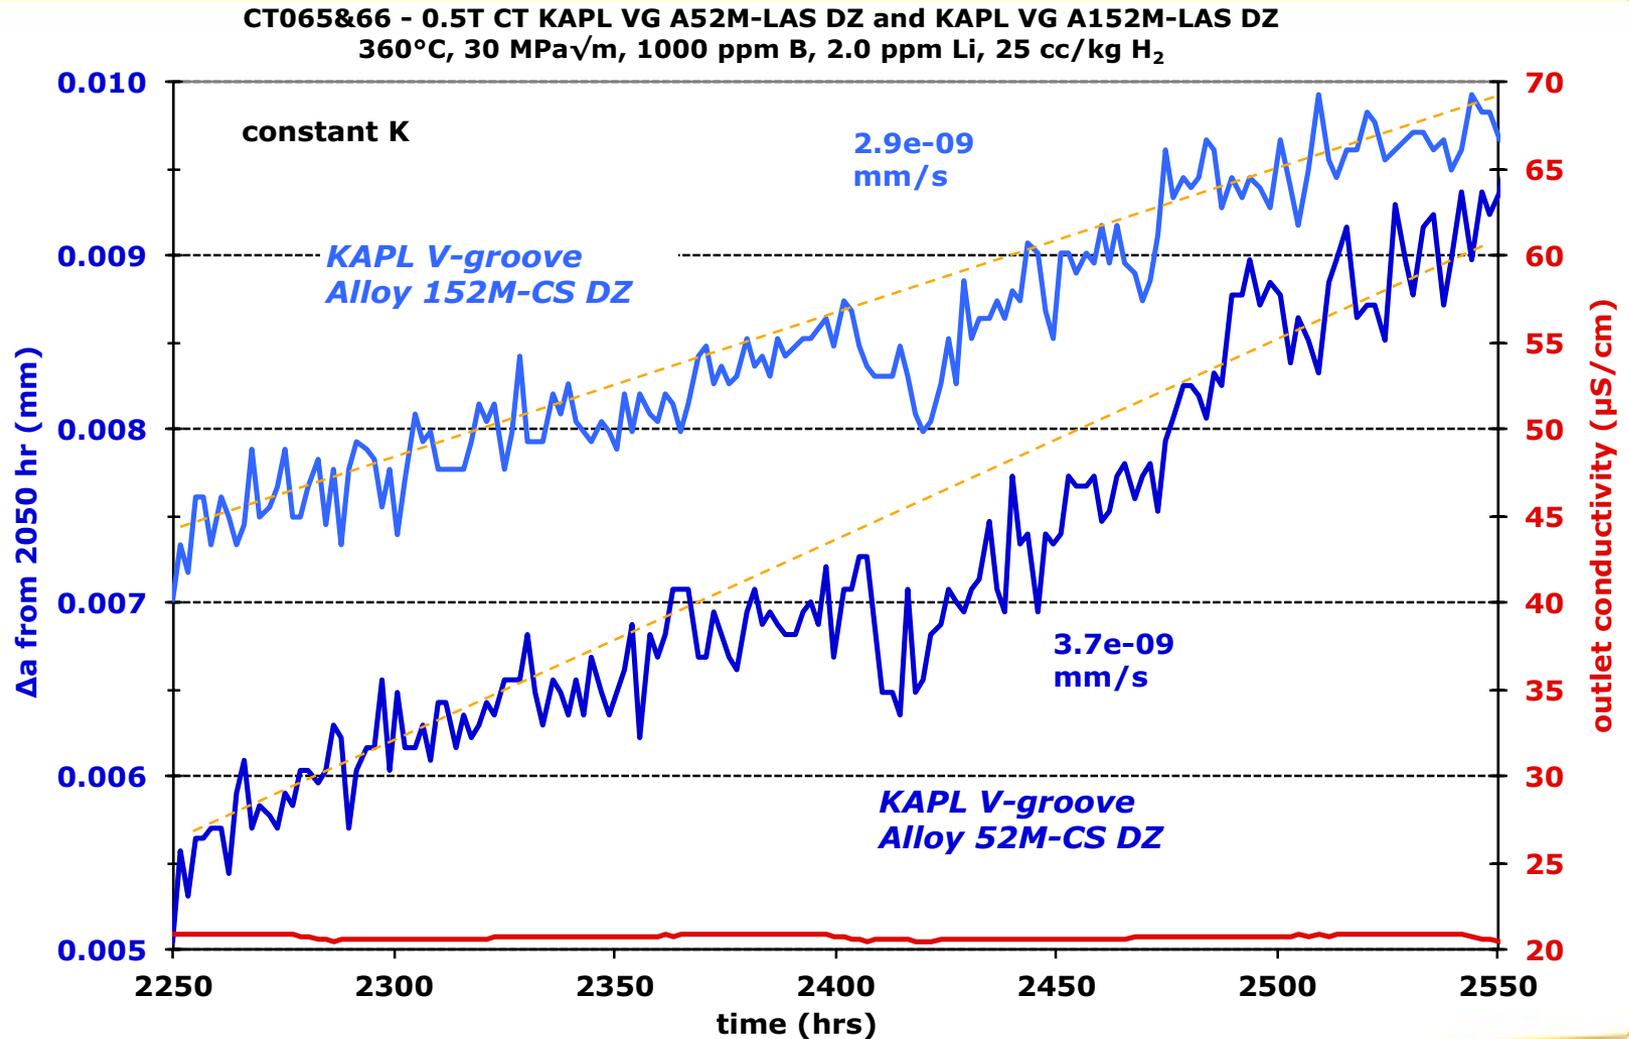
First Constant K Evaluation of Alloy 52M/CS and 152M/CS Dilution Zone Test Specimens

52M/CS: Within weldment. Minor compositional change.

152M/CS: Within weldment. Significant Fe enrichment and Cr/Ni depletion.

For both specimens, weld GBs are strongly tilted relative to geometric crack path.

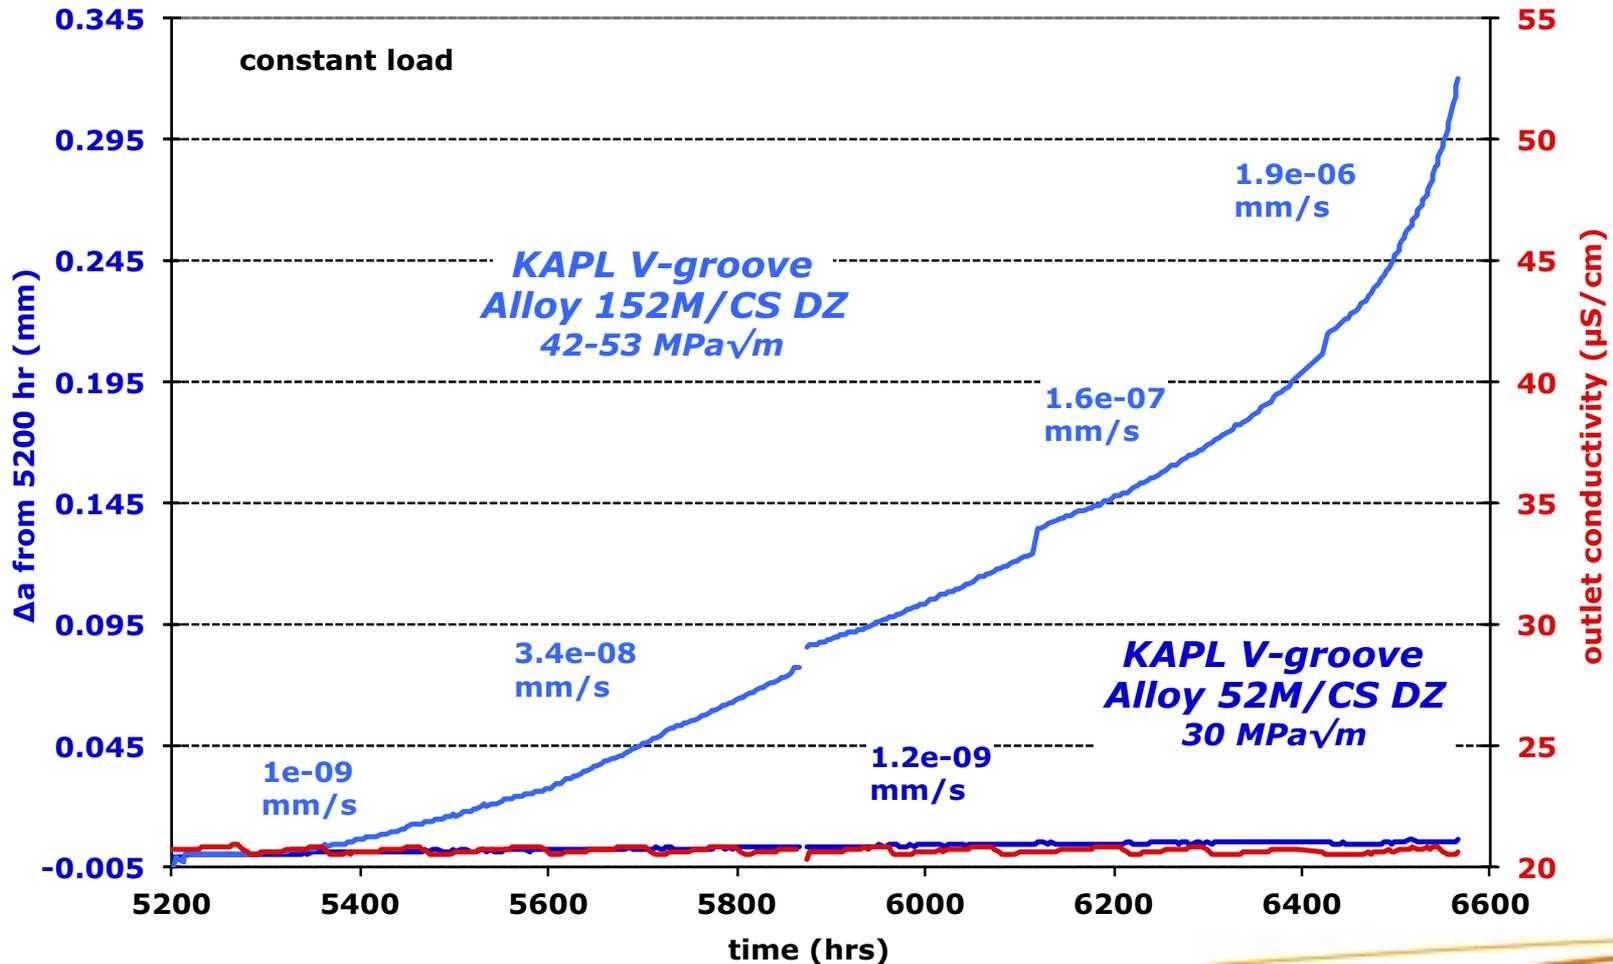
Second Constant K Evaluation of Alloy 52M/CS and 152M/CS Dilution Zone Test Specimens

CT065&66 - 0.5T CT KAPL VG A52M/CS DZ and KAPL VG A152M/CS DZ
360°C, 1000 ppm B, 2.0 ppm Li, 25 cc/kg H2

52M/CS: Crack is within the weld metal and at lower K, weld GBs tilted.
152M/CS: Crack is either on fusion line or CS HAZ and at high K.

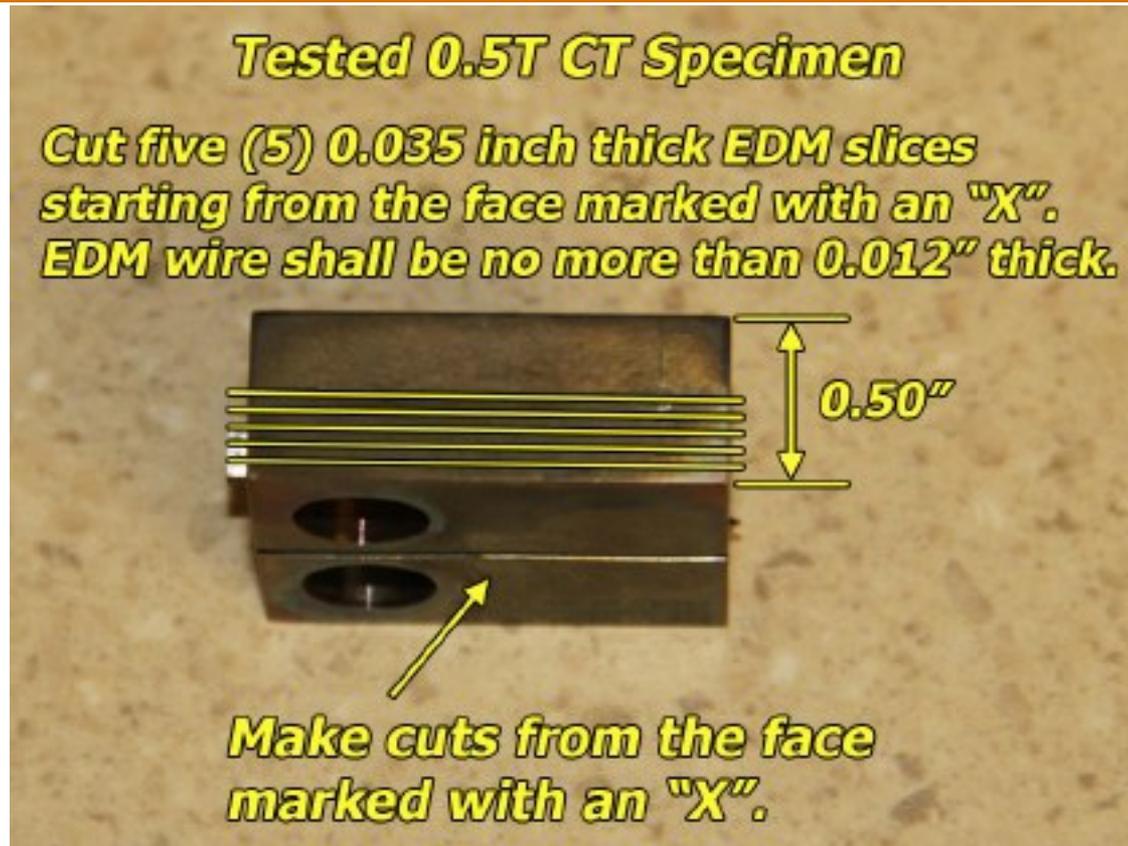
KAPL Alloy 152M/CS Dilution Zone Specimen CT066: Cross-Sectioning

- *High crack growth rate observed in 152M/CS specimen.*
- *Section half of the width of specimen into 5 slices. Slice #1 is nearest to the sidegroove while slice #5 is at the center of the specimen.*

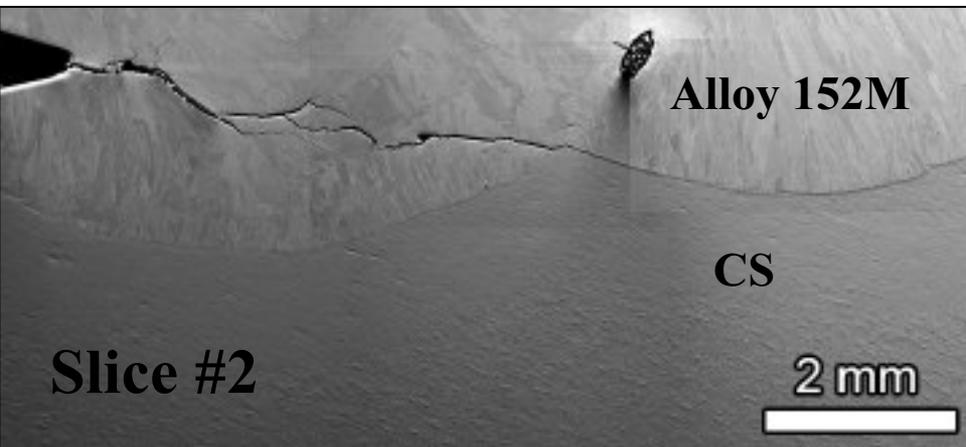
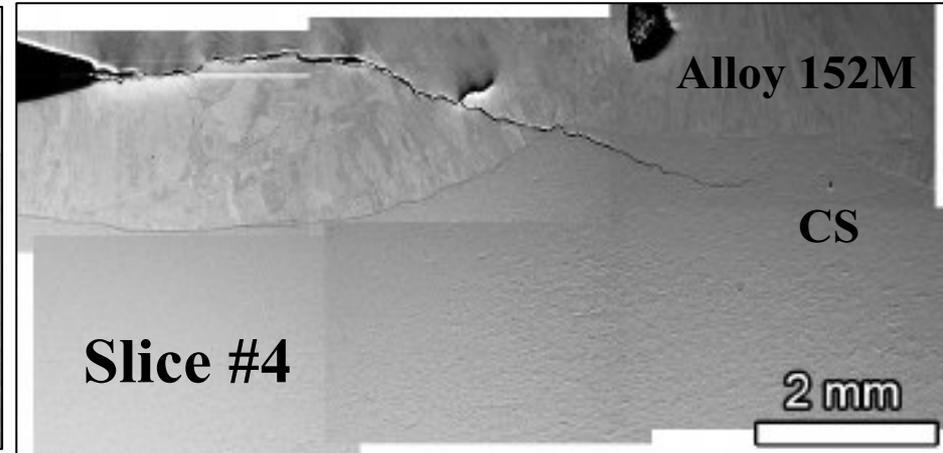
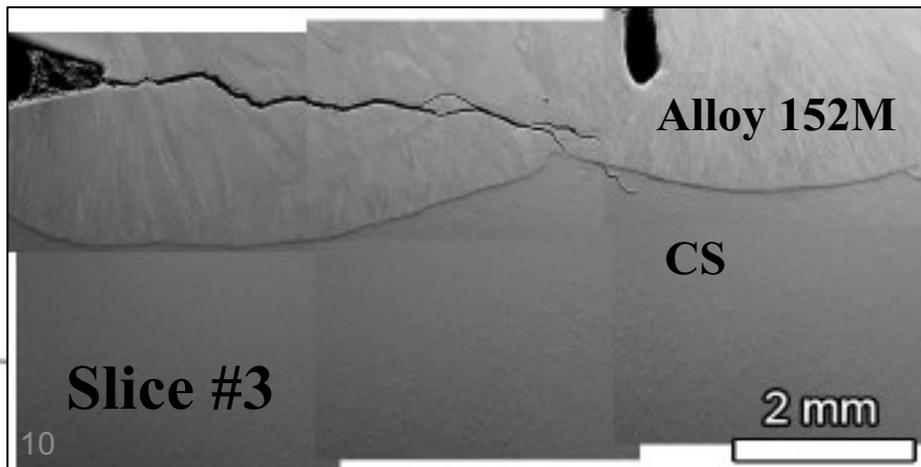
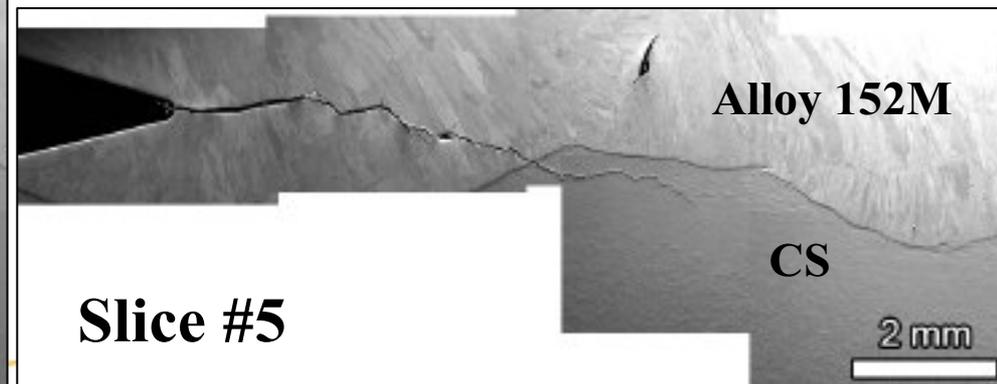
KAPL Alloy 152M/CS Dilution Zone Specimen CT066: Cross-Sectioning

- Slice #2 is nearest to sidegroove, and slice #5 is at the center of the specimen.
- Crack starts in alloy 152M weld and propagates toward and into the CS.

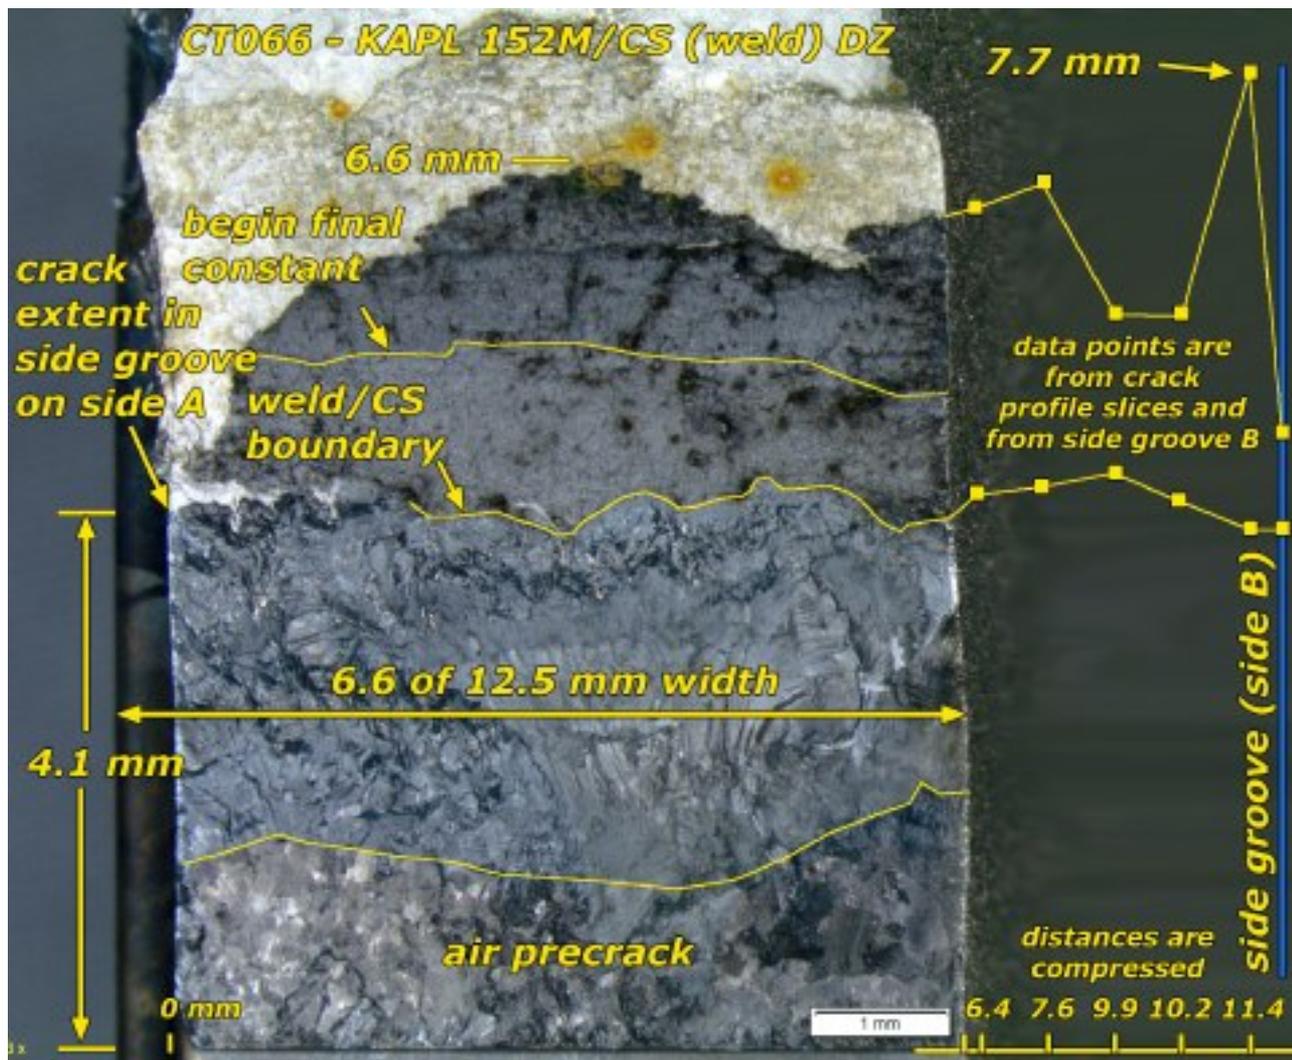
KAPL Alloy 152M/CS CT Specimen CT066: Crack Growth Surface

Extensive SCC growth in carbon steel during final constant load exposure at high K in CT066.

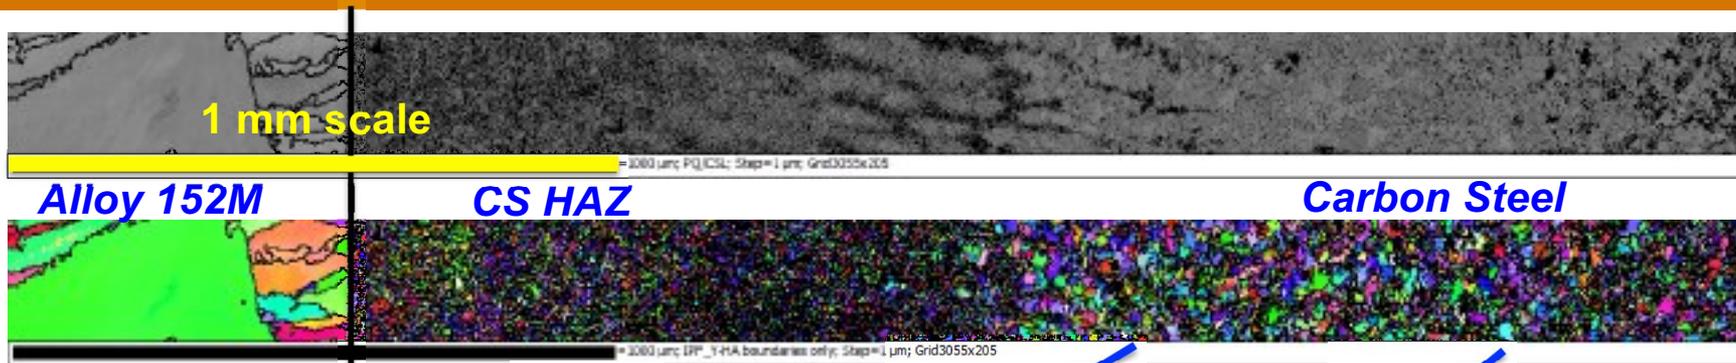
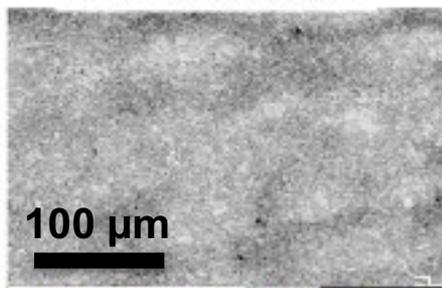
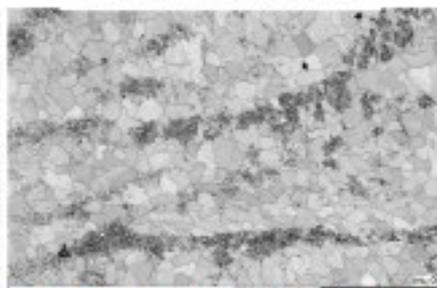
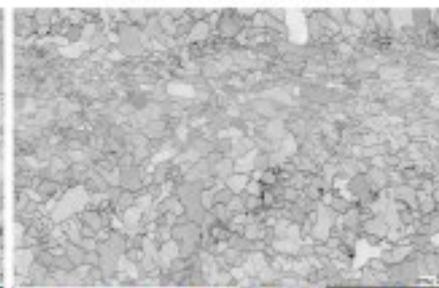
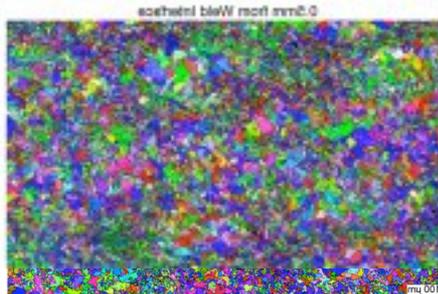
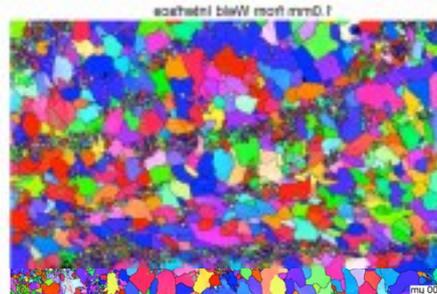
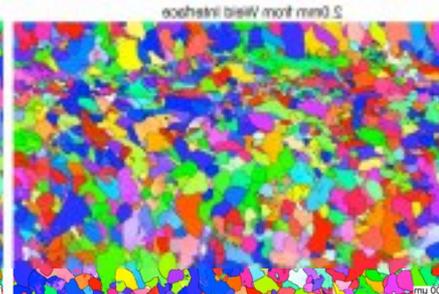
KAPL Alloy 152M/CS Dilution Zone Specimen CT066: EBSD Cross-Section #5

0.5 mm from FL

1.0 mm from FL

2.0 mm from FL

*EBSD reveals extremely fine grained microstructure
in CS HAZ within ~1 mm of weld fusion line*

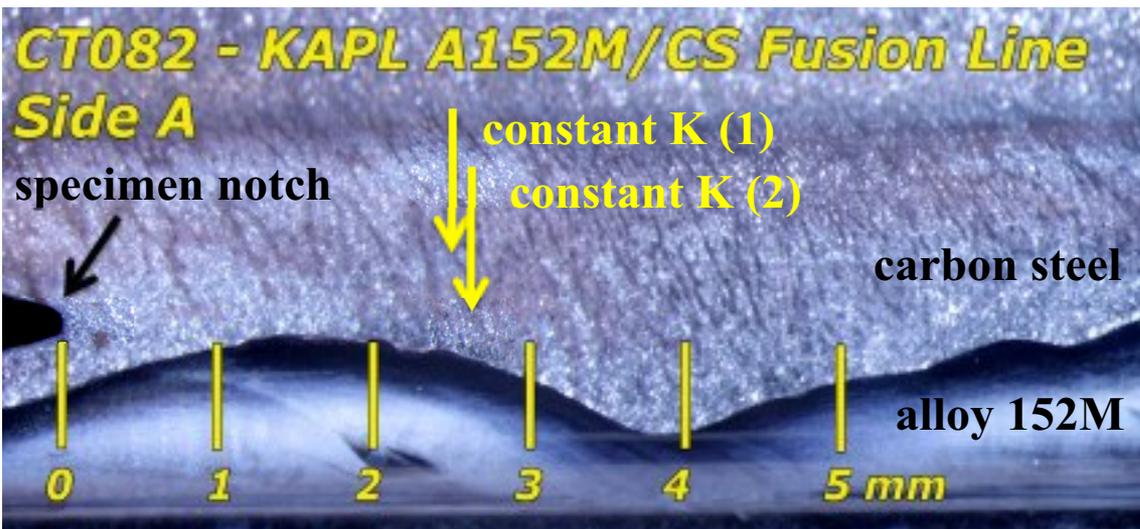
KAPL 152M/CS (CT082) and 52M/CS (CT083) Fusion Line Specimens

- 1) Notch positions selected to produce precrack at **weld fusion line or slightly within CS HAZ.**
- 2) Arrows show location of first constant *K* evaluation.

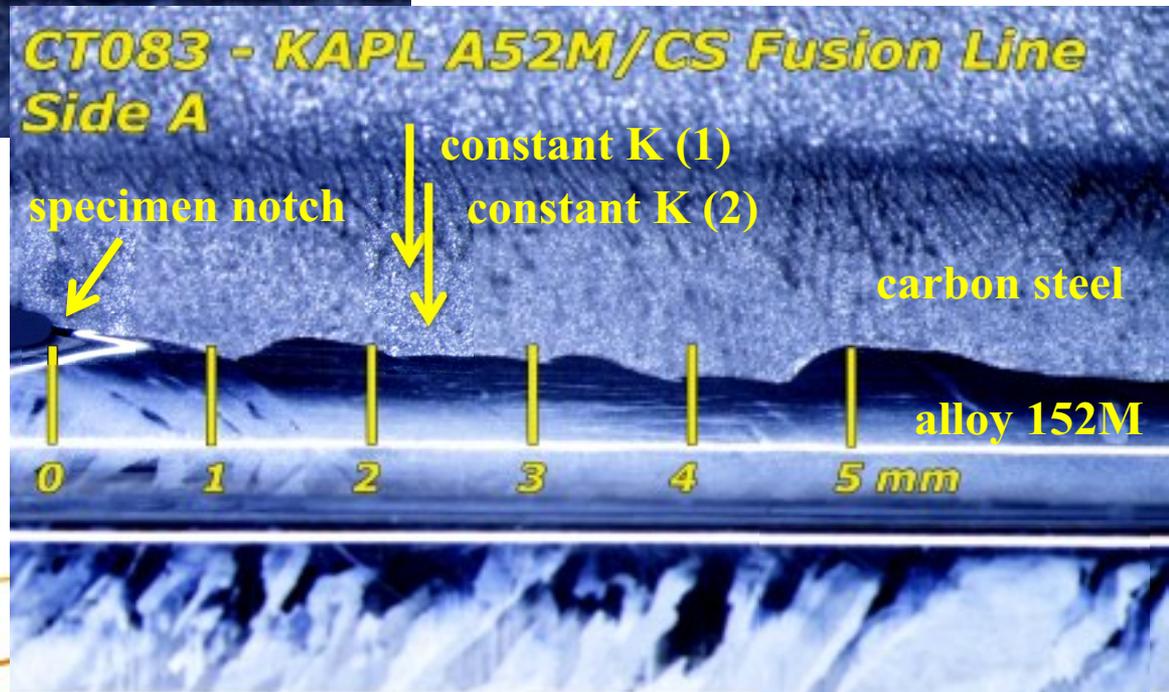
- 3) *K* levels are being increased by dK/da in an attempt to duplicate high growth rates seen previously.
- 4) Follow by removing specimens, apply PWHT, and reevaluate crack growth response.

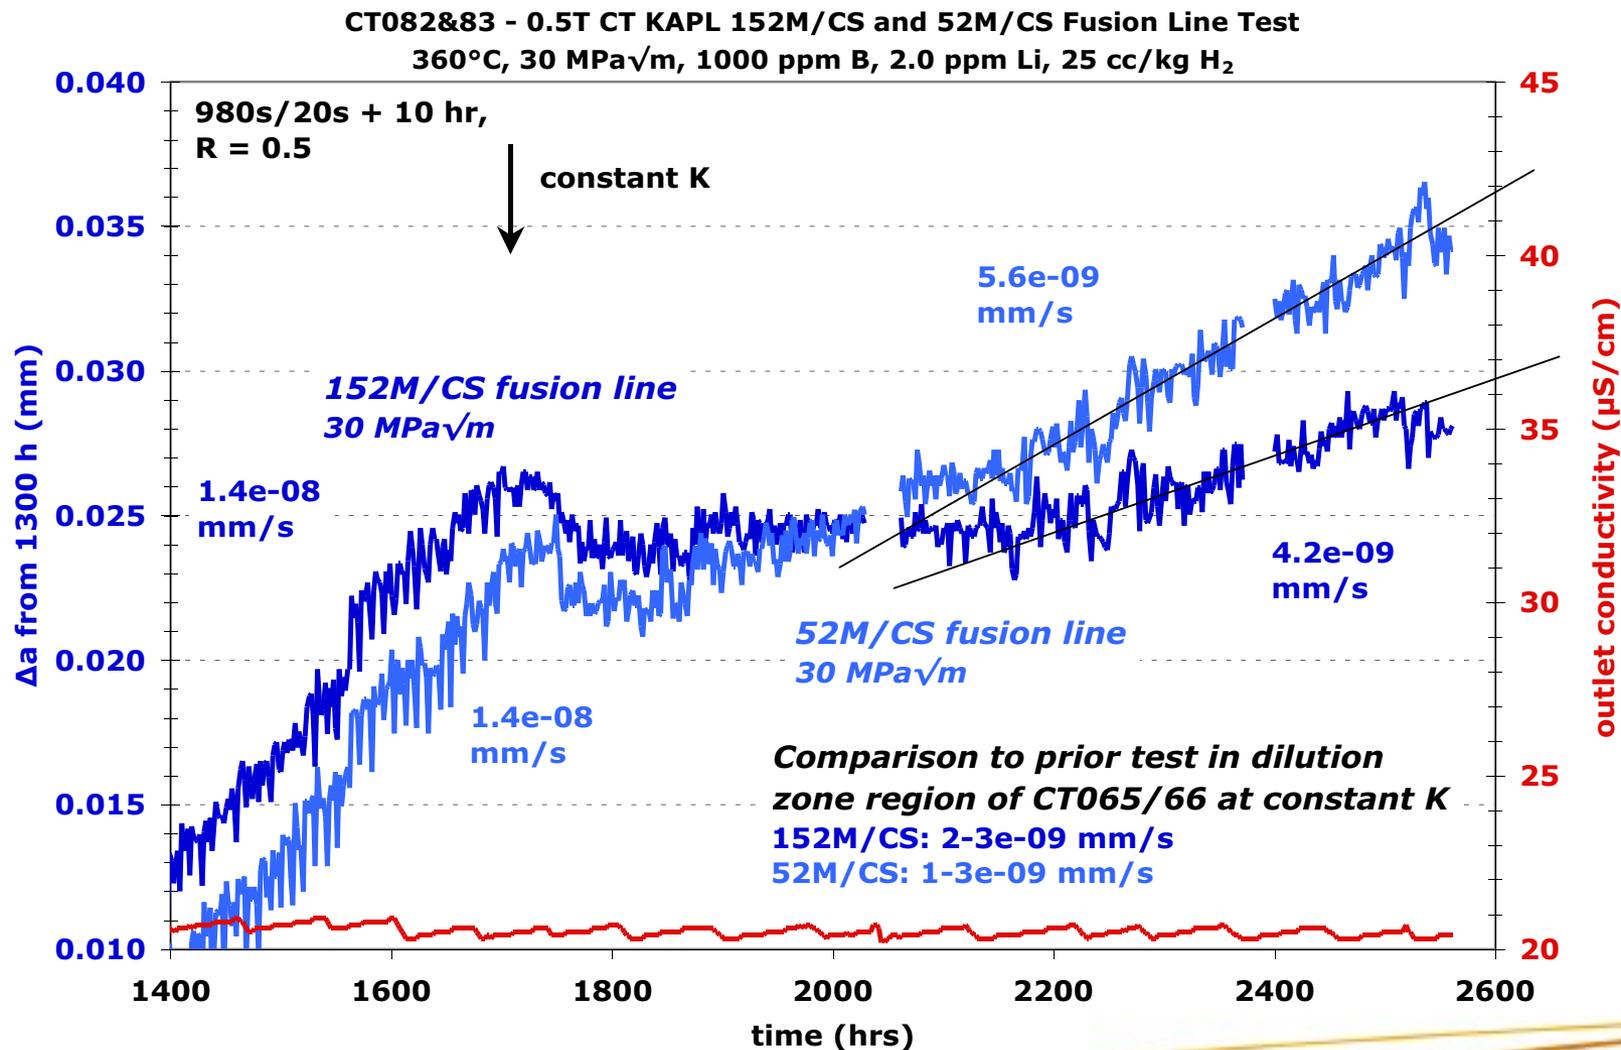
Ongoing Results on Alloy 152M/CS and 52M/CS Fusion Line Test – $30 \text{ MPa}\sqrt{m}$

Slightly higher CGRs than in dilution zone evaluation of previous test but lower than fusion line/HAZ response in previous test. K only $30 \text{ MPa}\sqrt{m}$.

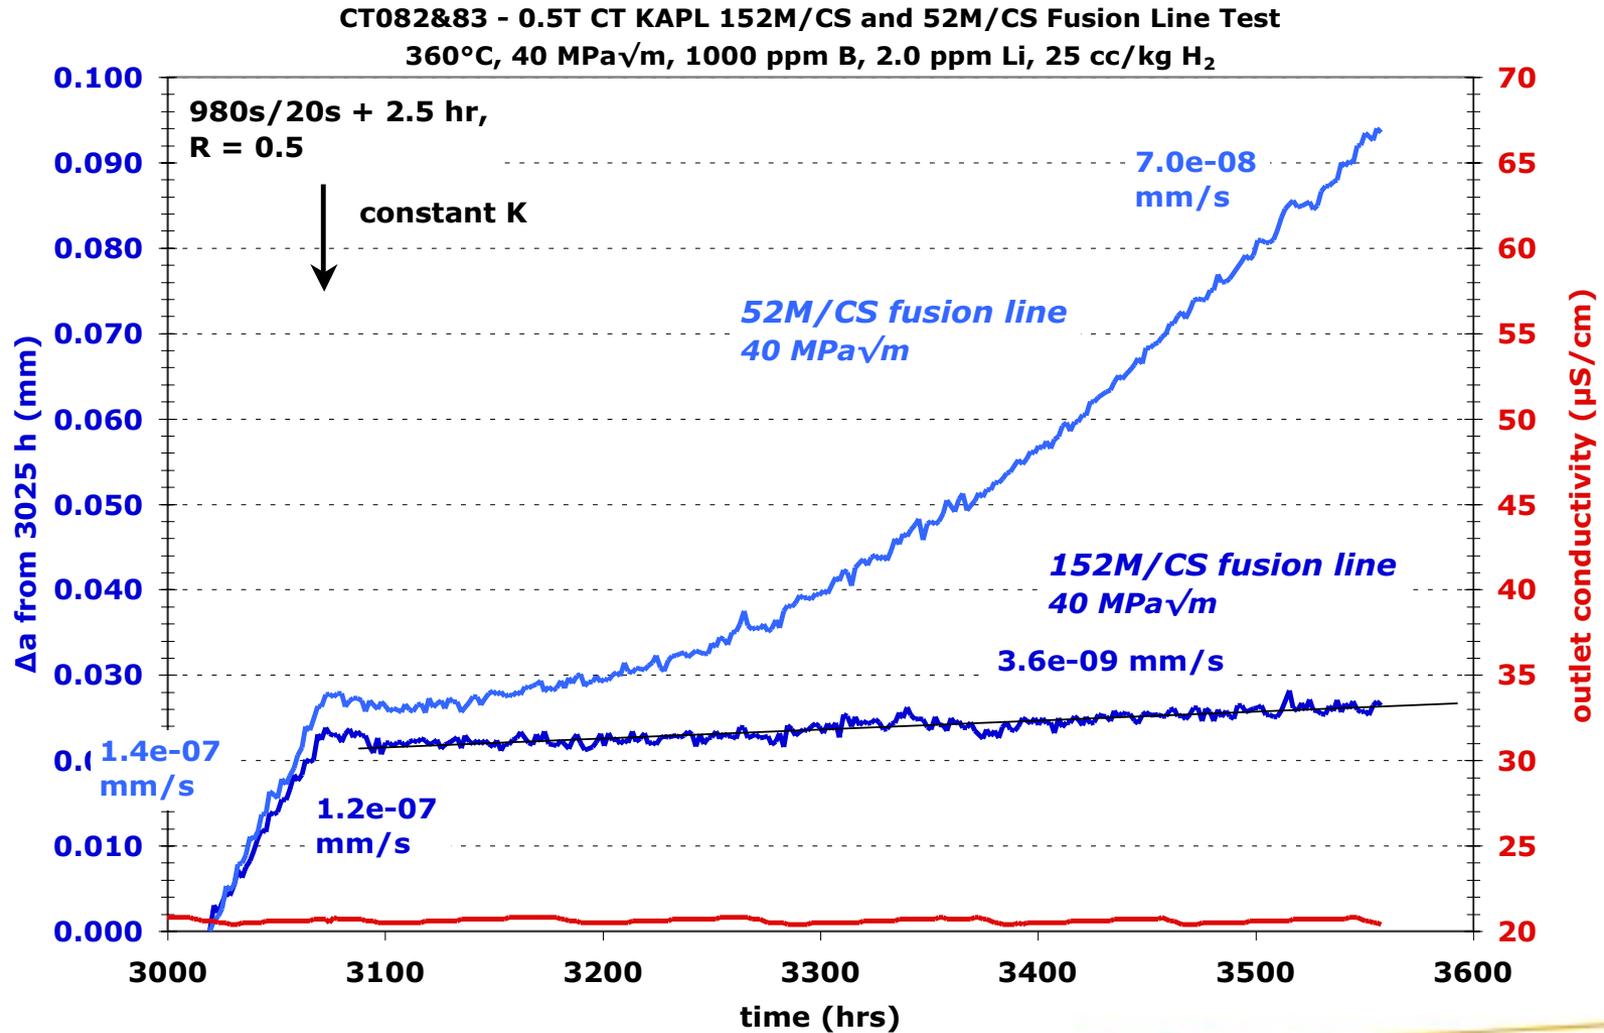
Ongoing Results on Alloy 152M/CS and 52M/CS Fusion Line Test – $40 \text{ MPa}\sqrt{m}$

- 52M/CS fusion line CGR is 10x higher than at 30 MPa√m, and still increasing.
- 152M/CS specimen CGR is similar to 30 MPa√m. Crack in this specimen is further from the fusion line.
