**Humboldt Bay Power Plant (HBPP)**

**Historical Site Assessment**

**2011 Update**

**July 2011**

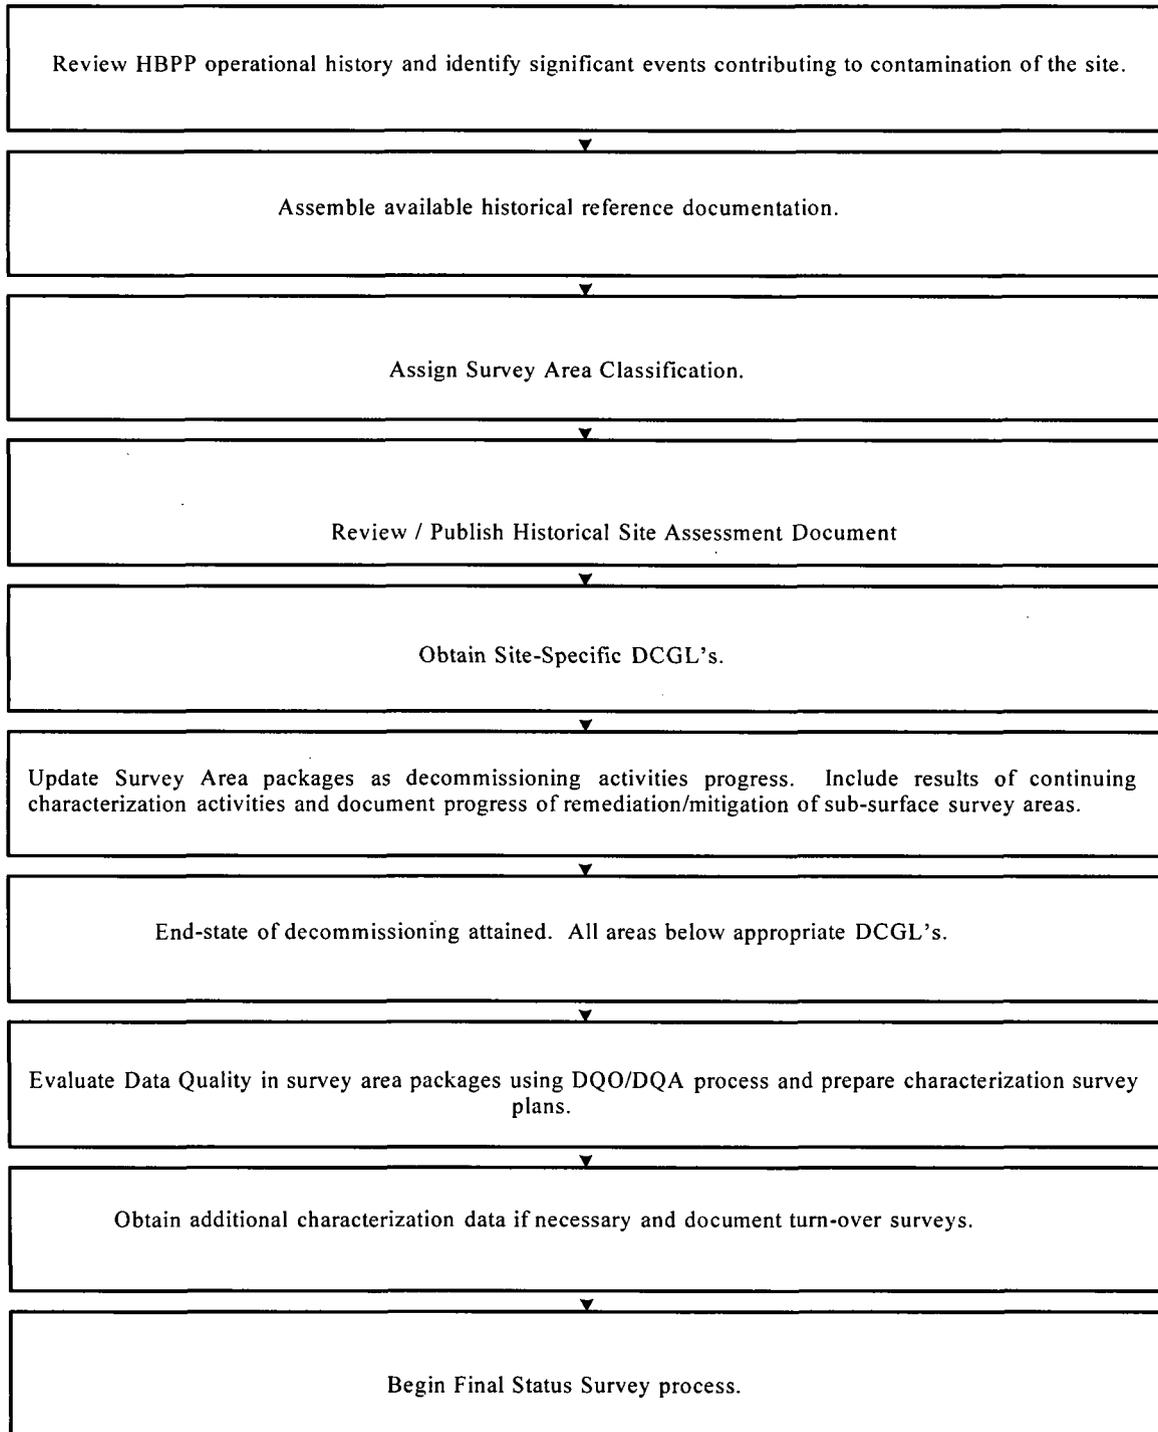
## PROCESS FOR INTEGRATING HSA WITH CHARACTERIZATION AND FSS

The general process for integrating the HSA with continuing characterization, DCGL Development, and the Final Status Survey is shown in the following flowchart.

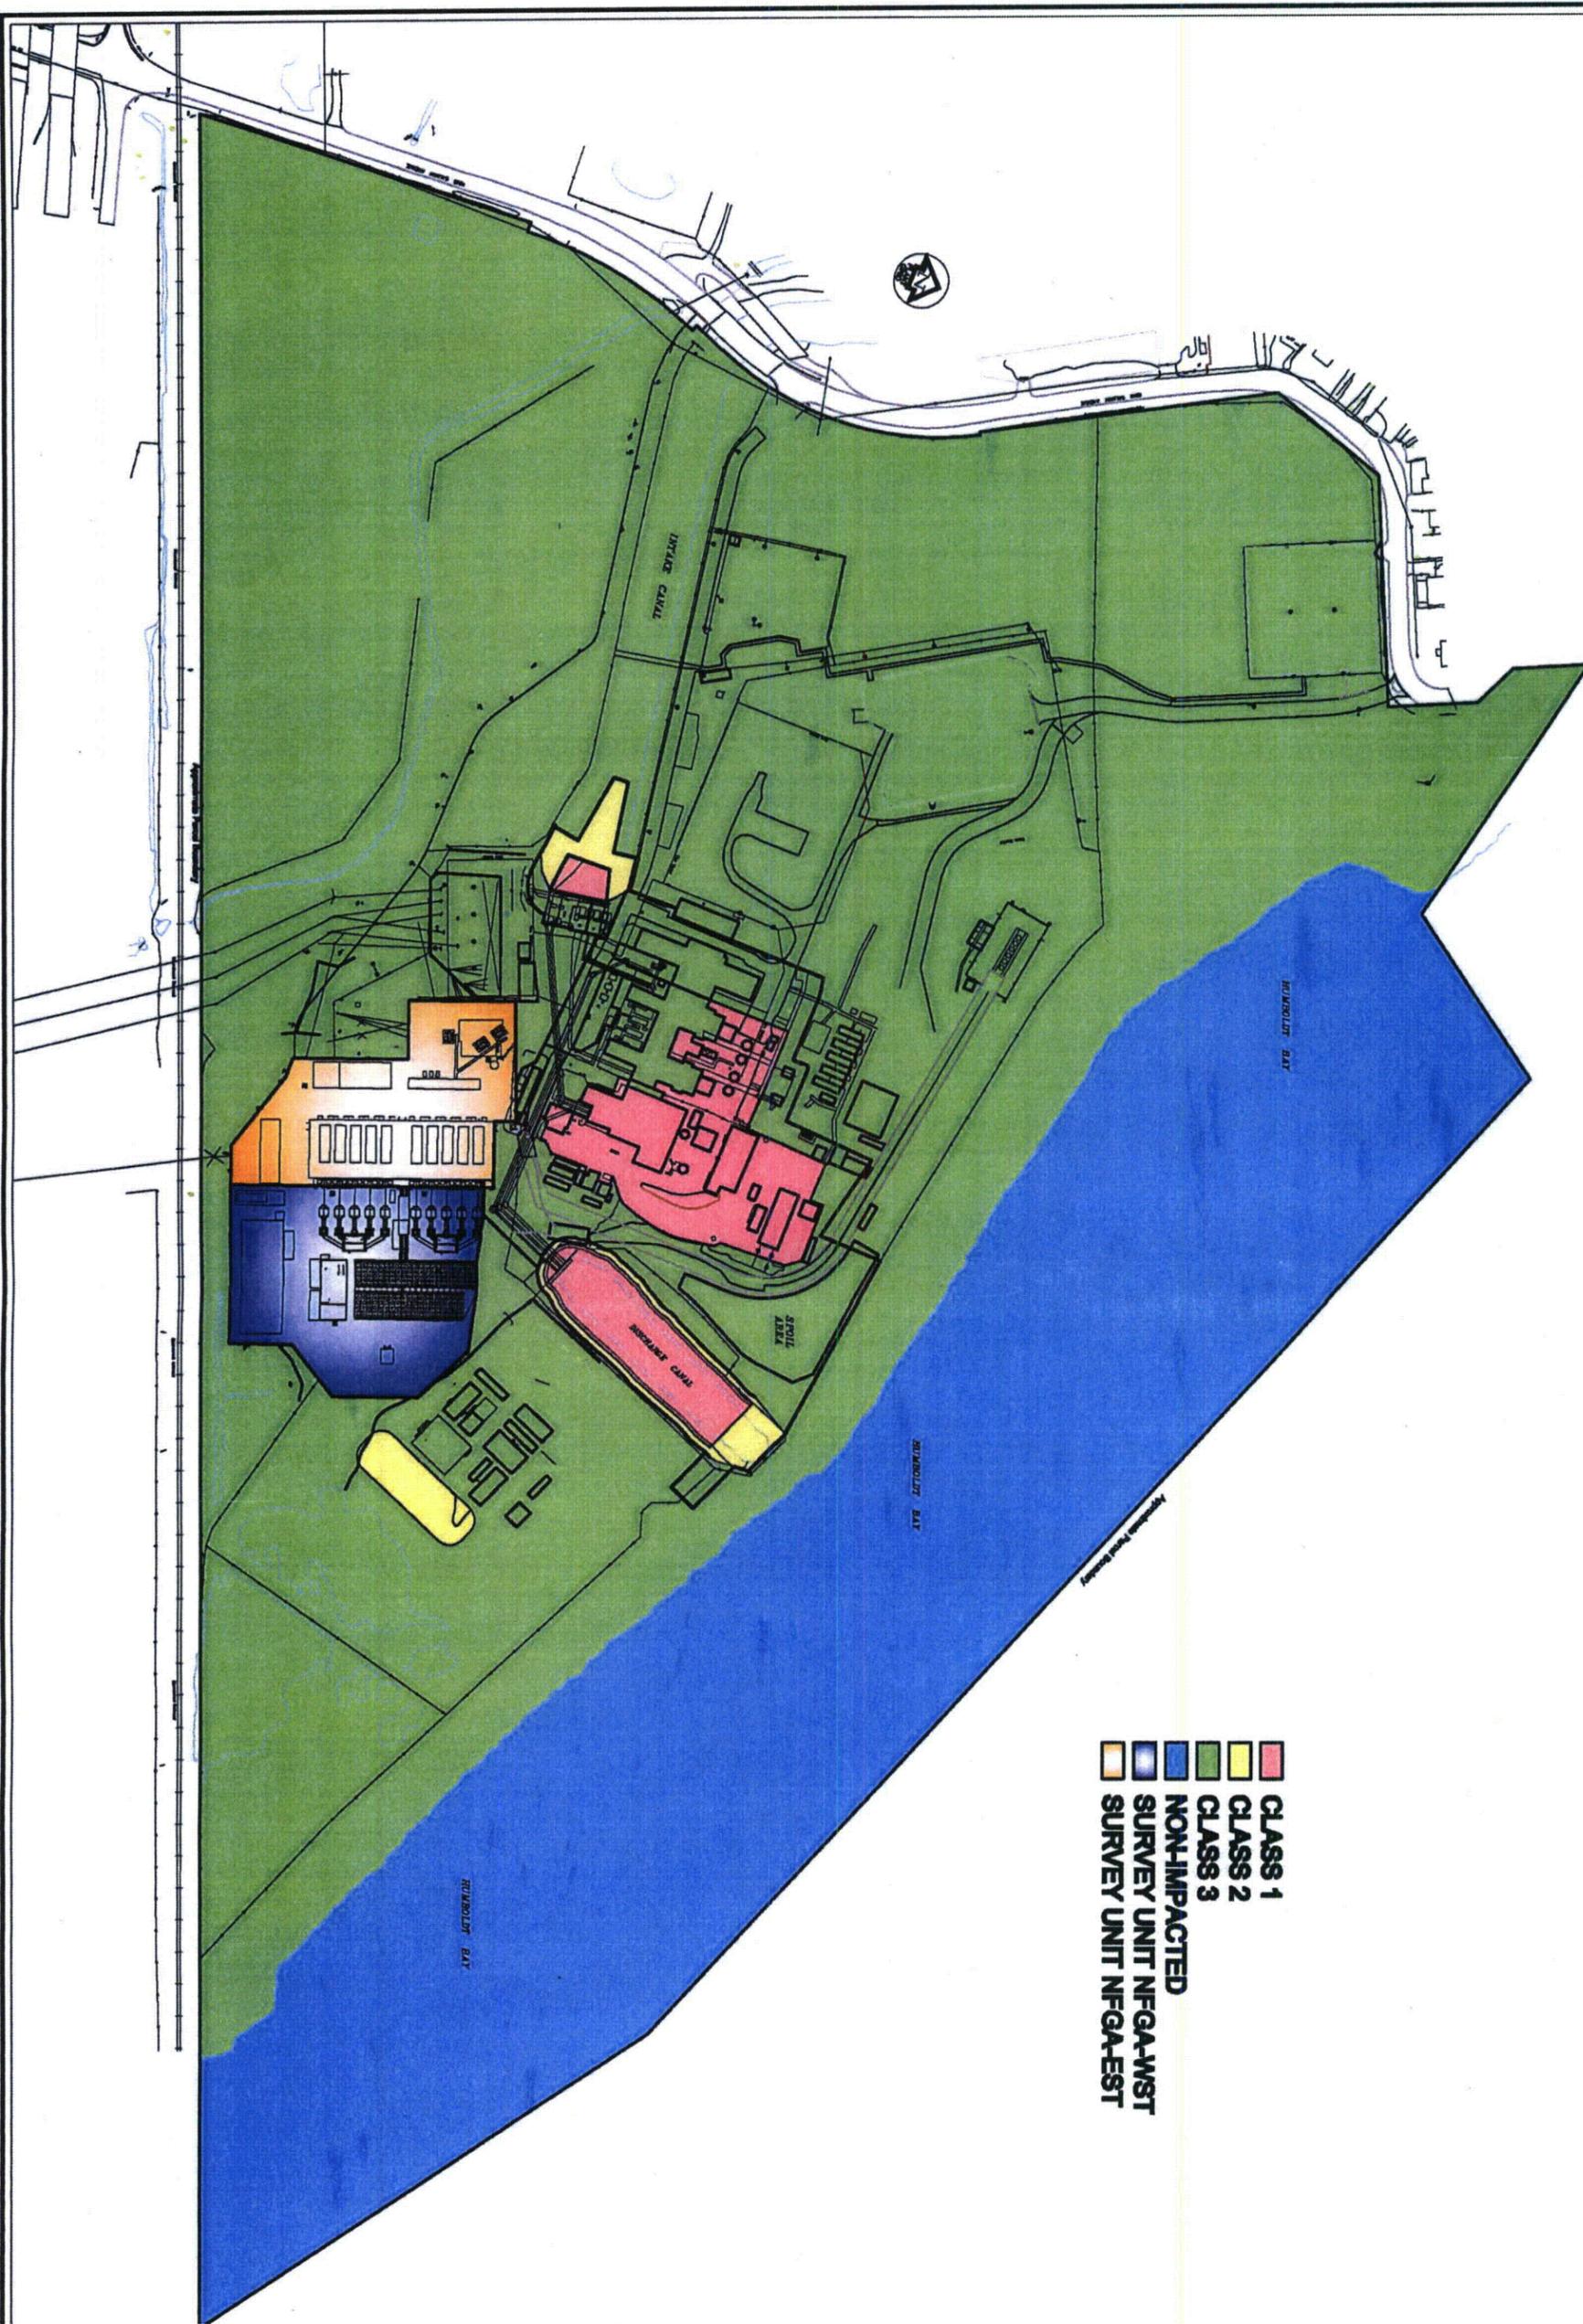
DATE: 09-PGE-087

**SITE DIAGRAMS SHOWING MARSSIM CLASSIFICATIONS**

The HSA information was used to bound and classify survey areas. The boundaries of the identified survey areas, as depicted in Appendix A, are based on operational history, including recorded significant events and common radiological profiles from previous characterization efforts. The preliminary survey area classifications are listed in Appendix B for structures and open land areas. Survey areas for structures and land will be broken into multiple survey units where appropriate in order to meet the survey unit size limitations recommended by NUREG-1575 (Ref. 1) prior to final status surveys.

Based upon the current /best information concerning the radiological conditions and the conditions and events identified in the operating history the subsurface soils within 3 feet of each side of the piping and drain lines identified in this survey package are a MARSSIM Class 1 area. The soils around the Radioactive Waste Tankage Drain Line and the Discharge Tubes are also Class 1 areas as shown in Appendix A-2.
