Re: **Lost Creek ISR LLC, Permit 788, Class 3 UIC Well Acceptance for Mine Unit 1 (MU1), Header House 1 (HH1)**

**Wyoming Department of Environmental Quality (WDEQ)- Land Quality Division (LQD)**  
**Inspection Memorandum**

Subject: Inspection of UIC Class 3 Wells – Mine Unit 1, Header House 1

**Photo Addendum to accompany the June 5, 2013 MU1 – HH1 Class 3 UIC Well Inspection Permit 788**

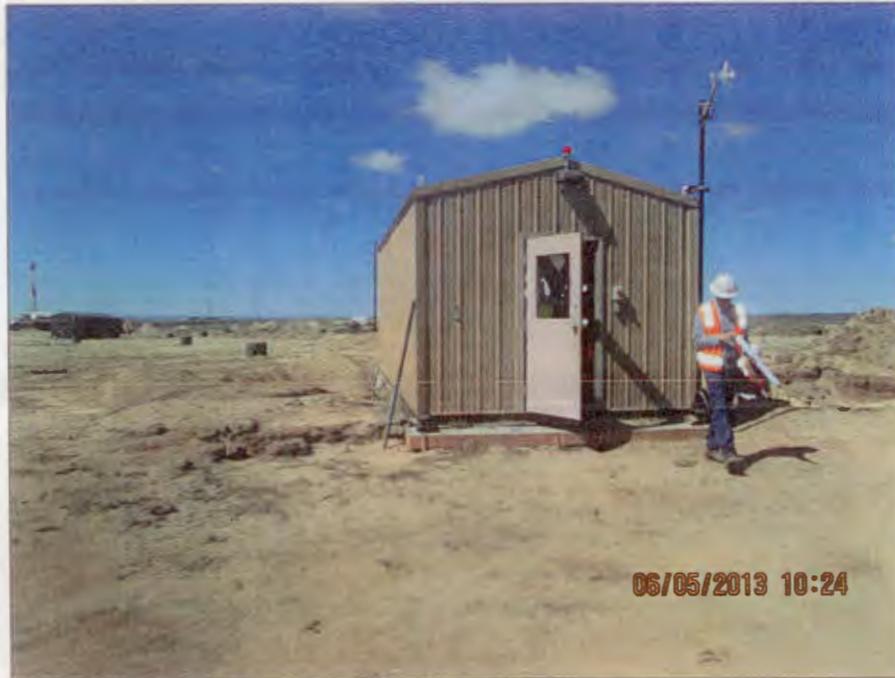
**Photo Number 1: This depicts the outside of Header House 1.**

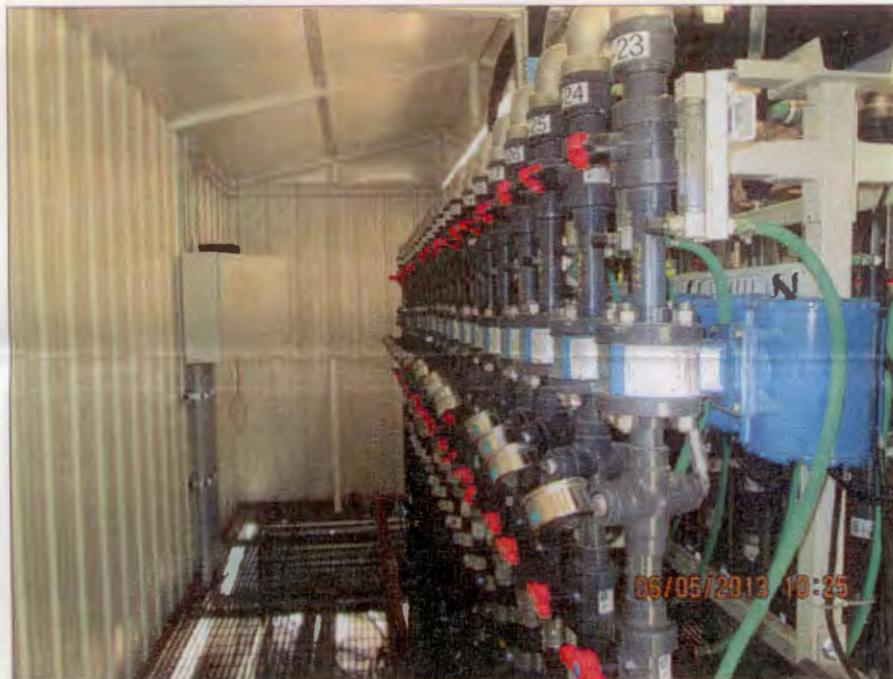
**Photo Number 2: This depicts one side of the Injection Well manifolds in Header House 1.**

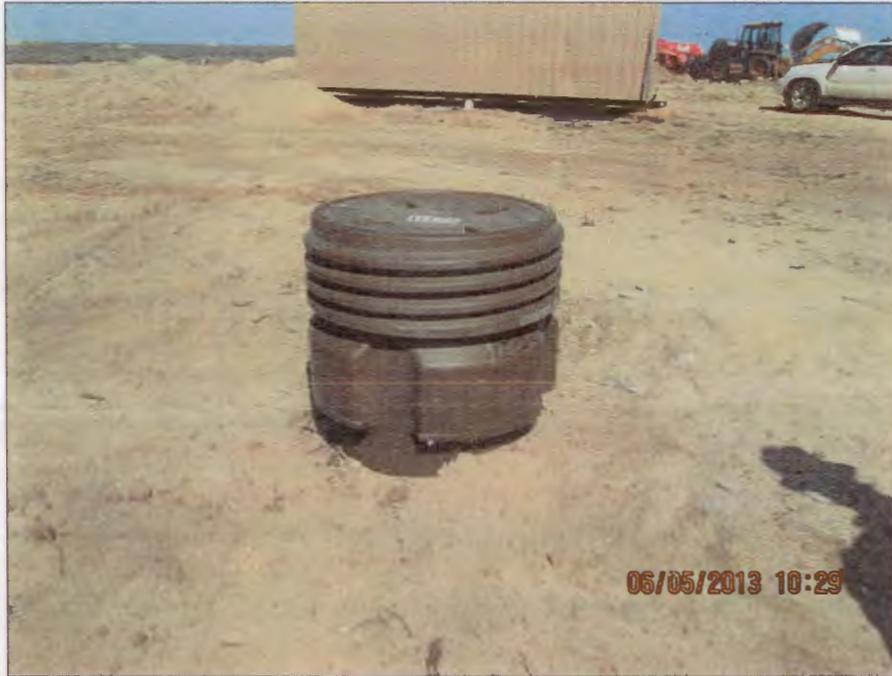
**Photo Number 3: Well cover over a well in MU1 - Header House 1.**

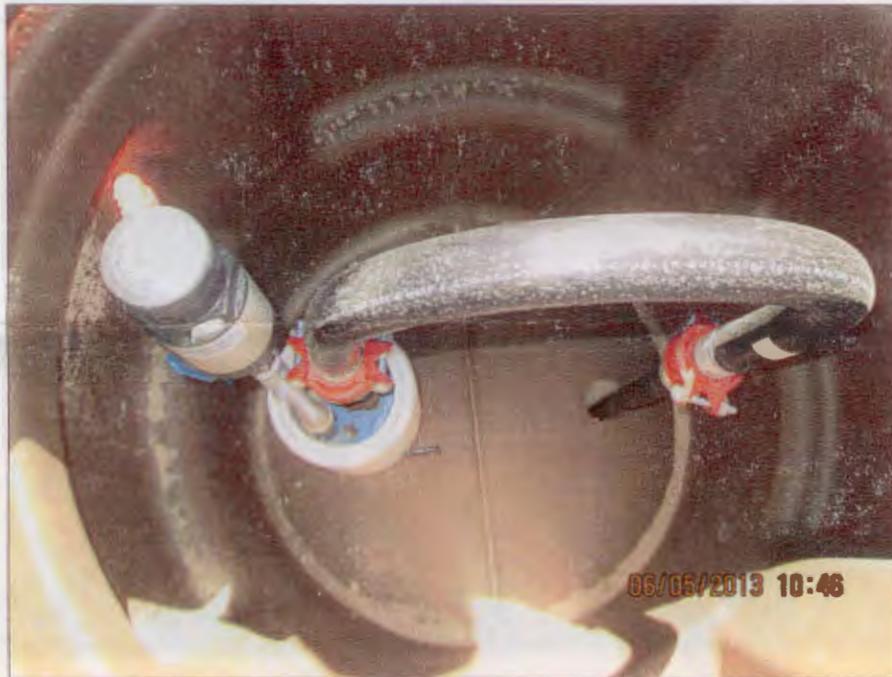
†A leak detection float valve was present on all wells. However, the polyurethane foam (PUF) had not yet been applied to the base of the well cover. This was scheduled to occur within the week. The application of PUF to the gaps in the bottom of the well's cover, however, is not a Class 3 UIC concern. Rather, it is a permit commitment.

**Photo Number 4: This depicts the inside of one of the Header House 1 well covers.**

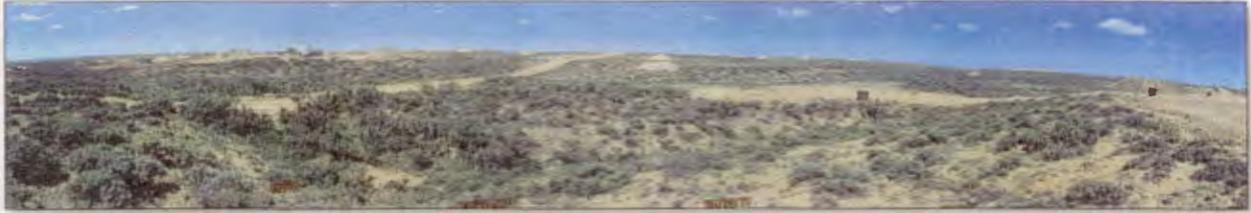
The location of Well 1I-106 is on an “island” of elevated ground between a bifurcation in the drainage west of Header House 1. There are currently no concerns with this location, as there is no evidence of surface water flow at the location of the well head. However, it will be monitored over time.

**Photo Number 5: This is a panoramic view looking generally to the west at the bifurcated drainage in which Well 1I-106 is located.**

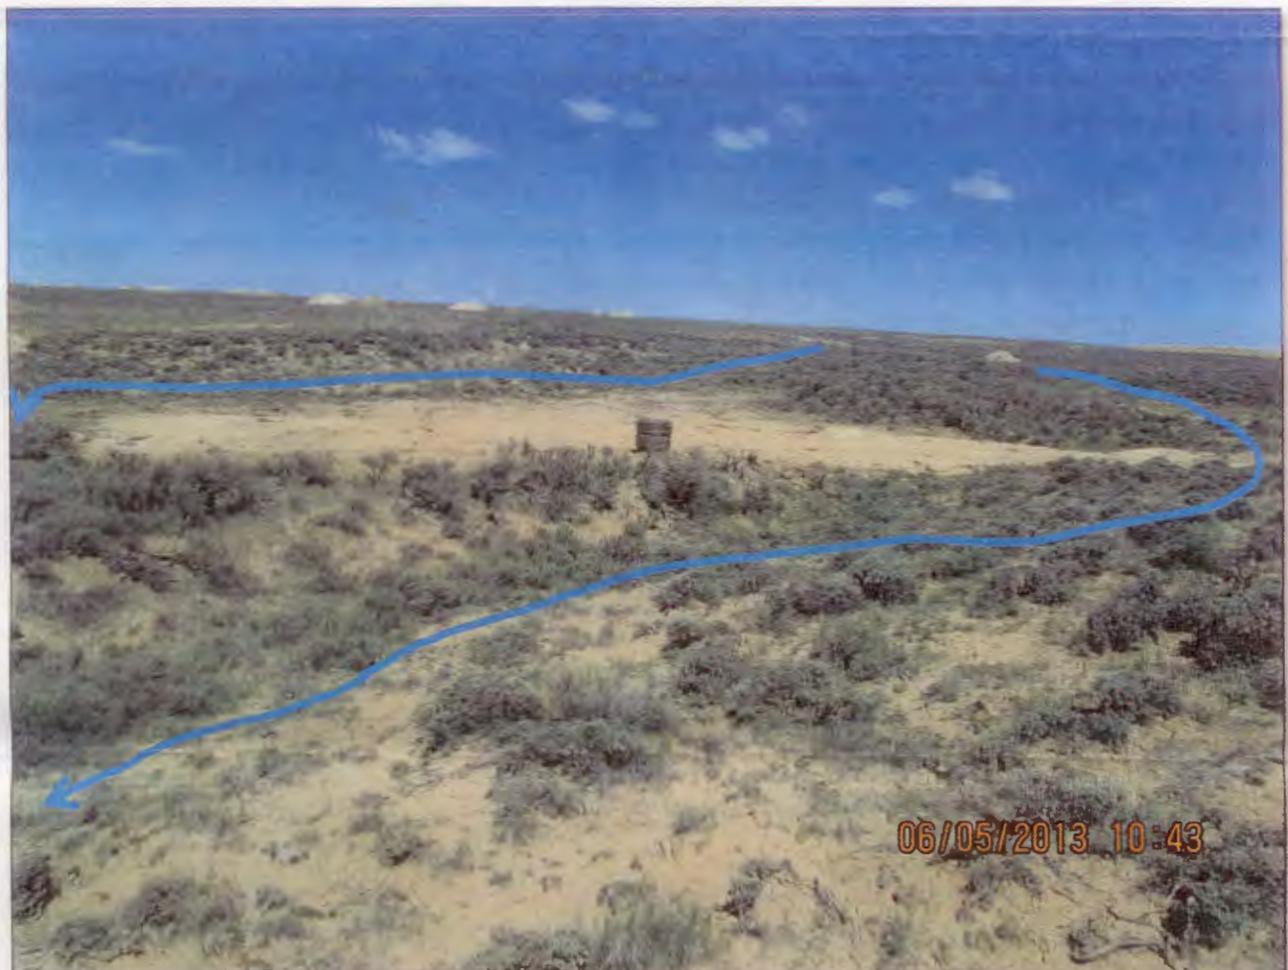
**Photo Number 6: This is a closer view of Well 1I-106 (depicted in the panoramic photo, above). The two blue lines indicate the two drainage channels that go around the well.**
