**Subject: License SUA-1341, Docket No. 40-8502
Willow Creek Project
June 15, 2013
8S218-1 Injection Well Release
Christensen Ranch Mine Unit 8**

Uranium One USA, Inc. - Willow Creek Project
Spill Report Summary
Mine Unit 8 ISR Injection Fluid Release

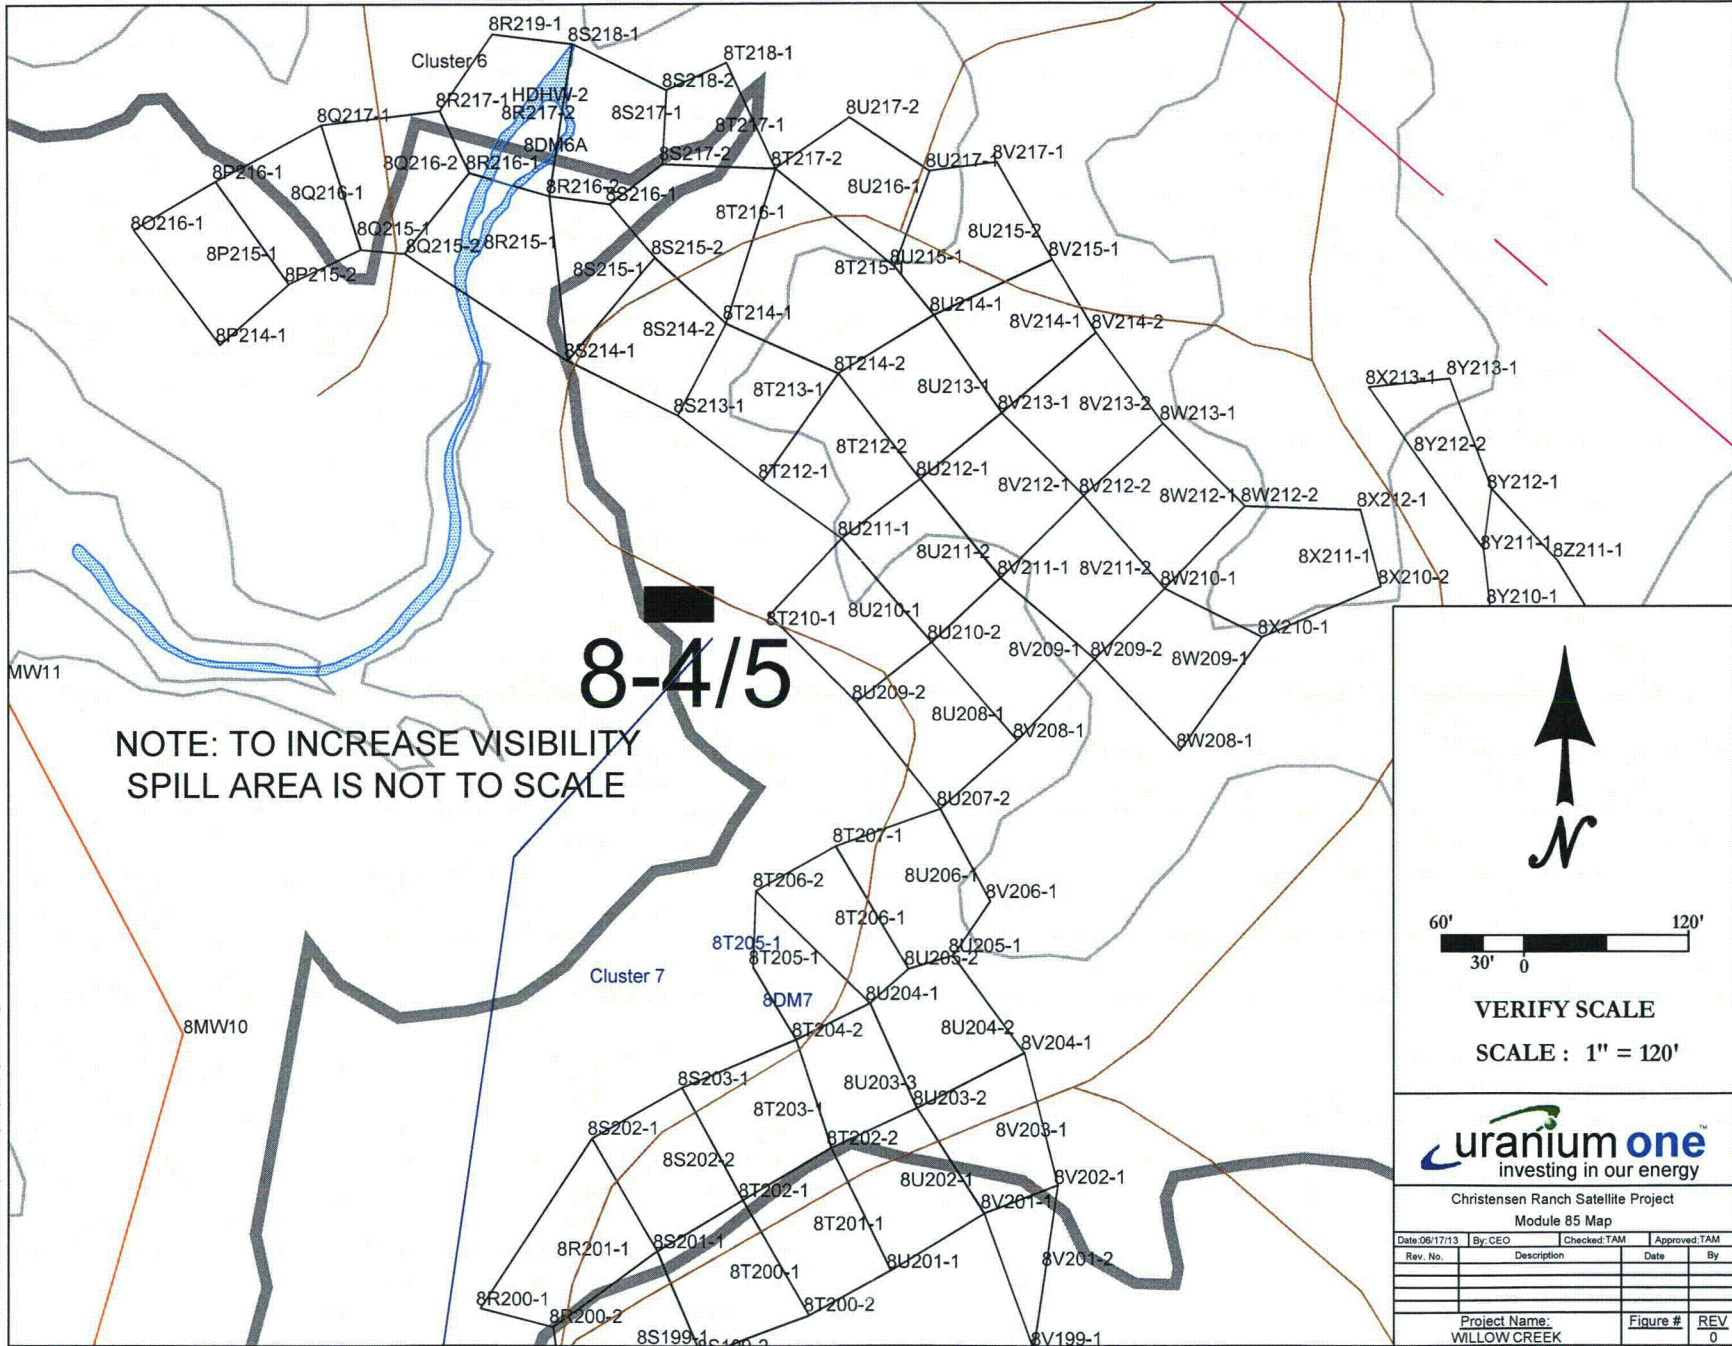
Christensen Ranch Satellite Project
Module 85 Map

Spilled: Approximately 1,400 gallons of ISR injection fluid was released from Injection Well 8S218-1 when a glue joint associated with a 5" pvc coupler and the 5" pvc well casing failed. The injection well is located on a bench above a cut bank at the head of a small dry ephemeral draw that is a tributary to ephemeral Willow Creek in the 8-4/5 Wellfield. The failed joint was located at ground level just beneath the well box.

The release followed site drainage for approximately 200 feet and migrated down the adjacent ephemeral draw approximately 500 feet (see map). It is estimated that 1,900 square feet (0.04 acre) of soil was impacted. No wildlife or livestock were affected. No significant erosion resulted from the spill, as it all soaked into the ground.

NOTE: TO INCREASE VISIBILITY
SPILL AREA IS NOT TO SCALE

The well was immediately shut off and repaired.
