# Energy, Air, Water, & Earth Electricity Three Mile Island Reactor Accident

# Fukushima Tsunami-Reactor Situation

#### National Academies of Sciences April 19, 2011 Lake H. Barrett

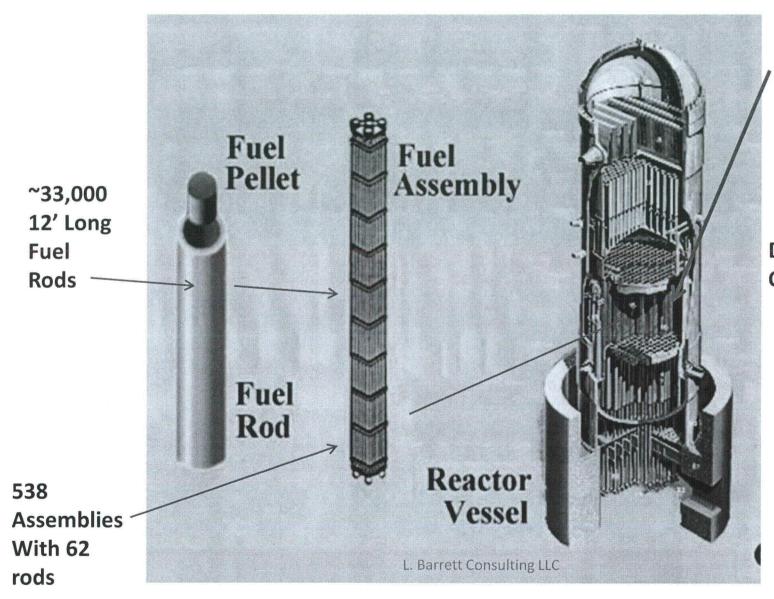
#### **Nuclear Fuel Barriers & Heat Output**

Fukushima 2-4 Core Produces ~2400MWT

At Full Power can Melt a Ton of Steel in ~1 second

**Decay Heat Drops** Quickly @ Scram 1Min 3.0% ~30 sec to melt 1 ton 1hr 1.3% 8 Hr 0.7% ~2 min to melt 1 ton 1 Day 0.5% 1 Week 0.3% 1Month 0.2% ~7 min to melt 1 ton 6 Months 0.1% 5

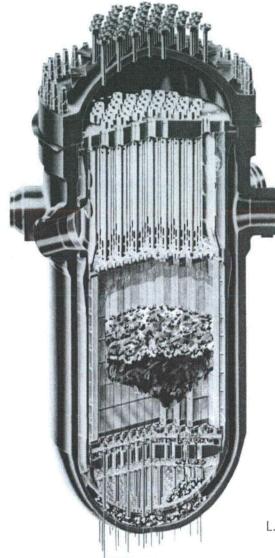
#### TMI Core Configuration ~Evening 3/28/1979

**Damaged Fuel Rods**

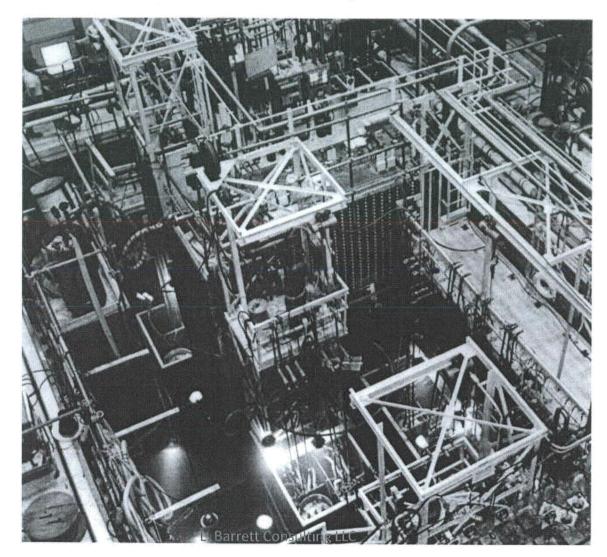
## High Rad Reactor Water Cleanup System Installed in Spent Fuel Pool

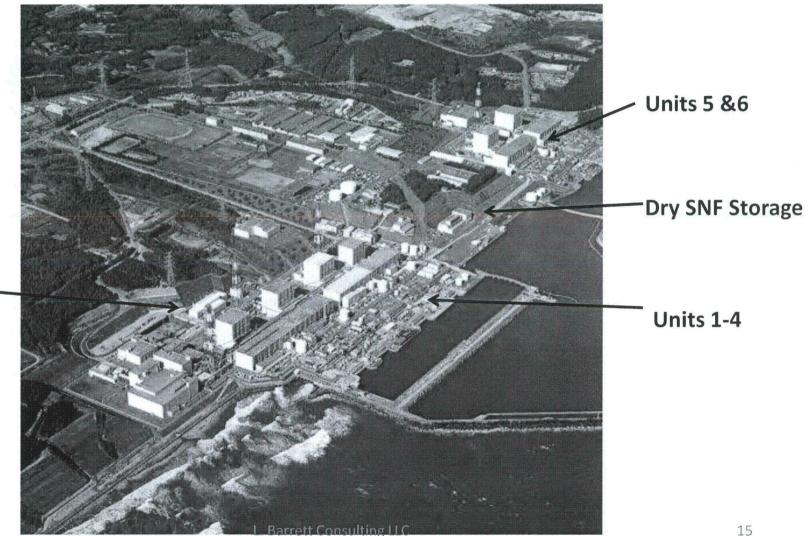
#### **Fukushima Daiichi Nuclear Power Station**

Common **Spent Fuel** Pool

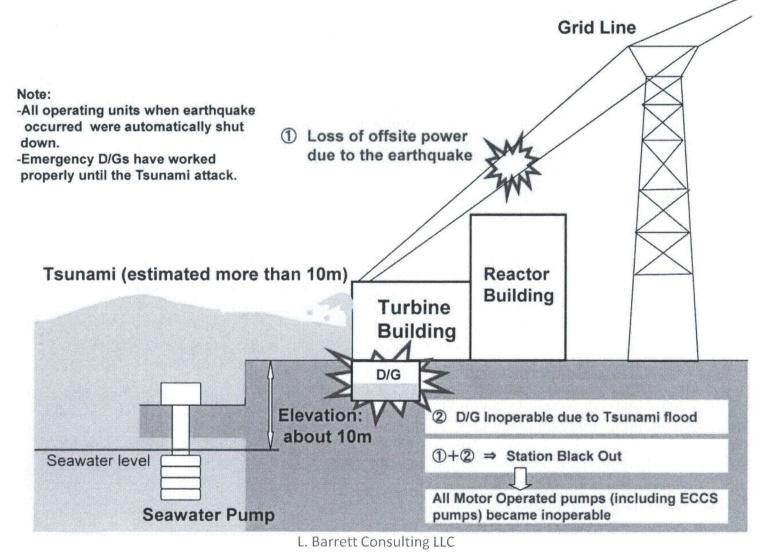
#### Tsunami Size Was Accident Cause 3/11 15:45

•~ 15:45, a tsunami 14 meters high inundated the site, whose design basis was 5.7 meters – the reactors and backup diesel power sit roughly 10 to 13 meters above sea level

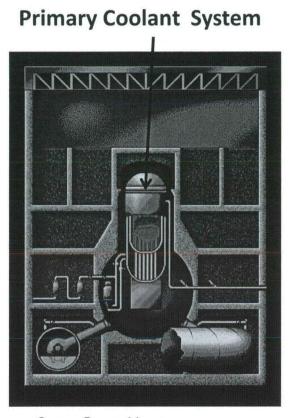
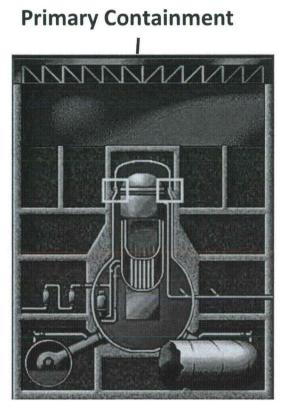
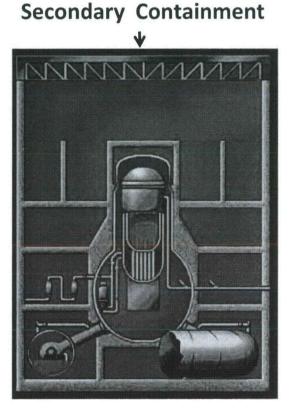
# Fukushima: Reactor Vessel-Primary-Secondary Containment Sequence

Core Over Heat -Clad Burst ~900C -Clad Oxidize ~1200C -H2 Release -Partial Melt~1800C-2700C -Primary Coolant System Overpressure

Vent from Primary Coolant Sys to Primary Containment- H2, Steam, & Fission Products (Xe, Kr, I, Cs L. Barrett Consulting LLC etc)

No Primary Containment Cooling therefore Primary Containment Overpressure-Vent to Secondary Containment

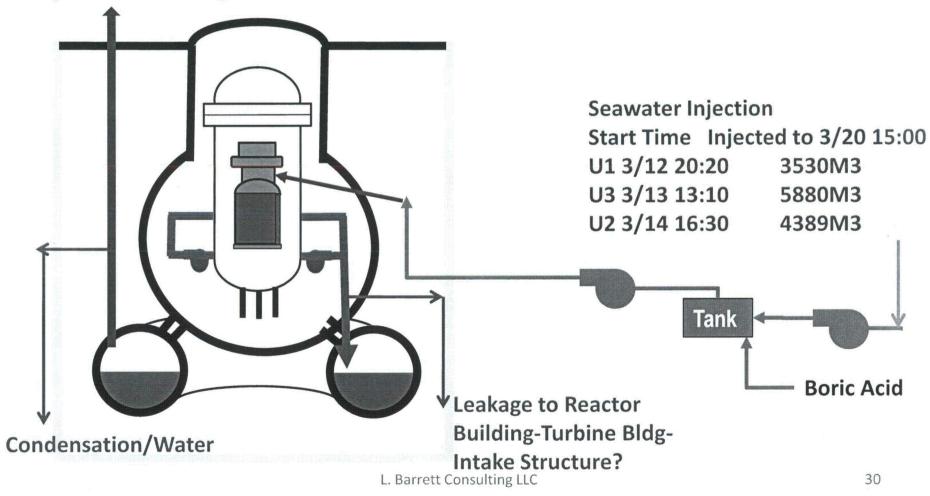
# **Bleed & Feed Core Cooling Established**

Seawater Injection Started Using Fire Engine Pump Shift to Fresh Water Injection ~3/26-Present:To Dissolve Vapor Venting Possible Salt Cakes

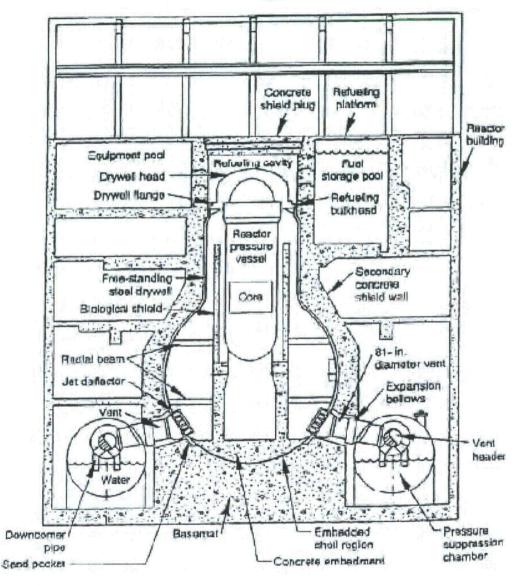
#### **Reactor Building Cross Section**

L. Barrett Consulting LLC Figure 20. Mark 1 General Electric, GE BWR Containment.
