UT Erosion/Corrosion Examination

Code: ANSI B.31.1, 1955 Edition Cat./Item: N/A Location: Transformer Yard - 10'
 Drawing No.: 9321-F-2737 & 2236 Description: Buried pipe examination of the 2" and 8" pipe.

System ID: City Water
 Component ID: 2" Line # 1511 and 8" Line # 1502 Size/Length: 2" / 8" Sch 40 Thickness/Diameter: C/S .154"/.322"
 Limitations: None Component File No.: 2-1511 / 1511A & 8-1502 Start Time: 1135 Finish Time: 1230

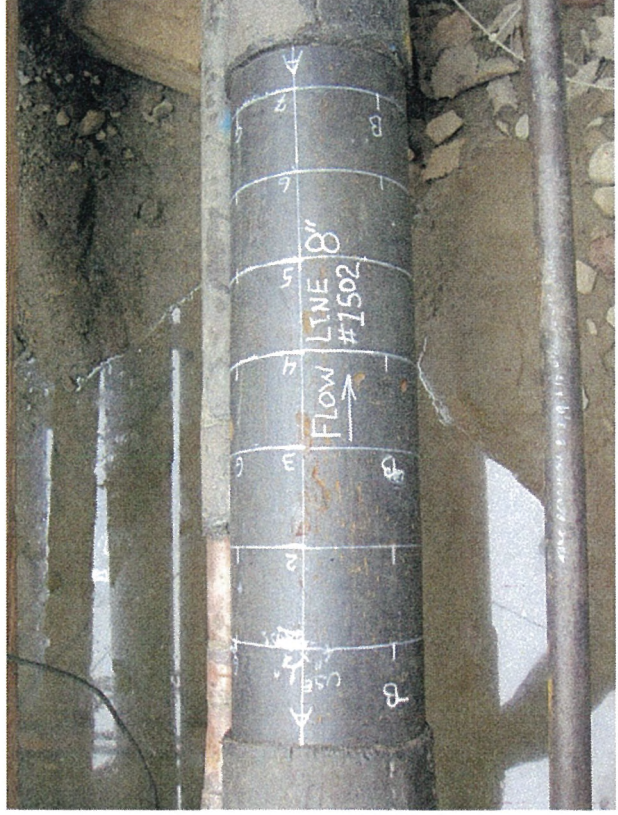
\\Client\Y\$\Idea\Ver 8\Idea\Server\Idea\IP2\Graphics-Pictures\Burried Pipe\8-1502.jpg

Comments/Obstructions: Coating and was removed prior to this examination. Grid point readings taken.
 Results: Accept Reject Info Tmin = 0.134" & 0.282" (87.5% of nominal thickness).

Comments: Sketch left below of the grid layouts. Photo right below of the 8" pipe examined.

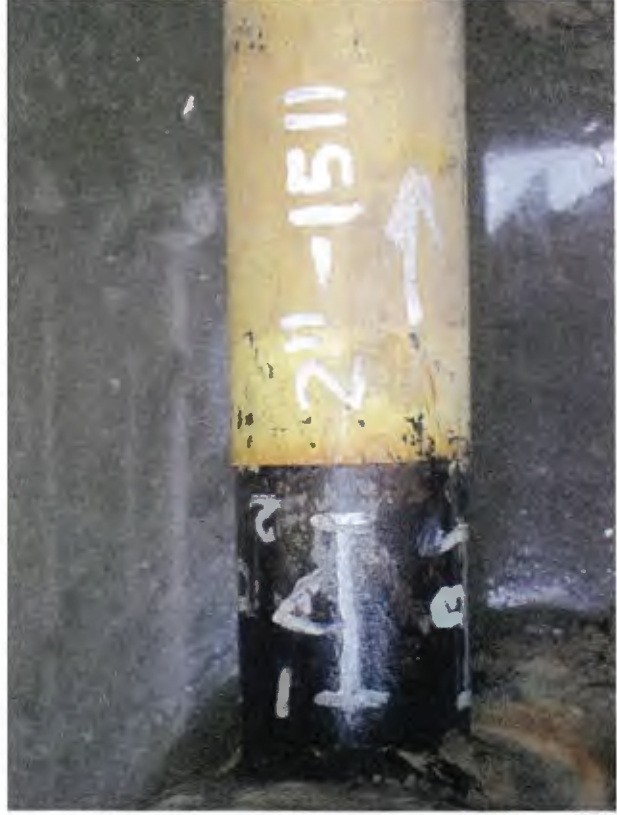
Sketch or Photo: \\Client\Y\$\Ideall Ver 8\Ideall_Server\Ideall_IP2\Graphics-Pictures\Burried Pipe\2-1511.jpg

Component Information	
Component Geometry:	Pipe
Outside Diameter:	2" / 8" Grid Size: See Pg. 2
Max. Thickness:	.168"/.352" Min. Thickness: .135"/.310"
Nominal Thickness:	.154"/.322" Tmin.: .134"/.282"
Min. Thickness Location:	2" pipe area 1 - B2
Max. Thickness Location:	8" pipe - G 3

Comments: Photo's of the 2" pipe examined; left below of Area 1 and right below of Area 2.
