Seismic Walkdown Checklist (SWC)Equipment ID No. 2-1805-53-BBC Equip. Class¹² Motor Control Centers & Wall-Mounted ControllersEquipment Description 480V MOT Control CTR 2BBCLocation: Bldg. Control Floor El. 180'-0" Room, Area R/B18

Seismic Walkdown Checklist (SWC)Equipment ID No. 2-1806-S3-DCC Equip. Class¹² 1-Motor Control Centres and Wall-mounted ControllersEquipment Description 125 VDC MCC 2C D1MLocation: Bldg. Control Floor El. 180'-0" Room, Area RB85

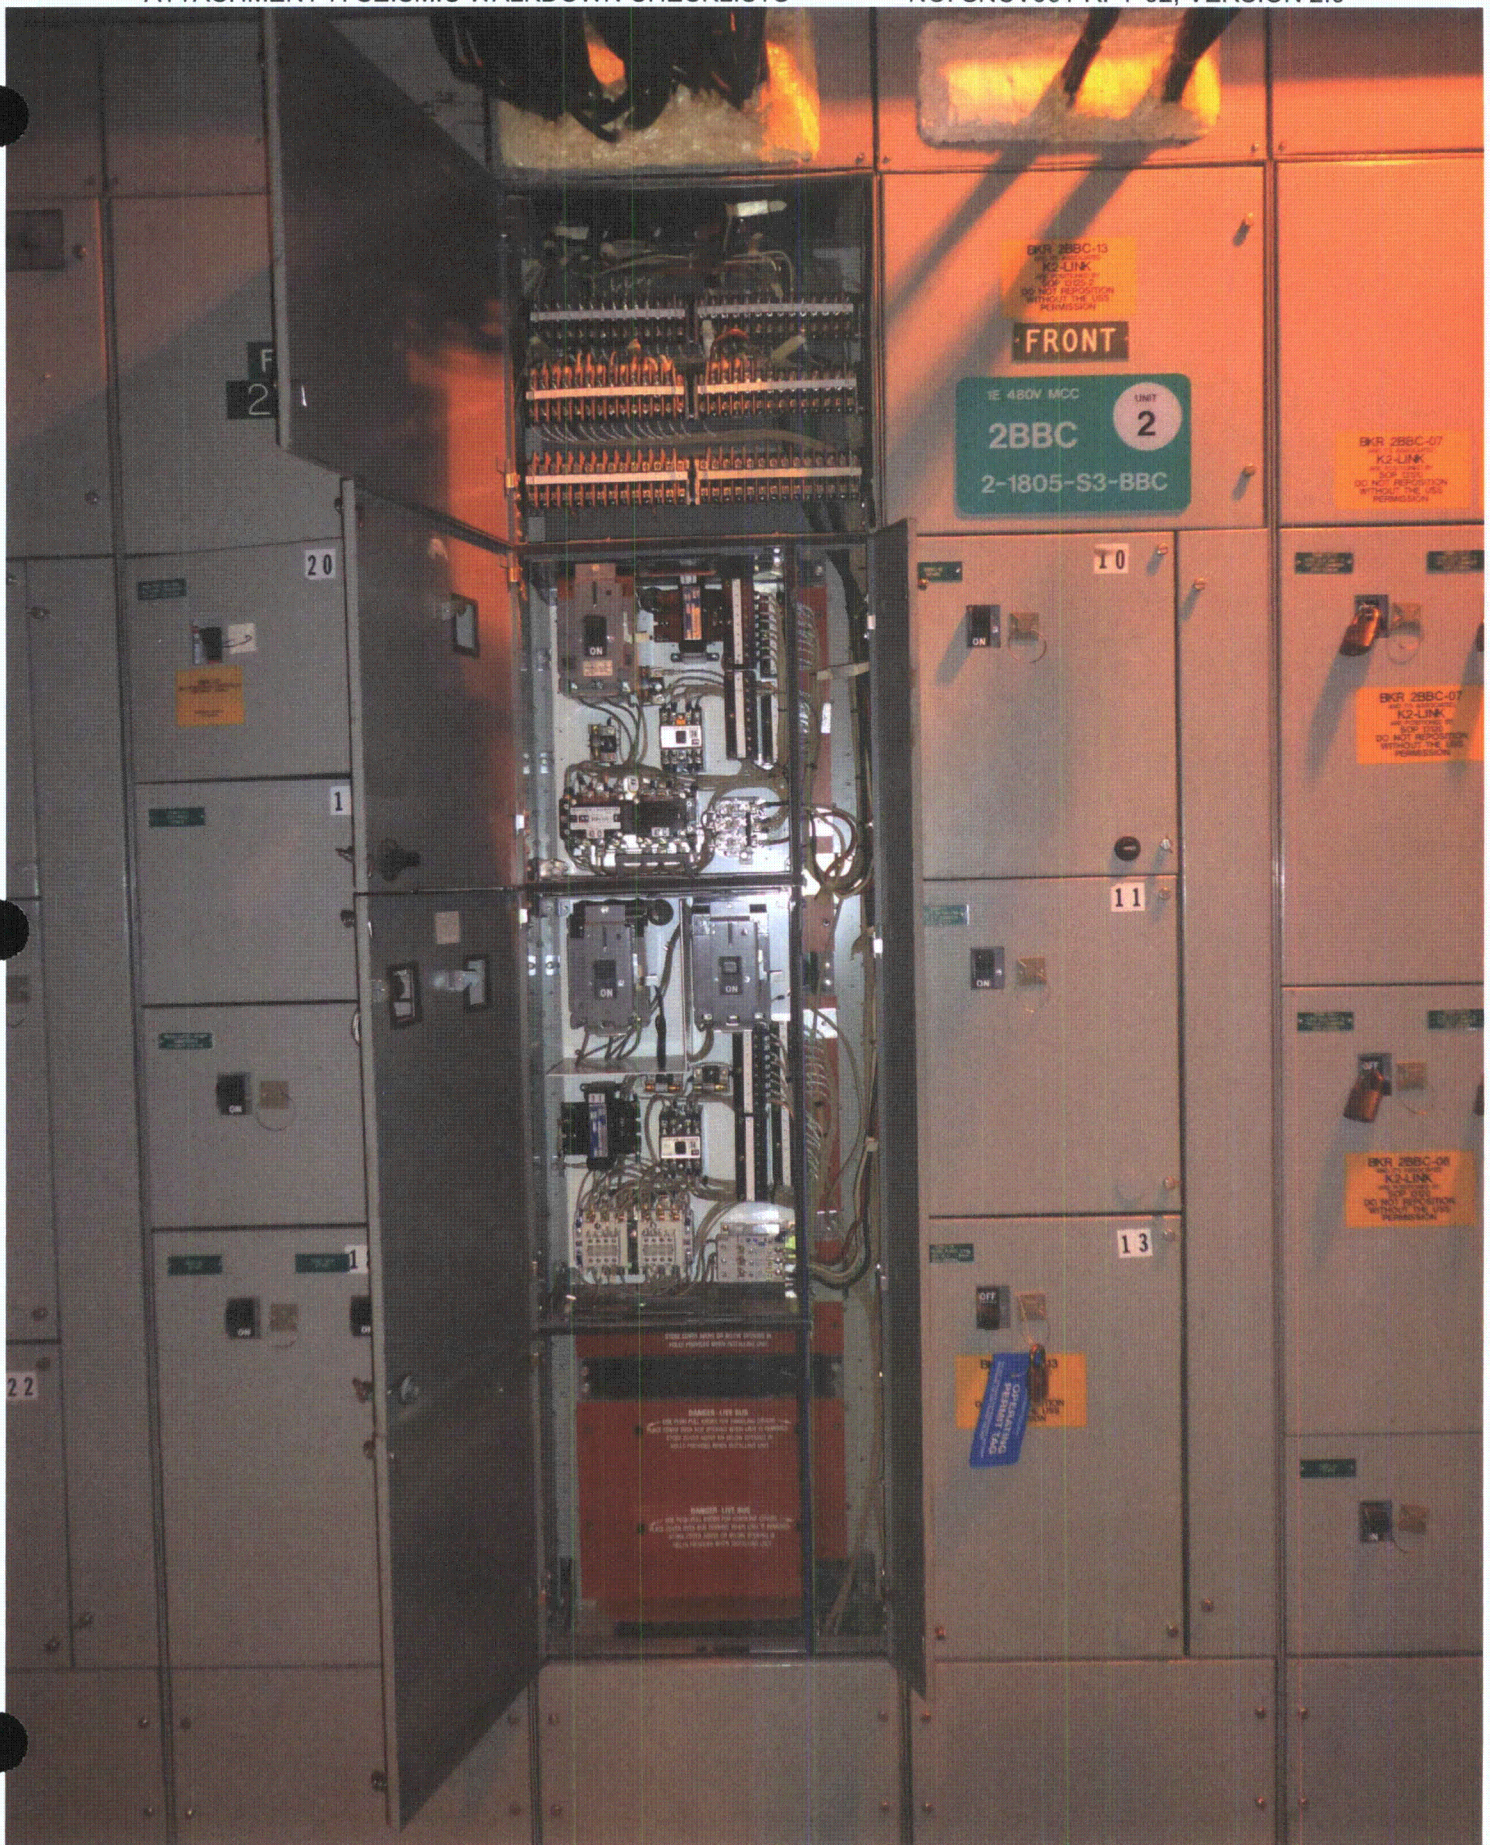
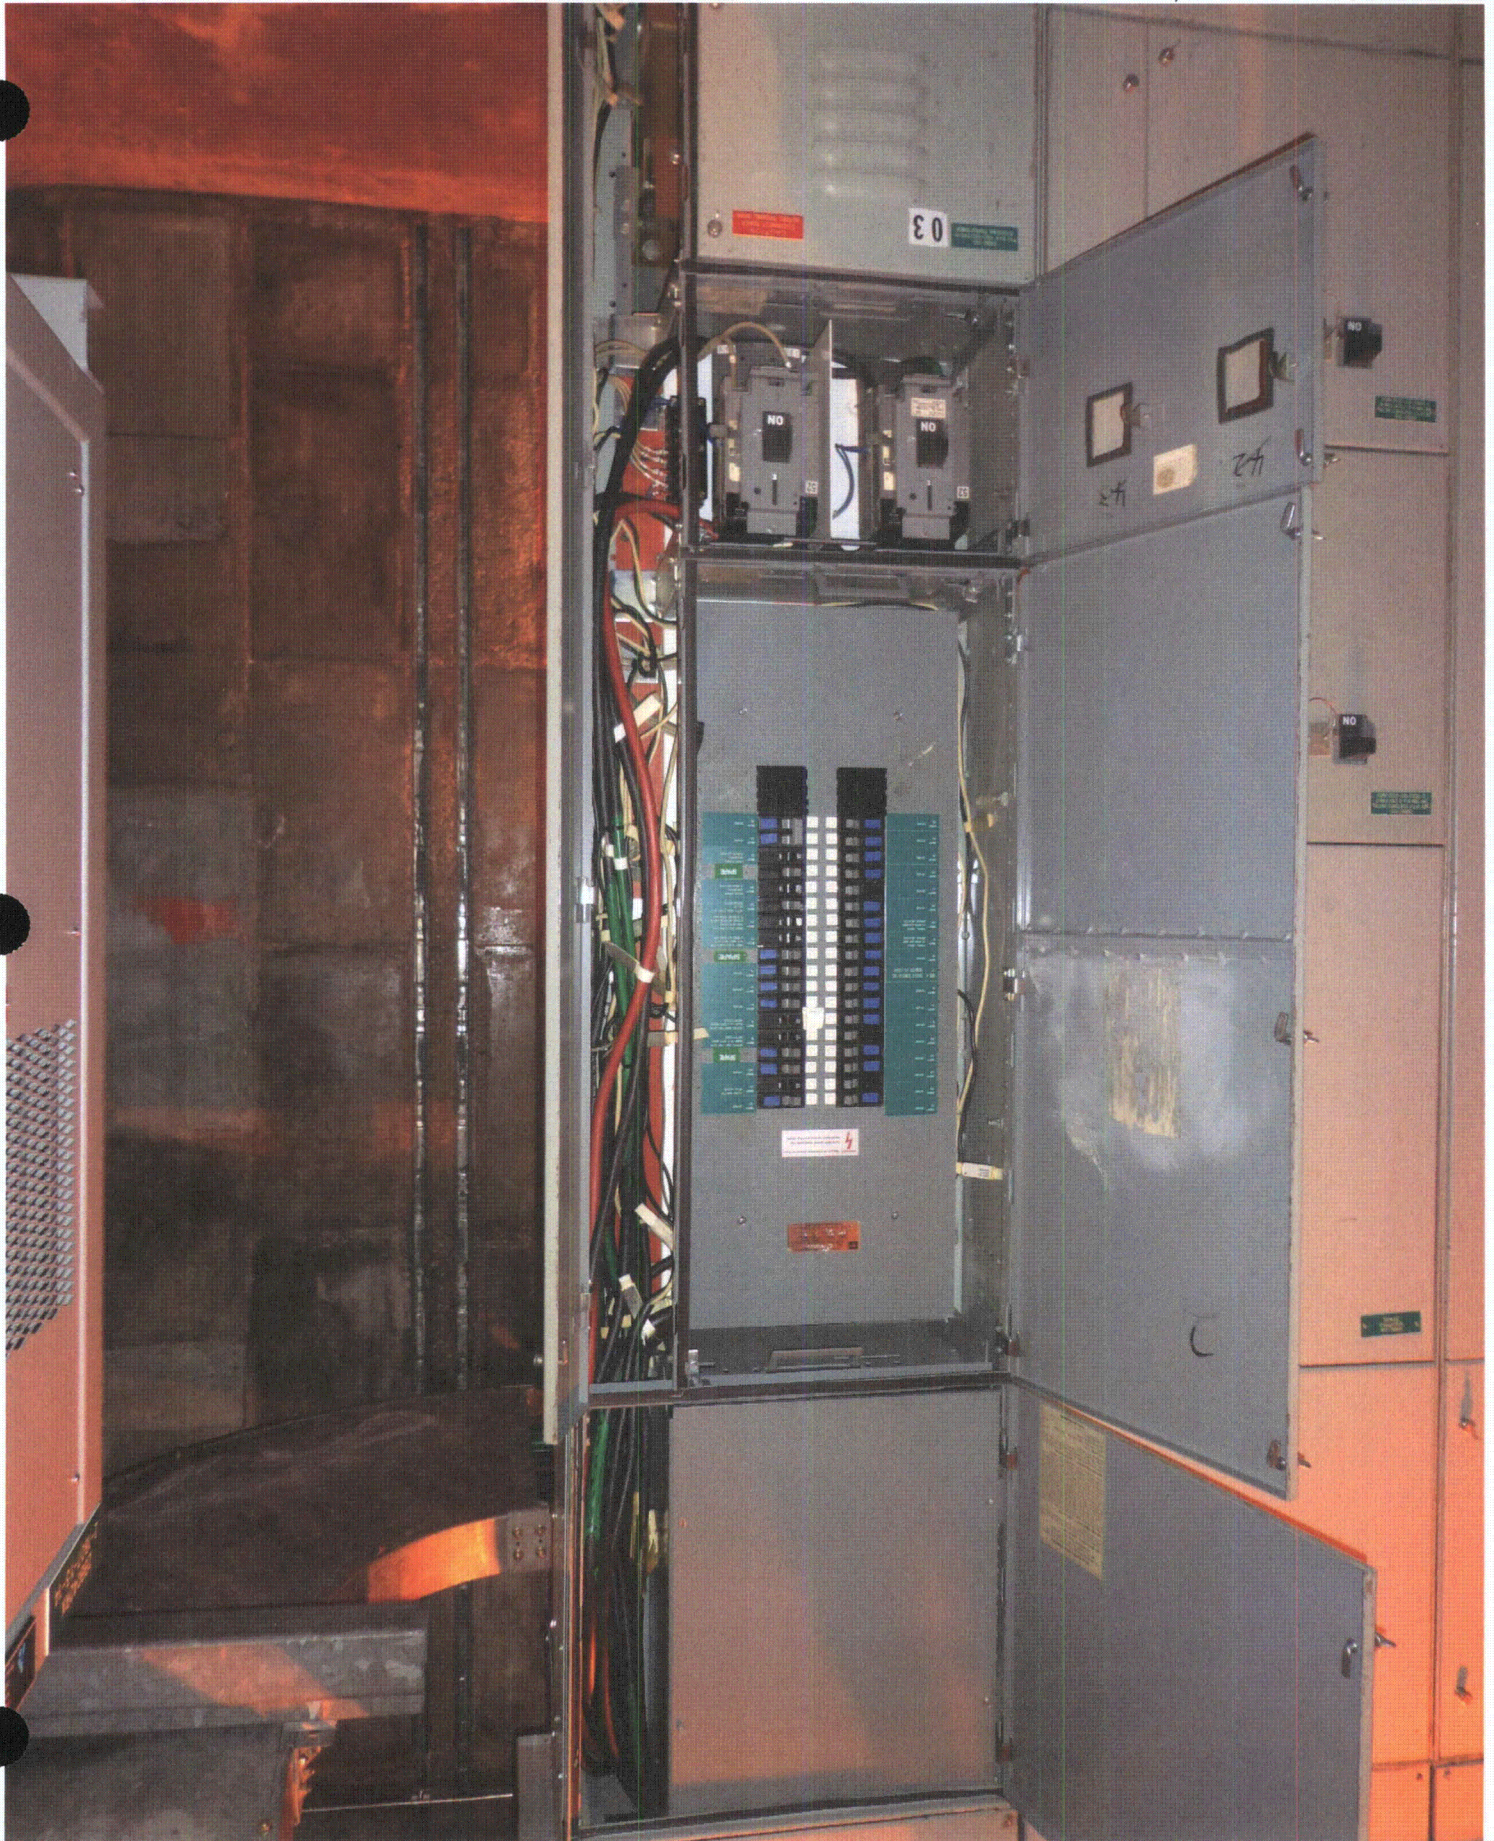
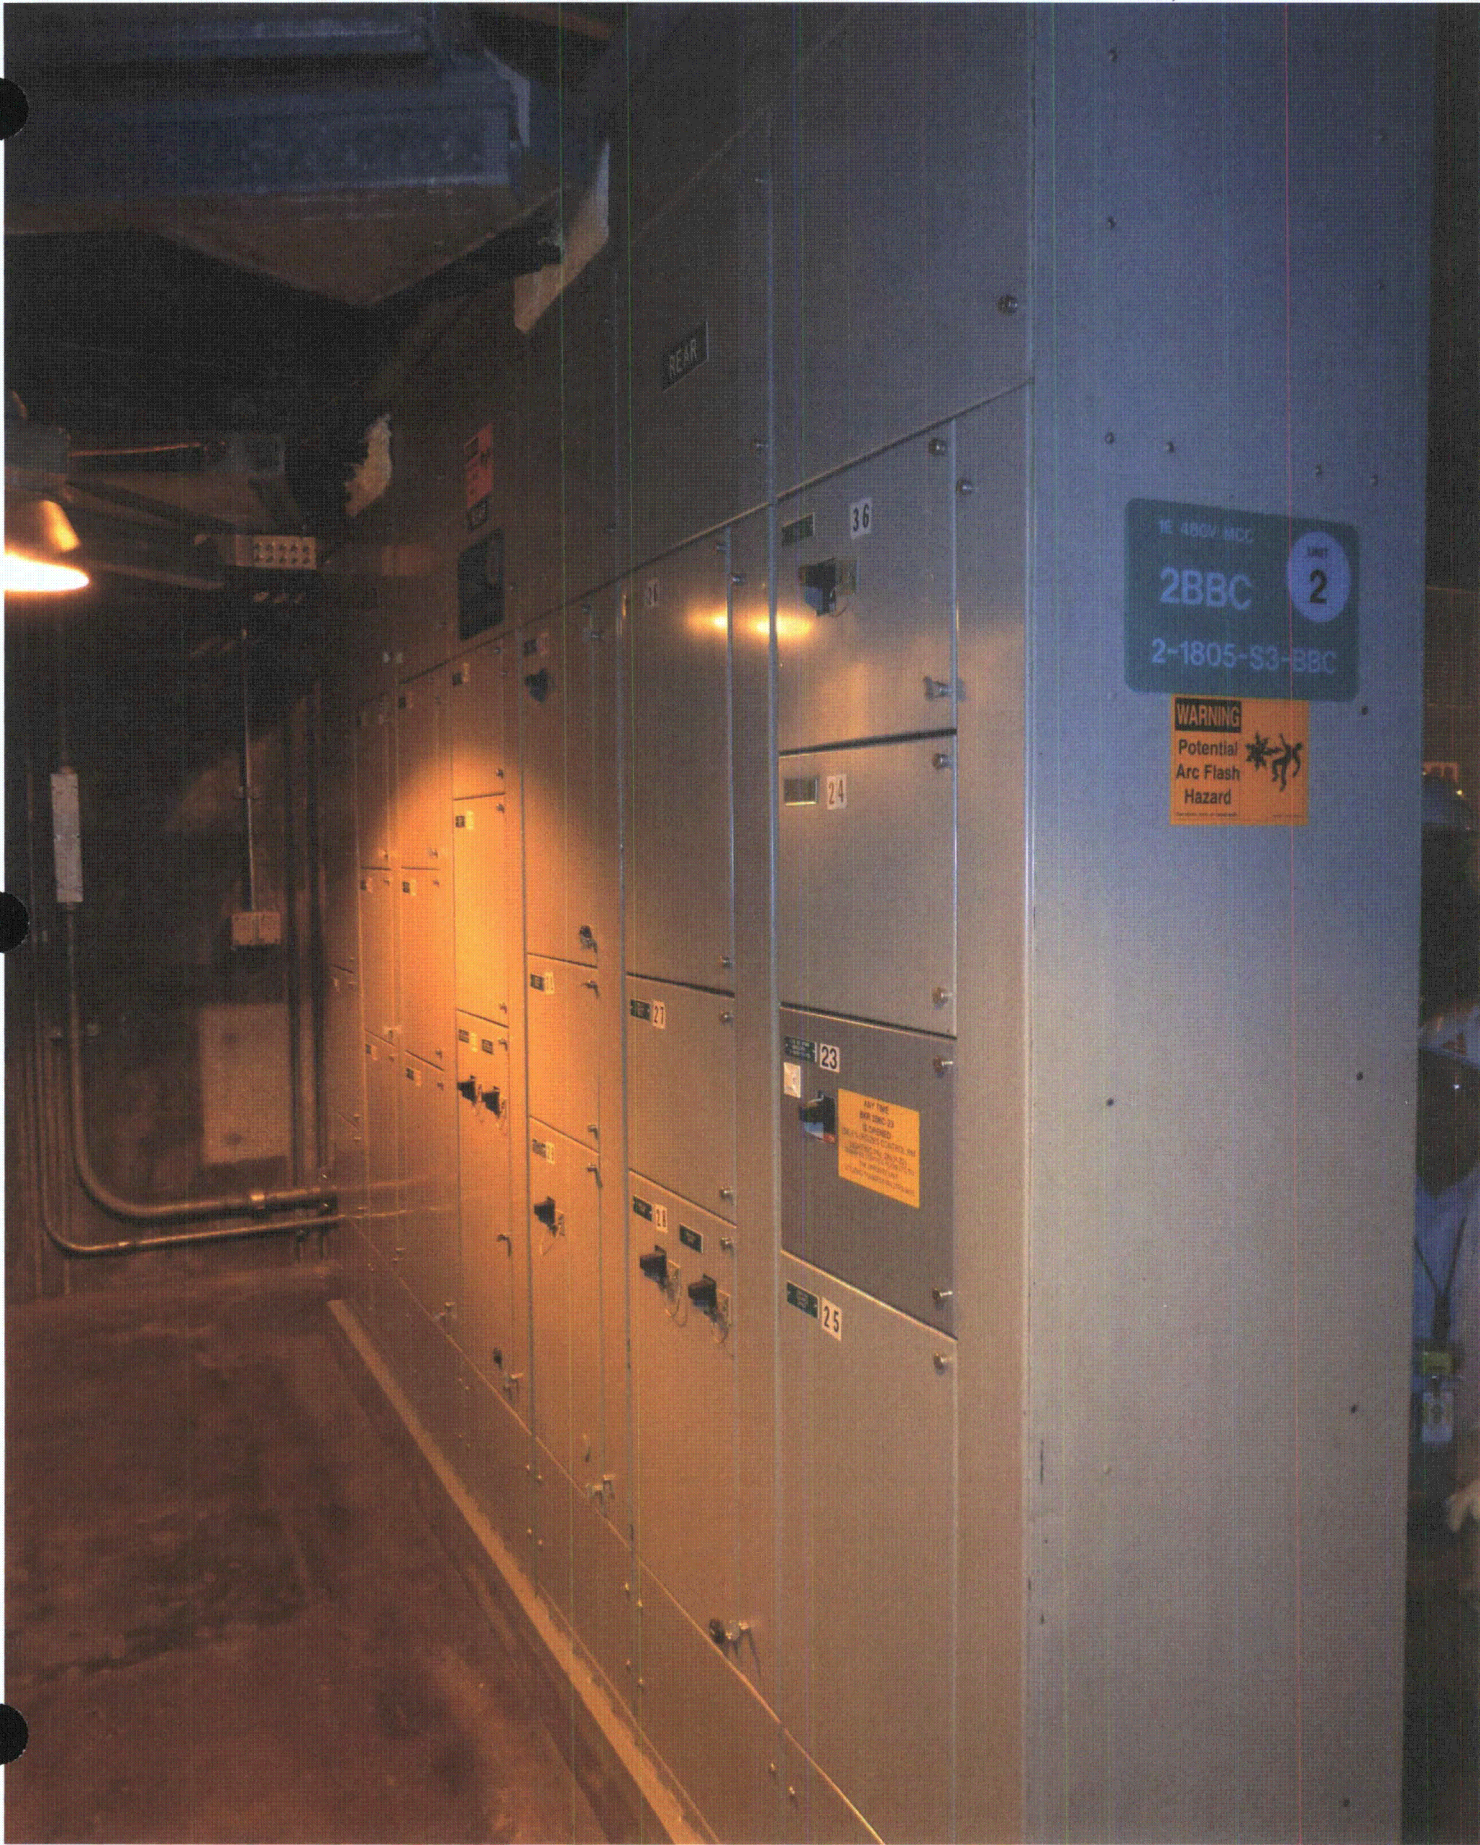
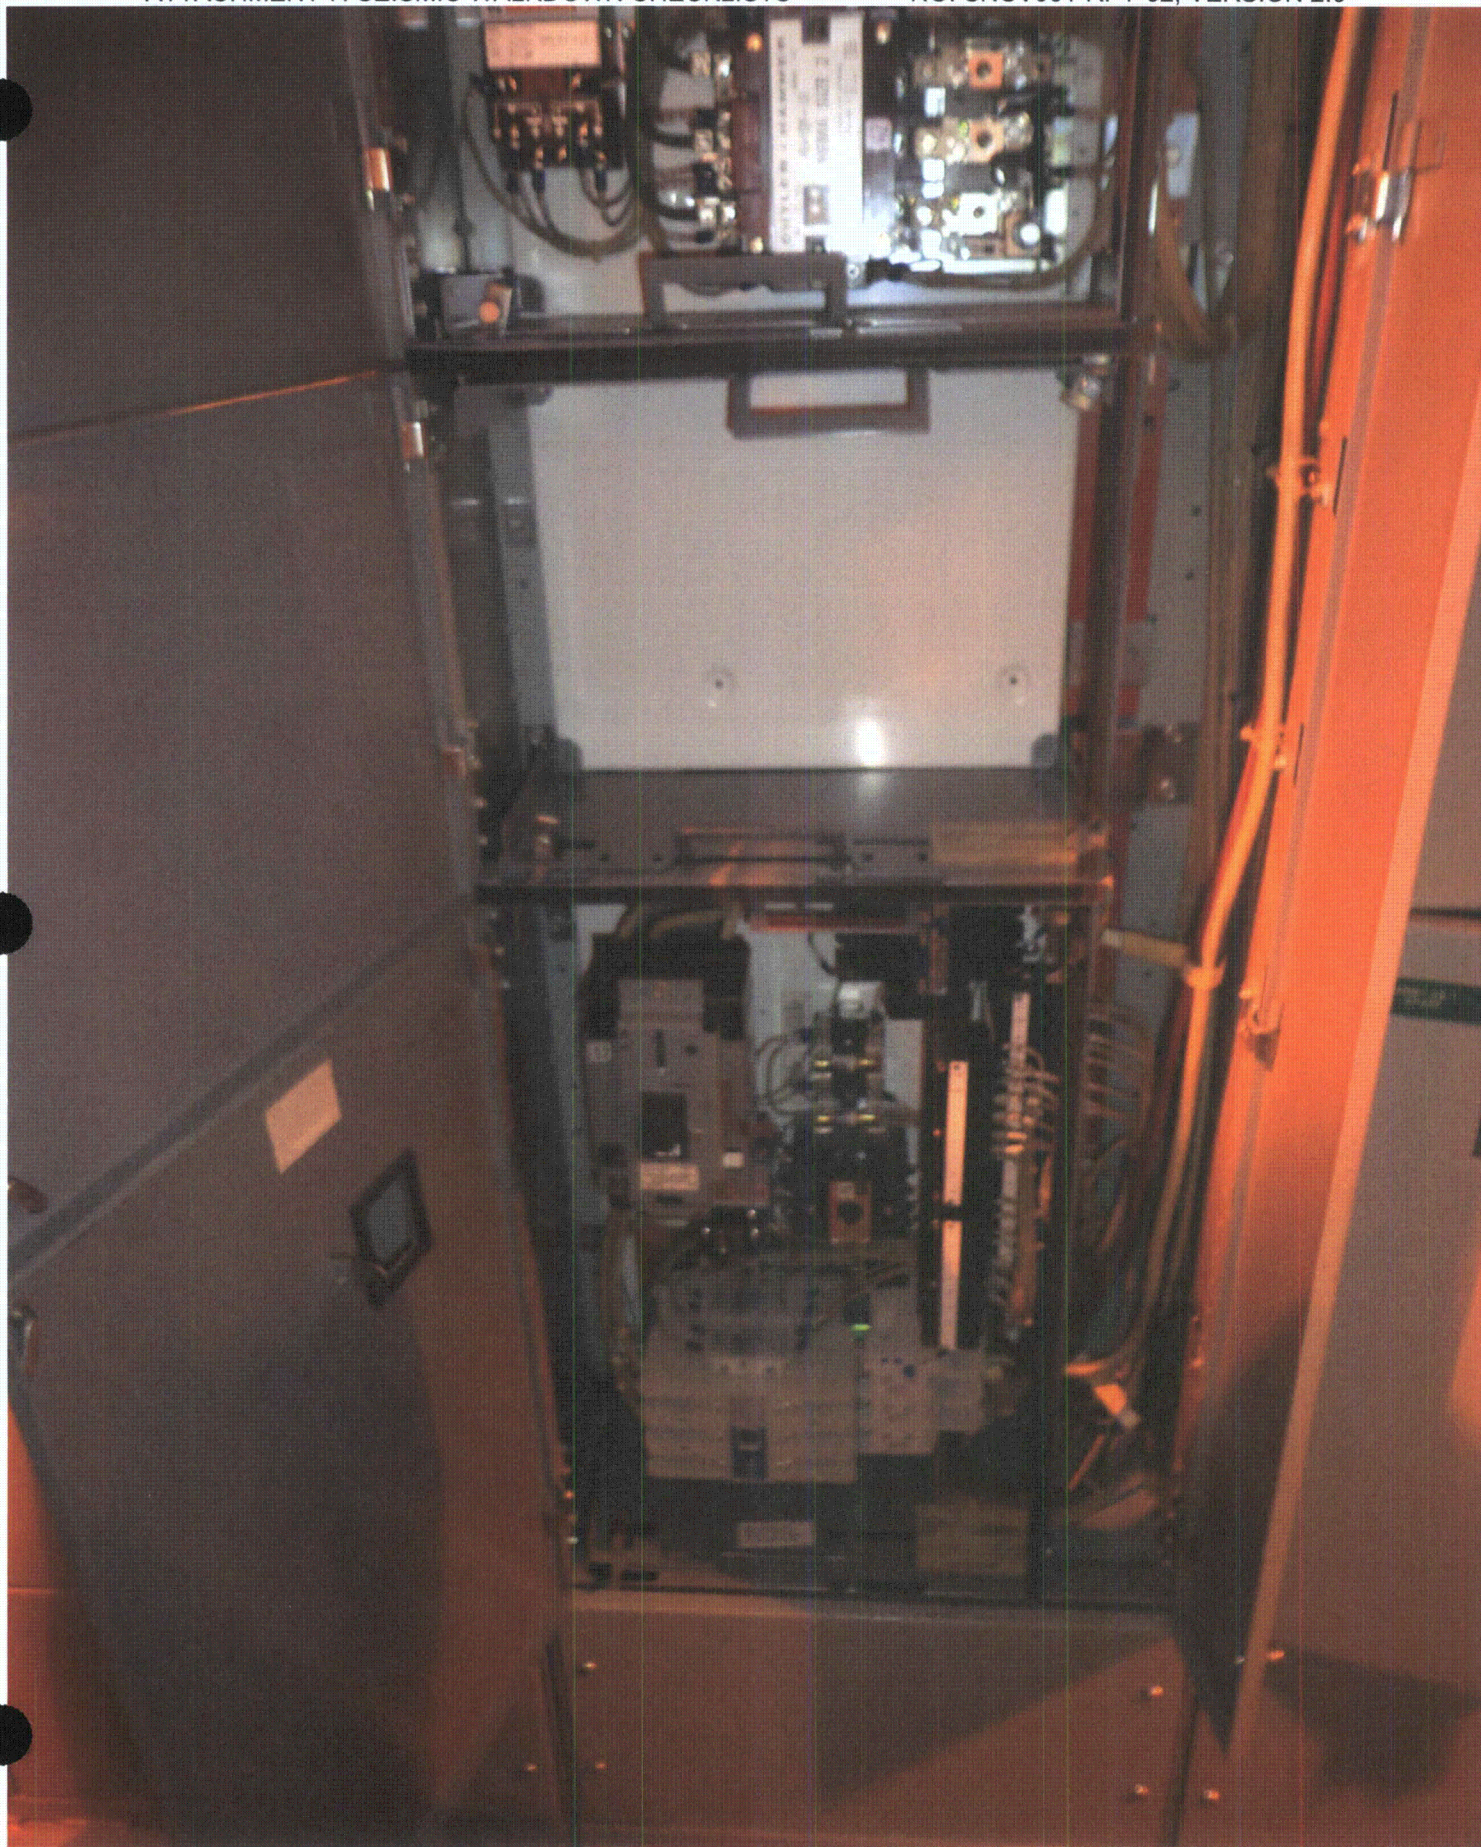
2BBC-22

It has been judged by the SWB team that these issues do not represent a seismic or operability concern for this cabinet. Condition Report 611859 has been generated to document the condition.

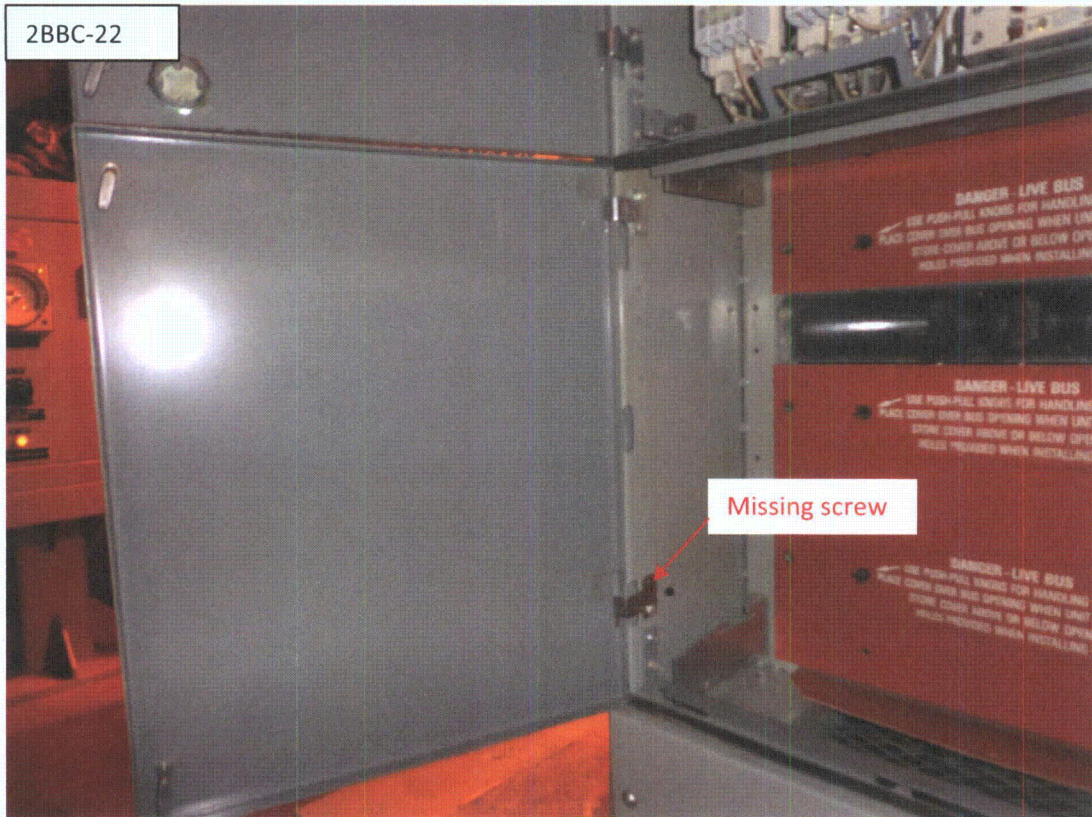
Some minor issues were found:

- One (1) missing screw for a door hinge in compartment 2BBC-22.
- One (1) missing screw for a door hinge in the top of the 4th compartment.
- One (1) door that could not be opened for compartment 2BBC-18.

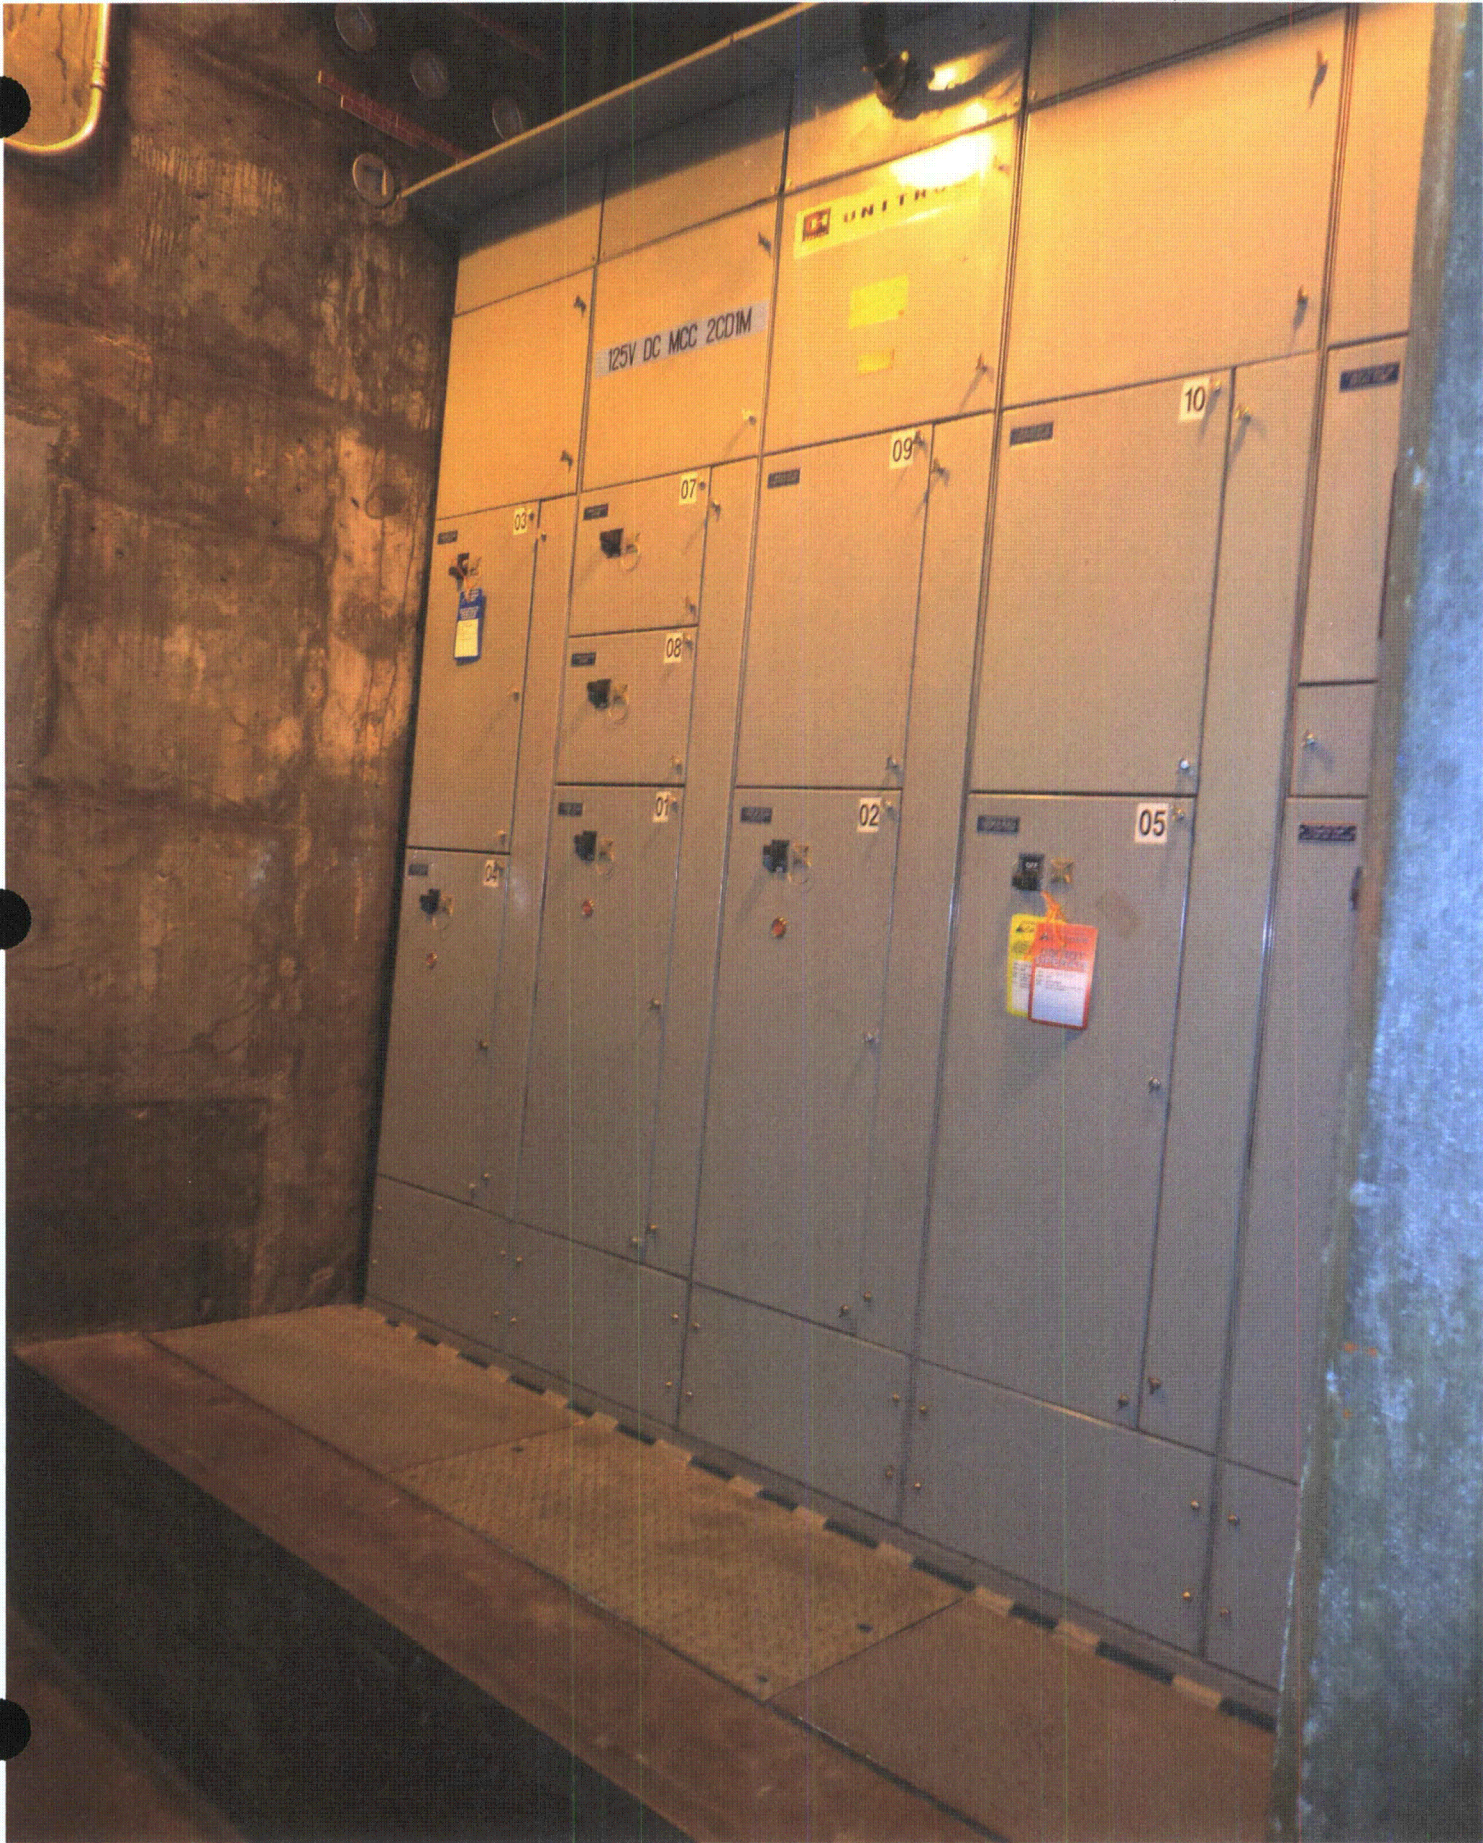
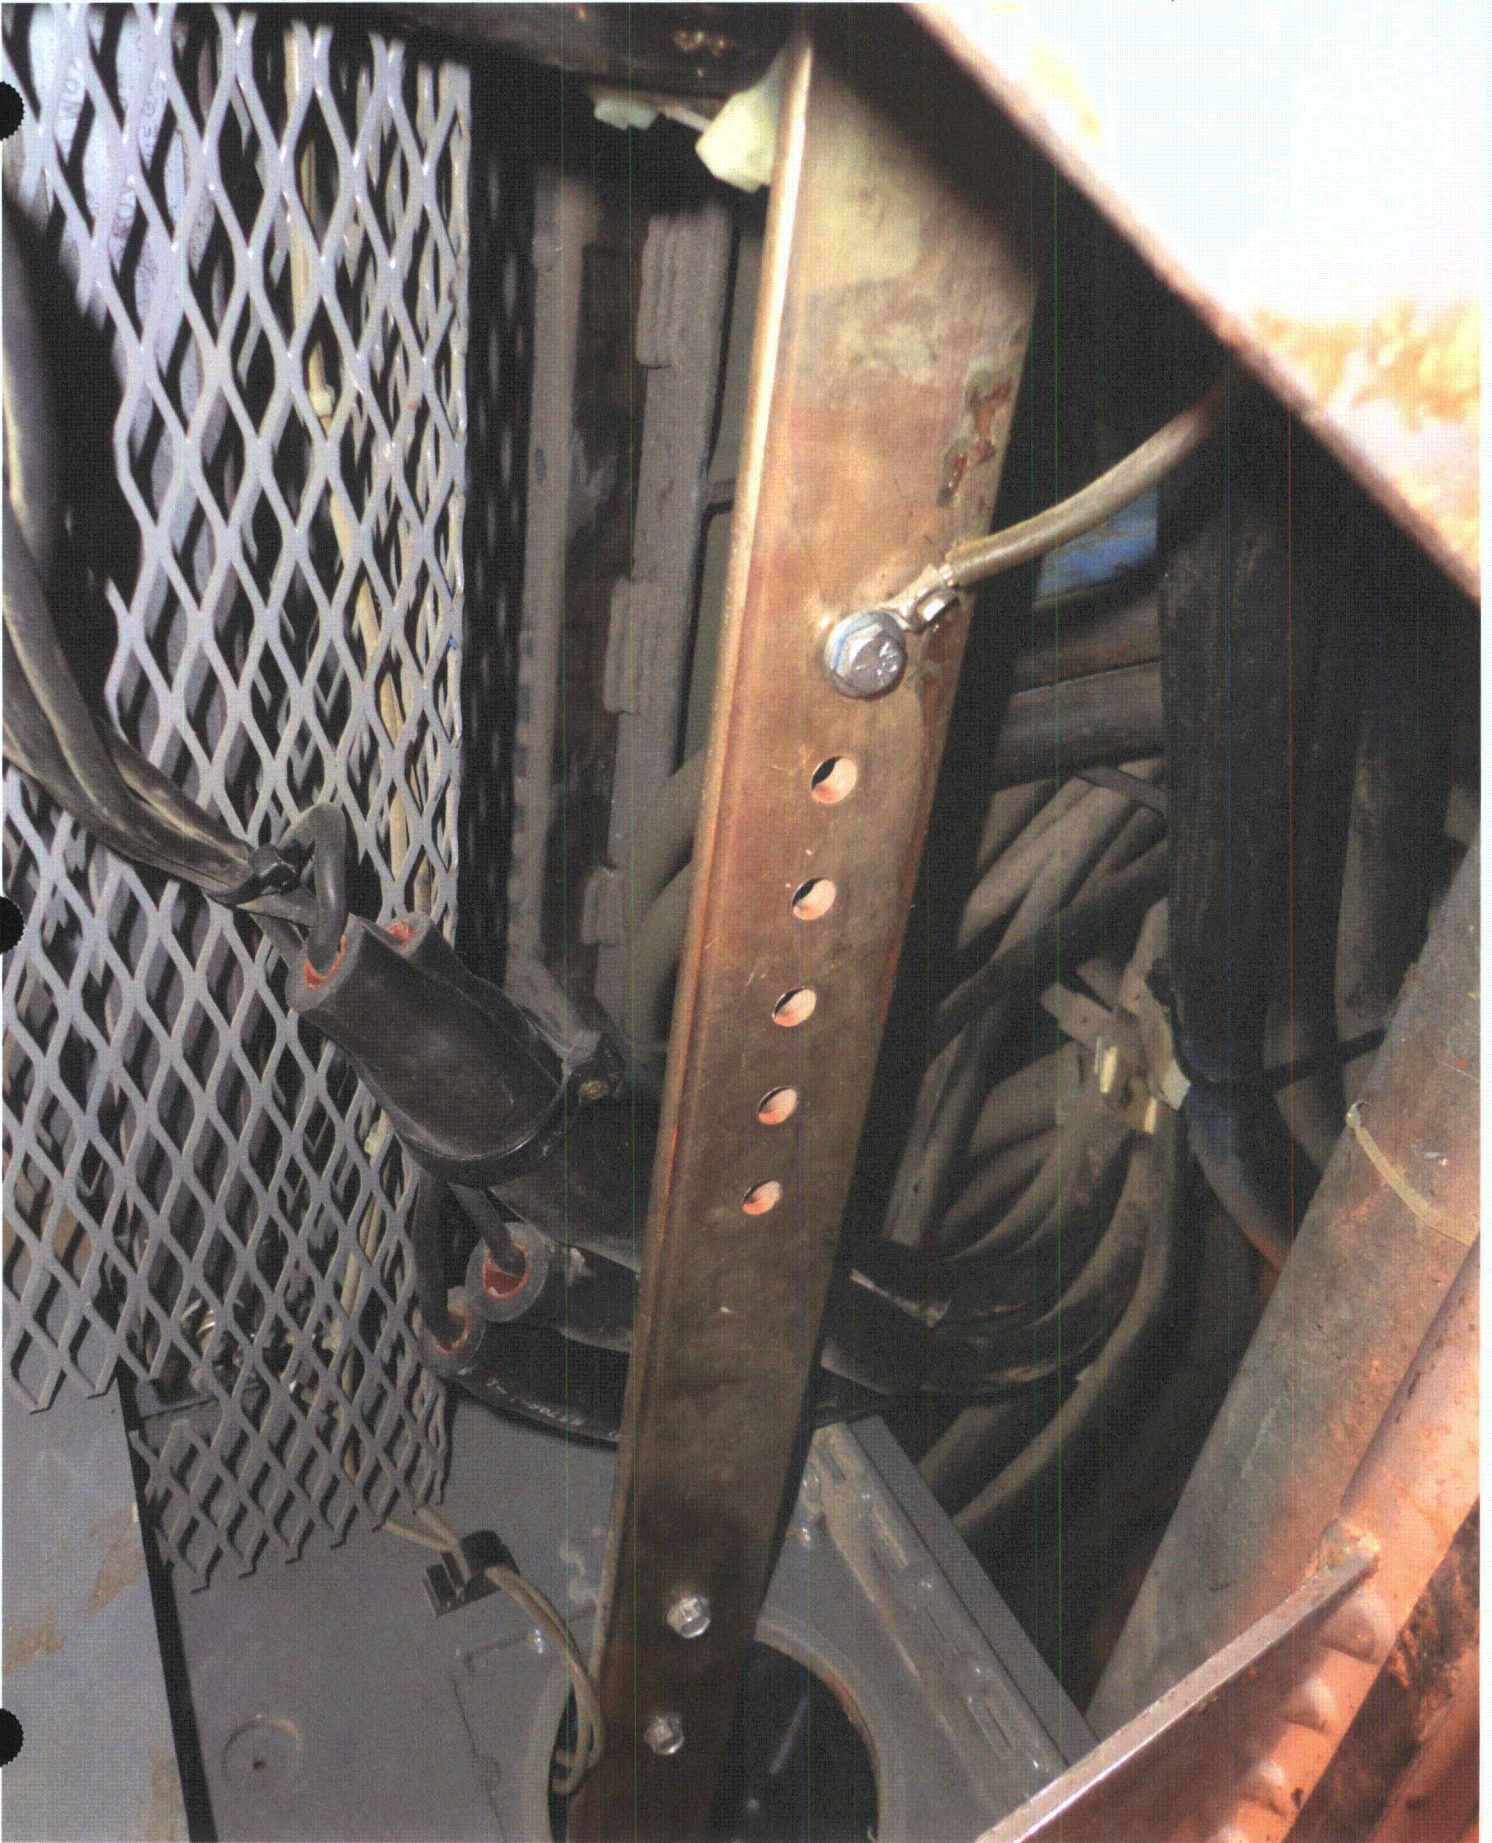
① A minor issue was found: three (3) screws for terminal blocks were missing. It has been judged by the SWE team that this condition does not represent a seismic or operability concern for this cabinet. Condition report 604433 has been generated to document the condition.
