Seismic Walkdown Checklist (SWC)Equipment ID No. 2-1805-53-BBC Equip. Class¹² Motor Control Centers & Wall-Mounted ControllersEquipment Description 480V MOT Control CTR 2BBCLocation: Bldg. Control Floor El. 180'-0" Room, Area R/B18

Seismic Walkdown Checklist (SWC)Equipment ID No. 2-1806-S3-DCC Equip. Class¹² 1-Motor Control Centres and Wall-mounted ControllersEquipment Description 125 VDC MCC 2C D1MLocation: Bldg. Control Floor El. 180'-0" Room, Area RB85

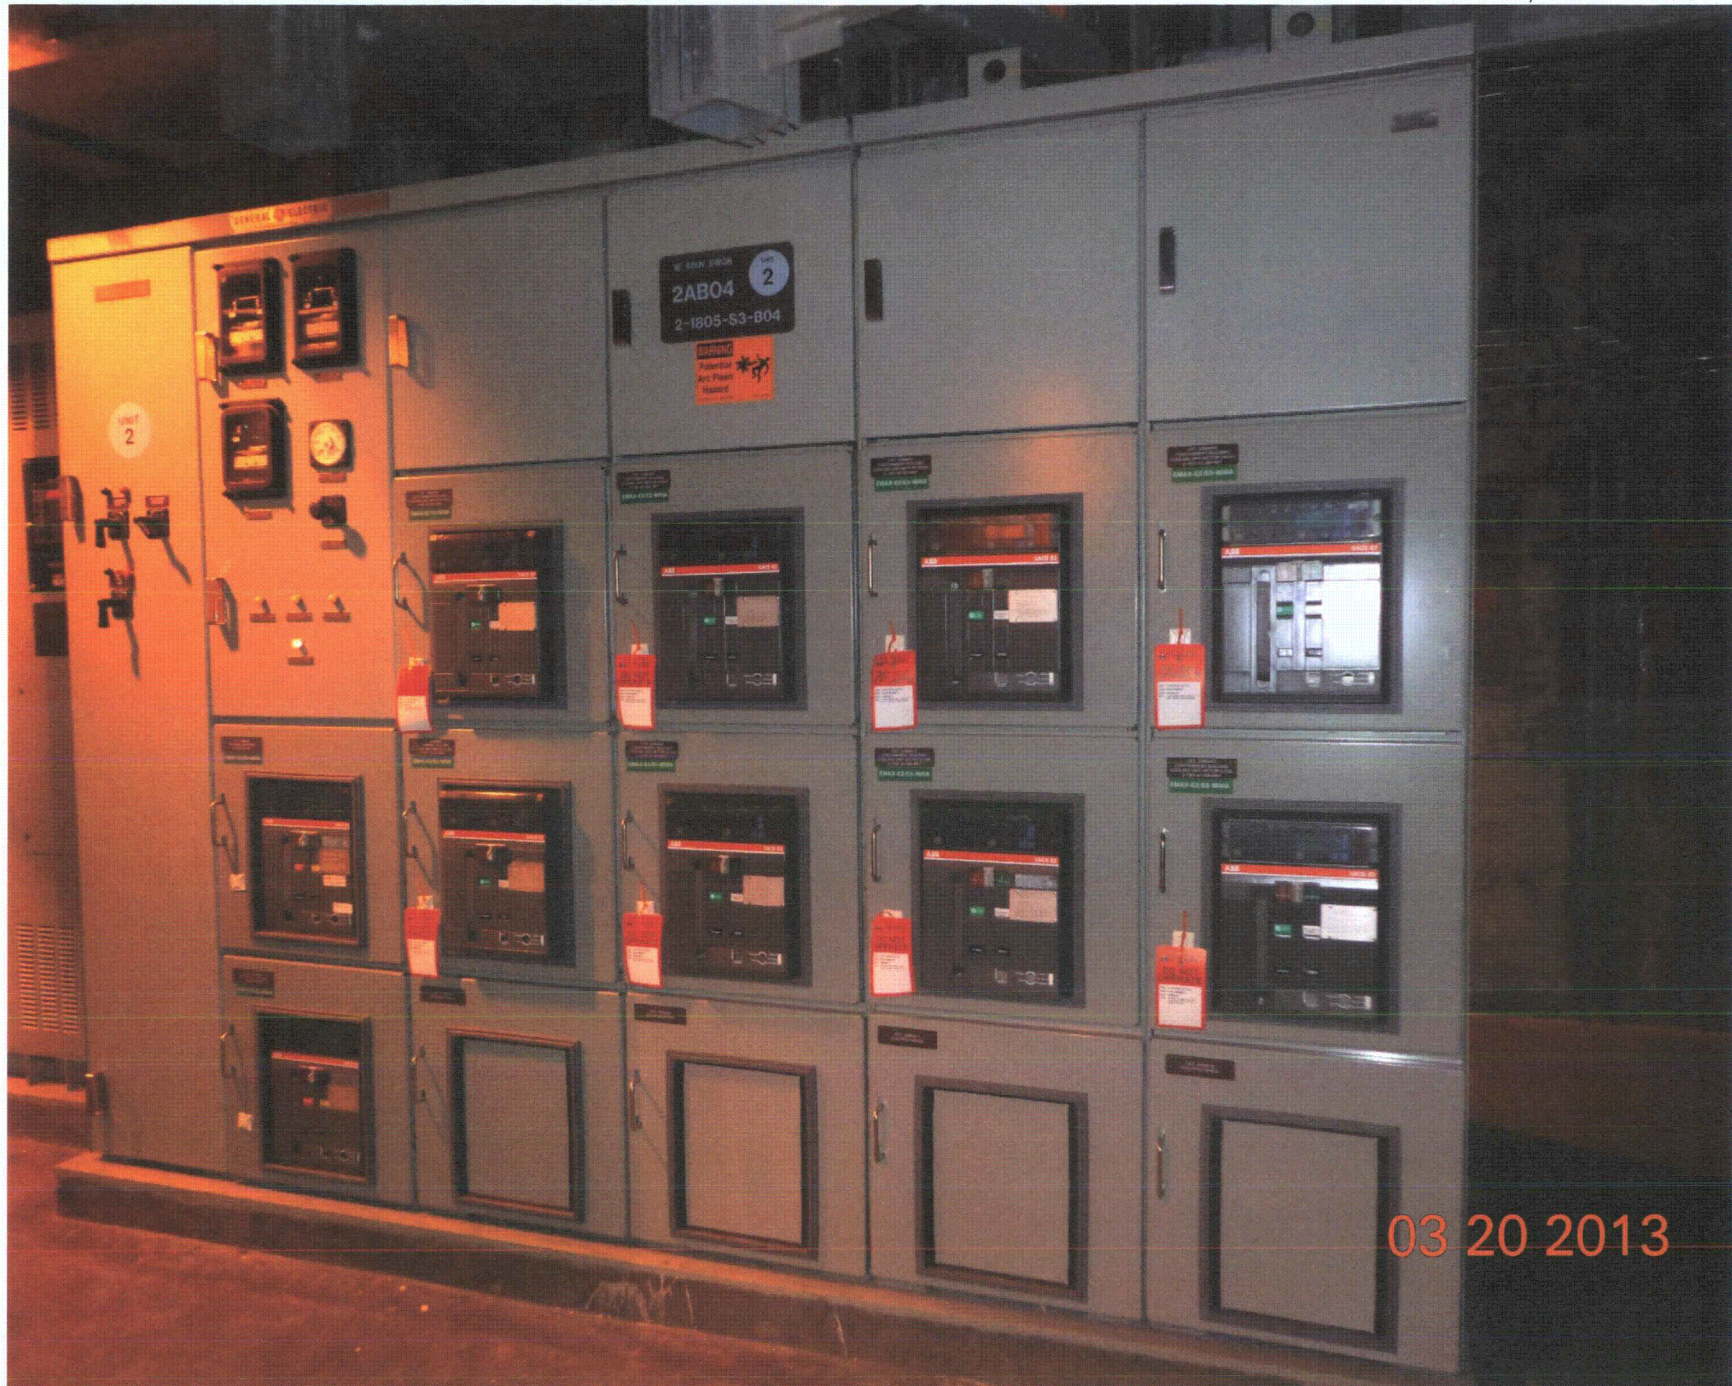
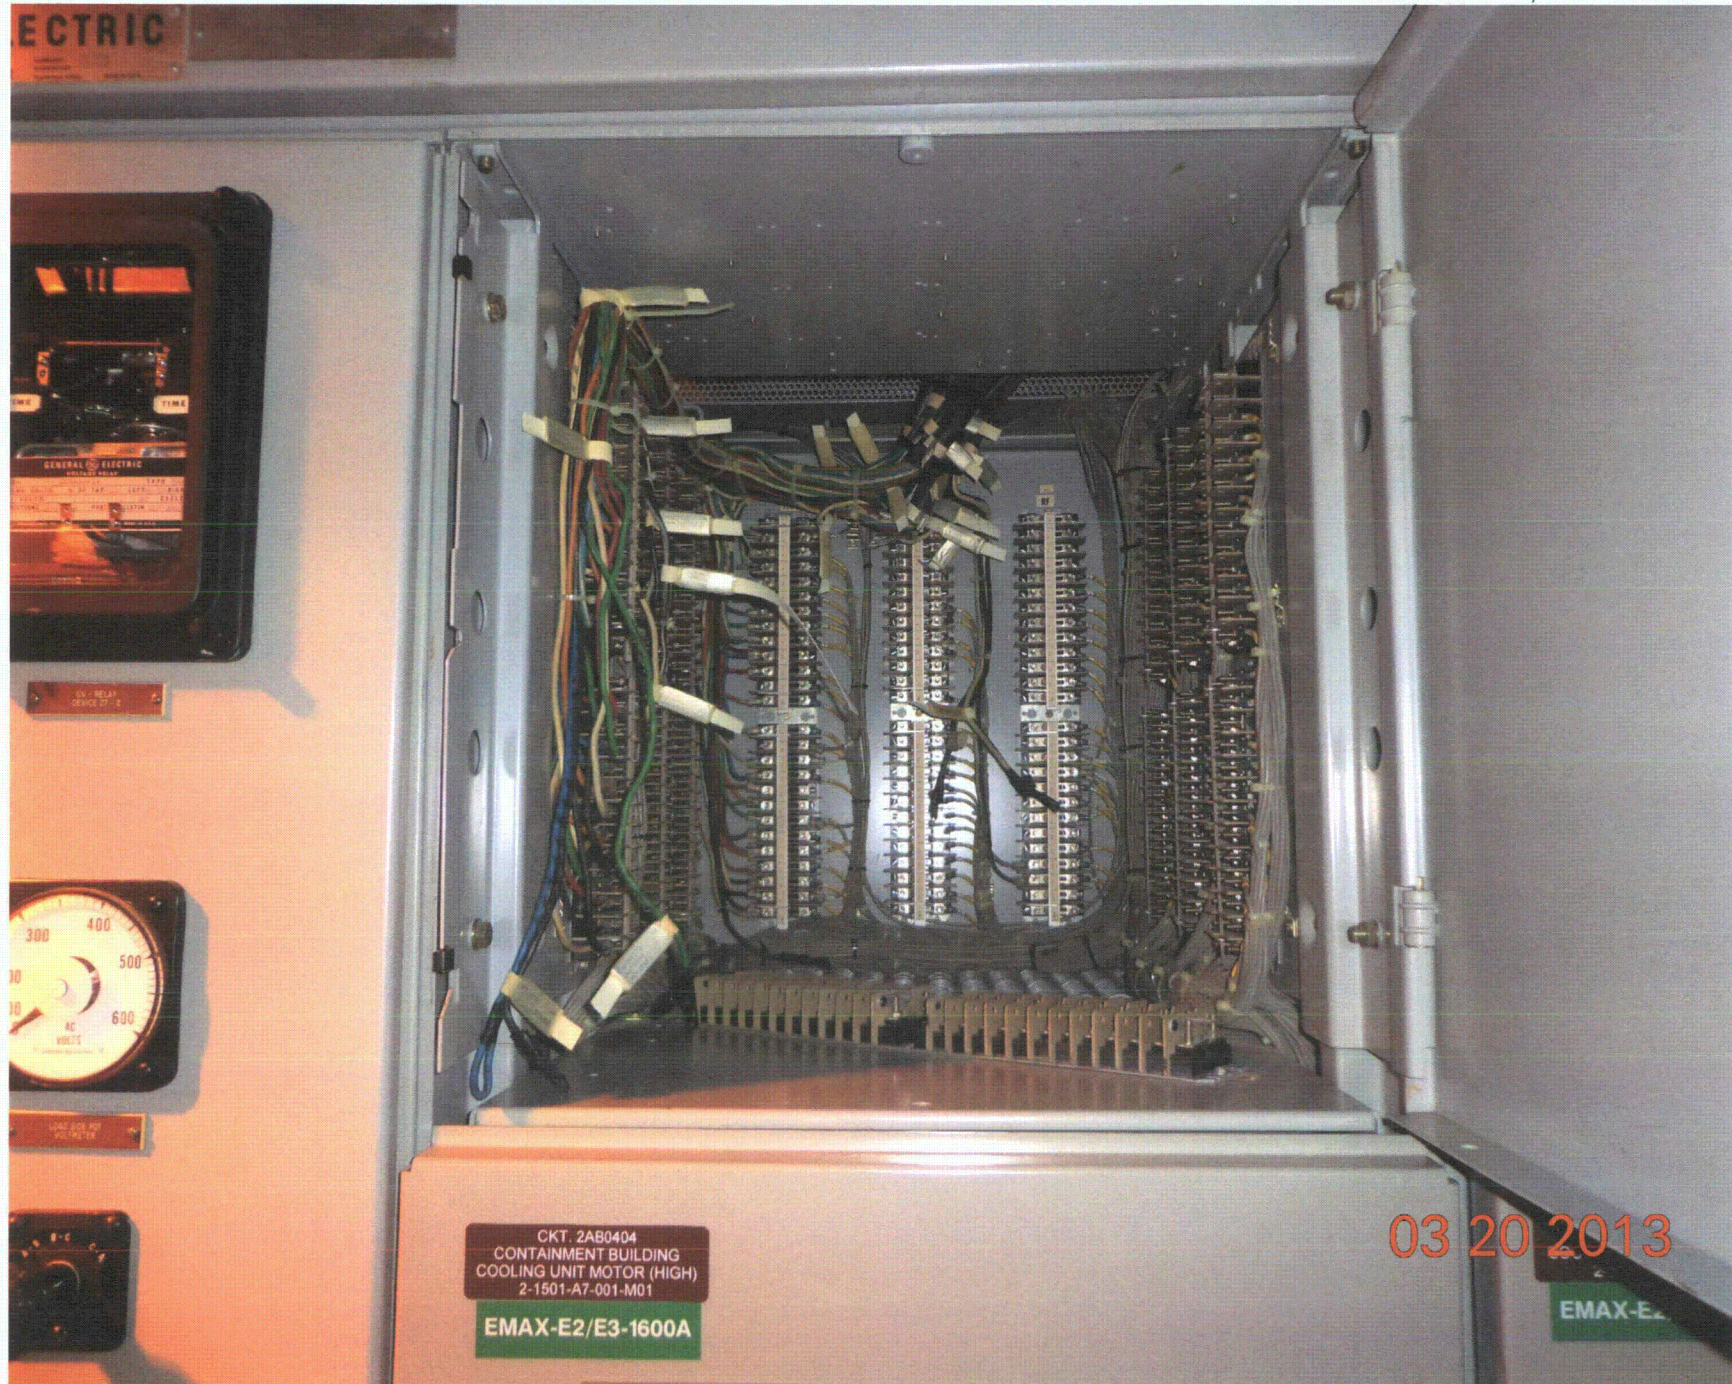
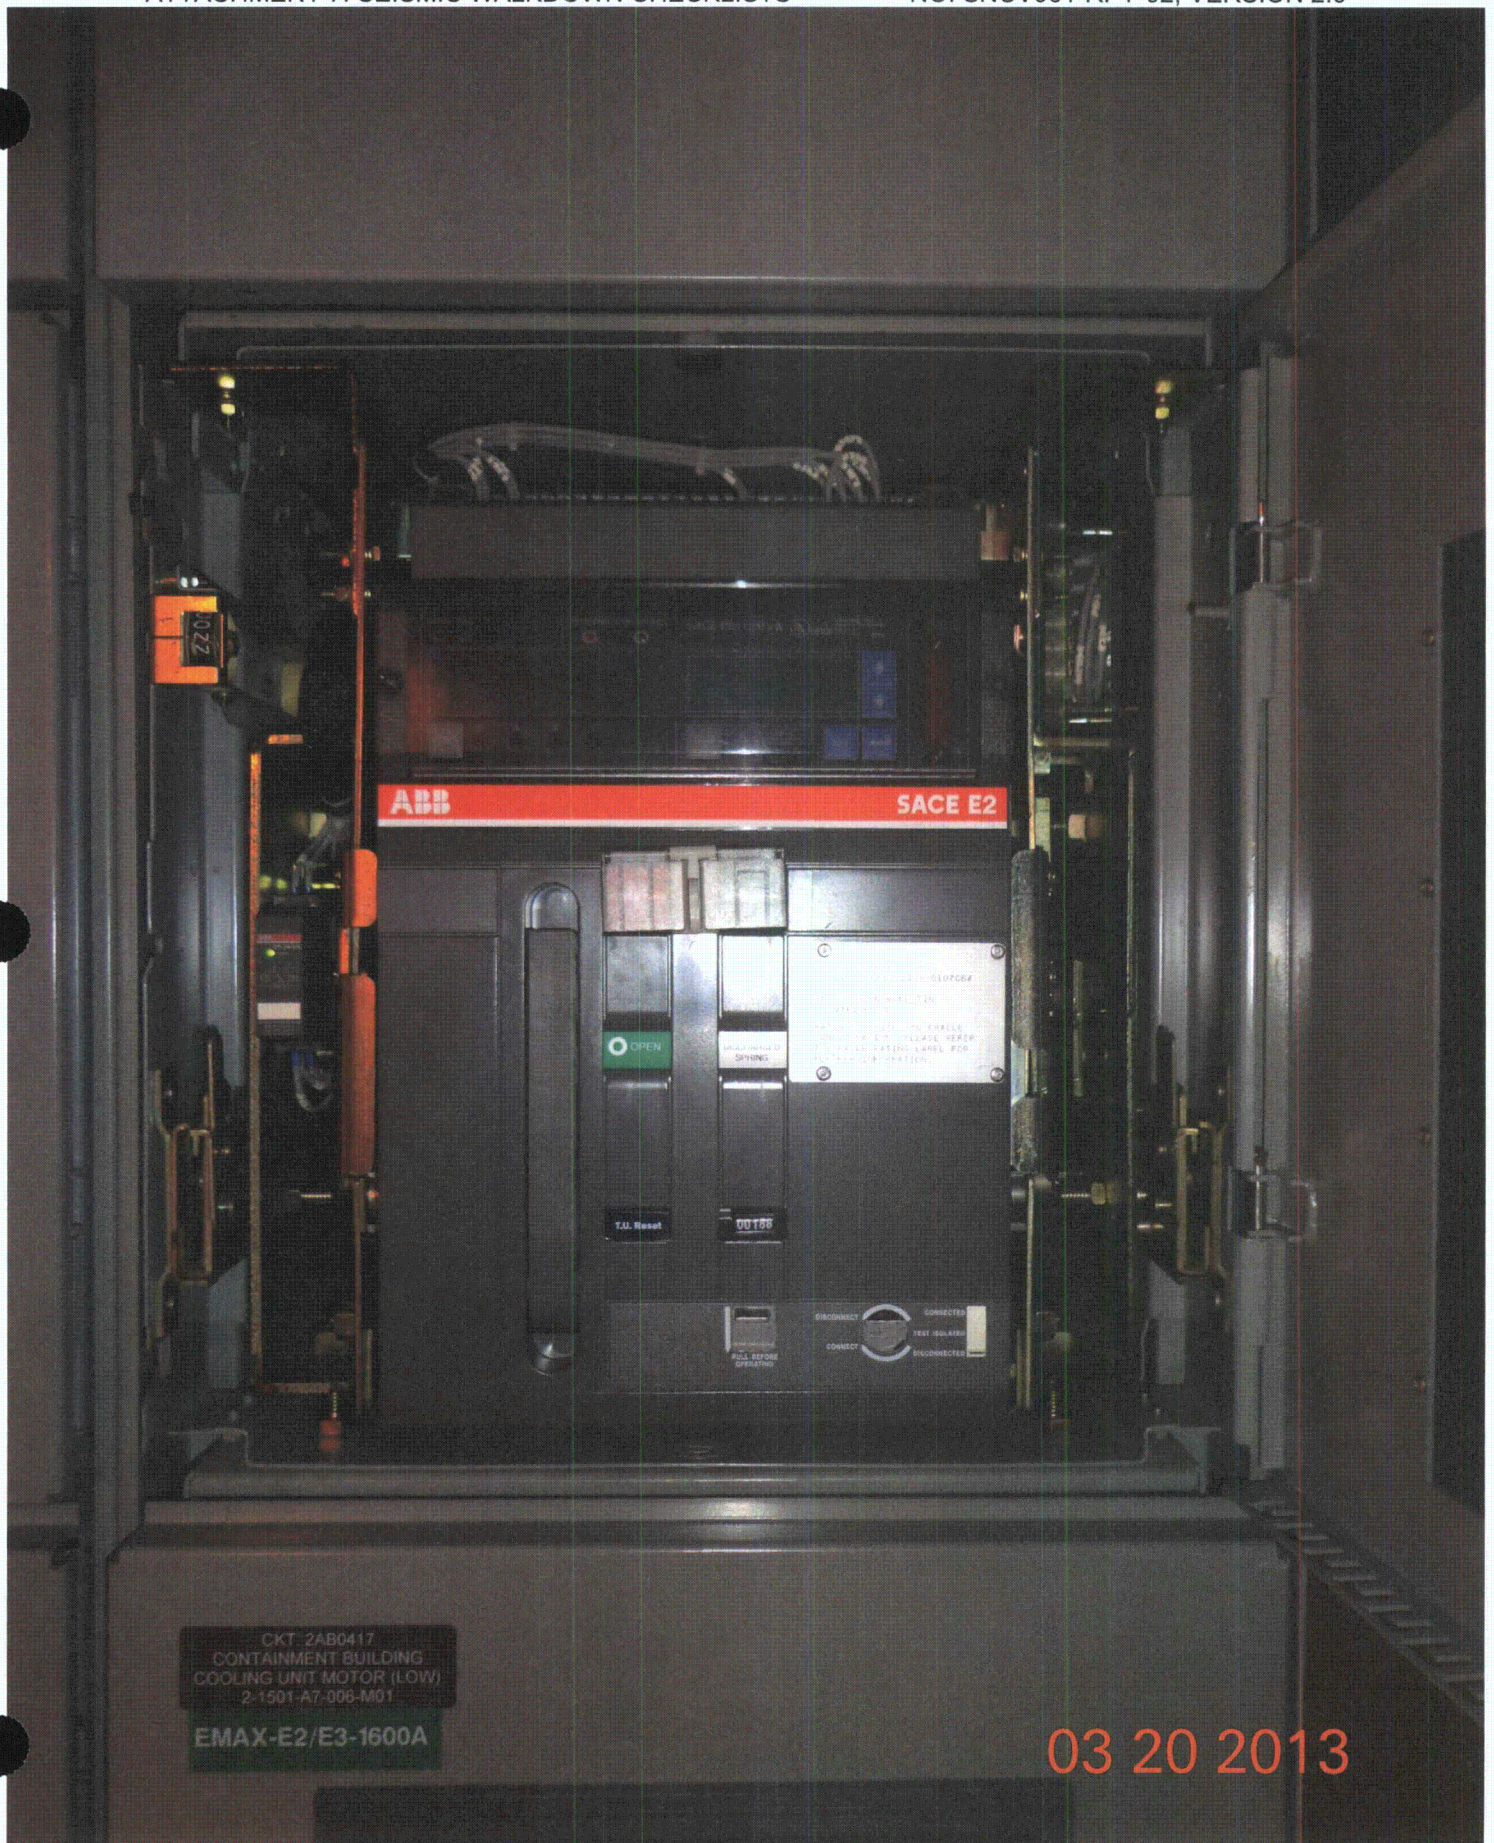
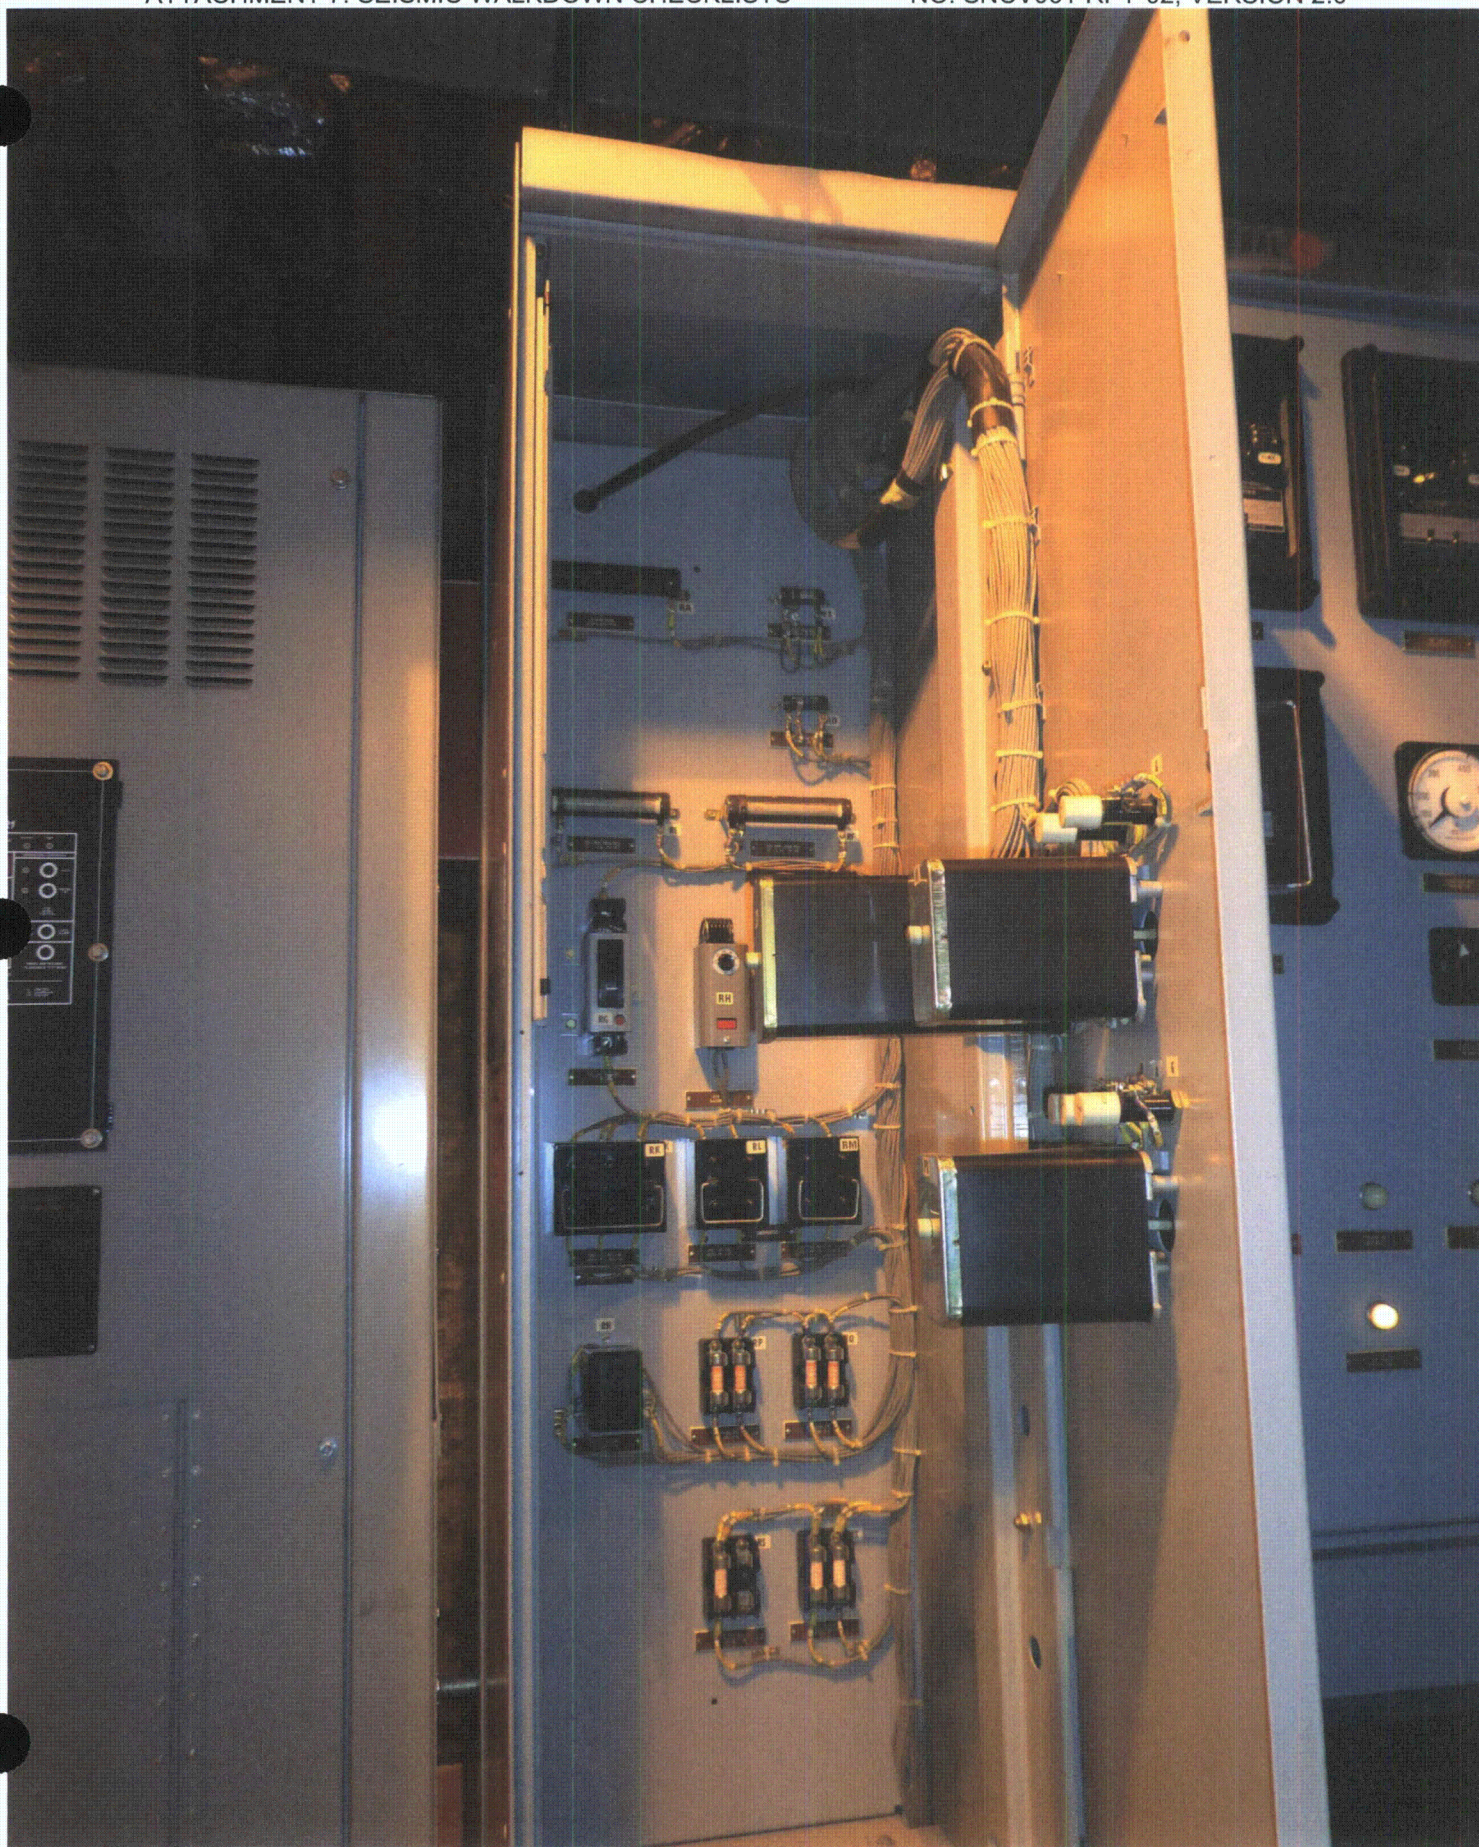
A visual inspection of the internal components of this cabinet was performed on 3/22/13 to check for other adverse conditions. In particular, the SWE team looked to verify internal components were adequately secured, any necessary fasteners connecting adjacent cabinets were in place, as well as searching for missing or damaged bolts/screws/connections. No adverse conditions were found.

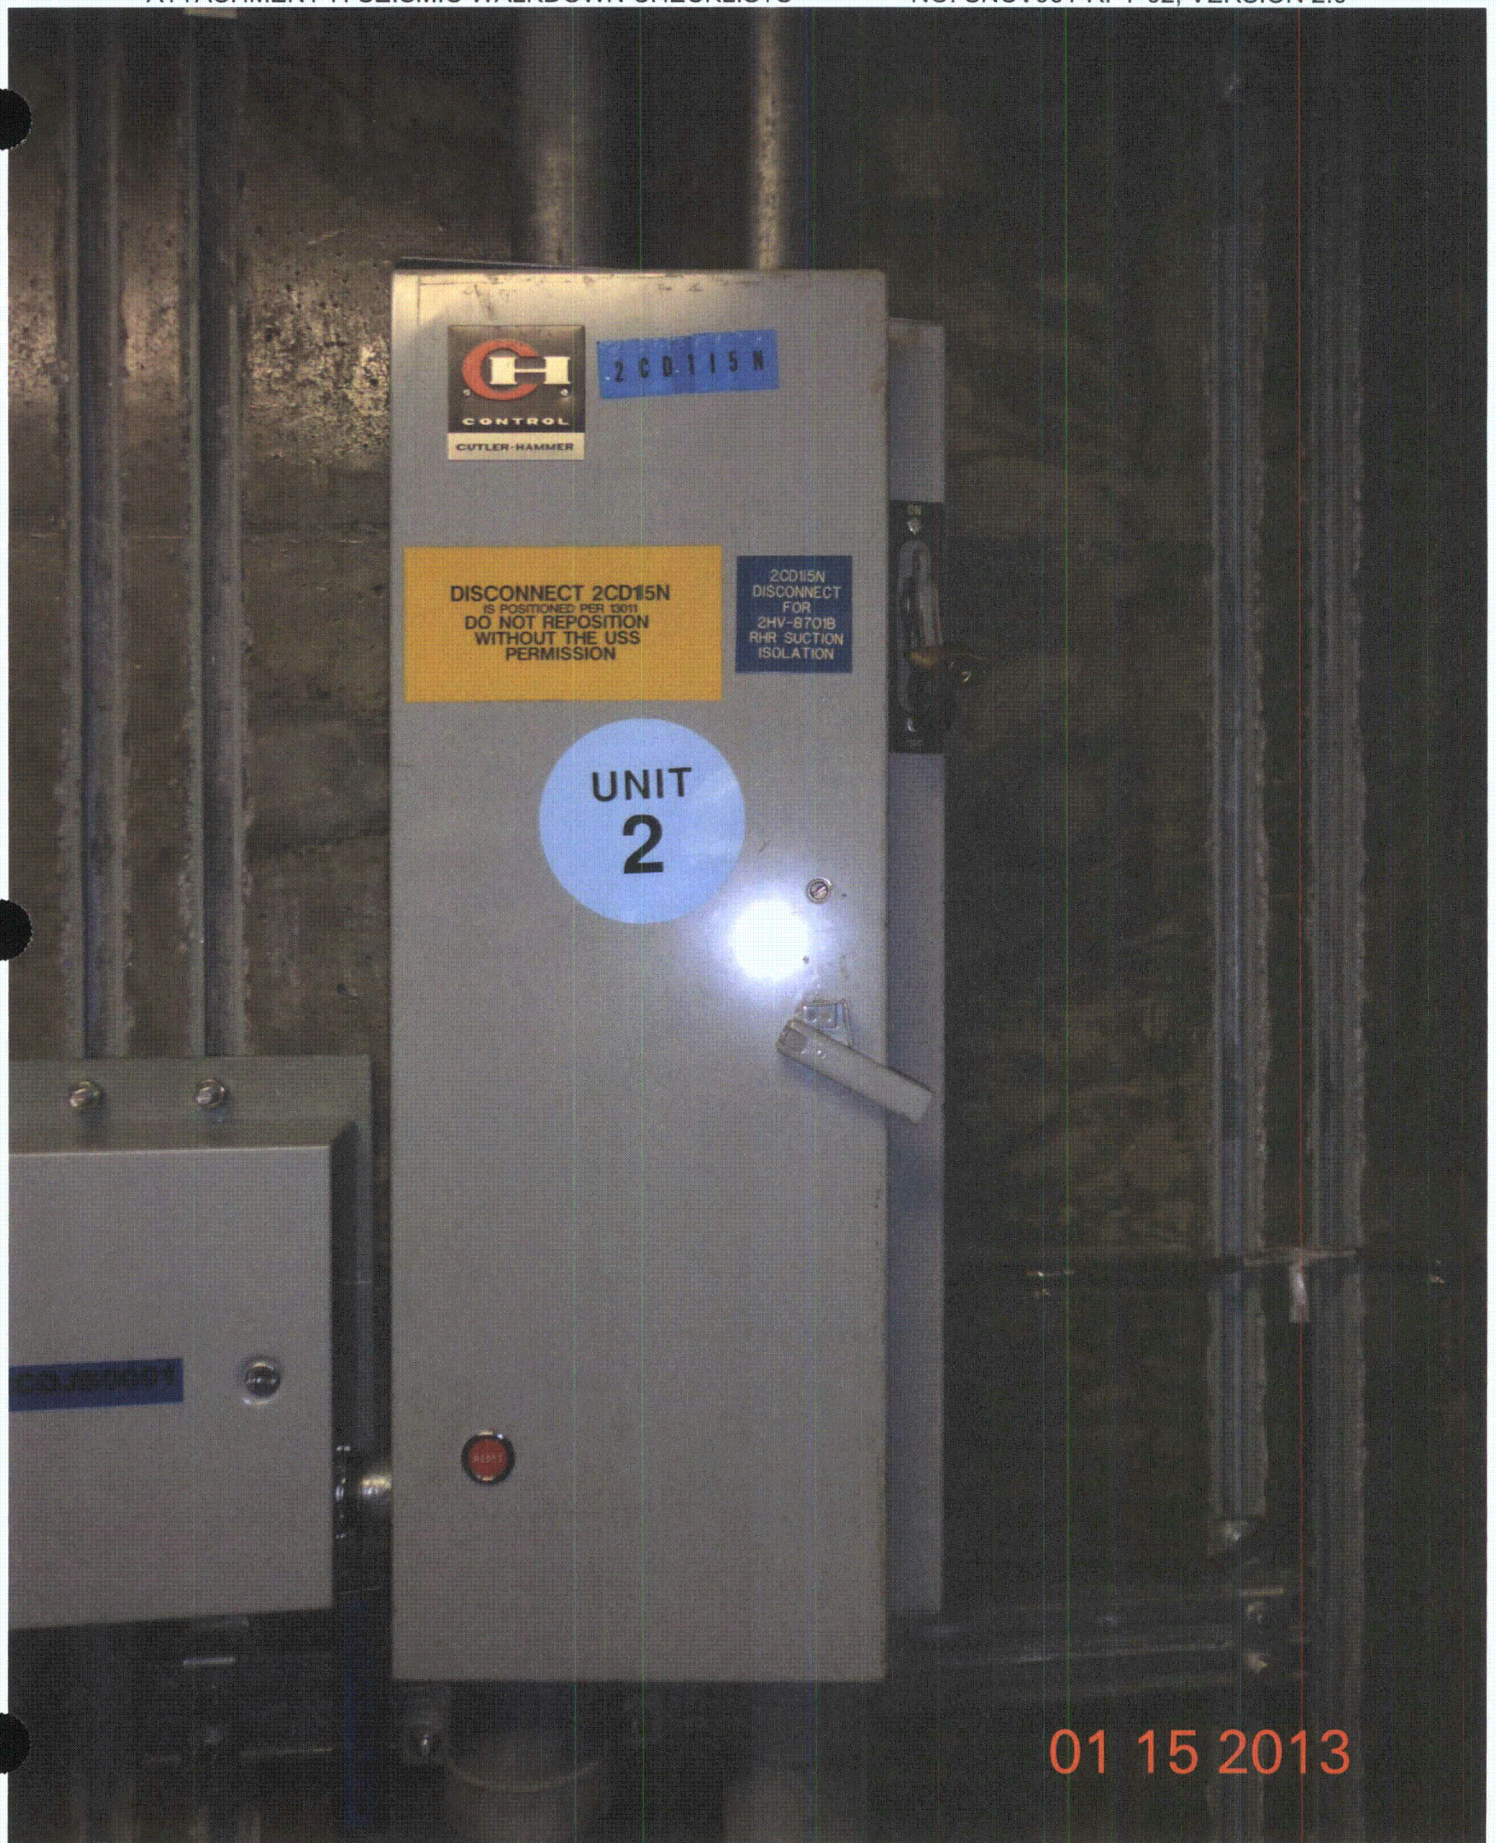
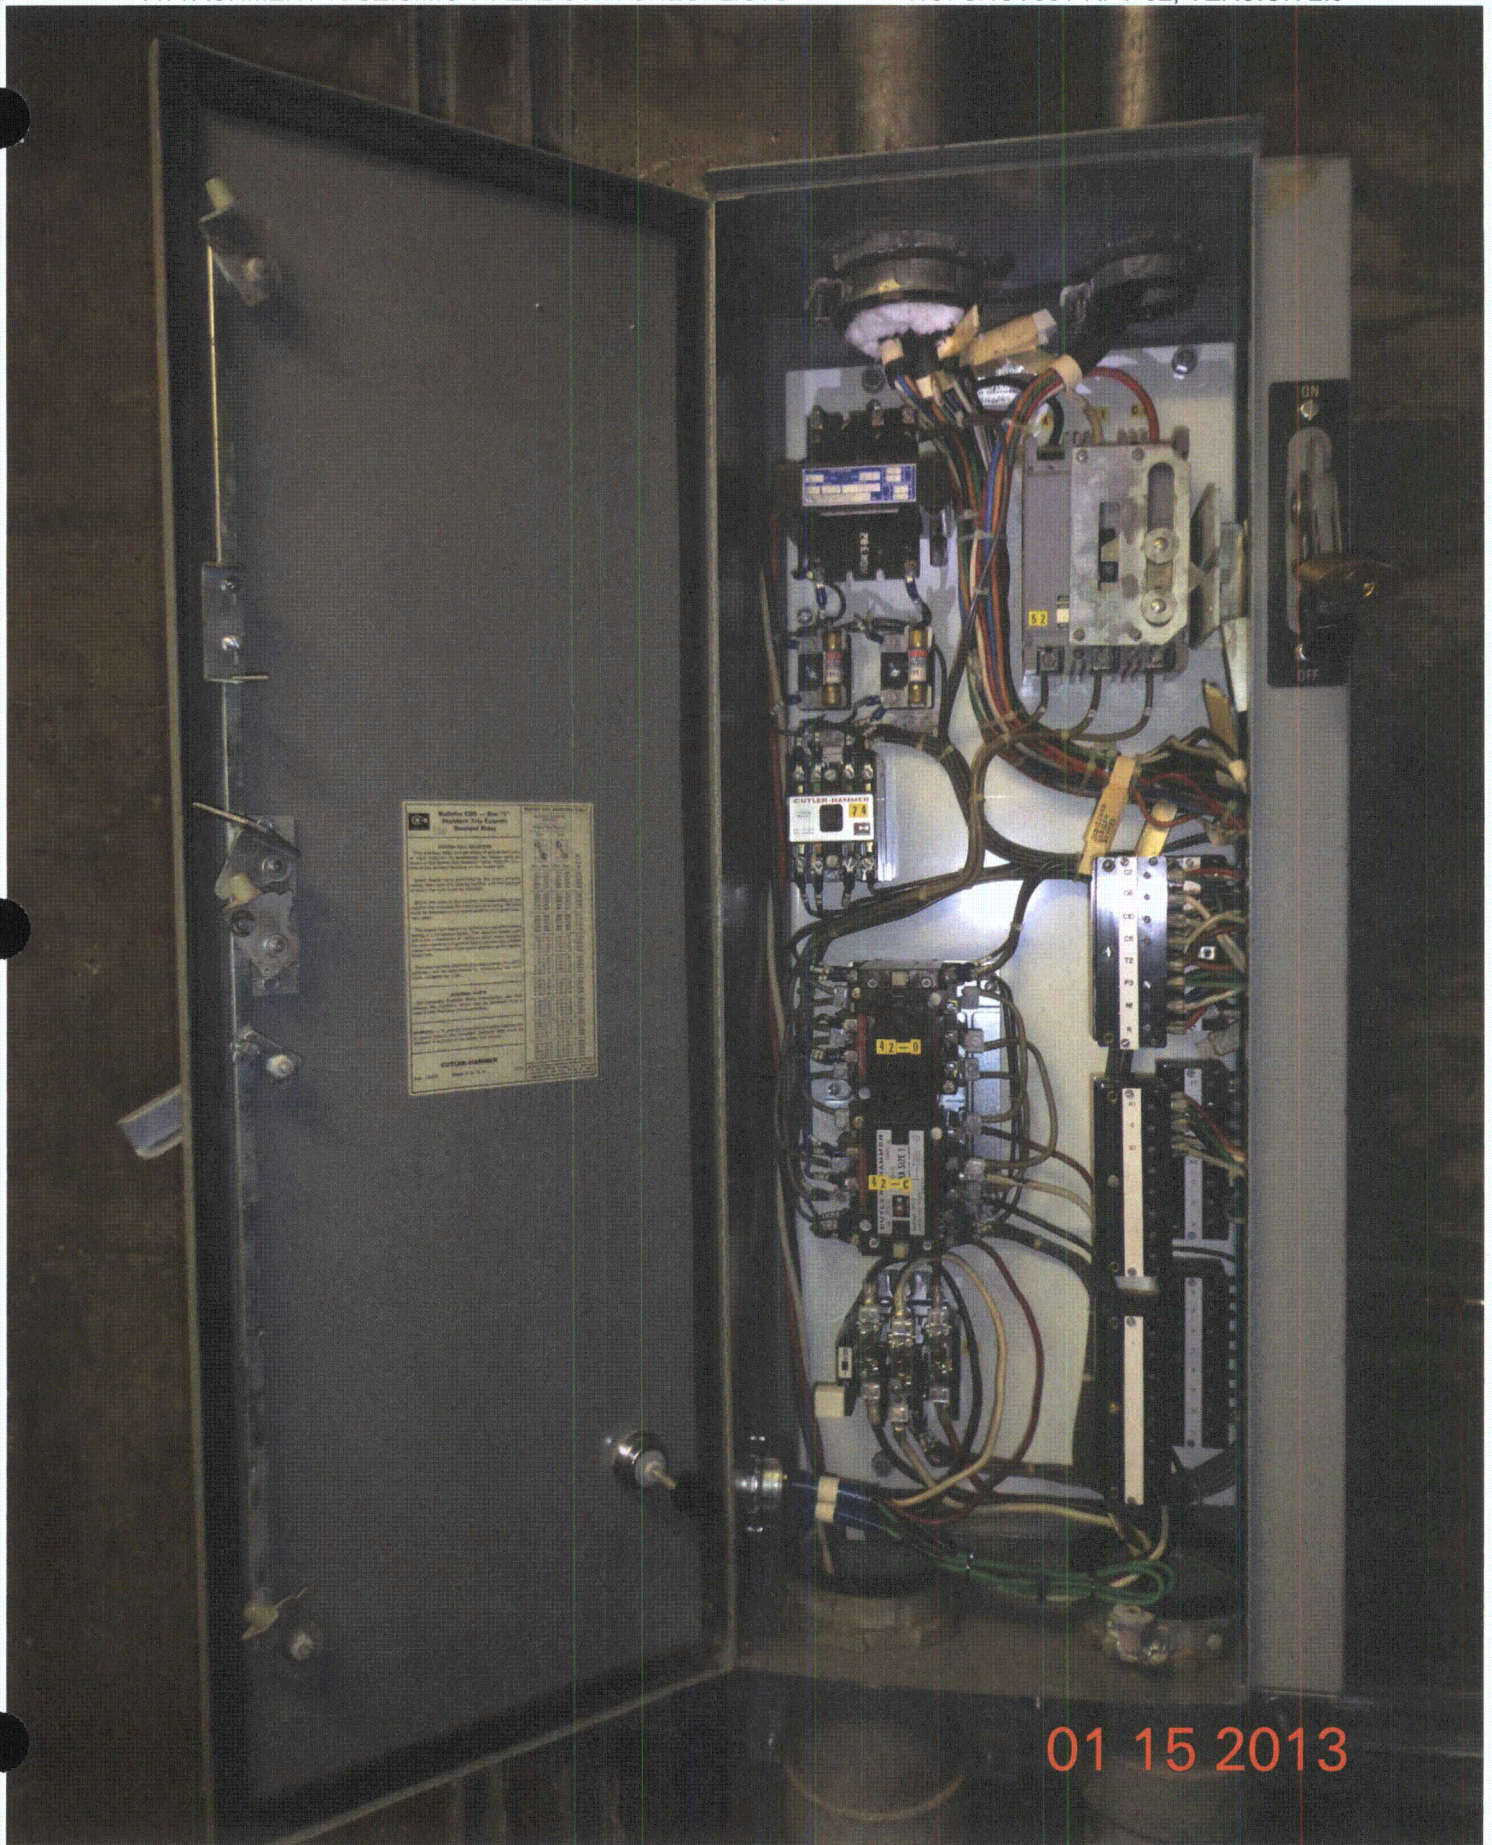
11. Have you looked for and found no other seismic conditions that could adversely affect the safety functions of the equipment? A visual inspection of the internal components of this cabinet was performed on 1/15/2013 to check for other adverse conditions. In particular, the SW E team looked to verify internal components were adequately secured, any necessary fasteners connecting adjacent cabinets were in place, as well as searching for missing or damaged bolts/screws/connections. No adverse conditions were found.

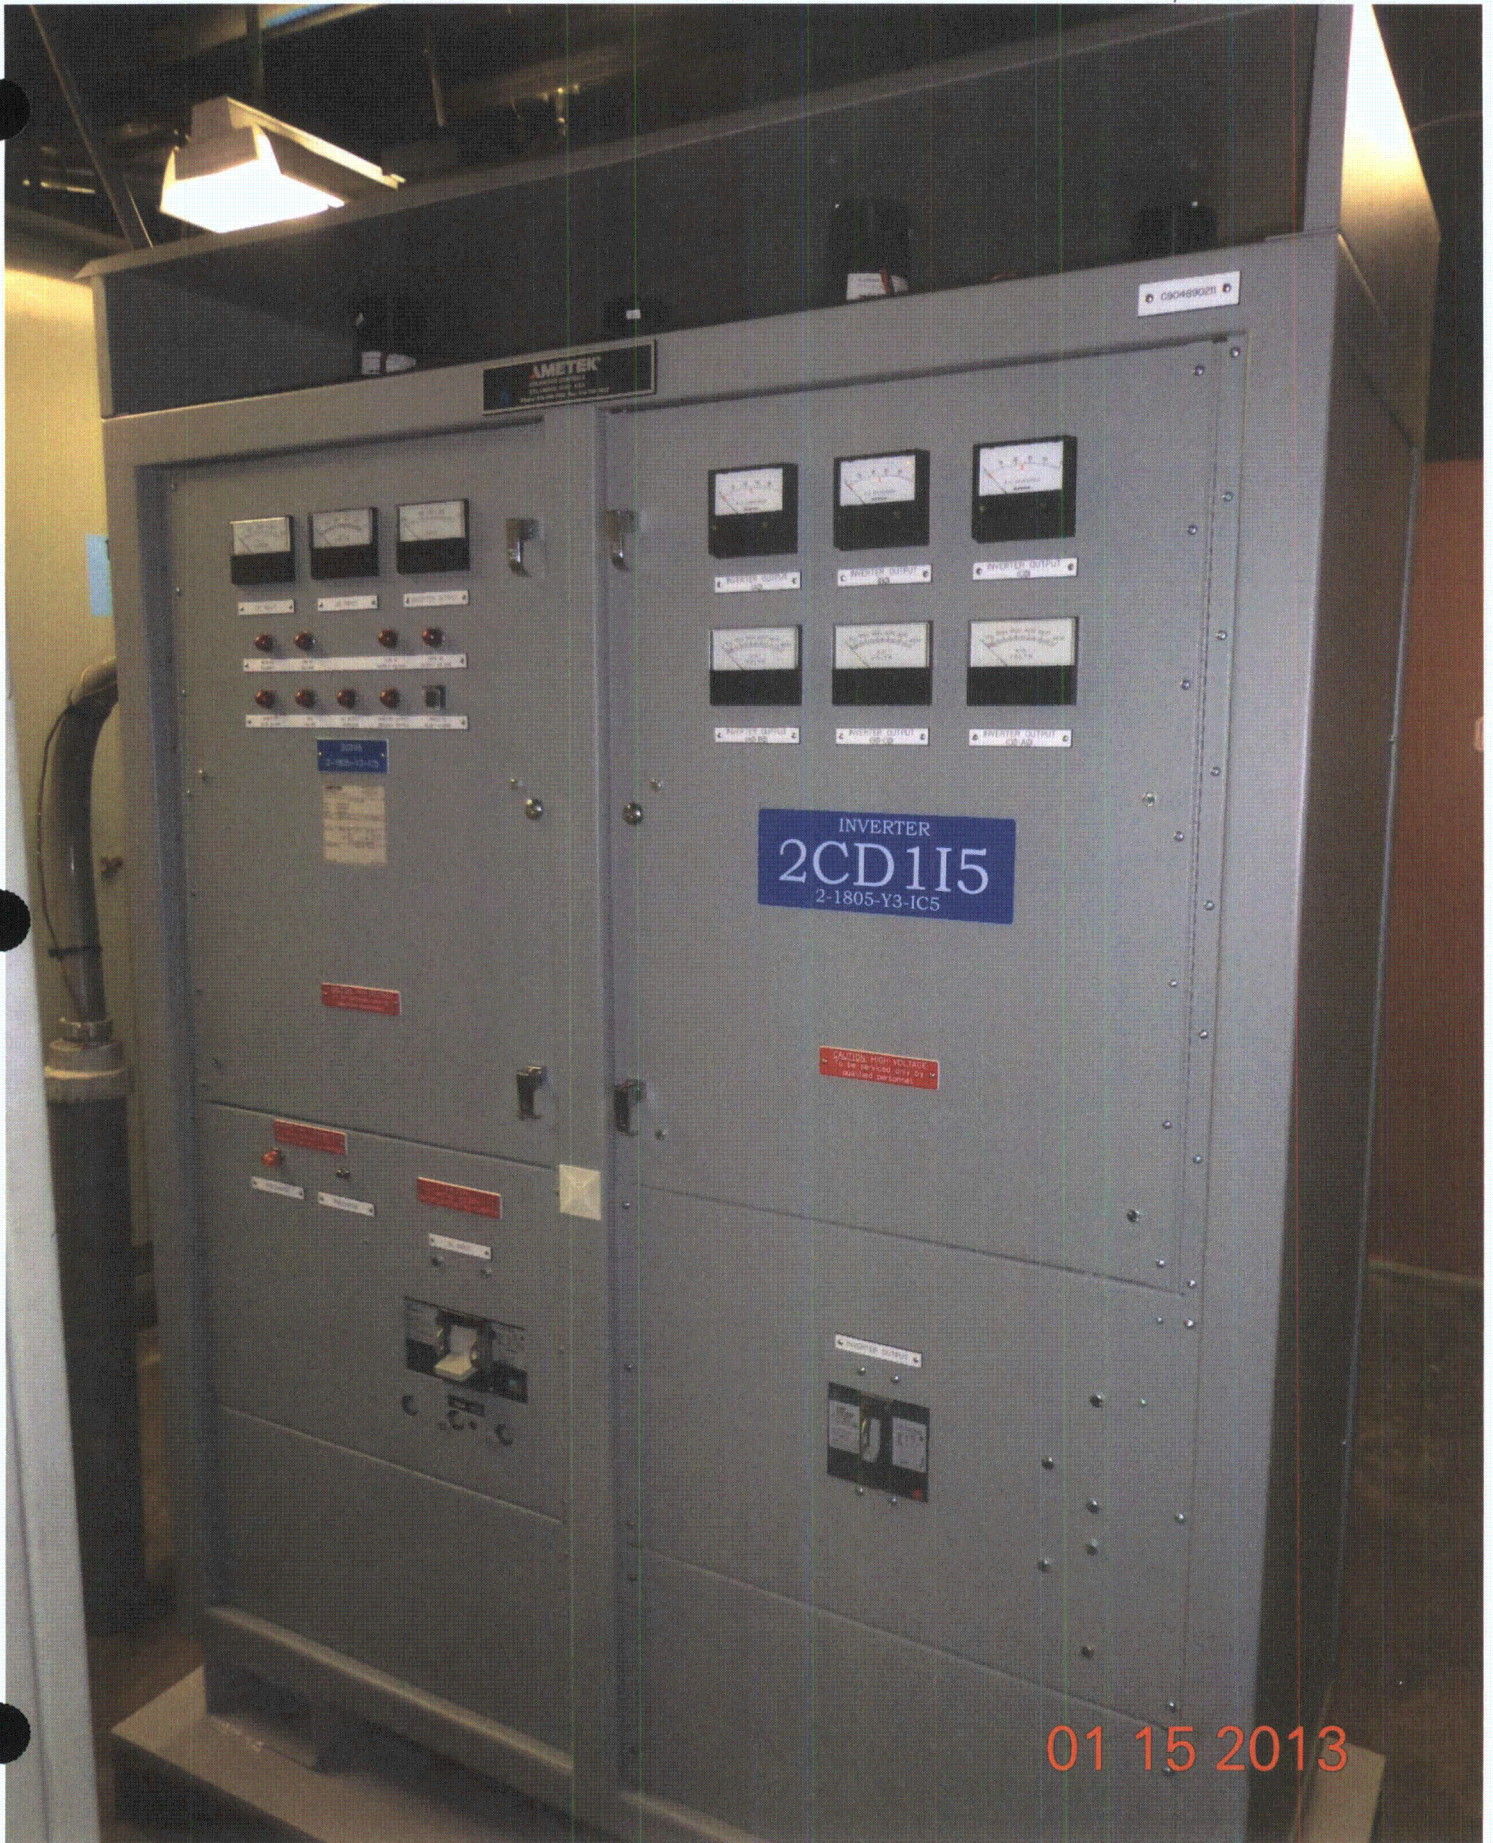
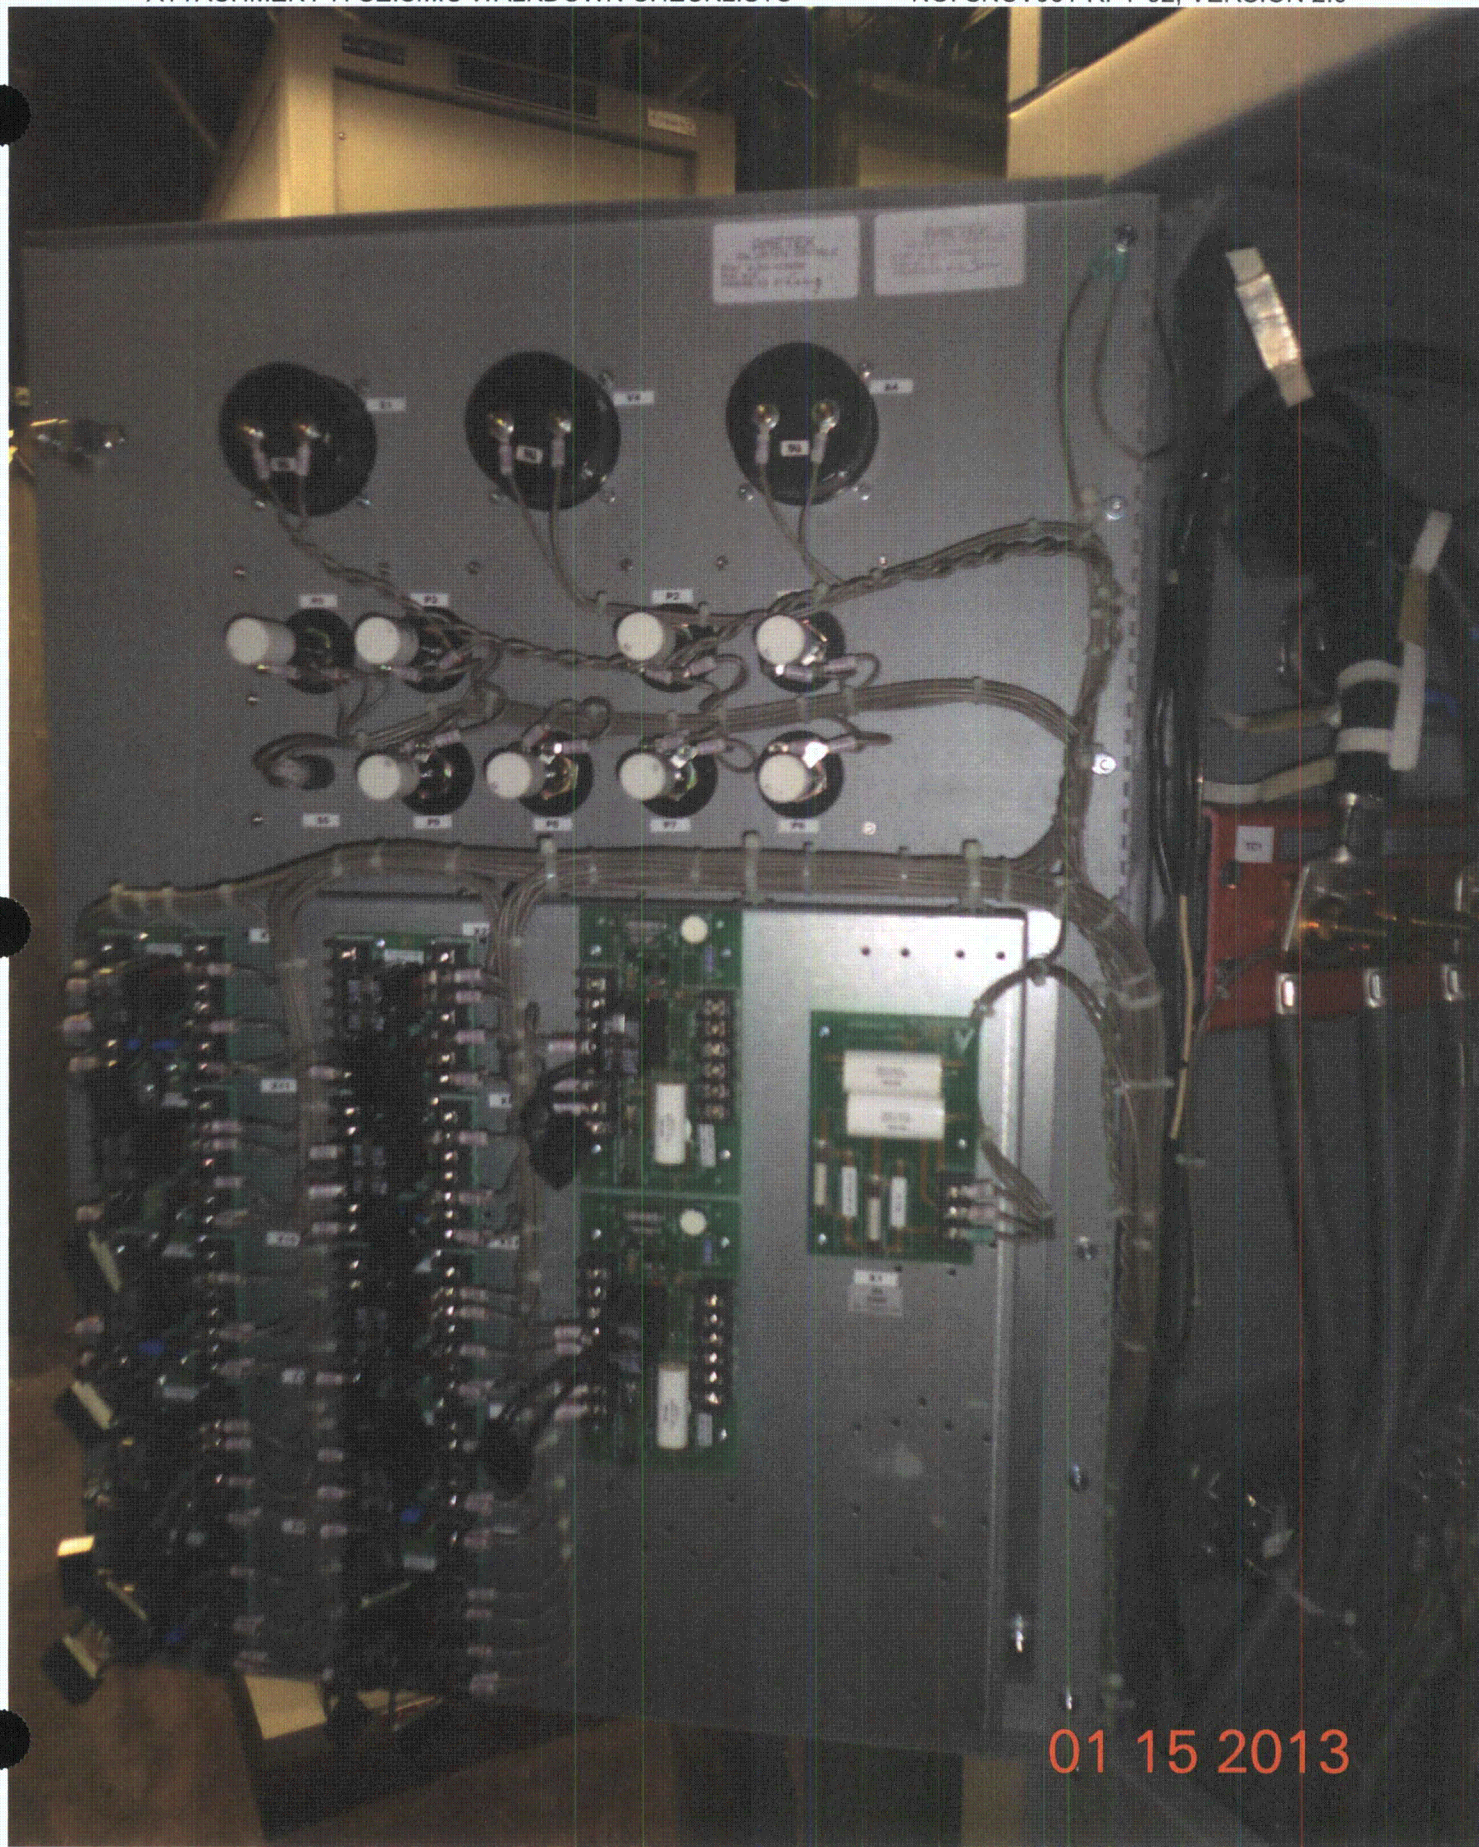
This cabinet is in perfect condition given that it was recently installed.
